WATER QUALITY MEMORANDUM

Utah Coal Regulatory Program

RE: 2008 Second Quarter Water Monitoring, Genwal Resources, Inc., Crandall Canyon Mine, WQ08-2, Task ID #3139

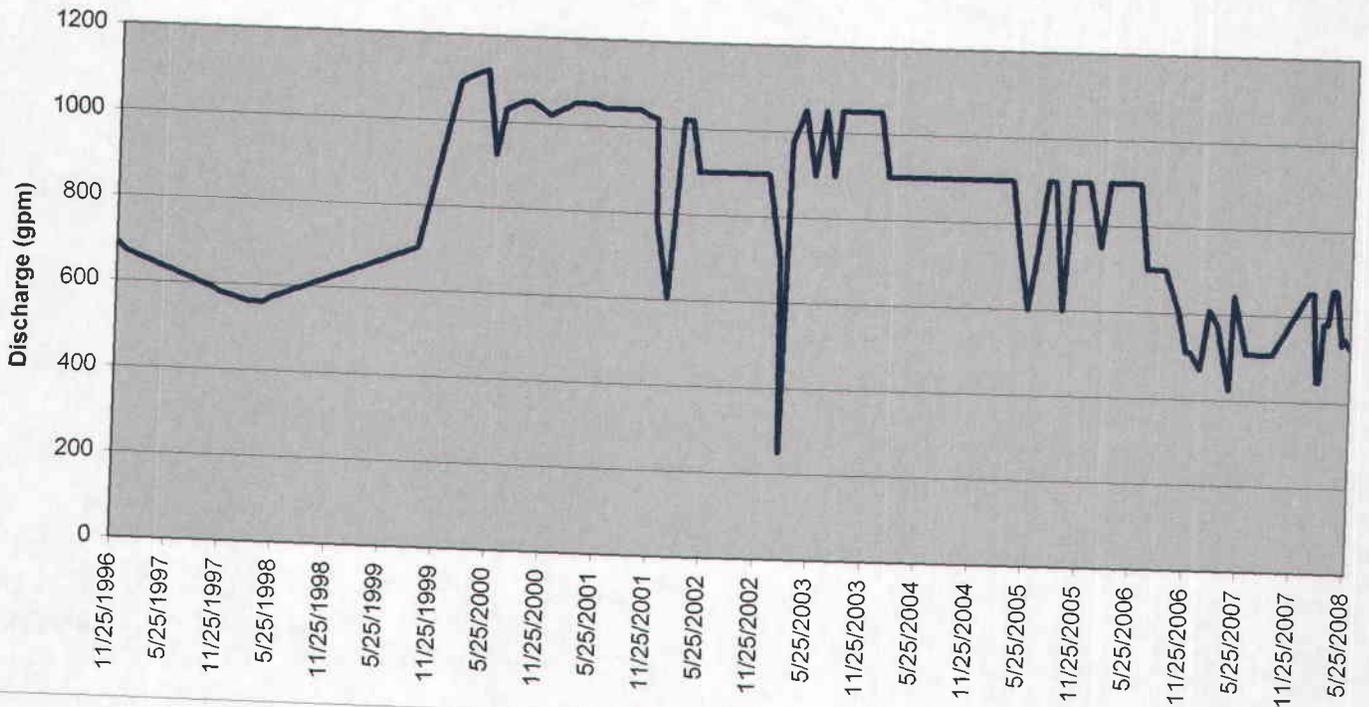
Mine Water Discharge (Outfall 002)

Outfall 001 did not discharge during the 2nd quarter of 2008. Outfall 002 discharged an average of 585.8 gallons per minute (gpm) based on 5 sampling events conducted during the quarter.

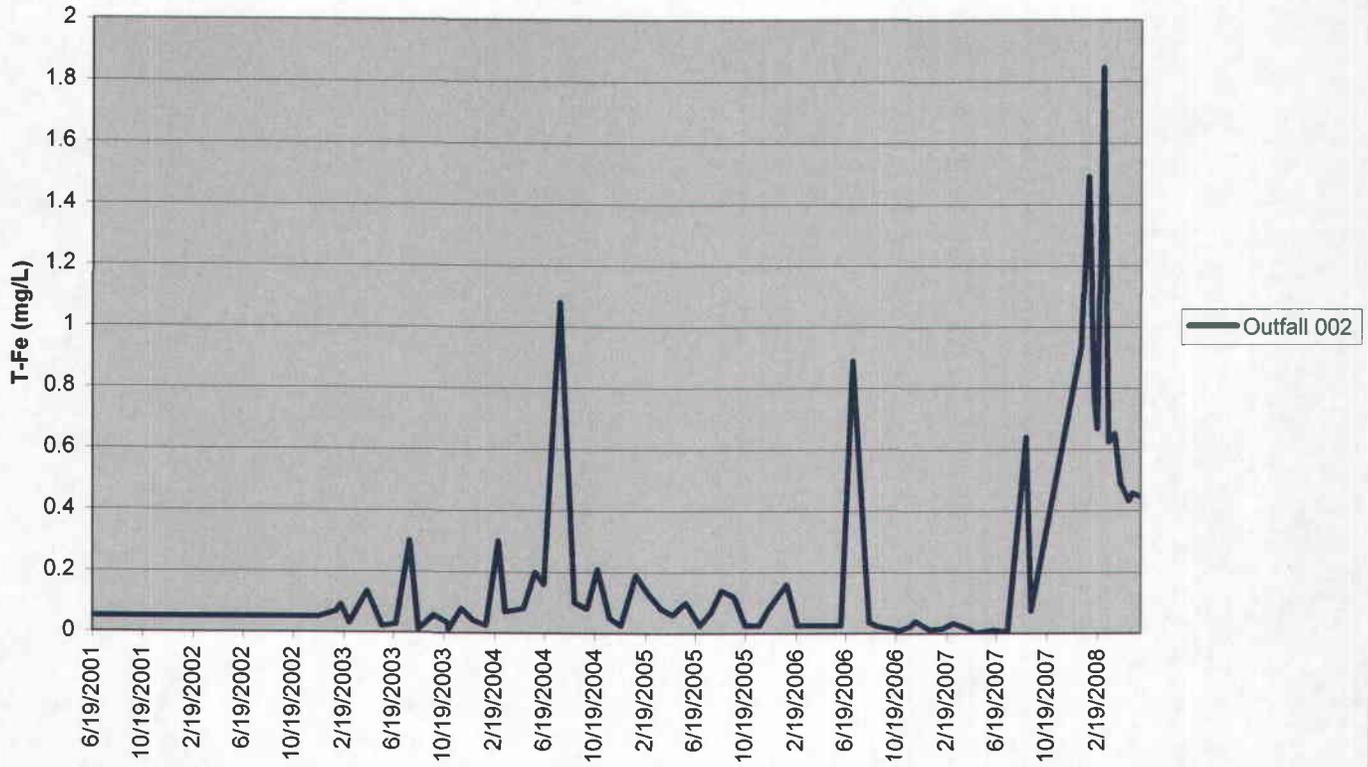
Total Iron (T-Fe): Outfall 002

During the 1st quarter of 2008, 4 of 6 sampling events produced analytical results that were outside the compliance levels established by the Permittee's UPDES permit. The compliance level for T-Fe (as established by the UPDES discharge permit) is 1 part-per-million (ppm). The sampling events of January 28th and March 3rd of 2008 produced T-Fe analytical results of 1.491 ppm and 1.85 ppm respectively for T-Fe. The compliance level for TDS (as established by the UPDES discharge permit) is 1,200 ppm. The sampling events of January 10th and January 28th of 2008 produced analytical results of 1,523 ppm and 1,108 ppm respectively for TDS.

However, during the 2nd quarter of 2008 (based upon 5 sampling events of the mine-water discharge), no analytical results were obtained for either TDS or T-Fe that were outside of the compliance levels established in the UPDES discharge permit (1.0 ppm for T-Fe and 1,200 ppm for TDS).

What's causing the fluctuations of TDS and T-Fe levels within the mine-water discharge is currently unknown. TDS and T-Fe levels obtained from the lower Crandall Creek flume (Site LOF-1) were both well within UPDES compliance levels (575 mg/L and 0.136 respectively).

Continued data collection and monitoring of the mine-water discharge will be necessary to determine if a trend is emerging relative to TDS and T-Fe. The data will be essential in

determining whether the mine-water discharge remains in compliance with the UPDES permit.
