WATER QUALITY MEMORANDUM

Utah Coal Regulatory Program

March 15, 2010

RE: 2009 Second Quarter Water Monitoring, Genwal Resources, Inc., Crandall Canyon Mine, Permit & Tracking #3335

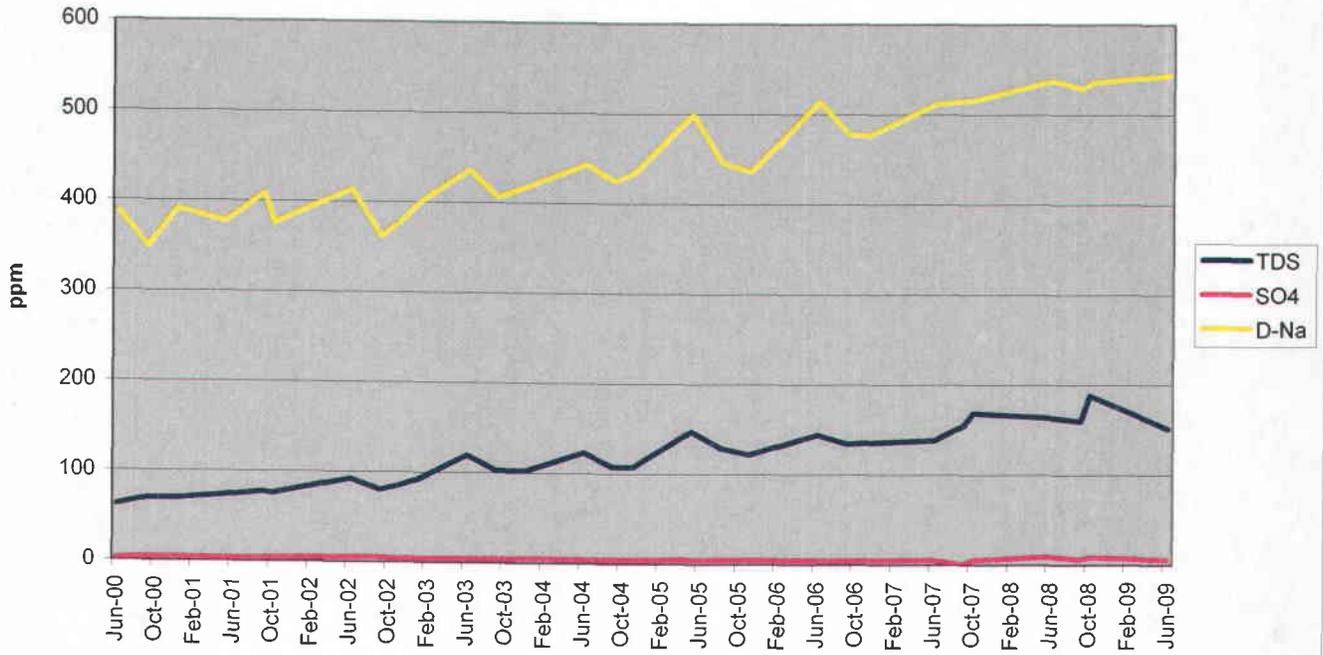
Spring SP-58 Water Quality

Spring SP-58 had produced several analytical results that were outside 2 standard deviations: D-Na (2.72 standard deviations), SO₄ (2.41 standard deviations) and TDS (2.01 standard deviations) during the 4th Quarter of 2008. However, the site was inaccessible due to snow conditions during the 1st quarter of 2009.

Analytical results obtained during the 2nd quarter of sampling for 2009 produced D-NA, SO₄ and TDS values that were again within 2 standard deviations as established by the data set. At this time, the exact cause for the elevated values during the 4th quarter of 2008 is unknown. Particular attention will be paid to this site and these parameters in future quarters.

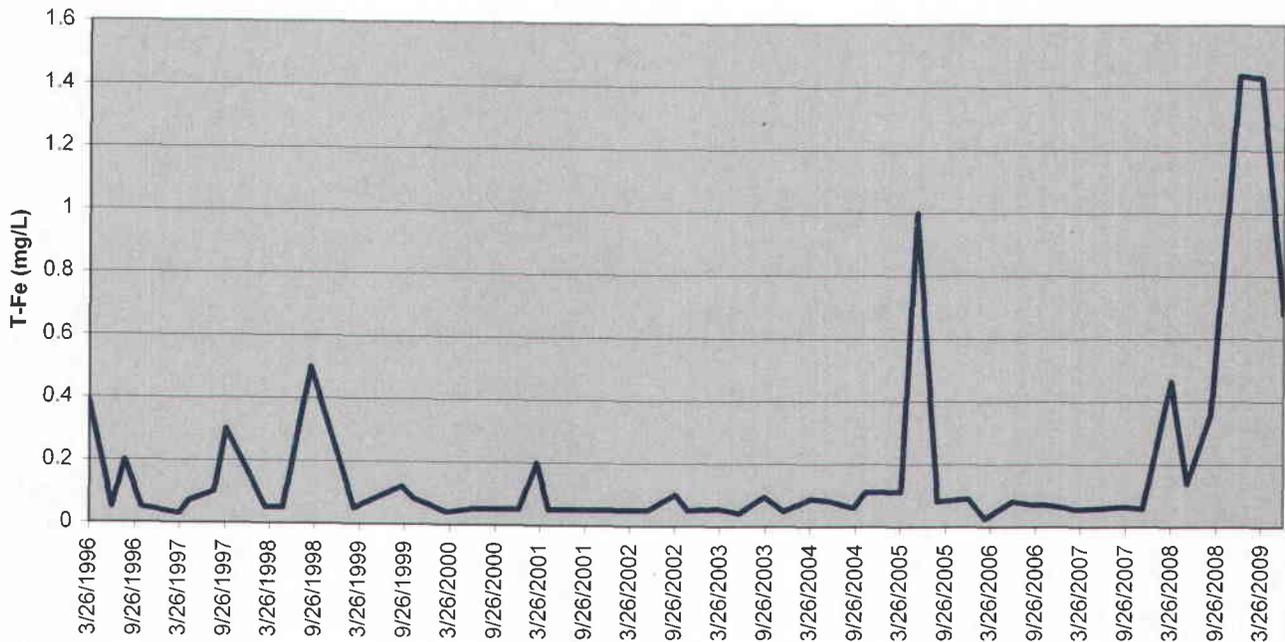
Crandall Creek Lower Flume (LOF-1): Total Iron Levels

T-Fe levels measured below the mine facilities within Crandall Creek (Site LOF-1) dropped for the first time in two quarters. The previous two quarters had shown elevated levels of T-Fe (1.438 ppm 4th Qtr. 2008 and 1.432 pm 1st Qtr. 2009). However, the T-Fe levels obtained from Site LOF-1 within Crandall Creek for the 2nd quarter of 2009 was 0.679 ppm.

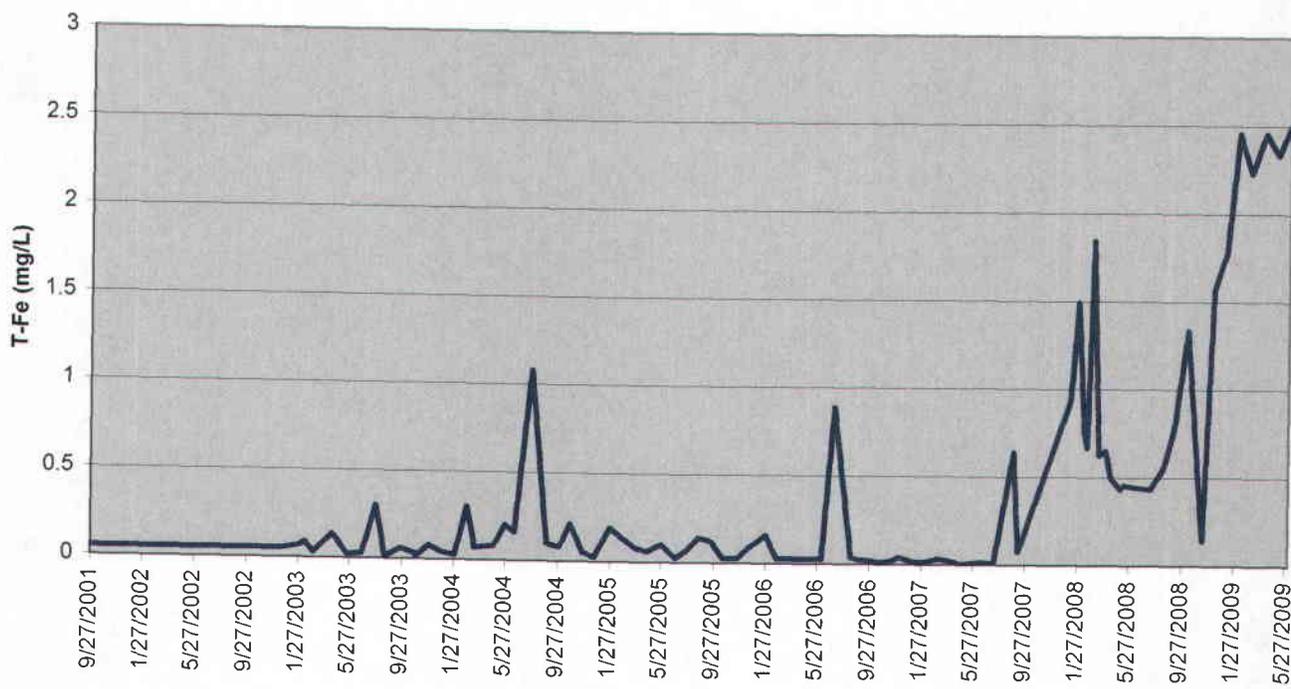
Total Iron (T-Fe): Outfall 002

The results from the 4th quarter of 2008 again produced levels of TDS below the UPDES standard of 1,200 ppm. However, T-Fe values had increased to levels beyond the 1.0 ppm range established in the UPDES permit (1.59 and 1.335 ppm respectively for 4th qtr., 2008).

Mine-water analytical results for the 1st quarter of 2009 were again a mixed bag of compliant TDS levels with elevated T-Fe levels (1.783 ppm, 2.454 ppm and 2.23 ppm for T-Fe).

The sampling results for the 2nd quarter of 2009 followed the same pattern as produced during the previous quarter: compliant TDS levels combined with three samples producing T-Fe levels well over the 1.0 ppm criteria established in the UPDES permit. Sampling events on April 6th, May 6th and June 3rd produced T-Fe levels of 2.455 ppm, 2.331 ppm and 2.501 ppm respectively.

Continued data collection and monitoring of the mine-water discharge will be necessary to evaluate the T-Fe levels.

Continue to work with the Permittee in identifying a mine-water treatment system that will effectively lower the T-Fe concentrations to compliant UPDES levels.

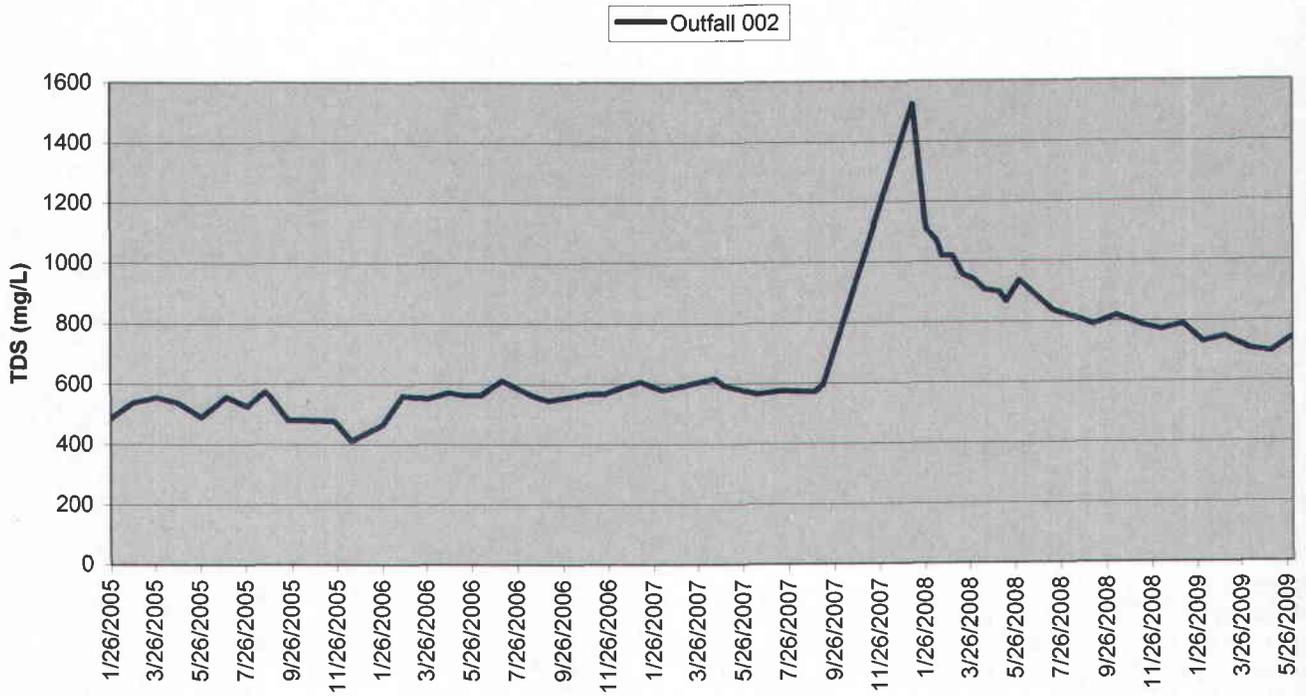
Total Dissolved Solids (TDS): Outfall 002

Three months following the sealing of the north portals, the mine water discharge began to exhibit fluctuating levels of T-Fe and TDS at UPDES Outfall 002. The 1st quarter of 2008 produced analytical results that were outside the Permittee's UPDES compliances levels for both TDS and T-Fe.

However, during the 2nd and 3rd quarters of 2008, analytical results obtained for TDS and T-Fe from the mine-water discharge were within the compliance levels established by the UPDES discharge permit (1.0 ppm for T-Fe and 1,200 ppm for TDS).
