Inspection Report

Permit Number:	C0150032
Inspection Type:	PARTIAL
Inspection Date:	Tuesday, June 26, 2012
Start Date/Time:	6/26/2012 9:30:00 AM
End Date/Time:	6/26/2012 2:30:00 PM
Last Inspection:	Wednesday, June 20, 2012

Permitee: **GENWAL RESOURCES INC**
 Operator: **GENWAL RESOURCES INC**
 Site: **CRANDALL CANYON MINE**
 Address: **PO BOX 910, EAST CARBON UT 84520-0910**
 County: **EMERY**
 Permit Type: **PERMANENT COAL PROGRAM**
 Permit Status: **ACTIVE**

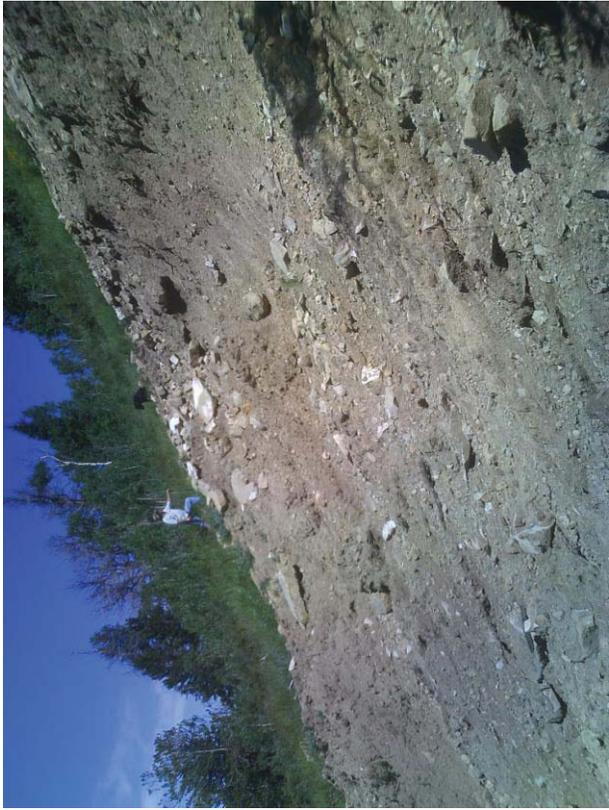
The slide area below pad #6 on East Mountain still looks pretty raw. The excelsior logs that were installed last year have retained sediment and helped to establish vegetation at the head of the cut. The site was hand seeded last year, but little growth has resulted. A comparison of 2011 and 2012 photos show that the slide has not enlarged. (2011 and 2012 photos are attached.) To further stabilize the site, hand crews could install excelsior logs on the contour every 15 ft. down the length of the slide to create mini terraces, followed by hand seeding.

2011 slide head cut (looking west)

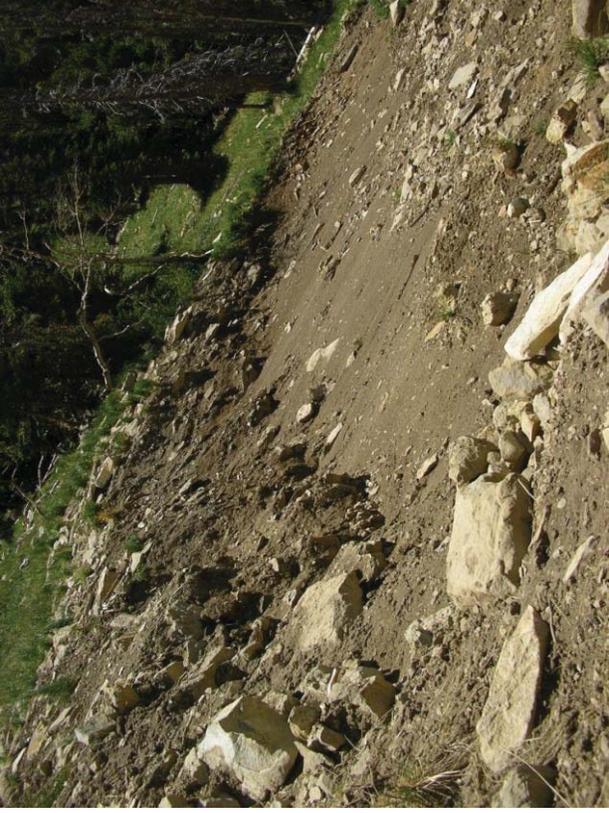
2012 slide head cut (looking east)

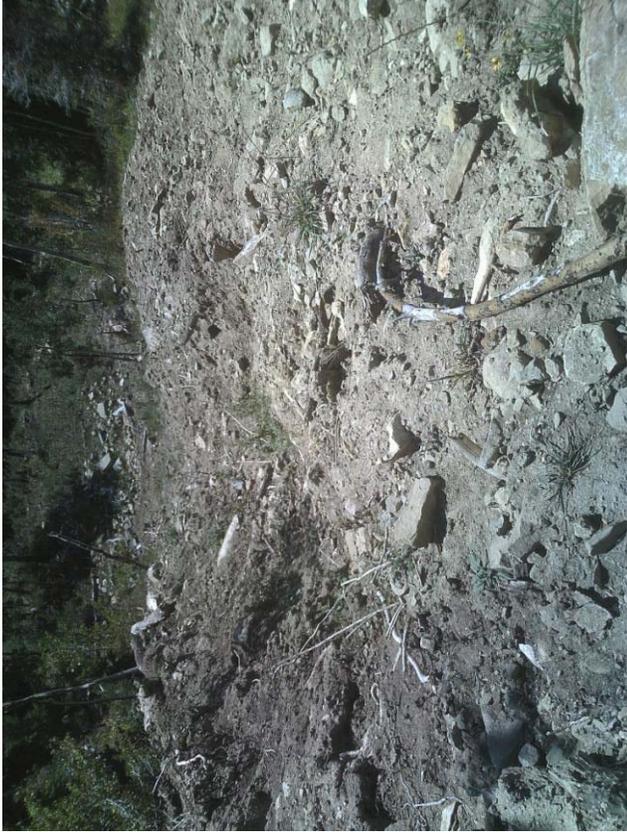
2011

Looking down the length of the slide (approximately 150 ft.)

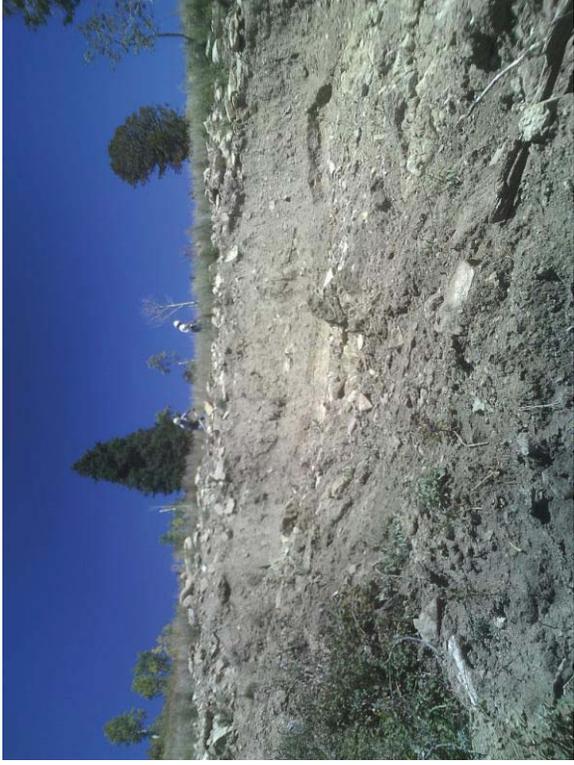
2011, Men installing excelsior logs at head of slide.

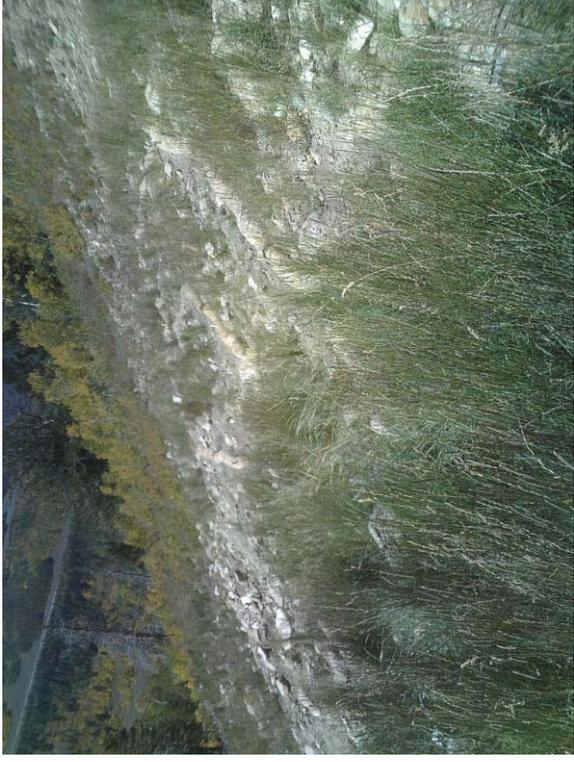
2011, 3 excelsior logs at head of slide

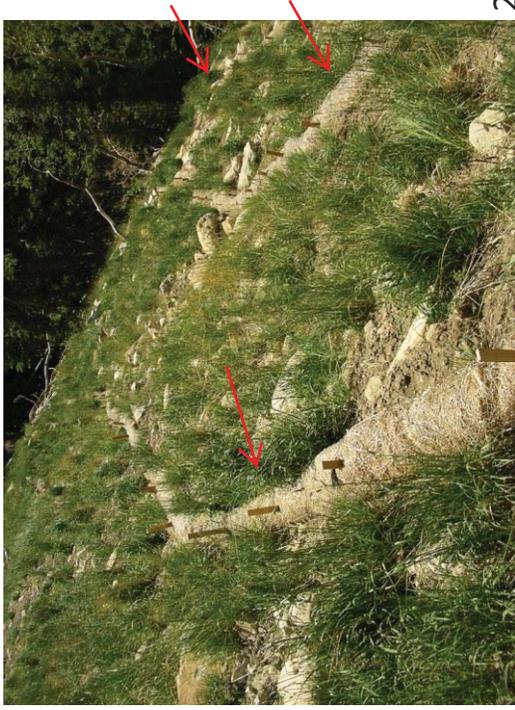
2012, 3 excelsior logs area visible in this photo.
