Inspection Report

Permit Number:	C0150032
Inspection Type:	TECHNICAL
Inspection Date:	Tuesday, July 17, 2012
Start Date/Time:	7/17/2012 9:00:00 AM
End Date/Time:	7/17/2012 1:30:00 PM
Last Inspection:	Tuesday, June 26, 2012

Permitee: **GENWAL RESOURCES INC**
 Operator: **GENWAL RESOURCES INC**
 Site: **CRANDALL CANYON MINE**
 Address: **PO BOX 910, EAST CARBON UT 84520-0910**
 County: **EMERY**
 Permit Type: **PERMANENT COAL PROGRAM**
 Permit Status: **ACTIVE**

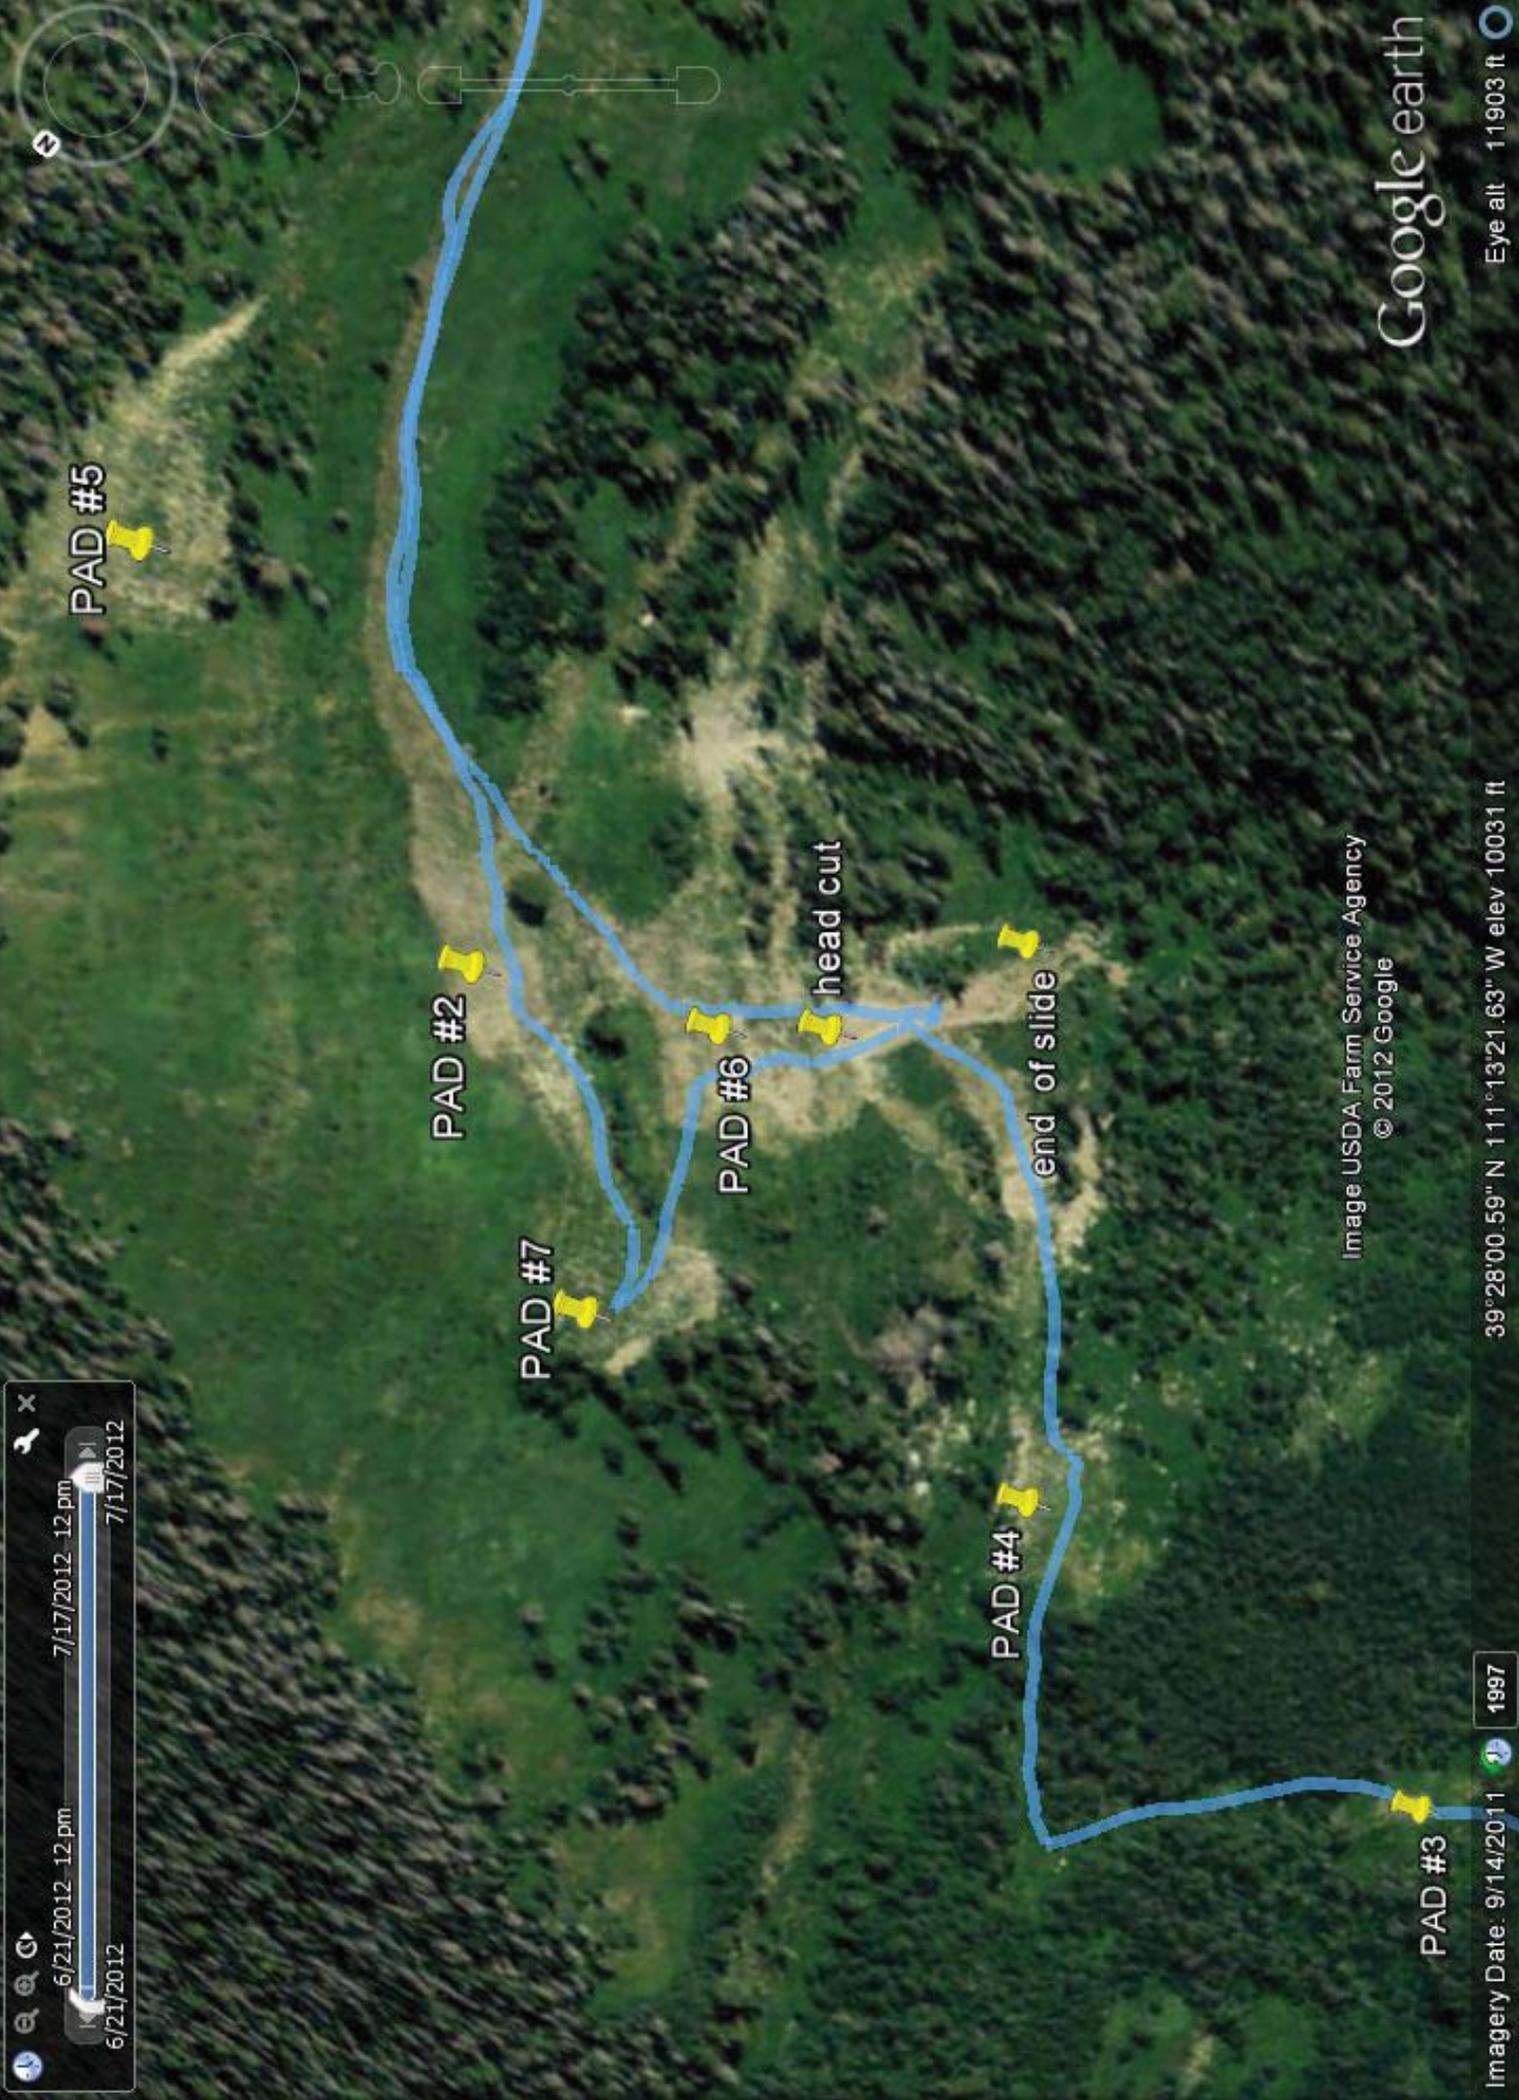
We observed the surface failure below pad #6. (Please refer to Attachment #5 of Appendix 5-22A for pad locations.) This slide is approximately 150 ft. in length and approximately 30 ft. wide. At its head, the cut is 15 ft. high. The soil at the head cut rests on fractured sandstone and is unstable. Last fall, three rows of excelsior logs were installed above the head cut to deflect surface flow away from the cut. There has been no movement since the original slide, but last year there was little snow pack. Loose sediment continues to move down the slide and needs to be stabilized with excelsior logs or wood straw and the slide area needs to be seeded. SITLA representatives are of the opinion that deflecting water away from the head cut may buy time for vegetation to establish on the cut and slide area. Their recommendation was for excelsior logs every 10 - 15 ft. up the slope for a distance of approximately 150 ft. (to the top of the reclaimed pad #6 disturbance). Logs should be placed on a 2% slope from the contour to direct surface flow to the undisturbed vegetation on either side of the cut (measuring from the center of the cut that's a distance of approximately 100 ft. to either side of center). The location of the slide is shown on the attached google earth map.

6/21/2012 12:00 pm
6/21/2012 12:00 pm
7/17/2012 12:00 pm
7/17/2012 12:00 pm
