WATER QUALITY MEMORANDUM

Utah Coal Regulatory Program

October 1, 2012

RE: First Quarter of 2012 Water Monitoring, Genwal Resources, Inc., Crandall Canyon Mine, C015-0032 Task ID #4019

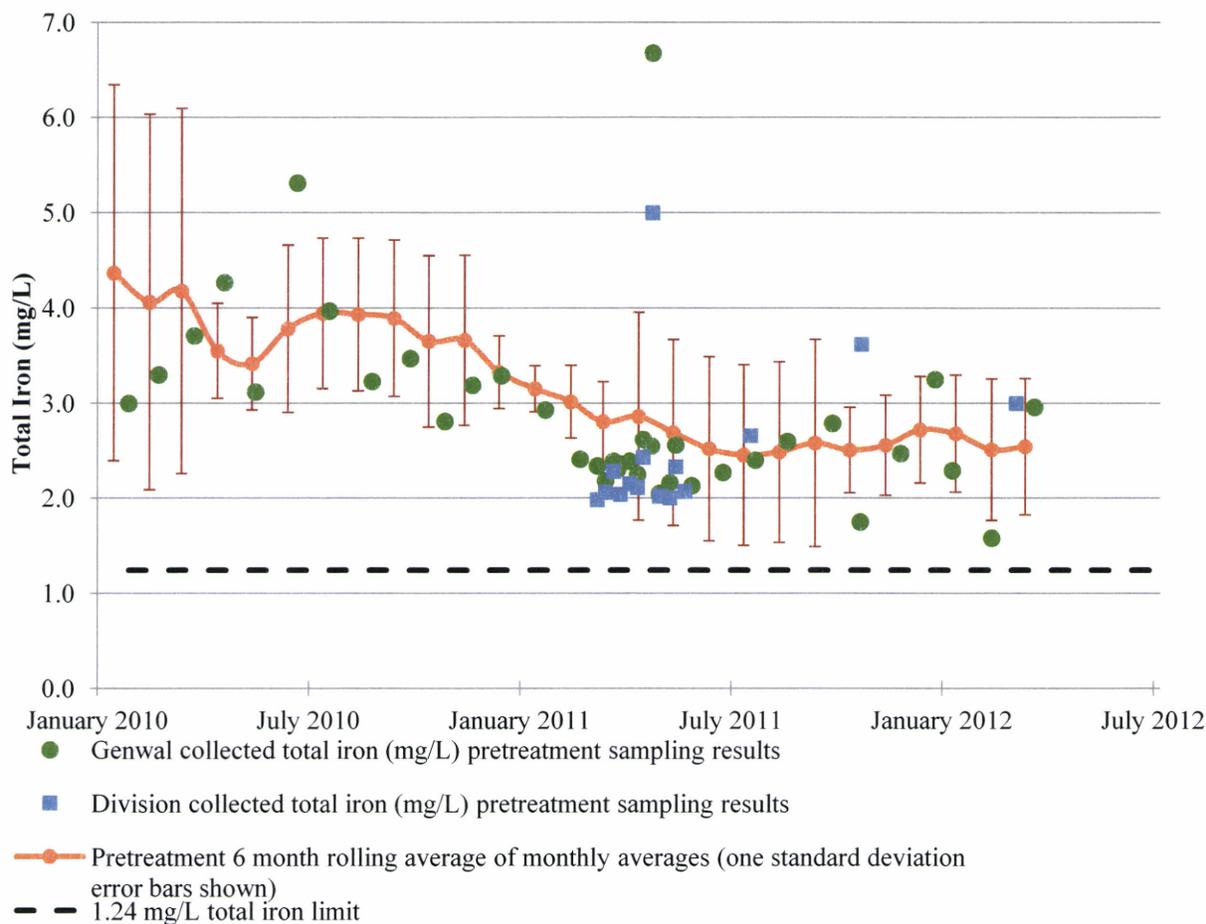
The total iron concentrations in the pre-treatment mine water remains well above the 1.24 mg/L UPDES limit. Based on three sampling events the resulting concentrations for total iron were 2.29, 1.58 and 2.21, and 2.96 mg/L for January, February (two samples), and March, respectively. In addition, the Division collected one sample in March 2012 for total iron resulting in a concentration of 3.0 mg/L. The data show that total iron concentration still remains variable but since January 2010 to March 2011 a downward trend occurred. However since March 2011 the concentration of total iron has begun to level off around 2.5 mg/L. It remains undetermined whether the concentration of total iron will decrease below the total iron maximum daily effluent limitation of 1.24 mg/L is yet to be demonstrated. In addition, bicarbonate in February 2012 and total alkalinity, and field conductivity in March 2012 were found to be more than two standard deviations from the mean. Residual polymer testing was conducted on a sample collected March 21, 2012 by SGS laboratory and determined a level of 0.16 mg/L of residual flocculent.

Below is a graph of the pretreatment total iron concentration since January 2010. The graph shows the measured total iron concentration and rolling 6 month average total iron concentration (including one standard deviation error bars) compared to the curves generated in the November 2011 Investigation of Iron Concentration in the Genwal Resources, Inc. Crandall Canyon Mine Discharge Water by Petersen Hydrologic, LLC report.

Continued data collection and monitoring of the mine-water discharge will be necessary to evaluate the effectiveness of the mine-water treatment system. Monitoring of the pre-treatment mine-water will help determine the overall chemistry of the raw mine-water and help determine if the total iron concentrations are showing any change in concentration. To this end it is critical to maintain on time submittal of the pretreatment and Outfall 002 sampling results to DOGM, as required by Appendix 7-65.
