WATER QUALITY MEMORANDUM

Utah Coal Regulatory Program

December 20, 2012

RE: Second Quarter of 2012 Water Monitoring, Genwal Resources, Inc., Crandall Canyon Mine, C/015/0032 Task ID #4115

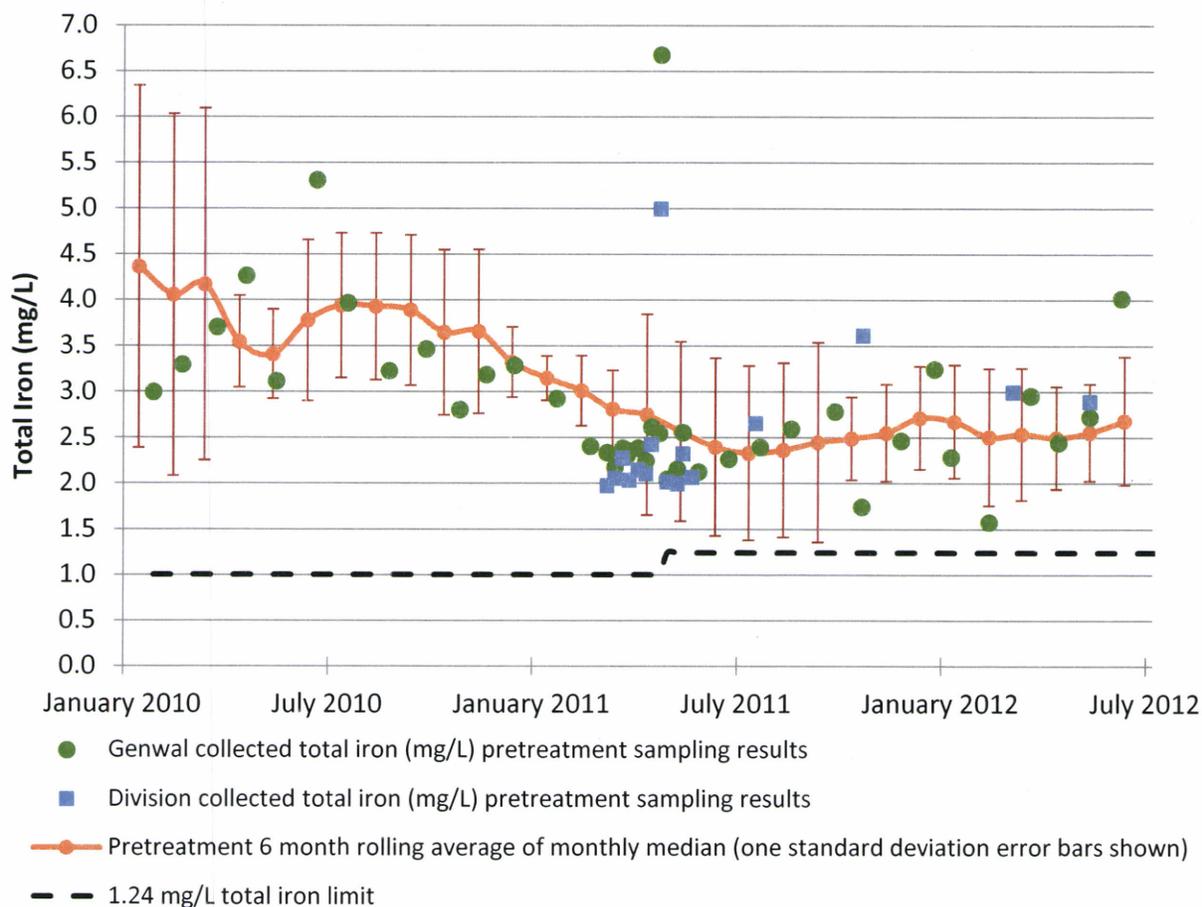
The total iron concentrations in the pre-treatment mine water remains well above the 1.24 mg/L UPDES limit. Based on three sampling events the resulting concentrations for total iron were 2.45, 2.73, and 4.02 mg/L for April, May, and June, respectively. In addition, the Division collected one sample in May 2012 for total iron resulting in a concentration of 2.9 mg/L. The data show that total iron concentration still remains variable but since January 2010 to March 2011 a downward trend occurred. However since March 2011 the concentration of total iron has begun to level off around 2.5 mg/L. It remains undetermined whether the concentration of total iron will decrease below the total iron maximum daily effluent limitation of 1.24 mg/L is yet to be demonstrated. Residual polymer testing was conducted by SGS laboratory and determined a level of residual flocculent of 0.92 mg/L, non-detect (ND), and ND on samples collected on April 17, May 15, and June 12, 2012, respectively.

Below is a graph of the pretreatment total iron concentration since January 2010. The graph shows the measured total iron concentration and rolling 6 month average total iron concentration (including one standard deviation error bars).

Continued data collection and monitoring of the mine-water discharge will be necessary to evaluate the effectiveness of the mine-water treatment system. Monitoring of the pre-

treatment mine-water will help determine the overall chemistry of the raw mine-water and help determine if the total iron concentrations are showing any change in concentration. To this end it is critical to maintain on time submittal of the pretreatment and Outfall 002 sampling results to DOGM, as required by Appendix 7-65.
