OGMCOAL - Crandall Canyon Inspection Report: 5/15/2012

Inspection Report

Permit Number:	C0150032
Inspection Type:	PARTIAL
Inspection Date:	Tuesday, May 15, 2012
Start Date/Time:	5/15/2012 1:30:00 PM
End Date/Time:	5/15/2012 3:30:00 PM
Last Inspection:

Permitee: **GENWAL RESOURCES INC**
 Operator: **GENWAL RESOURCES INC**
 Site: **CRANDALL CANYON MINE**
 Address: **PO BOX 910, EAST CARBON UT 84520-0910**
 County: **EMERY**
 Permit Type: **PERMANENT COAL PROGRAM**
 Permit Status: **ACTIVE**

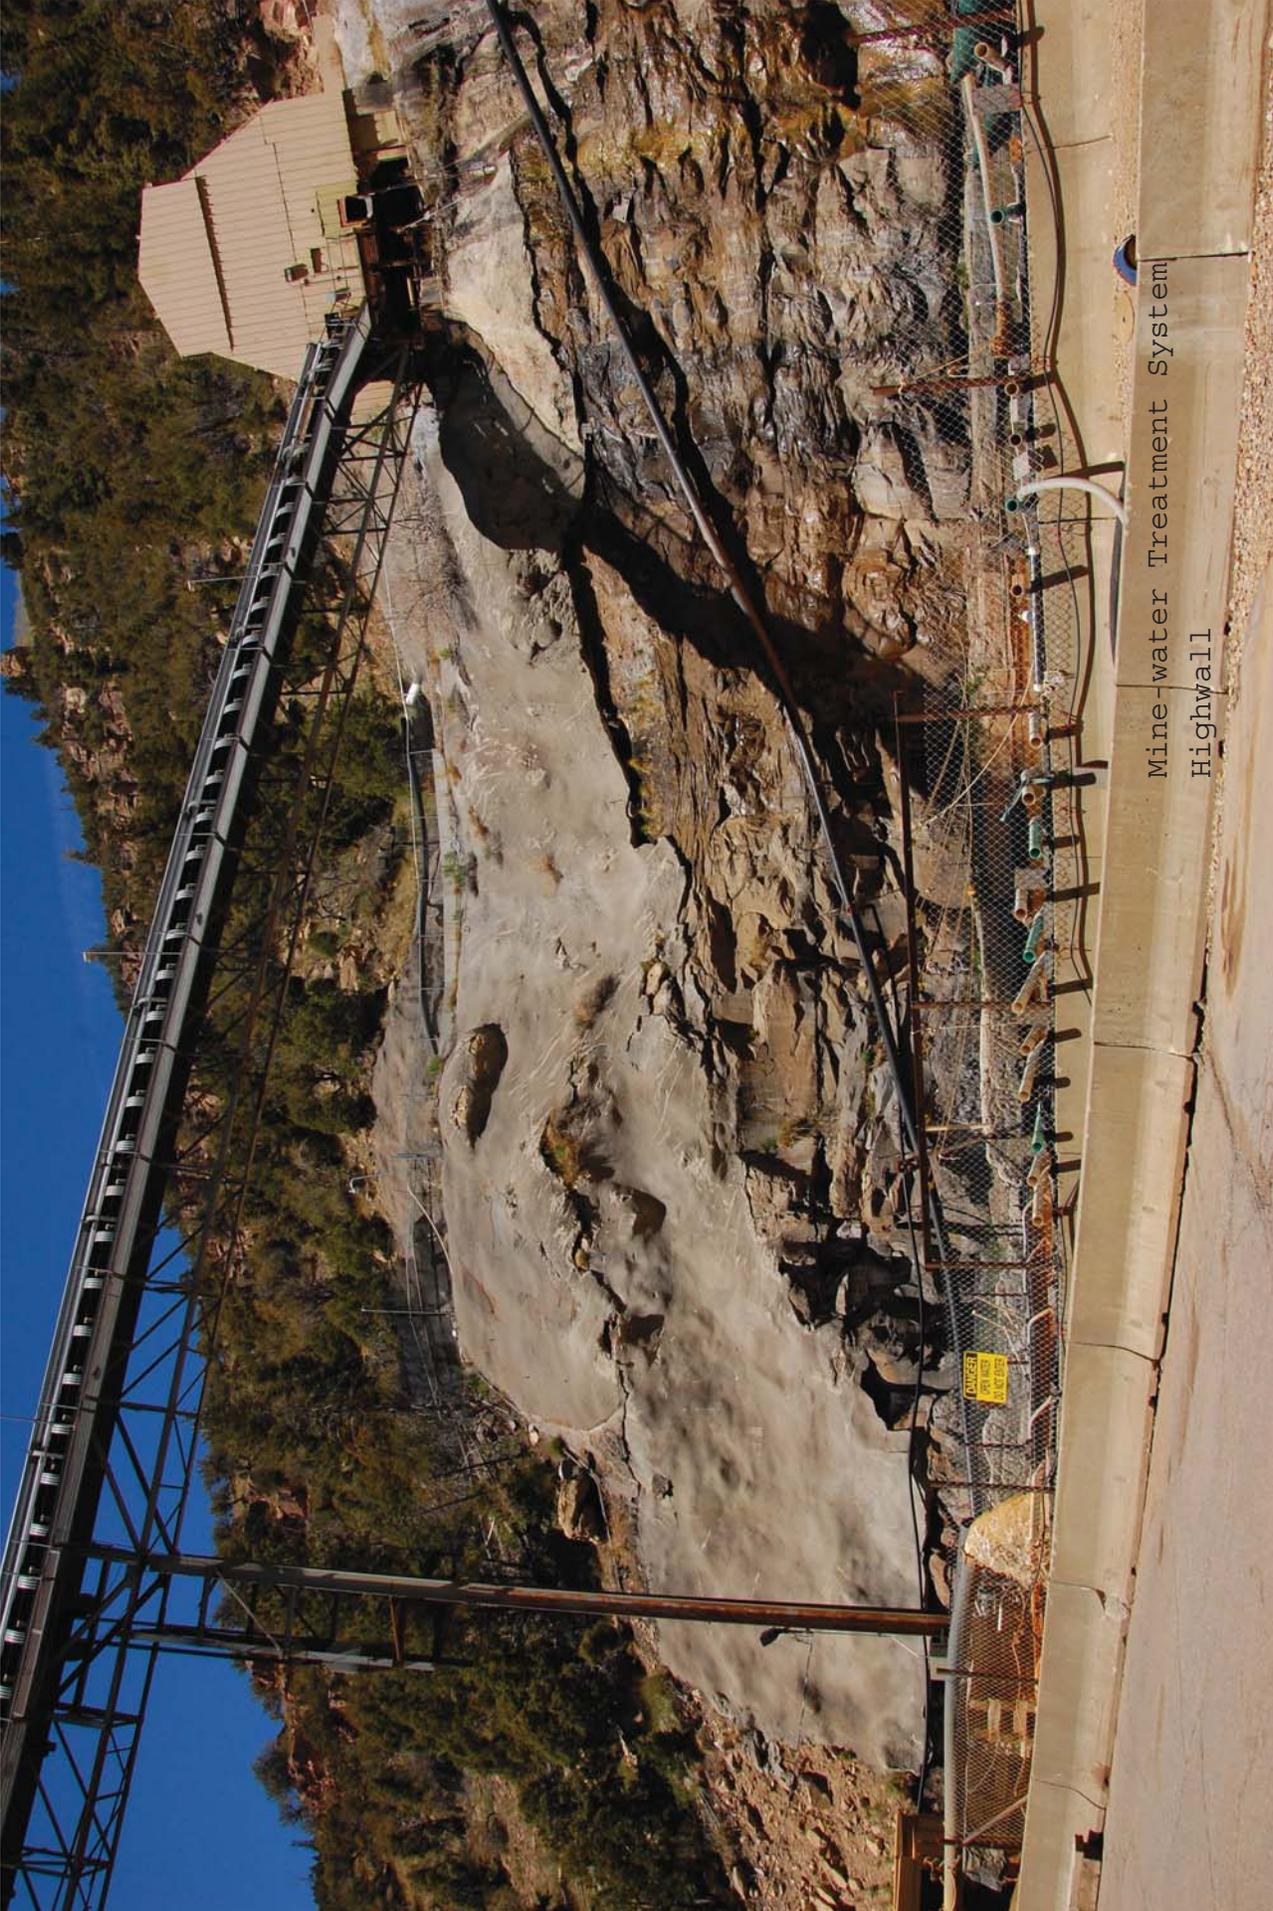
Mine-water Treatment System
Highwall

It appeared that the treatment basin had been thoroughly cleaned recently. Accumulated iron sludge was noted in cells 1 and 2. Cells 3-5 were exceptionally clean with only limited accumulations of iron sludge noted in cell 3 on the extreme northern and southern ends of the cell. Cells 4 and 5 were extremely clean with virtually no iron sludge accumulations noted at the time of the inspection. Mr. Leonard indicated that no debris had fallen from the highwall since the last inspection.

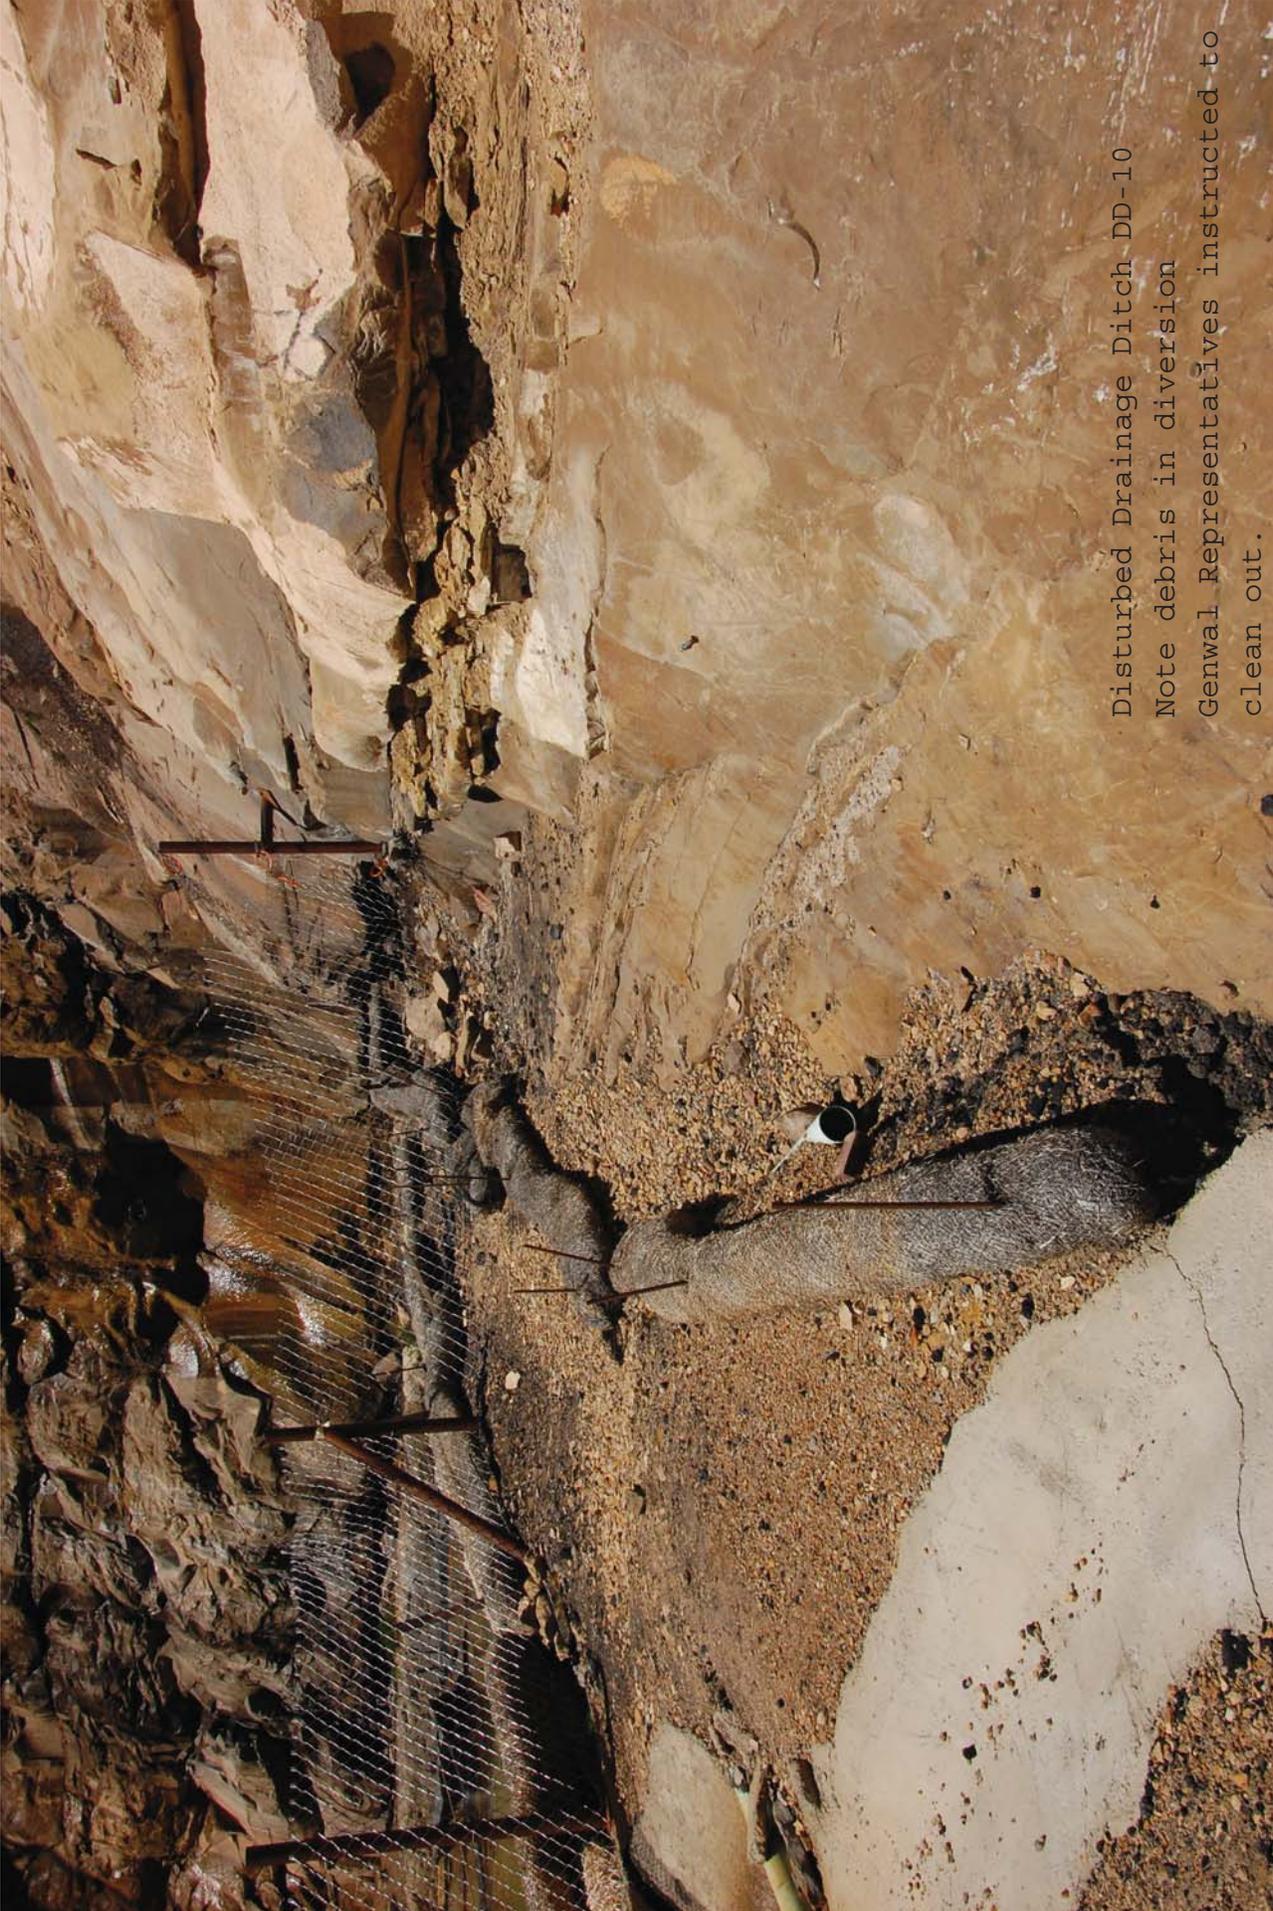
Upon inspection of disturbed drainage ditch DD-10 (located directly adjacent to the east end of the treatment basin), rock and coal material from the overhanging highwall was observed. Mr. Leonard and Mr. Marshall were instructed to remove the debris from the diversion.

Disturbed Drainage Ditch DD-10
Note debris in diversion
Genwal Representatives instructed to
clean out.

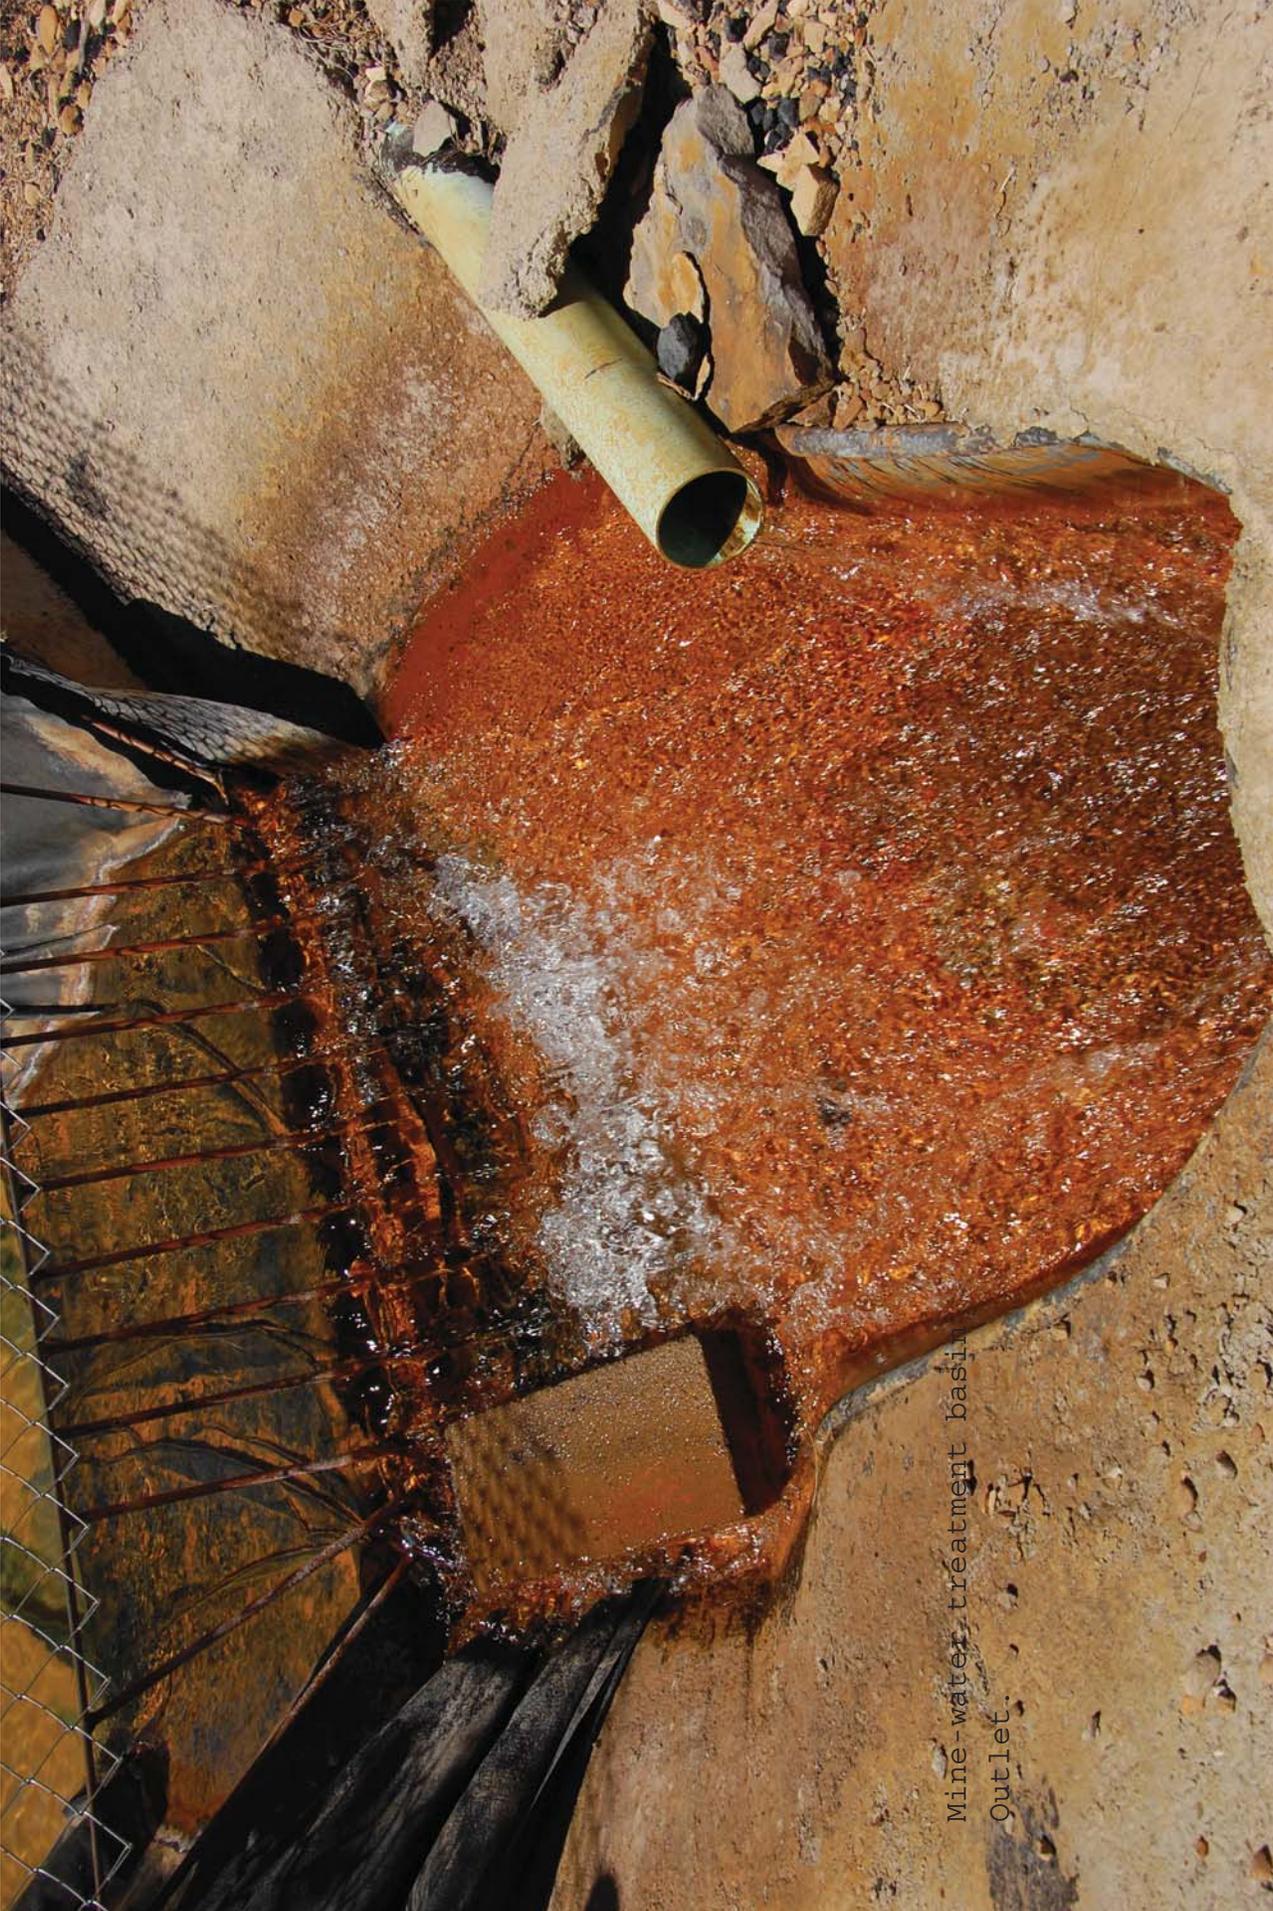
Mine-water treatment basin
Outlet.

At the time of the inspection, the mine-water discharging from the treatment basin appeared clear. Material was not observed discharging with the treated mine-water. The highwall seep collection pipe was observed to be flowing at approximately 2-3 gpm.

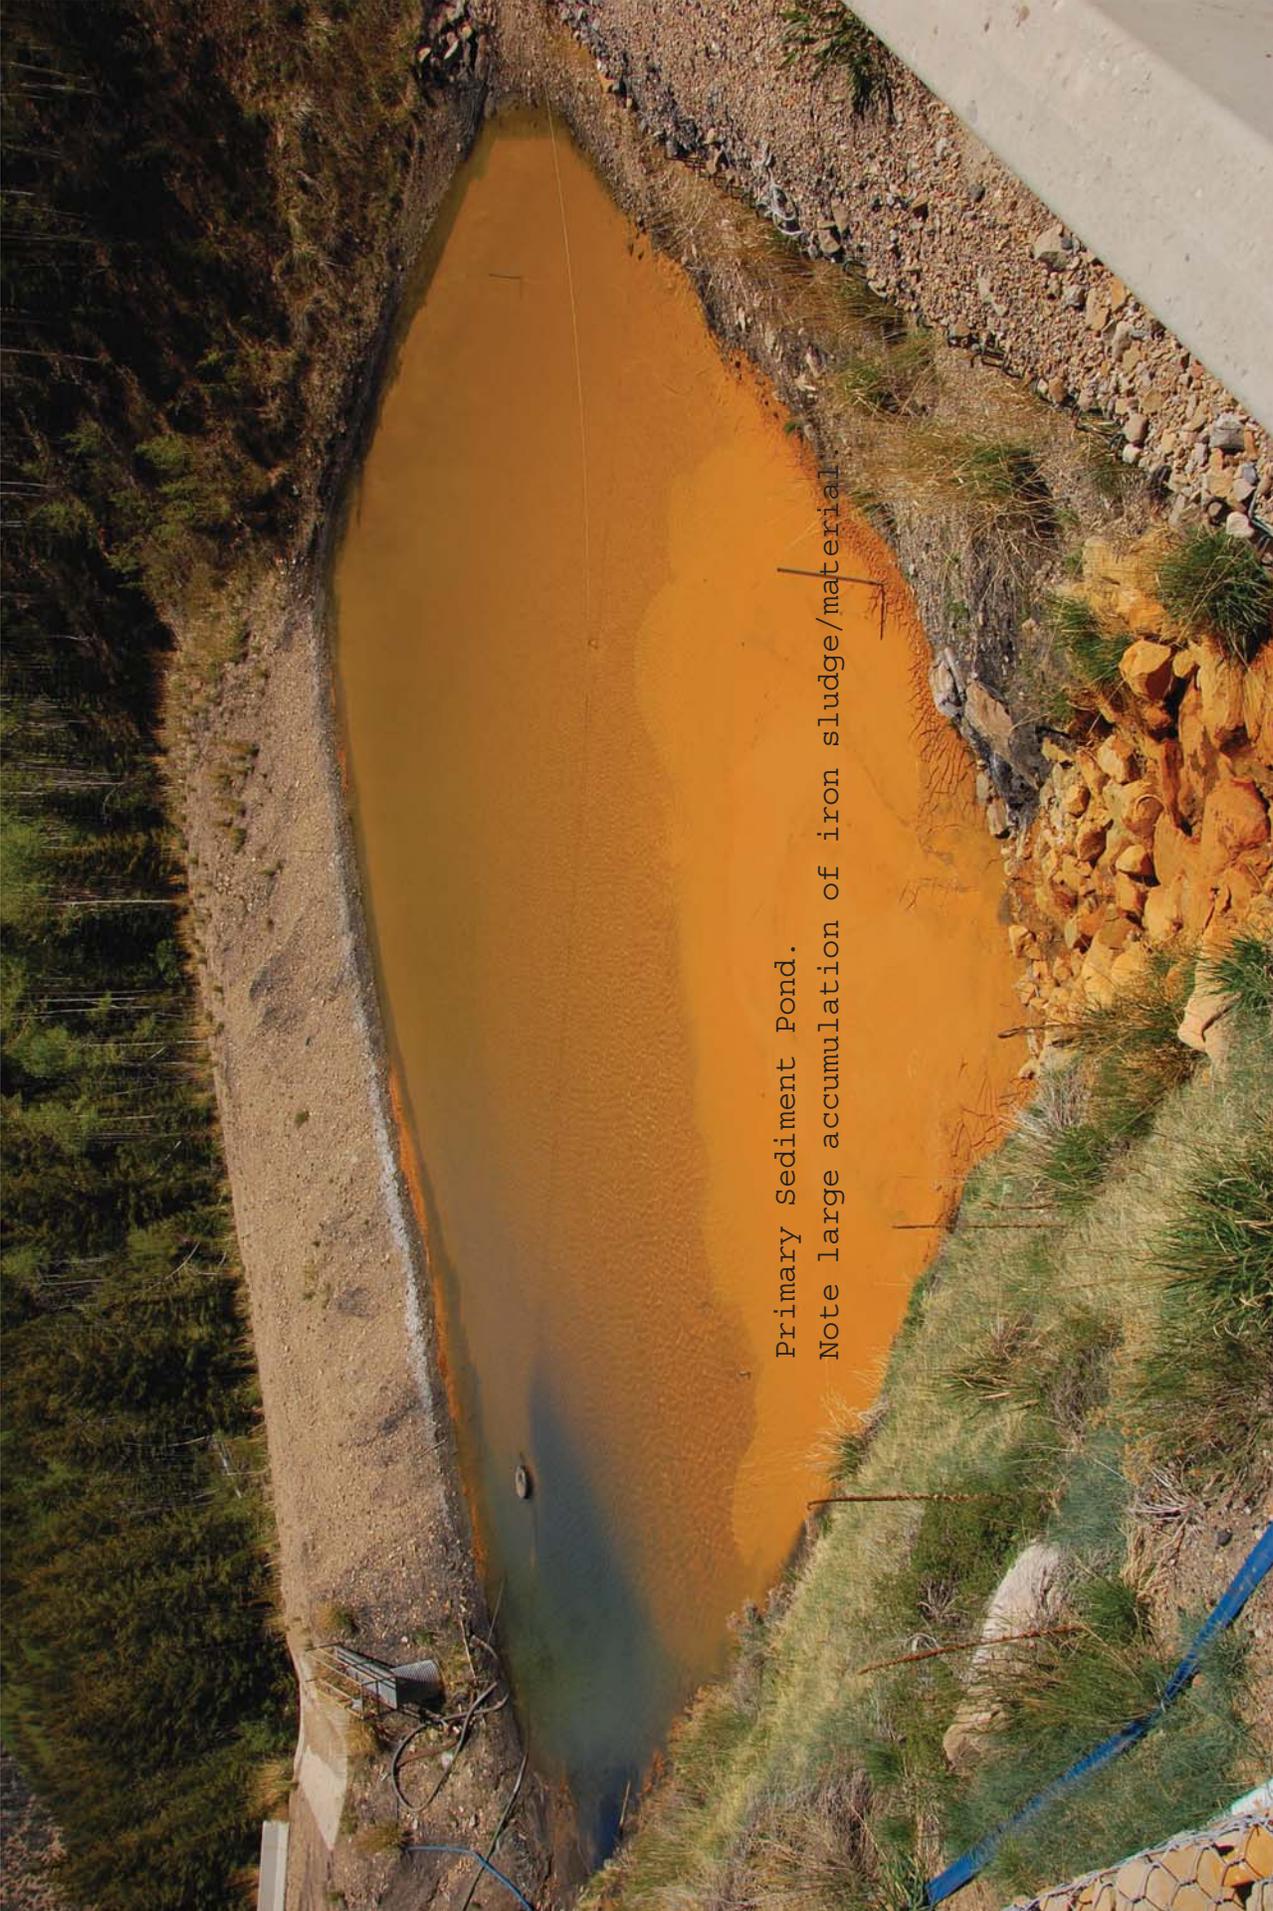
The primary sediment pond was observed during the inspection. A large accumulation of iron sludge material was observed at the inlet to the pond. The two sediment clean-out markers were observed to be buried by the accumulated sludge material. Mr. Marshall and Mr. Leonard were instructed to have the primary sediment pond cleaned as it appears that the clean-out level had been surpassed by the accumulated iron sludge material.

Primary Sediment Pond.
Note large accumulation of iron sludge/material.

Additionally, Mr. Marshall and Mr. Leonard were informed that following the summer construction season of 2012, the Division will no longer allow the utilization of the primary sediment pond for storage of the mine-water treatment basin iron sludge material. Mr. Marshall indicated that he would confirm the sediment clean out levels with Cody Ware (surveyor who installed the sediment clean-out markers as well as the 10-year, 24-hour design storm level). A meeting has been arranged for May 22nd, 2012 to discuss the outstanding deficiencies associated with the proposed Burma Pond evaporation basin.

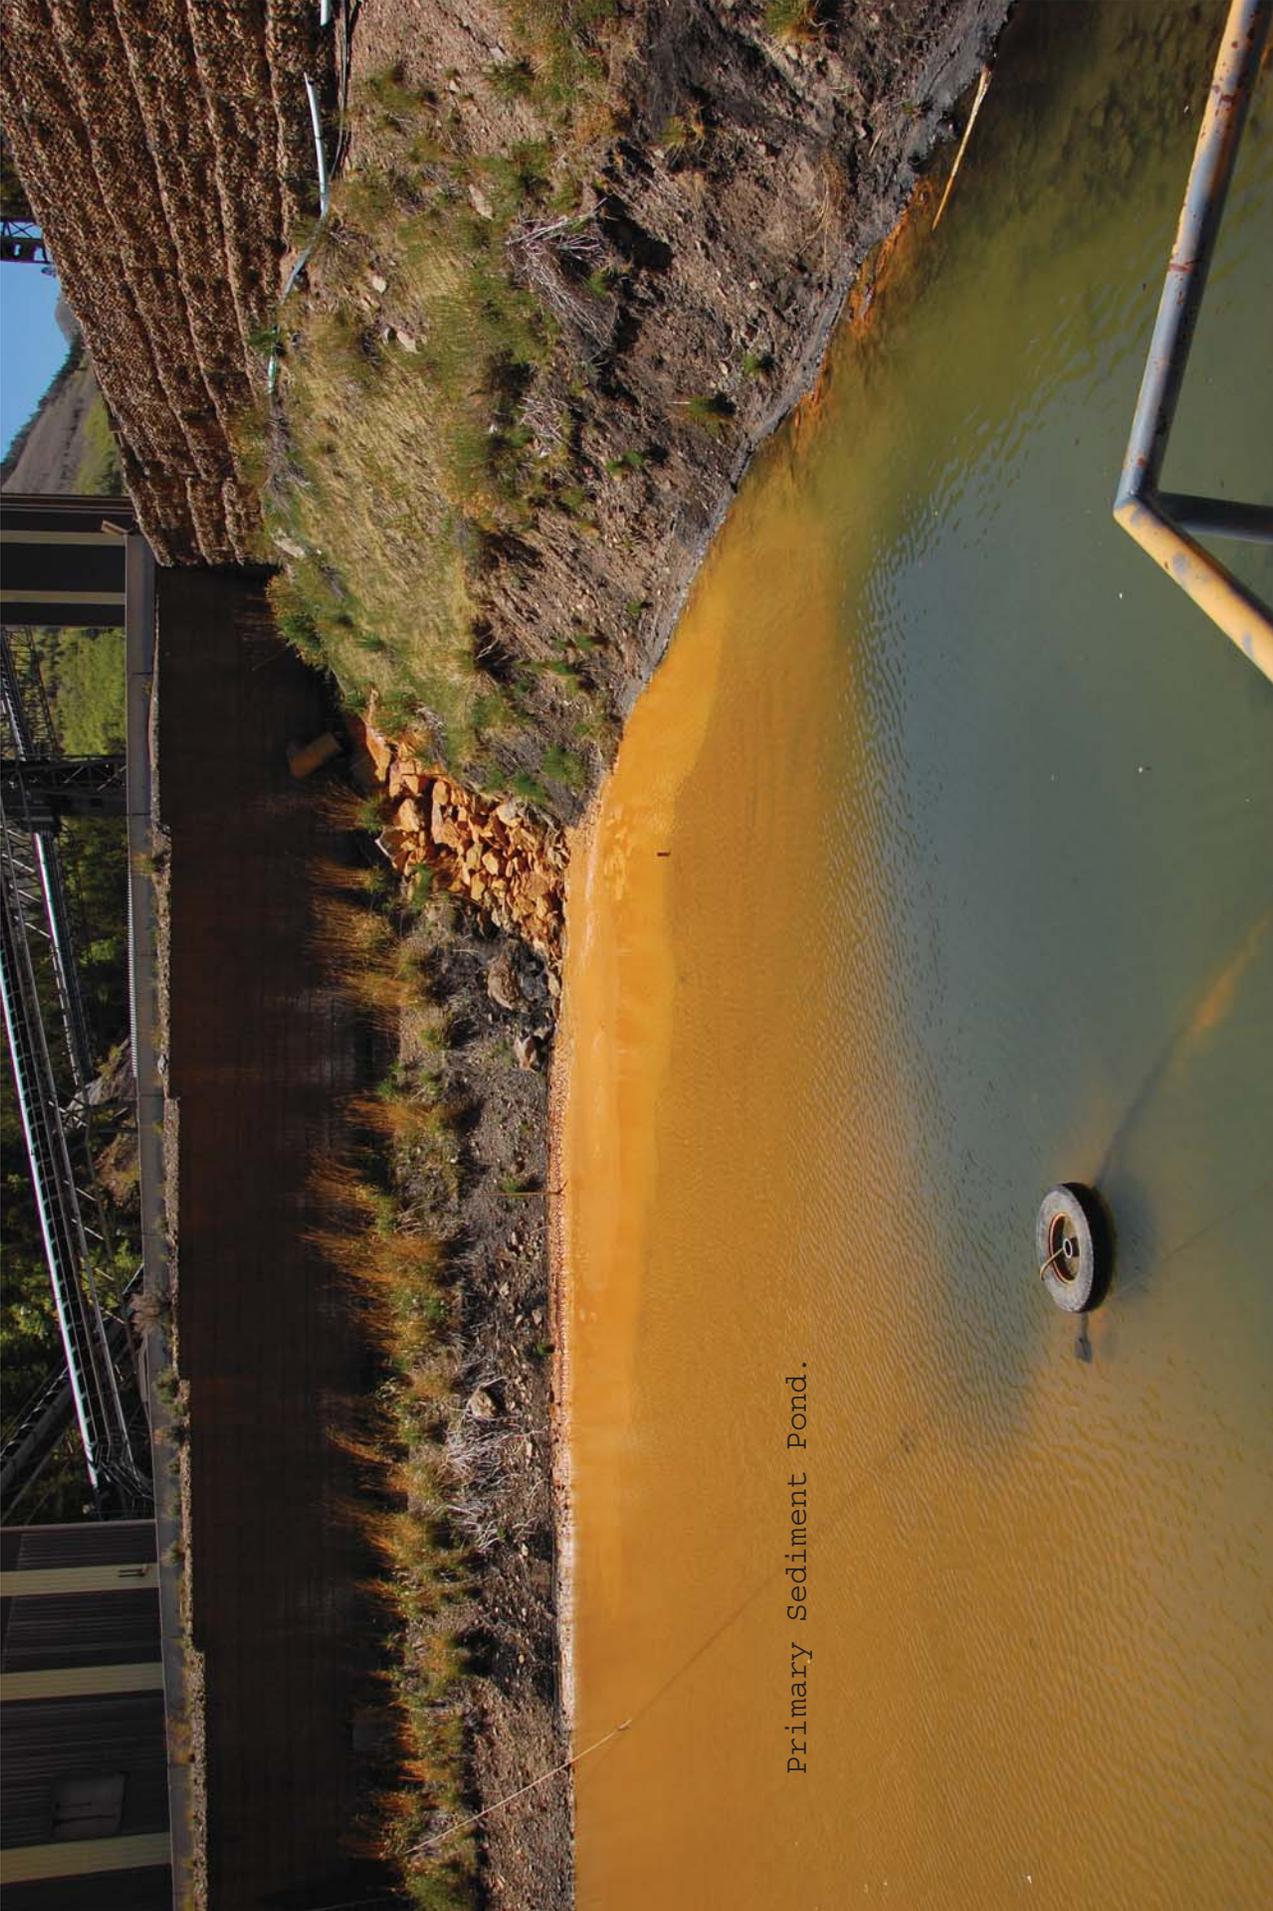
Primary Sediment Pond.

The primary sediment ponds 10-year, 24-hour design storm level was observed during the inspection. The water level in the primary sediment pond was approximately 8"-10" below the marker.
