Inspection Report

Permit Number:	C0150032
Inspection Type:	PARTIAL
Inspection Date:	Thursday, March 14, 2013
Start Date/Time:	3/14/2013 11:30:00 AM
End Date/Time:	3/14/2013 1:30:00 PM
Last Inspection:	Tuesday, March 19, 2013

Permittee: **GENWAL RESOURCES INC**
 Operator: **GENWAL RESOURCES INC**
 Site: **CRANDALL CANYON MINE**
 Address: **PO BOX 910, EAST CARBON UT 84520-0910**
 County: **EMERY**
 Permit Type: **PERMANENT COAL PROGRAM**
 Permit Status: **ACTIVE**

On March 14th, 2013, a partial inspection of the Crandall Canyon Mine facility was conducted by Division of Oil, Gas and Mining (the Division) staff member Steve Christensen. The purpose of the field inspection was to document the status of the mine-water discharge pipe and water treatment system following a rock fall event that occurred in the early morning of March 13th, 2013.

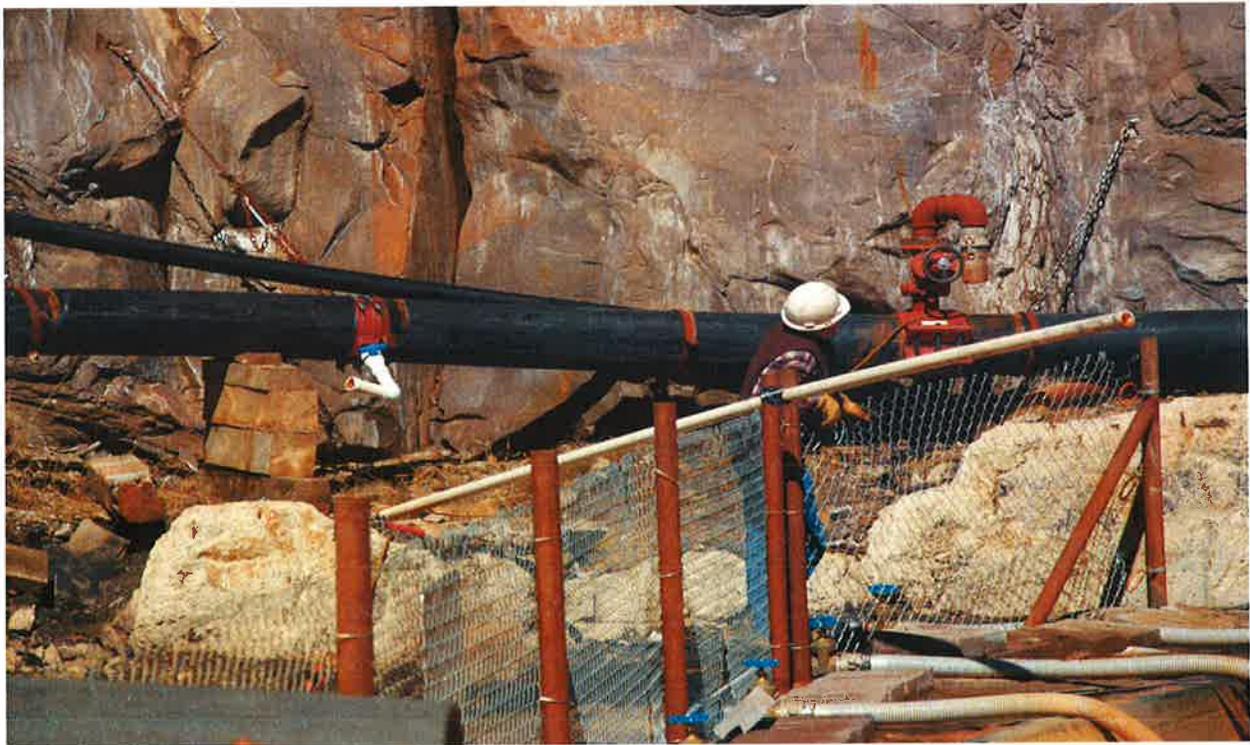
Due to the rock fall, the newly established sample port was broken and no longer operable (See photo). Company representative Dale Davis indicated that the old sample port located in the treatment shed would be utilized until such time as a new sample port can be re-established.

Broken Test Port

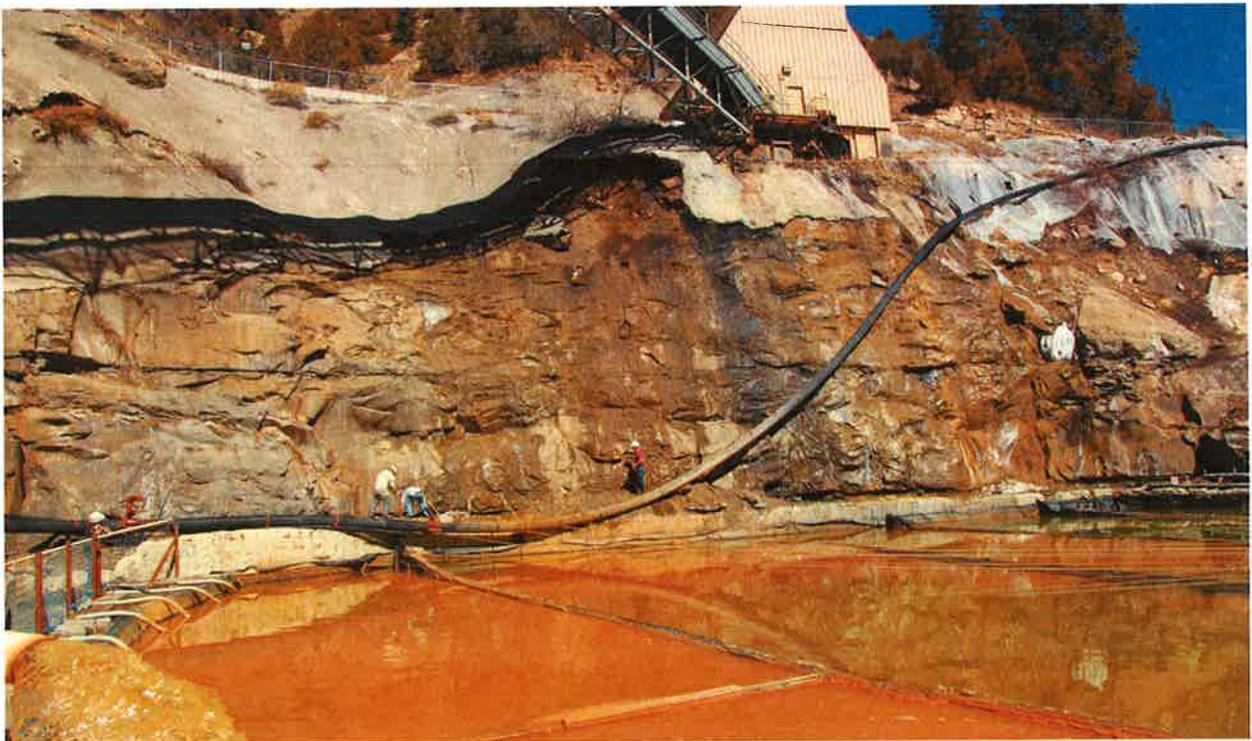
Highwall/Treatment Basin

The Permittee reported that a rock fall event had occurred at the Crandall Canyon Mine facility sometime in the early a.m. hours of March 13th, 2013. Shotcrete material on the highwall located directly adjacent to the north side of the treatment basin dislodged from the face and impacted the mine-water effluent pipe. Anchor bolts that affixed the mine-water discharge pipe to the highwall were pulled out allowing the pipe to sag. As a result, a "T" fitting near the portals above the treatment basin failed allowing the mine-water discharge to cascade uncontrolled down the slope east of the treatment basin.

As discussed previously, the purpose of the inspection was to document the status following a rock fall event on March 13th, 2013. The shotcrete material on the highwall directly adjacent to the treatment basin has shown evidence of increased instability in recent years. In July 2010, it was reported to Division staff that the treatment basin lining had to be replaced due to falling rock tearing the liner (See Inspection Report #2440). Additionally, the slope directly overhead of disturbed drainage ditch DD-10 (east side of treatment basin) frequently loses material

following rainfall events. As a result, ditch DD-10 requires frequent cleaning of the deposited overhead material. Currently, a large boulder is located in the treatment basin itself after becoming dislodged from the overhead highwall area.

As has been documented previously, the highwall and associated shotcrete/boulder material overhead the treatment basin has produced evidence of instability. A pulley system was installed by the Permittee in the two western most cells of the treatment basin in order to facilitate safe clean-out operations.

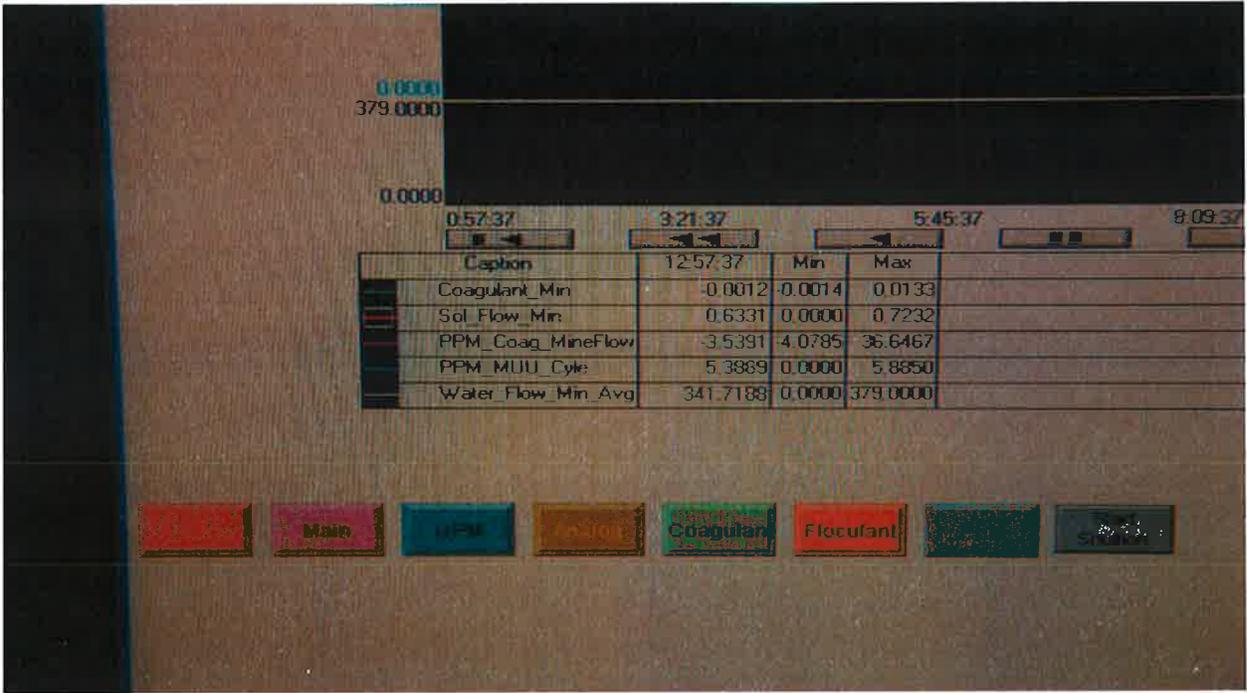
The mine-water treatment system monitor was observed in the main office at the mine site. The mine-water treatment system has been equipped with sensors that allow for remote monitoring of the various components of the system. Dale Davis showed the screen that monitors coagulant and flocculent injection rates (See photo). The reading labeled "PPM_Coag_Mine Flow" depicts the coagulant injection rate. The reading labeled "PPM_MUU_Cyle" provides the flocculent injection rate. At the time of the inspection, Dale Davis indicated that the coagulant injection rate sensor was not functioning properly as a reading of -3.5391 was displayed. Mr. Davis indicated that a technician for the mine would fix the coagulant sensor. The flocculent injection rate at the time of the inspection was 5.3889 ppm.

PPM_Coag_MineFlow= Coagulant injection rate, PPM-MUU-Cycle= Flocculent injection rate

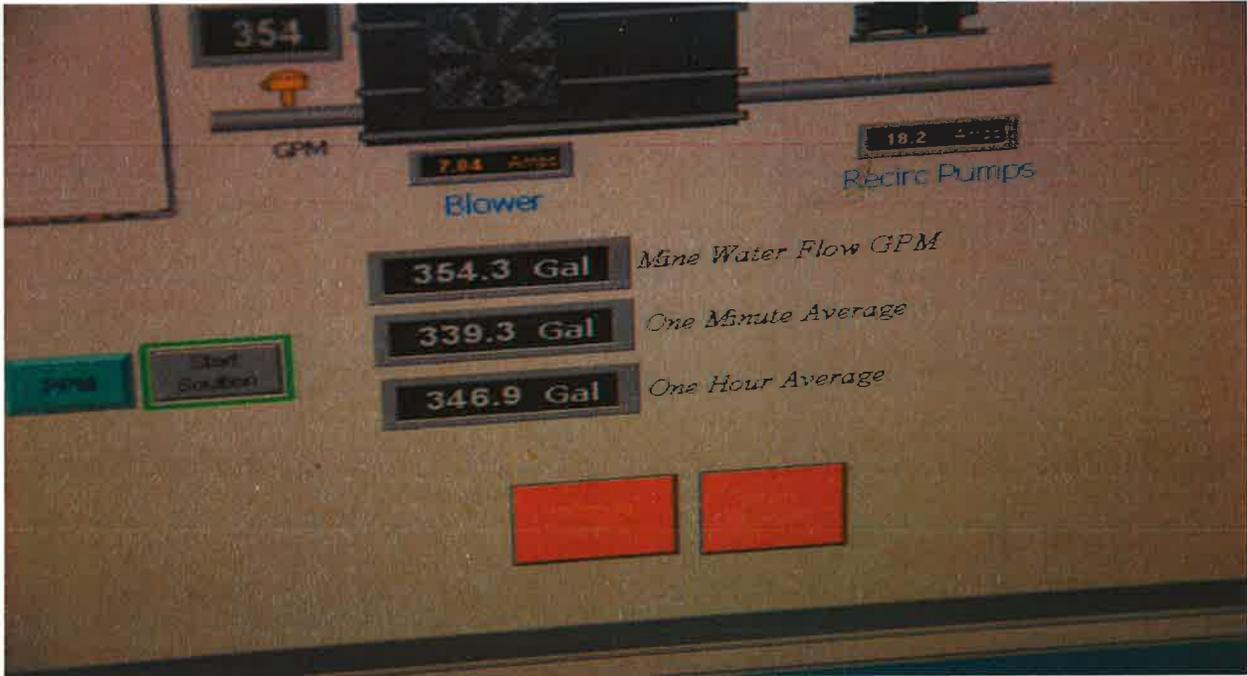
Another screen of the monitoring system provides the mine-water discharge rates (See photo). At the time of the inspection, the mine-water discharge was flowing at a rate of 354.3 gallons per minute (gpm).

Mine Water Flow GPM (top row) = 354.3 gpm

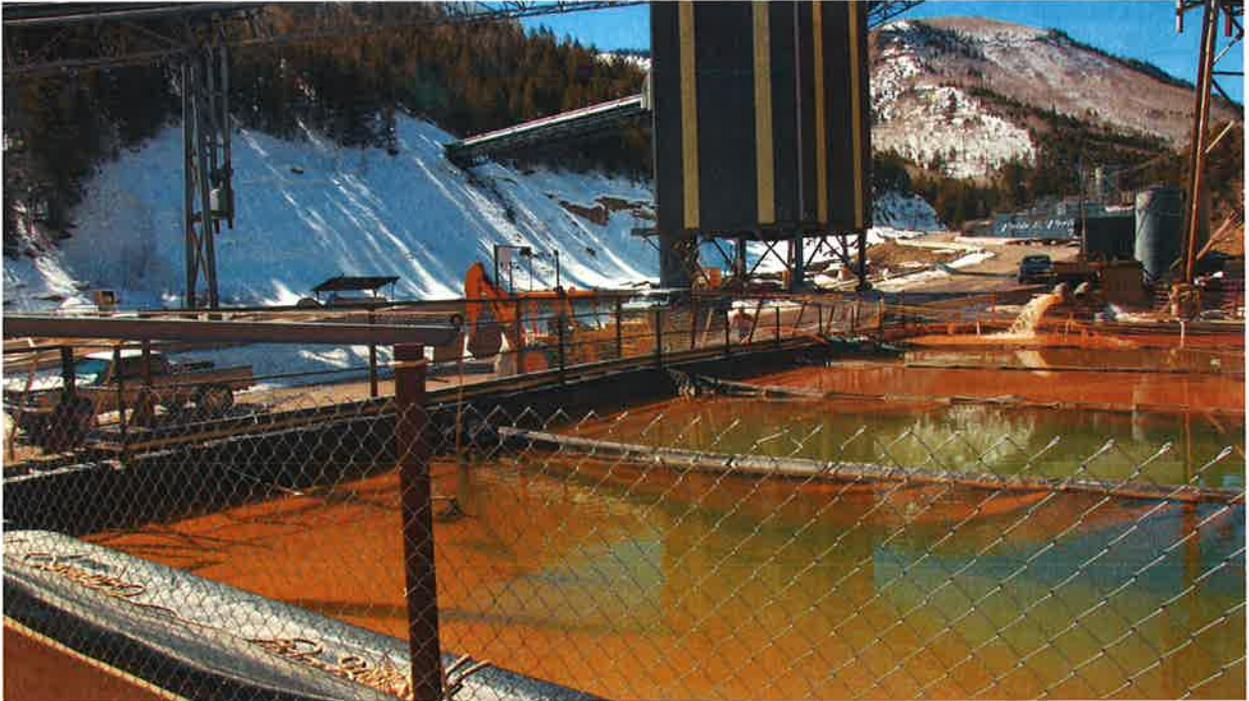
Treatment Basin looking west

At the time of the inspection, the "T" fitting had been repaired and the mine-water was being routed to the treatment shed as designed. Treated mine-water was observed discharging from the treatment basin at the time of the inspection. It appeared that the mine-water discharge water was contained within the disturbed drainage network of the mine site and was routed into the primary sediment pond.

A water sample was obtained at the outfall of the treatment basin (Sample ID UPDES 002 13:05). The sample was submitted for laboratory analysis of total iron (T-Fe) and sulfate (SO₄) concentrations. Once the results are obtained from the lab, a copy will be provided to the Permittee. The water discharging from UPDES 002 appeared clear at the time of the inspection (i.e. no evidence of suspended material discharging from the treatment basin was noted).

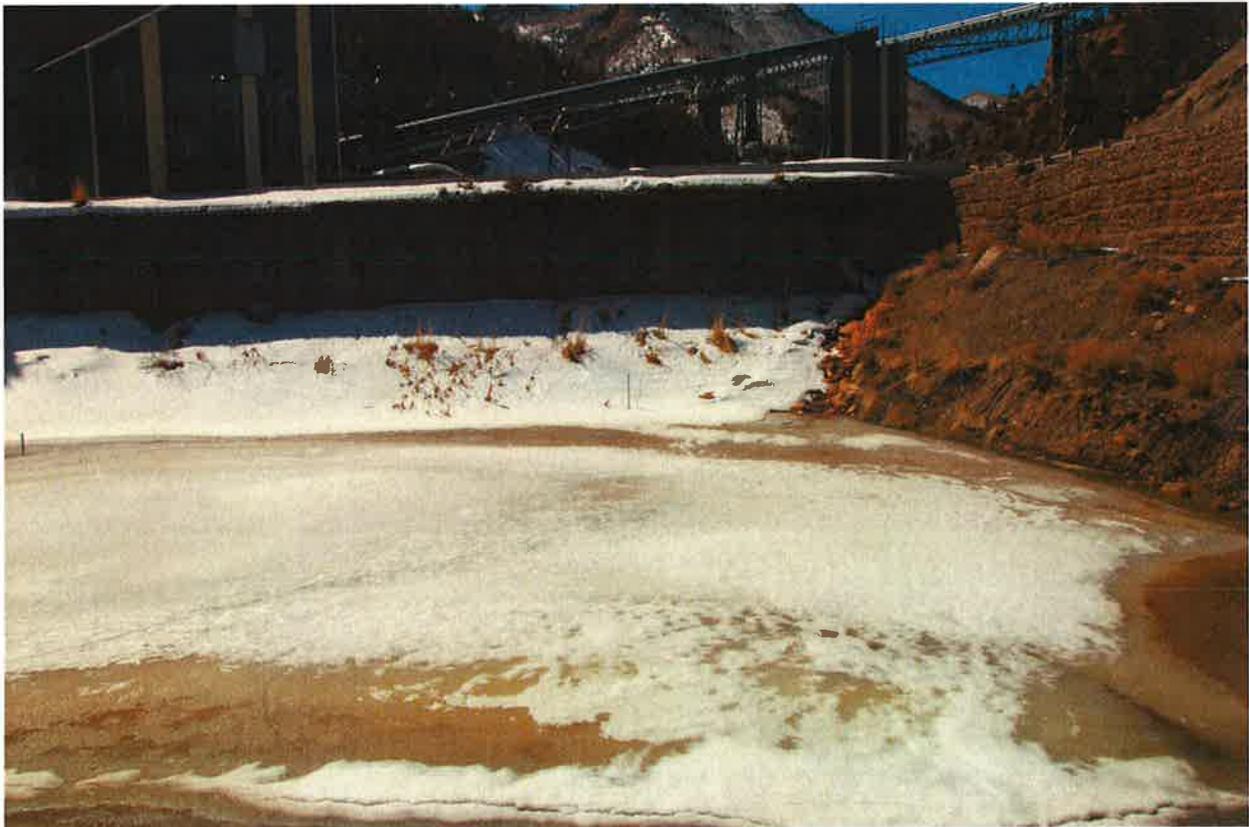
Sediment Pond Looking West

Upon review of the MRP, the sediment clean-out level of the pond is 7,769.0' (See Plate 7-3 and Table 12 on page 34 of Appendix 7-4). Information obtained during the last complete inspection by Crandall Canyon Mine Inspector Karl Houskeeper (3/19/2013) indicates that the sediment pond is overdue for cleaning. According to a sediment pond inspection report reviewed during the complete inspection (data obtained September 12th, 2012, report PE Stamped by Jay Marshall January 7th, 2013), the estimated sediment elevation of the pond is 7,772.59' (3.59' above the sediment clean-out level of 7,769' and 2.59' above the maximum sediment elevation of 7,770').

The approved MRP also discusses that the sediment pond was designed to contain the 10-year, 24-hour event, "along with 3 years of sediment storage" (See page 36 of Appendix 7-4). It is important to note that the sedimentation yield calculations performed in sizing the sediment pond and its sediment holding capacity did not take into account the deposited accumulations of iron-sludge from the treatment basin. Rather, the sediment holding capacity of the pond was based on a Universal Soil Loss Equation conducted for the surface areas of the mine site that contribute drainage to the sediment pond (See page 30 of Appendix 7-4). However, as discussed above, the sediment pond received the accumulated iron-sludge material from approximately May 2011 until late 2012. While storage of the iron-sludge material in the sediment pond was approved, at no time did the Division authorize exceeding the approved design standards of the sediment pond (i.e. the sediment clean-out level of the pond).

On May 15th, 2012 Division staff Daron Haddock and Steve Christensen conducted an inspection of the Crandall Canyon mine facility along with company representatives Jay Marshall and JD Leonard (See Inspection Report #3104, e-mailed to JD Leonard on 5/18/2012). During the inspection, it was noted that the sediment markers had been buried by accumulated material and were no longer visible. Mr. Marshall and Mr. Leonard were directed to initiate clean-out operations on the primary sediment pond. To date, the clean-out of the sediment pond has not been done. With the onset of the spring snowmelt period, the sediment pond must be cleaned as soon as possible.

As a result of the observations discussed above and upon review of the approved design considerations for the Crandall Canyon sediment pond, NOV #10105 was issued to the Permittee on March 18th, 2013 for failure to maintain adequate storage capacity within the primary sediment pond. The Permittee has until May 4th, 2013 to address the abatement requirements of the NOV.

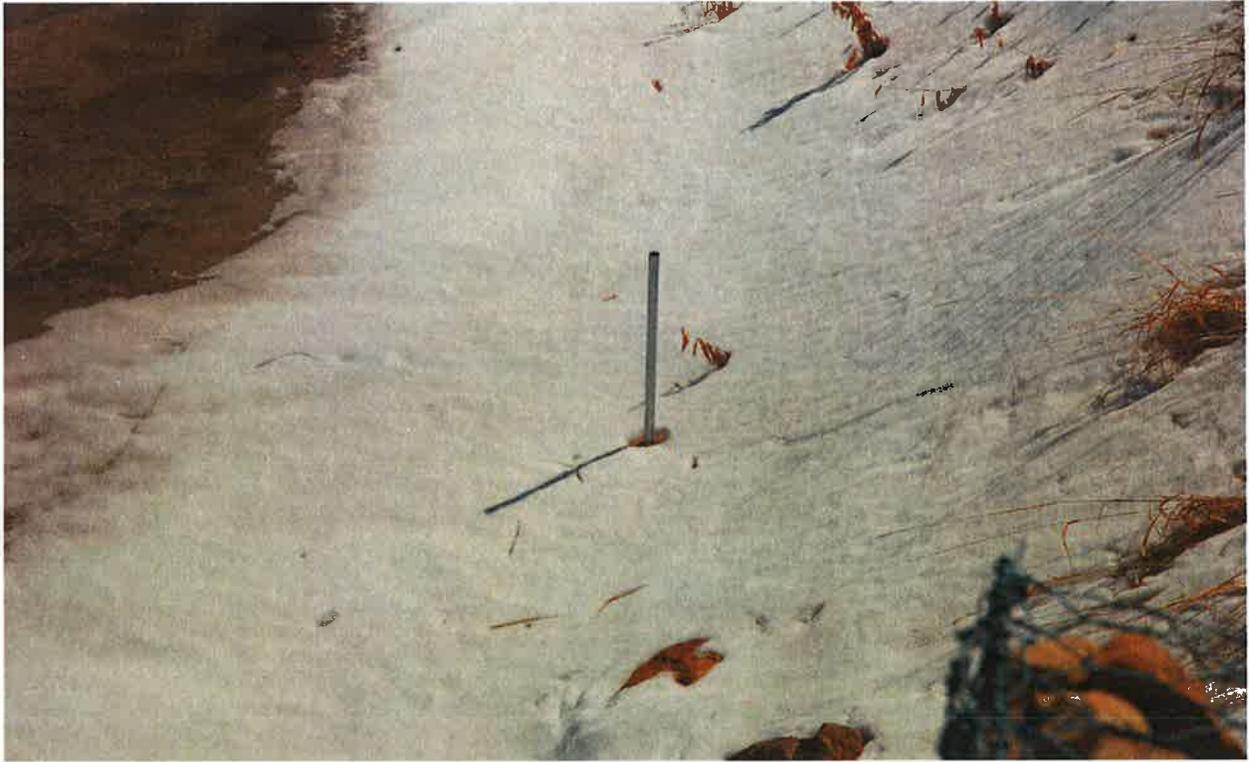
The 10-year, 24-hour design storm event marker was also inspected (See photo). At the time of the inspection, there was approximately 1-2" of snow in the area of the design storm event marker. However, no portion of the marker was visible indicating that the water level in the sediment pond is at or above the design storm event elevation.

Former employee Dave Shaver indicated to Division staff that the sediment markers installed in the Crandall Canyon primary sediment pond identified the clean out elevation as shown in the approved MRP (See Plate 7-3: elevation 7,769.0'). The 10-year, 24-hour design storm event marker depicted the elevation at which mine-water discharge to the sediment pond would need to cease in order to maintain the capacity to contain the design storm event (See Table 12 on page 34 of Appendix 7-4: elevation 7773.2').

10-year, 24-hour design storm marker. No sign of marker visible at time of inspection

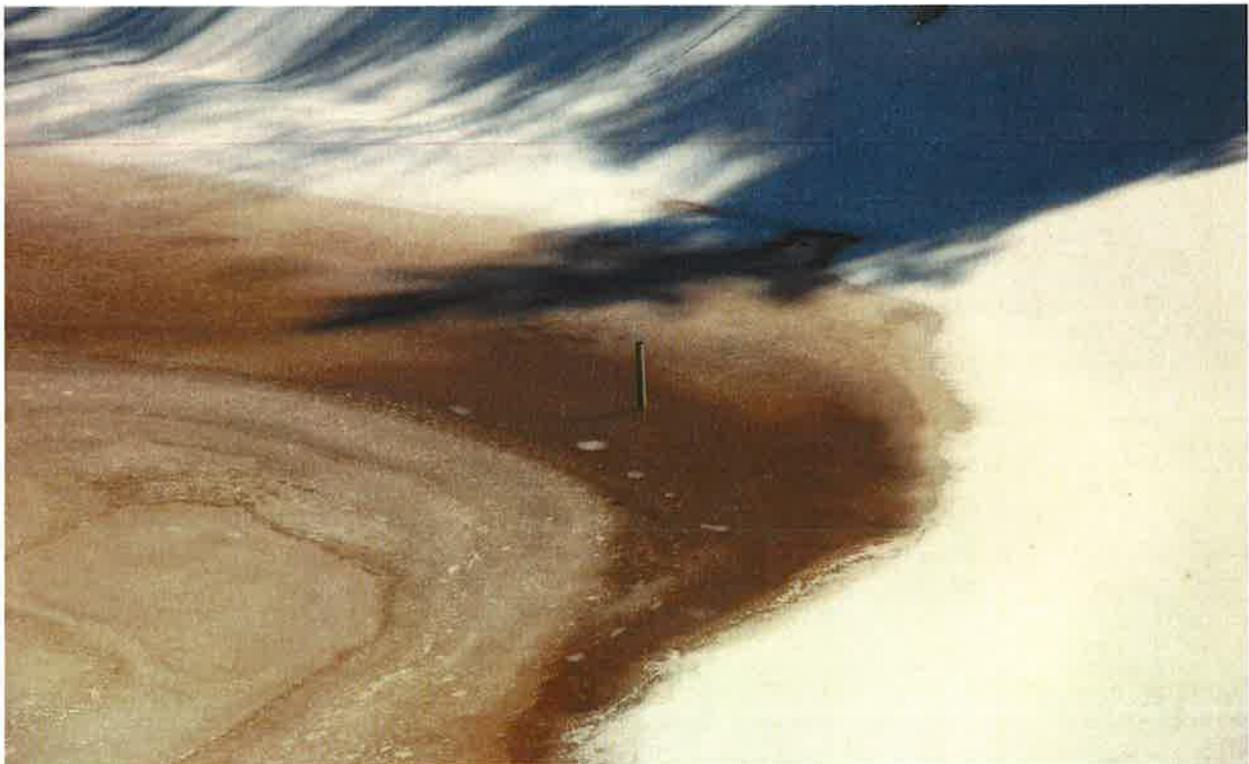
Sediment Marker

The primary sediment pond for the Crandall Canyon mine site was inspected during the field visit. The two sediment markers were inspected. Due to the water level in the pond, the sediment markers were not visible (See photo).
