Inspection Report

Permit Number:	C0150032
Inspection Type:	PARTIAL
Inspection Date:	Tuesday, August 30, 2016
Start Date/Time:	8/30/2016 10:00:00 PM
End Date/Time:	8/30/2016 11:00:00 PM
Last Inspection:	Thursday, August 04, 2016

Permittee: **GENWAL RESOURCES INC**
Operator: **GENWAL RESOURCES INC**
Site: **CRANDALL CANYON MINE**
Address: **PO BOX 910, EAST CARBON UT 84520-0910**
County: **EMERY**
Permit Type: **PERMANENT COAL PROGRAM**
Permit Status: **INACTIVE**

The Division of Oil, Gas and Mining (the Division) conducted a partial inspection of the Crandall Canyon Mine's Burma Pond. The Burma Pond is the designed evaporation basin that receives the accumulated iron sludge material from the Crandall Canyon Mine's mine water treatment system located at the main surface facility. Questions had arose as to the extent of the accumulated iron sludge material in the Burma Pond as well as to sampling of the sludge itself for laboratory analysis. Refer to Dwg 5-3A for facilities layout.

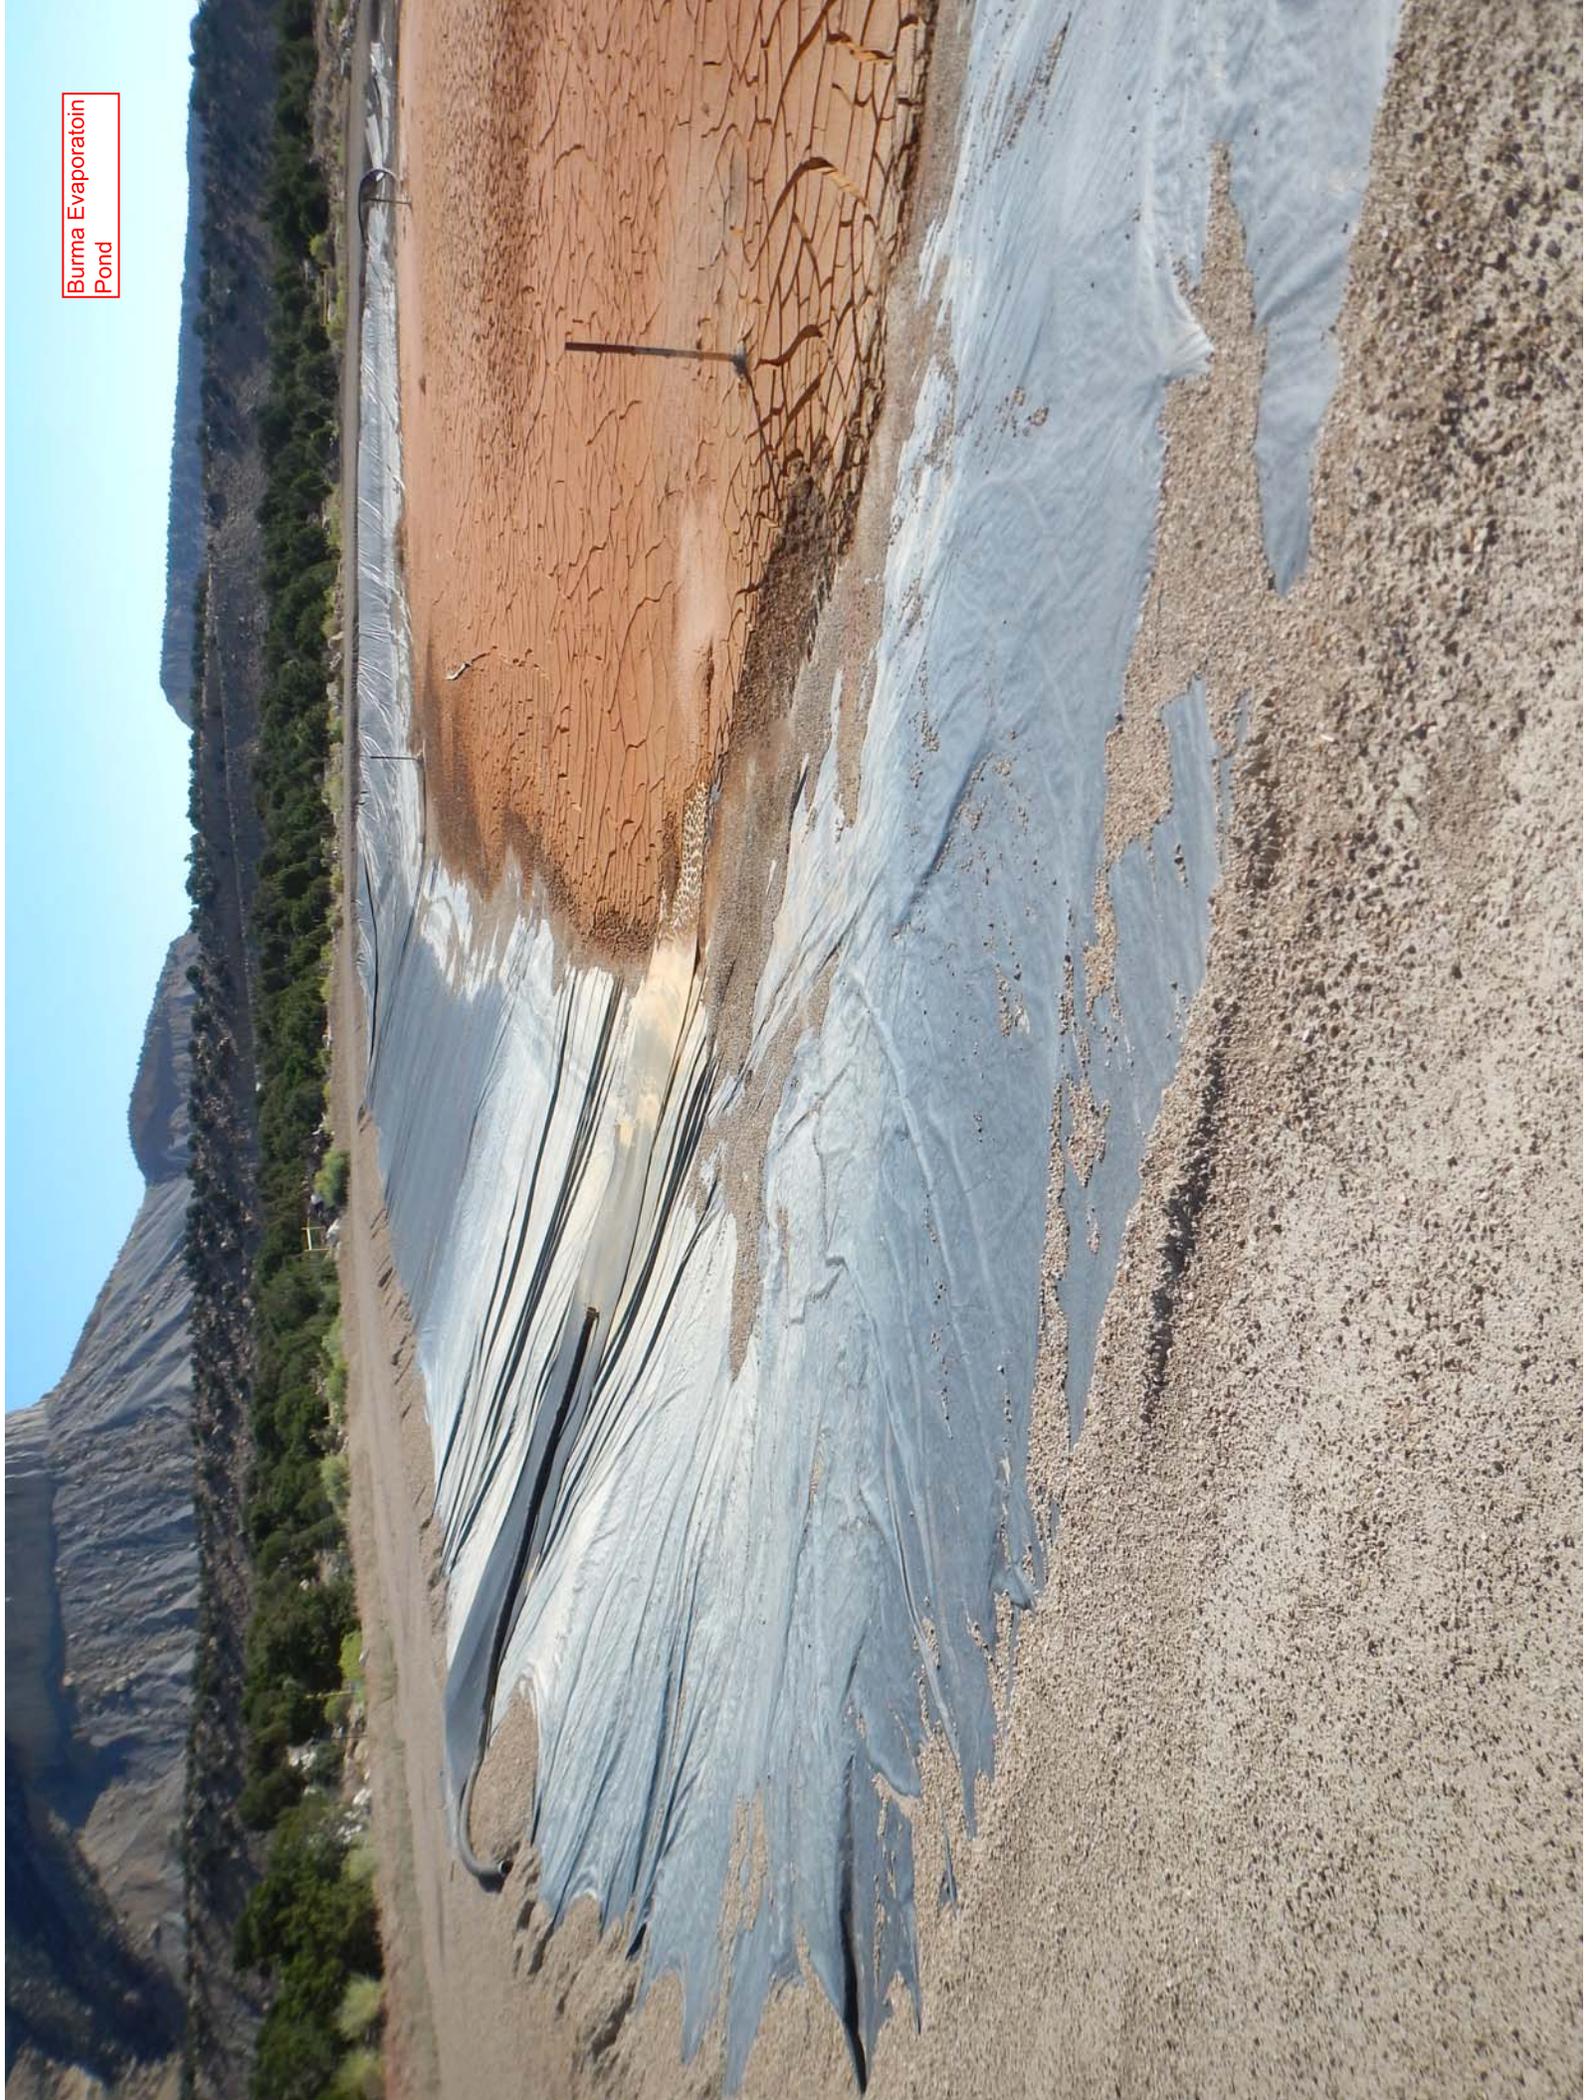
Burma Evaporatoin
Pond

The embankments of the basin and the liner were observed to be in good order. No signs of instability or erosion were noted with the embankments. The basin liner was also observed to be in good shape. No signs of excessive wear or issues were noted.

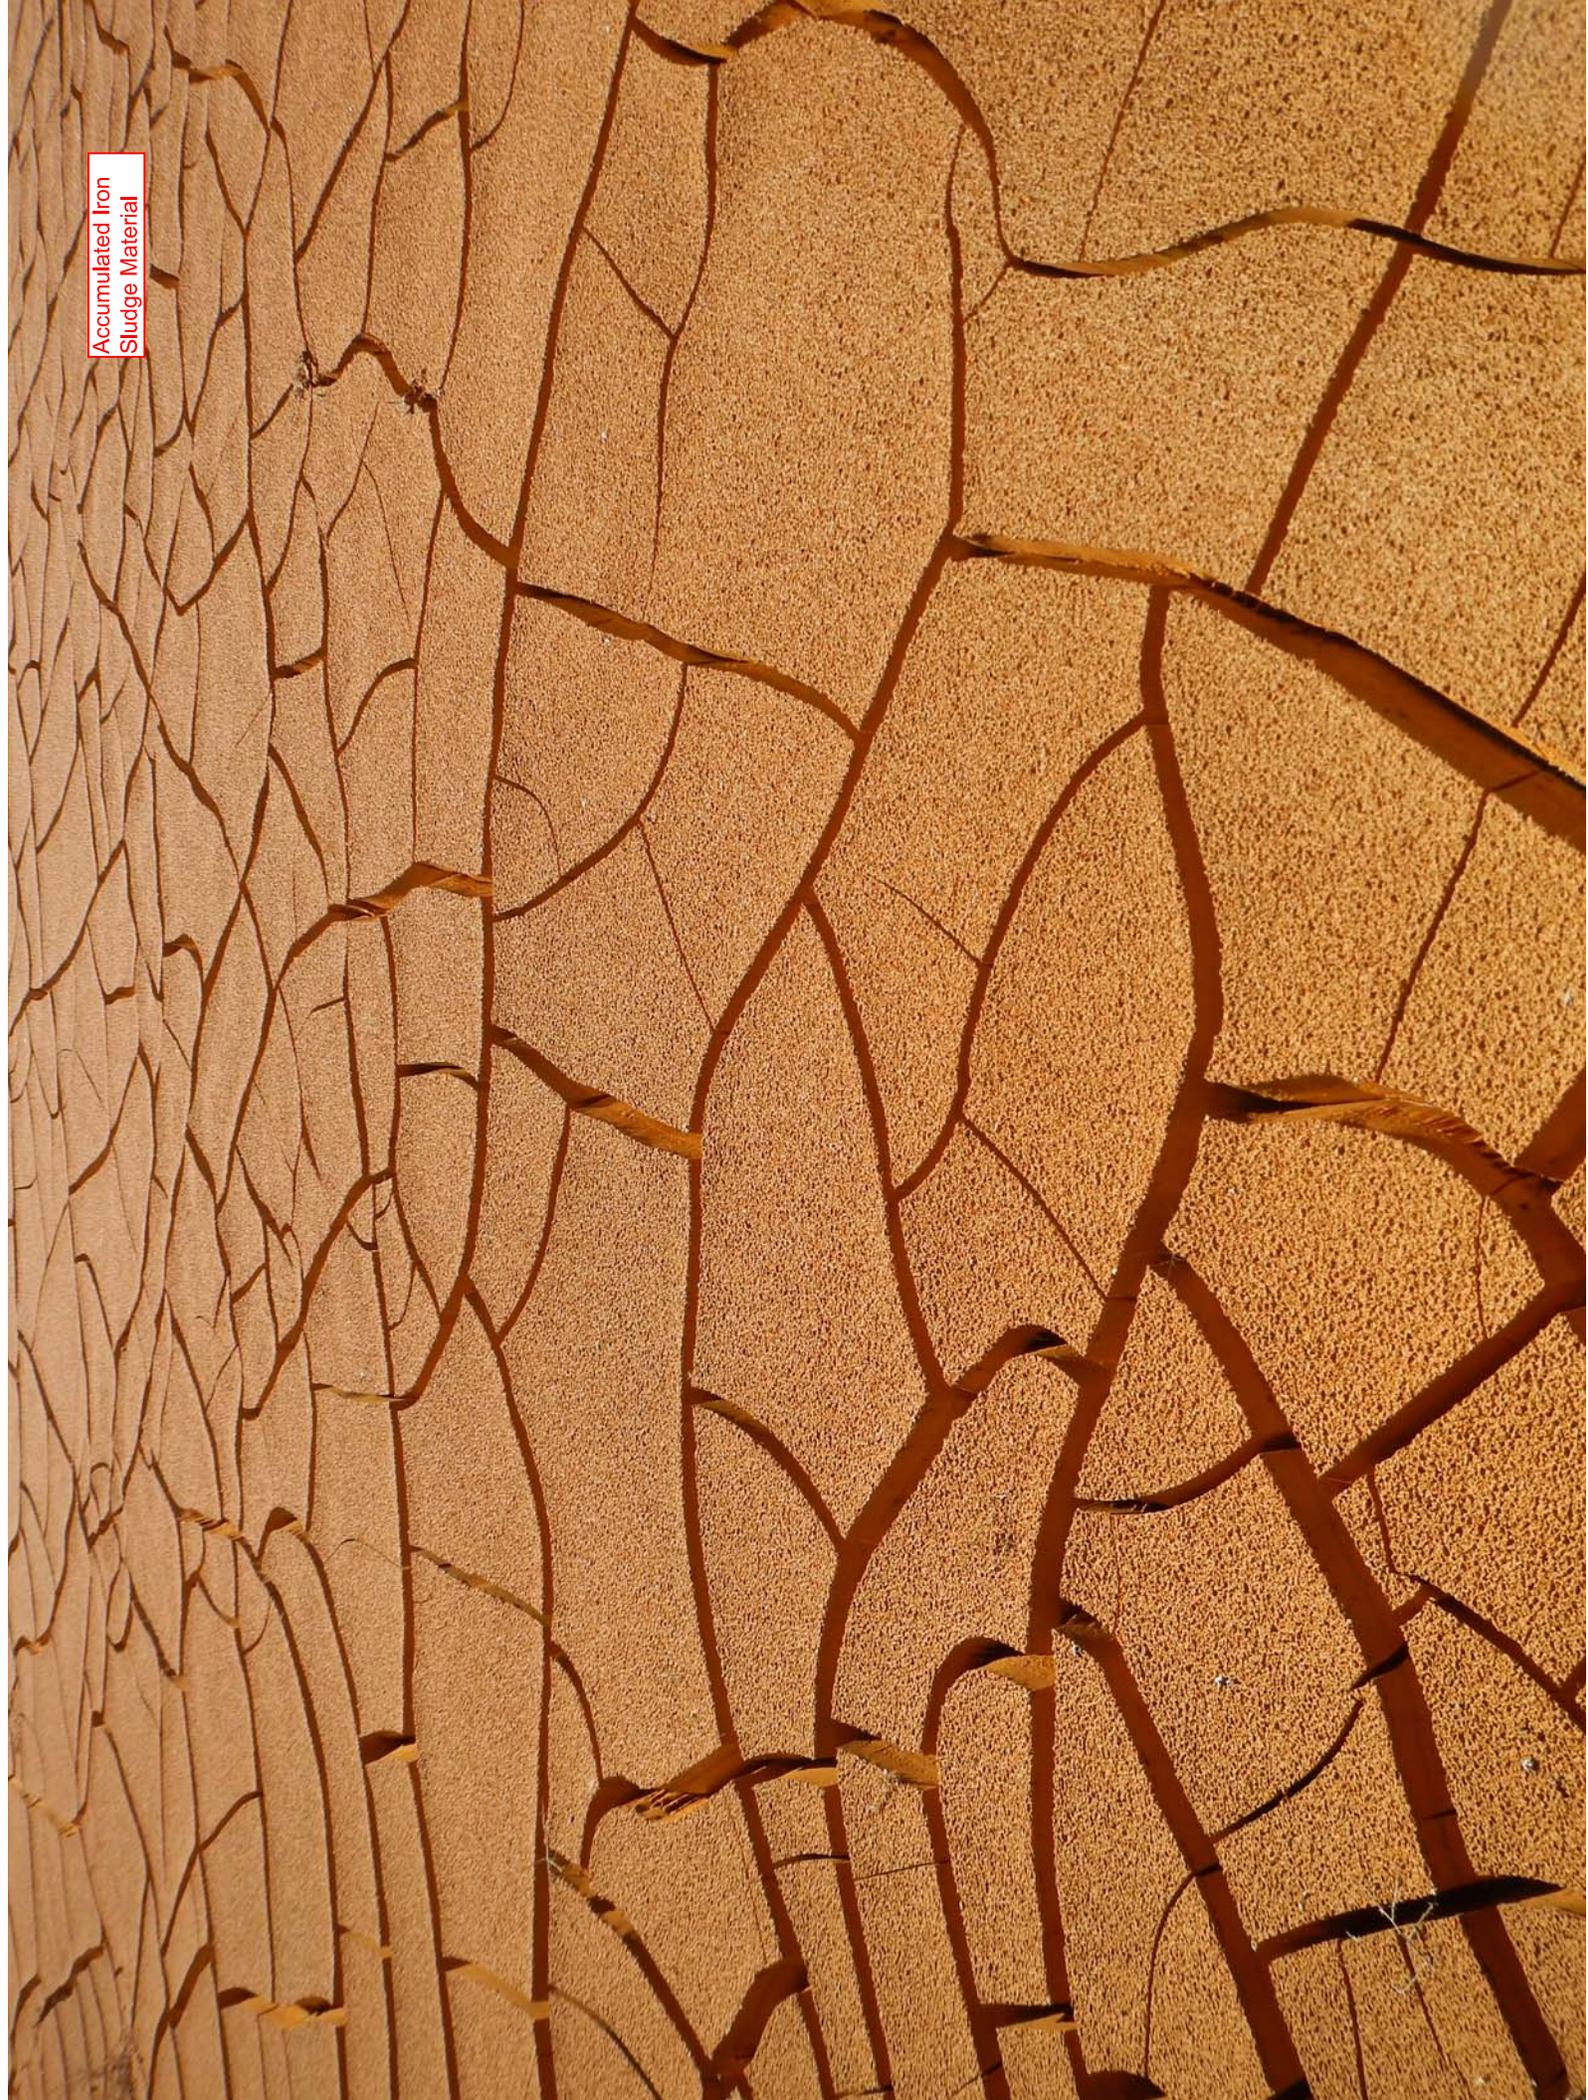
The Burma Pond evaporation basin (the basin) was inspected during the field inspection. The basin was dry during the inspection. No standing water was observed. The bottom of the basin is somewhat uniformly covered with the accumulated iron sludge material from the Crandall Canyon mine water treatment facility. Karin Madsen indicated that the last cleaning of the mine water treatment facilities detention pond was conducted for six consecutive days during the month of July. No subsequent cleaning had occurred since that time which aided in drying out the remaining moisture in the basin. In addition to evaporation of the water from the basin, Ms. Madsen indicated that Scamp Construction (the contractor utilized for cleaning of the mine water treatment facility pond and transport of said material to the Burma Pond) had also pumped residual water from the basin and transported it back to the mine water treatment pond. Ms. Madsen further indicated that a professional survey of the accumulated sludge elevation has been scheduled and would be conducted within the next two weeks. Depth of sludge at the pond's edge was measured at 5 inches. The pond has been in operation since 2013. Additionally, Mt. Nebo has been contracted to sample the accumulated sludge material and submit the samples for laboratory analysis per the requirements of the Mining and Reclamation Plan (MRP). Mt Nebo will subcontract with Robert Long, a Certified Soil Scientist. Pond sampling is described in Appendix 7-66 Chapter 5, Item 2. During the inspection, the four sediment clean-out markers established in the basin were observed. It was unclear as to how the clean-out elevation (6,519.0') was discerned on the four markers. It was agreed that when the professional surveyor (Cody Ware) was on-site, the markers would be marked in some way (e.g. spray-paint) as to clearly identify the sediment clean-out elevation. Assigned inspector Steve Demczak will verify the establishment of the clean-out elevation on the markers in subsequent inspections.

Accumulated Iron
Sludge Material
