## May 1, 2017 Crandall Canyon partial inspection report

# Inspection Report

Permit Number:	C0150032
Inspection Type:	PARTIAL
Inspection Date:	Monday, May 1, 2017
Start Date/Time:	5/1/2017 11:30:00 AM
End Date/Time:	5/1/2017 2:30:00 PM
Last Inspection:	Monday, April 17, 2017

Permittee: **GENWAL RESOURCES INC**  
 Operator: **GENWAL RESOURCES INC**  
 Site: **CRANDALL CANYON MINE**  
 Address: **PO BOX 910, EAST CARBON UT 84520-0910**  
 County: **EMERY**  
 Permit Type: **PERMANENT COAL PROGRAM**  
 Permit Status: **INACTIVE**

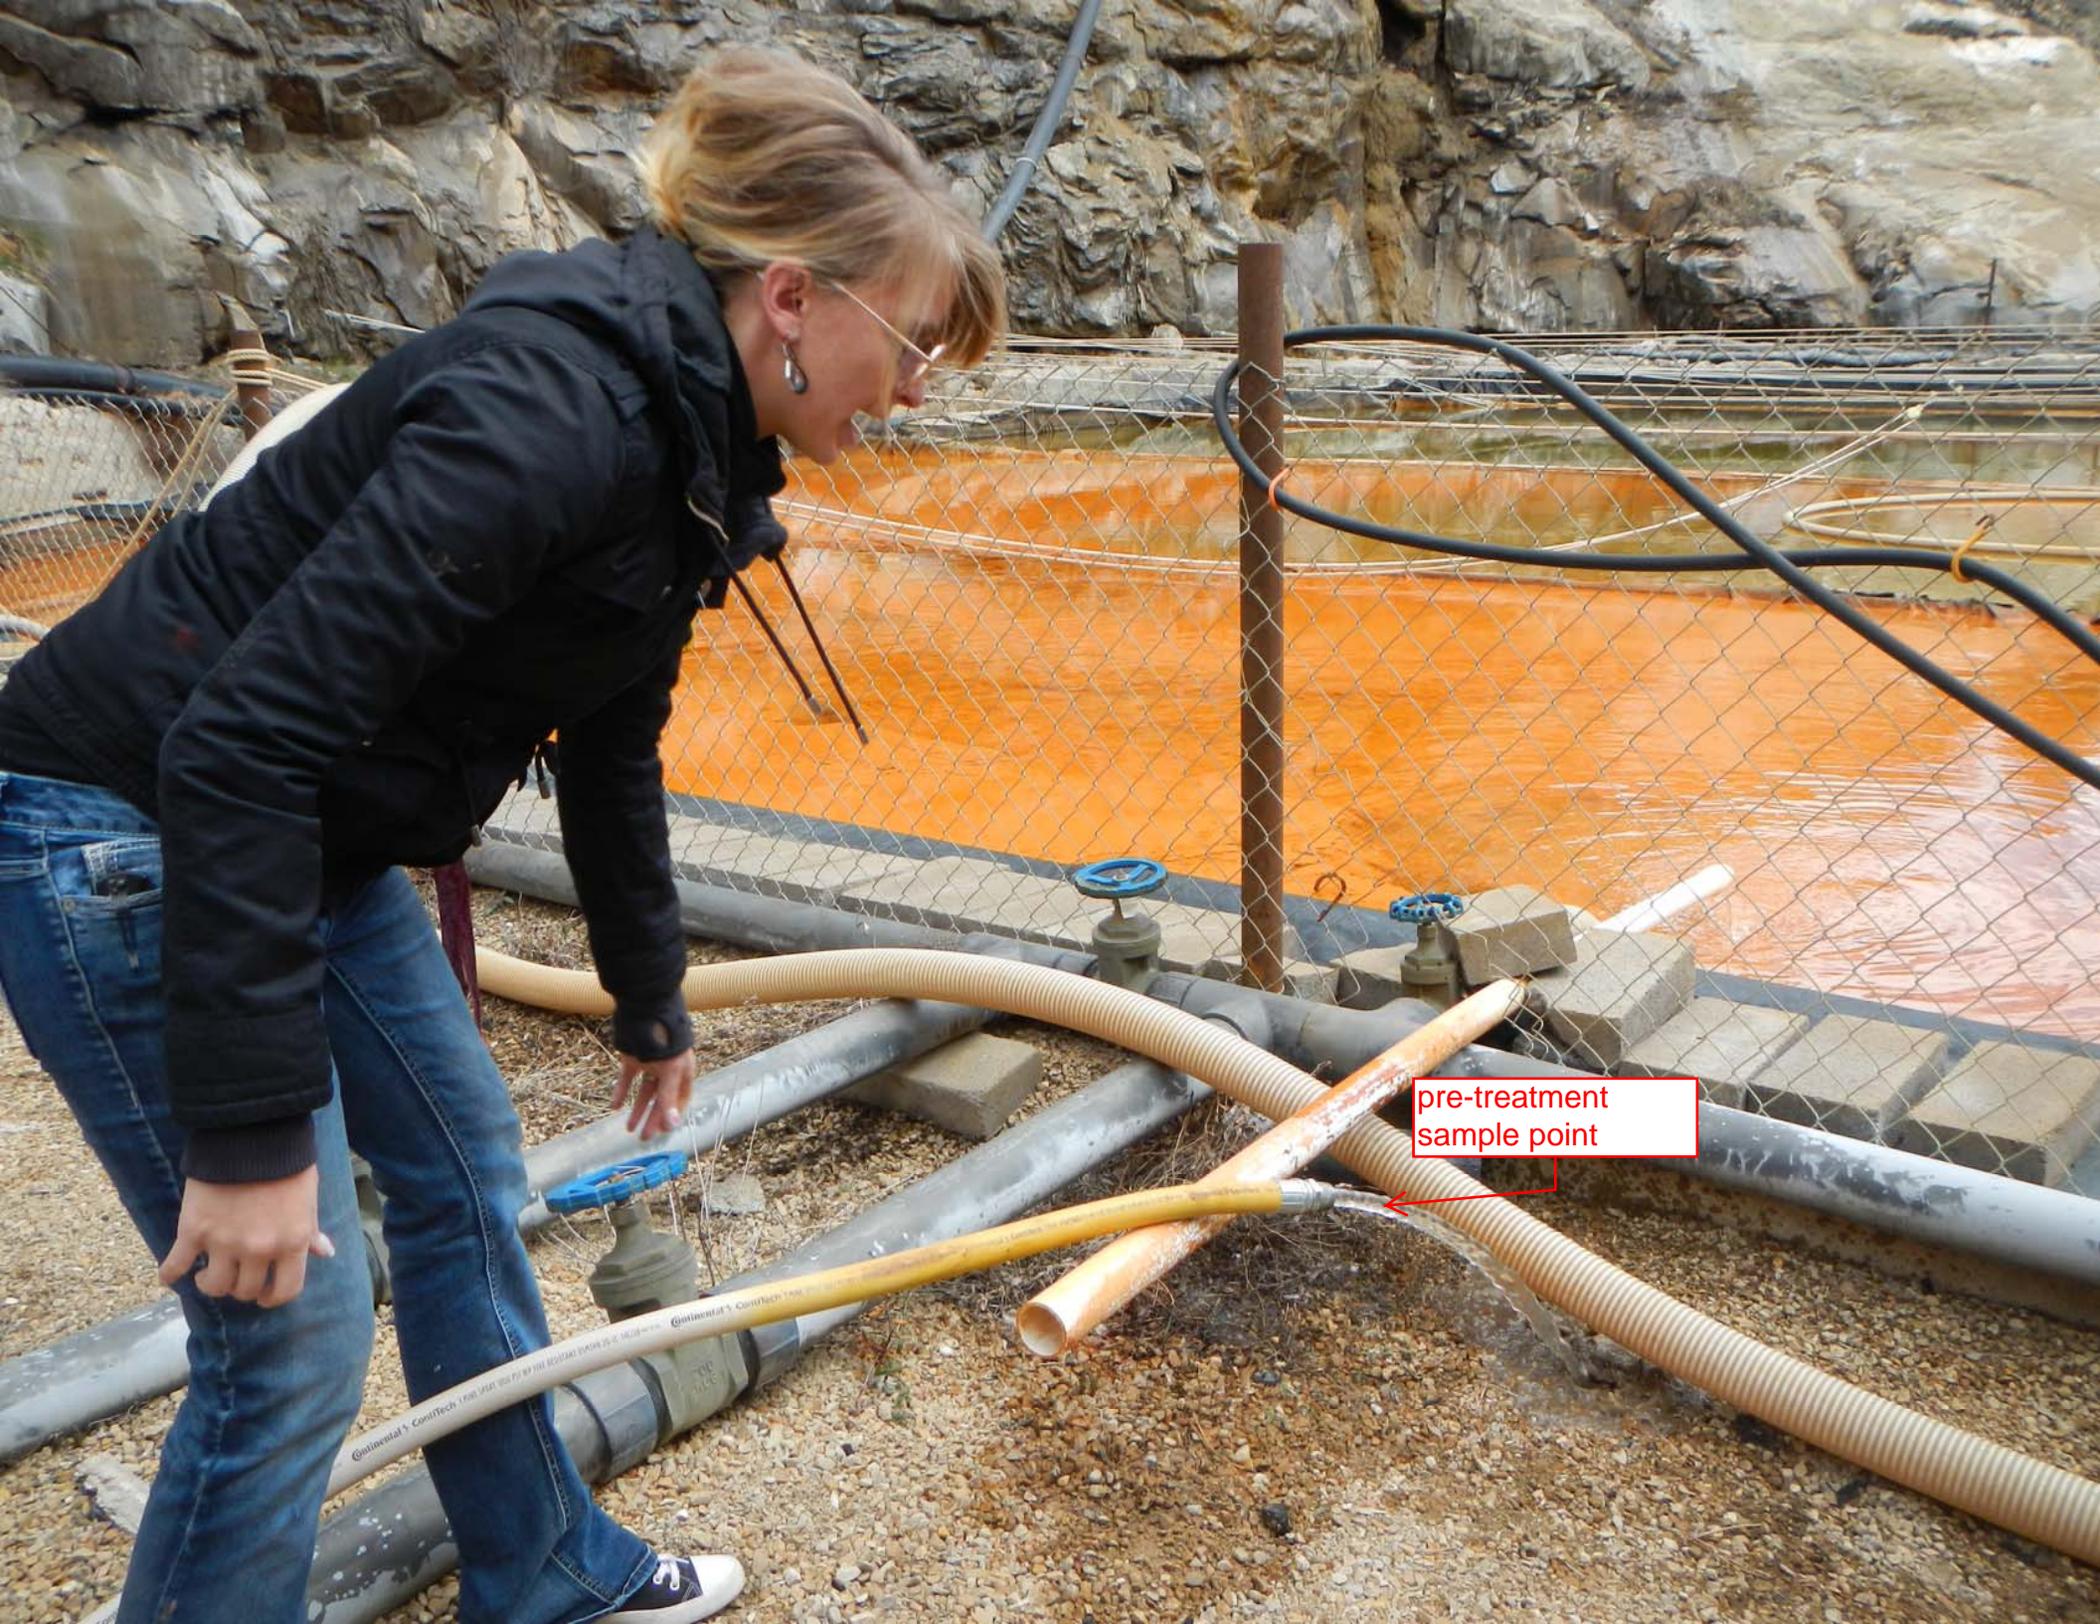
Ms. Madsen gave us a tour of the treatment facilities and described the treatment process in detail. At the time of the inspection, mine water was flowing at 261 gpm. To treat the water, coagulant (Al+Cl-) was being added at 6.5 ppm and flocculant (polyacrilimide) was being added at 5.7 ppm. Samples of the mine water pre-treatment (location pre-001) and at the discharge point post-treatment (discharge location 001) were taken.

pre-treatment  
sample point

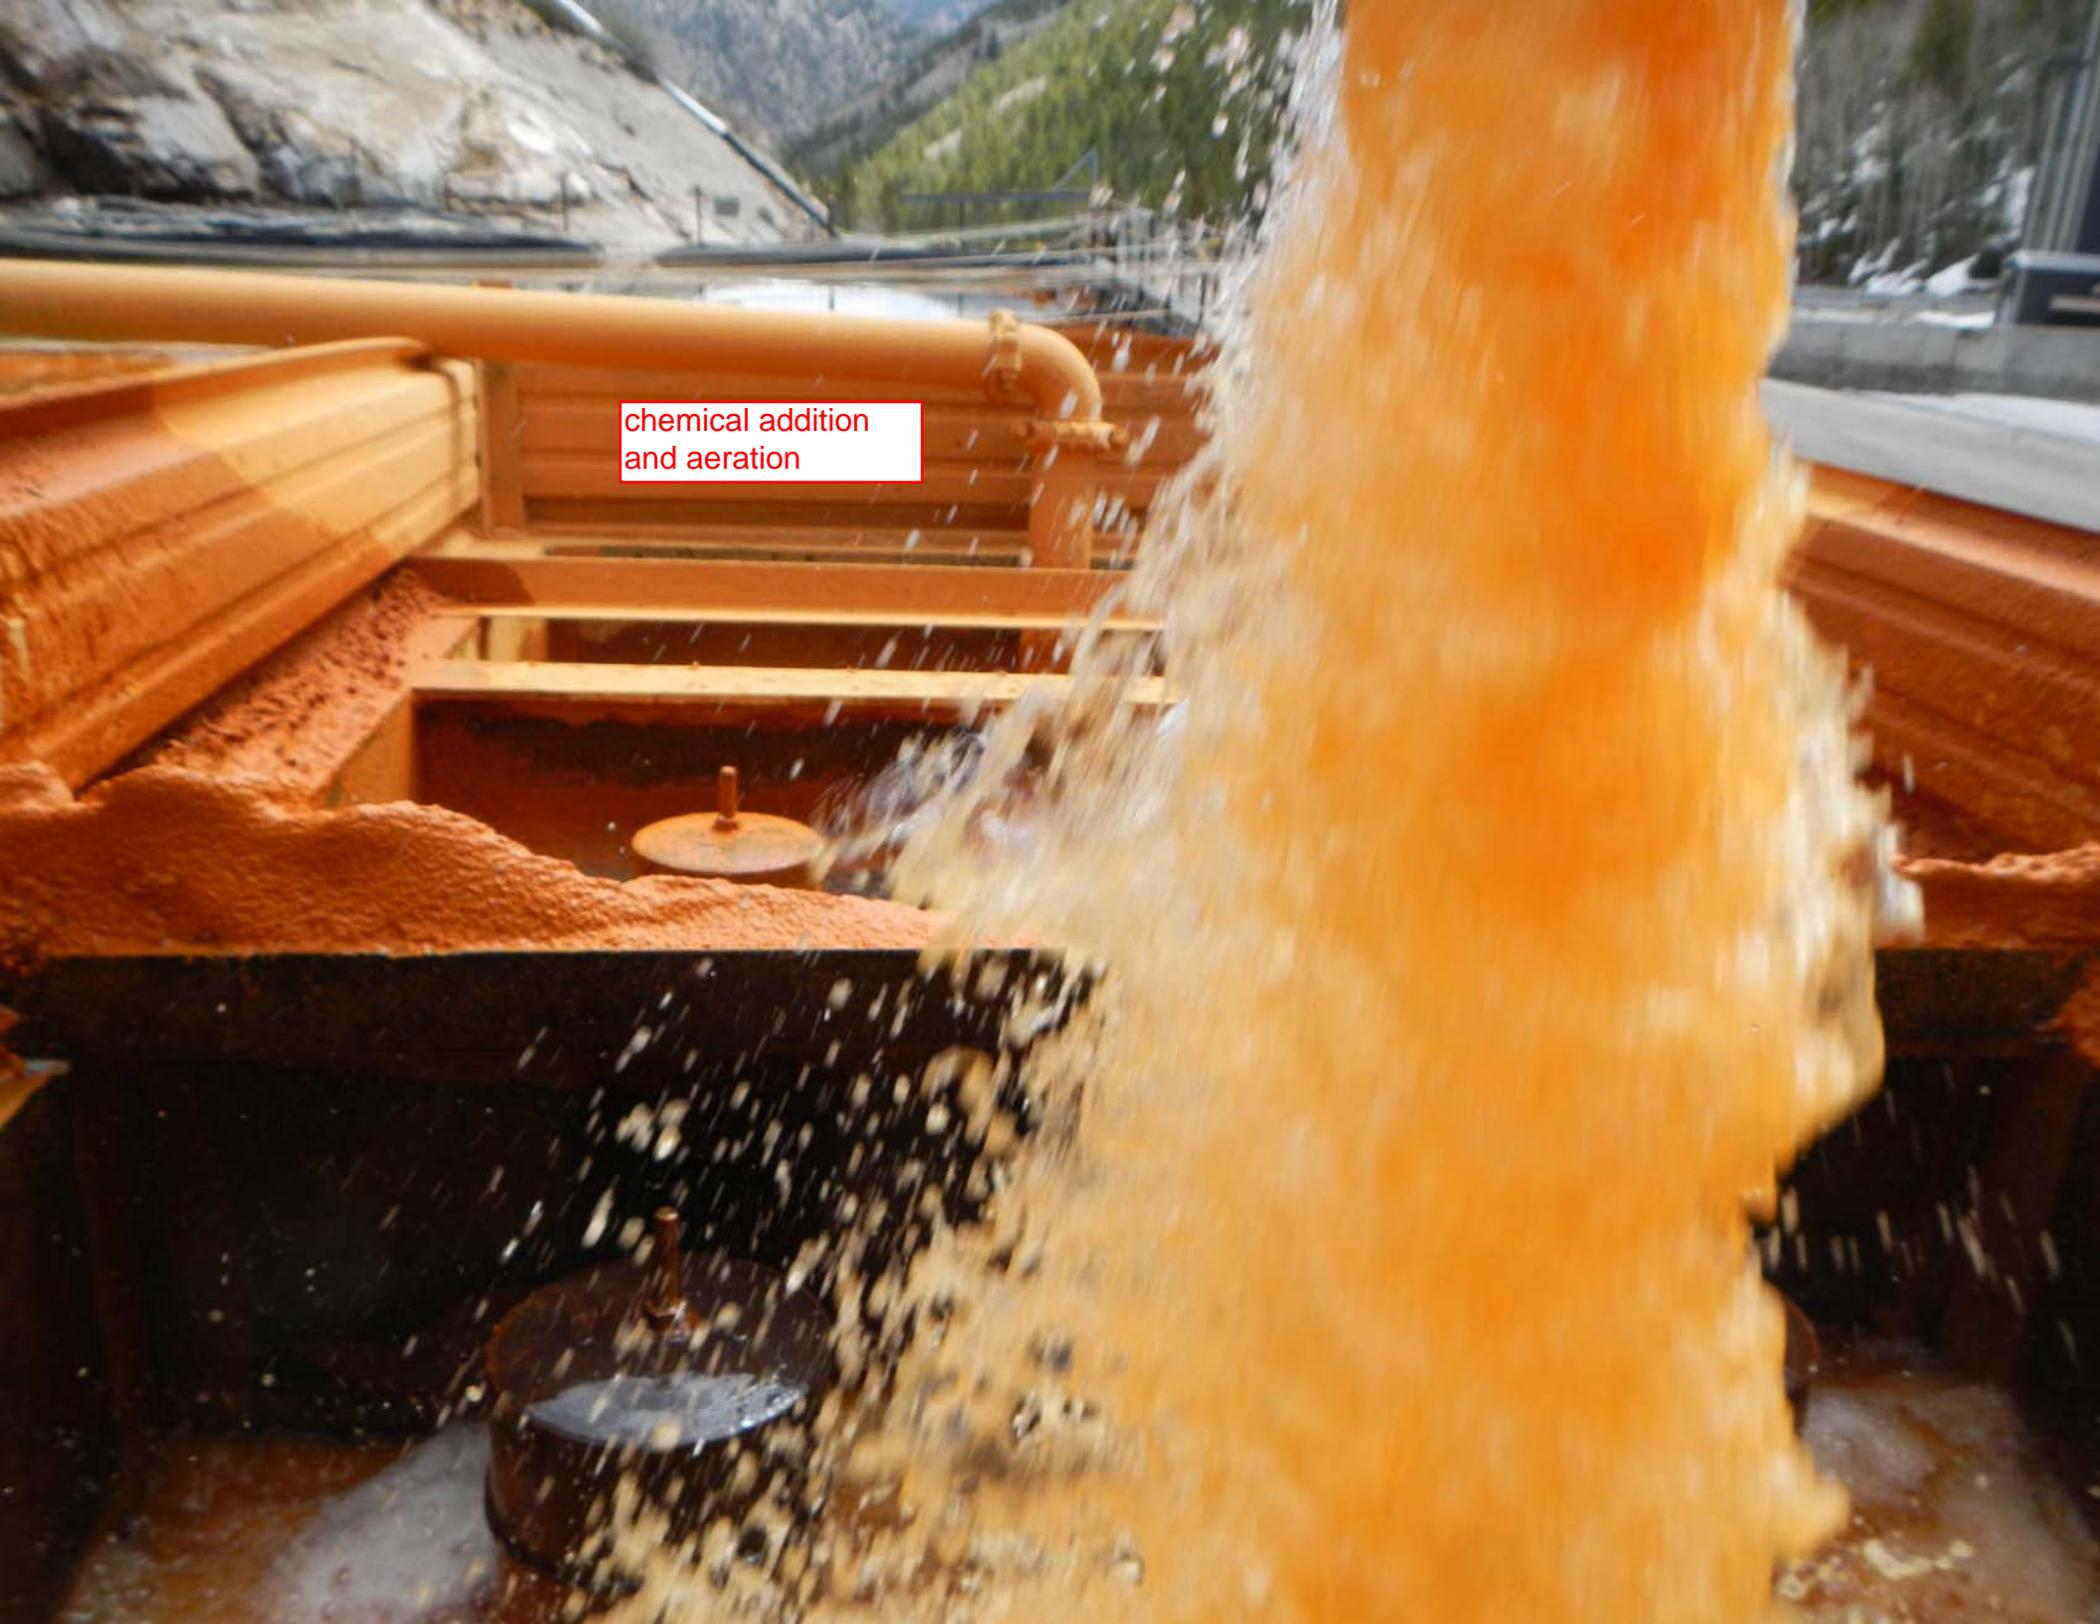
chemical addition  
and aeration

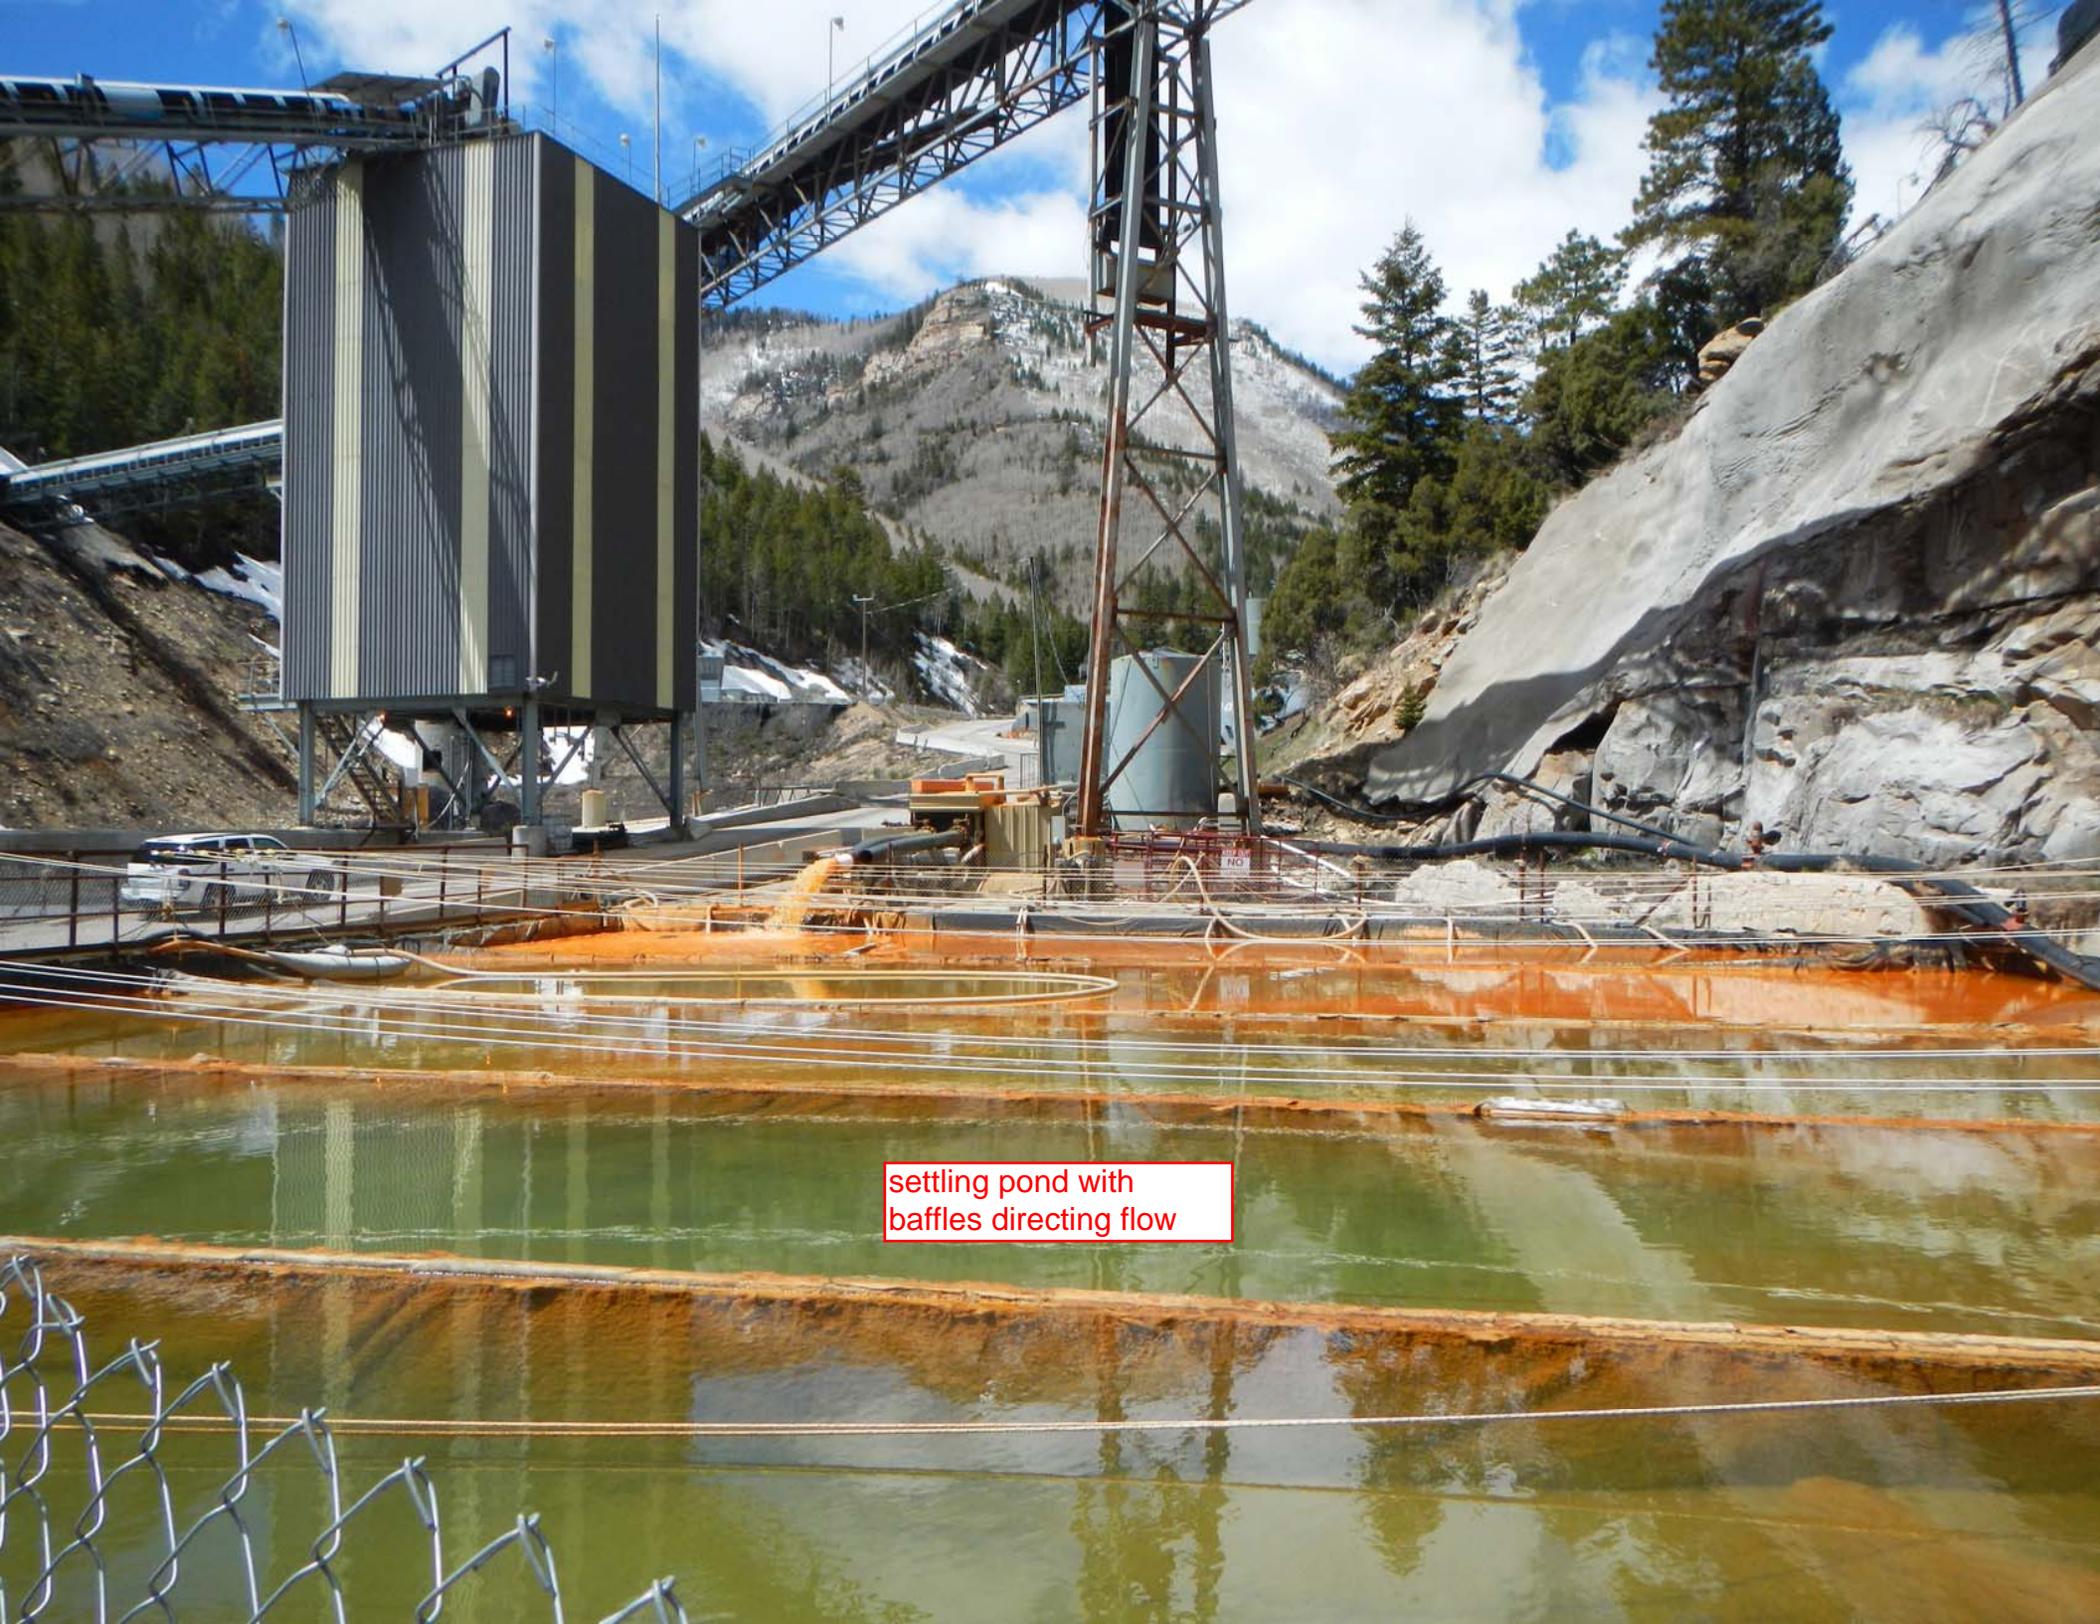
The mine-water discharge treatment system was inspected and found to be functioning as designed. Karin Madsen indicated that the treatment system settling pond had last been cleaned approximately two months ago. With the exception of the re-circulation cell (cell one), excessive accumulations of iron sludge accumulations were not observed in the remaining cells. The flocculant and coagulant injections were noted during the inspection. At the time of the inspection, a flocculant (Nalco 7763) injection rate of 5.77 parts per million (ppm) was noted. The coagulant (Nalco 8187) injection rate was 6.5 ppm. The storage unit that houses the aforementioned treatment chemicals was inspected. The secondary containment units and bulk storage tanks were observed to be in good condition. No evidence of leaks or spills were noted during the inspection.

settling pond with baffles directing flow

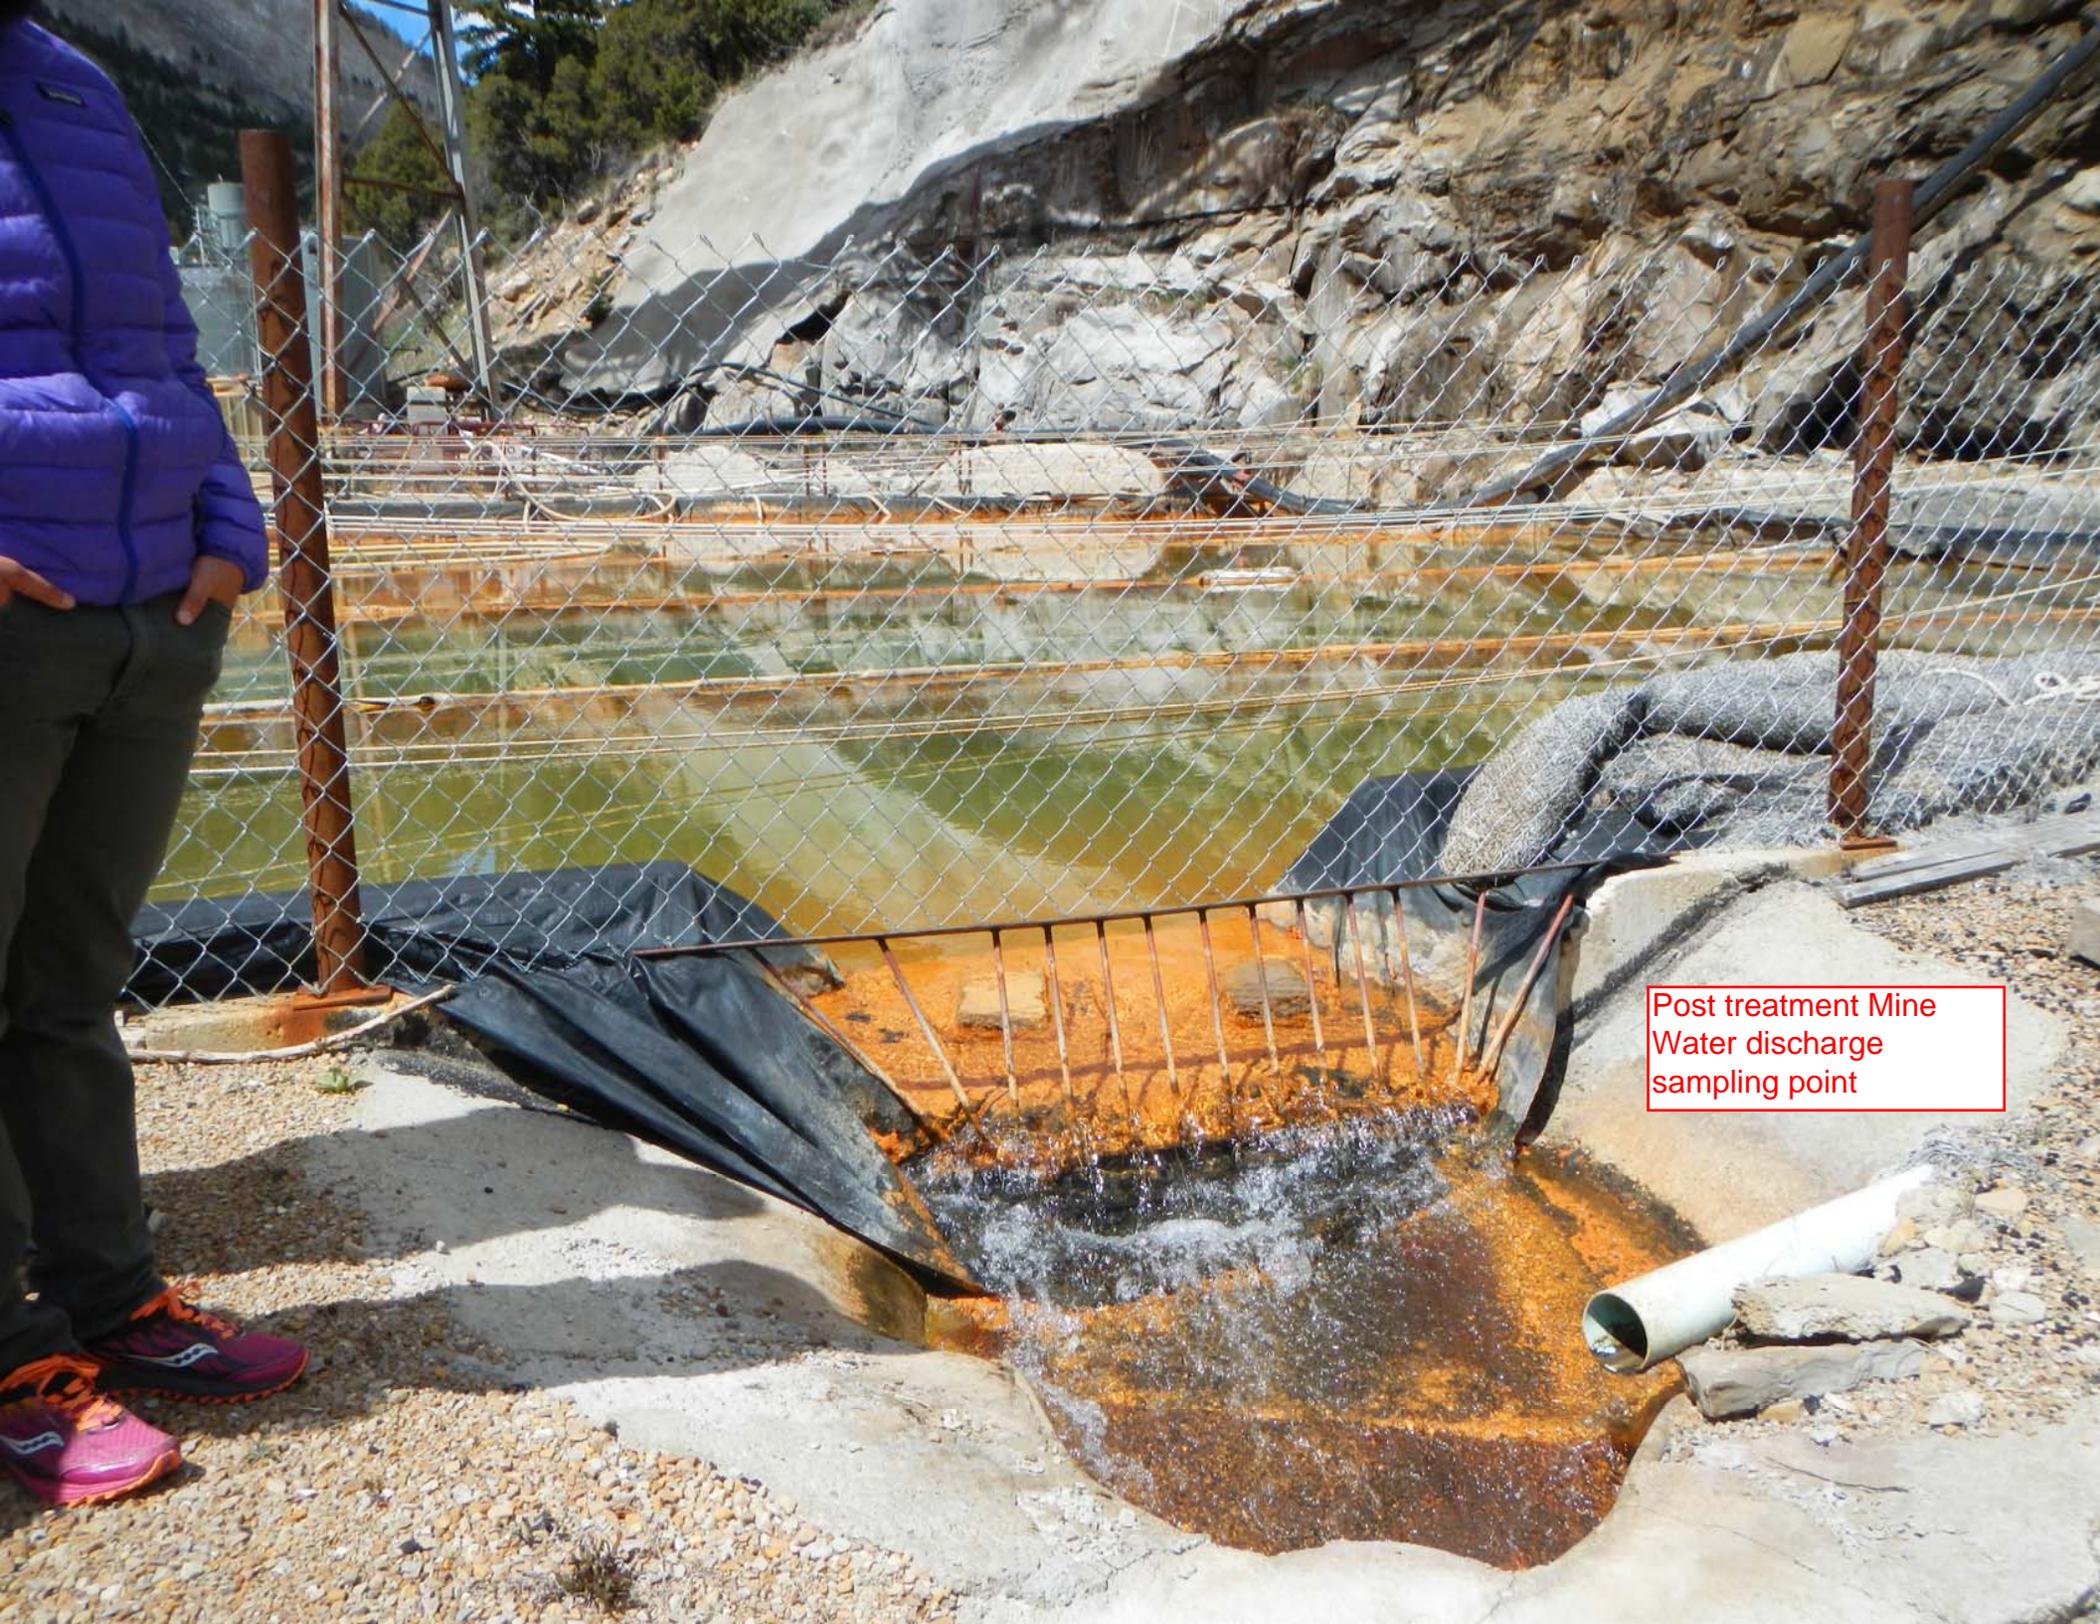
Post treatment Mine  
Water discharge  
sampling point

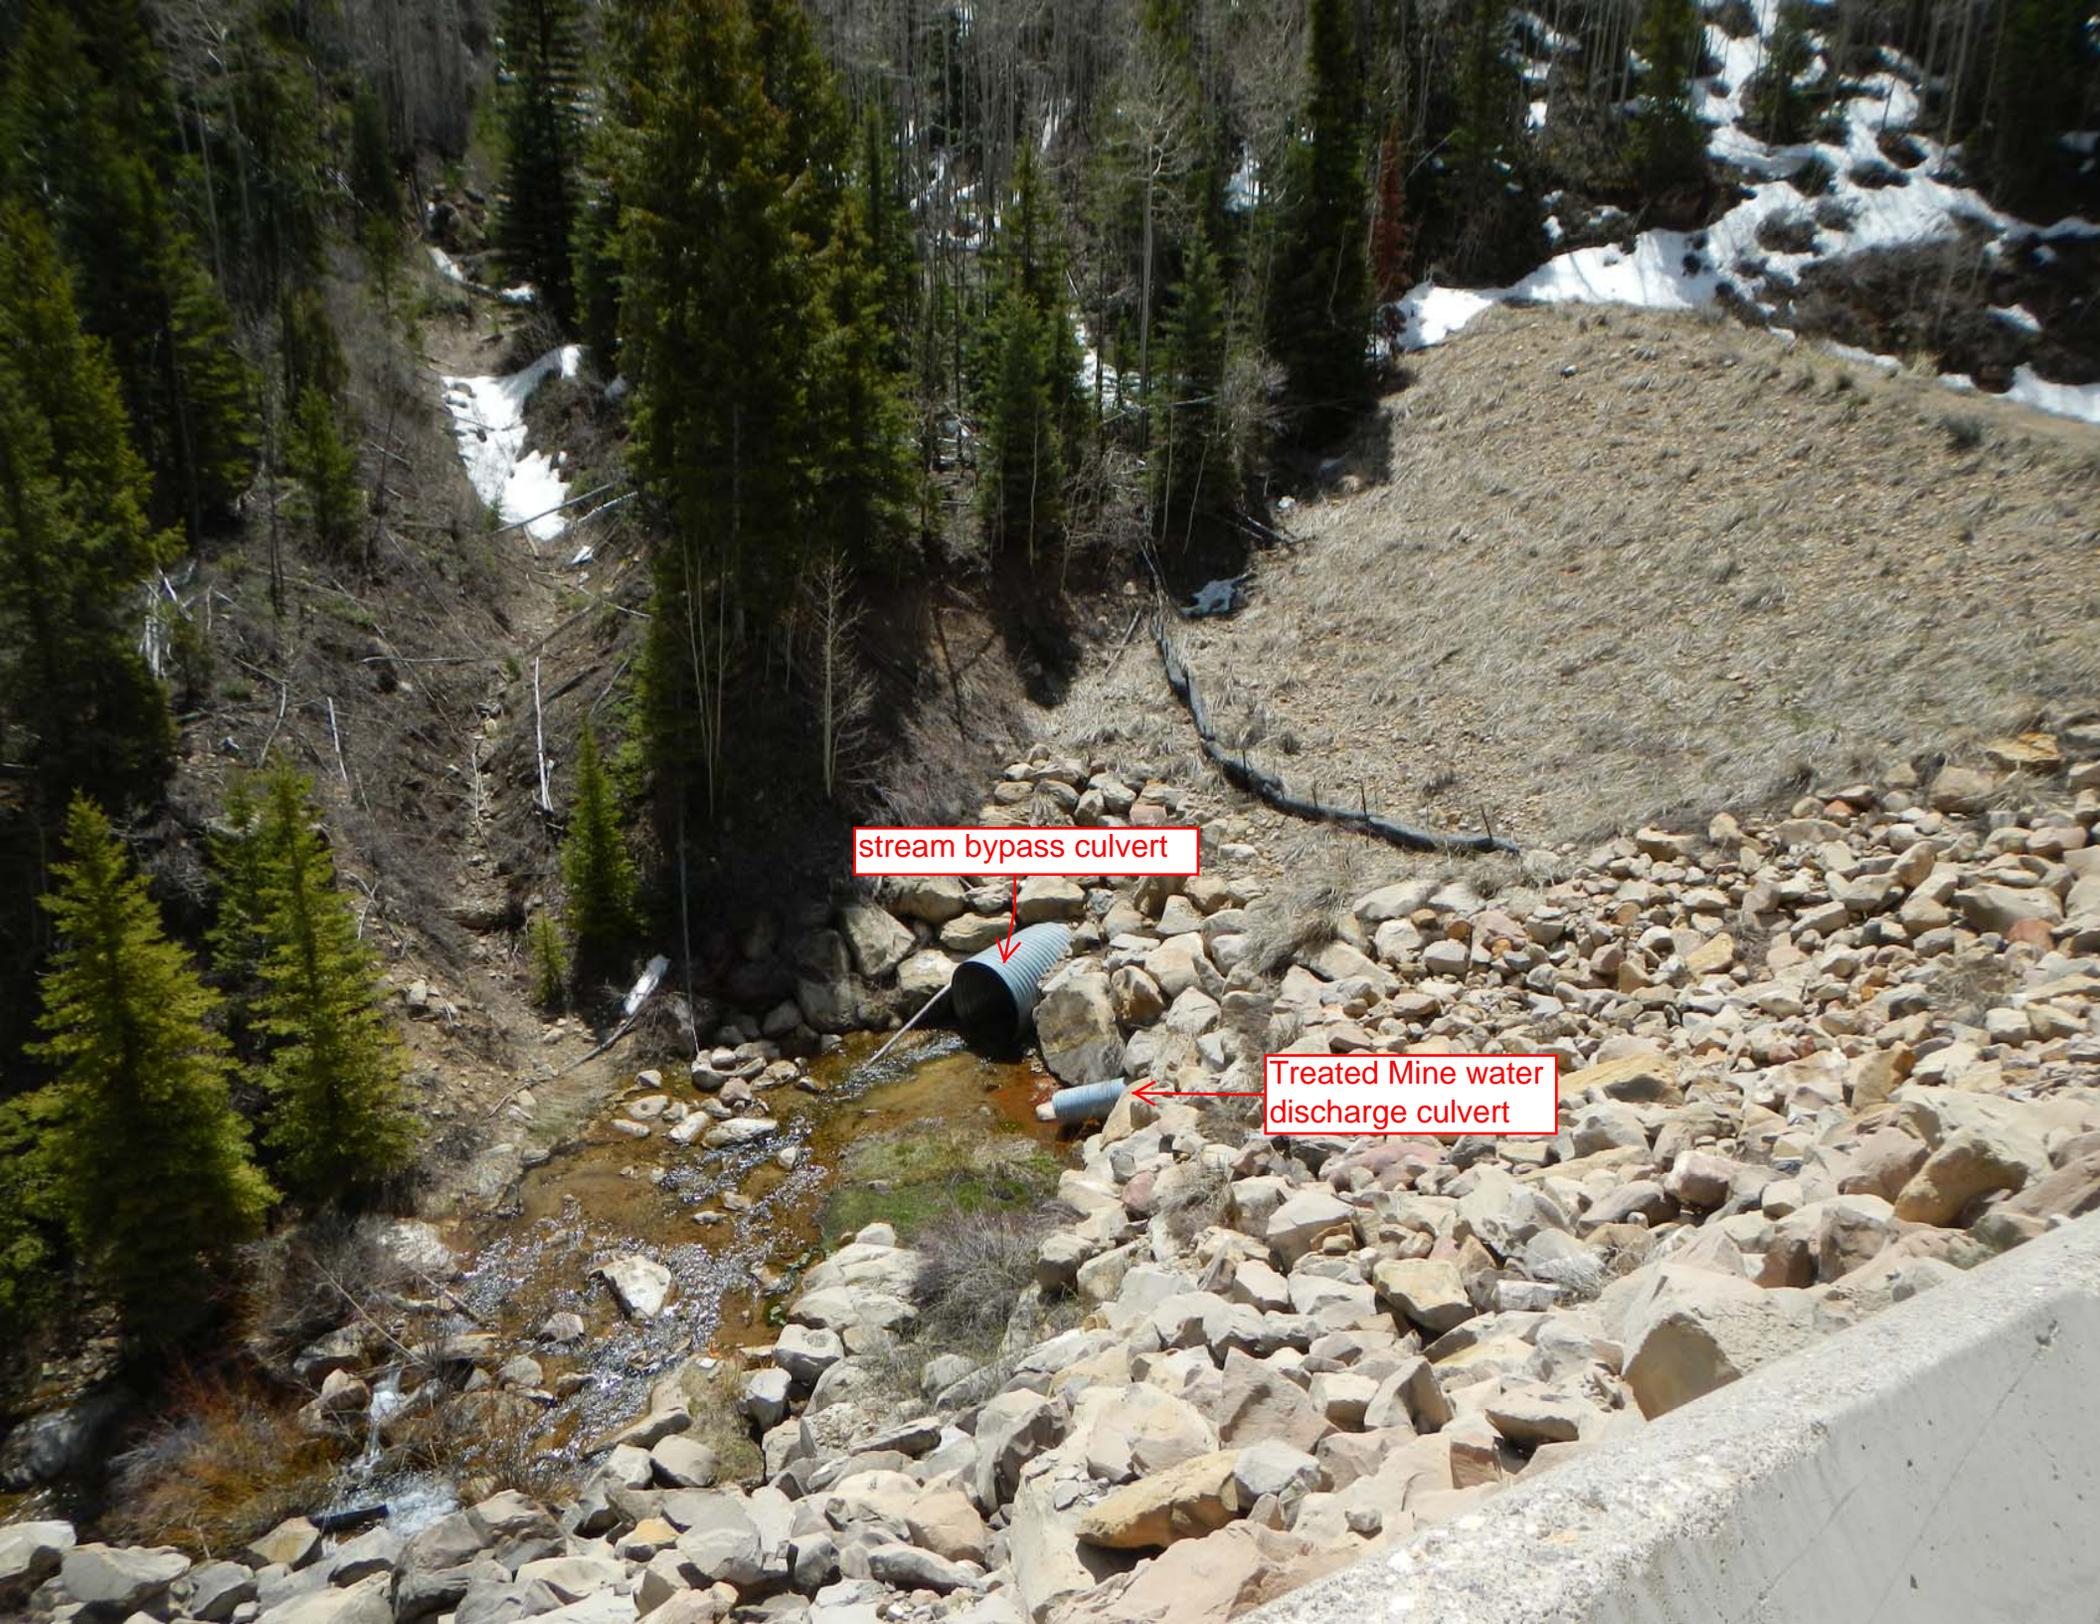
stream bypass culvert

Treated Mine water discharge culvert

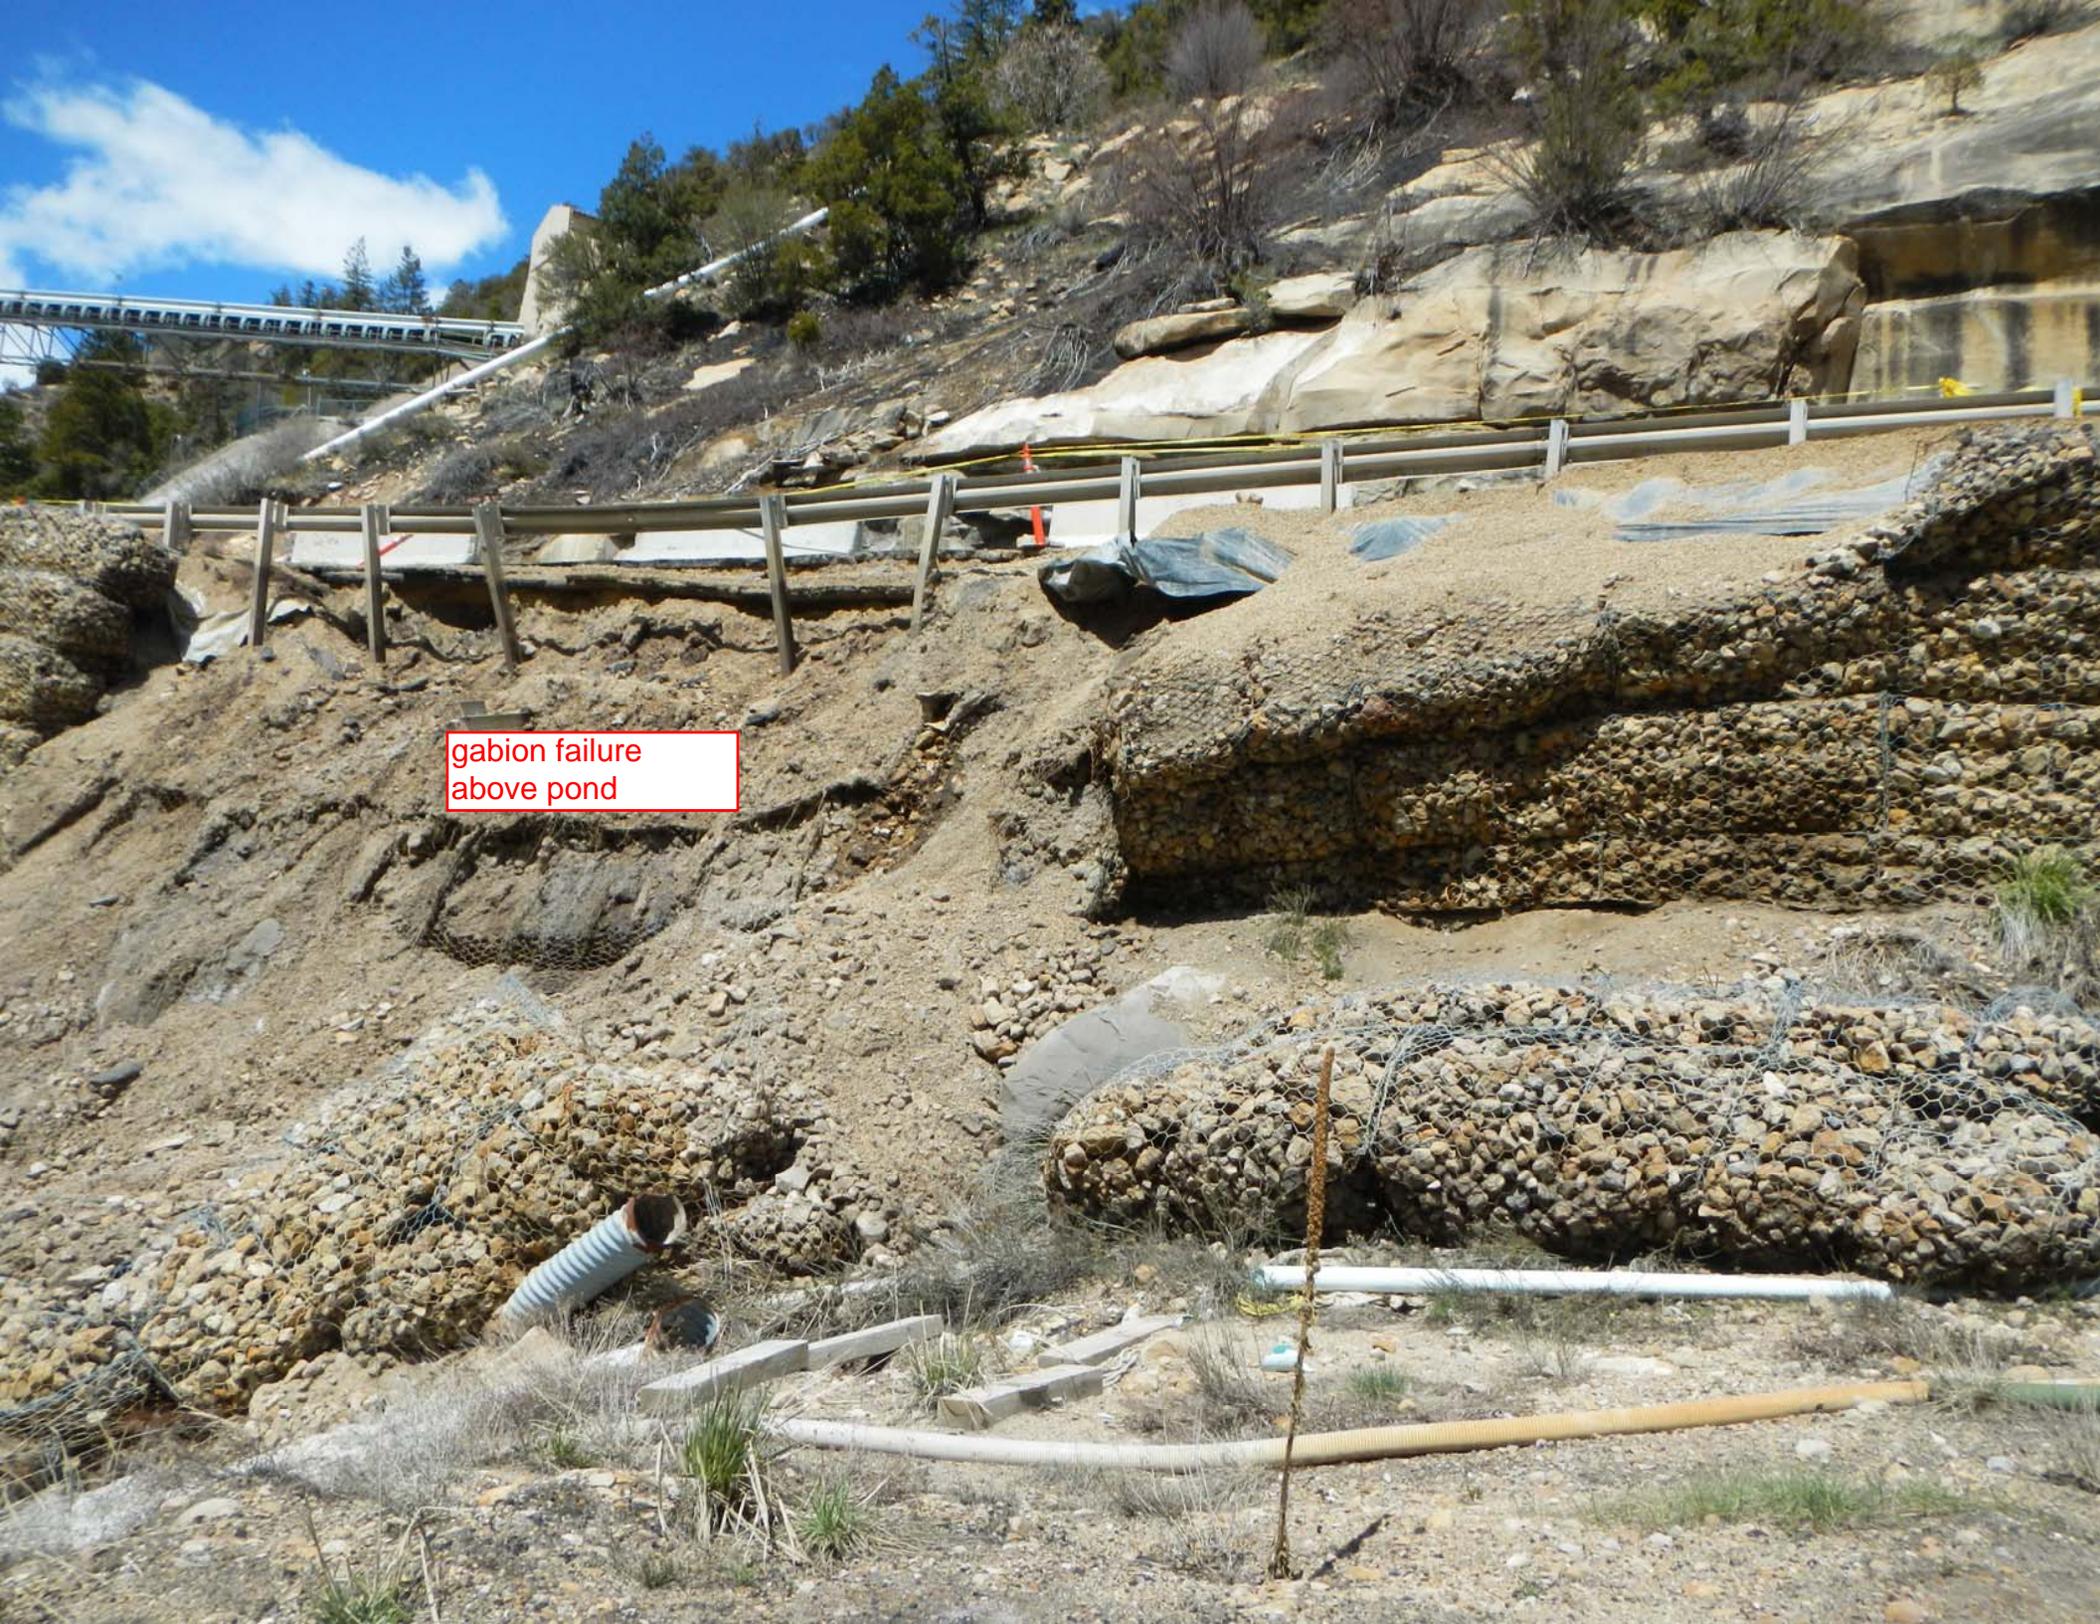
We observed damage to the gabion baskets supporting the USFS road directly above sediment pond 001. A plan for reconstruction is being formulated. The damage is within the permit area boundary. An application will be filed with the Division if changes to the approved plan are necessary.

gabion failure  
above pond
