## May 1, 2017 Crandall Canyon partial inspection report

# Inspection Report

Permit Number:	C0150032
Inspection Type:	PARTIAL
Inspection Date:	Monday, May 1, 2017
Start Date/Time:	5/1/2017 11:30:00 AM
End Date/Time:	5/1/2017 2:30:00 PM
Last Inspection:	Monday, April 17, 2017

Permittee: **GENWAL RESOURCES INC**  
 Operator: **GENWAL RESOURCES INC**  
 Site: **CRANDALL CANYON MINE**  
 Address: **PO BOX 910, EAST CARBON UT 84520-0910**  
 County: **EMERY**  
 Permit Type: **PERMANENT COAL PROGRAM**  
 Permit Status: **INACTIVE**

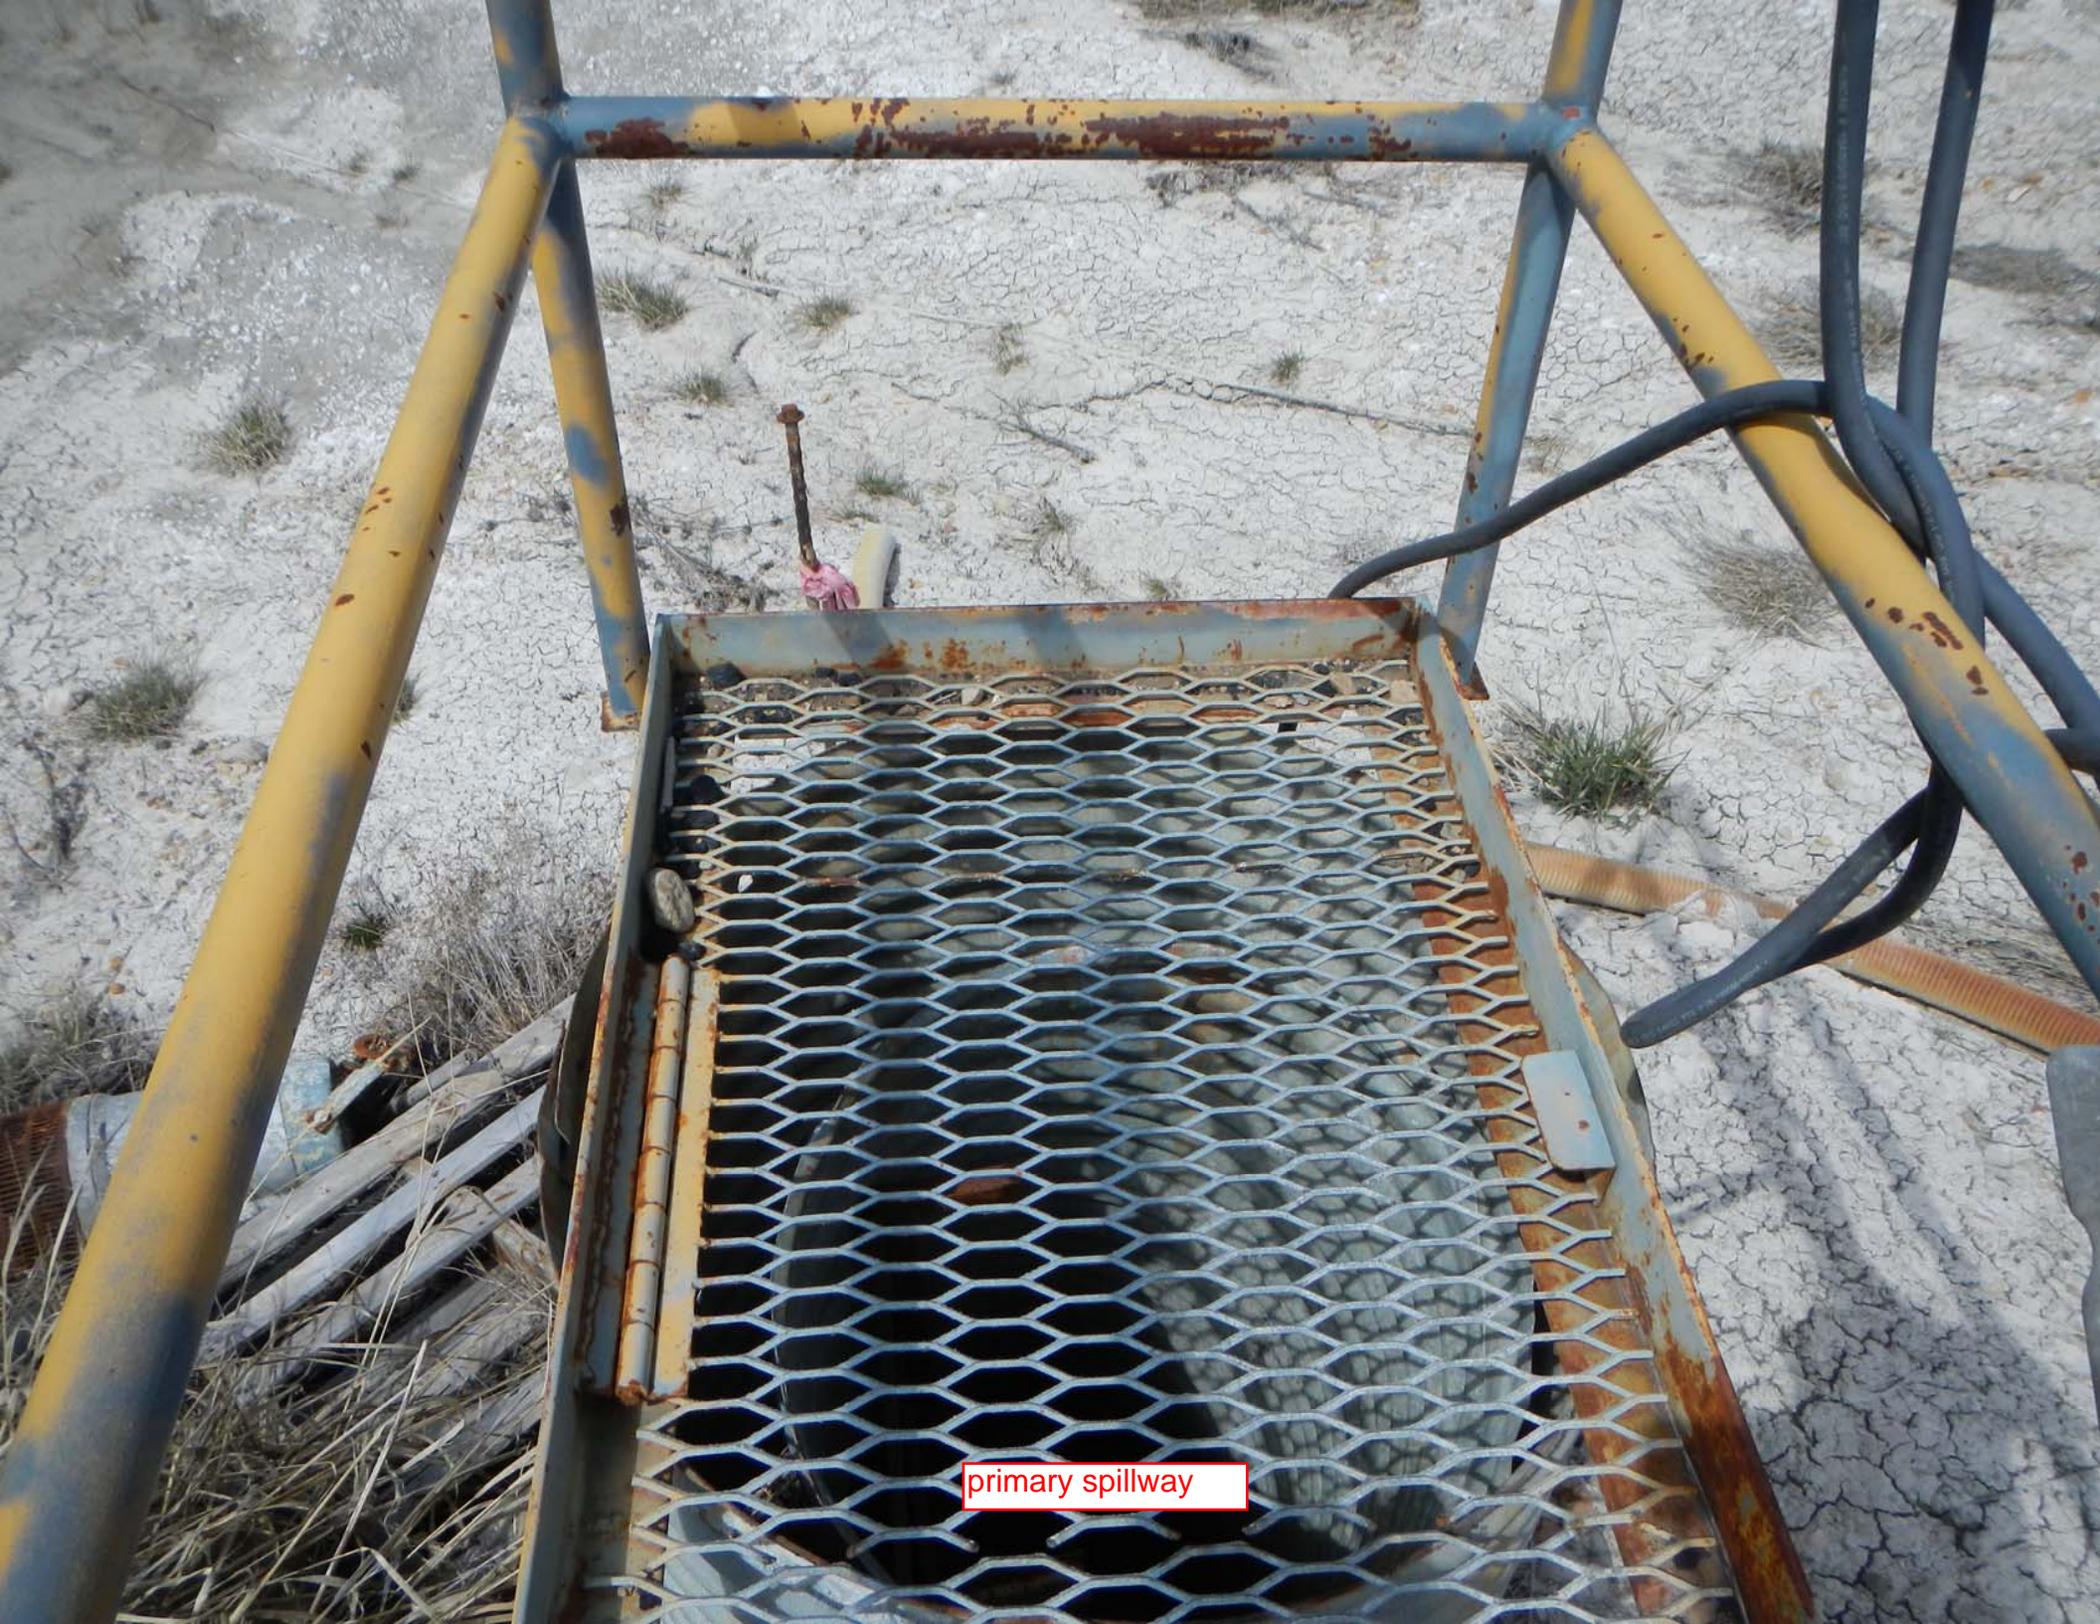
The water level in pond 001 is far below the primary spillway. The oil skimmer on the primary spillway of pond 001 is not functional. The trash rack is missing from the principal spillway and the access walkway is functioning as a trashrack. Maintenance is required on the primary spillway to allow the trash rack and oil skimmer to function as designed. The primary sediment pond sediment markers were inspected. Two of the sediment markers were visible during the inspection. The third sediment marker (located in the south-west section of the sediment pond) was not visible. Karin Madsen indicated that Cody Ware (Ware Surveying) would be surveying the sediment markers when the sediment pond had dried out. At that time, the 60% sediment clean-out levels will be re-established on the three sediment markers. The jersey barriers located adjacent to the primary sediment ponds access road were observed in disrepair and require maintenance. Several of the barriers were leaning excessively and unstable. The Permittee must repair these barriers.

primary spillway

I have attached the Division's report for the partial inspection conducted on May 1, 2017. As a reminder, during this inspection, we noted that the trash rack on the primary spillway needs repair.

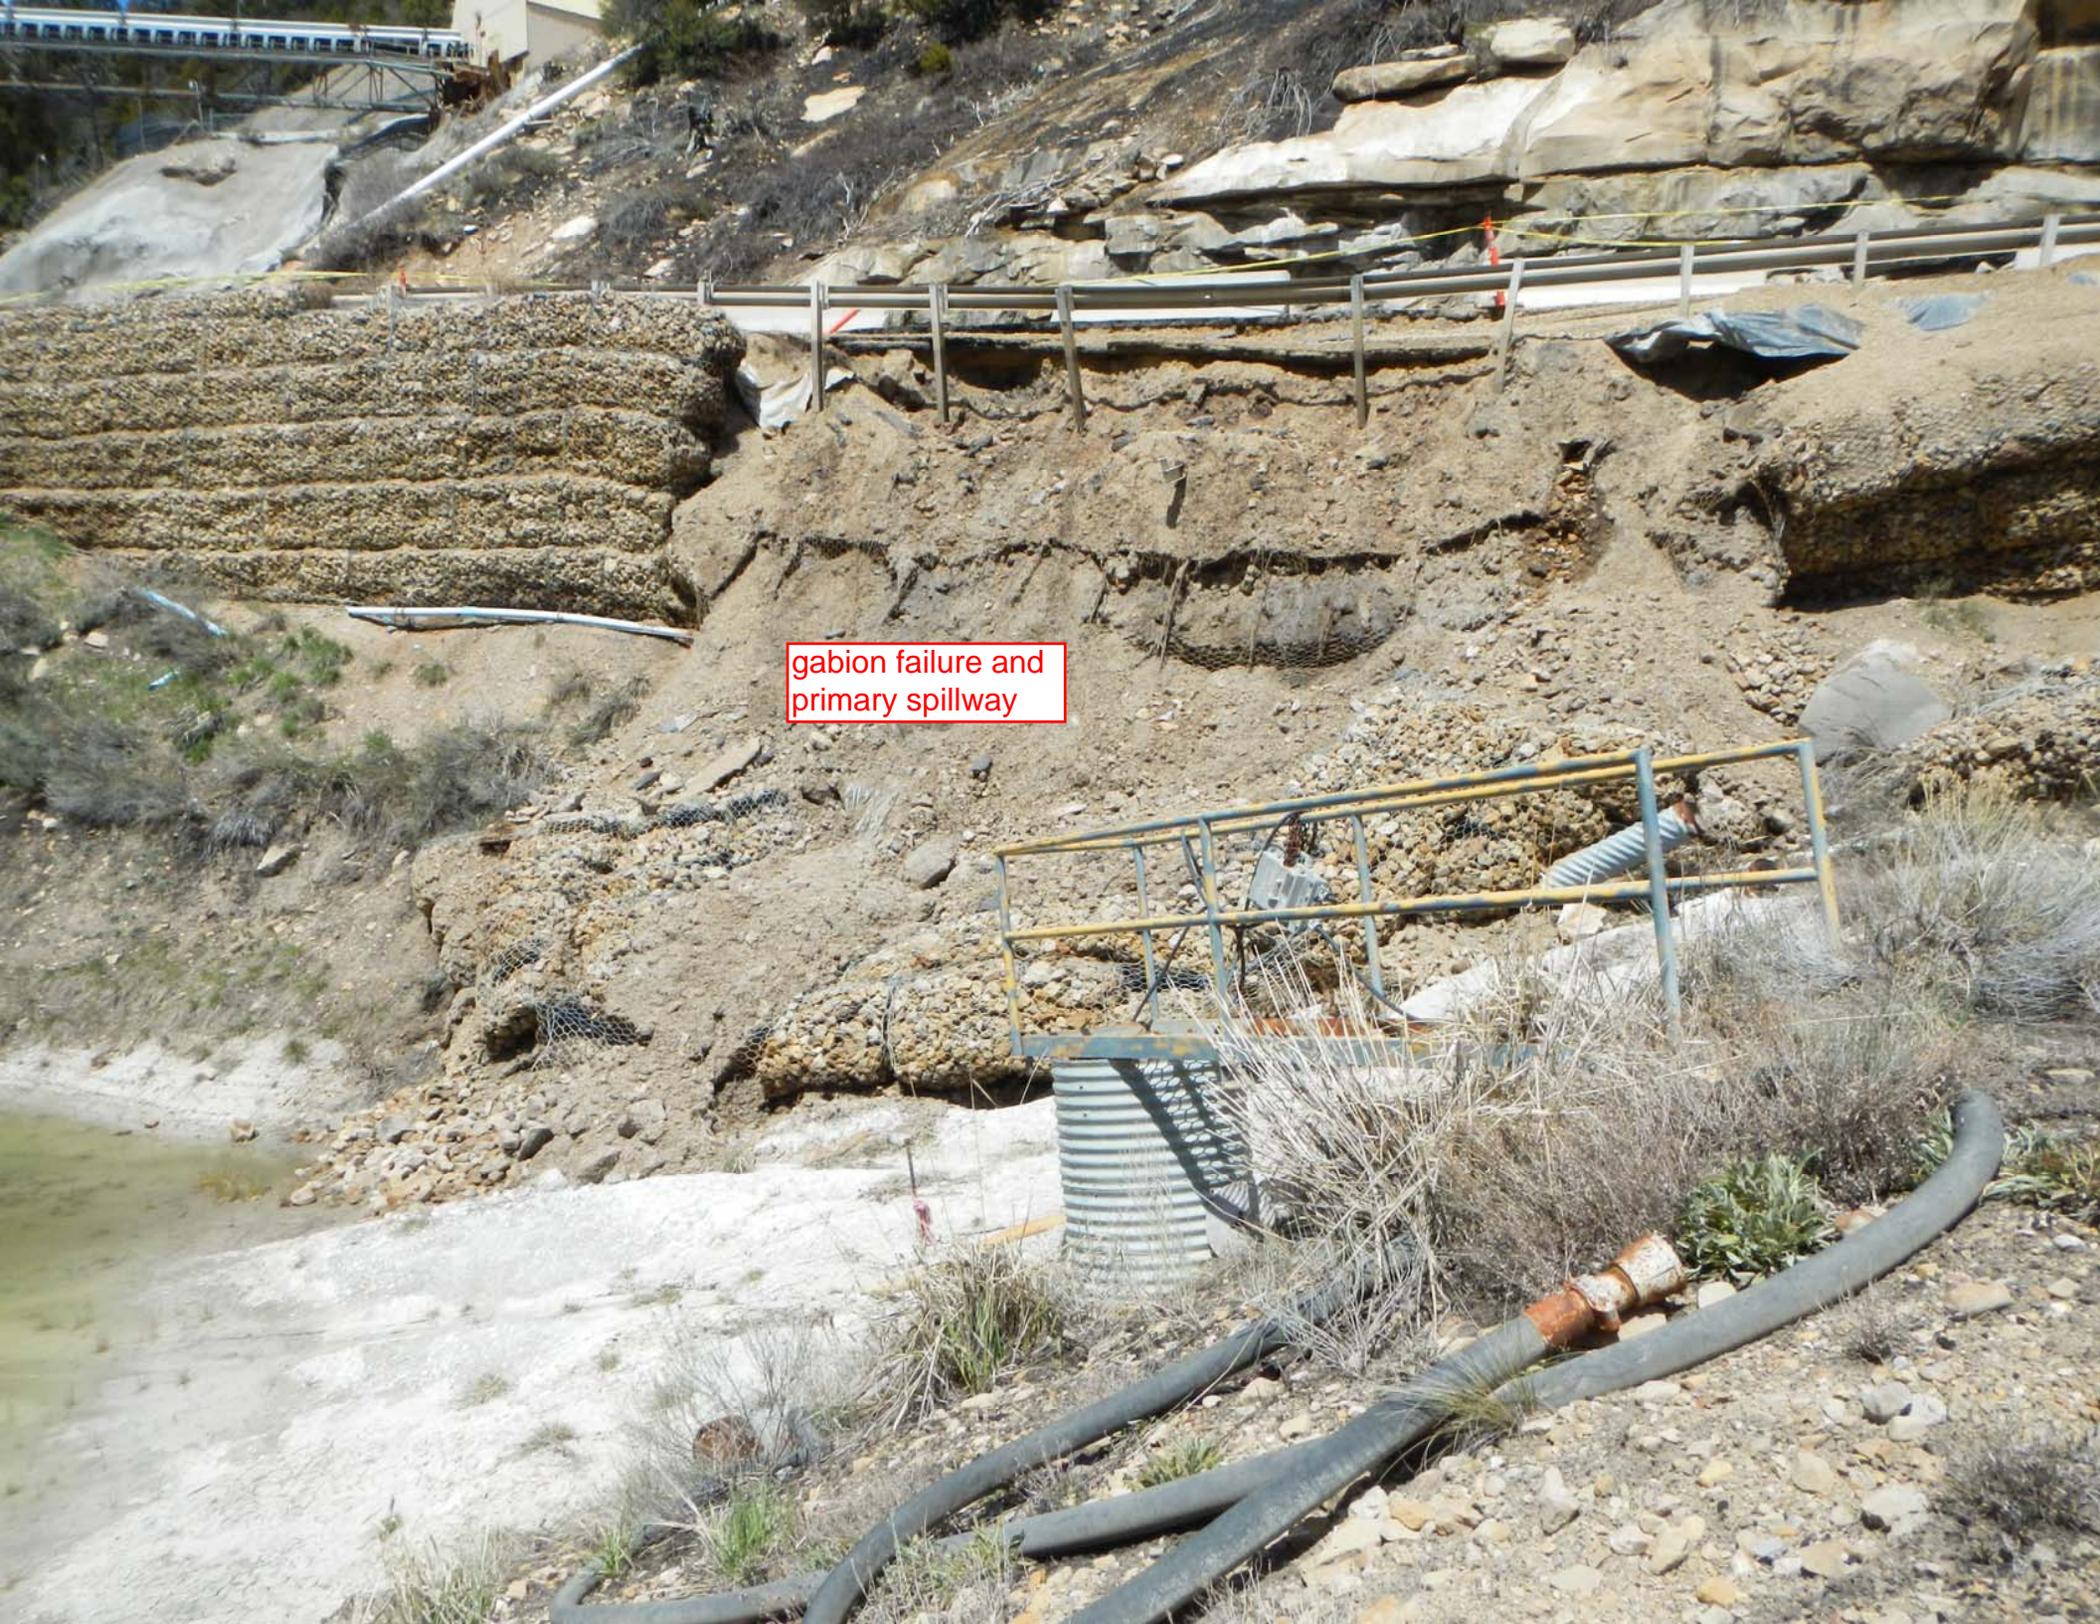
We observed damage to the gabion baskets supporting the USFS road directly above sediment pond 001. A plan for reconstruction is being formulated. The damage is within the permit area boundary. An application will be filed with the Division if changes to the approved plan are necessary.

gabion failure and  
primary spillway
