# Inspection Report

Permit Number:	C0150032
Inspection Type:	PARTIAL
Inspection Date:	Tuesday, July 31, 2018
Start Date/Time:	7/31/2018 1:00:00 PM
End Date/Time:	7/31/2018 3:30:00 PM
Last Inspection:	Wednesday, June 20, 2018

Permitee: **GENWAL RESOURCES INC**  
 Operator: **GENWAL RESOURCES INC**  
 Site: **CRANDALL CANYON MINE**  
 Address: **PO BOX 910, EAST CARBON UT 84520-0910**  
 County: **EMERY**  
 Permit Type: **PERMANENT COAL PROGRAM**  
 Permit Status: **INACTIVE**

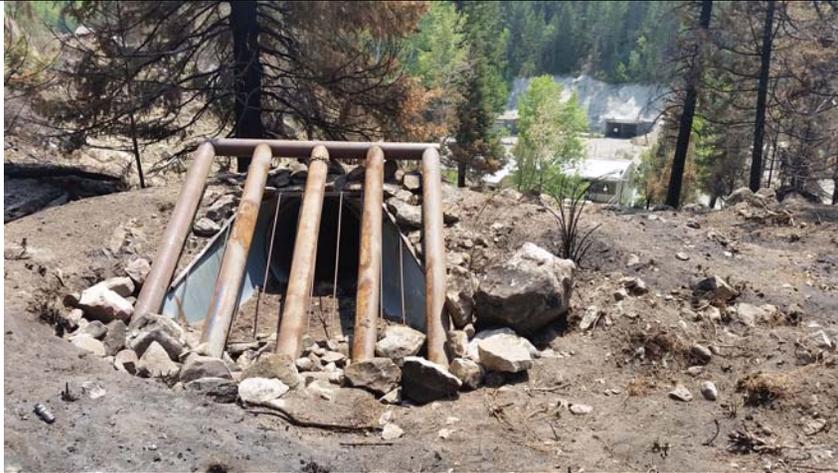
**PHOTO 1 – CULVERT C-6**

The trash racks that are located at the intake of the undisturbed culverts were beefed up in anticipation of a potential debris flow from the burned out areas at the head of Crandall Canyon. The old trash racks were left in place, and newer, larger trash racks were installed over the top of the old ones. The jersey barriers in the Miner's Memorial parking lot to were moved and oriented such that if a large surge of debris overflowed the banks of Crandall Creek that the flow would be directed away from the mine office and other related structures.

The reinforced trash rack at the intake of culvert C-6 is constructed of welded 6" steel pipes. This is behind the main office.  
July 31, 2018

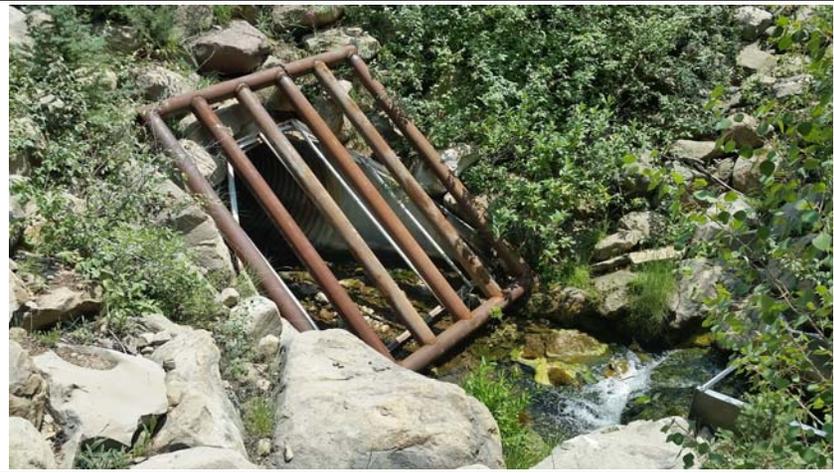
**PHOTO 2 – CRANDALL CREEK CULVERT**

The trash rack at the intake to the 72" undisturbed Crandall Creek culvert.  
July 31, 2018

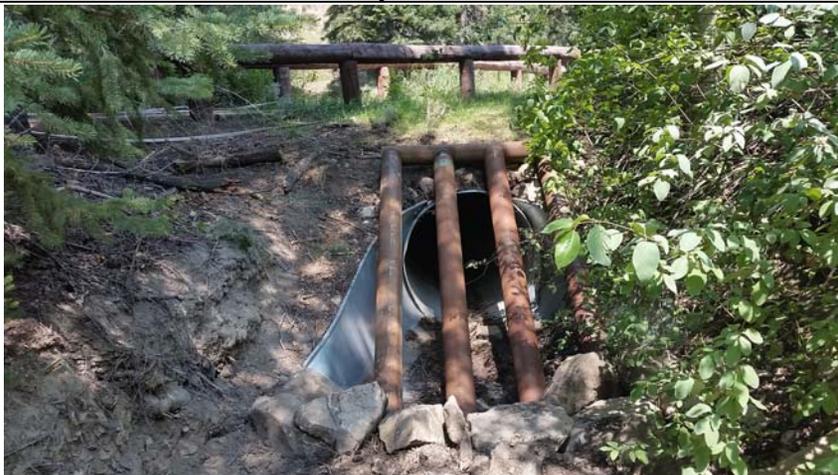
**PHOTO 3 – CRANDALL CREEK CULVERT**

This culvert runs under the Memorial walkway and feeds directly into Crandall Creek at the entrance to the main 72" culvert.  
July 31, 2018

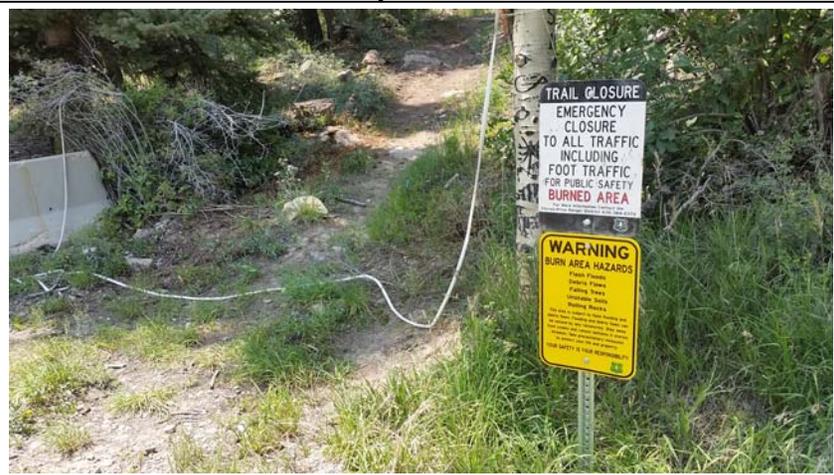
**PHOTO 4 – TRAIL CLOSURE**

As a result of the large size of the burn scar at the head of Crandall Canyon, the Crandall Canyon hiking trail has been temporarily closed to all traffic. Additionally, a large diversion structure will be built within the course of the stream channel that flows past the Miner's Memorial. The purpose of the diversion structure is to redirect mudflows around the Miner's Memorial in the event of a catastrophic post-fire flood event. This structure will be 14 feet high, with 5 feet of freeboard extending above the stream bank to the west of the memorial. Engineering is to be completed by Johansen & Tuttle Engineering out of Castle Dale, Utah, and is expected to be funded by the Permittee, Emery County, and the USFS.

The Crandall Canyon hiking trail has been temporarily closed to all traffic.  
July 31, 2018

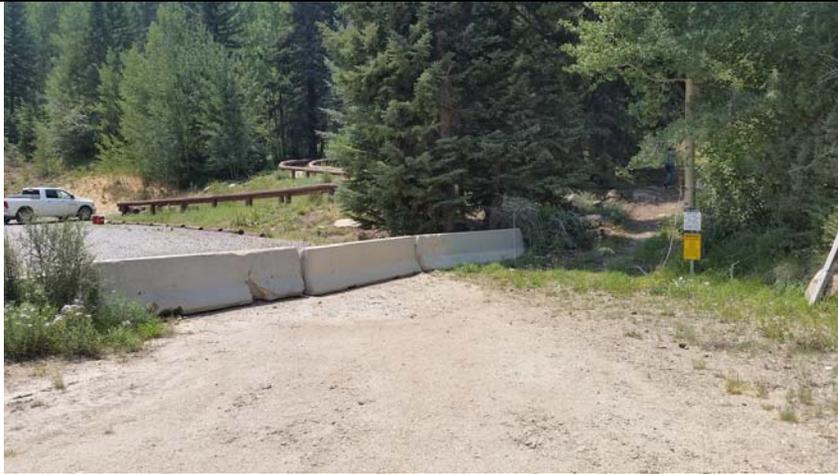
**PHOTO 5 – JERSEY DIVERSIONS**

Jersey barriers were reset and oriented such that if Crandall Creek should overflow that flows would be directed away from structures.  
July 31, 2018

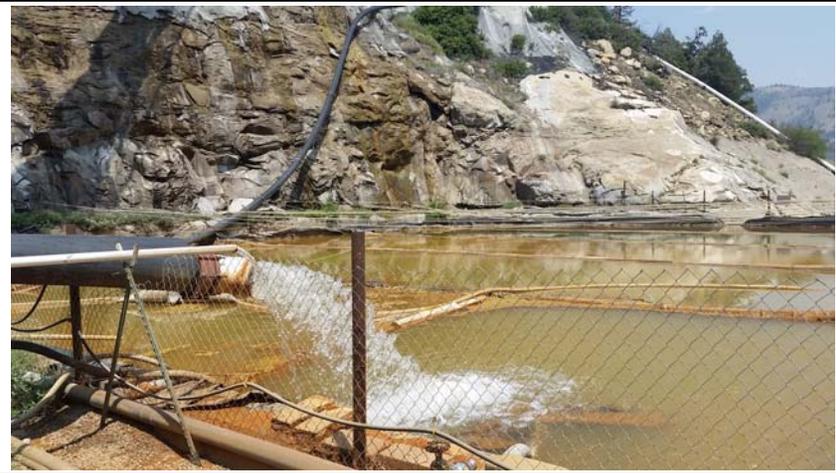
**PHOTO 6 – TREATMENT POND INTAKE**

The flowrate of the water discharging from the mine was 275 gpm, and no treatment was applied to the water. The water is allowed to flow through the treatment pond, although coagulant and flocculant are not being applied. Since the forest fire knocked out power to the treatment plant, the discharging mine water has been treatment free for over a month. Water samples were taken at the intake to the treatment pond, and again at the outfall. At the time of this inspection, Scamp was on site cleaning sludge out of the freshwater intake tank and cell #1 in the pond. Additionally, the entire treatment system had been disassembled and reassembled in order to apply updates and upgrades.

Mine water discharging into the treatment pond.  
July 31, 2018

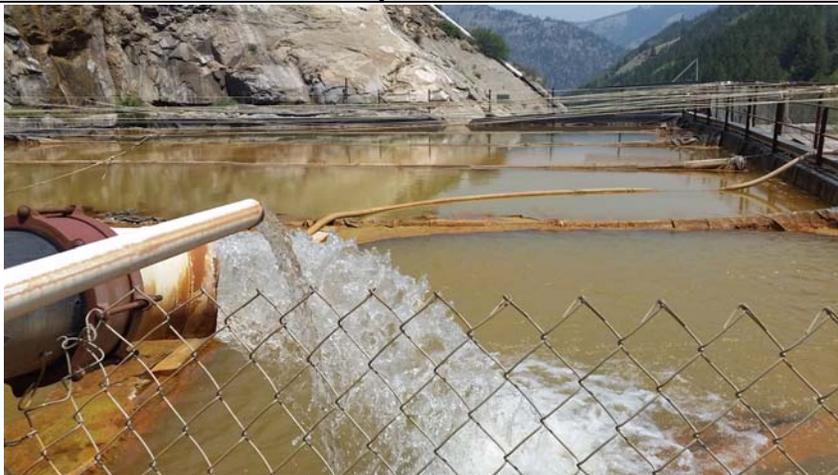
**PHOTO 7 – TREATMENT POND INTAKE**

Also showing cells #1 and #2.  
July 31, 2018

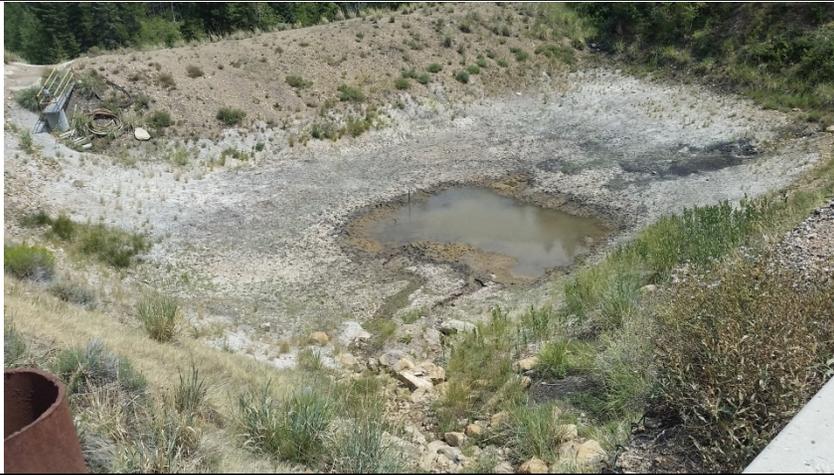
**PHOTO 9 – SEDIMENT POND**

Mostly dry except for a small puddle in the bottom.  
July 31, 2018

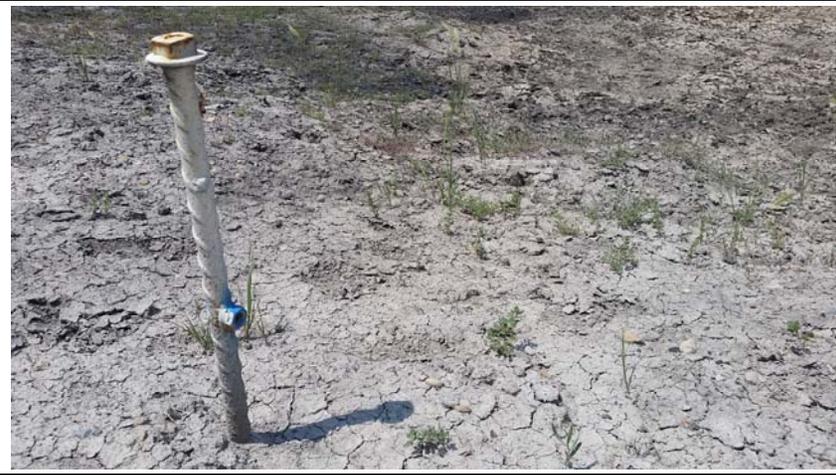
**PHOTO 10 - SEDIMENT MARKER**

Three new sediment markers were installed in the bottom of the relatively dry sediment pond. The 60% cleanout level on the markers was designated with a nut and/or blue paint.

60% cleanout level designated with nut and blue paint.  
July 31, 2018

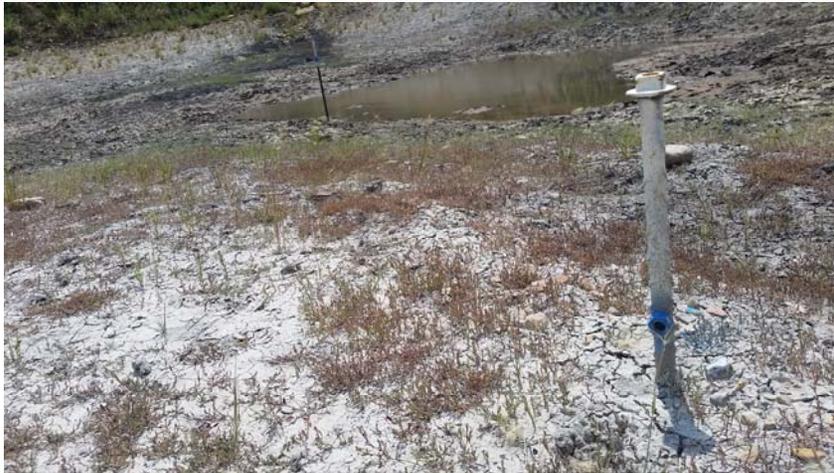
**PHOTO 11 – SEDIMENT MARKER**

60% cleanout level designated with nut and blue paint.  
July 31, 2018

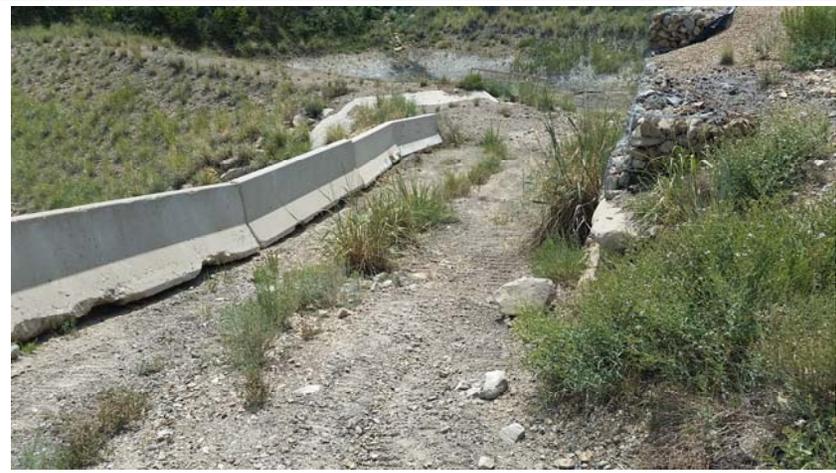
**PHOTO 12 – RESET JERSEY BARRIERS**

The jersey barriers at the entrance to the sediment pond that had been leaning precariously at a 45 degree angle were recently repaired and reset by Scamp Construction.

These barriers along the sed pond access road used to lean at a precarious 45 degree angle towards Crandall Creek.  
July 31, 2018

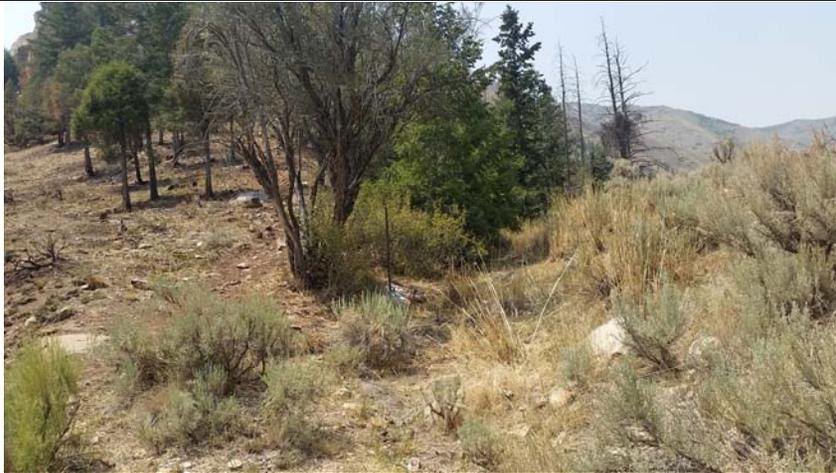
**PHOTO 13 – CHAR FREE TOPSOIL STOCKPILE**

The forest fire that burned through Crandall Canyon approached a large topsoil pile on the USFS road, near the junction with State Highway 31. Since the burned area stopped within feet of the topsoil pile, it did not appear that the topsoil pile had been affected by the fire.

The forest fire stopped just short of this topsoil stockpile. Notice burned bushes and grass on the left.  
July 31, 2018

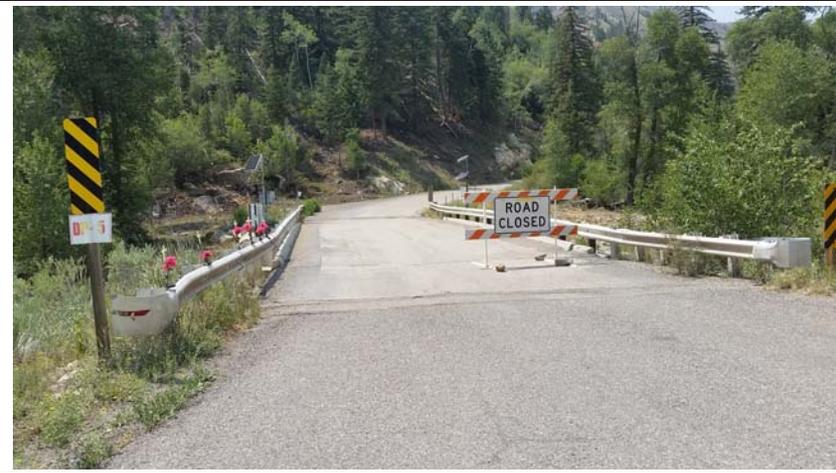
**PHOTO 14 – ROAD CLOSED**

The Road Closed sign left over from firefighting efforts remains in place.  
July 31, 2018

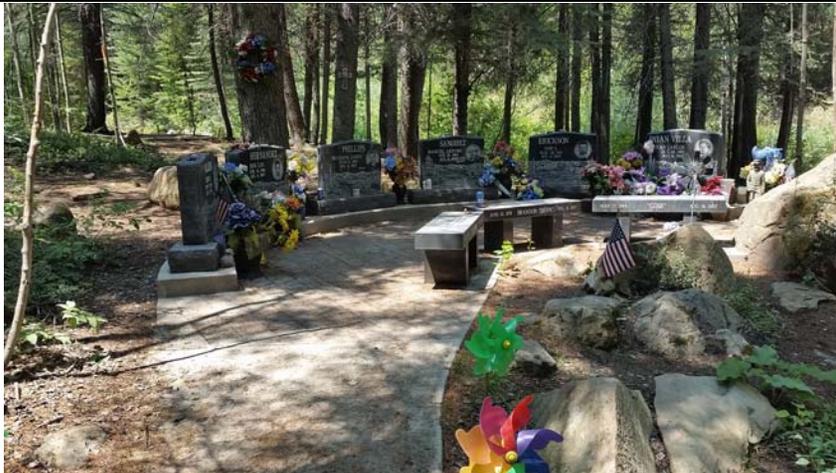
**PHOTO 15 – MINER'S MEMORIAL**

A robust wall will be built just beyond this memorial in the streambed of Crandall Creek.  
July 31, 2018

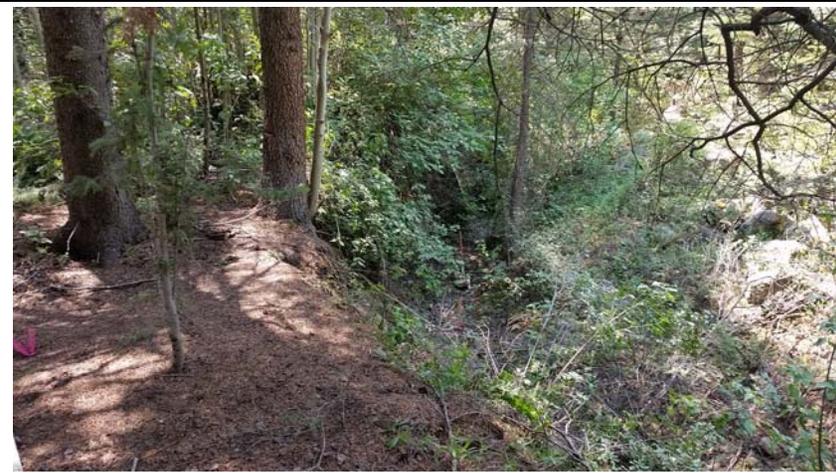
**PHOTO 16 – MEMORIAL WALL SITE**

The bottom of the stream channel here is where a wall will be built to protect the memorial from a potential flood surge.  
July 31, 2018

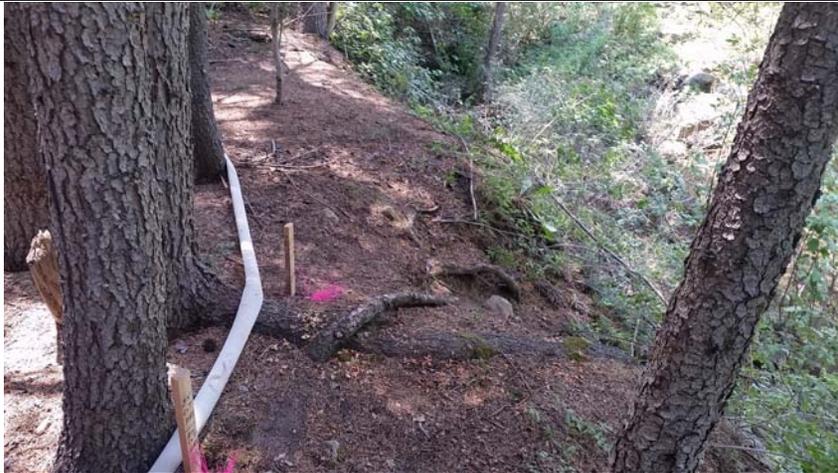
**PHOTO 17 – MEMORIAL WALL SITE**

Offset stakes designate the location and cut for the wall footings.  
July 31, 2018

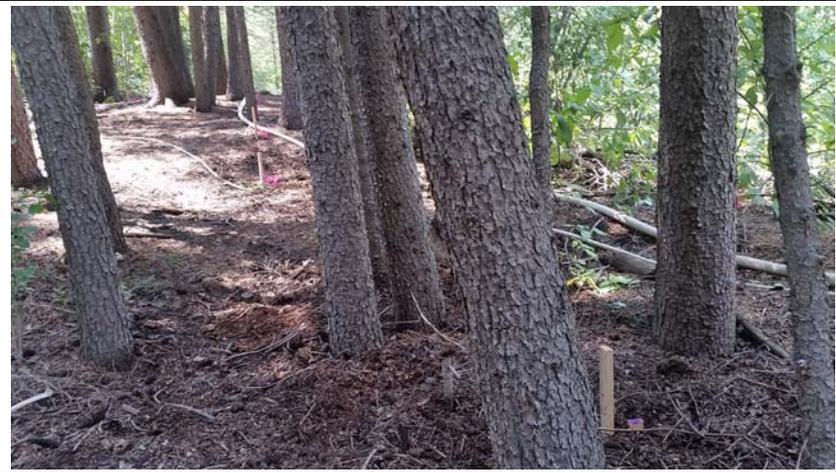
**PHOTO 18 – MEMORIAL WALL SITE**

Offset stakes designate the location and cut for the wall footings.  
July 31, 2018

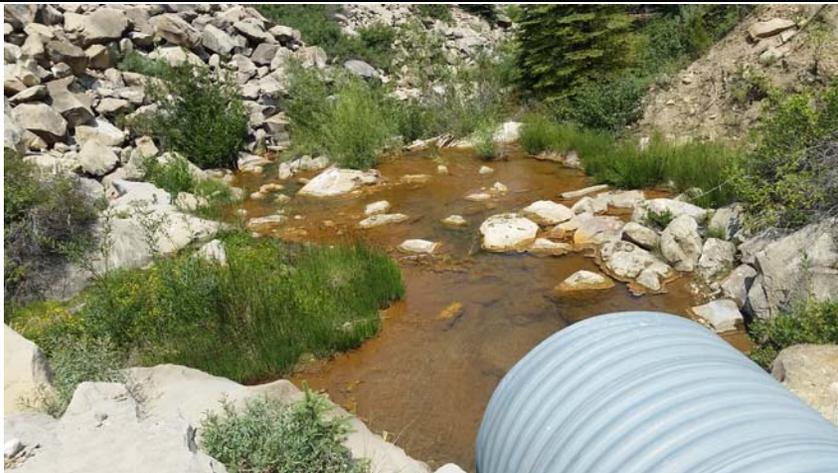
**PHOTO 19 – CRANDALL CREEK**

Crandall Creek exiting the 72" undisturbed culvert.

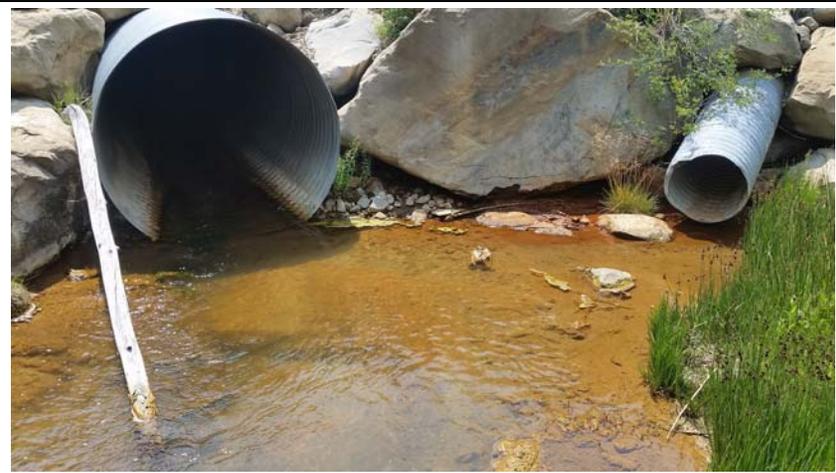
**PHOTO 20 – CRANDALL CREEK**

Crandall Creek exiting the 72" undisturbed culvert.
