Inspection Report

Permittee: **GENWAL RESOURCES INC**
 Operator: **GENWAL RESOURCES INC**
 Site: **CRANDALL CANYON MINE**
 Address: **PO BOX 910, EAST CARBON UT 84520-0910**
 County: **EMERY**
 Permit Type: **PERMANENT COAL PROGRAM**
 Permit Status: **INACTIVE**

ATTACHMENT A – Crandall Canyon partial inspection, August 20, 2018

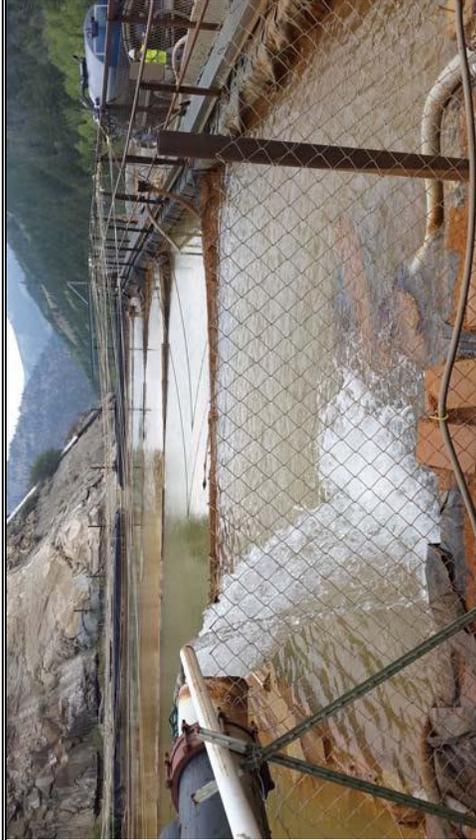
PHOTO 1 – WATER TREATMENT FACILITY

Looking east over cells 1, 2, and 3. Water sampling location Pre-002 is from the end of the white PVC. Scamp is cleaning cell #2.
August 20, 2018

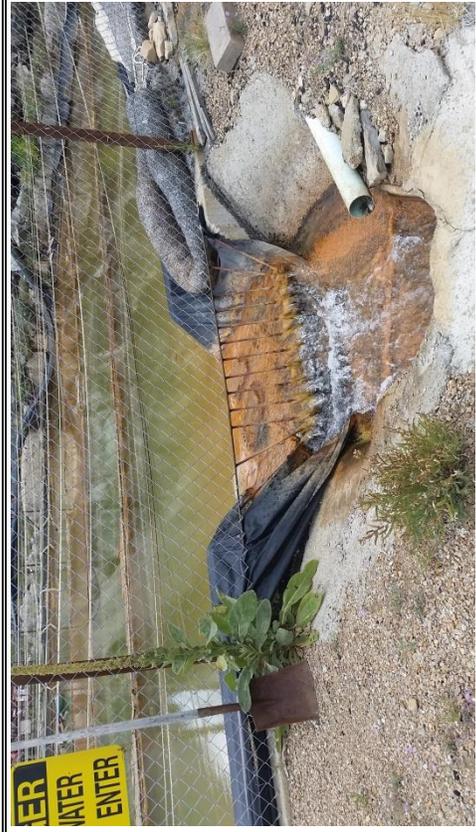
PHOTO 2 – SETTLING POND OUTFALL

This is sampling location 002.

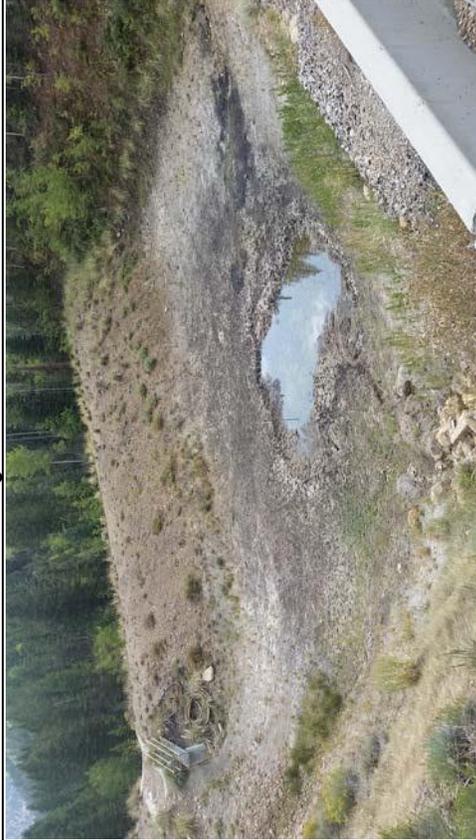
PHOTO 3 – SEDIMENT POND

Very little water in the sediment pond.

The sediment pond currently holds very little water.

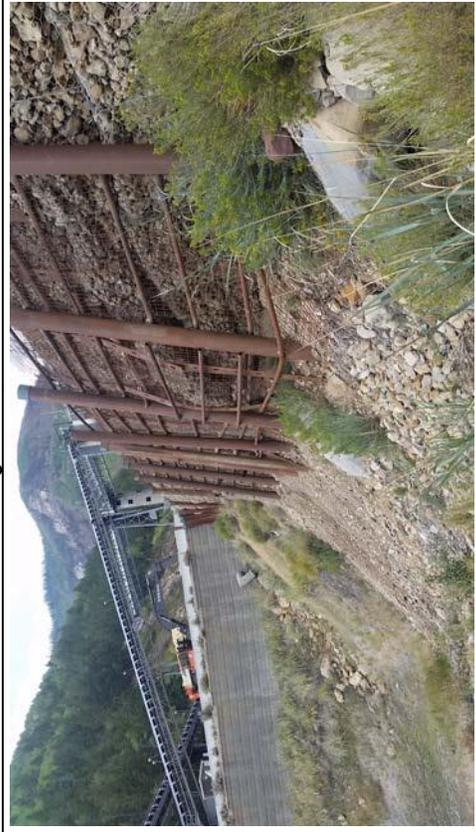
PHOTO 4 – GABION WALL

The steel pylons and other support structures have not shown any signs of movement recently, and appear stable.

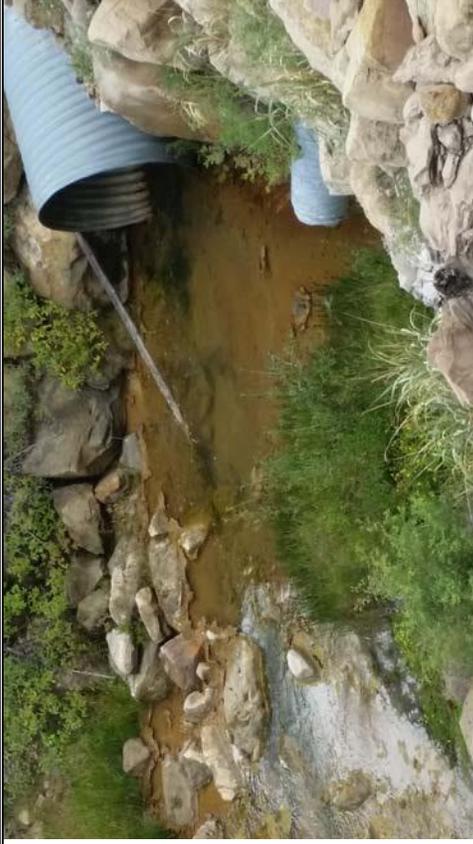
PHOTO 5 – CRANDALL CREEK
The outlet of the 72" culvert that runs beneath the main mine site.
August 20, 2018

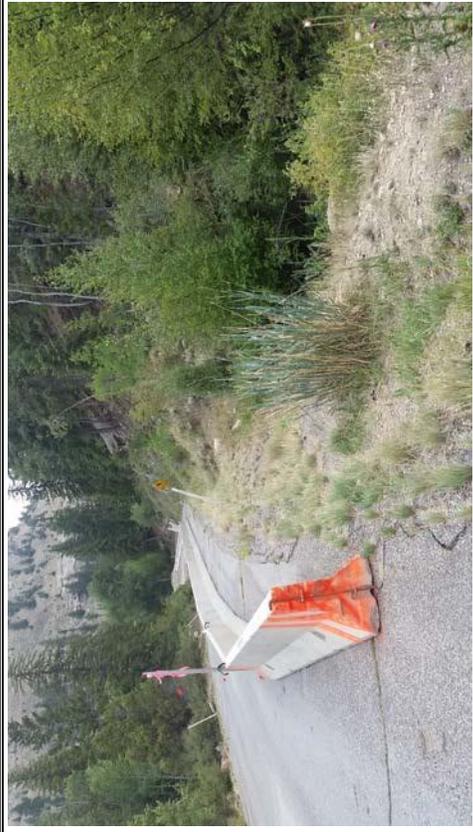
The trash racks that had been supplemented with larger, more robust structures last month are free of debris and in good condition. Jersey barriers had been recently placed on the USFS road at the entrance to the site, where Crandall Creek flows under the road. There had been rainfall in the region, and the Jersey barriers were placed along the road in an effort to divert potential flood waters away from the road (see photos). The barriers will not be a permanent feature, and will be removed from the road when not needed.

PHOTO 6 – TEMPORARY JERSEY BARRIERS
These Jersey barriers were placed on the paved USFS road at the entrance in anticipation of possible flooding from Crandall Creek.
August 20, 2018

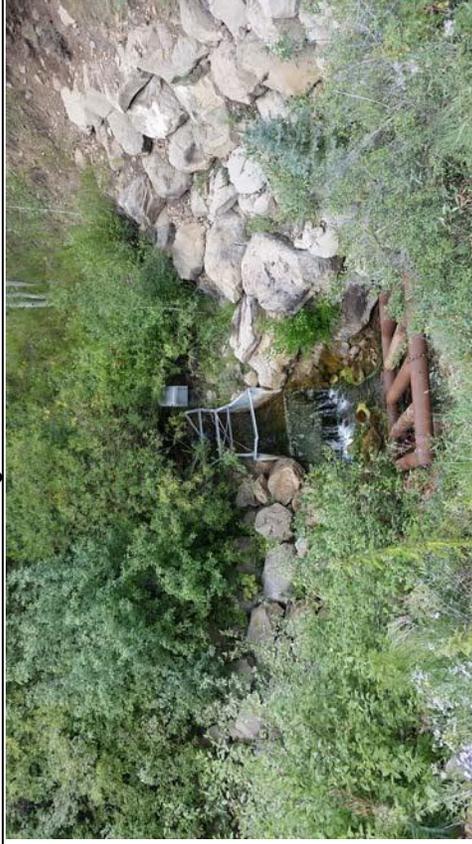
PHOTO 7 – CRANDALL CREEK
This is at the intake of the 72" culvert running beneath the main site. Trash racks appear clear and stable.
August 20, 2018

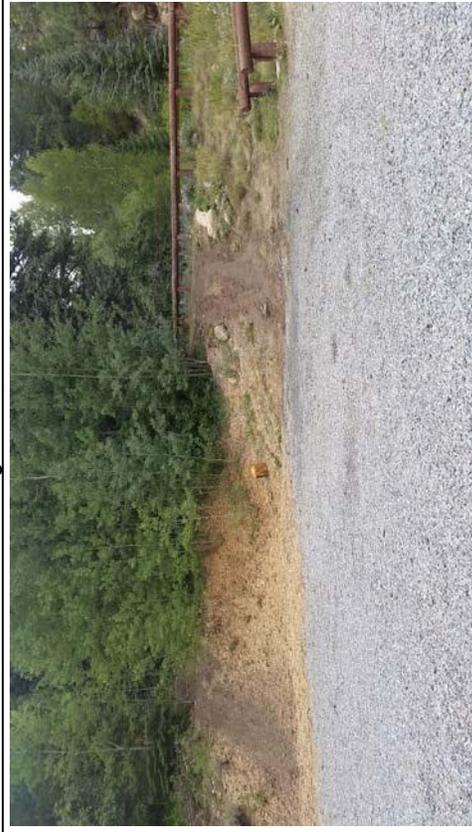
The construction of a large concrete wall in Crandall Creek was recently completed in an effort to protect the Miner Memorial from a potential debris flow from the burn scar at the head of Crandall Canyon. The construction effort resulted in some minor damage as a trackhoe and other equipment blazed two small trails from the Memorial parking lot to the section of Crandall Creek just north of the Memorial. In all, some trees were pruned, and a small section of sidewalk was removed in the effort. The Forest Service has committed to reclaim/reseed the dirt paths that were created from the equipment, and replace the section of sidewalk that was removed.

PHOTO 8 – MINER MEMORIAL PARKING LOT
These two dirt paths were created as a result of construction traffic to and from the Memorial site.
August 20, 2018

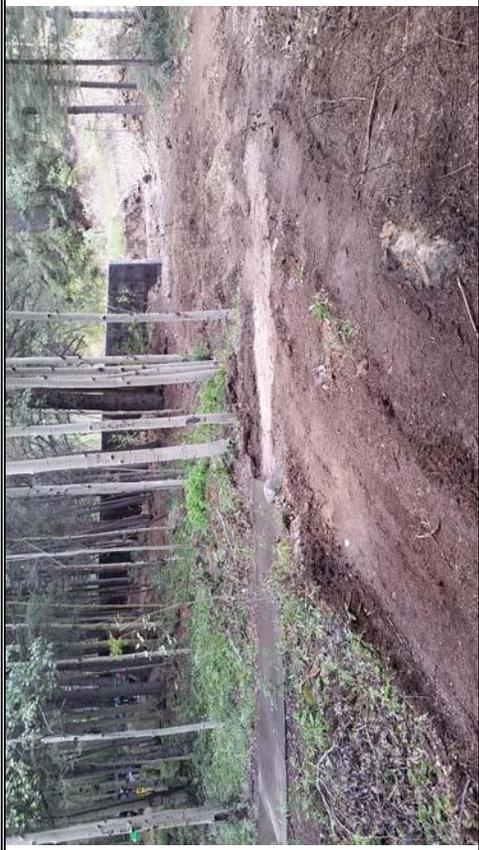
PHOTO 9 – MEMORIAL FLOOD CONTROL WALL
Memorial is in front of the wall in the trees on the left. Notice section of missing sidewalk at center.
August 20, 2018

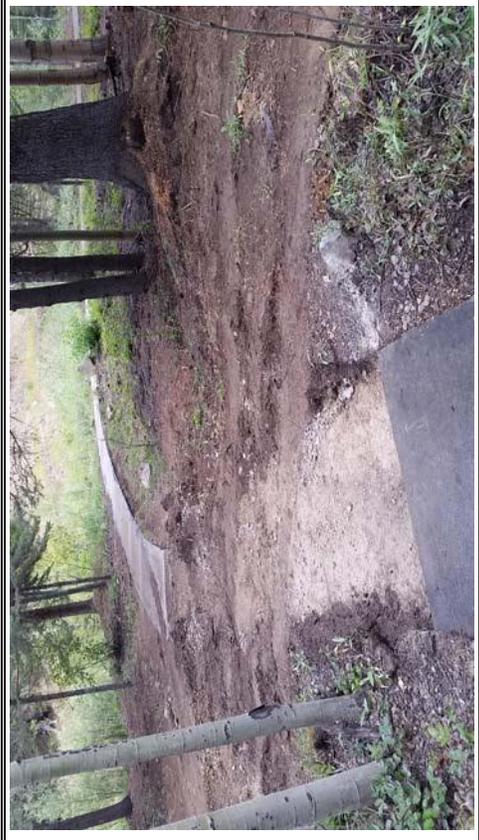
PHOTO 10 – MEMORIAL WALKWAY DAMAGE
Sidewalk was destroyed/removed from construction traffic. It will be replaced.
August 20, 2018

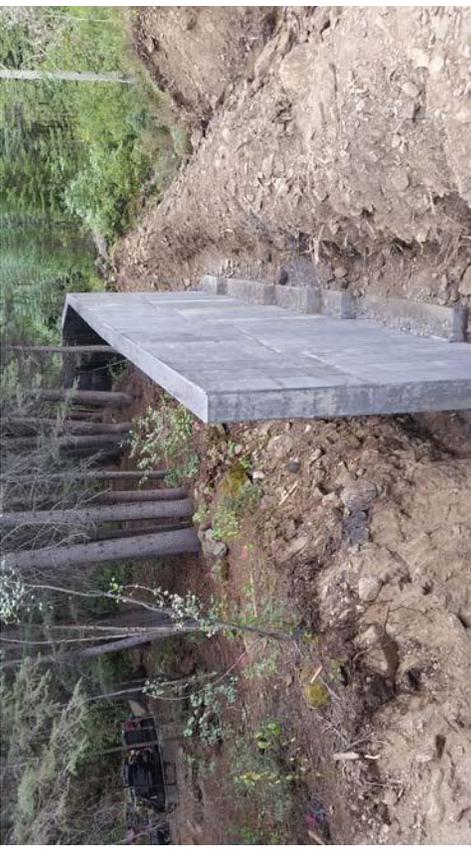
PHOTO 11 – MEMORIAL FLOOD CONTROL WALL
Memorial site is on the left, and Crandall Creek is to the right of the wall.
August 20, 2018

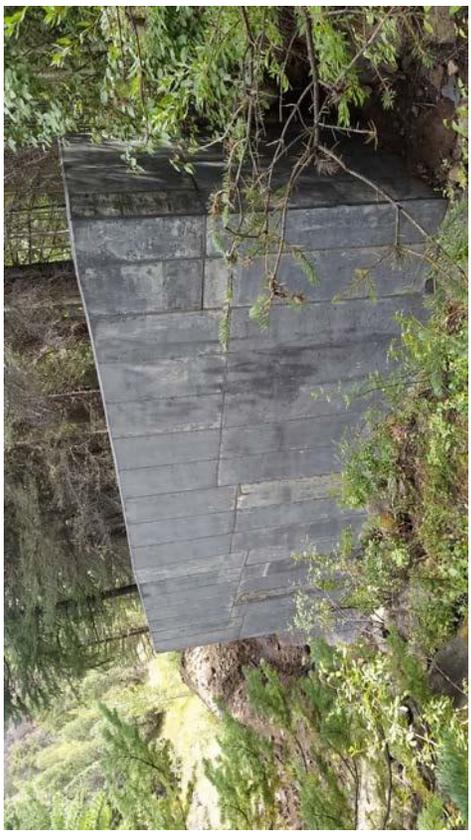
PHOTO 12 - MEMORIAL FLOOD CONTROL WALL
This is the upstream end of the wall. It has been keyed into the stream bank at this point.
August 20, 2018

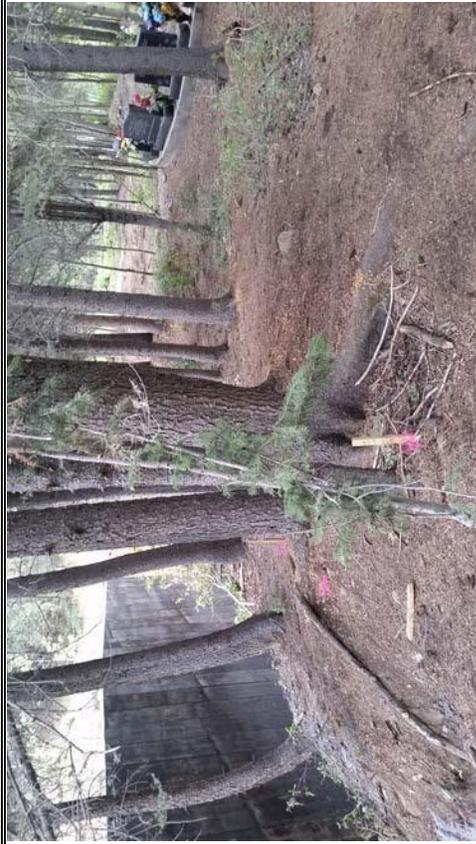
PHOTO 13 – MEMORIAL FLOOD CONTROL WALL
 This photo illustrates the distance between the Miner Memorial and the flood control wall.
 August 20, 2018

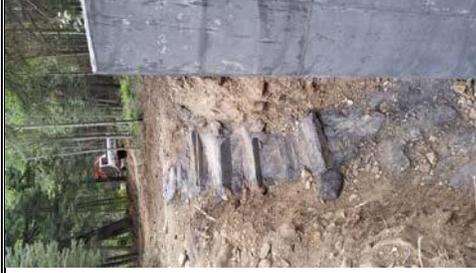
PHOTO 14 – MEMORIAL FLOOD CONTROL WALL
 This is the downstream end of the wall. These stairs were poured to provide access for the construction crews building the wall. Notice trackhoe in the background.
 August 20, 2018

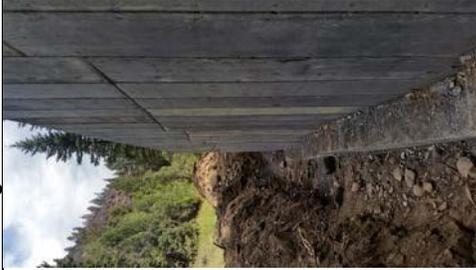
PHOTO 15 – MEMORIAL FLOOD CONTROL WALL
 A view from the footings on the creek side. These will be buried once the concrete has fully cured.
 August 20, 2018

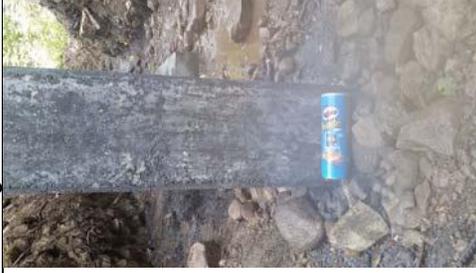
PHOTO 16 - MEMORIAL FLOOD CONTROL WALL
 Highly technical methods illustrate the thickness of the wall. This potato chip container measures 8.75 inches.
 August 20, 2018

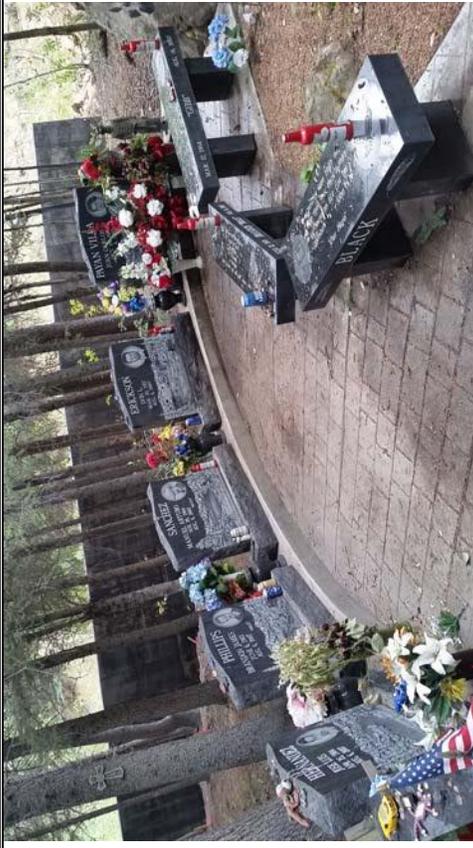
PHOTO 17 – MINER MEMORIAL
With finished wall in background.

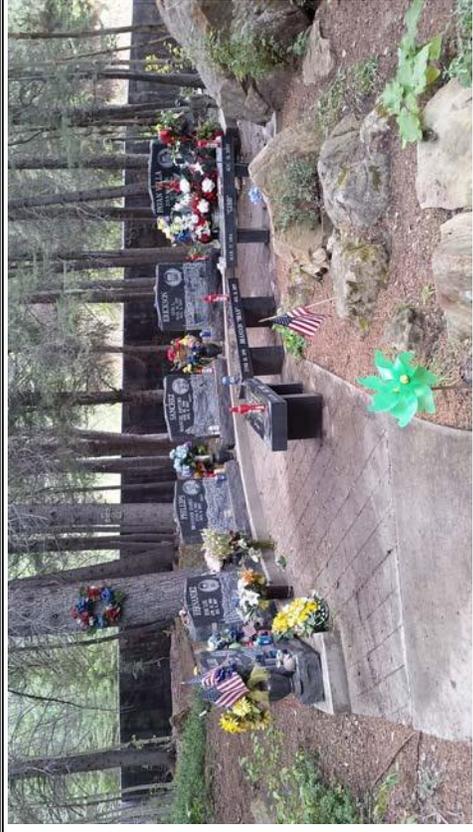
PHOTO 18 – MINER MEMORIAL
With finished wall in background.
