# Inspection Report

Permit Number:	C0150032
Inspection Type:	PARTIAL
Inspection Date:	Wednesday, October 17, 2018
Start Date/Time:	10/17/2018 10:30:00 AM
End Date/Time:	10/17/2018 12:30:00 PM
Last Inspection:	Tuesday, September 25, 2018

Permittee: **GENWAL RESOURCES INC**  
 Operator: **GENWAL RESOURCES INC**  
 Site: **CRANDALL CANYON MINE**  
 Address: **PO BOX 910, EAST CARBON UT 84520-0910**  
 County: **EMERY**  
 Permit Type: **PERMANENT COAL PROGRAM**  
 Permit Status: **INACTIVE**

**ATTACHMENT A – Crandall Canyon partial inspection, October 17, 2018**

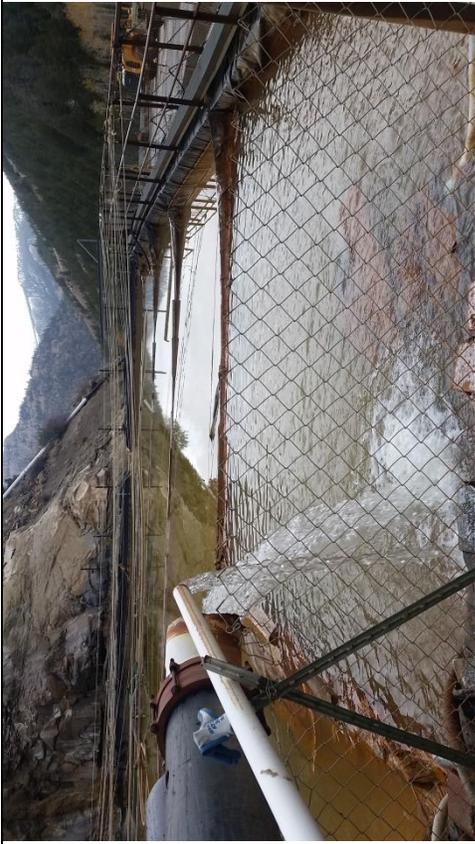
**PHOTO 1 – WATER TREATMENT FACILITY**

Looking east over cells 1, 2, and 3. Water sampling location Pre-002 is from the end of the white PVC.

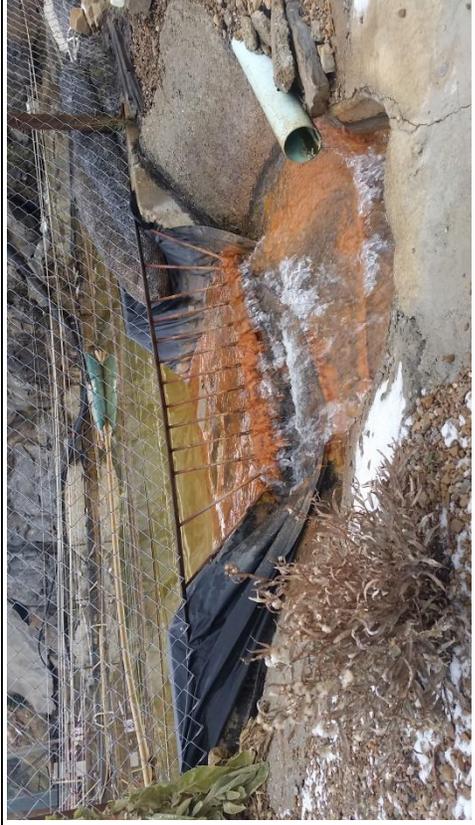
**PHOTO 2 – TREATMENT POND OUTFALL**

Samples were taken where the mine discharges into the treatment facility and again at UPDES outfall #002. Flowrate = 236 gpm, Flocculant = 3.1 ppm, and Coagulant = 0. Coagulant was zero because the coagulant lines had frozen over the previous night, and Karin was in the process of thawing out and flushing the lines to restore flow.

The water flowing under the trash rack is sampling point for UPDES discharge #002. The white PVC pipe drains water that collects at the base of the weeping highwall adjacent to the treatment pond.

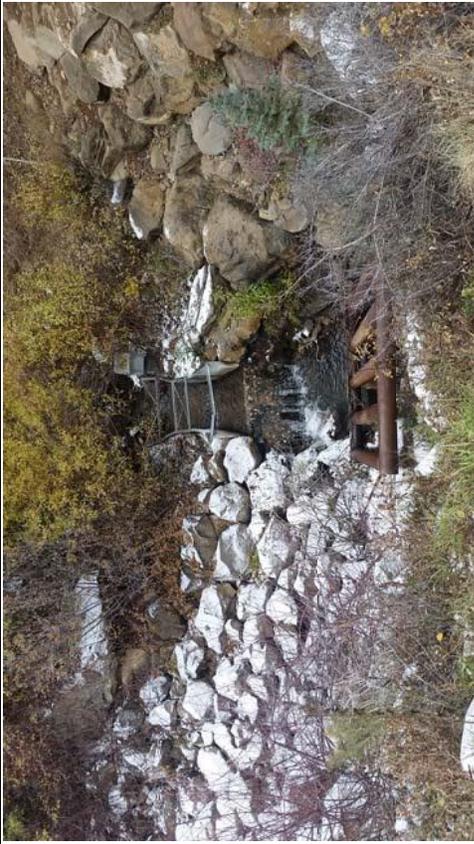
**PHOTO 3 – CRANDALL CREEK**

The inlet of the 72” culvert running beneath the main mine site. It does not appear to have been affected by any flooding or debris flows.

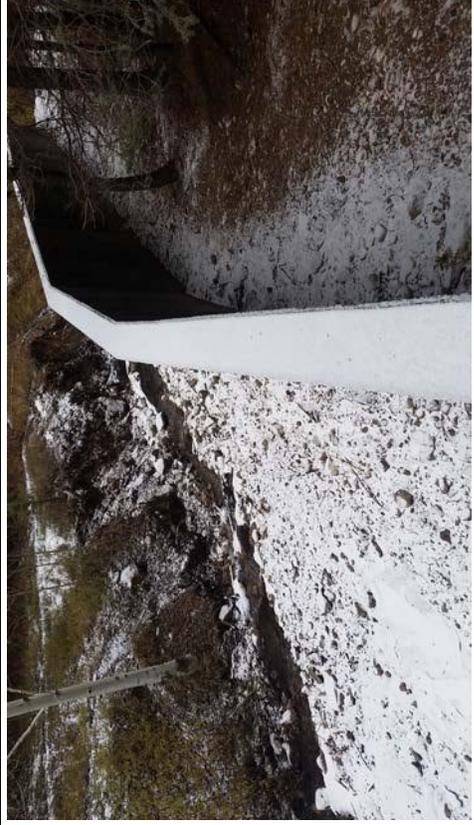
**PHOTO 4 – MEMORIAL WALL**

The memorial is to the right of this, and Crandall Creek is to the left. It does not appear that any flooding has taken place here.

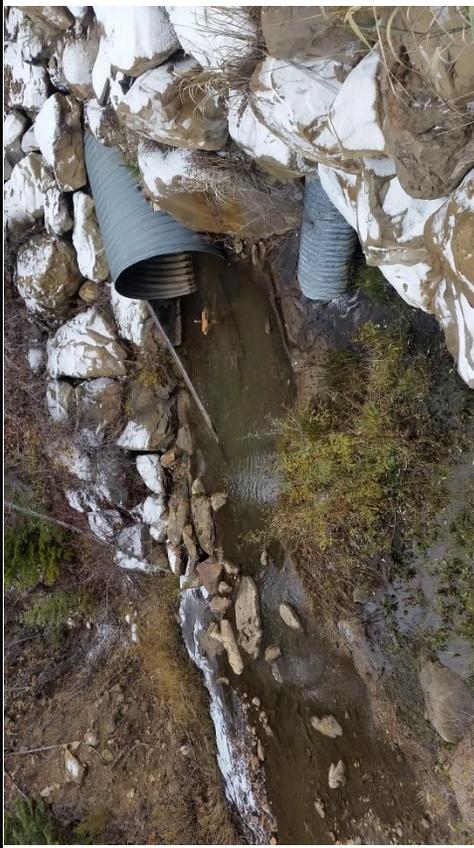
**PHOTO 5 – CRANDALL CREEK**

The larger culvert is the 72" bypass that runs beneath the main mine site. The smaller CMP is the outlet of UPDES discharge #001 coming out of the sediment pond.

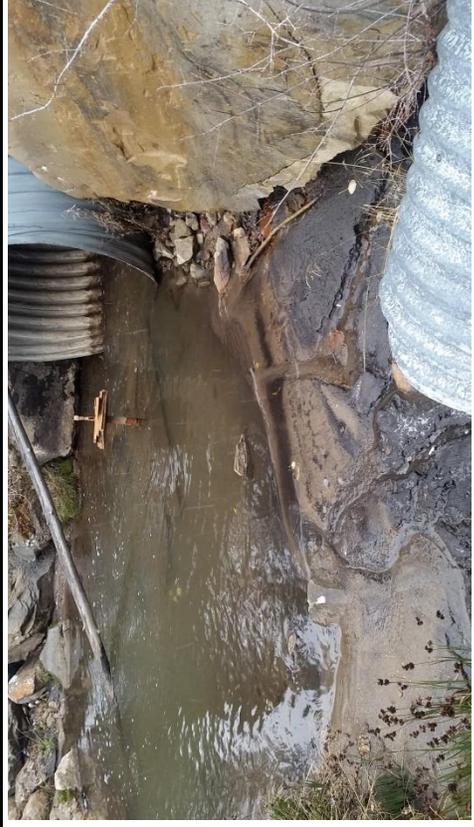
**PHOTO 6 – CRANDALL CREEK**

Closeup of the outlets.

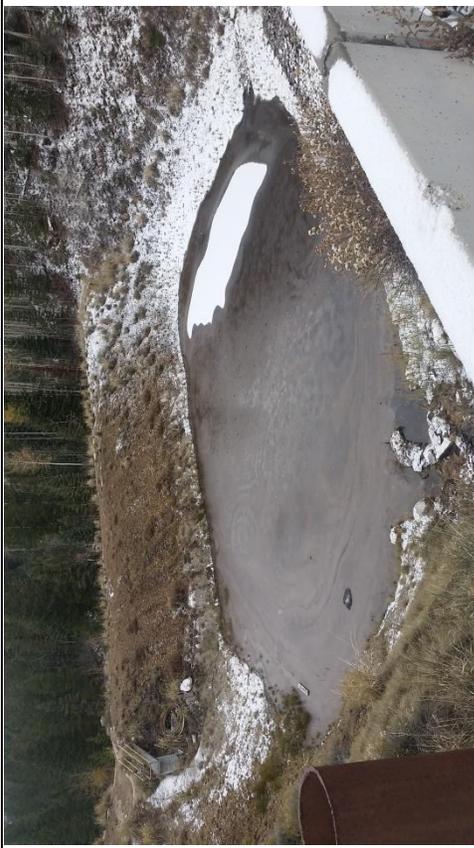
**PHOTO 7 – SEDIMENT POND**

The sediment pond was impounding a modest amount of water and the surface was frozen.

The sediment pond is currently frozen, although the ice is not very thick.

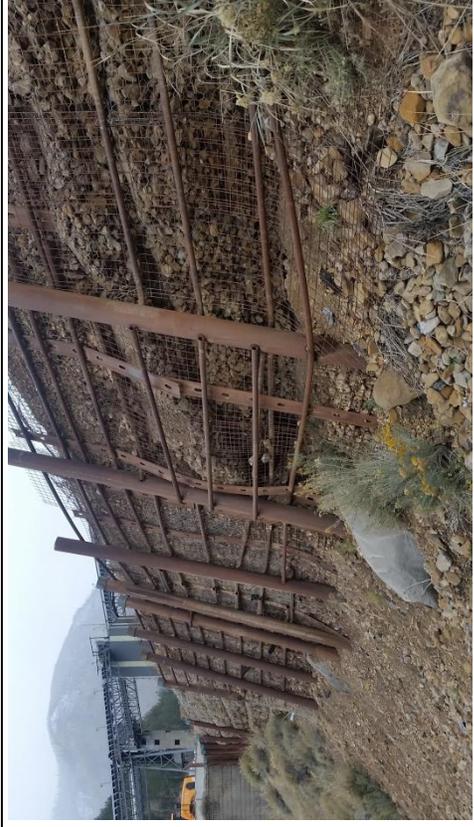
**PHOTO 8 – GABION WALL**

The steel pylons and other support structures have not shown any signs of movement recently, and appear stable.

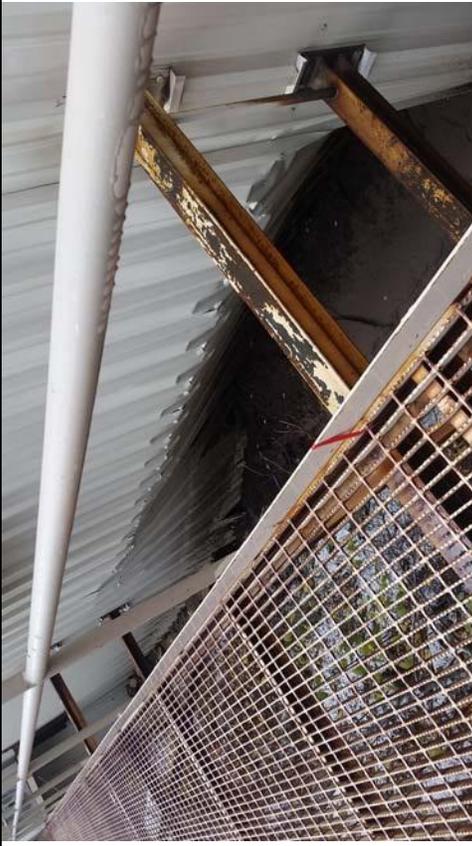
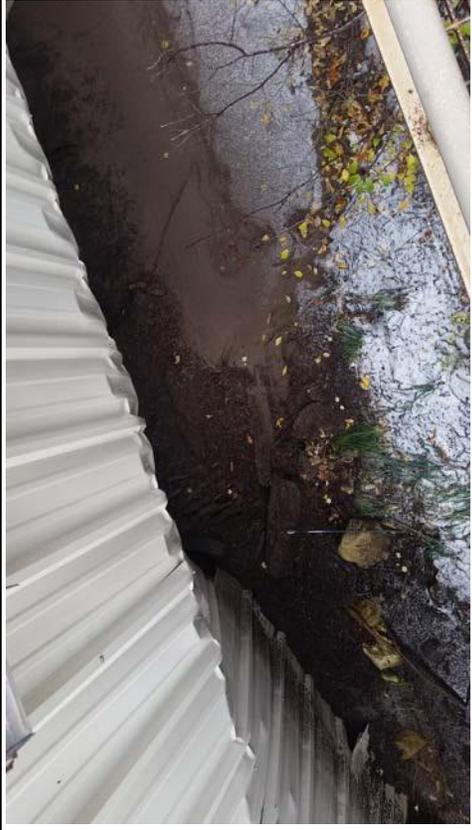
As stated previously, the main offices had been damaged by a debris flow from the overwhelmed culvert C-6. One of the north walls of the building was breached, and the door of a smaller office on the west of the building was forced open.

**PHOTO 9 – BUCKLED NORTH WALL**

This section of wall has been buckled under by the debris flow coming off of the hillside behind the main office.

**PHOTO 10 – BUCKLED NORTH WALL**

A close up view.

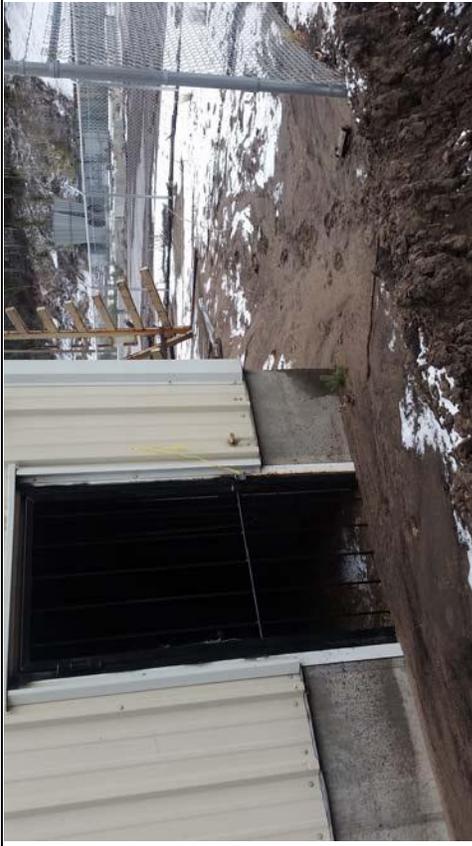
**PHOTO 11 – MUD FLOW**

The mud flows forced this door open and mud and other debris entered this door on the west side of the building.

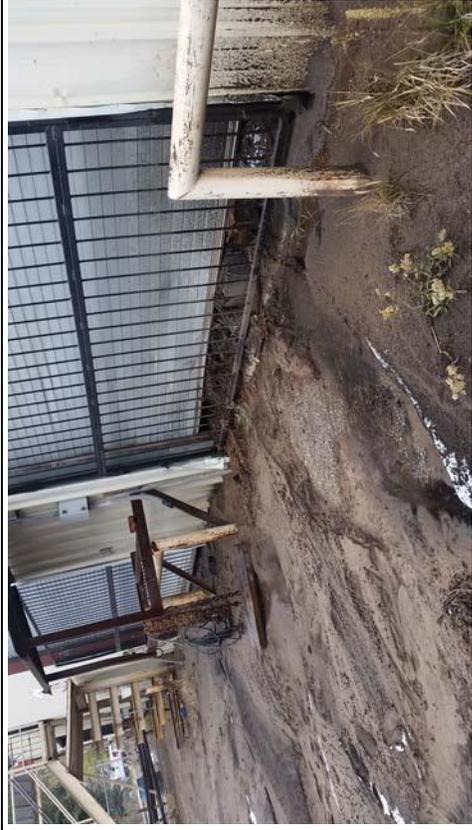
**PHOTO 12 – MAIN OFFICE BUILDING**

Mud and debris leaking from underneath the roll-up doors in the shop.

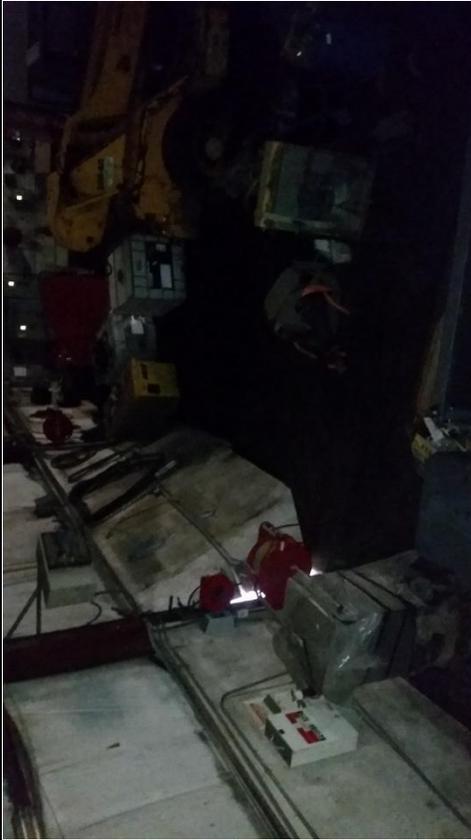
**PHOTO 13 – INSIDE THE SHOP**

This is the section of wall that buckled and enabled the mud flow to enter the building.

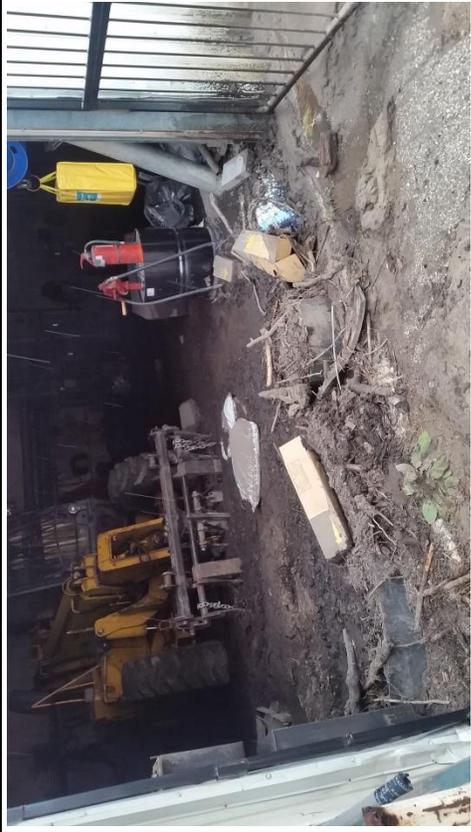
**PHOTO 14 – INSIDE THE SHOP**

Another view showing the thick blanket of debris that has collected in the shop. This Hylift is encased in mud.

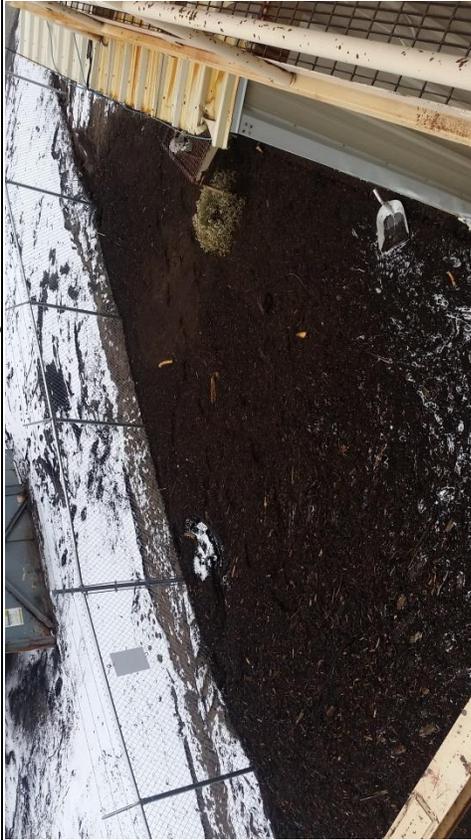
**PHOTO 15 – EAST END OF MAIN OFFICE BUILDING**

The debris flow lost a lot of momentum here, leaving behind a thick blanket of mud, sticks, and other organic material.

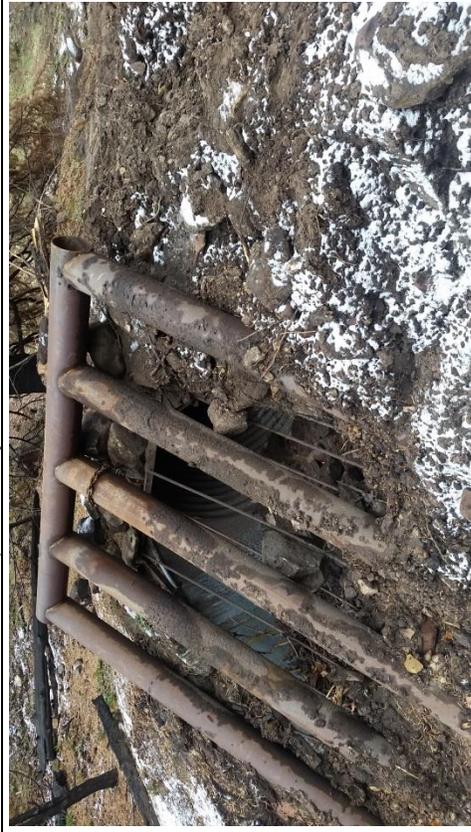
**PHOTO 16 – CULVERT C-6**

A debris flow from the burn scarred area to the north appears to have overwhelmed the C-6 culvert behind the main office building. The overflowing debris then progressed down the slopes and breached the north office building wall, flooding the shop with mud and other organic debris. A smaller office on the west of the building was also breached and flooded with mud. No other culvert within the permit area had been adversely affected, although several diversion ditches along the USFS road had been overwhelmed, intermittently spilling mud and other organic debris out over the road.

A torrent of mud and rocks overwhelmed this culvert and overflowed to the side and down towards the main office building. It appears the trash rack held, but requires cleaning.

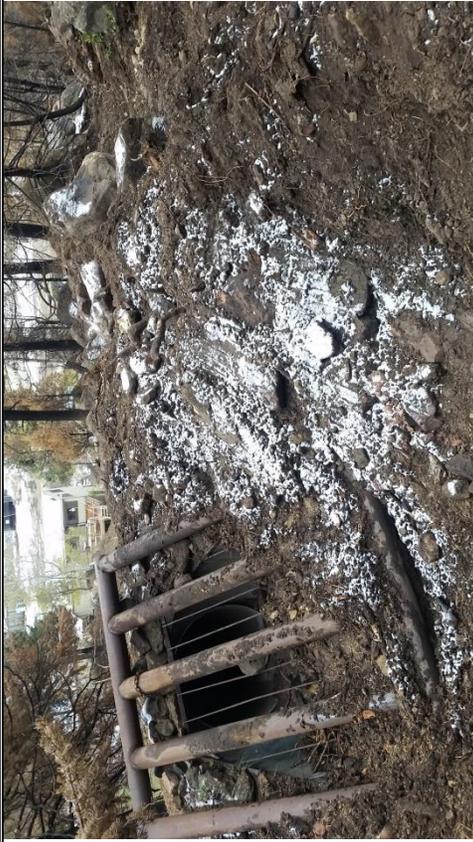
**PHOTO 21 – CULVERT C-6 RELIEF TRENCH**  
Scamp cut a temporary relief trench to the side of the culvert, enabling time to clean out the culvert and trash racks.

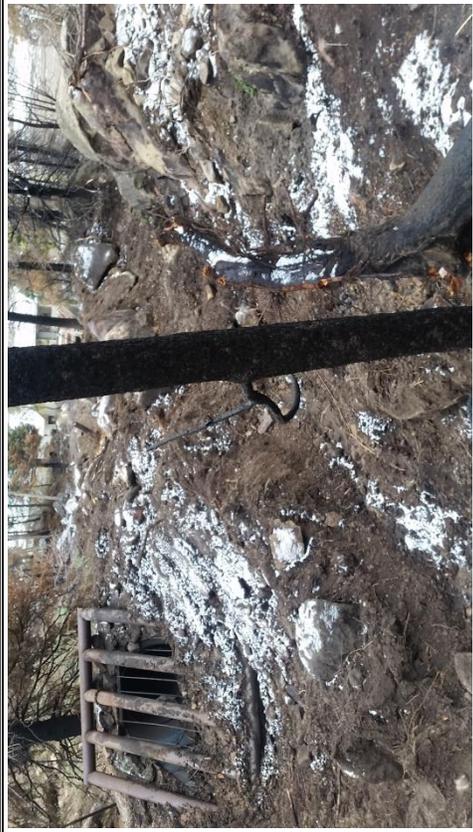
**PHOTO 22 – CULVERT C-6 RELIEF TRENCH**  
Scamp Construction cut this diagonal trench after the flood event. The objective of the trench is to redirect any additional flood events away from the path of the main office.

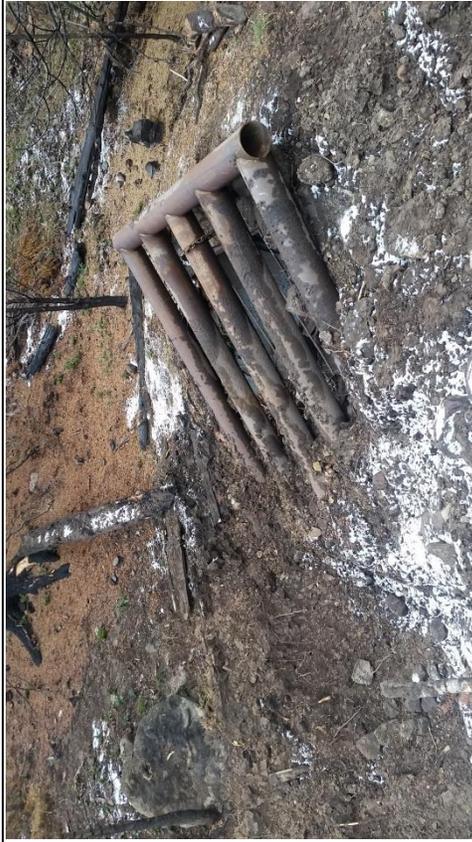
**PHOTO 23 – CULVERT C-6, SIDE VIEW**  
Structurally, the trash racks held but require cleaning.
