## Inspection Report

Permit Number:	<b>C0150032</b>
Inspection Type:	COMPLETE
Inspection Date:	Tuesday, December 11, 2018
Start Date/Time:	12/11/2018 11:00:00 AM
End Date/Time:	12/11/2018 1:30:00 PM
Last Inspection:	Monday, November 19, 2018

Permittee: **GENWAL RESOURCES INC**  
 Operator: **GENWAL RESOURCES INC**  
 Site: **CRANDALL CANYON MINE**  
 Address: **PO BOX 910, EAST CARBON UT 84520-0910**  
 County: **EMERY**  
 Permit Type: **PERMANENT COAL PROGRAM**  
 Permit Status: **INACTIVE**

**ATTACHMENT A – Crandall Canyon Complete inspection, December 11, 2018**

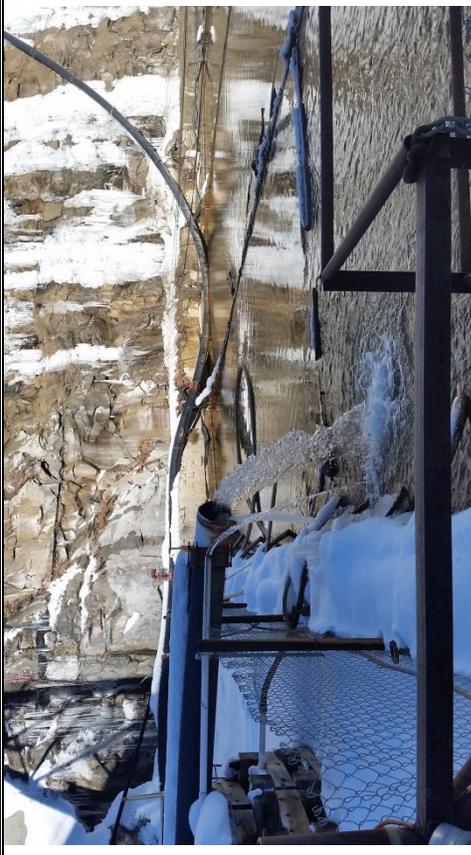
Water continues to discharge from the mine and into the treatment facility. The severe cold weather has caused the coagulant and flocculant lines to freeze and plug in the treatment facility recently. The reported flowrate was 232 gpm. Water samples were taken at a point just prior to treatment and again at the UPDES discharge point 002, after the water has flowed through the treatment system. The samples were delivered to the Utah State Laboratory for processing yesterday afternoon.

**PHOTO 1 – WATER TREATMENT FACILITY**  
 Overlooking cell 1. Water sampling location Pre-002 is from the end of the white PVC at center.

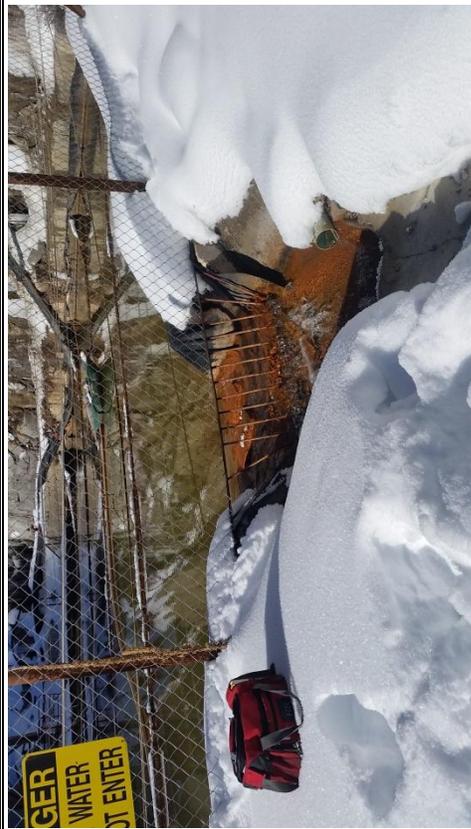
**PHOTO 2 – TREATMENT POND OUTFALL**  
 The water flowing under the trash rack is sampling point for UPDES discharge #002. The white PVC pipe drains snowmelt that collects at the base of the weeping highwall adjacent to the treatment pond.

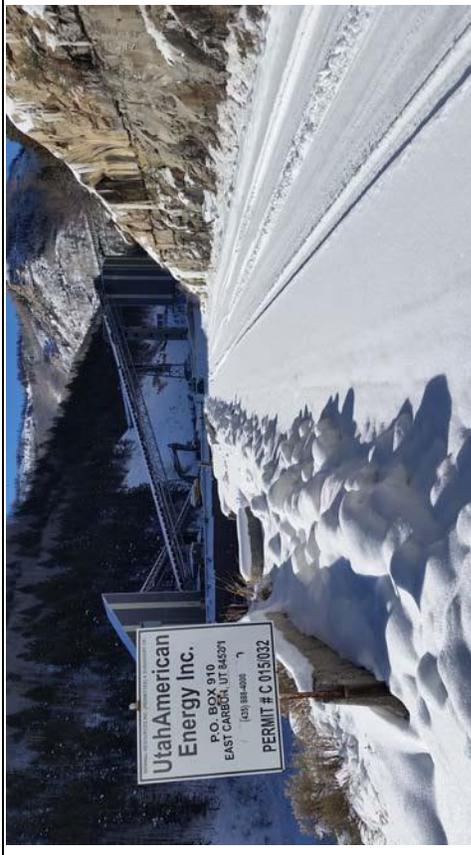
The permit identification sign at the entrance contains all of the necessary information. Topsoil signs are posted and visible on all topsoil piles, and disturbed area perimeter signs are in place.

**PHOTO 3 – PERMIT SIGN**  
 This is the Mine Permit sign at the entrance to the mine site.

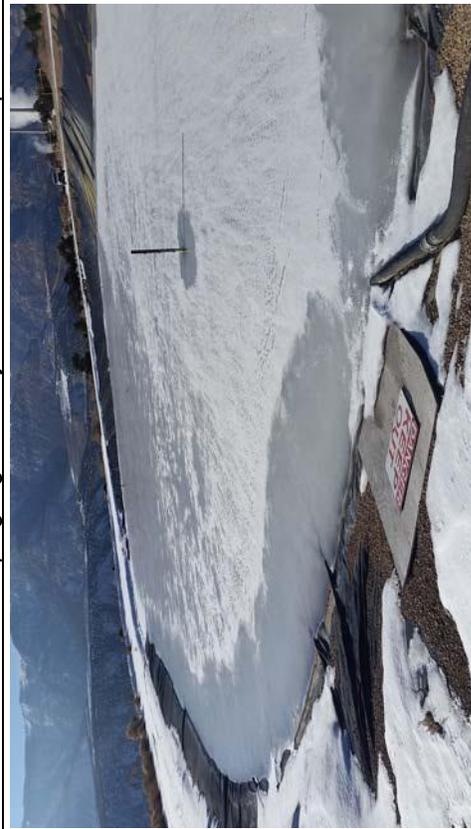
Both the mine sediment pond and the Burma pond appeared stable and the surfaces frozen. Both ponds were inspected on October 24, 2018, and found to have no instability, structural weakness, or other visible hazards. The inspection reports for the lower pond at the main site as well as the Burma pond were both stamped and signed by J. Thomas Paluso, a Professional Engineer for the State of Utah.

**PHOTO 4 – BURMA POND**  
 The Burma pond appears to be about half full, and is currently an ice skating rink.

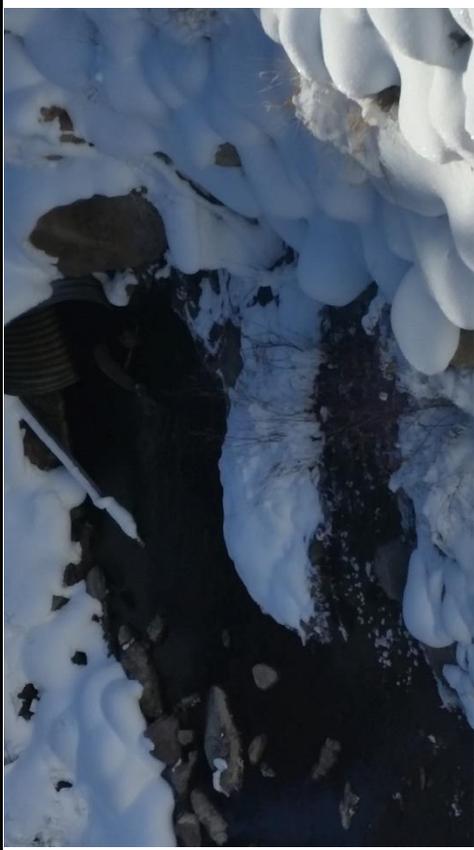
**PHOTO 5 – CRANDALL CREEK**

This culvert is the 72" bypass that runs beneath the main mine site.

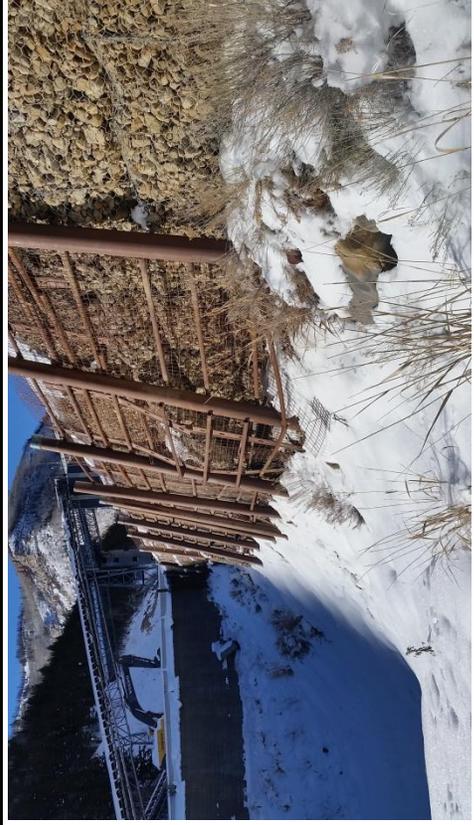
**PHOTO 6 – GABION WALL**

The steel pylons and other support structures appear stable

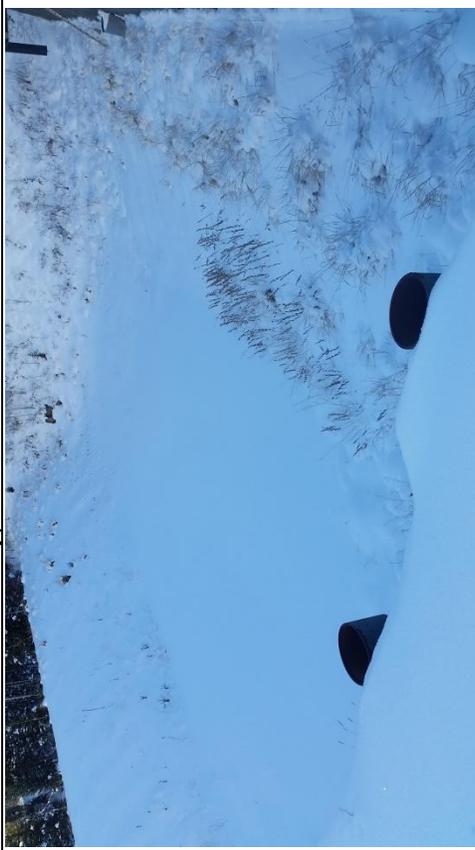
**PHOTO 7 – SEDIMENT POND**

The sediment pond is currently a frozen winterland.

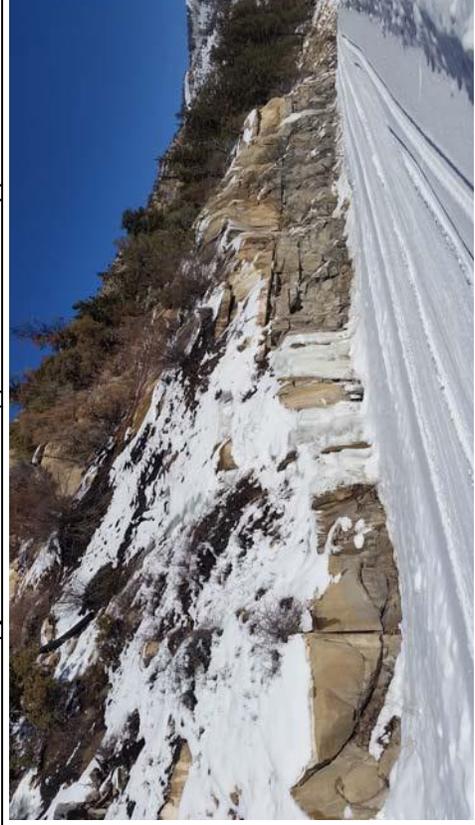
**PHOTO 8 – CULVERT C-5**

Notice the black culvert C-5 at the top of the image. It drains DD-11 which by design is supposed to trickle down the slope and collect at the base of the highwall in DD-7. However, in the winter this turns into an ice flow that can grow over the road.
