## Inspection Report

Permit Number:	C0150032
Inspection Type:	COMPLETE
Inspection Date:	Wednesday, March 20, 2019
Start Date/Time:	3/20/2019 3:30:00 PM
End Date/Time:	3/20/2019 6:00:00 PM
Last Inspection:	Tuesday, February 26, 2019

Permittee: **GENWAL RESOURCES INC**  
 Operator: **GENWAL RESOURCES INC**  
 Site: **CRANDALL CANYON MINE**  
 Address: **PO BOX 910, EAST CARBON UT 84520-0910**  
 County: **EMERY**  
 Permit Type: **PERMANENT COAL PROGRAM**  
 Permit Status: **INACTIVE**

**ATTACHMENT A – Crandall Canyon Complete Inspection, March 20, 2019**

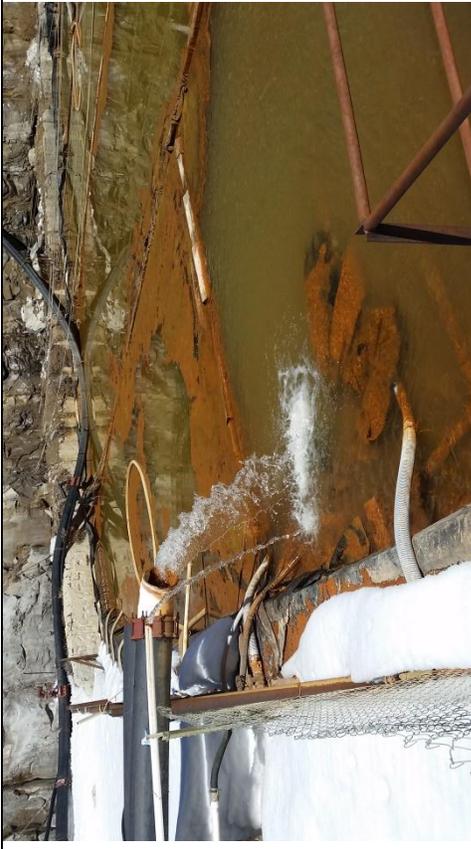
**PHOTO 1 – WATER TREATMENT FACILITY**  
Overlooking the water treatment pond. Water sampling location Pre-002 is from the end of the white PVC left of center.

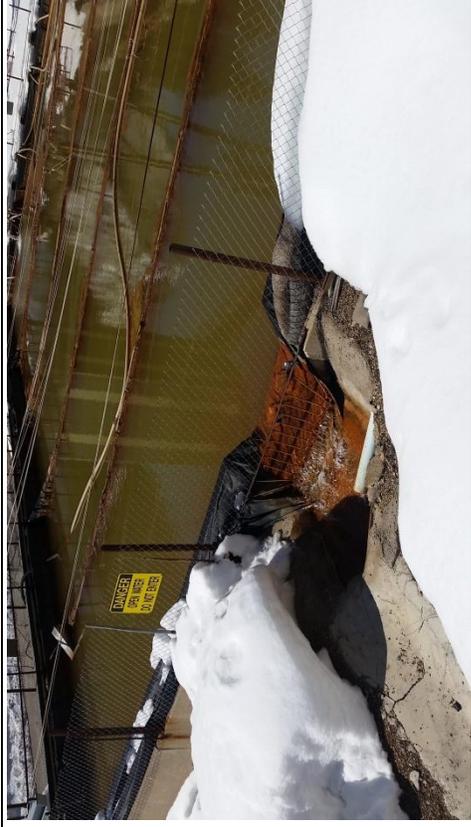
Water continues to discharge from the mine at a rate of 196 gpm. There is no flocculant or coagulant being applied to the mine water at this time since the water has been compliant for over a year. Water samples were taken at a point just prior to treatment and again at the UPDES discharge point 002, after the water has flowed through the treatment system. The samples were delivered to the Utah State Health Laboratory for processing.

**PHOTO 2 – TREATMENT POND OUTFALL**  
The water flowing through the outlet is sampling point for UPDES discharge #002.

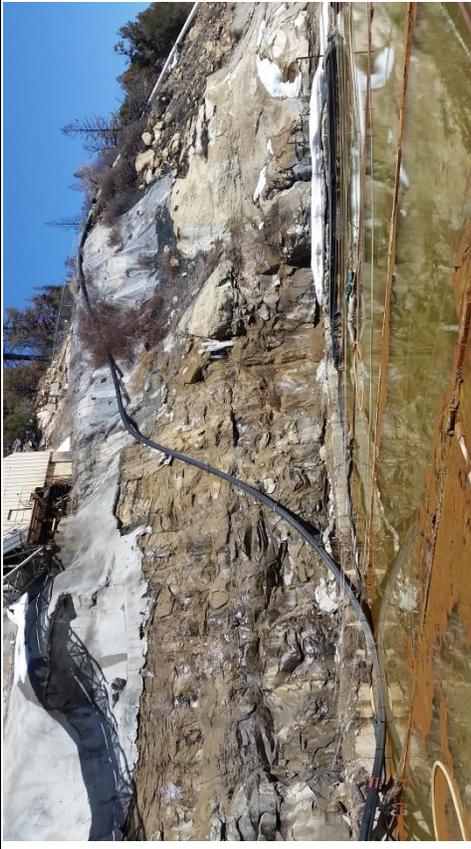
**PHOTO 3 – WEEPING HIGHWALL**  
The face of the highwall overlooking the water treatment facility. No recent spalling or sloughing is evident.

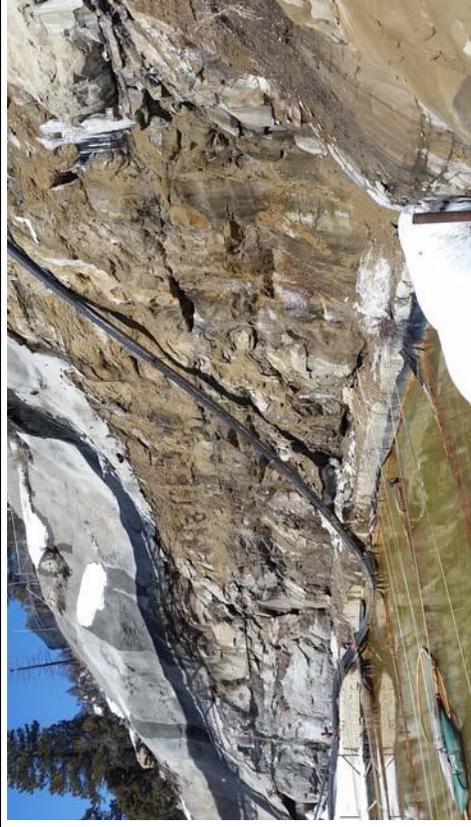
**PHOTO 4 – WEEPING HIGHWALL**  
A view of the highwall from a different angle.

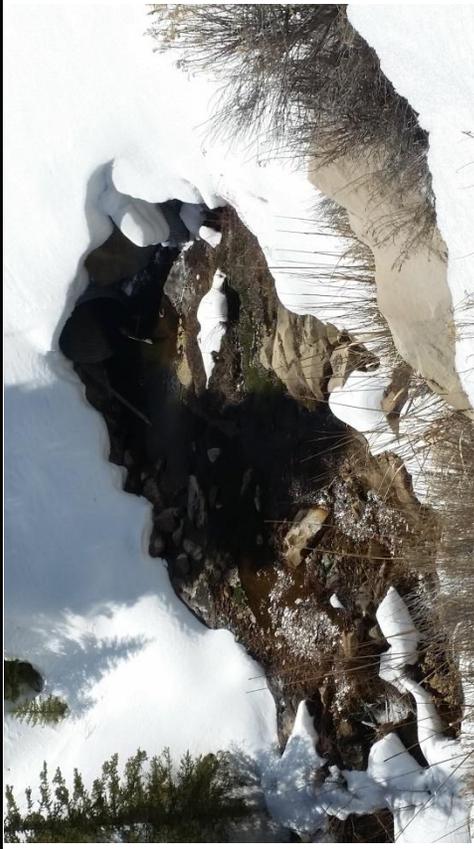
**PHOTO 5 – CRANDALL CREEK**

The discharging culvert at center is the 72" bypass that runs beneath the main mine site.

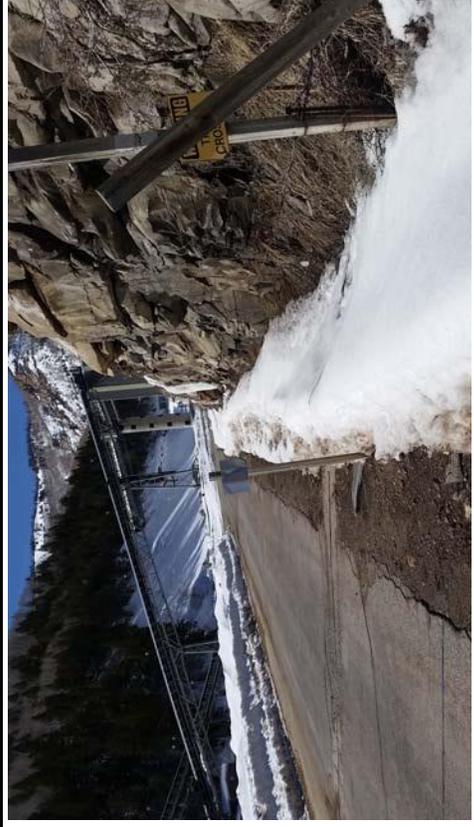
**PHOTO 6 – DD-7**

Drainage ditch DD-7 is located beneath the snow drift that lines the USFS road here. Highwall appears stable.

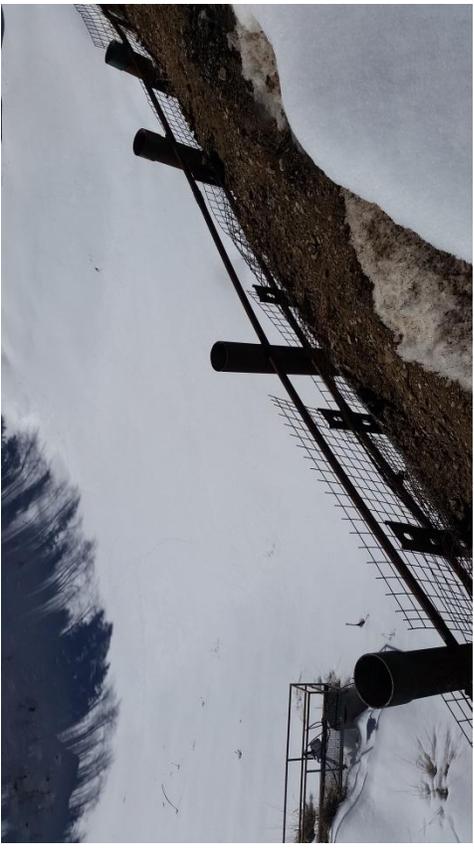
**PHOTO 7 – SEDIMENT POND**

The mine sediment pond is covered by several feet of snow. The Burma pond appeared to be at approximately 70% capacity and partially frozen. Both ponds were inspected on October 24, 2018, and found to have no instability, structural weakness, or other visible hazards. The inspection reports for the lower pond at the main site as well as the Burma pond were both stamped and signed by J. Thomas Paluso, a Professional Engineer for the State of Utah.

The sediment pond is still covered by a thick blanket of snow.

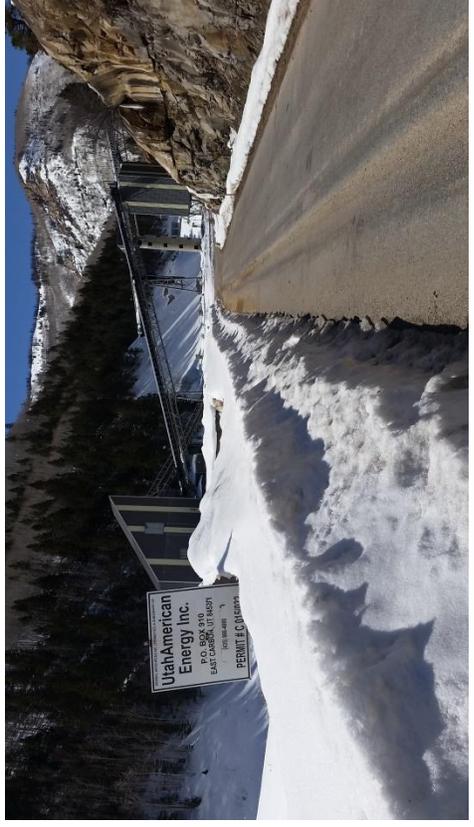
**PHOTO 8 – USFS ROAD**

Roads into the site were in good repair and the snow removed. No signs of sloughing or cracking were apparent anywhere.

The road into the site was in good condition and free of ice and snow.

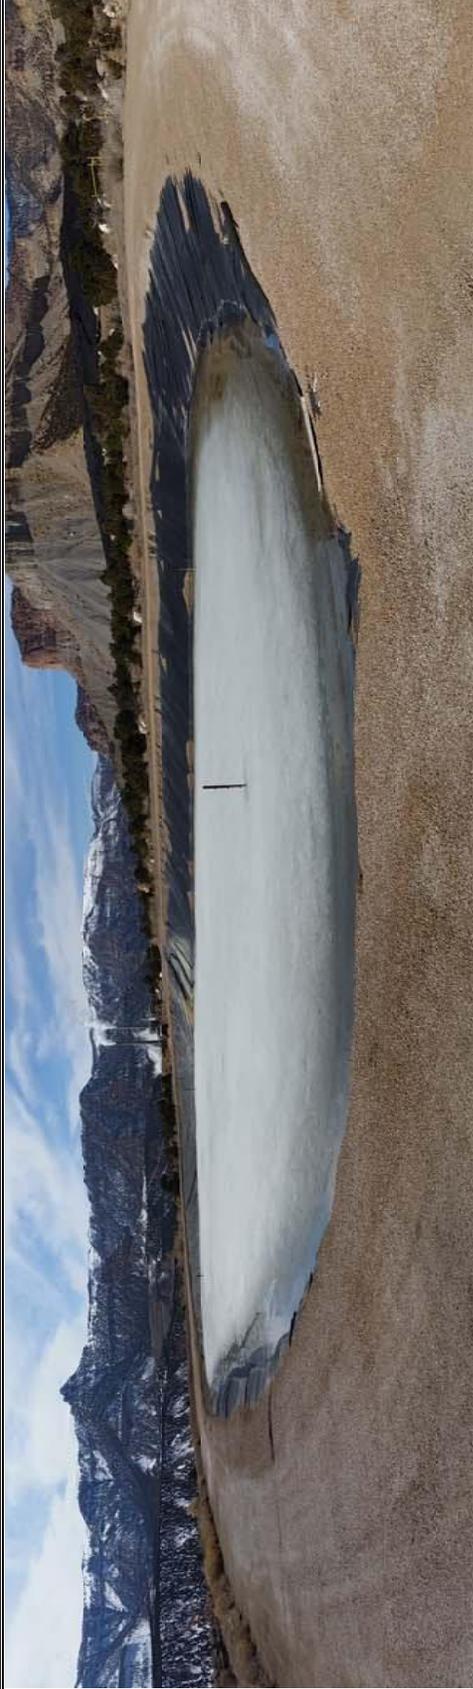
**PHOTO 9 - BURMA POND, LOOKING SOUTHWEST**

Pond appears to be at approximately 60% - 70% capacity, and is covered by a layer of ice that is diminishing around the edges. Pond appears stable, and the liner free of rips or tears.
