Inspection Report

Permit Number:	C0150032
Inspection Type:	PARTIAL
Inspection Date:	Tuesday, April 16, 2019
Start Date/Time:	4/16/2019 12:30:00 PM
End Date/Time:	4/16/2019 3:00:00 PM
Last Inspection:	Wednesday, March 20, 2019

Permittee: **GENWAL RESOURCES INC**
 Operator: **GENWAL RESOURCES INC**
 Site: **CRANDALL CANYON MINE**
 Address: **PO BOX 910, EAST CARBON UT 84520-0910**
 County: **EMERY**
 Permit Type: **PERMANENT COAL PROGRAM**
 Permit Status: **INACTIVE**

ATTACHMENT A – Crandall Canyon Partial Inspection, April 16, 2019

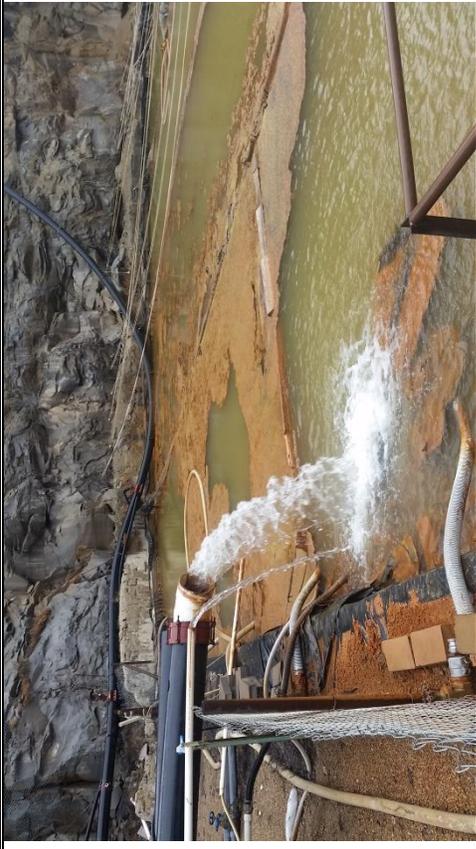
PHOTO 1 – WATER TREATMENT FACILITY
Overlooking the water treatment pond. Water sampling location Pre-002 is from the end of the white PVC left of center.

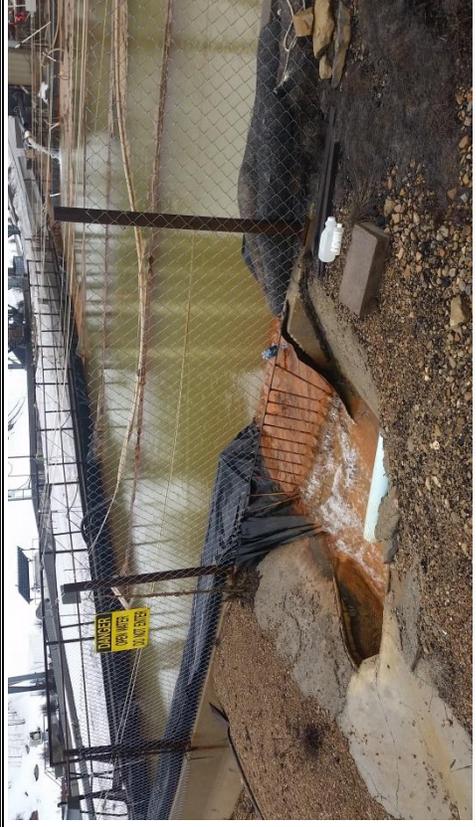
PHOTO 2 – TREATMENT POND OUTFALL
The water flowing through the outlet is sampling point for UPDES discharge #002.

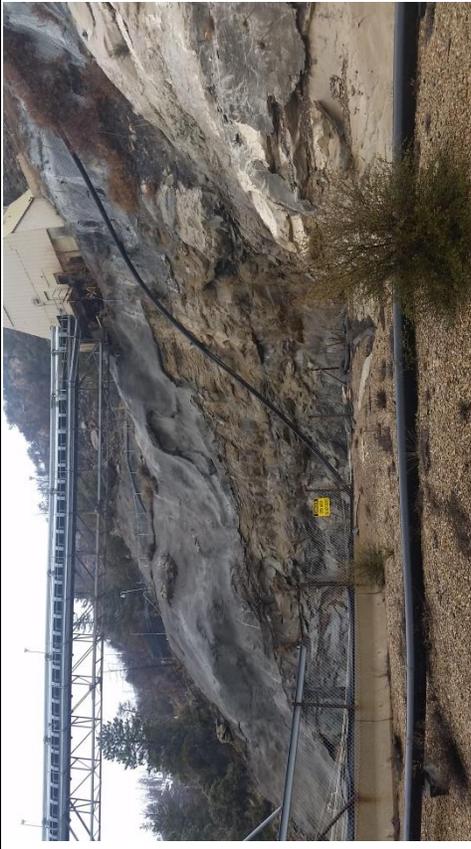
PHOTO 3 – WEEPING HIGHWALL
The face of the highwall overlooking the water treatment facility. No recent spalling or sloughing is evident.

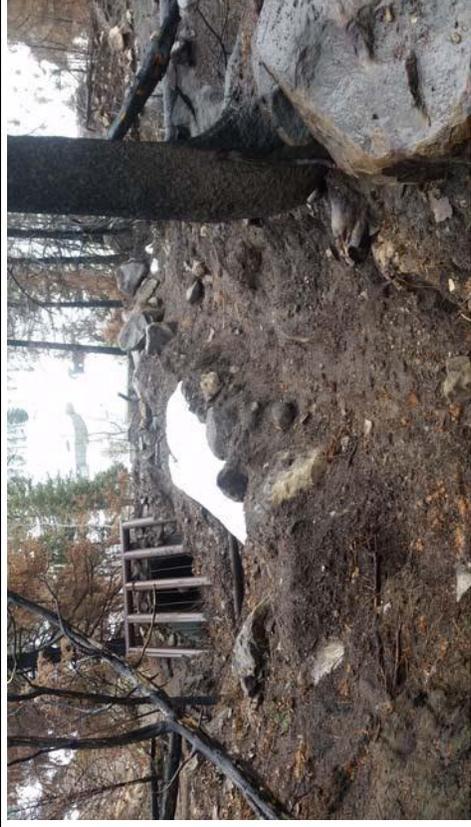
Diversions ditches along the USFS road leading into the mine showed evidence of being washed out in recent weeks. Maintenance work on the UD culvert above the main offices will commence once conditions dry up and heavy equipment can be mobilized up the slopes.

PHOTO 4 – C-6 CULVERT (ABOVE MAIN OFFICE)
This culvert will be cleaned and rehabilitated later this year when conditions are less muddy.

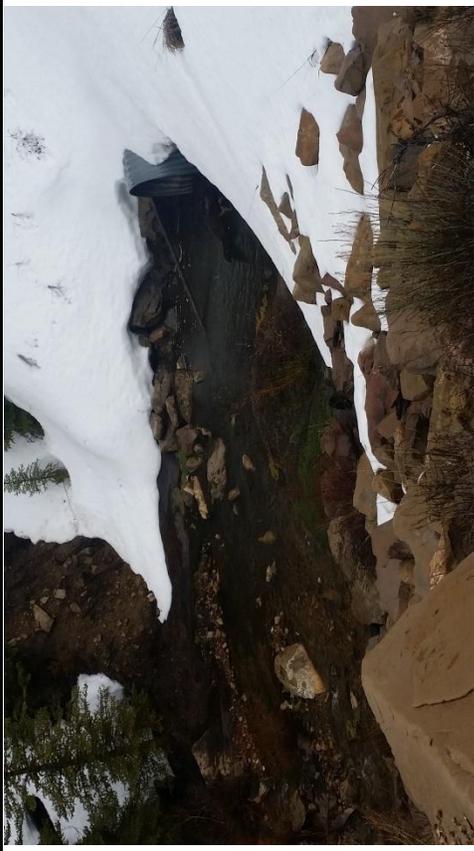
PHOTO 5 – CRANDALL CREEK

The discharging culvert at center is the 72" bypass that runs beneath the main mine site.

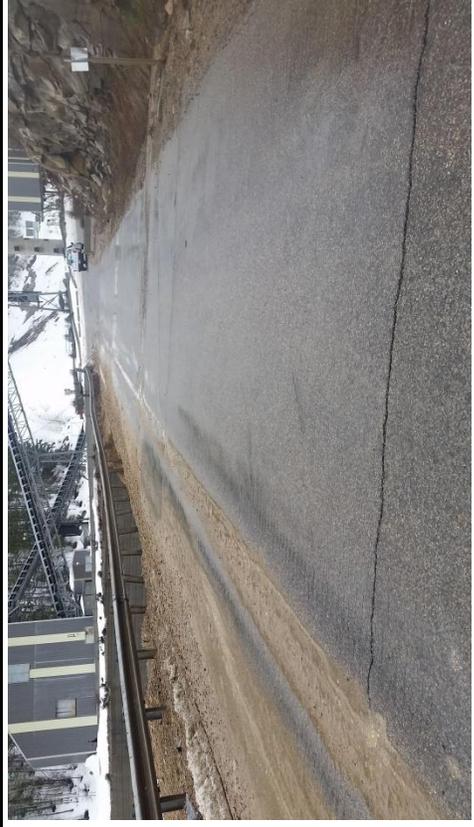
PHOTO 6 – USFS ROAD

The shoulder of the USFS road adjacent to the sediment pond has sloughed and failed where the old support structures were installed last year. The road is still stable and no new cracks appear to have formed, although it is likely that more sloughing could occur considering the amount of rain this area has been receiving recently. Karin last visited the site on April 1, and no sloughing had occurred at that time. SCAMP was notified immediately at the beginning of the inspection, and barricades have been installed to divert traffic around the damaged area. Plans to repair the road as soon as possible are currently in place.

Notice that although the shoulder has sloughed slightly on the left, the road otherwise appears stable.

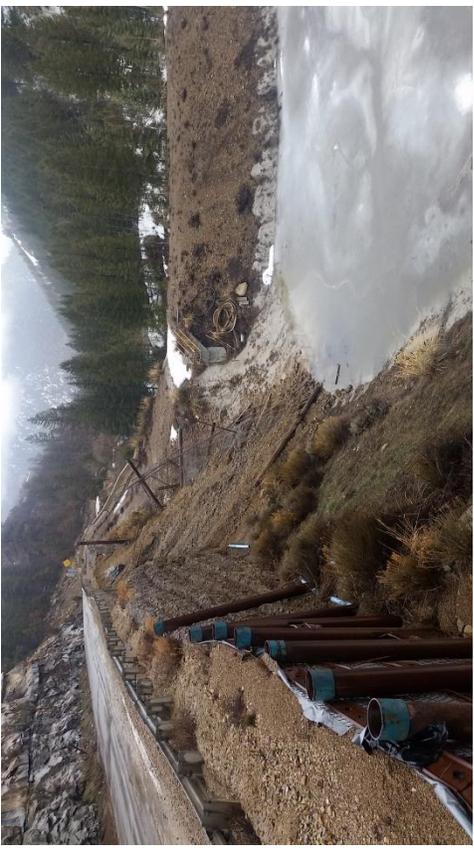
PHOTO 7 – SEDIMENT POND

Sediment pond holding a modest amount of water. The layer of ice that used to be on the top of the pond has been replaced by a layer of slush.

The sediment pond currently covered by a layer of slush. Gabion basket failure on the left.

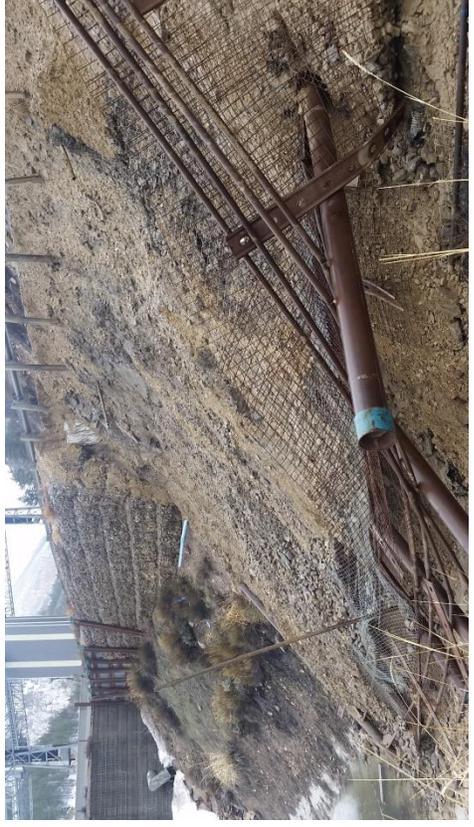
PHOTO 8 – SHOULDER FAILURE

The wet weather and melting snow are likely causes for this failure.

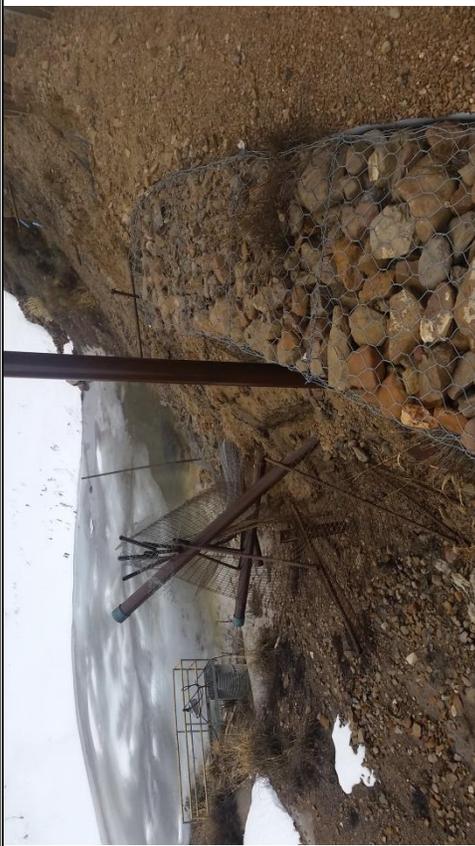
PHOTO 9 – SHOULDER FAILURE

A different perspective, overlooking the sediment pond.

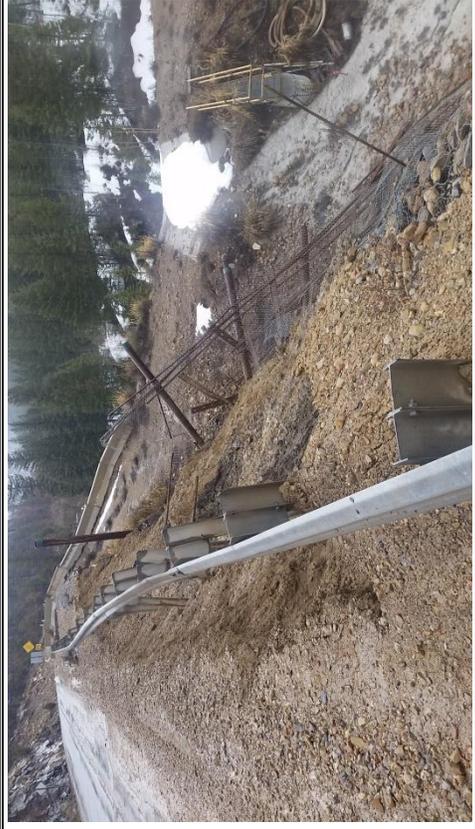
PHOTO 10 – SHOULDER FAILURE

View of the failure, straddling the guard rail.

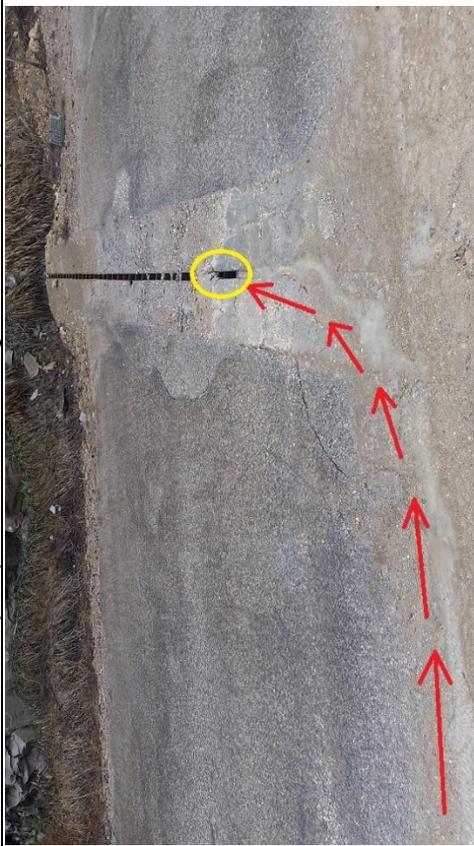
PHOTO 11 – INSTALLED ROAD DRAIN

Rain water appears to be seeping into inset drains installed into the pavement of the USFS road above the section that recently failed, but no obvious outlet is visible (see photos).

This section of drain is located adjacent to the failure. The red lines highlight the path of flow, and the water disappears at the yellow circle. It is not clear where the water goes from there.

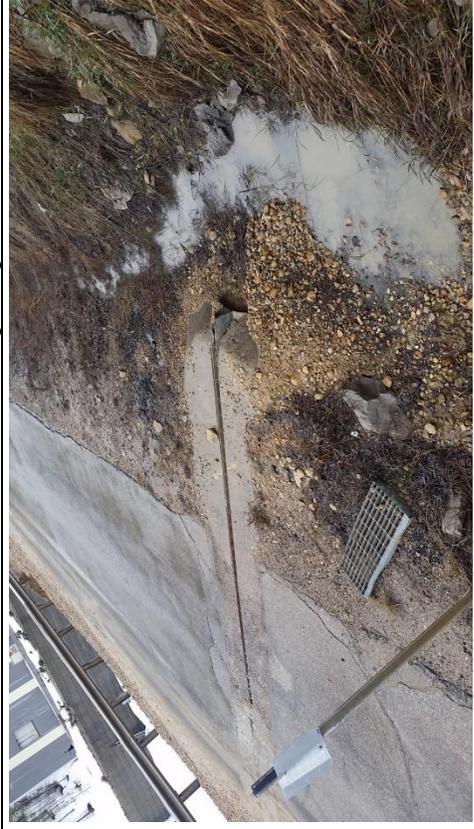
PHOTO 12 – INSTALLED DRAIN

This is the highlighted drain in Photo 11. Notice the ponding water in the drainage ditch. This is a common phenomenon, and may have contributed to the failure.
