Division of Oil, Gas and Mining

Inspection Report

Permit Number:	C0150032
Inspection Type:	PARTIAL
Inspection Date:	Thursday, May 23, 2019
Start Date/Time:	5/23/2019 12:00:00 PM
End Date/Time:	5/23/2019 2:30:00 PM
Last Inspection:	Tuesday, April 16, 2019

Permittee: **GENWAL RESOURCES INC**
 Operator: **GENWAL RESOURCES INC**
 Site: **CRANDALL CANYON MINE**
 Address: **PO BOX 910, EAST CARBON UT 84520-0910**
 County: **EMERY**
 Permit Type: **PERMANENT COAL PROGRAM**
 Permit Status: **INACTIVE**

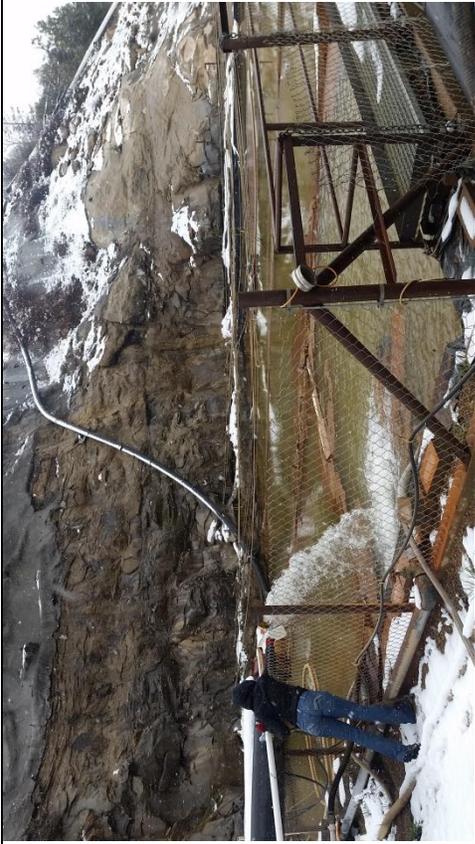
PHOTO 1 – WATER TREATMENT FACILITY

Karin collecting water from sampling location Pre-002.

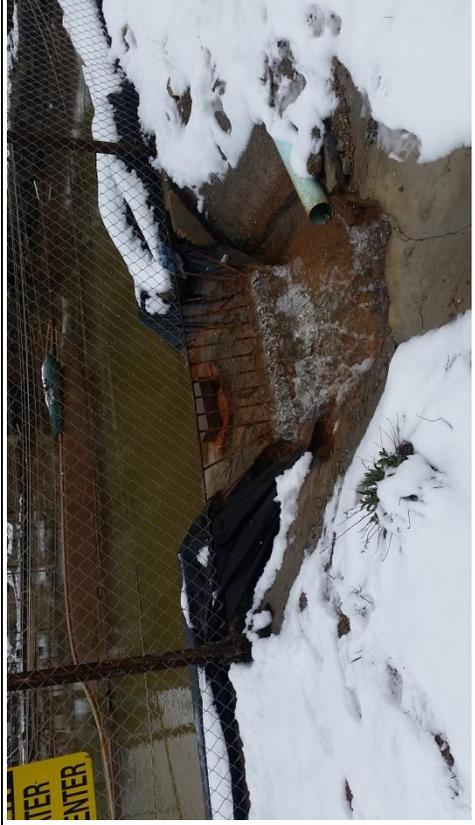
PHOTO 2 – TREATMENT POND OUTFALL

The water flowing through the trash rack is sampling point for UPDES discharge #002.

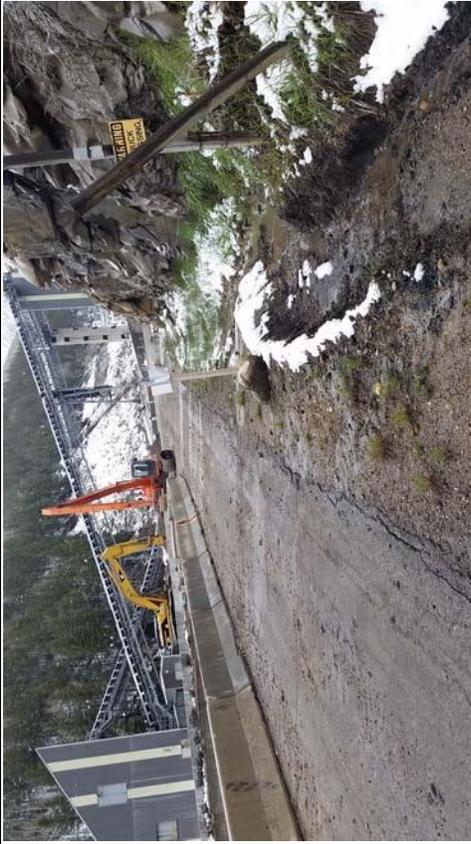
PHOTO 3 – DRAINAGE DITCH DD-7

The drainage ditch DD-7 adjacent to USFS Road 0248 has been partially dredged and slightly extended to promote adequate drainage. Runoff that would ordinarily be impounded here is now flowing along the drainage ditch beside the USFS road and away from the damaged area.

This view is looking west – notice the toe of the slope has been cut and pulled back to allow ditch DD-7 to drain during construction.

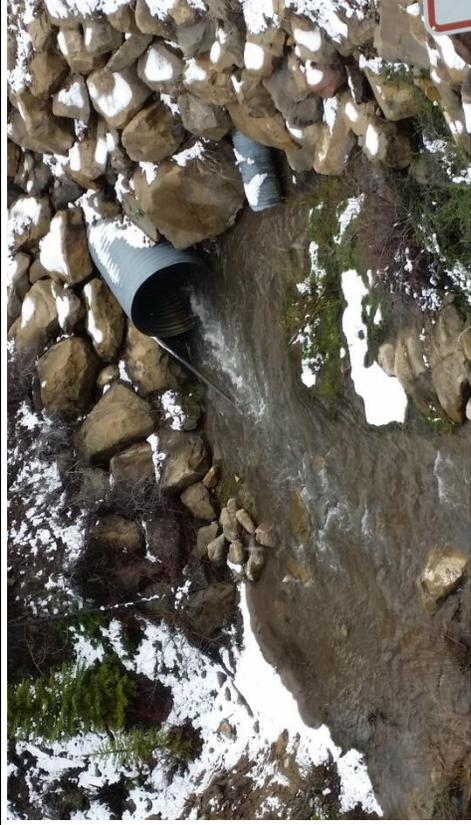
PHOTO 4 – CRANDALL CREEK

The discharging culvert at center is the 72" bypass that runs beneath the main mine site.

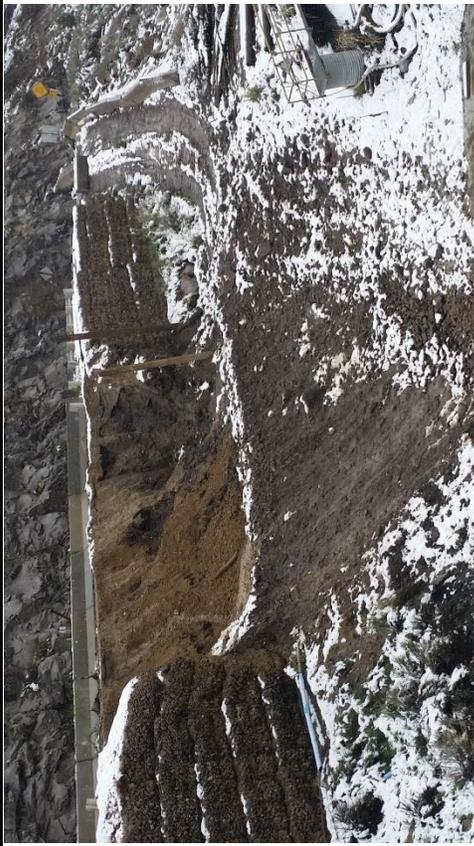
PHOTO 5 – ROAD REPAIRS

The outslope failure of USFS Road 0248 has been completely excavated in preparation for extensive repairs. Originally, the Gabion wall that had failed was going to be restored to pre failure specifications, but Gabion baskets could not be acquired sooner than six weeks out so other arrangements were made. The alternate outslope restoration requires a concrete base be poured beneath where the slide occurred, and the backfill installed in lifts. Each lift will be reinforced with steel mesh and concrete blocks instead of Gabion baskets. Culvert C-3 will be reestablished as construction progresses, and the placement of the steel mesh will provide additional drainage channels through the backfill. Once the road and the outslope have been restored, drainage ditch DD-7 will be lined with concrete to ensure that runoff will be promptly conveyed off site and not allowed to impound and saturate the road base. Currently the biggest construction hindrance is the weather since it has either rained or snowed almost daily since construction got underway.

The section of road that failed has been excavated and the backfill set aside until concrete can be poured.

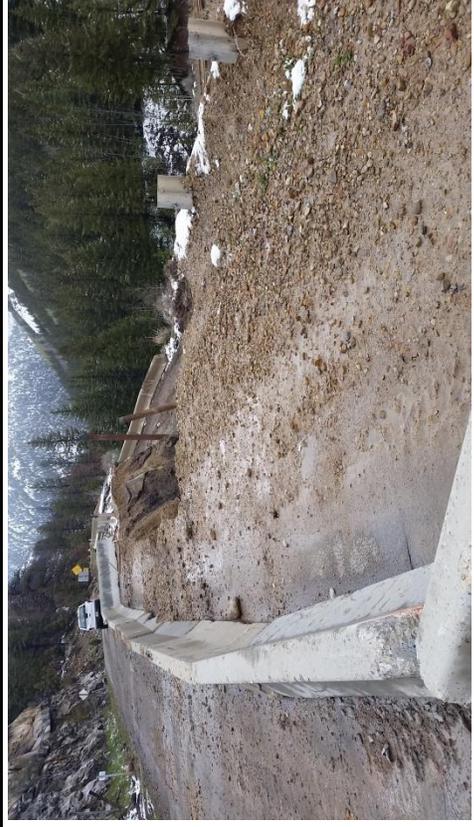
PHOTO 6 – SAFETY BARRIERS

The Jersey barriers have been in place since the failure was discovered last month.

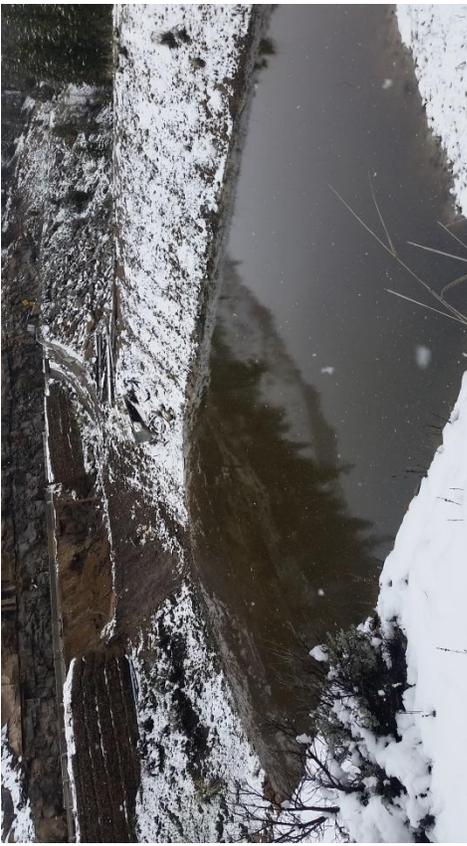
PHOTO 7 – SEDIMENT POND

Sediment pond 001 is completely thawed and holding a modest amount of water - approximately a third full.

The sediment pond is currently completely thawed. Gabion basket failure at center.

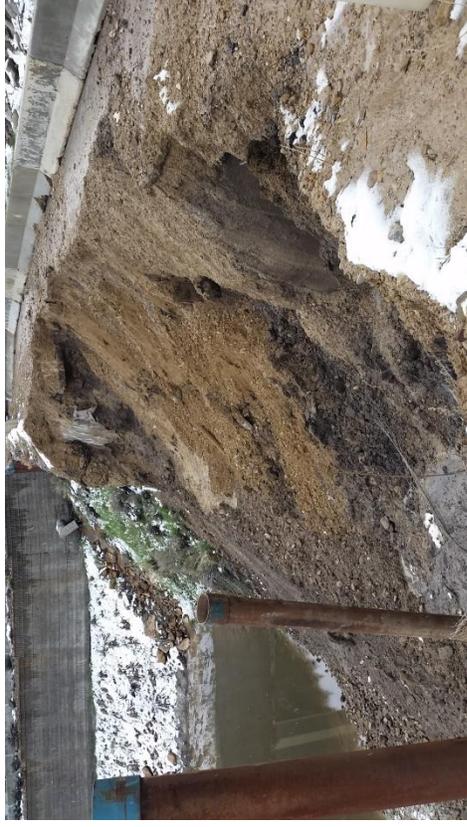
PHOTO 8 – ROAD REPAIRS

Gabion baskets and other support structures have been excavated and the loose road base dug back.

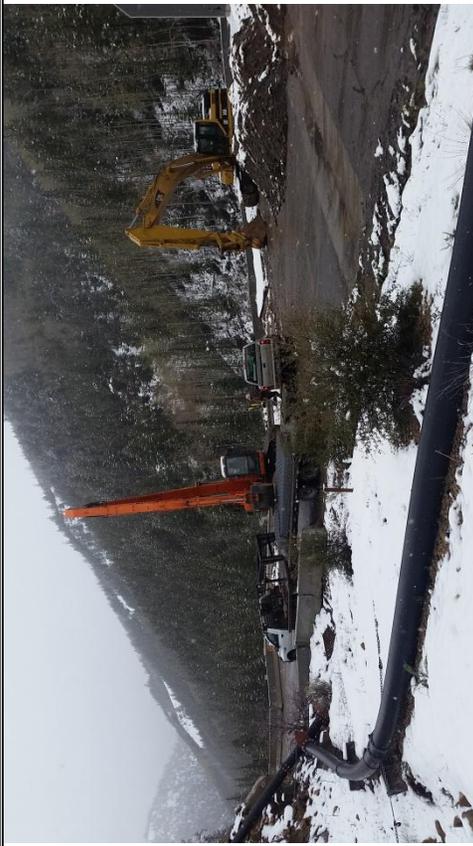
PHOTO 9 – CONSTRUCTION CREW

Heavy machinery mobilized to repair the road failure.

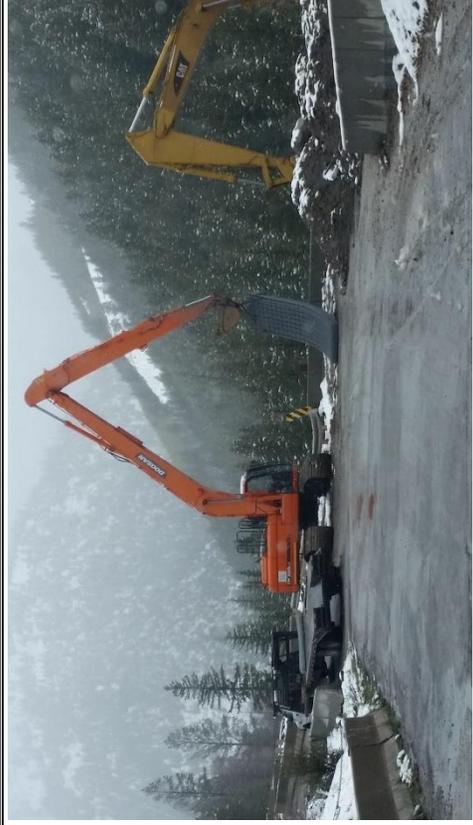
PHOTO 10 – CONSTRUCTION CREW

This trackhoe is removing steel mesh from the flatbed truck.
