Division of Oil, Gas and Mining

Inspection Report

Permit Number:	C0150032
Inspection Type:	PARTIAL
Inspection Date:	Wednesday, August 14, 2019
Start Date/Time:	8/14/2019 10:00:00 AM
End Date/Time:	8/14/2019 12:30:00 PM
Last Inspection:	Monday, July 15, 2019

Permittee: **GENWAL RESOURCES INC**
 Operator: **GENWAL RESOURCES INC**
 Site: **CRANDALL CANYON MINE**
 Address: **PO BOX 910, EAST CARBON UT 84520-0910**
 County: **EMERY**
 Permit Type: **PERMANENT COAL PROGRAM**
 Permit Status: **INACTIVE**

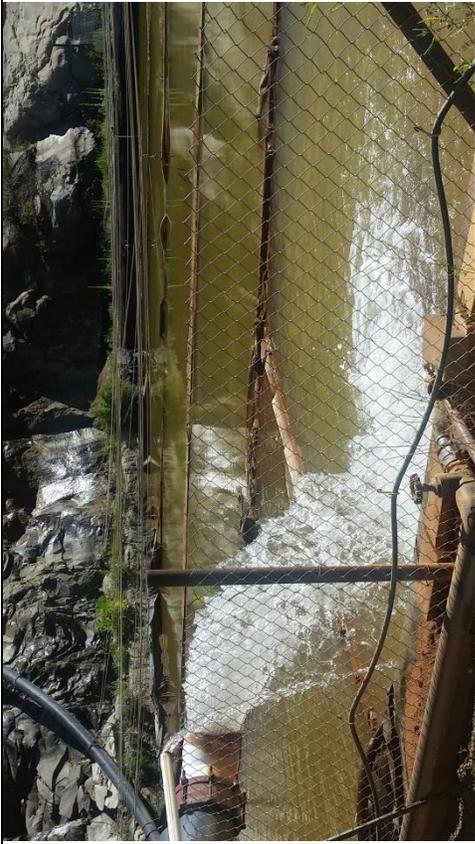
PHOTO 1 – WATER TREATMENT FACILITY
Overlooking the water treatment pond. Water sampling location Pre-002 is from the end of the white PVC left of center.

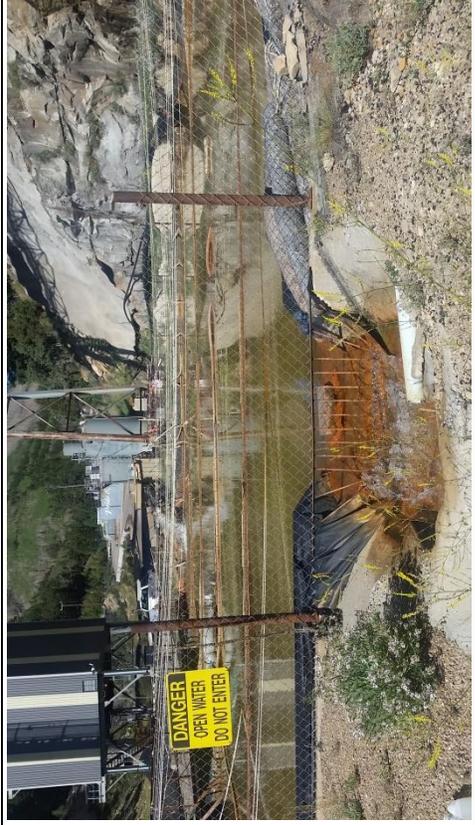
PHOTO 2 – TREATMENT POND OUTFALL
The water flowing through the outlet is sampling point for UPDES discharge #002.

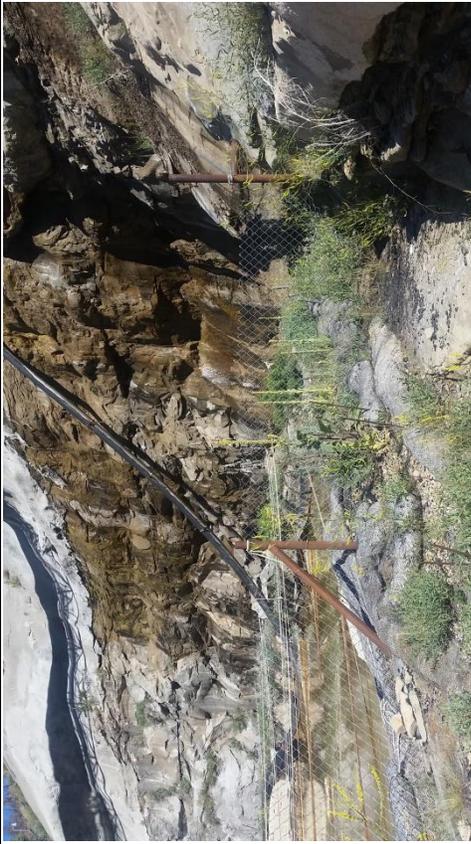
PHOTO 3 – WEEPING HIGHWALL
The face of the highwall overlooking the water treatment facility. No recent spalling or sloughing is evident.

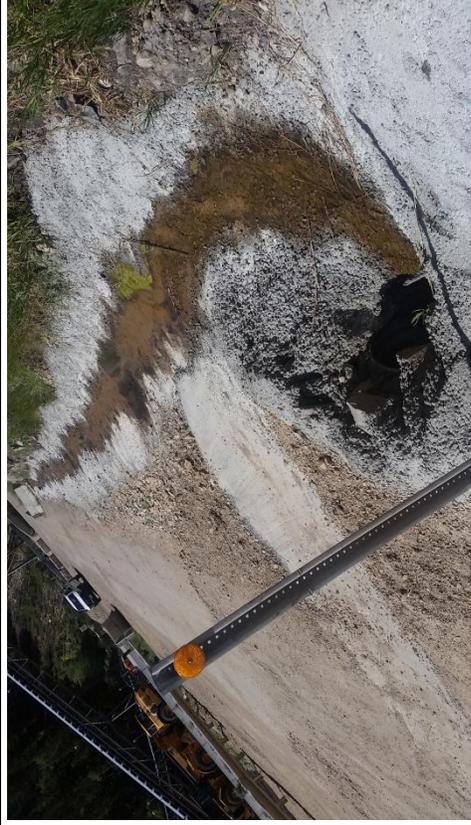
Drainage ditch DD-7 was paved last month and it appears to be redirecting runoff into the sediment pond as designed.

Drainage ditch DD-7 is currently redirecting approximately 1 - 2 gpm of water from the north slopes through culvert C-3 and into the sediment pond. The concrete lined ditch appears to be performing well.

PHOTO 4 – ARMORED DRAINAGE DITCH
This is drainage ditch DD-7 – it appears to be draining into culvert C-3 as planned.

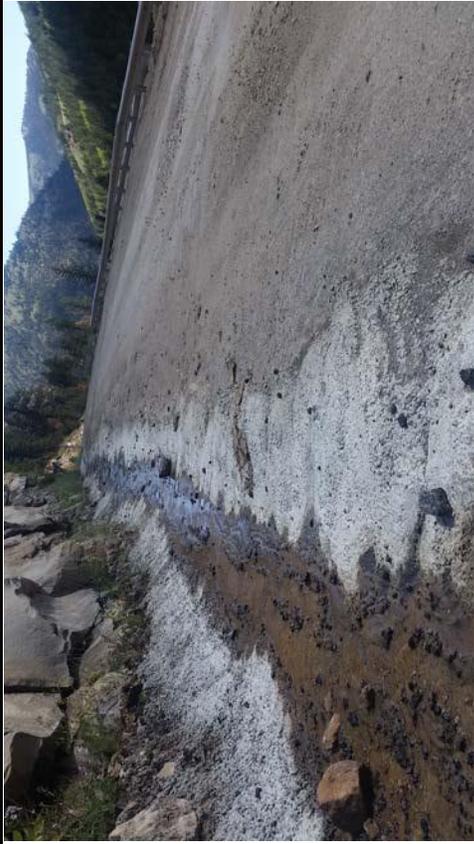
PHOTO 5 – ARMORED DRAINAGE DITCH

This is drainage ditch DD-7 – Fairly steady flow ~ approx. 1 gpm coming off the north sideslopes.

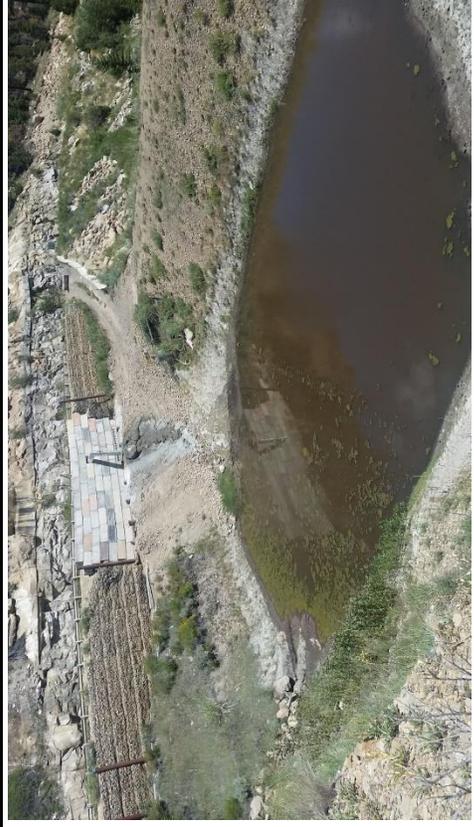
PHOTO 6 – SEDIMENT POND

Sediment pond appears approximately 1/3 full.

Perhaps 1/4 full and a little mossy.

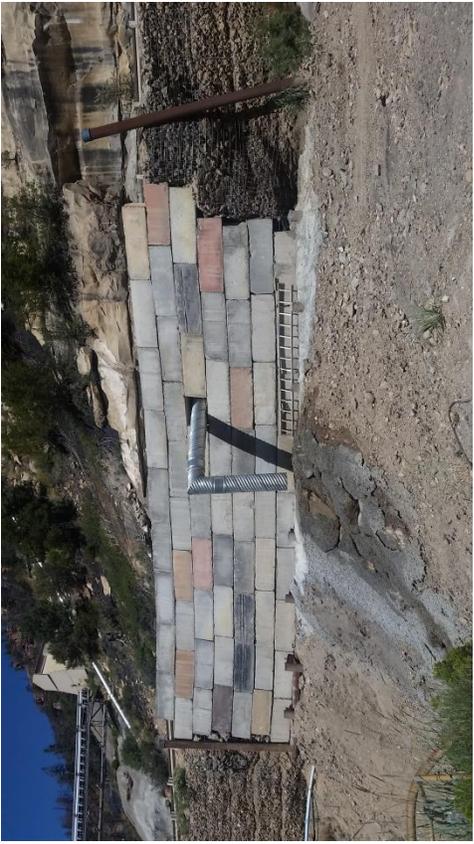
PHOTO 7 – USFS 0248 REPAIRS

This is the completed section of repairs.

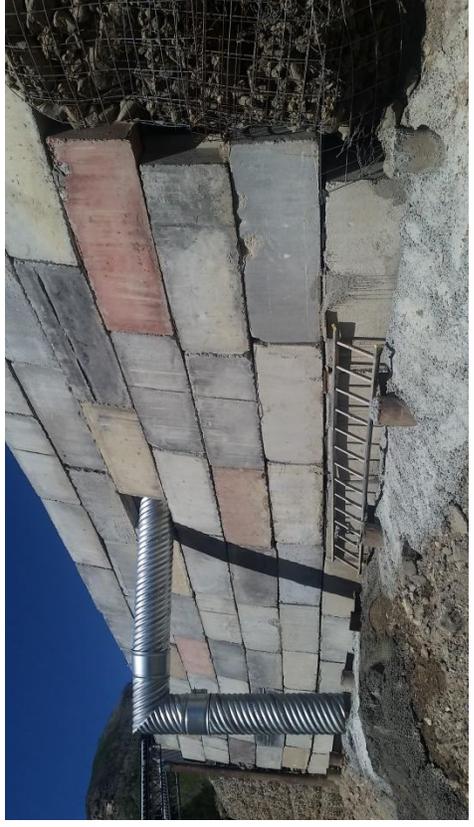
PHOTO 8 – USFS 0248 REPAIRS

A side view of the wall.

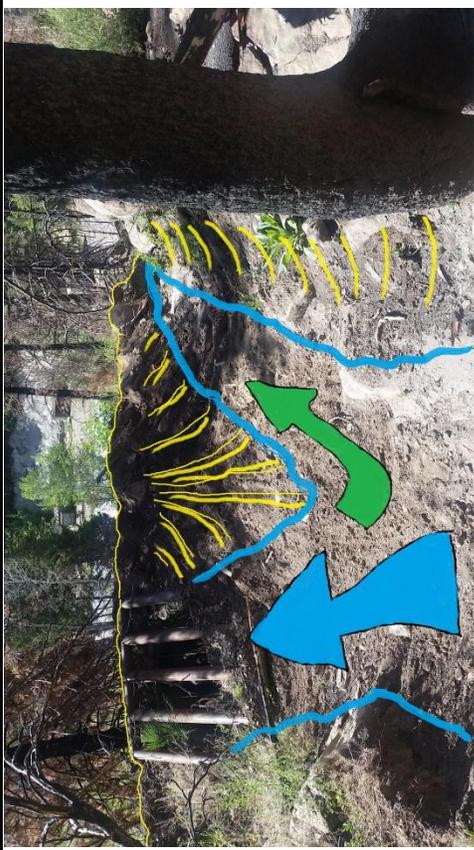
PHOTO 9 – CULVERT C-6

The earthen dike that was previously redirecting all runoff past the entrance to culvert C-6 was recently removed and the drainage recontoured to direct all runoff into the culvert. The overflow trench still resides adjacent to the culvert to capture excess runoff in the event that the culvert should become plugged.

The drainage around the culvert has been contoured so that runoff flows into the culvert (blue arrow), and overflow follows the green arrow into bypass trench in case the culvert becomes plugged.

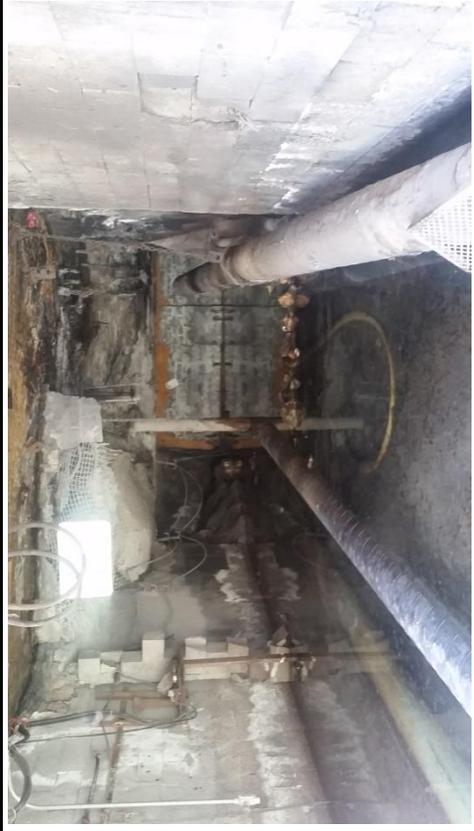
PHOTO 10 – SEALED NORTH PORTAL

.These pipes drain the mine water behind the cinderblock seals.

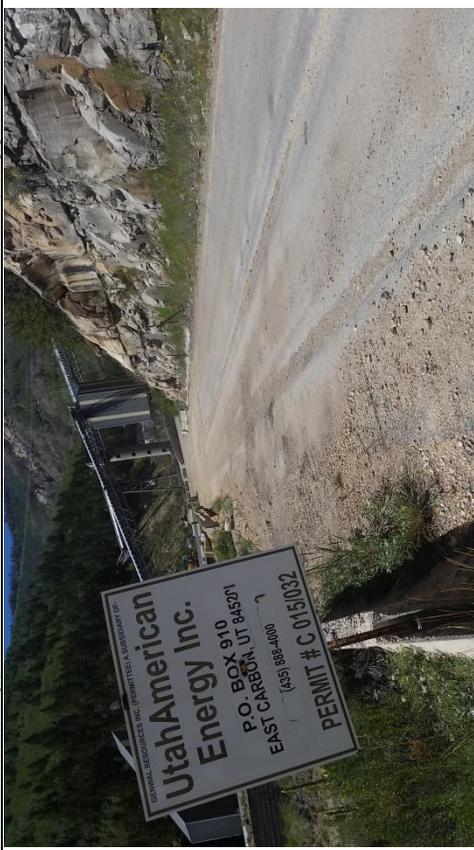
PHOTO 11 – PERMIT SIGN

The permit identification sign at the entrance contains all of the necessary information. Topsoil signs are posted and visible on all topsoil piles, and disturbed area perimeter signs are in place.

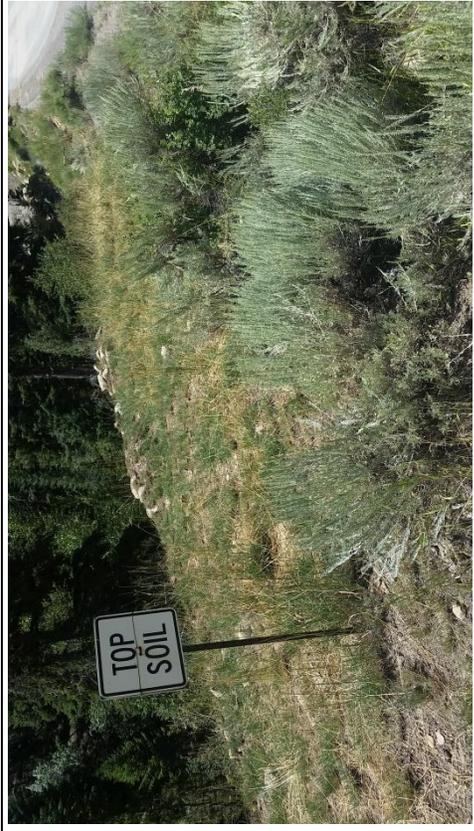
PHOTO 12 – TOPSOIL SIGNAGE

All topsoil piles were posted.
