Division of Oil, Gas and Mining

Inspection Report

Permit Number:	C0150032
Inspection Type:	PARTIAL
Inspection Date:	Wednesday, October 16, 2019
Start Date/Time:	10/16/2019 12:00:00 PM
End Date/Time:	10/16/2019 2:30:00 PM
Last Inspection:	Monday, September 30, 2019

Permittee: **GENWAL RESOURCES INC**
 Operator: **GENWAL RESOURCES INC**
 Site: **CRANDALL CANYON MINE**
 Address: **PO BOX 910, EAST CARBON UT 84520-0910**
 County: **EMERY**
 Permit Type: **PERMANENT COAL PROGRAM**
 Permit Status: **INACTIVE**

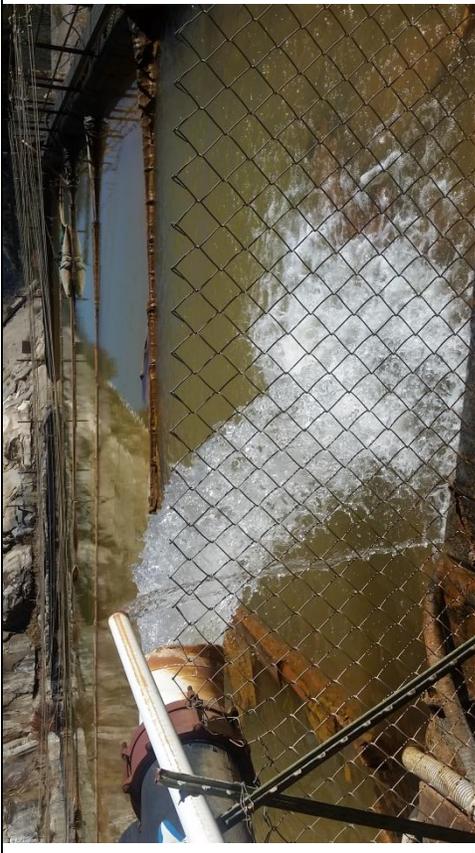
PHOTO 1 – WATER TREATMENT FACILITY

Overlooking the water treatment pond. Water sampling location Pre-002 is from the end of the white PVC left of center.

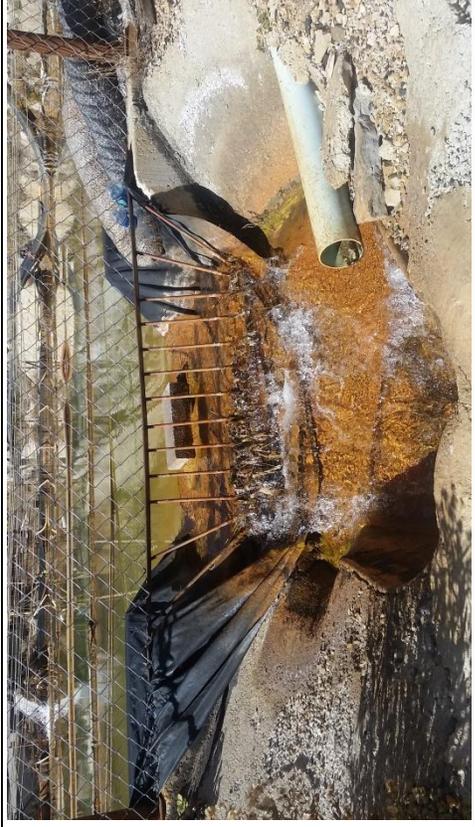
PHOTO 2 – TREATMENT POND OUTFALL

The water flowing through the trash rack is sampling point for UPDES discharge #002.

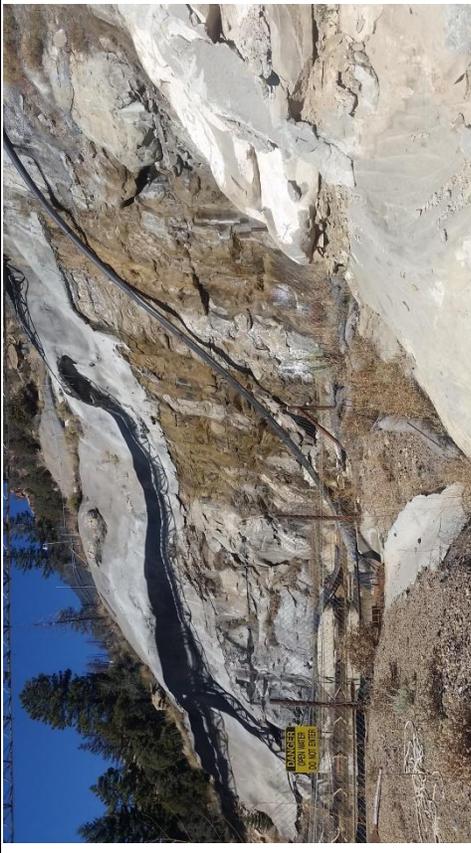
PHOTO 3 – WEEPING HIGHWALL

The face of the highwall overlooking the water treatment facility. No recent spalling or sloughing is evident.

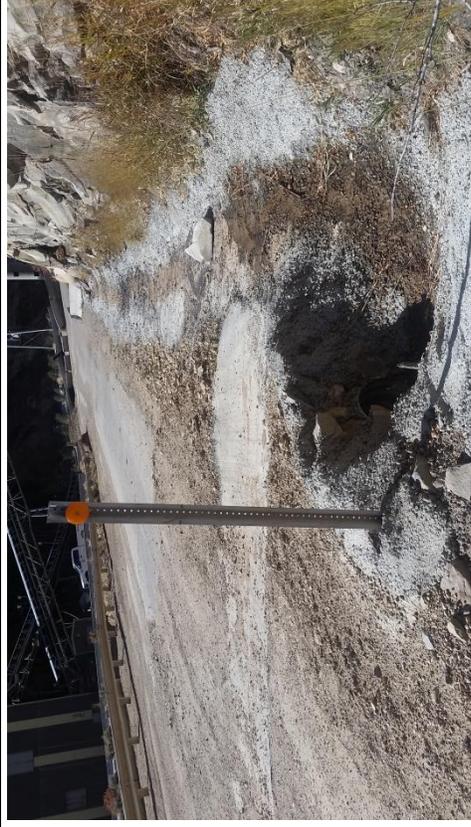
PHOTO 4 – ARMORED DRAINAGE DITCH

Drainage ditch DD-7 and culvert C-3 are clear of debris and continually divert a steady trickle from the headcut beside the road to the sediment pond.

Drainage ditch DD-7 draining into culvert C-3 as planned.

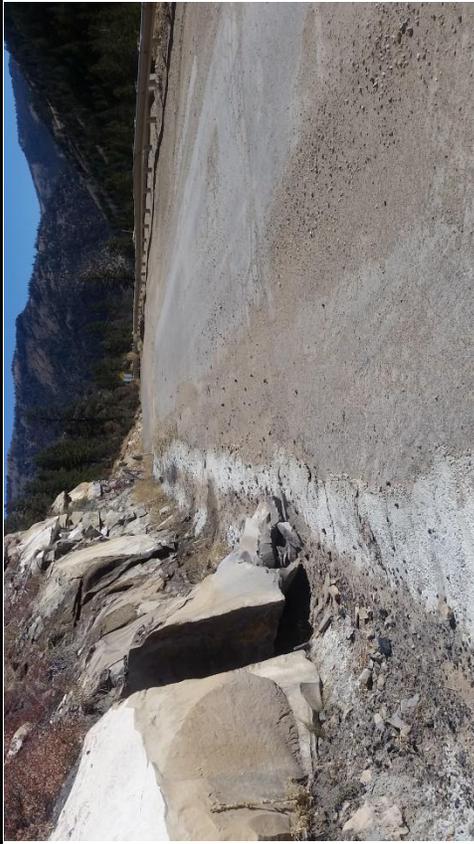
PHOTO 5 – ARMORED DRAINAGE DITCH
Drainage ditch DD – recent minor rock fall at center.

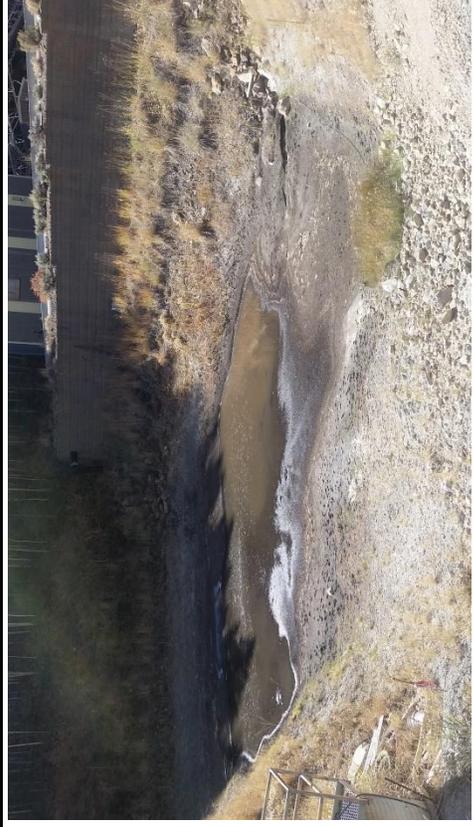
The lower sediment pond is currently not much more than a large puddle, and partially frozen.

PHOTO 6 – SEDIMENT POND
Partially frozen on the fringes.

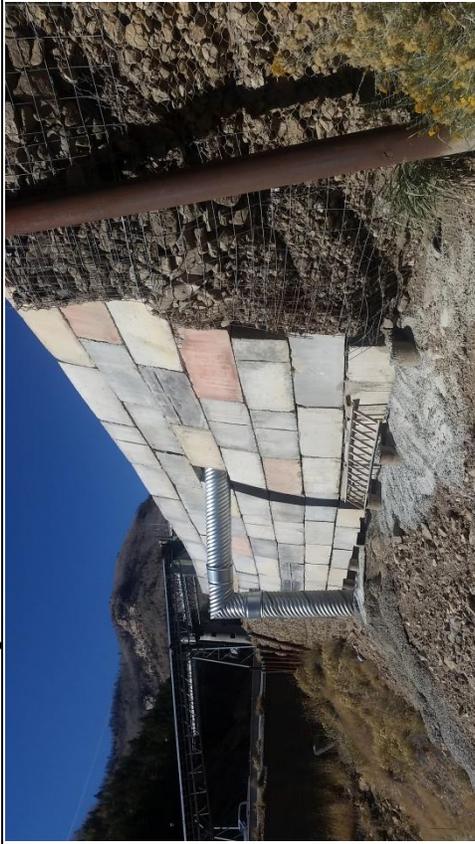
The rebuilt section of FR 0248 is still stable and shows no cracking or other signs of movement.

PHOTO 7 – USFS 0248 REPAIRS
Completed section of repairs.

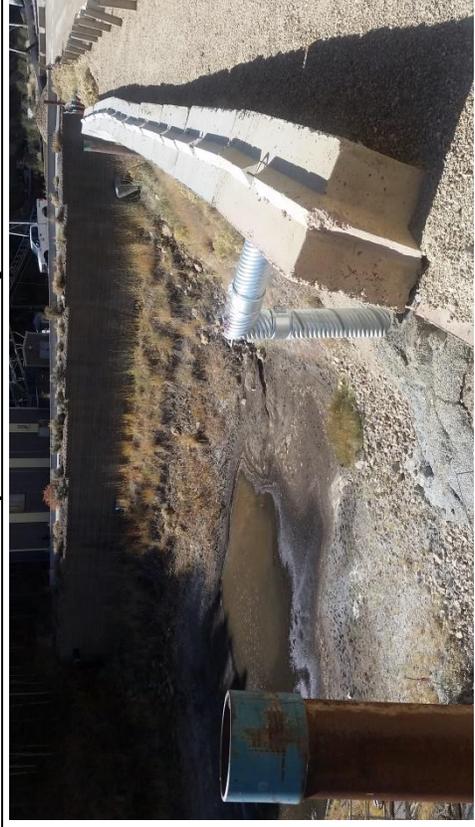
PHOTO 8 – USFS 0248 REPAIRS
A view from the top.

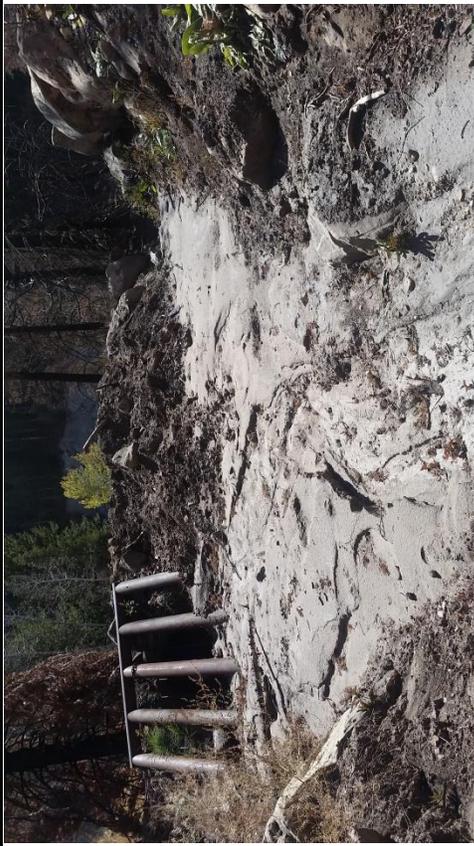
PHOTO 9 – CULVERT UD-1

Modest amount of silt collecting at the mouth of the culvert.

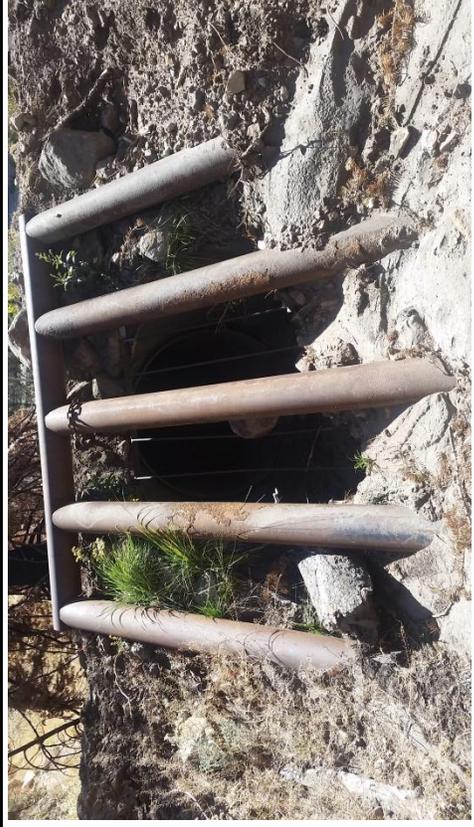
PHOTO 10 – CULVERT UD-1

Close up of the culvert inlet.

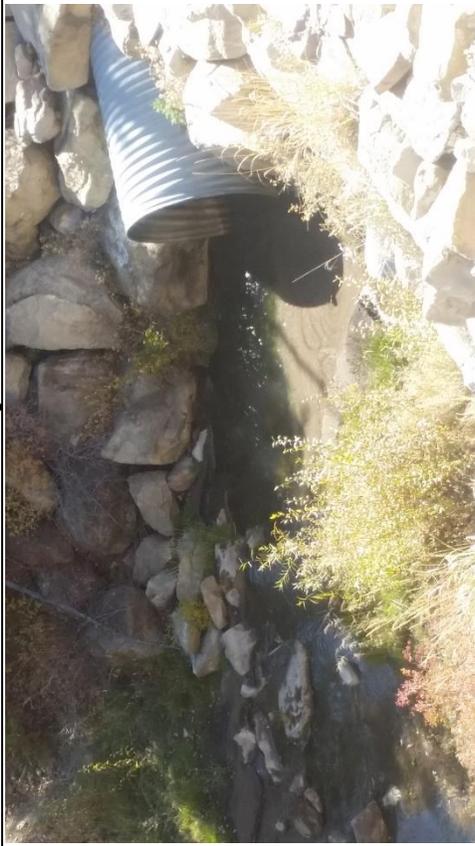
PHOTO 11 – CRANDALL CREEK

The outfall of the 72" culvert beneath the main site.

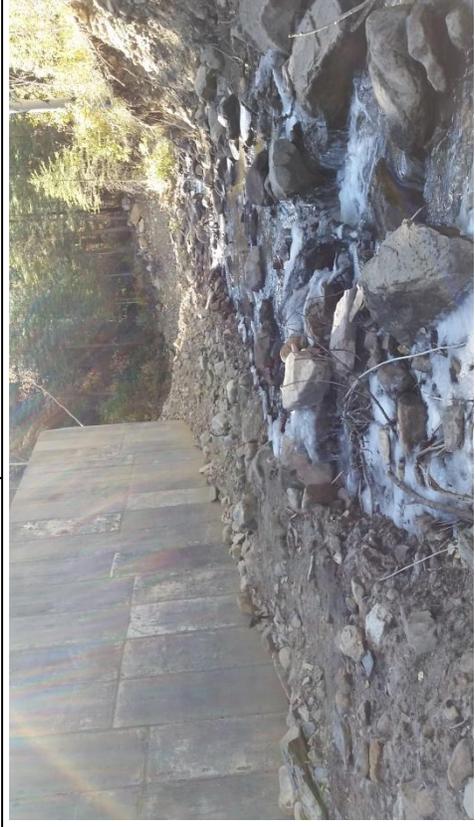
PHOTO 12 – MINER MEMORIAL WALL

The flood control wall appears stable. Crandall Creek is at low flow.
