Citation for Non-Compliance
Utah Coal Regulatory Program
 1594 West North Temple, Salt Lake City, UT 84114
 Phone: (801) 538-5340 Fax: (801) 359-3940

Citation #: 21216
Permit Number: C0150032
Date Issued: 5/7/19

Inspection Report

ATTACHMENT A – Crandall Canyon Partial Inspection, April 16, 2019

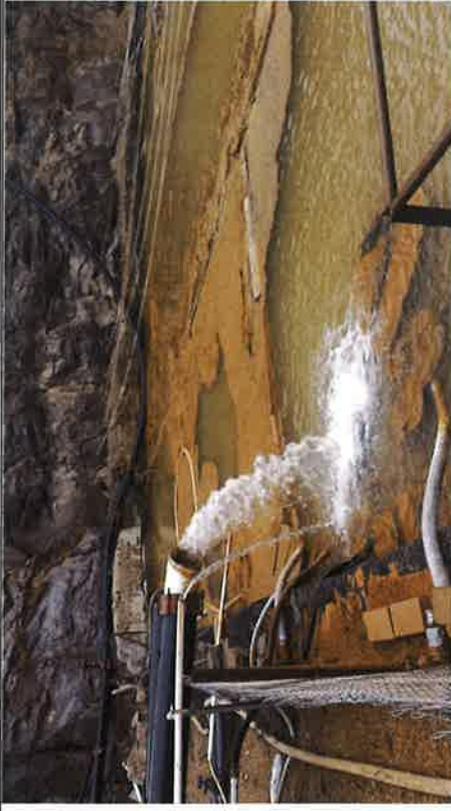
PHOTO 1 – WATER TREATMENT FACILITY
Overlooking the water treatment pond. Water sampling location Pre-002 is from the end of the white PVC left of center.

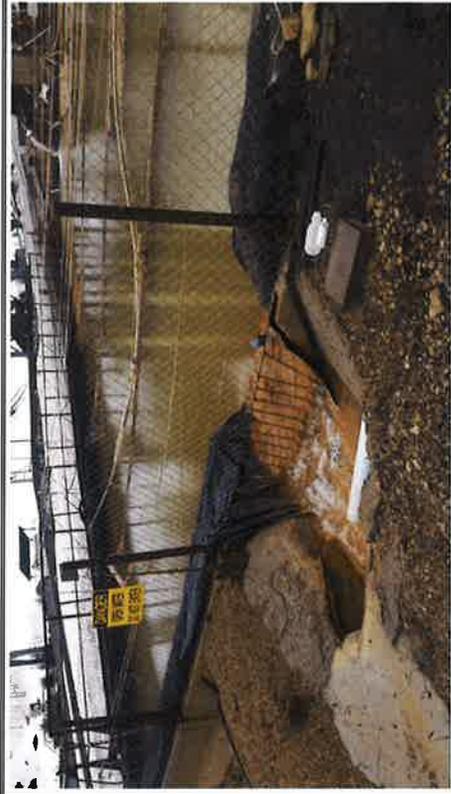
PHOTO 2 – TREATMENT POND OUTFALL
The water flowing through the outlet is sampling point for UPDES discharge #002.

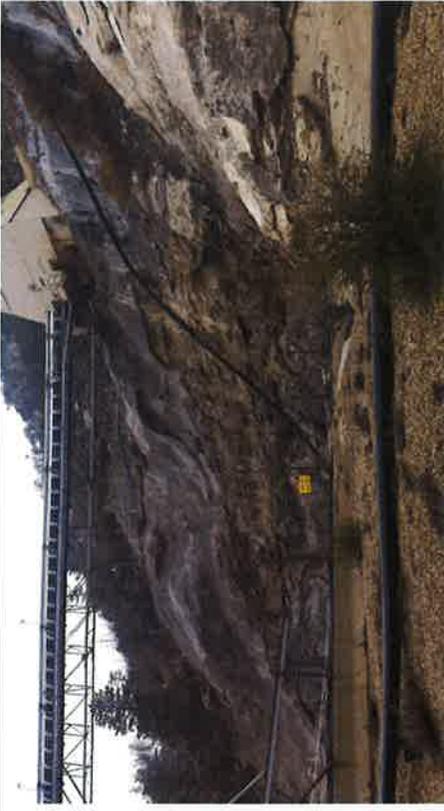
PHOTO 3 – HIGHWALL
The face of the highwall overlooking the water treatment facility. No recent spalling or sloughing is evident.

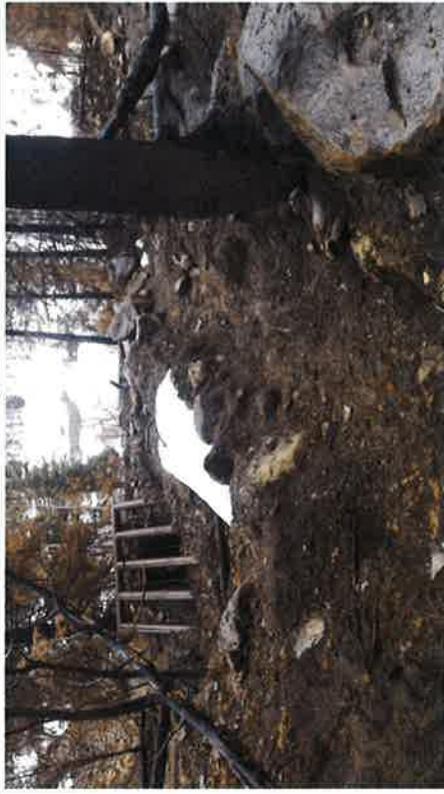
PHOTO 4 – C-6 CULVERT (ABOVE MAIN OFFICE)
This culvert will be cleaned and rehabilitated later this year when conditions are less muddy.

Maintenance work on the UD culvert above the main offices will commence once conditions dry up and heavy equipment can be mobilized up the slopes.

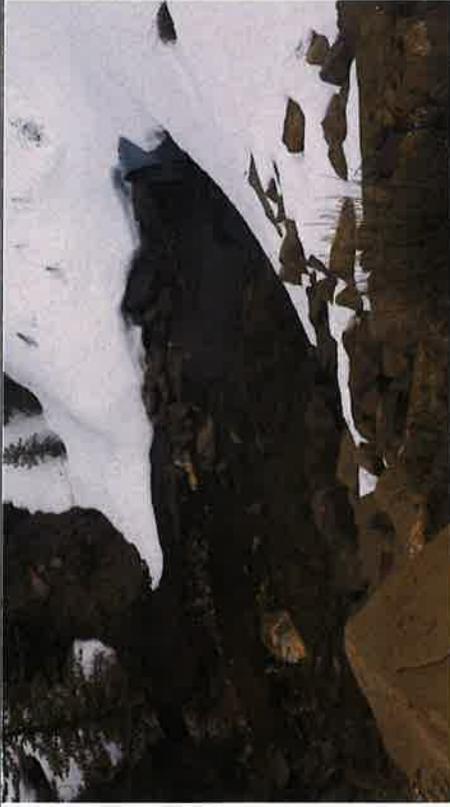
PHOTO 5 – CRANDALL CREEK

The discharging culvert at center is the 72" bypass that runs beneath the main mine site.

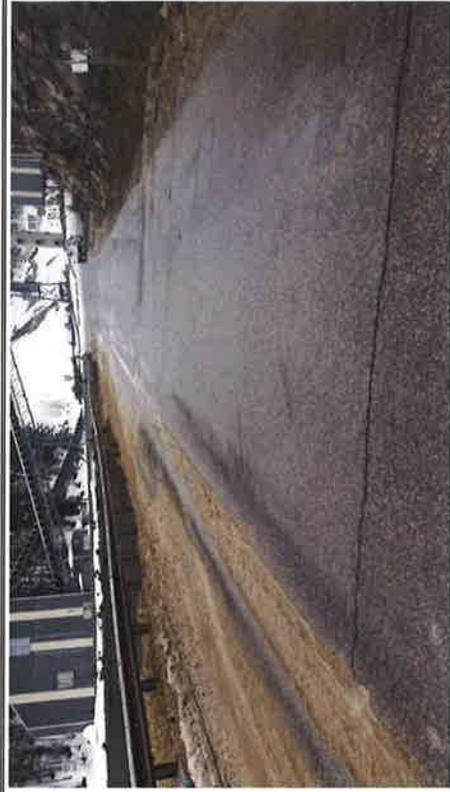
PHOTO 6 – USFS ROAD

Notice that although the shoulder has sloughed slightly on the left, the road otherwise appears stable.

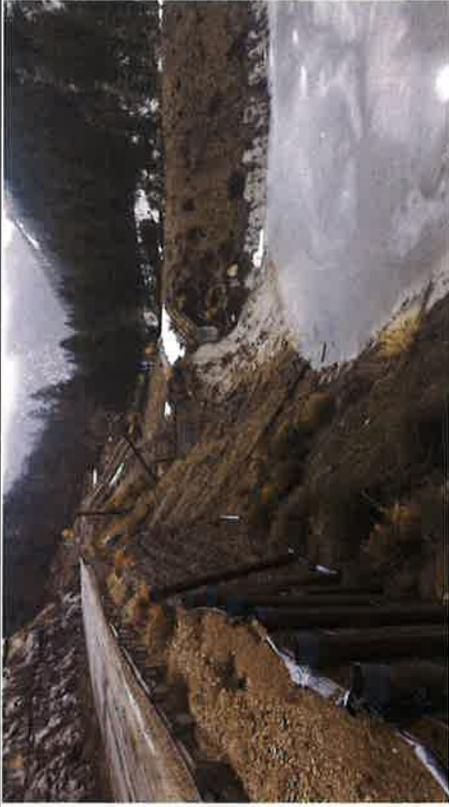
PHOTO 7 – SEDIMENT POND

A significant slope failure was observed during the inspection. Approximately 50' of the Gabion wall support structure located directly adjacent to USFS Road 0248 and the north embankment of Sediment Pond 1 has collapsed. The material was observed directly within Sediment Pond 1, thus the slope failure has not produced an off-site impact at this time. The stability of the Gabion structure has been an issue previously with a similar failure reported in May 2017 (Inspection Report #5835). Given the continued instability issues/failures in this area, it's the Division finding that the currently approved surface drainage control design is insufficient. Notice of Violation #21216 has been issued in an effort to address this persistent instability issue (See attached).

The sediment pond currently covered by a layer of slush. Gabion basket failure left of center.

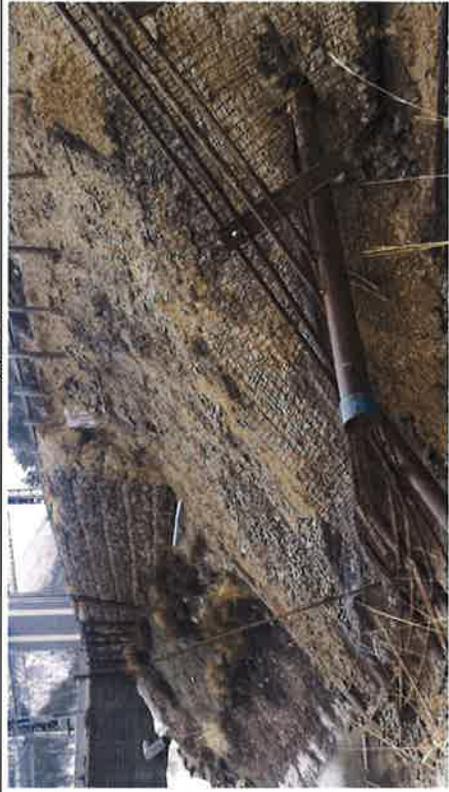
PHOTO 8 – SHOULDER FAILURE

The outslope of the USFS road adjacent to the Sediment Pond 1 has sloughed and failed where support pylons were installed after a similar failure in May 2017. It appears that a major contributing factor to the instability of the road in this area is primarily due to inadequate drainage control. Previous inspections by the Division document a consistent pattern of inadequate drainage control for drainage ditch DD-7 that runs parallel to USFS Road 0248. Inspection report #6016 specifically describes that the road cut above drainage ditch DD-7 appears to be seeping at a rate of 0.25 - 0.50 gpm and all of the water collects in the ditch beside the road without any functioning conveyance system in place to transport the seepage. Under those conditions, without a functioning drainage system in place the impounding water migrates into the ground at that point and saturates the roadbase eventually leading to failure. The plausibility of this scenario is supported by previous observations by the Division (Inspection Reports #6042, #6156) which describe seepage emanating from the base of the Gabion wall. Regardless of the robust appearance of the steel support structures, the hydrostatic forces behind the Gabion wall appear to have been building over time. The addition of snowmelt together with frequent rain events recently have lubricated the sediments within the roadbase to the point where those forces could be relieved in the form of failure.

The wet weather and melting snow may have saturated the road base, resulting in failure.

- Permittee must repair failure and stabilize USFS road and outslope within 2 weeks of receipt of NOV.
- Within 30 days of receipt of NOV, the Permittee must submit P.E. certified revisions of the surface drainage control plan in the approved Mining and Reclamation Plan (MRP) for review and subsequent approval and incorporation by the Division. The submission must include revisions to appropriate sections of Engineering and Hydrology (i.e. text, plates, calculations, design drawings).
- Within 30 days of receiving final approval of the surface drainage control MRP revisions, the Permittee must complete the construction of those plans.

SCAMP was notified immediately at the beginning of the inspection, and barricades were installed to divert traffic around the damaged area. Plans to repair the road as soon as possible are currently in place.

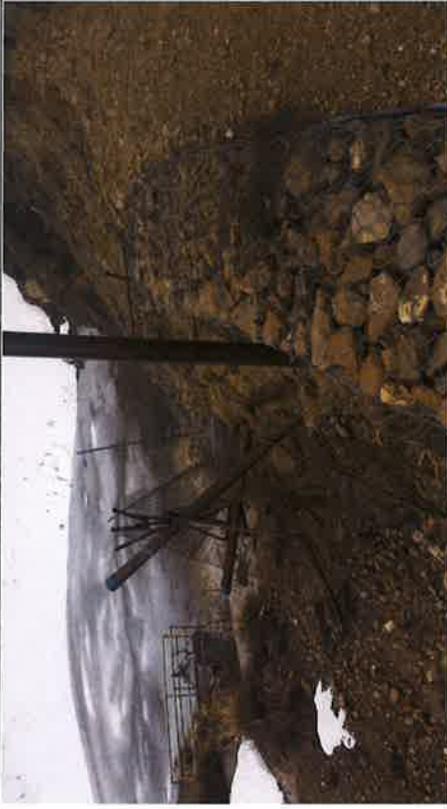
PHOTO 9 – SHOULDER FAILURE
A different perspective, overlooking the sediment pond.

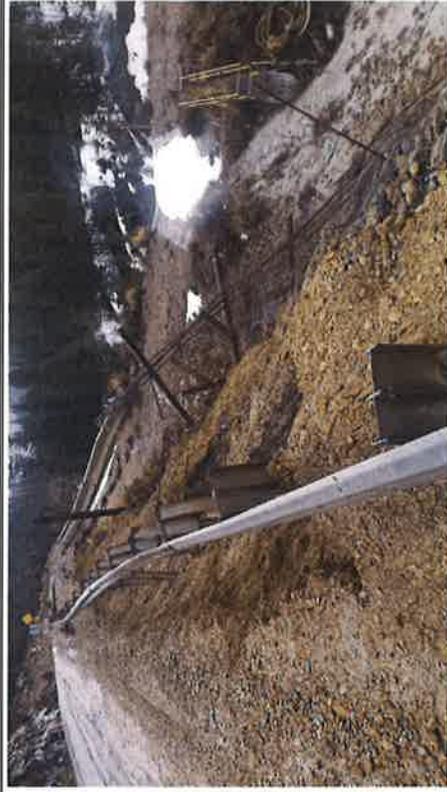
PHOTO 10 – SHOULDER FAILURE
View of the failure, straddling the guard rail.

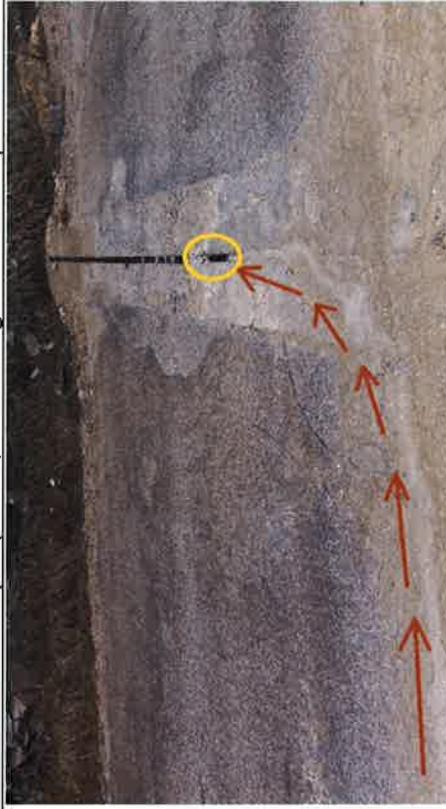
Rain water appears to be seeping into inset drains installed into the pavement of the USFS road above the section that recently failed, but no obvious outlet is visible (see photos).

PHOTO 11 – INSTALLED ROAD DRAIN
This section of drain is located adjacent to the failure. The red lines highlight the path of flow, and the water disappears at the yellow circle. It is not clear where the water goes from there.

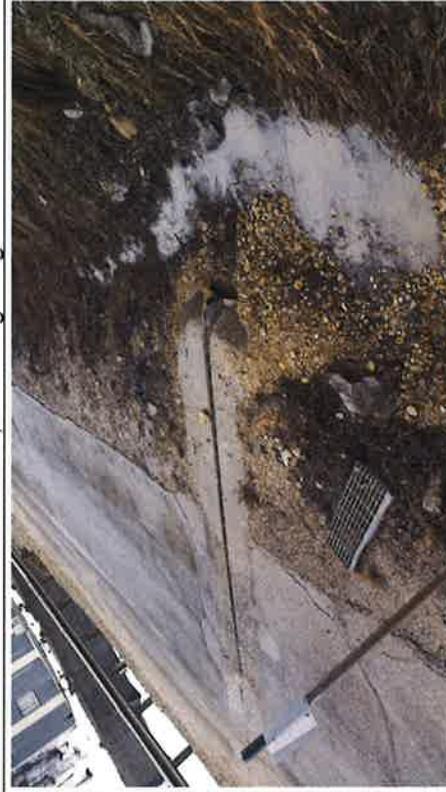
Diversions ditches along the USFS road leading into the mine showed evidence of being washed out in recent weeks. Drainage ditch DD-7 adjacent to the USFS road beside sediment pond 001 continues to impound water since the ditch itself needs to be cleaned out and culvert C-3 appears to be plugged and does not function as planned.

PHOTO 12 – INSTALLED DRAIN
This is the highlighted drain in Photo 11. Notice the ponding water in the drainage ditch. This is a common phenomenon, and may have contributed to the failure.
