Subject: Reconnaissance Inspection for the former Crandall Canyon Mine Facility  
**UPDES Permit No. UT0024368**

Enclosure: Inspection Report w/ Photos (DWQ-2020-020254)

## **INSPECTION PROTOCOL**

UPDES Permit #: UT0024368 – Former Crandall Canyon Mine Facility  
Inspection Type: Reconnaissance Inspection  
Inspection Dates: September 24 and October 2, 2020  
Weather Conditions: Sunny and mild, ~70°F (on site)

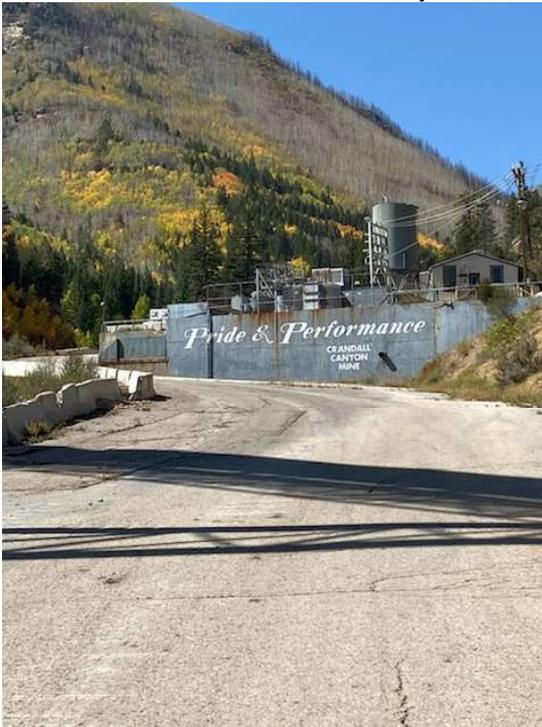
1. Entrance at the Crandall Canyon Mine site.

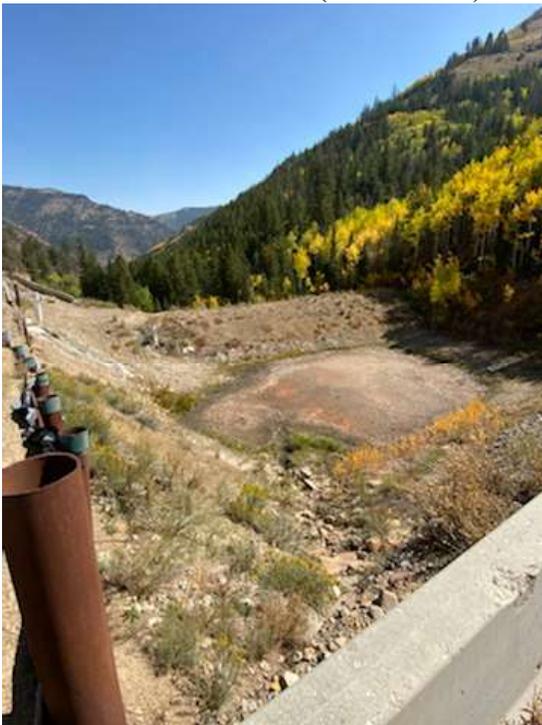
2. Sedimentation Pond (Outfall 001).

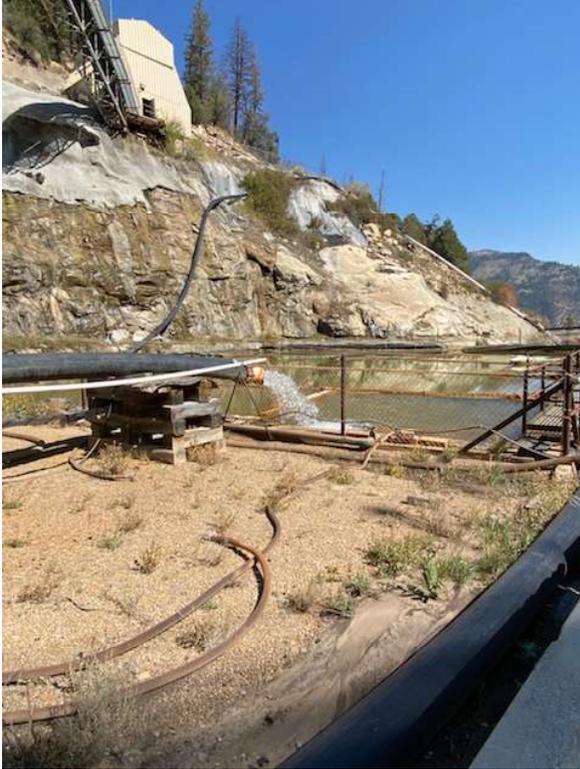
3. Mine water flowing from the mine portal pipeline above into the treatment pond.

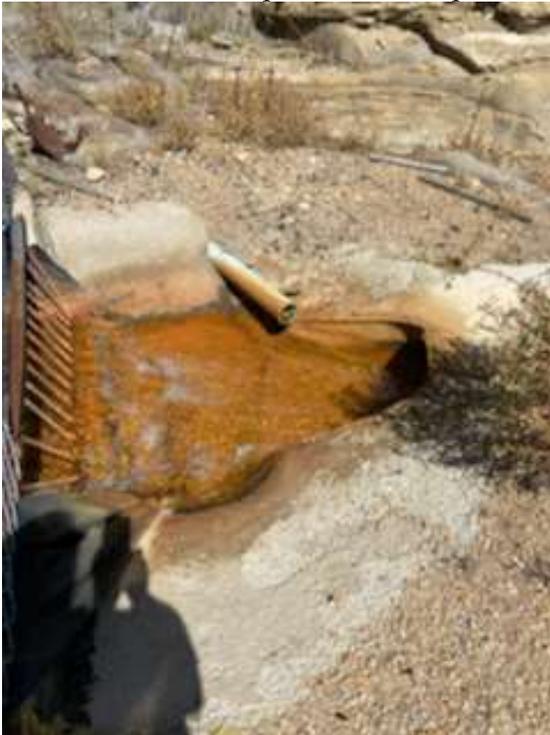
4. Mine water flow post treatment pond to Outfall 002.

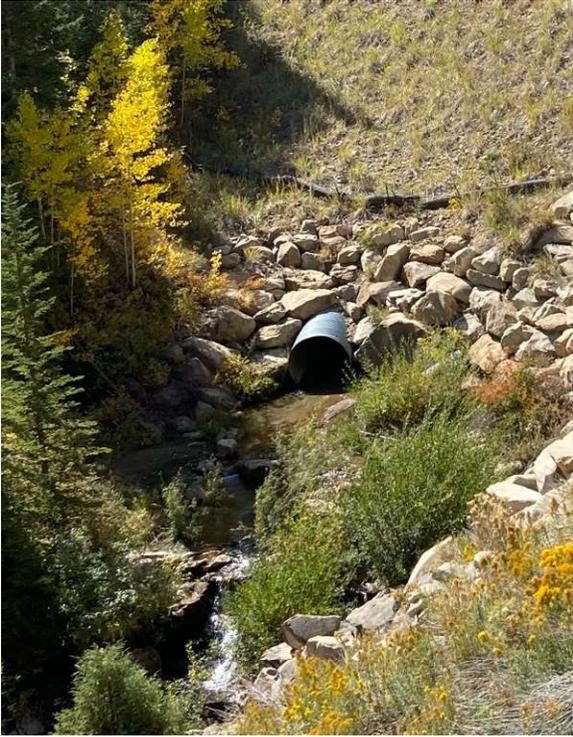
5. Crandall Creek culvert flowing below sedimentation pond (includes Outfall 002 discharges).

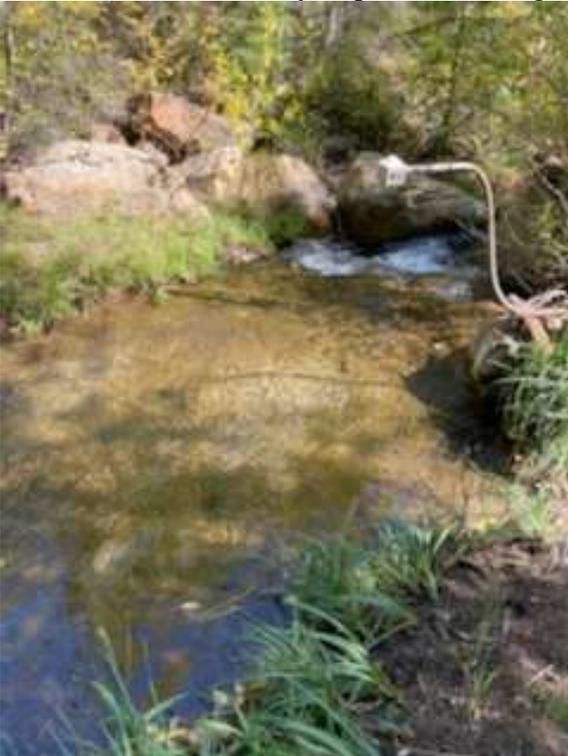
6. Crandall Creek flow just prior to mixing with Huntington Creek.
