# Inspection Report

| Permit Number: | C0150032 |
| Inspection Date: | Tuesday, January 28, 2020 |

Permitee: **GENWAL RESOURCES INC**  
 Operator: **GENWAL RESOURCES INC**  
 Site: **CRANDALL CANYON MINE**  
 Address: **PO BOX 910, EAST CARBON UT 84520-0910**  
 County: **EMERY**  
 Permit Type: **PERMANENT COAL PROGRAM**  
 Permit Status: **INACTIVE**

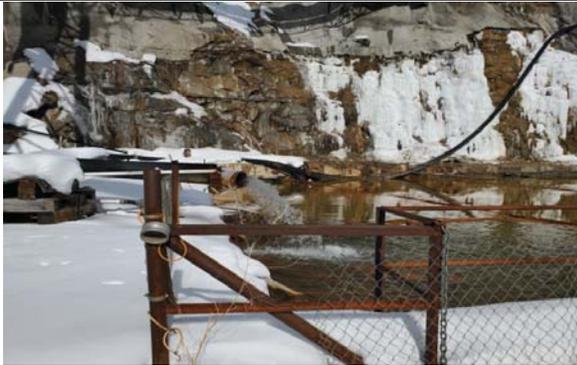
**PHOTO 1 – WATER TREATMENT FACILITY**

Overlooking the water treatment pond. Water sampling location Pre-002 is from the end of the white PVC left of center.

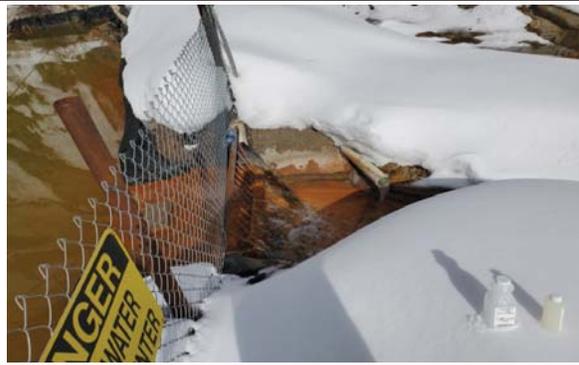
**PHOTO 2 – TREATMENT POND OUTFALL**

Water continues to discharge from the mine. Flowrate = 272gpm. Flocculant and coagulant were not being applied to the mine water at this time because the discharge lines had frozen in recent weeks. Samples were taken at 002 and pre-002 and delivered to the Utah State Health Laboratory in Taylorsville for processing.

The water flowing through the trash rack is sampling point for UPDES discharge #002. Snow drifts are over 2' deep here.

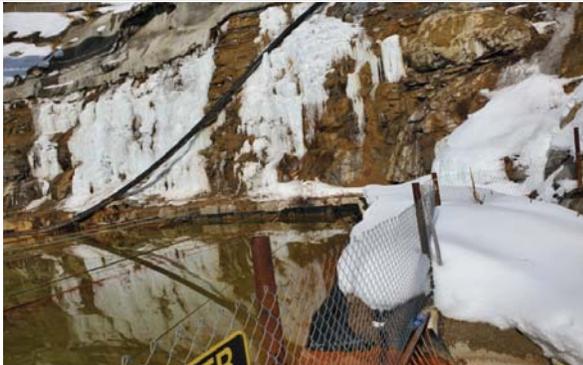
**PHOTO 3 – WEEPING HIGHWALL**

The face of the highwall overlooking the water treatment facility. No recent spalling or sloughing is evident.

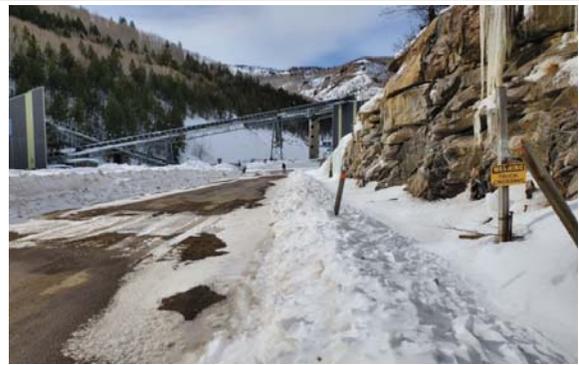
**PHOTO 4 – ARMORED DRAINAGE DITCH**

Drainage ditch DD-7 and culvert C-3 buried under snow.

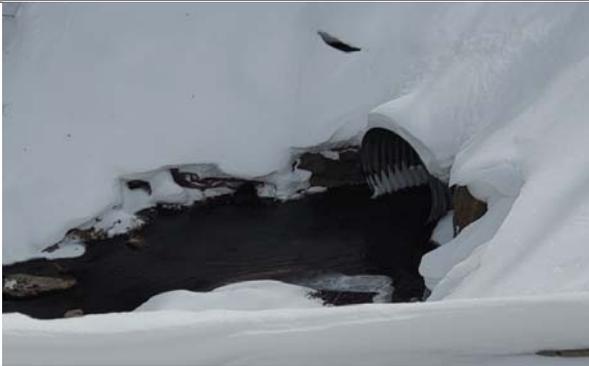
**PHOTO 5 – CRANDALL CREEK**  
The outfall of the 72" culvert beneath the main site.

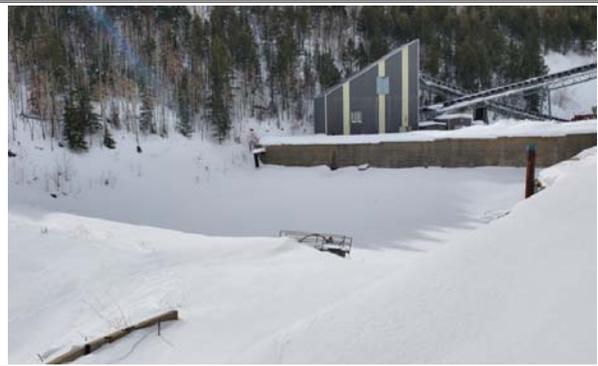
Sediment pond was completely buried under a thick blanket of snow.

**PHOTO 6 – SEDIMENT POND**  
Buried under snow.

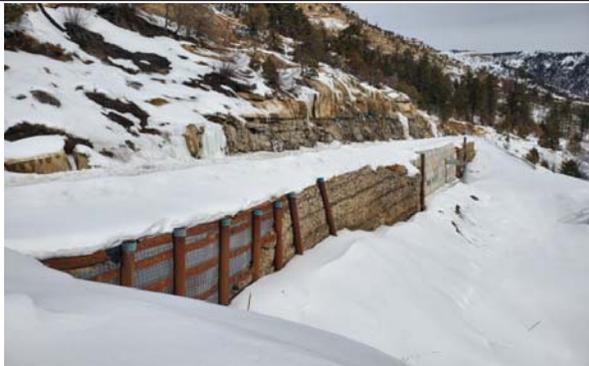
**PHOTO 7 – USFS 0248 REPAIRS**  
Blocks and Gabions appear stable.

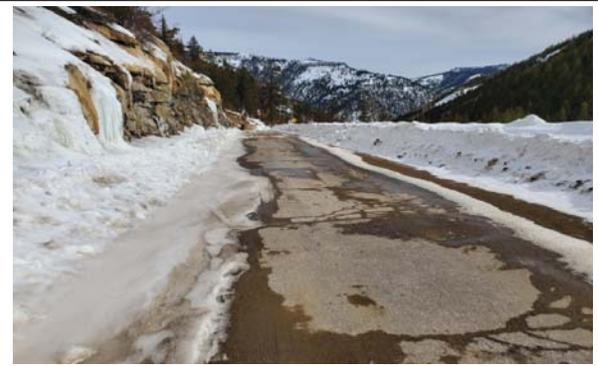
Roads leading into the site appeared to be in good repair, and had been plowed recently.

**PHOTO 8 – USFS 0248**  
Roads into the site were recently plowed.
