Division of Oil, Gas and Mining

Inspection Report

Permit Number:	C0150032
Inspection Type:	PARTIAL
Inspection Date:	Tuesday, May 19, 2020
Start Date/Time:	5/19/2020 1:30:00 PM
End Date/Time:	5/19/2020 2:15:00 PM
Last Inspection:	Tuesday, February 25, 2020

Permittee: **GENWAL RESOURCES INC**
 Operator: **GENWAL RESOURCES INC**
 Site: **CRANDALL CANYON MINE**
 Address: **PO BOX 910, EAST CARBON UT 84520-0910**
 County: **EMERY**
 Permit Type: **PERMANENT COAL PROGRAM**
 Permit Status: **INACTIVE**

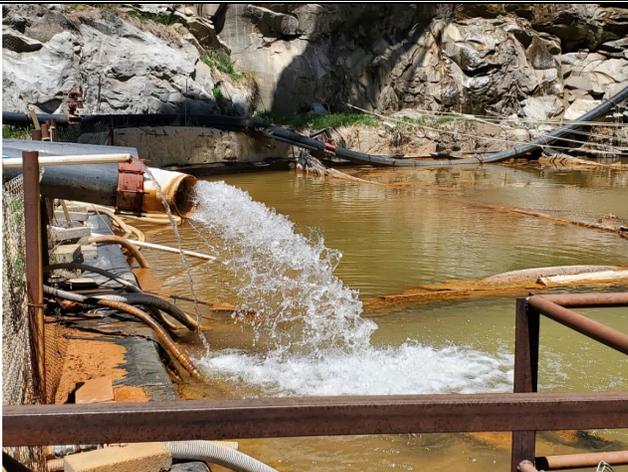
PHOTO 1 – WATER TREATMENT FACILITY

Overlooking the water treatment pond. Water sampling location Pre-002 is from the end of the white PVC left of center.

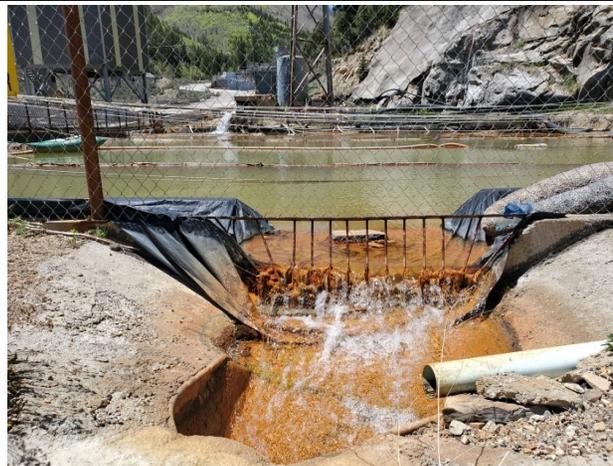
PHOTO 2 – TREATMENT POND OUTFALL

The water flowing through the trash rack is sampling point for UPDES discharge #002.

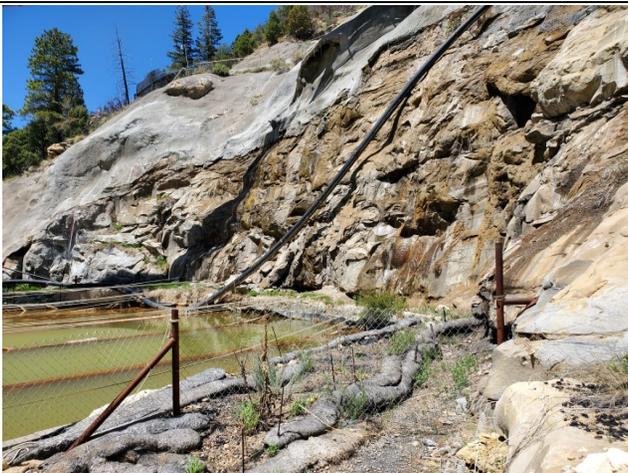
PHOTO 3 – WEEPING HIGHWALL

The face of the highwall overlooking the water treatment facility. No recent spalling or sloughing is evident.

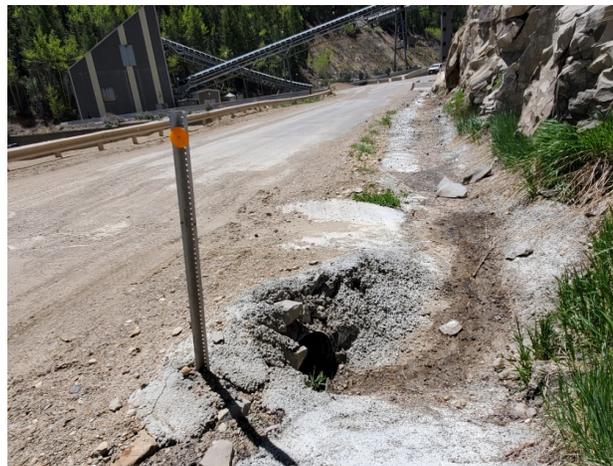
PHOTO 4 – ARMORED DRAINAGE DITCH

Drainage ditch DD-7 and culvert C-3.

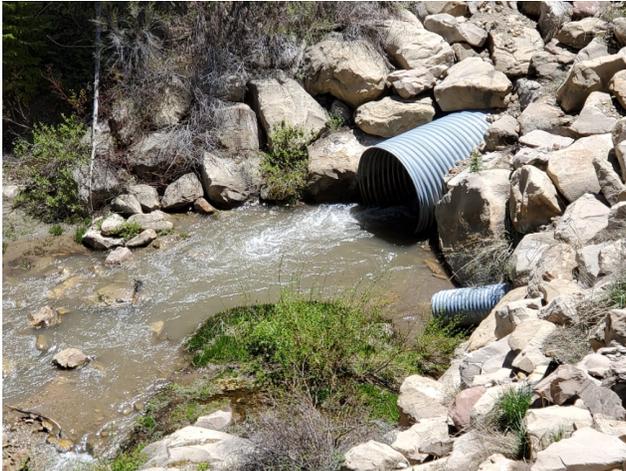
PHOTO 5 – CRANDALL CREEK
The outfall of the 72" culvert beneath the main site.

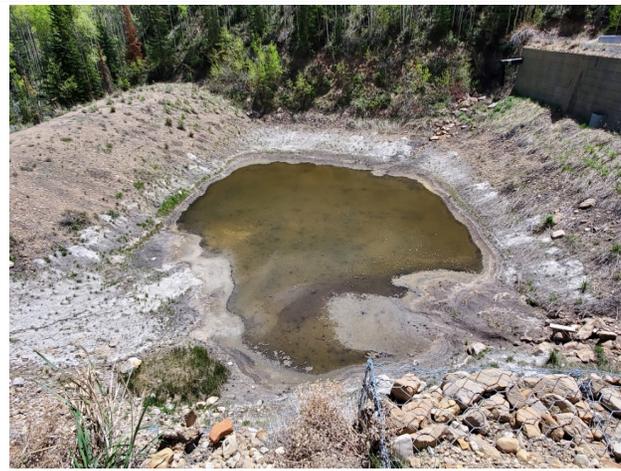
Sediment pond is currently not impounding much water.

PHOTO 6 – LOWER SEDIMENT POND
Currently not much water.

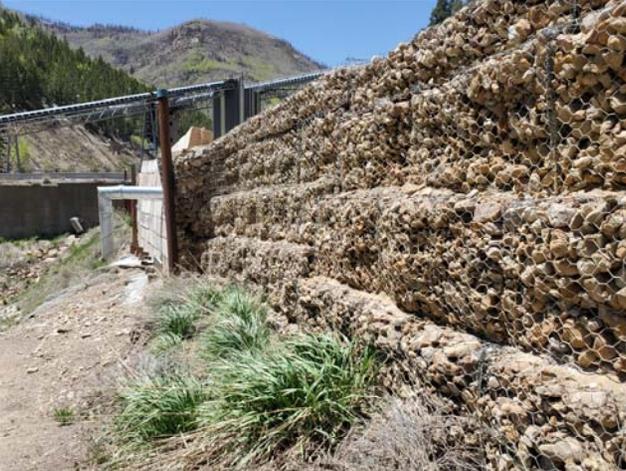
PHOTO 7 – USFS 0248 REINFORCED SECTION
Blocks and Gabions appear stable.

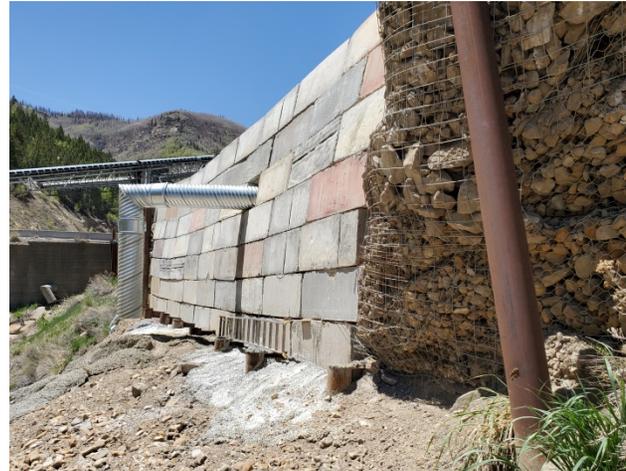
PHOTO 8 – USFS 0248 REINFORCED SECTION
Close up of repaired section.

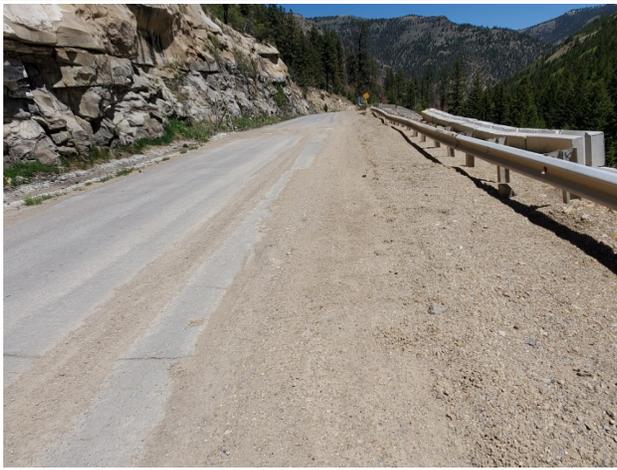
PHOTO 9 – USFS 0248

No sloughing or cracking apparent.

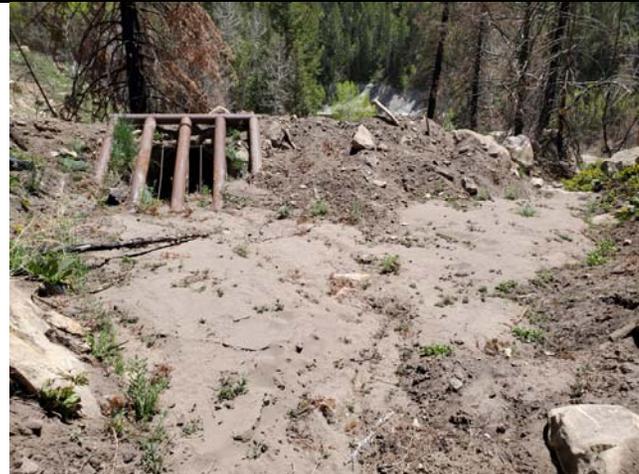
PHOTO 10 – CULVERT C-6

The C-6 culvert behind the main office is open and unobstructed although silt is beginning to build at the inlet.

Silt starting to collect at the mouth of the culvert.

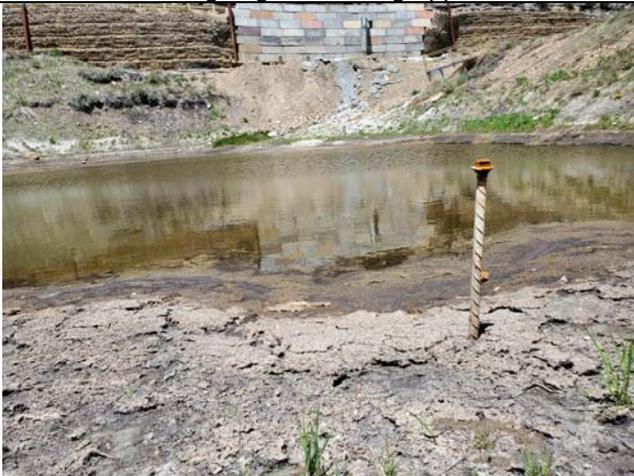
PHOTO 11 – SEDIMENT MARKER

This is one of two sediment markers in the Lower Sediment Pond. The welded nut on the right side = 60% sediment capacity.

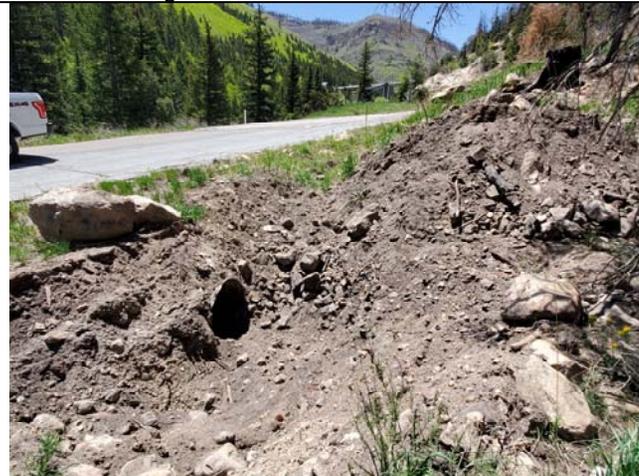
PHOTO 12 – CULVERT CLEARED

Most of the culverts that divert drainage beneath FR 0248 appear to have been cleaned recently.

Several culverts that drain the slopes north of FR 0248 have been cleared recently.
