Inspection Report

Permit Number:	C0150032
Inspection Type:	COMPLETE
Inspection Date:	Tuesday, June 23, 2020
Start Date/Time:	6/23/2020 2:45:00 PM
End Date/Time:	6/23/2020 4:30:00 PM
Last Inspection:	Tuesday, May 19, 2020

Permittee: **GENWAL RESOURCES INC**
 Operator: **GENWAL RESOURCES INC**
 Site: **CRANDALL CANYON MINE**
 Address: **PO BOX 910, EAST CARBON UT 84520-0910**
 County: **EMERY**
 Permit Type: **PERMANENT COAL PROGRAM**
 Permit Status: **INACTIVE**

ATTACHMENT A – Crandall Canyon Complete Inspection, June 23, 2020

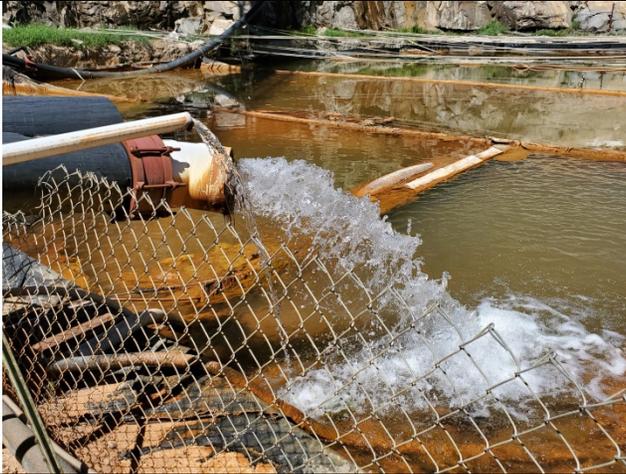
PHOTO 1 – WATER TREATMENT FACILITY

The Division met with Karin Madsen on the afternoon of June 23 to conduct a Complete inspection. Overall, the site appeared stable and no structural damage was apparent on FR 0248 in the gabion enforced section adjacent to the sediment pond. Water continues to flow from the sealed portals, and samples were taken from the inlet and outlet of the water treatment pond.

Water continues to discharge from the mine. Flowrate at the time of inspection = 268gpm. Flocculant and coagulant are not being applied to the mine water at this time. Samples were taken at 002 and pre-002 and delivered to the Utah State Health Laboratory in Taylorsville for processing. Samples were delivered on Wednesday, June 24, the day following this inspection.

Overlooking the water treatment pond. Water sampling location Pre-002 is from the end of the white PVC left of center.

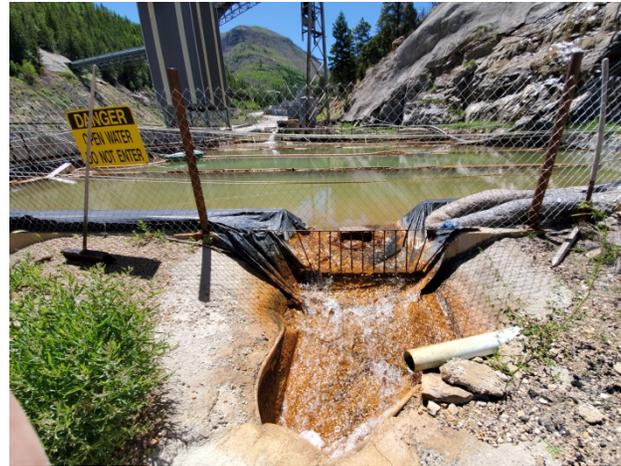
PHOTO 2 – TREATMENT POND OUTFALL

The water flowing through the trash rack is sampling point for UPDES discharge #002.

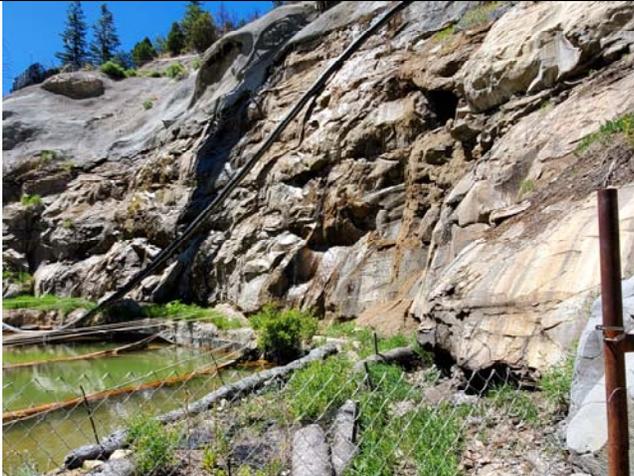
PHOTO 3 – WEEPING HIGHWALL

The face of the highwall overlooking the water treatment facility. No recent spalling or sloughing is evident. There appeared to be less seepage than usual.

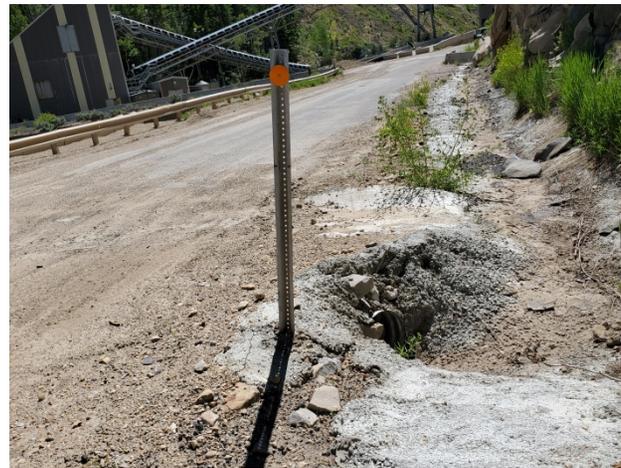
PHOTO 4 – ARMORED DRAINAGE DITCH

Drainage ditch DD-7 and culvert C-3.

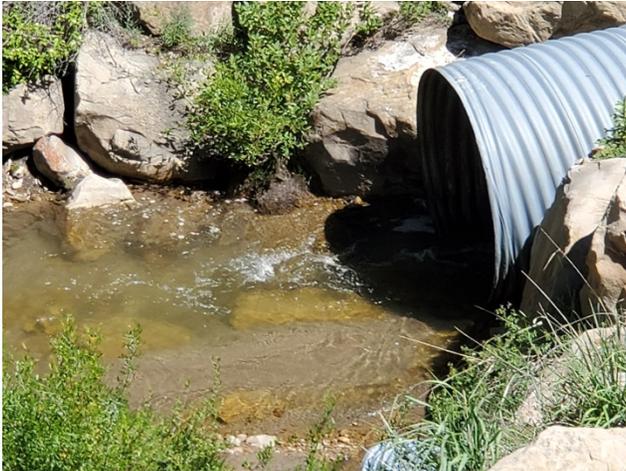
PHOTO 5 – CRANDALL CREEK
The outfall of the 72" culvert beneath the main site.

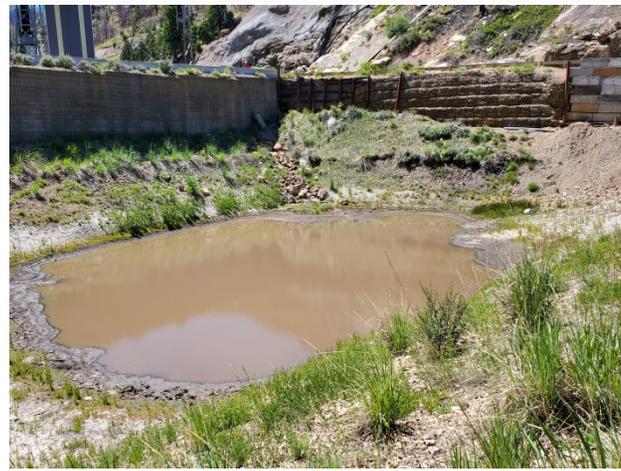
No appearance of instability or other structural weakness were observed at the time of this inspection. The pond is currently impounding a small amount of murky water. The sediment markers are standing and in good condition and sediment levels are several inches beneath the 60% cleanout elevation of 7769.0'. The pond is currently not discharging and appears as though it has not discharged in quite some time.

PHOTO 6 – LOWER SEDIMENT POND
Looking north. Gabion wall in background.

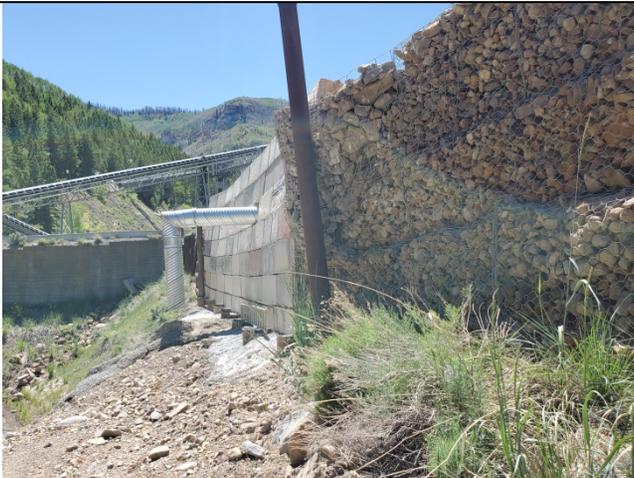
The rebuilt block wall beside the lower sediment pond appears to be stable and no signs of movement were visible. Gabion baskets appeared stable and in good operating condition.

PHOTO 7 – USFS 0248 REINFORCED SECTION
Blocks and Gabions appear stable.

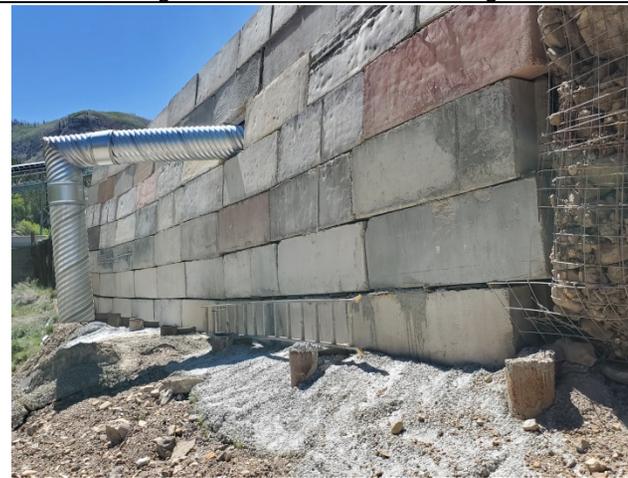
PHOTO 8 – USFS 0248 REINFORCED SECTION
Close up of repaired section.

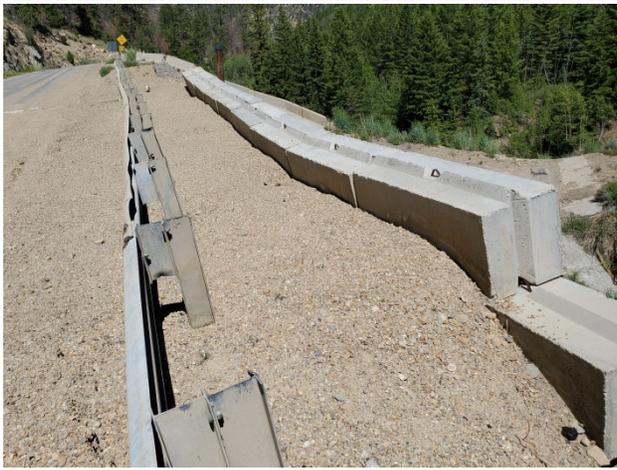
PHOTO 9 – USFS 0248

Forest road FR 0248 that leads into the site appeared to be in good operating condition. There did not appear to be any cracks or other signs of instability in the vicinity of the slide that occurred in April, 2019.

No sloughing or cracking apparent.

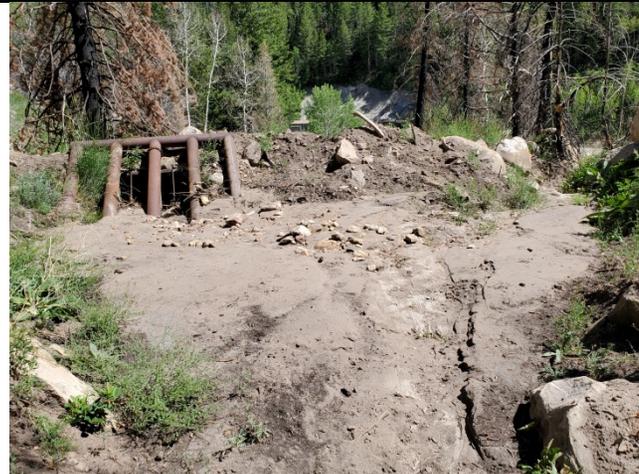
PHOTO 10 – CULVERT C-6

Most diversions on site appear to be in good condition and are free of debris. The C-6 culvert behind the main office is open and unobstructed, although silt is beginning to build at the inlet and might require removal if it continues to build. Culverts that run beneath FR 0248 appear clear and unobstructed after having been recently cleared out.

Silt starting to collect at the mouth of the culvert.

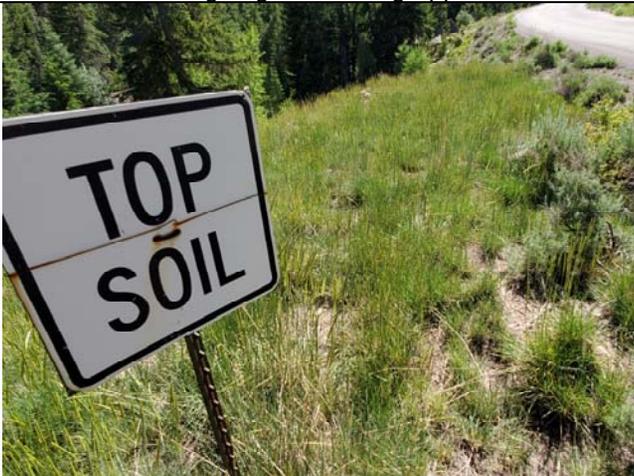
PHOTO 11 – TOPSOIL STOCKPILE

This stockpile is located on the south of FR 0248 on the way to the surface facilities. Stockpile is thickly vegetated.

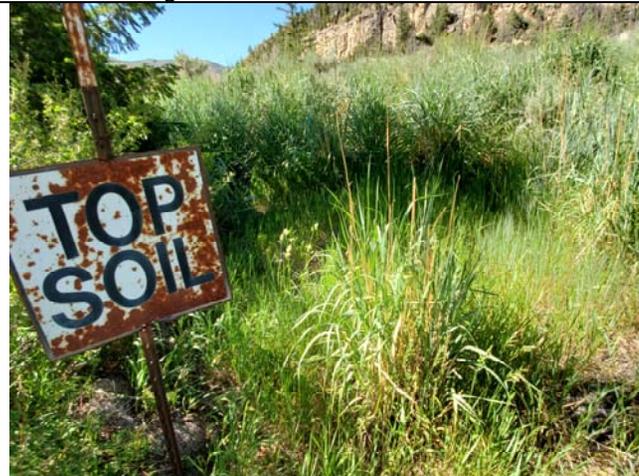
PHOTO 12 – TOPSOIL STOCKPILE

This stockpile is on the north of FR0 248 a few hundred feet from the entrance to the site. Native vegetation is abundant.

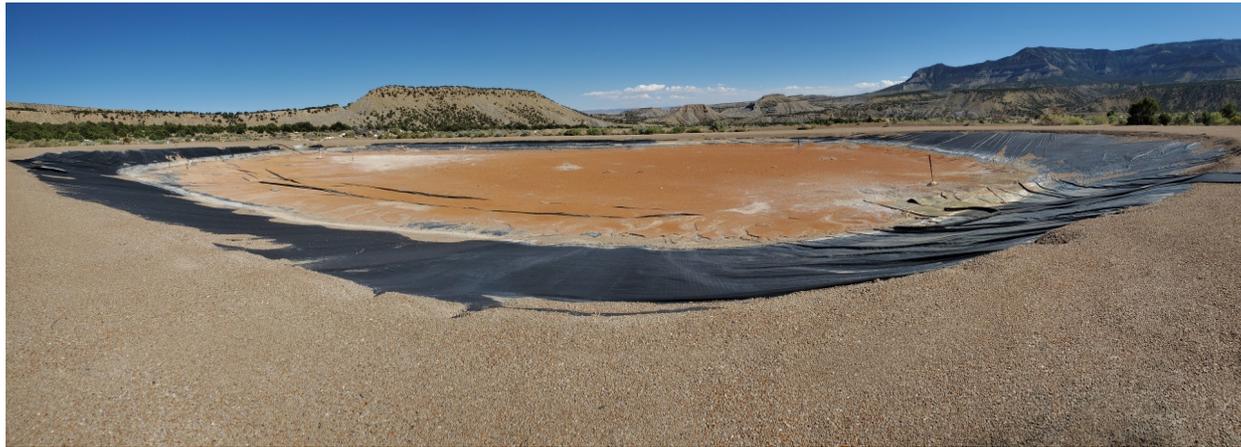
PHOTO 13 – BURMA POND
Pond is completely dry.
