Inspection Report

Permit Number:	C0150032
Inspection Type:	PARTIAL
Inspection Date:	Wednesday, July 29, 2020
Start Date/Time:	7/29/2020 2:30:00 PM
End Date/Time:	7/29/2020 4:00:00 PM
Last Inspection:	Tuesday, June 23, 2020

Permitee: **GENWAL RESOURCES INC**
 Operator: **GENWAL RESOURCES INC**
 Site: **CRANDALL CANYON MINE**
 Address: **PO BOX 910, EAST CARBON UT 84520-0910**
 County: **EMERY**
 Permit Type: **PERMANENT COAL PROGRAM**
 Permit Status: **INACTIVE**

ATTACHMENT A – Crandall Canyon Partial Inspection, July 29, 2020

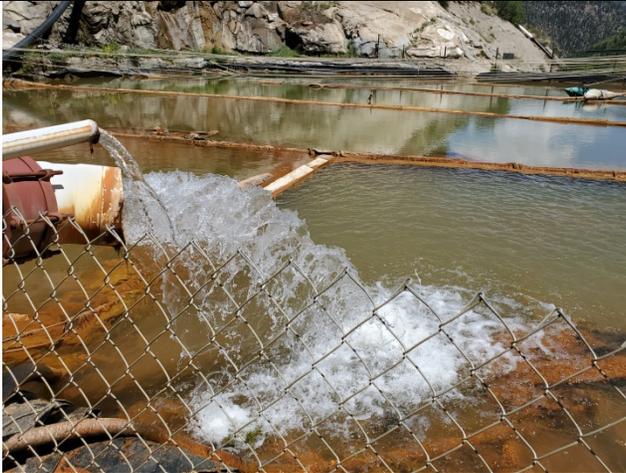
PHOTO 1 – WATER TREATMENT FACILITY

Overlooking the water treatment pond. Water sampling location Pre-002 is from the end of the white PVC left of center.

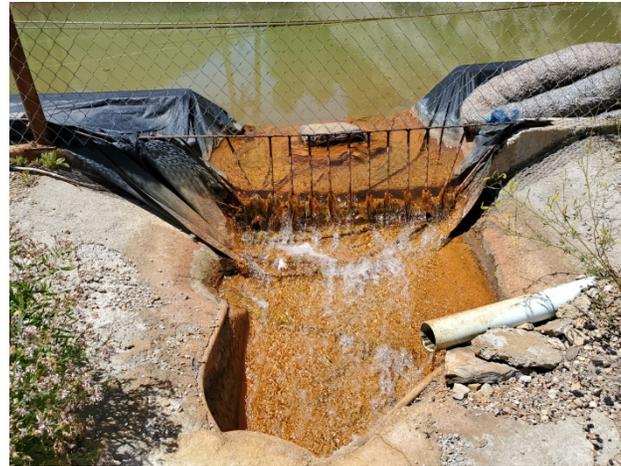
PHOTO 2 – TREATMENT POND OUTFALL

The water flowing through the trash rack is sampling point for UPDES discharge #002.

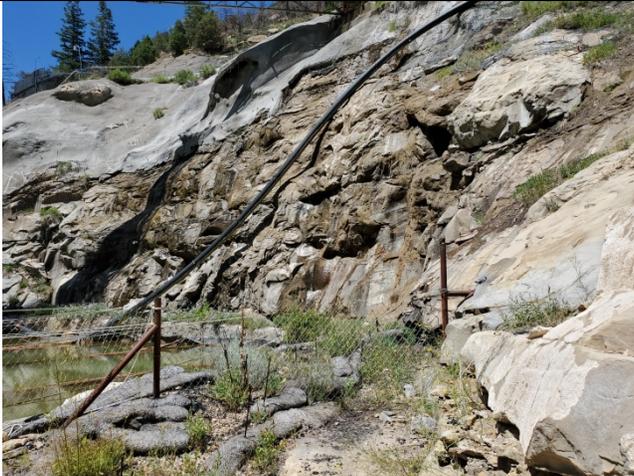
PHOTO 3 –HIGHWALL

The face of the highwall overlooking the water treatment facility. No recent spalling or sloughing is evident. There appeared to be less seepage than usual.

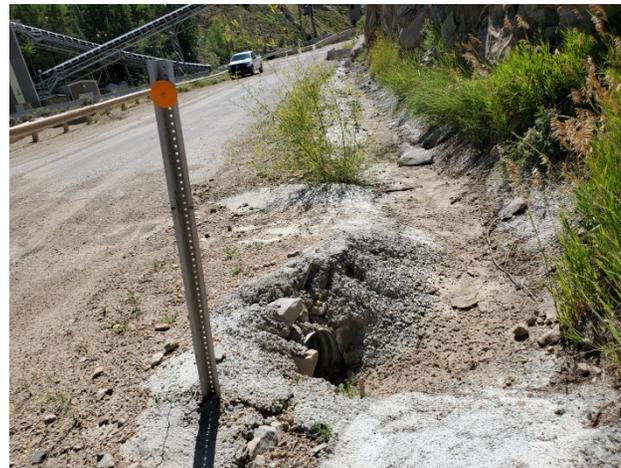
PHOTO 4 – ARMORED DRAINAGE DITCH

Drainage ditch DD-7 and culvert C-3.

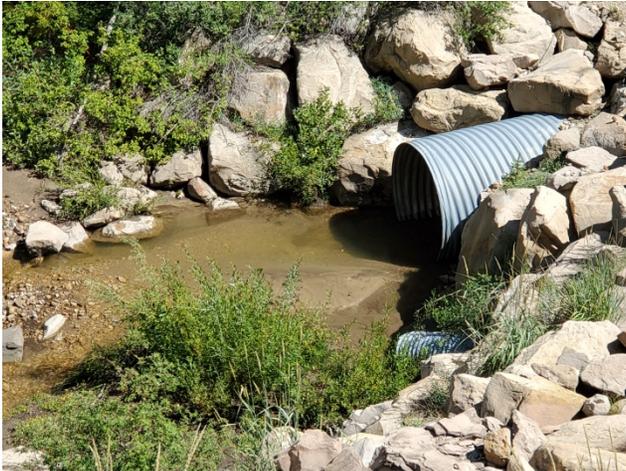
PHOTO 5 – CRANDALL CREEK
The outfall of the 72" culvert beneath the main site.

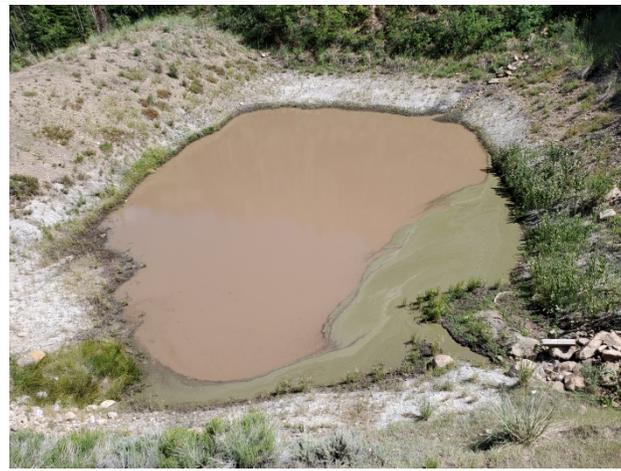
No appearance of instability or other structural weakness were observed at the time of this inspection. The pond is currently impounding a small amount of murky water which was made murkier by the recent rains. The sediment markers are standing and in good condition and sediment levels are several inches beneath the 60% cleanout elevation of 7769.0'. The pond is currently not discharging and appears as though it has not discharged in quite some time.

PHOTO 6 – LOWER SEDIMENT POND
Silty on the left, green organic debris on the right.

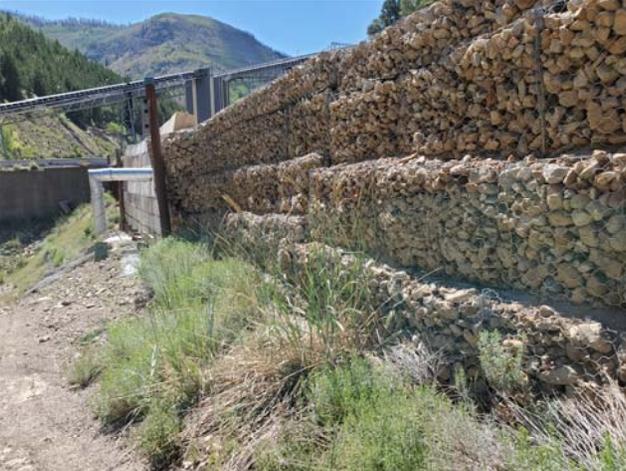
The rebuilt block wall beside the lower sediment pond appears to be stable and no signs of movement were visible. Gabion baskets appeared stable and in good operating condition.

PHOTO 7 – USFS 0248 REINFORCED SECTION
Blocks and Gabions appear stable.

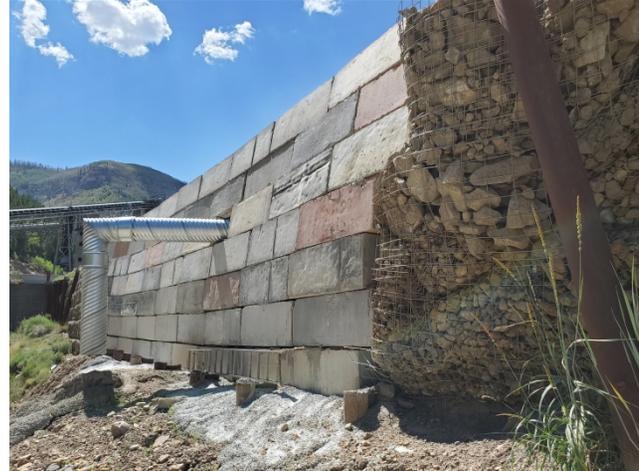
PHOTO 8 – USFS 0248 REINFORCED SECTION
Close-up picture of photo 7. The blocks and Gabions appear stable.

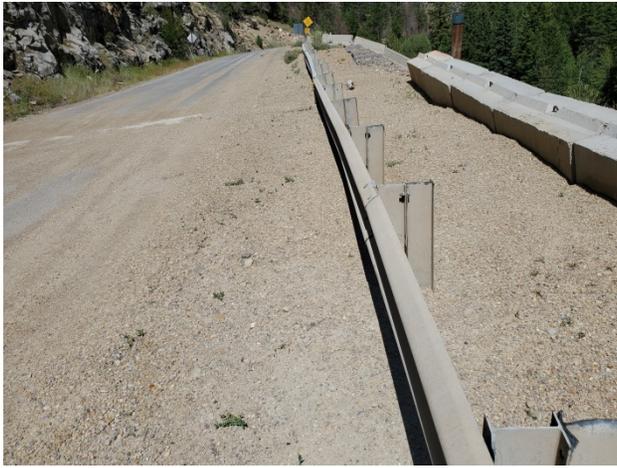
Forest road FR 0248 that leads into the site appeared to be in good operating condition. There did not appear to be any cracks or other signs of instability in the vicinity of the slide that occurred in April, 2019.

PHOTO 9 – USFS 0248
No sloughing or cracking apparent.

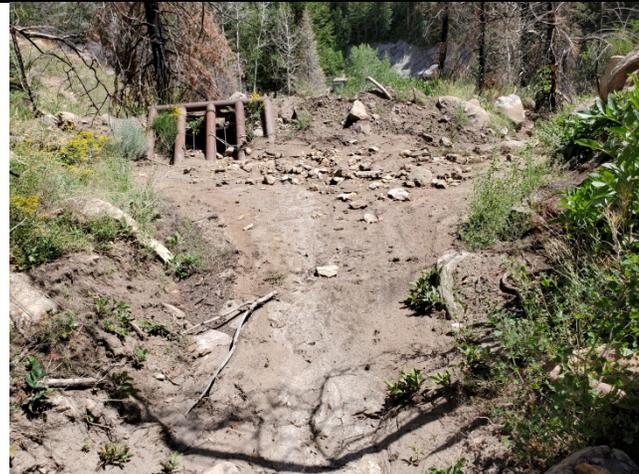
Most diversions on site appear to be in good condition and are free of debris although the C-6 culvert behind the main office is beginning to accumulate silt and other debris at the inlet. A recent rainstorm has contributed to the buildup of debris. Scamp Construction is scheduled to do maintenance work on site in August, and clearing this debris is one of the items they will be tasked with. Culverts that run beneath FR 0248 appear clear and unobstructed.

PHOTO 10 – CULVERT C-6
Silt starting to collect at the mouth of the culvert.

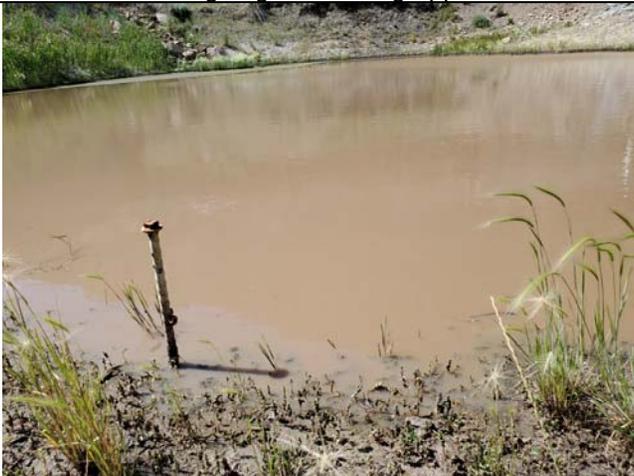
PHOTO 11 – SEDIMENT MARKER
This is the sediment marker on the south end of the sediment pond. The welded bolt 1/3 up from the water level = the 60% cleanout level.

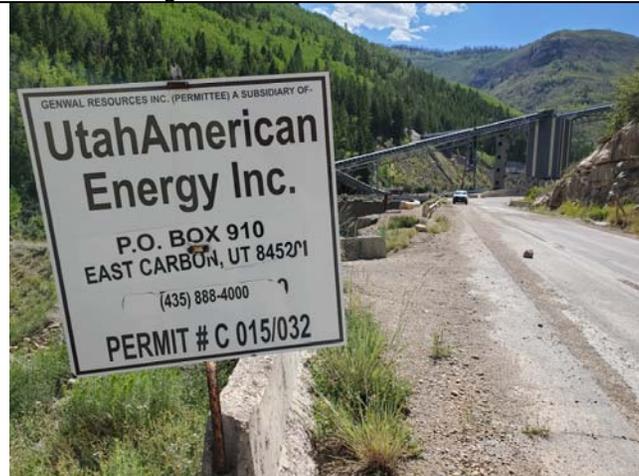
The permit identification sign at the entrance contains all of the necessary information. Topsoil signs are posted and visible on all topsoil piles, and disturbed area perimeter signs are in place as mandated by State of Utah regulation R645-301-521.200 through -521.250.

PHOTO 12 – PERMIT SIGN
Located at the entrance to the permit area.
