Inspection Report

Permit Number:	C0150032
Inspection Type:	PARTIAL
Inspection Date:	Thursday, August 20, 2020
Start Date/Time:	8/20/2020 12:00:00 PM
End Date/Time:	8/20/2020 2:00:00 PM
Last Inspection:	Wednesday, July 29, 2020

Permittee: **GENWAL RESOURCES INC**
 Operator: **GENWAL RESOURCES INC**
 Site: **CRANDALL CANYON MINE**
 Address: **PO BOX 910, EAST CARBON UT 84520-0910**
 County: **EMERY**
 Permit Type: **PERMANENT COAL PROGRAM**
 Permit Status: **INACTIVE**

ATTACHMENT A – Crandall Canyon Partial Inspection, August 20, 2020

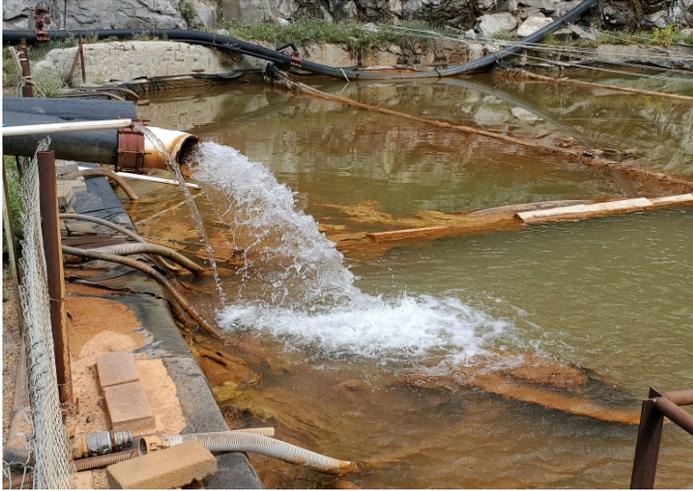
PHOTO 1 – WATER TREATMENT FACILITY

Overlooking the water treatment pond. Water sampling location Pre-002 is from the end of the white PVC left of center.

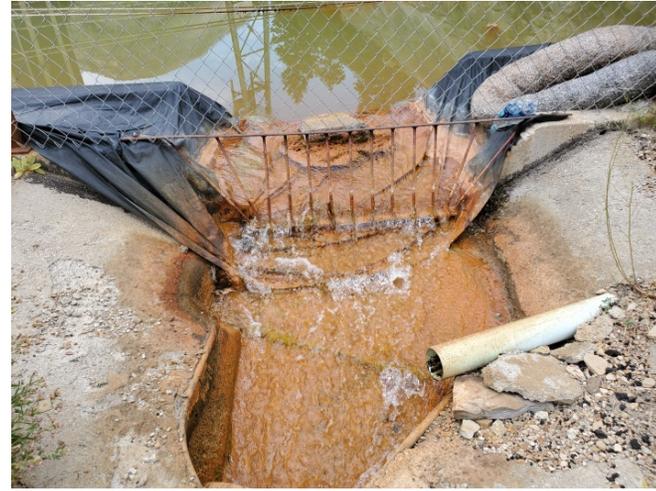
PHOTO 2 – TREATMENT POND OUTFALL

The water flowing through the trash rack is sampling point for UPDES discharge #002.

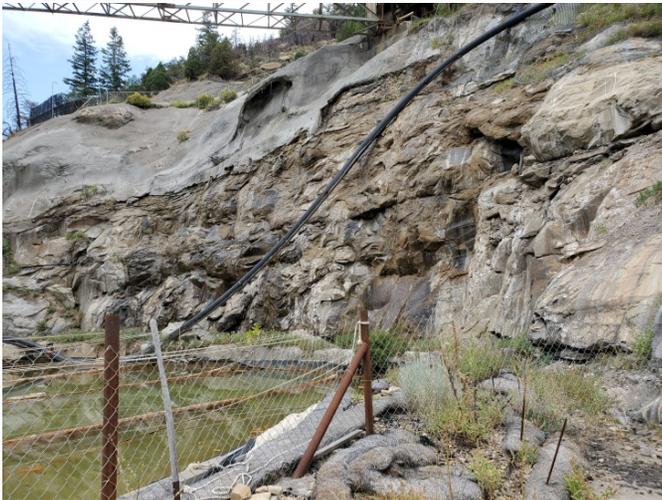
PHOTO 3 – WEEPING HIGHWALL

The face of the highwall overlooking the water treatment facility. No recent spalling or sloughing is evident. Seepage has been waning in recent months.

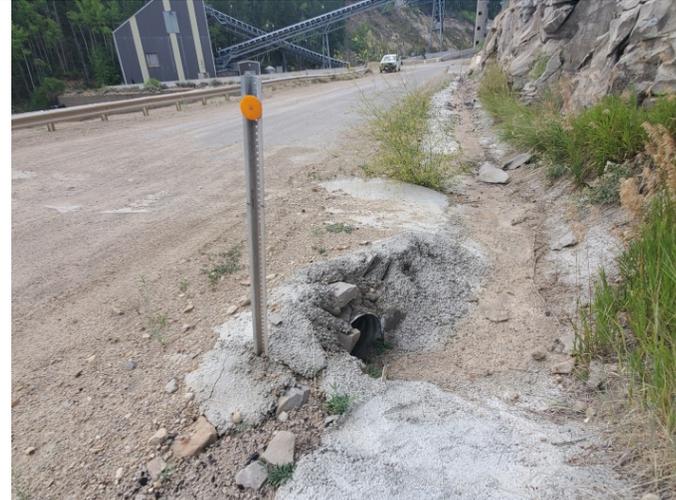
PHOTO 4 – ARMORED DRAINAGE DITCH

Drainage ditch DD-7 and culvert C-3.

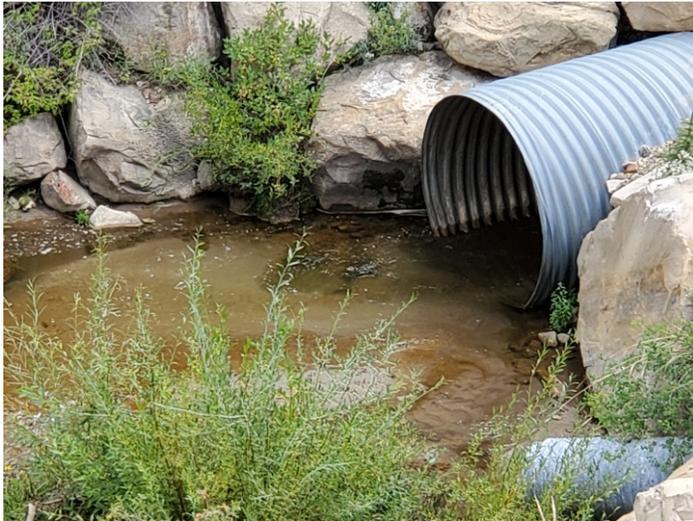
PHOTO 5 – CRANDALL CREEK
The outfall of the 72” culvert beneath the main site.

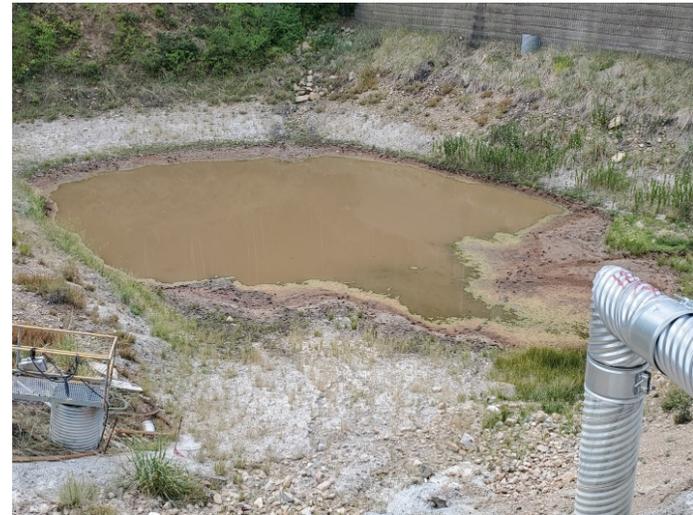
No appearance of instability or other structural weakness were observed at the time of this inspection. The pond is currently impounding a small amount of murky water. The sediment markers are standing and in good condition and sediment levels are several inches beneath the 60% cleanout elevation of 7769.0'. The pond is currently not discharging and appears as though it has not discharged in quite some time.

PHOTO 6 – LOWER SEDIMENT POND
Looking southwest from atop the Gabion wall.

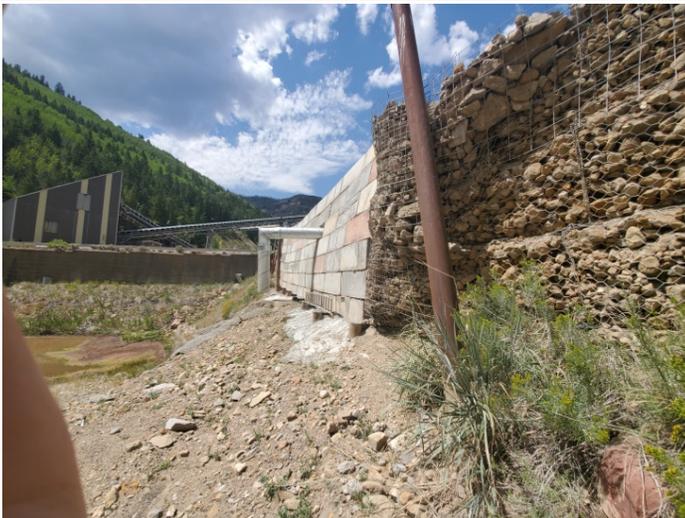
The rebuilt block wall beside the lower sediment pond appears to be stable and no signs of movement were visible. Gabion baskets appeared stable and in good operating condition.

PHOTO 7 – USFS 0248 REINFORCED SECTION
Blocks and Gabions appear stable.

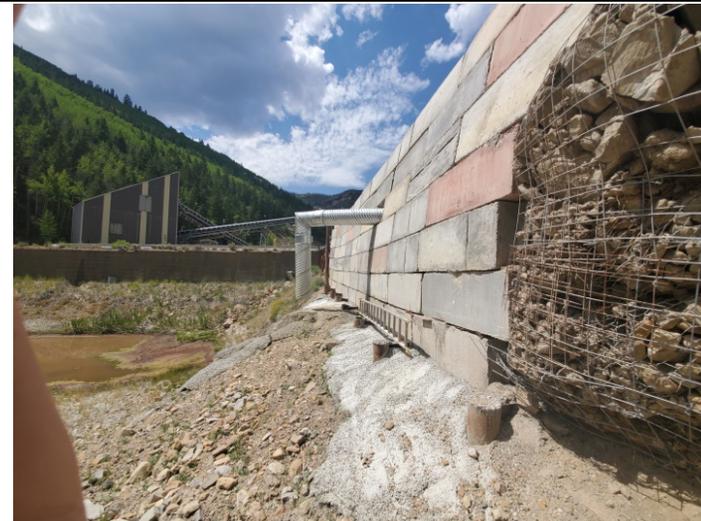
PHOTO 8 – USFS 0248 REINFORCED SECTION
Close up of repaired section.

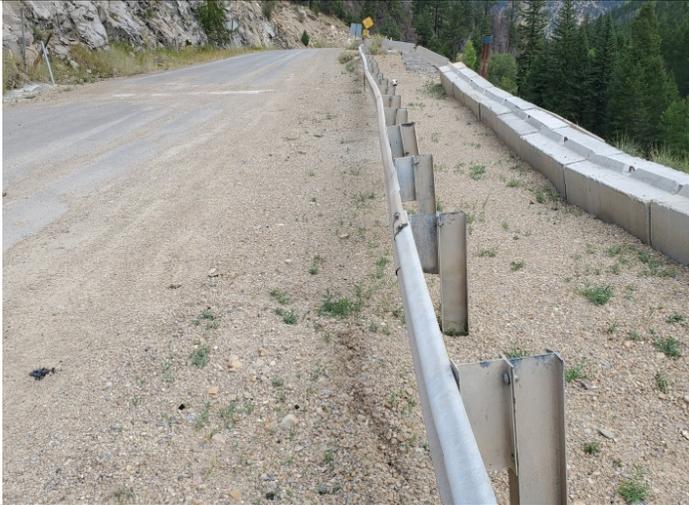
PHOTO 9 – USFS 0248
No sloughing or cracking apparent.

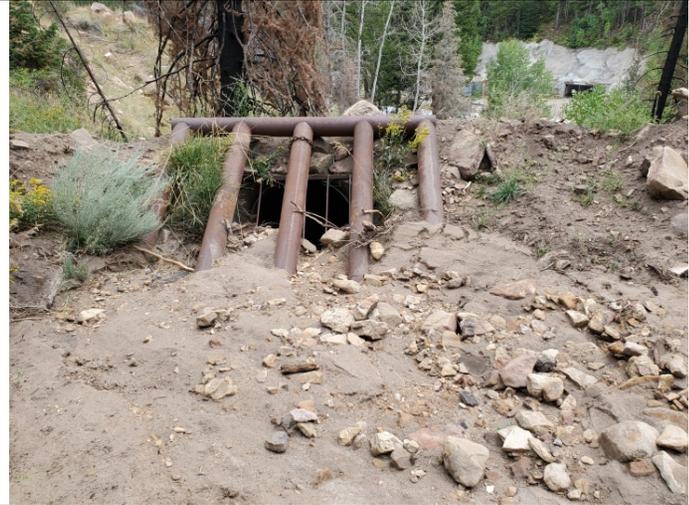
Most diversions on site appear to be in good condition and are free of debris although the C-6 culvert behind the main office is accumulating silt and other debris at the inlet. Scamp Construction is scheduled to do maintenance work on site soon, and clearing this debris is one of the items they will be tasked with. Culverts that run beneath FR 0248 appear clear and unobstructed.

PHOTO 10 – CULVERT C-6
Silt collecting at the mouth of the culvert.

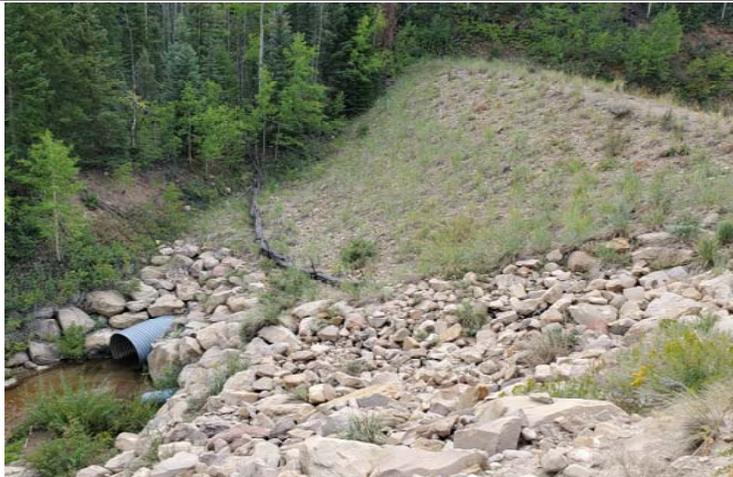
PHOTO 11 – CRANDALL CREEK OUTFALL
This photo also shows the west embankment adjacent to the sediment pond.
