**PRE-BLASTING SURVEY
OF THE
SWAPP RANCH
FOR
ALTON COAL DEVELOPMENT, LLC
COAL HOLLOW MINE**

**BY
DAN W. GUY, P.E.
AUGUST 23, 2011**

PRE-BLASTING SURVEY

SWAPP RANCH

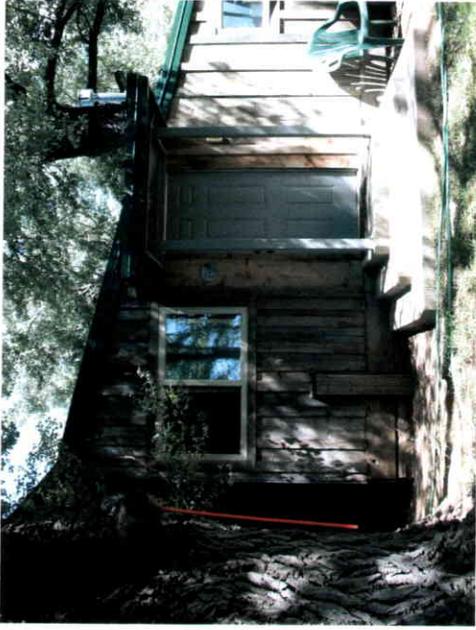
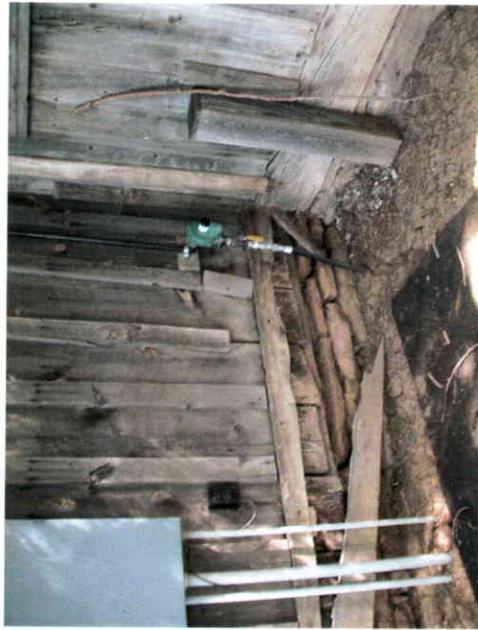
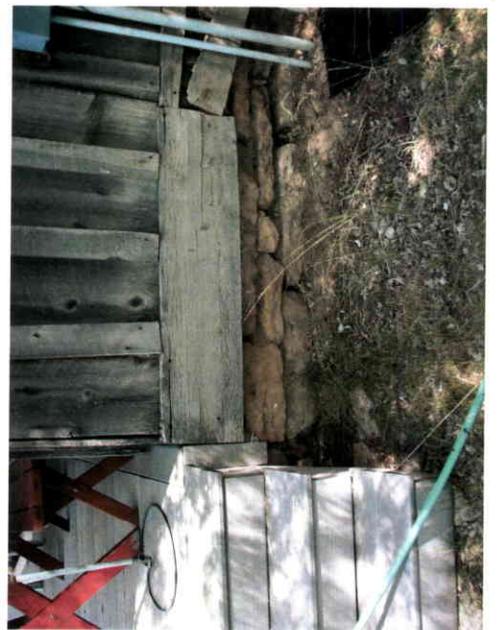
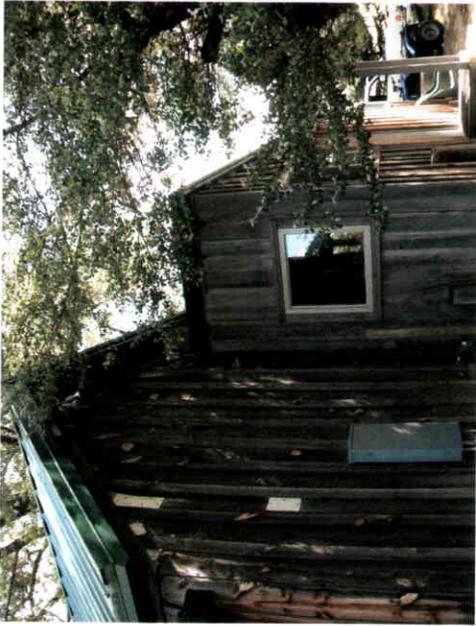
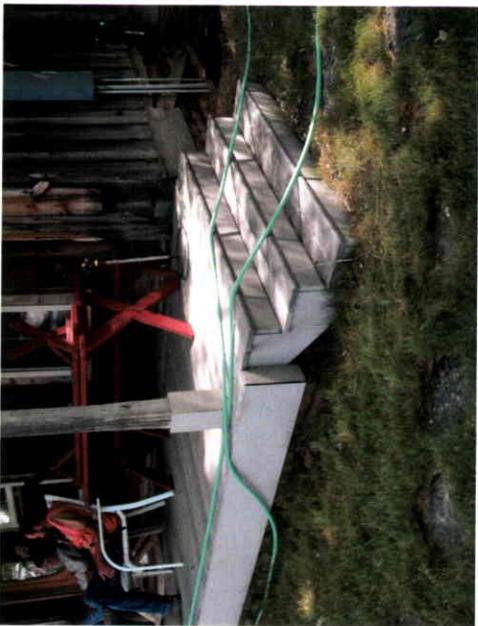
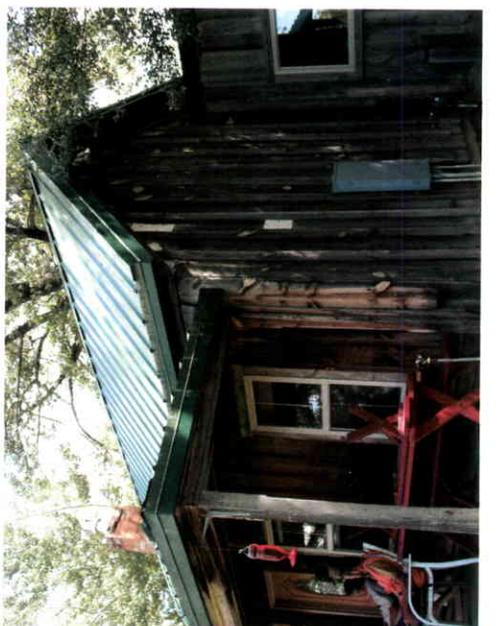
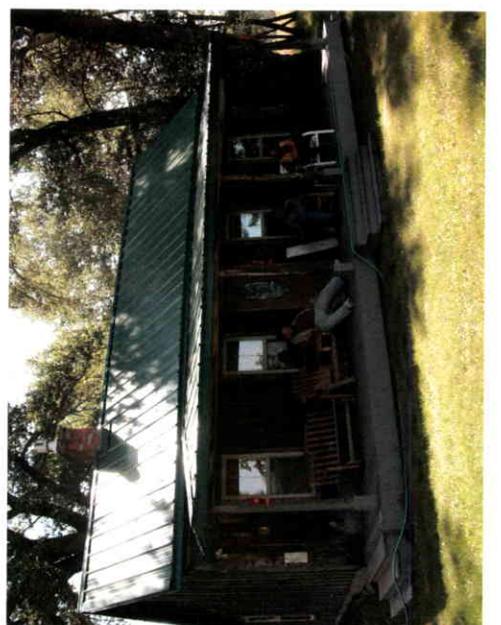
PLATE-3

An existing covered porch has been renovated at the front of the house, along with the addition of a steel roof. The sides and back of the house have not been recovered. Photos of the exterior of the house are shown in Plates 3 through 5. The house appears to be in very good condition for its age. The remodeling has brought it into standards of modern houses. The portions of the house that have not been altered (exterior side and back walls), are obviously weathered, but are also in good condition considering their age. Although the house sits on a layered rock foundation, it appears to be quite stable, with very few visible cracks in the interior walls. A small vertical crack was noted above the doorway in the northeast bedroom, and 2 small cracks were noted and photographed in the kitchen area. No cracks were observed in the floor or bathroom tiles. The present condition of the house was documented by numerous photos shown on Plates 3 through 13 of this report.

Plate 3 – Ranch House Exterior

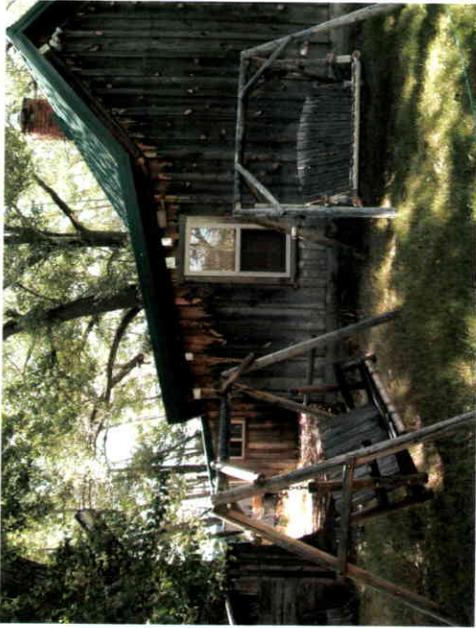
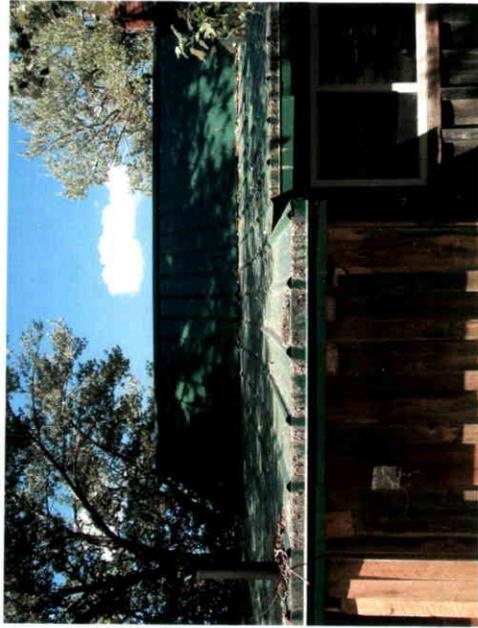
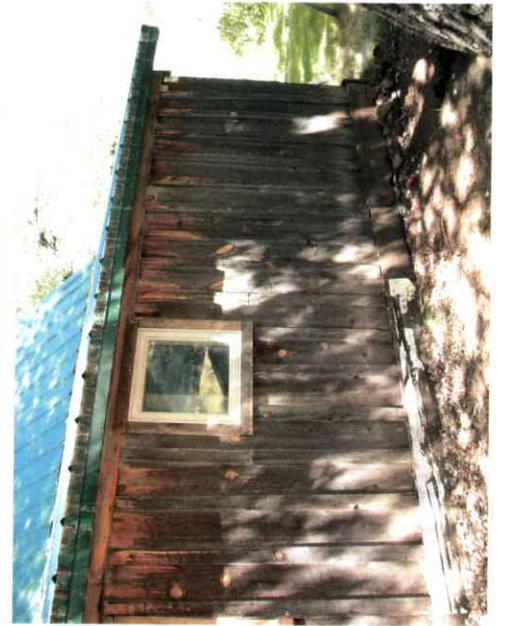
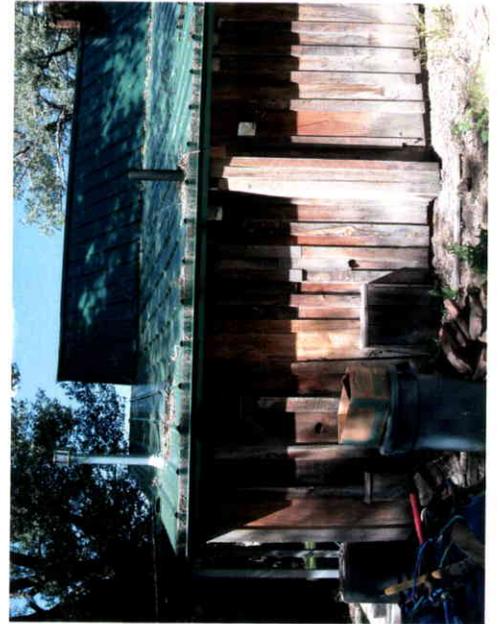
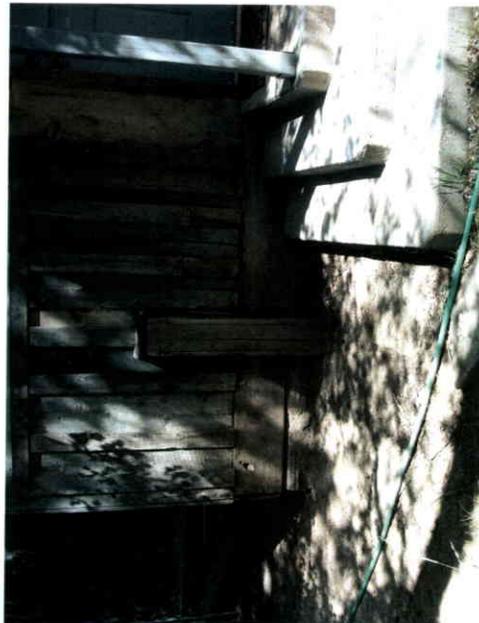
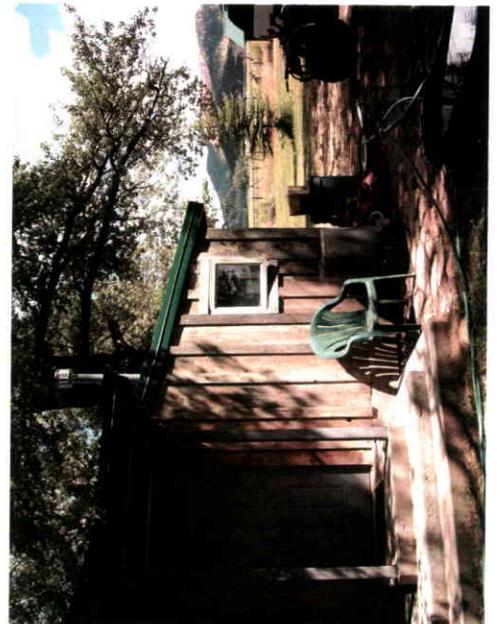
PLATE-4

Plate 4 – Ranch House Exterior

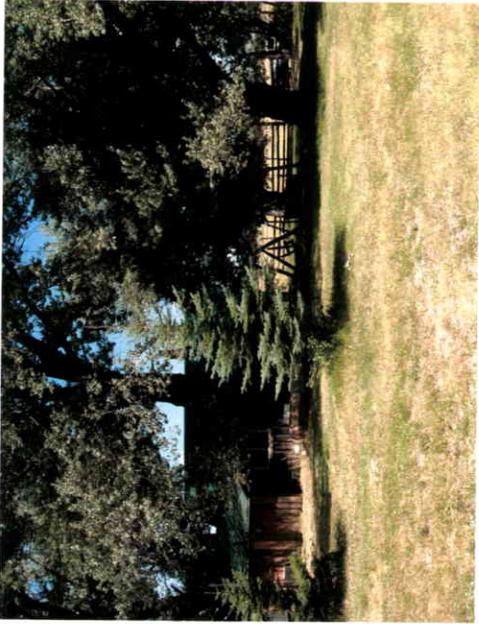
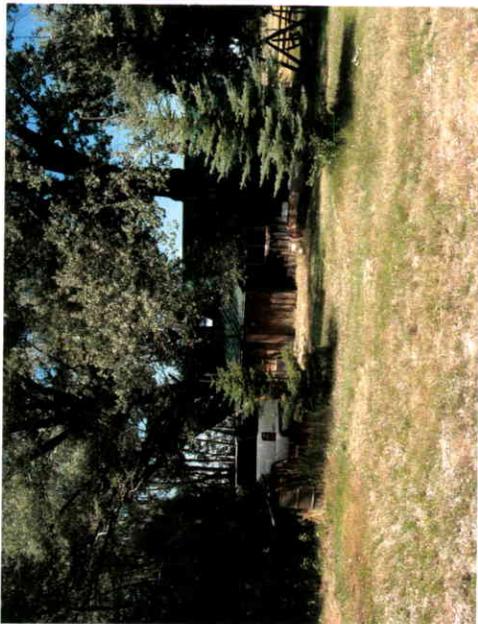
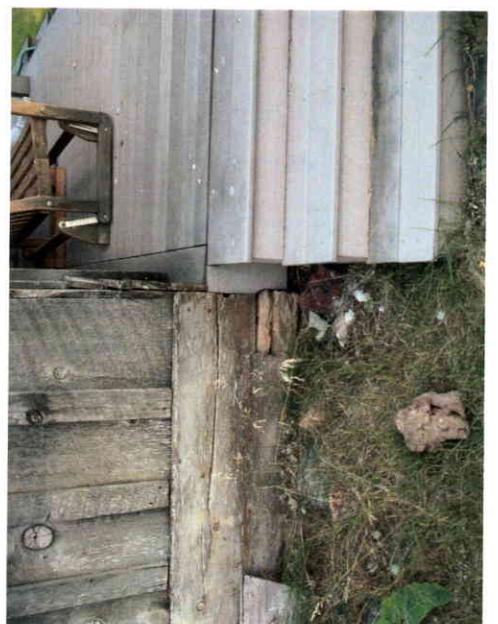
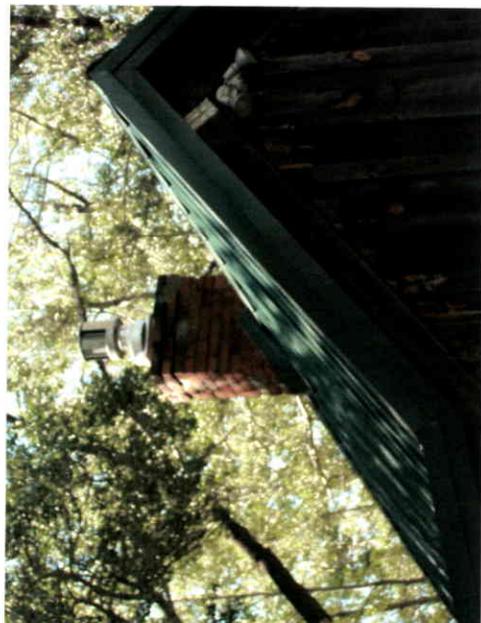
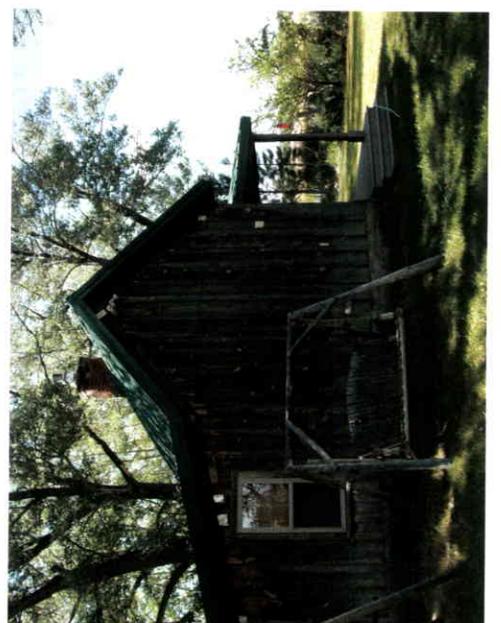
PLATE-5

Plate 5 – Ranch House Exterior

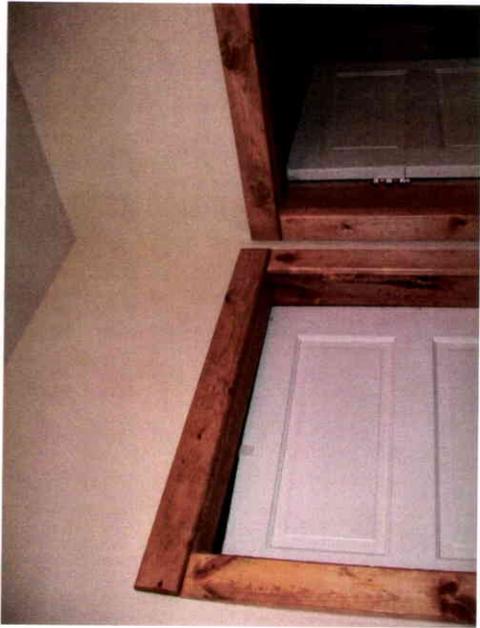
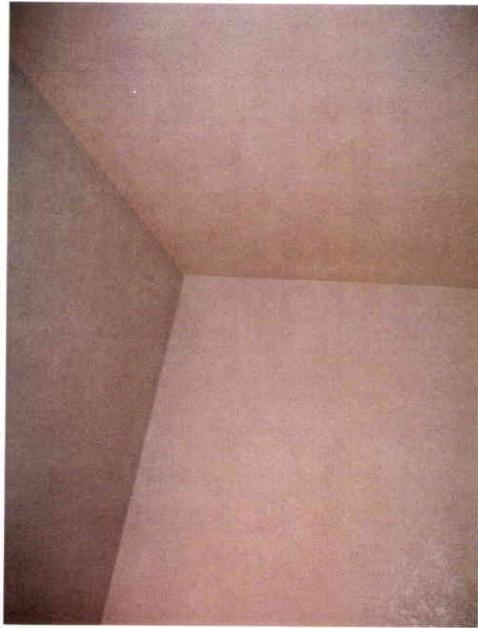
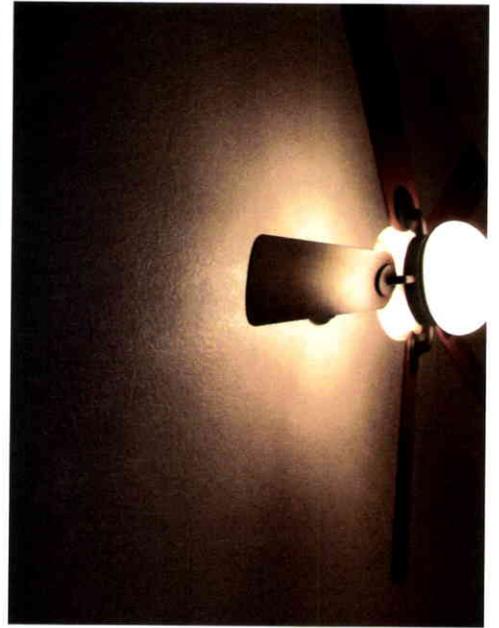
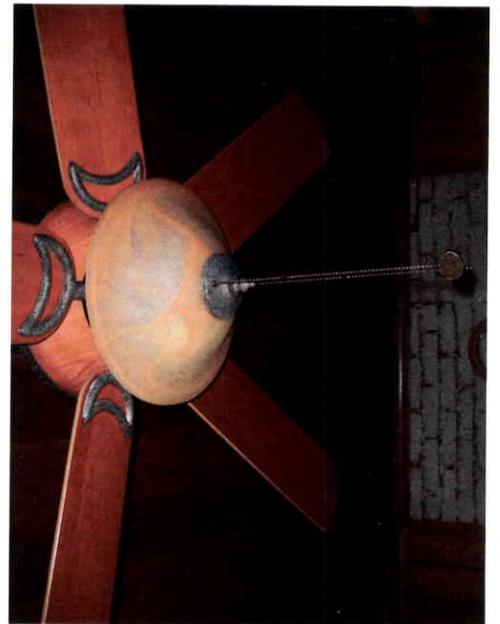
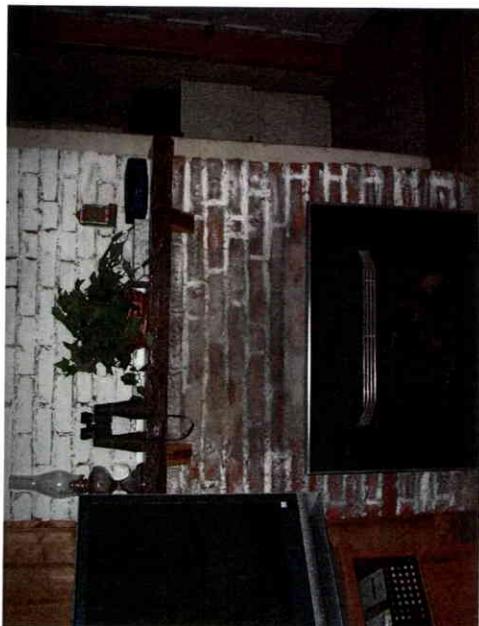
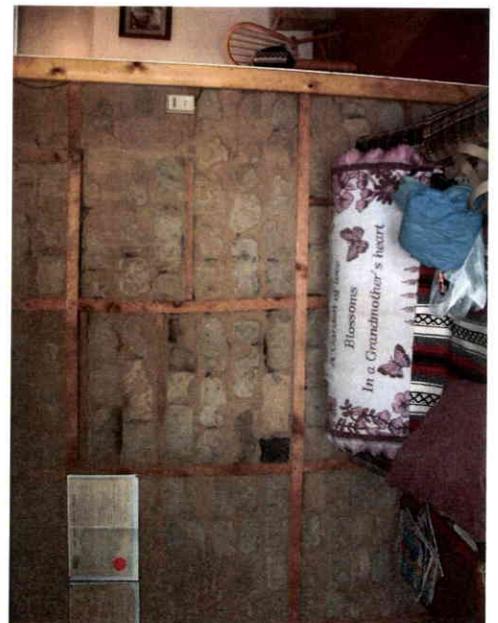
PLATE-6

Ranch House – The ranch house is basically wood construction with a layered rock foundation. According to the owner, the house was constructed in 1903-1904. It was originally located to the north and later moved to its present location. The interior walls are all adobe with wood frames, and the exterior walls are wood. The entire interior of the ranch house has been remodeled. All interior walls and ceilings have been recovered with wood or sheetrock and textured. The only exception is 2 of the adobe walls in the entry/living room have been left exposed. The floors have all been recovered with tile or carpet. The house is wired for power, which is provided by solar panels and batteries, and it is also plumbed, with water supplied by a nearby spring. The house has an entry/living area with a gas fireplace, tile floor, wood slat ceiling and adobe and wood slat walls. There are 3 bedrooms, all of which are carpeted with textured sheetrock walls and ceilings. The combined kitchen/dining area and adjacent closet/pantry all have tiled floors with textured sheetrock walls and ceilings. The bathroom also has a tile floor and tile shower. The walls and ceiling are

also textured sheetrock. The interior of the house is shown on Plates 6 through 13.

Plate 6 – Ranch House Interior

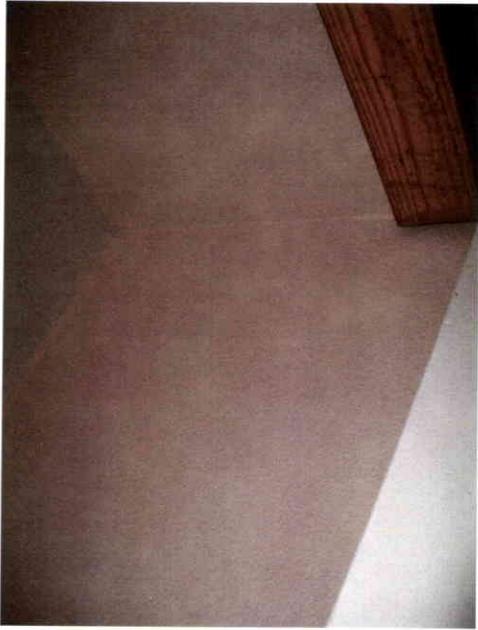
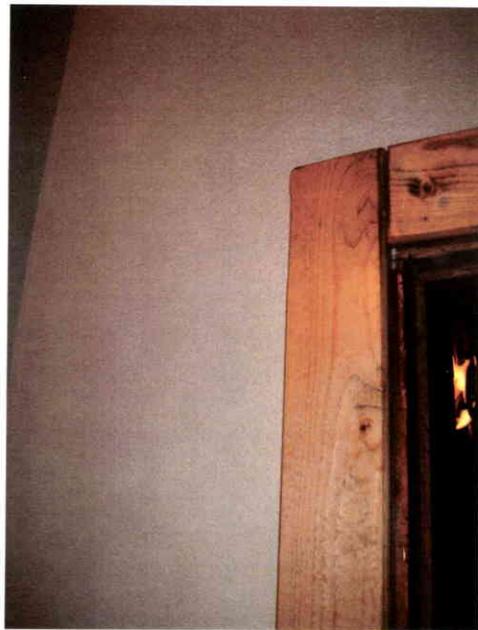
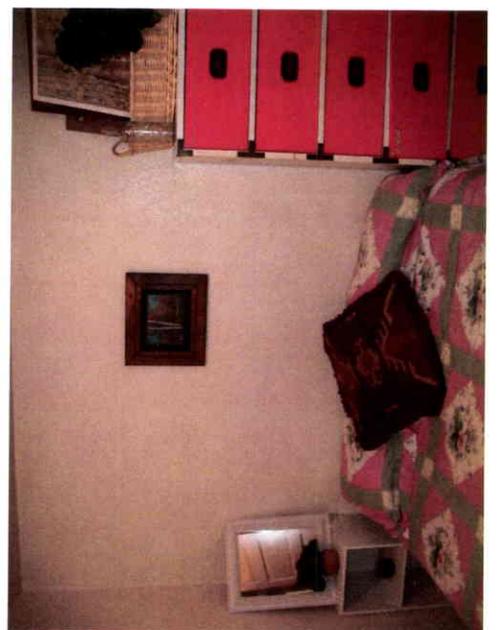
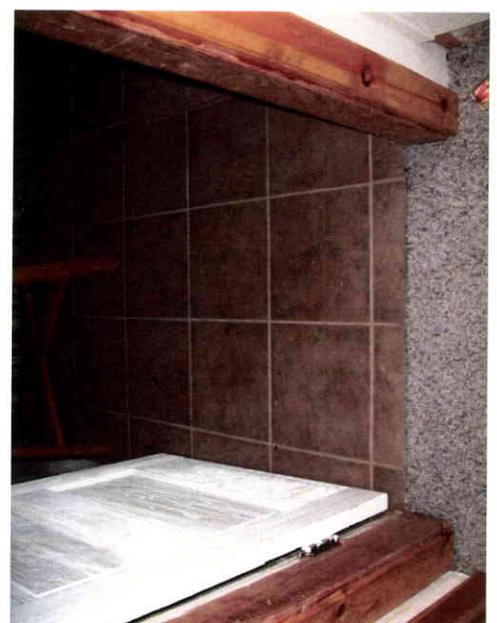
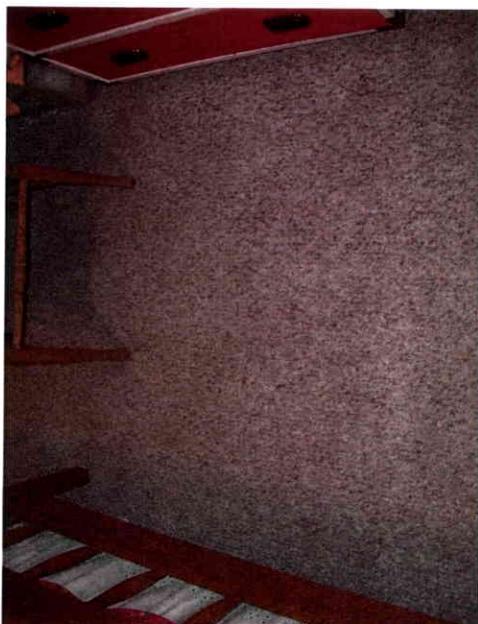
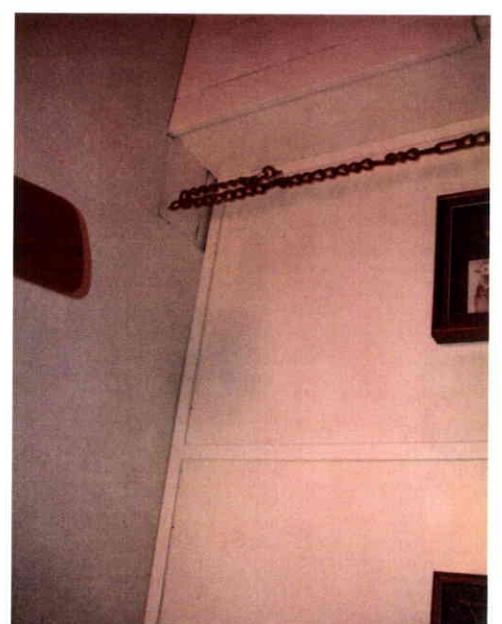
PLATE-7

Plate 7 – Ranch House Interior

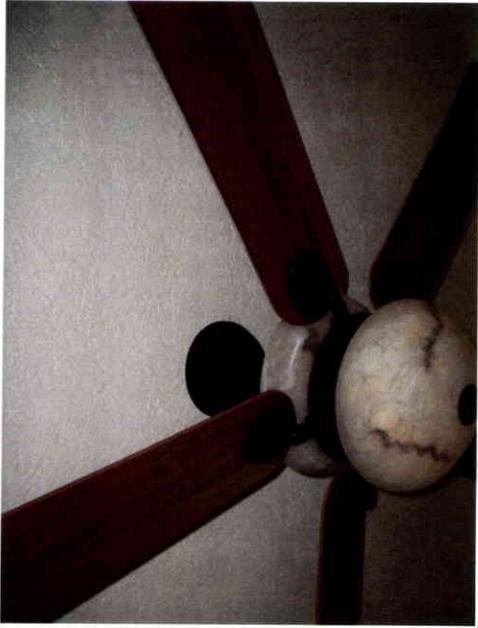
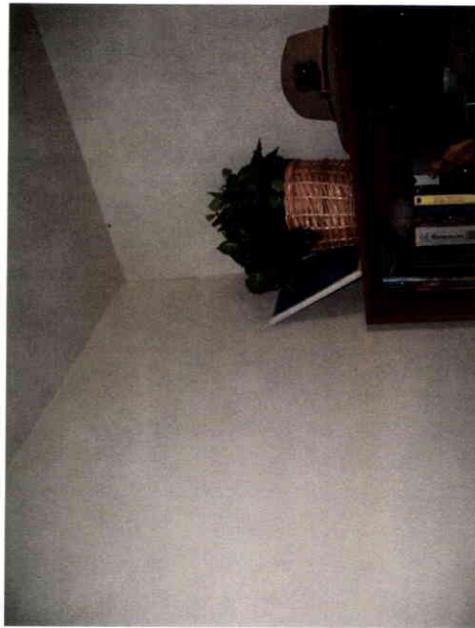
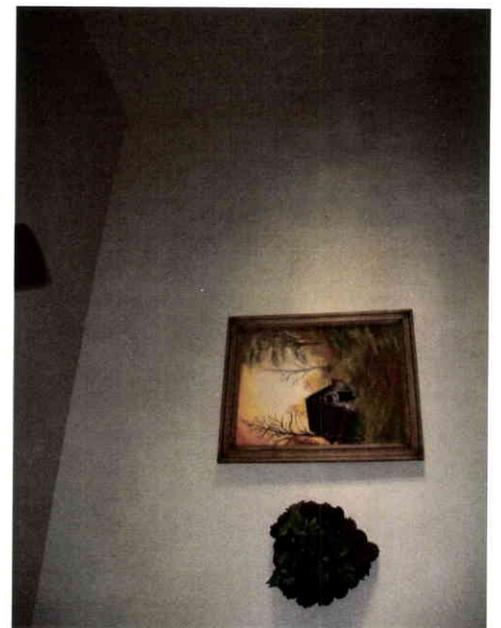
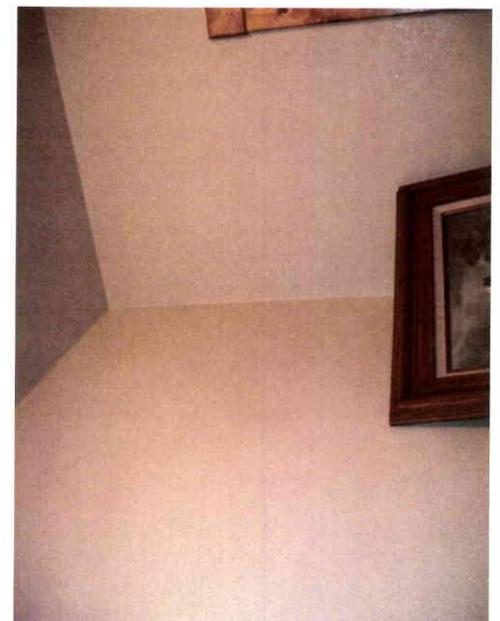
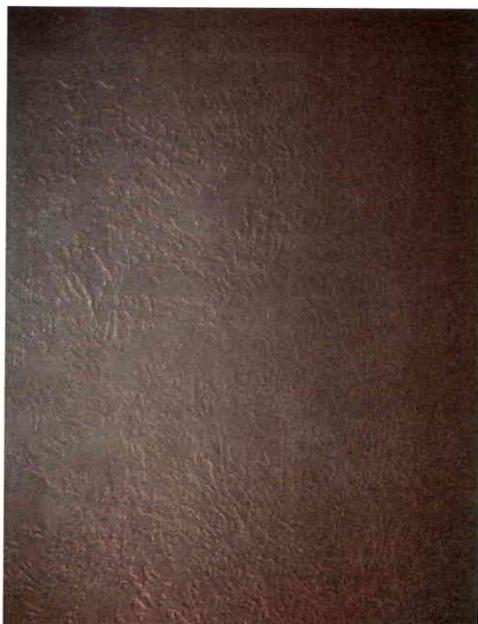
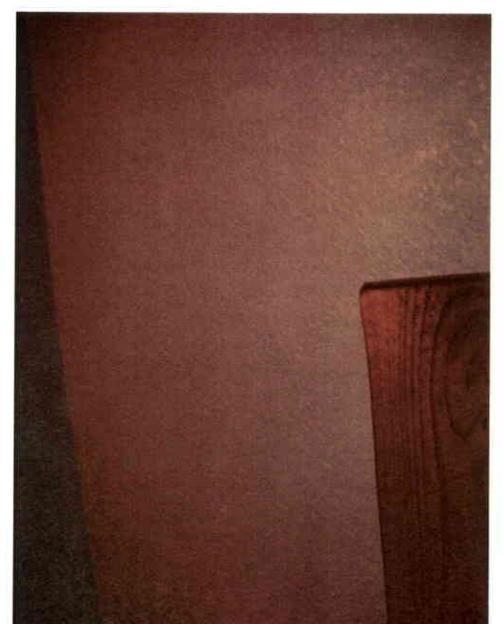
PLATE-8

Plate 8 – Ranch House Interior

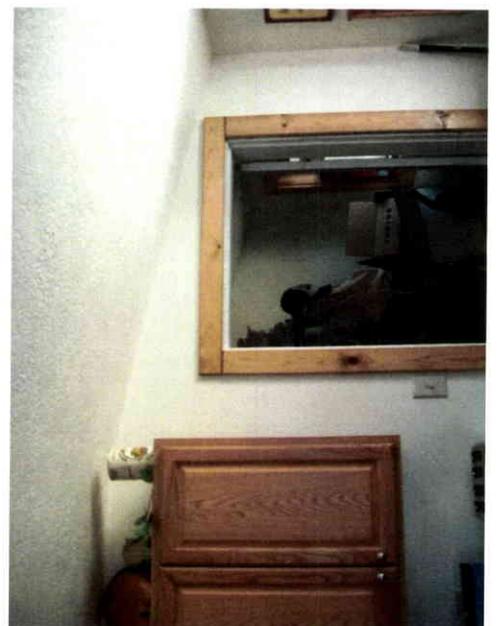
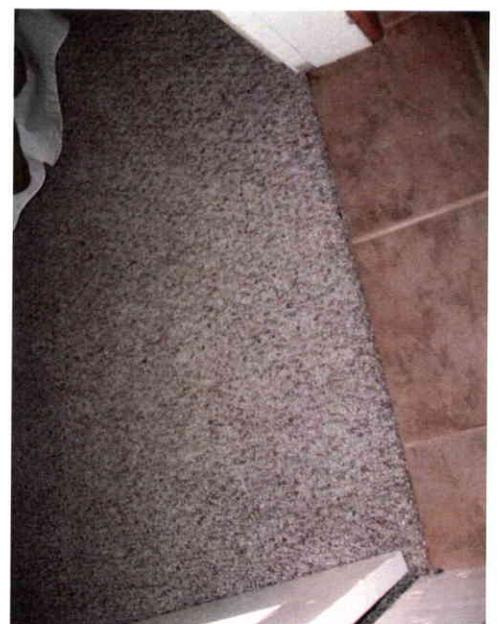
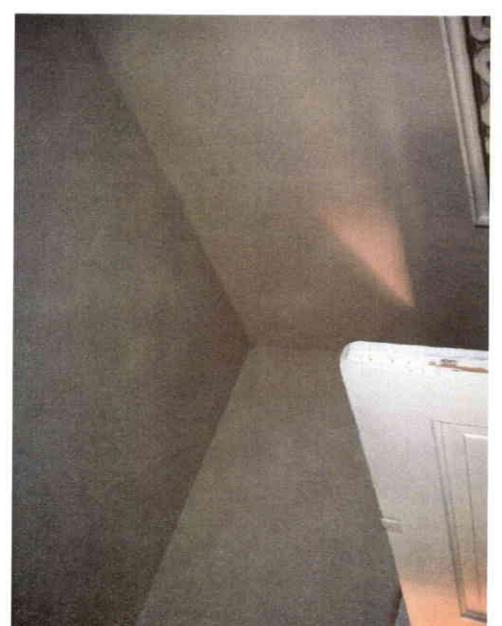
PLATE-9

Plate 9 – Ranch House Interior

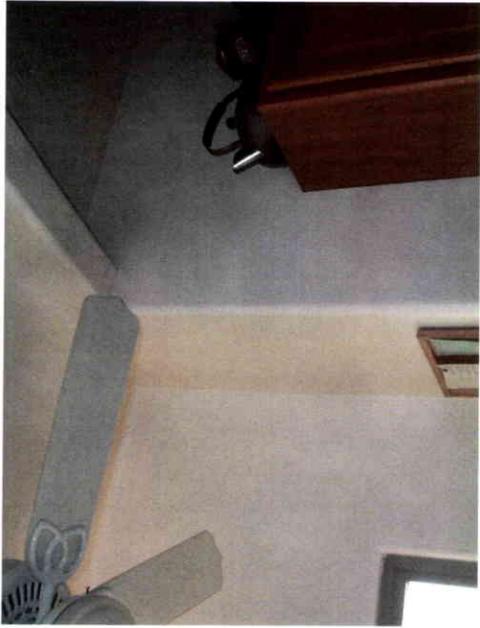
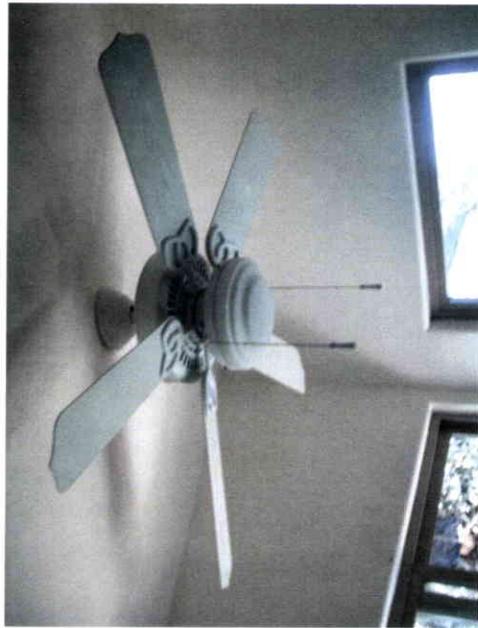
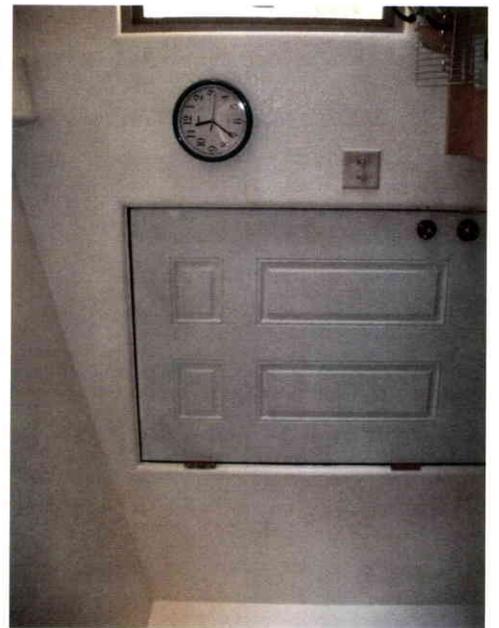
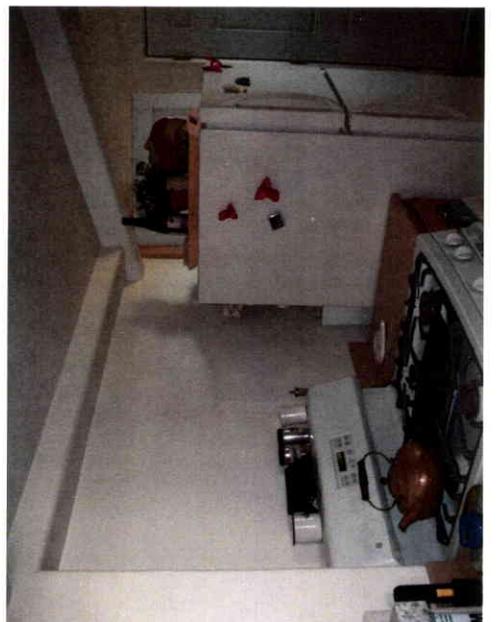
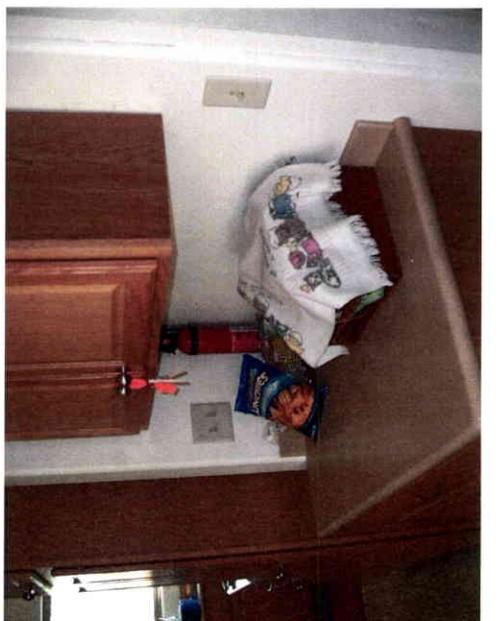
PLATE-10

Plate 10-Ranch House Interior

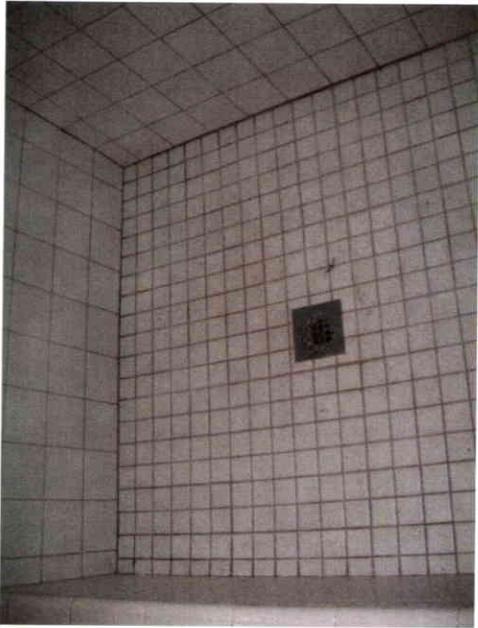
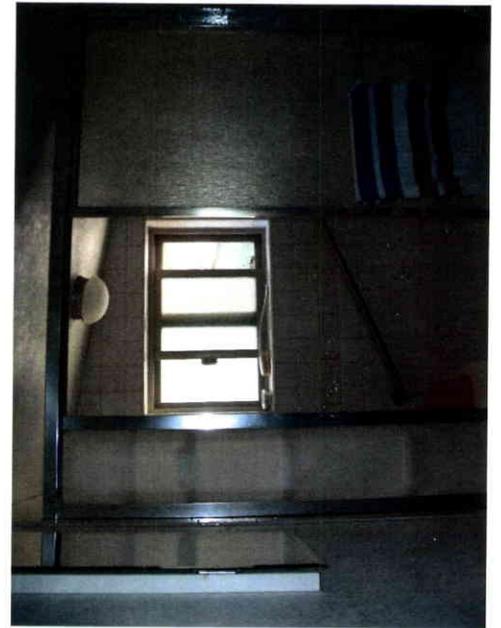
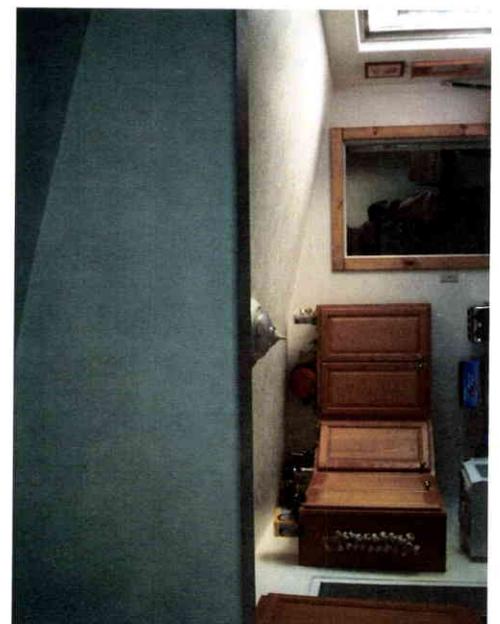
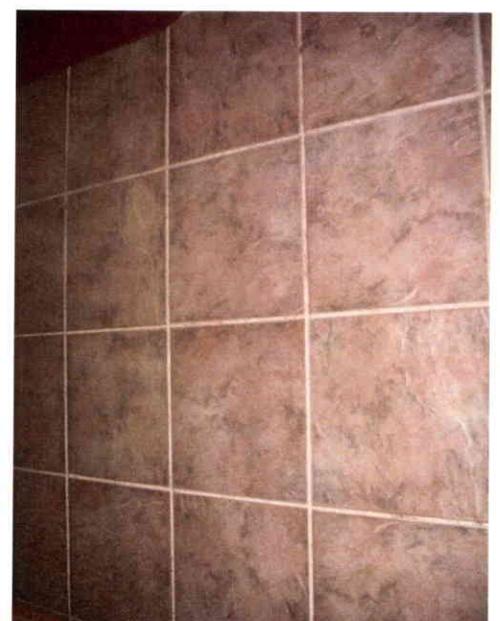
PLATE-11

Plate 11-Ranch House Interior

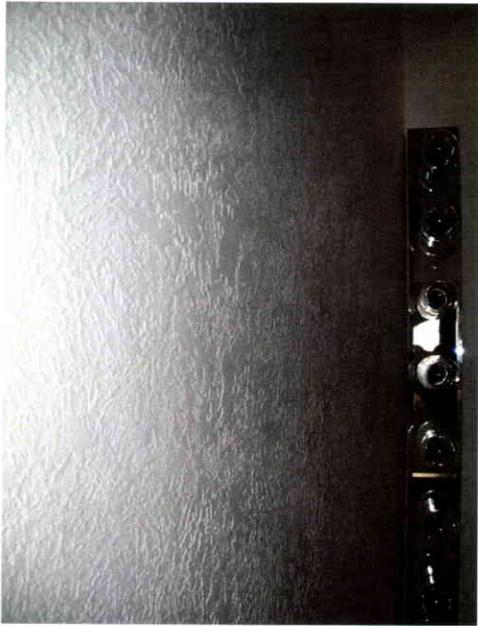
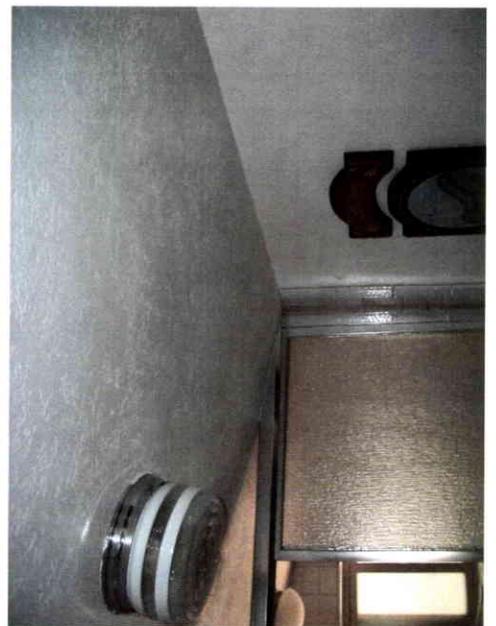
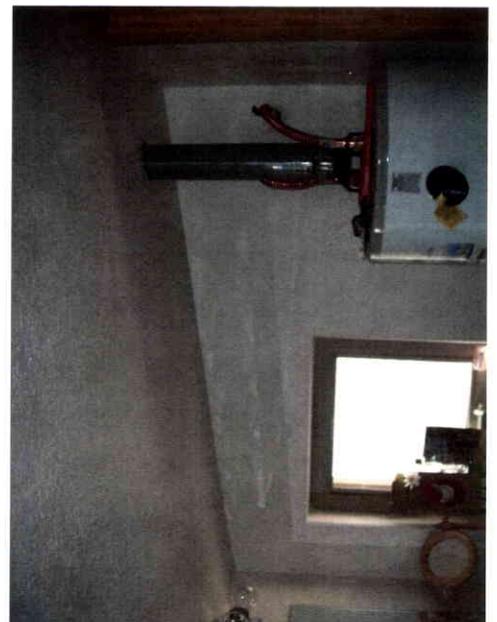
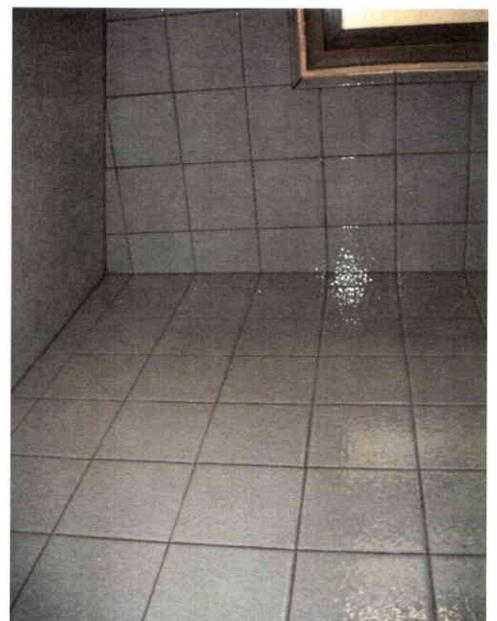
PLATE-12

Plate 12-Ranch House Interior

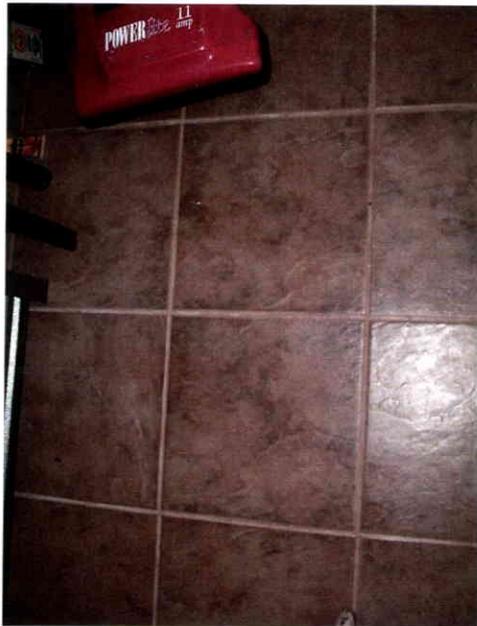
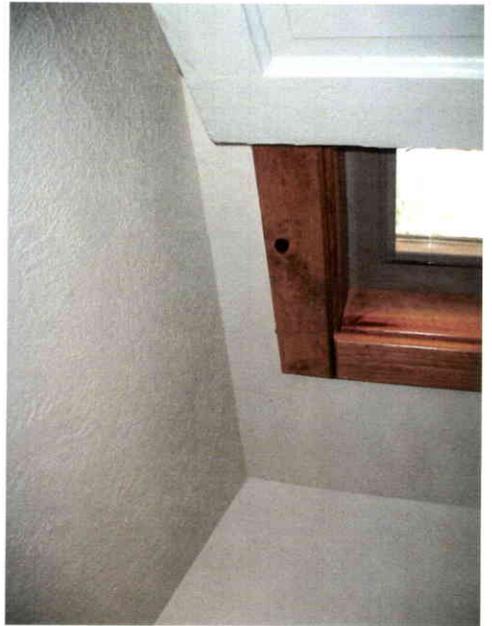
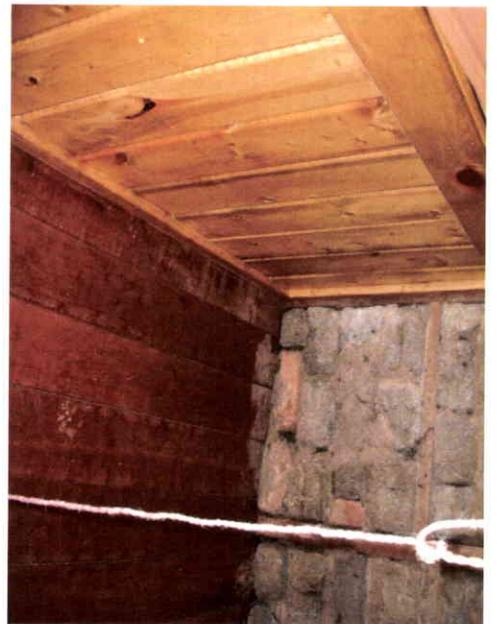
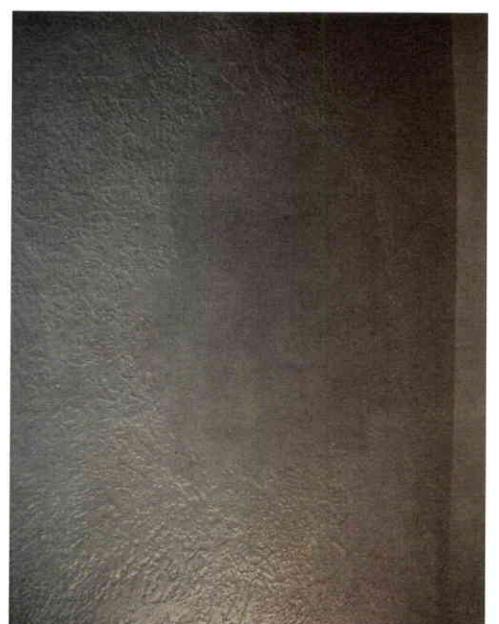
PLATE-13

Plate 13-Ranch House Interior

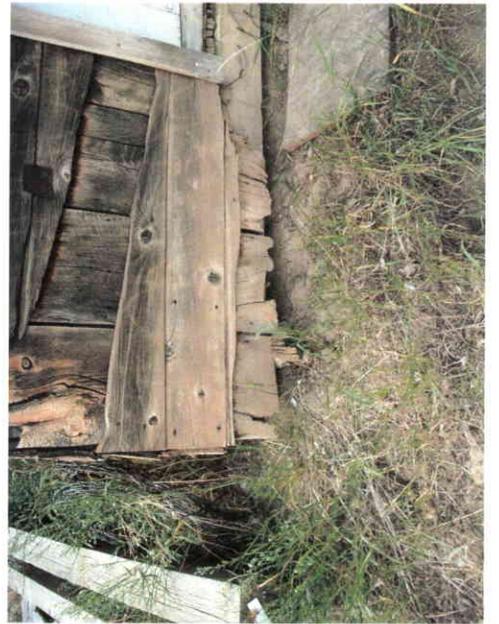
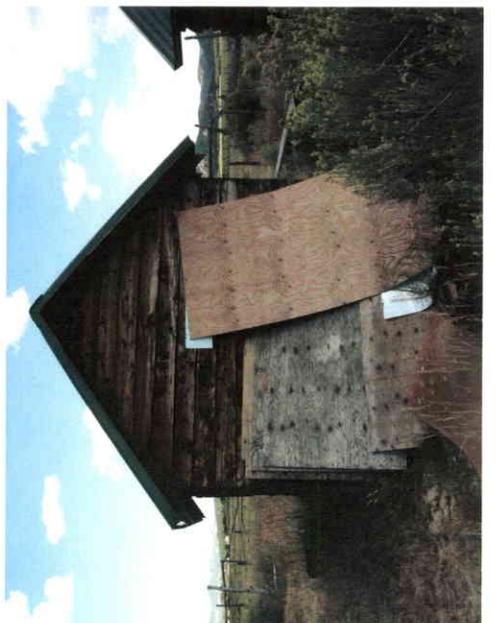
PLATE-14

Storage Building – The storage building is located northeast of the ranch house. It is a wood building with a steel roof. It has no foundation and sits on wooden blocks. The structure appears to be quite stable. The exposed wood is quite weathered, but undamaged. The newer steel roof also adds to the stability of the structure by adding strength and reducing accumulations of snow. Photos of this structure are shown on Plate 14 of this report.

Plate 14-Storage Building

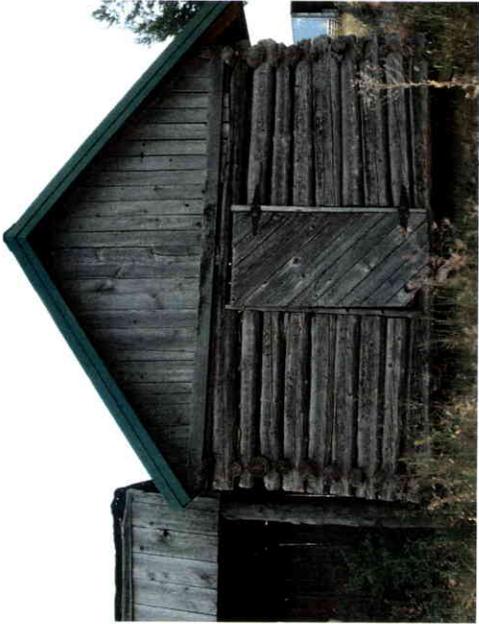
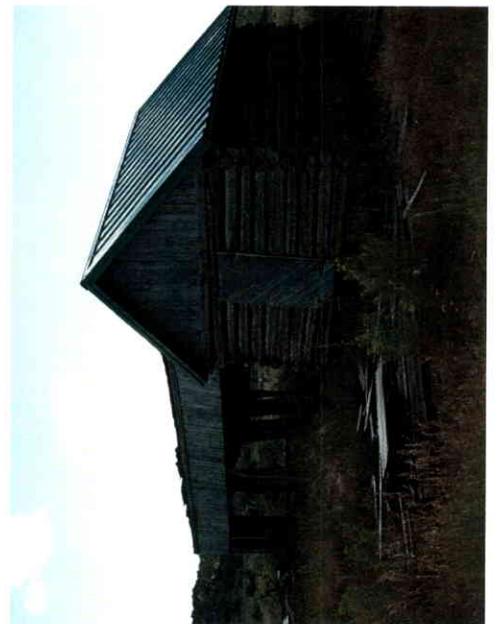
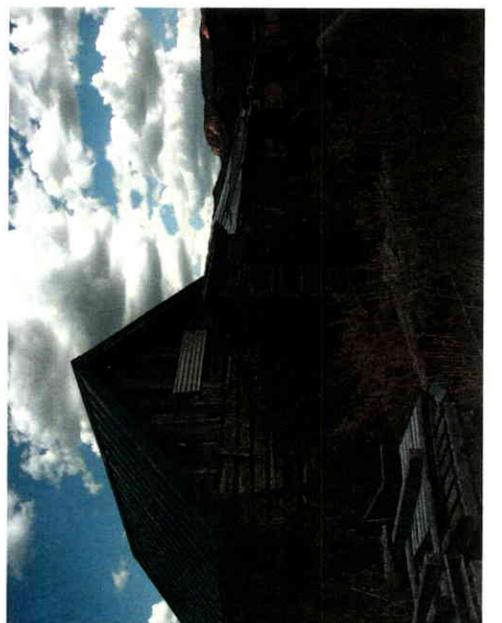
PLATE-15

Log Storage Building / Livestock Barn – These 2 structures are joined. The storage building is constructed of logs with a steel roof and no foundation. The livestock barn is wood construction with a dirt floor, open front, no foundation and a galvanized tin roof. The storage building is enclosed and appears to be stable and in fair to good condition. The livestock barn is quite weathered and is in relatively poor and less stable condition. These structures are shown on Plate 15.

Plate 15-Log Storage Building / Livestock Barn

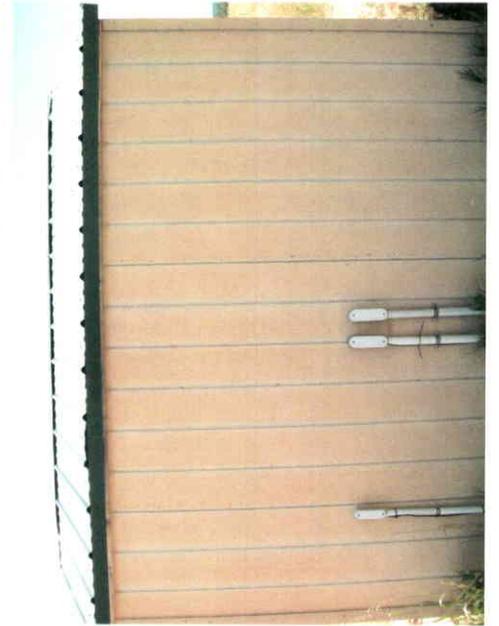
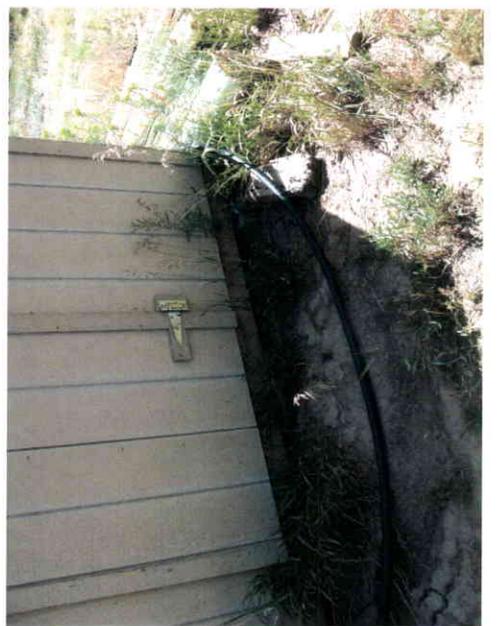
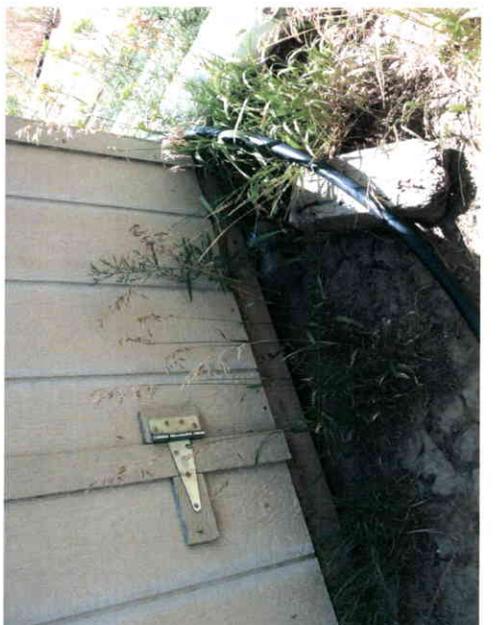
PLATE-16

Power Building – This is a combination wood laminate and steel building, with no foundation, sitting on wooden blocks. This building is described on Plate 2 as a garden shed. The power building houses the batteries which are charged by the solar panels and supply electricity to the ranch house. The building is fairly new, and appears to be in good, stable condition. It is shown on Plate 16.

Plate 16-Power Building

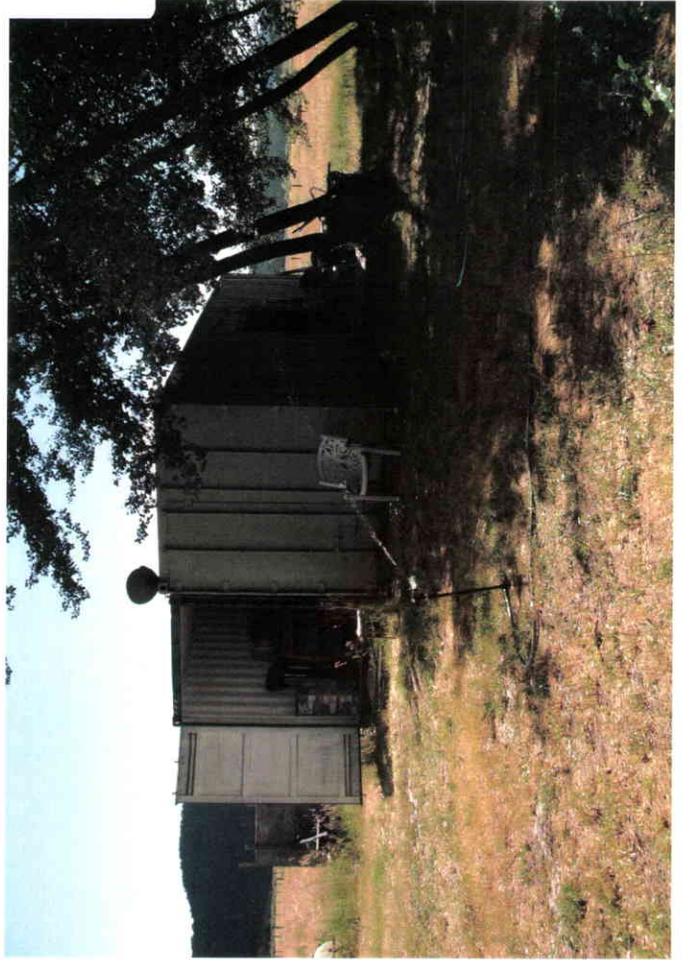
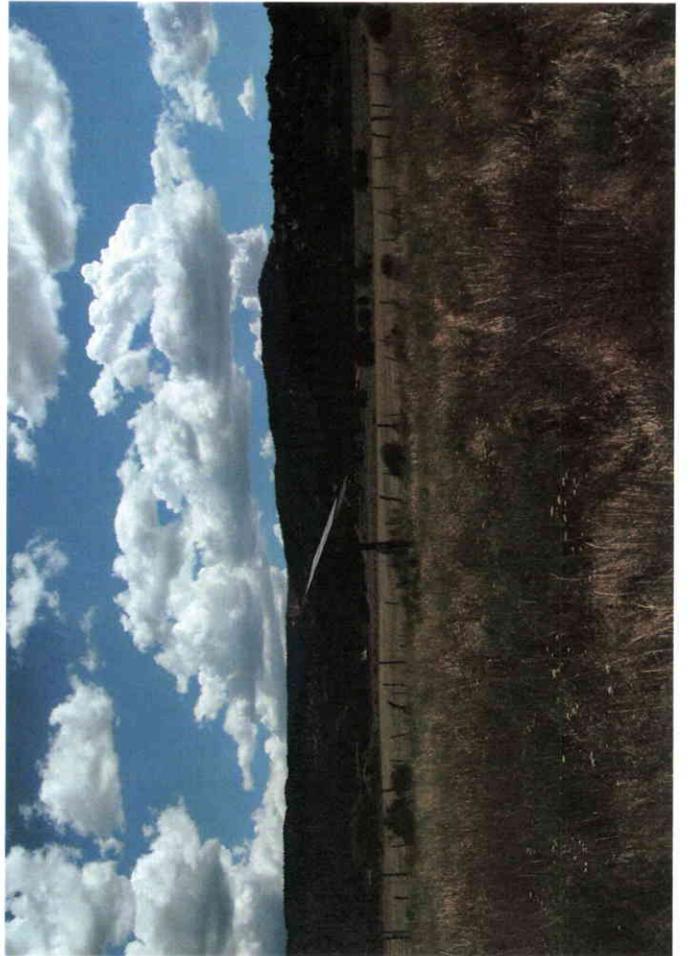
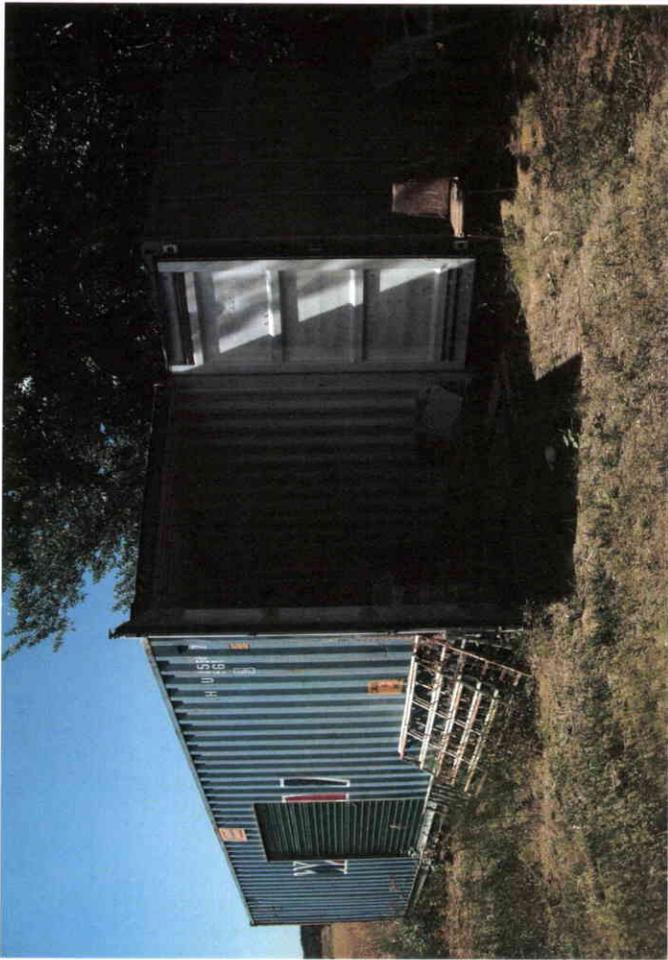
PLATE-17

Solar Panels / Steel Storage Containers – A large solar panel array is located in the field east of the ranch house and power building. The panels charge the batteries in the power building, which in turn supply power to the ranch house. There are also 2 large, steel storage containers located southeast of the ranch house. There is little, if any, potential for damage to these structures from blasting; however, they were photographed and are shown on Plate 17 of this report.

Plate 17-Solar Panels / Steel Storage Containers
