Division of Oil, Gas and Mining

Inspection Report

Permit Number:	C0250005
Inspection Type:	PARTIAL
Inspection Date:	Monday, March 04, 2013
Start Date/Time:	3/4/2013 2:00:00 PM
End Date/Time:	3/5/2013 1:00:00 PM
Last Inspection:	Thursday, February 21, 2013

Permittee: **ALTON COAL DEVELOPMENT LLC**
 Operator: **ALTON COAL DEVELOPMENT LLC**
 Site: **COAL HOLLOW**
 Address: **463 North 100 West, Suite 1, CEDAR CITY UT 84720**
 County: **KANE**
 Permit Type: **PERMANENT COAL PROGRAM**
 Permit Status: **ACTIVE**

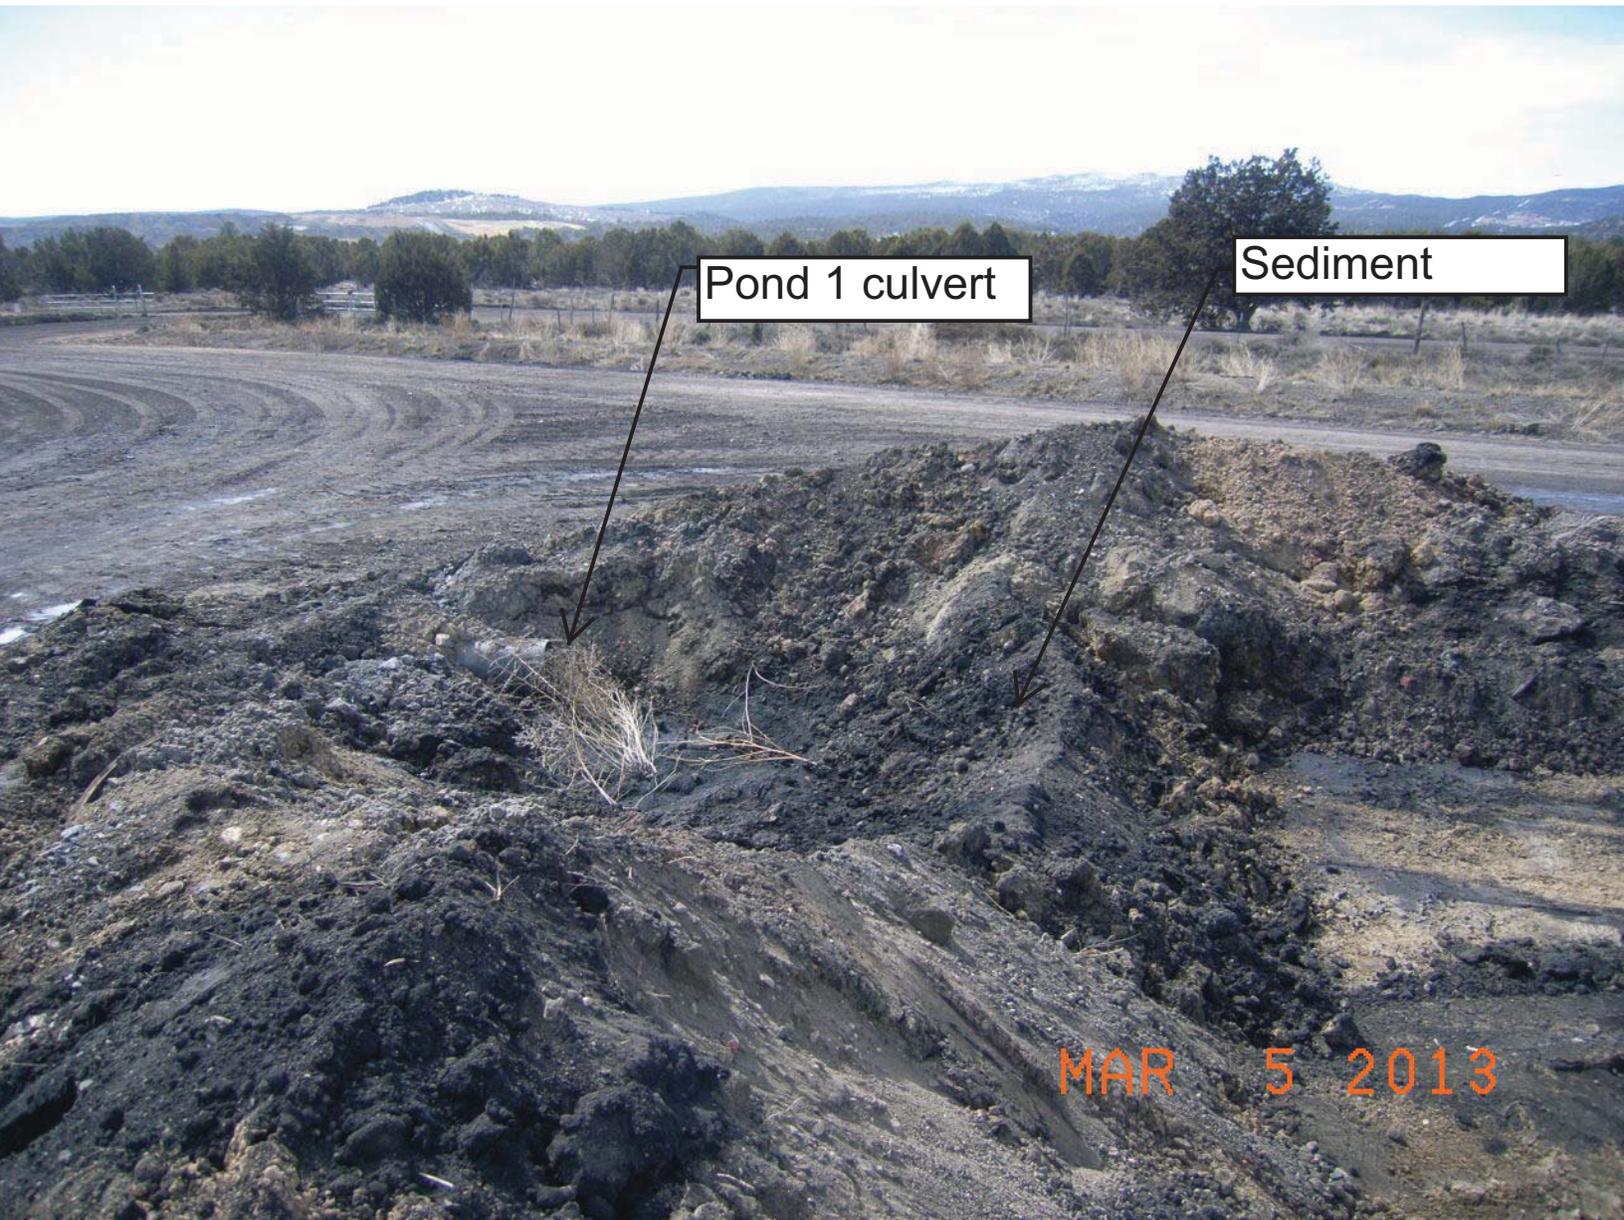
Pond 1 culvert

Sediment

The culvert to Pond 1b had been repaired and a large amount of sediment was present upgradient. Mr. Nicholes was notified this sediment needed to be cleaned out as soon as possible. Mr. Nicholes stated it would be completed by the end of the week.

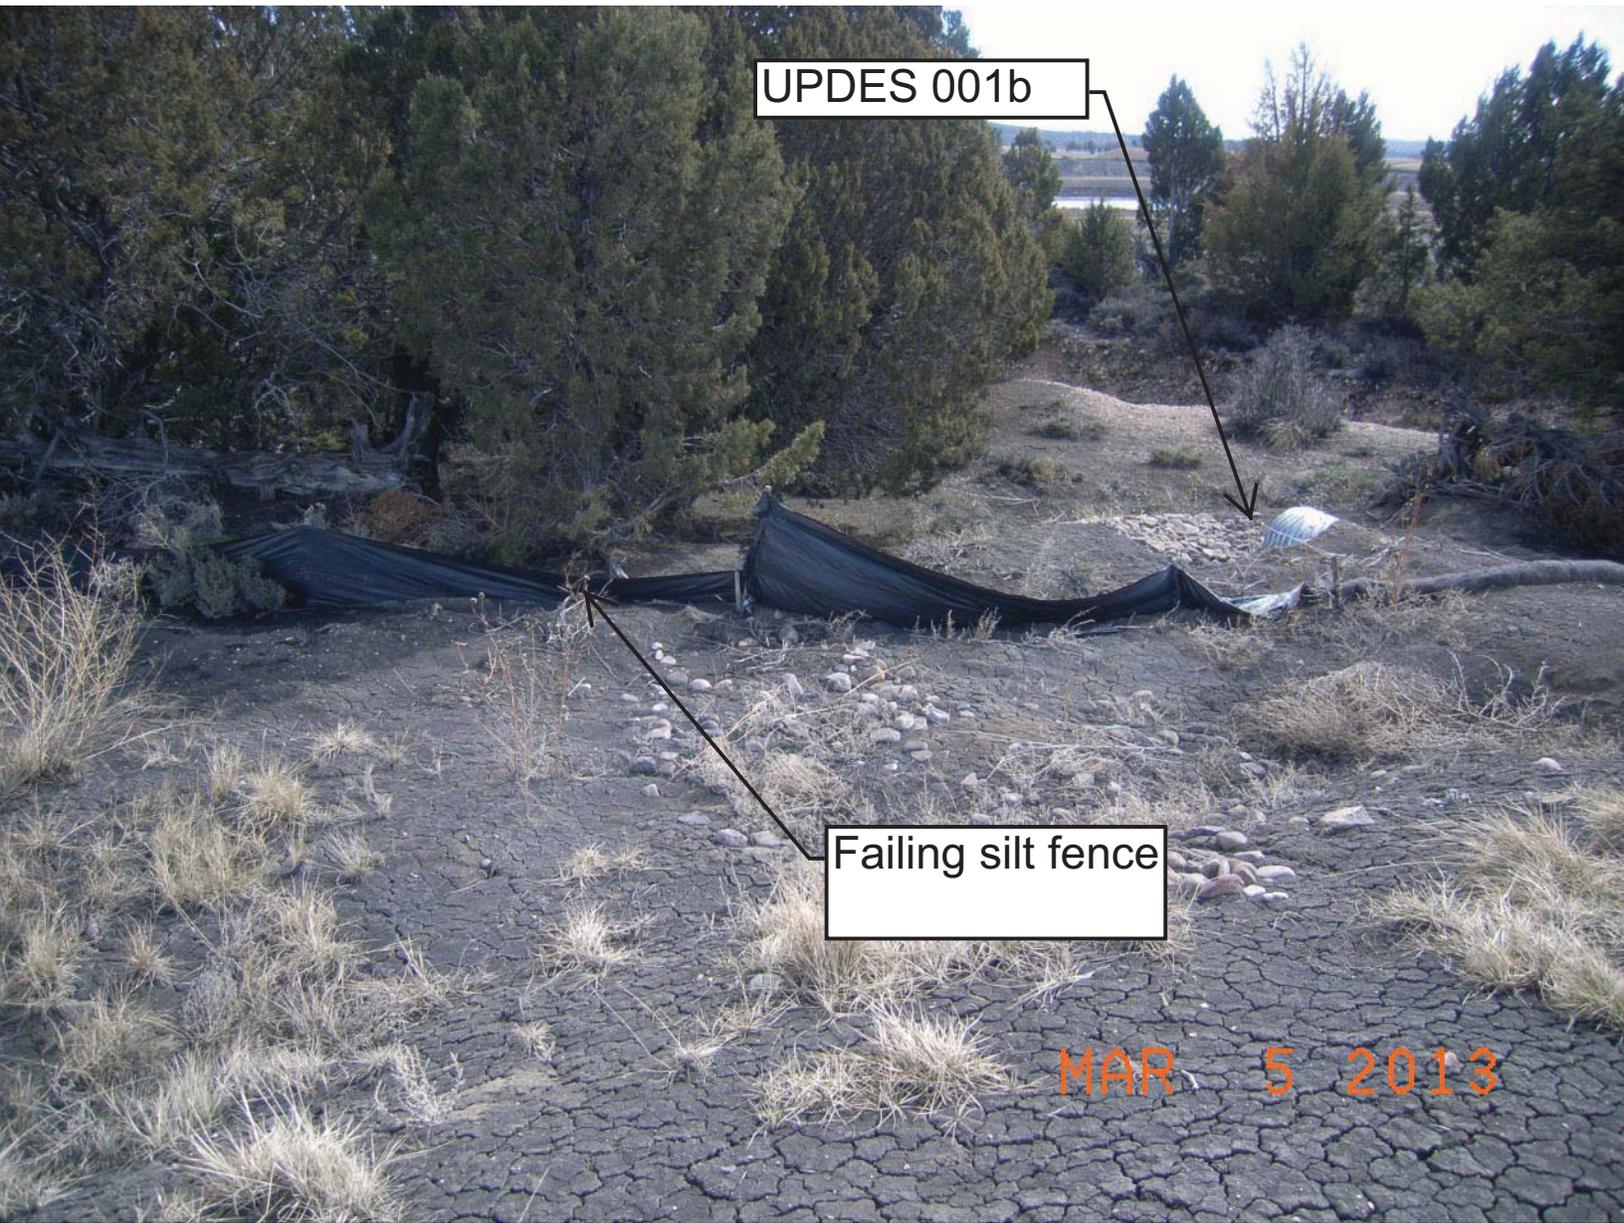
UPDES 001b

Failing silt fence

Two pairs of haybales at the entrance to the site were observed and appeared to have 50% capacity remaining. The silt fencing by Pond 1b was observed and in need of repair or replacement with new silt fence or excelsior logs. The silt fencing north of Ditch 4 was observed and in need of repair or replacement with new silt fence or excelsior logs. The silt fencing northwest of Pond 3 was observed and in need of repair or replacement with new silt fence or excelsior logs. Haybales near the end of Lower Robinson Creek diversion are buried in sediment and near being overtopped and need to be cleaned out and/or replaced. Repair or replacement of these sedimentation control measures was discussed with Mr. Nicholes and he agreed to have the work completed by June 3, 2013.

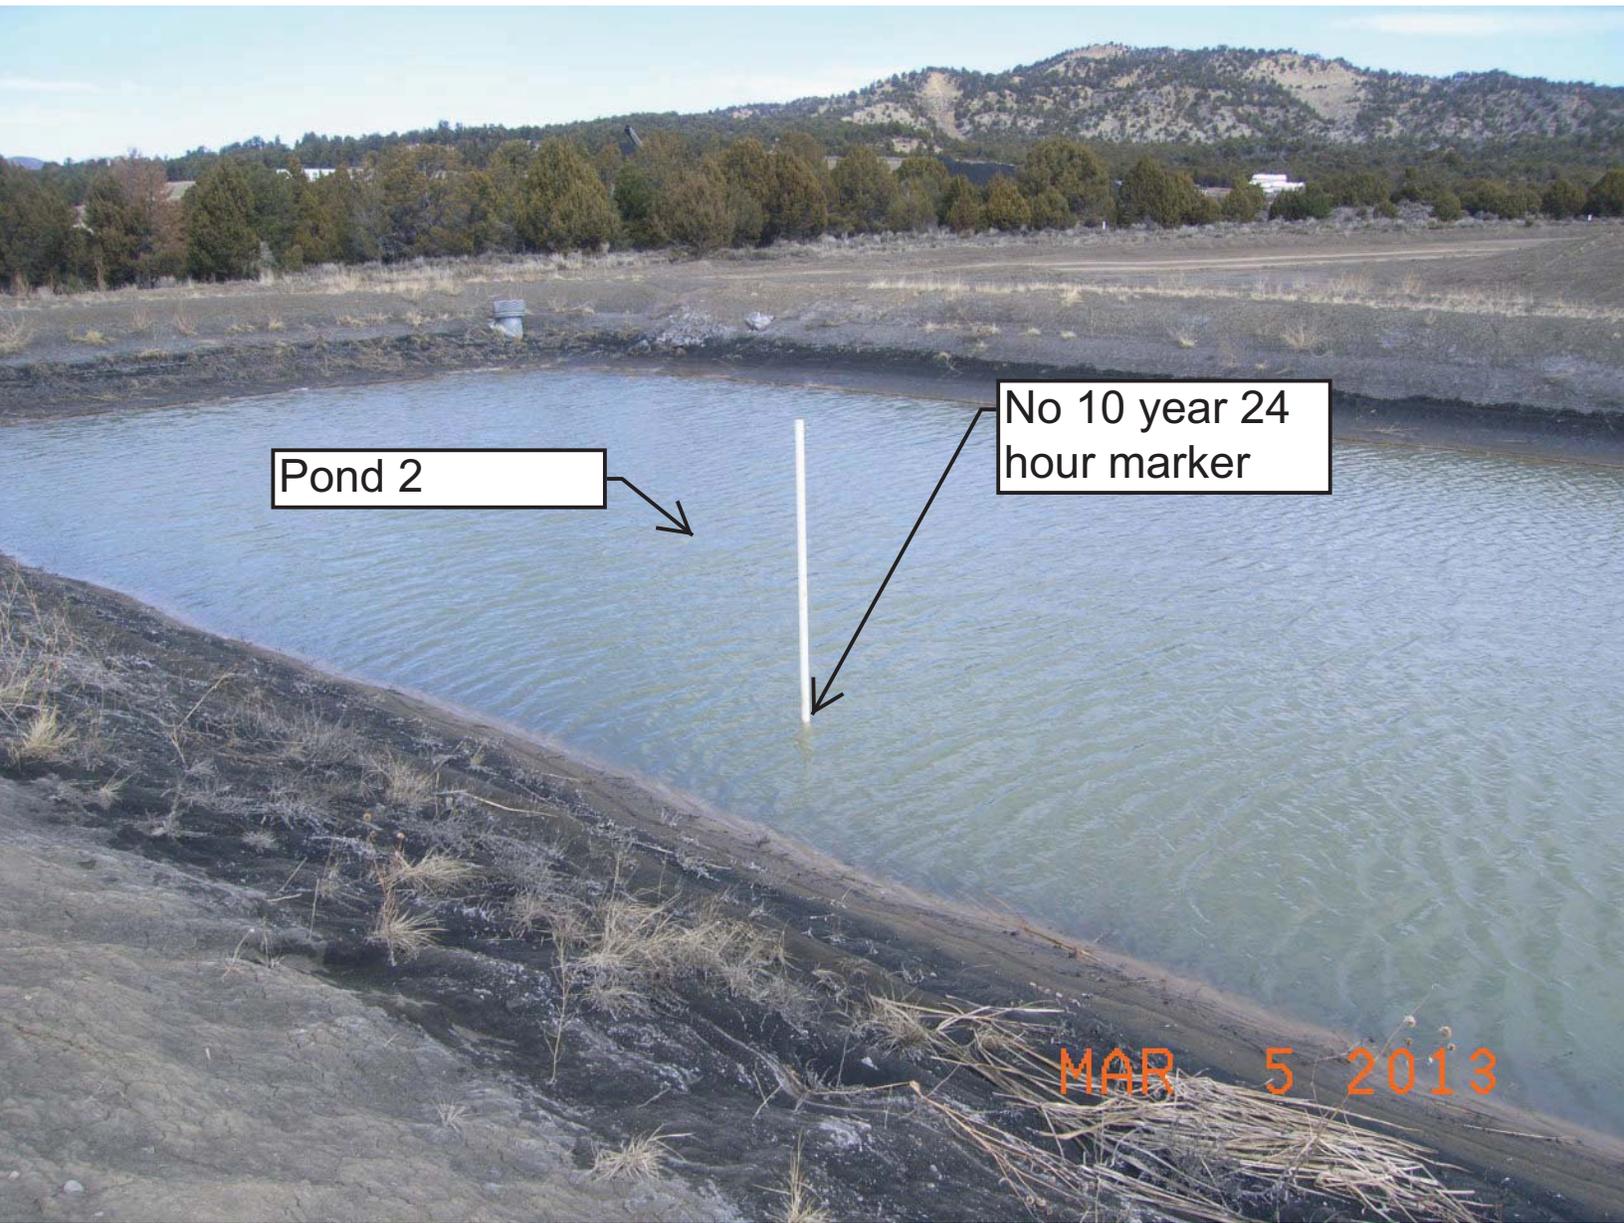
All sediment ponds and UPDES discharges were observed except sediment pond 4/UPDES 004 which has not yet been constructed. Pond 1 was nearly at the 10 year 24 hour capacity marker. Pond 1b was about 5% full. Pond 2 was missing the 10 year 24 hour marker but appeared to be approximately 50% full. Mr Nicholes was notified this sticker needs to be replaced as soon as possible. A water truck fill stand and pump were present at Pond 2. Since I was last at the site in August 2012 the inlet on the northwest corner has been moved. Pond 3 had 10% capacity remaining before the 10 year 24 hour marker. A pump was present and being used to fill a water truck. The water truck operates 10 loads per day or 100,000 gal/day.

No 10 year 24
hour marker

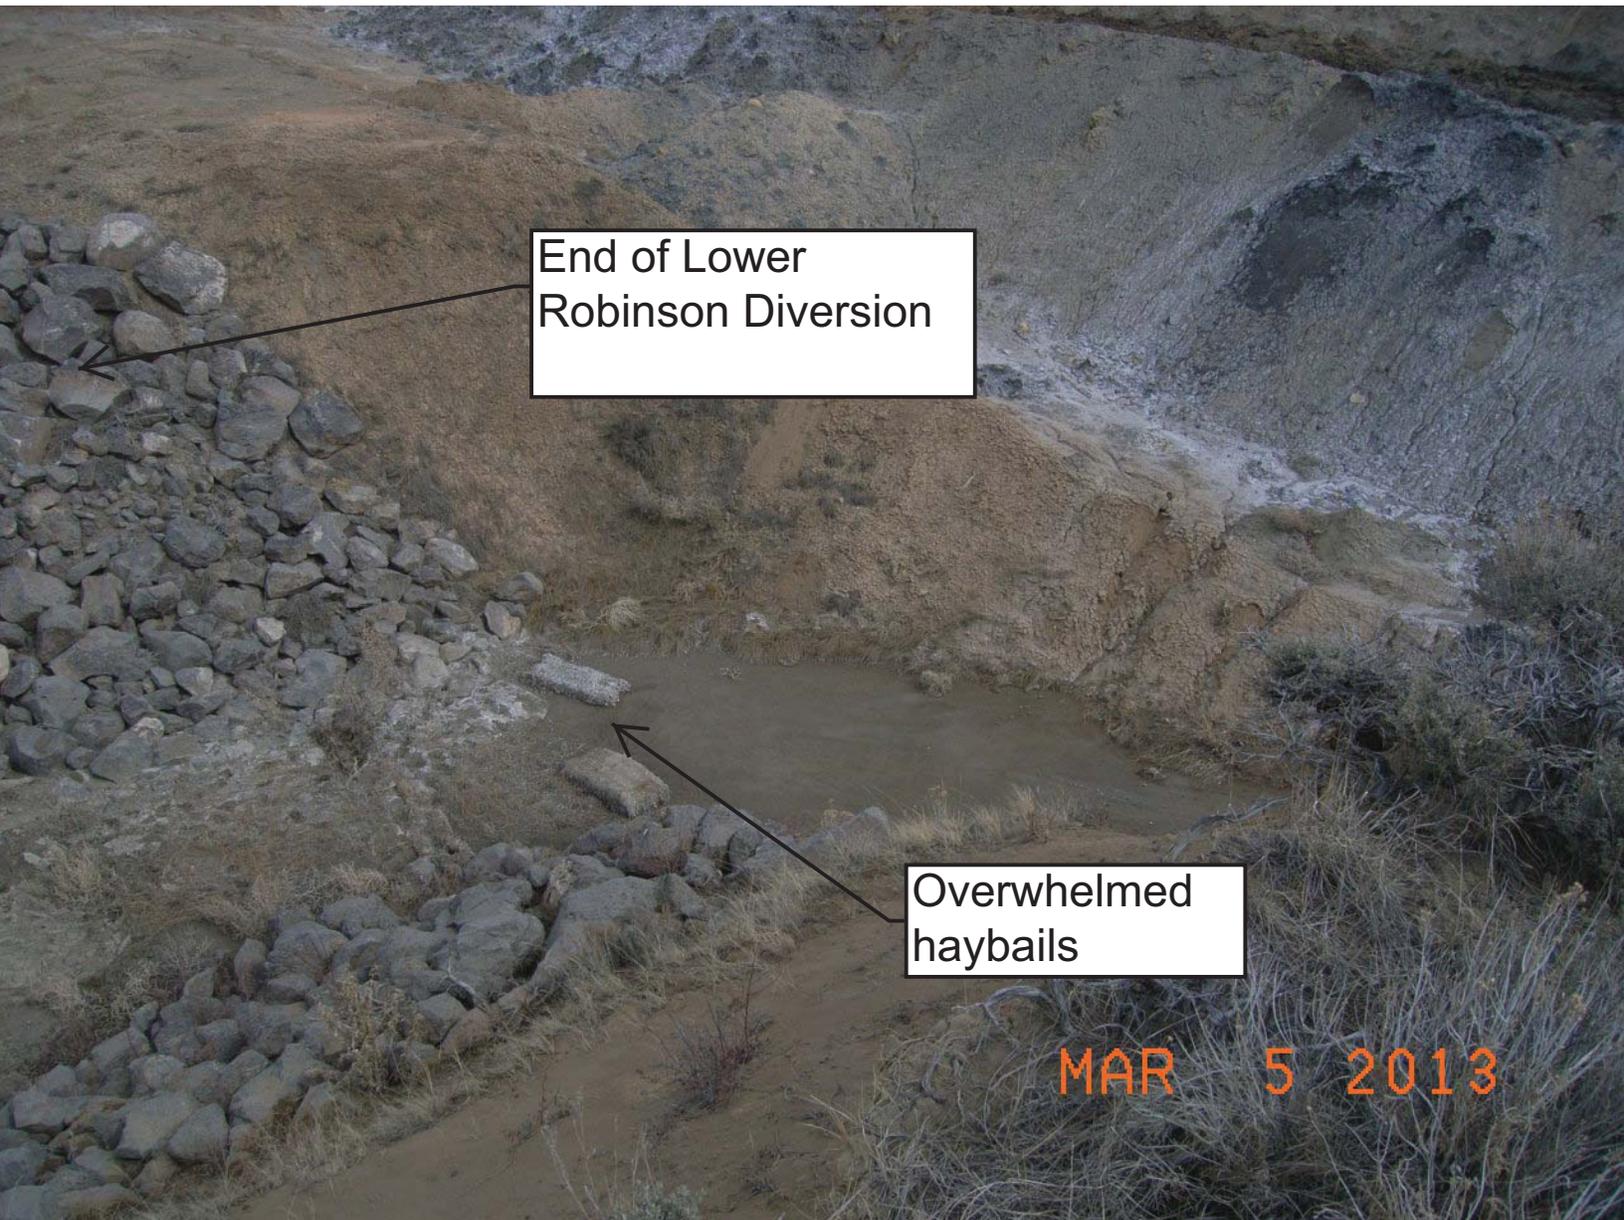
End of Lower Robinson Diversion

Overwhelmed haybails

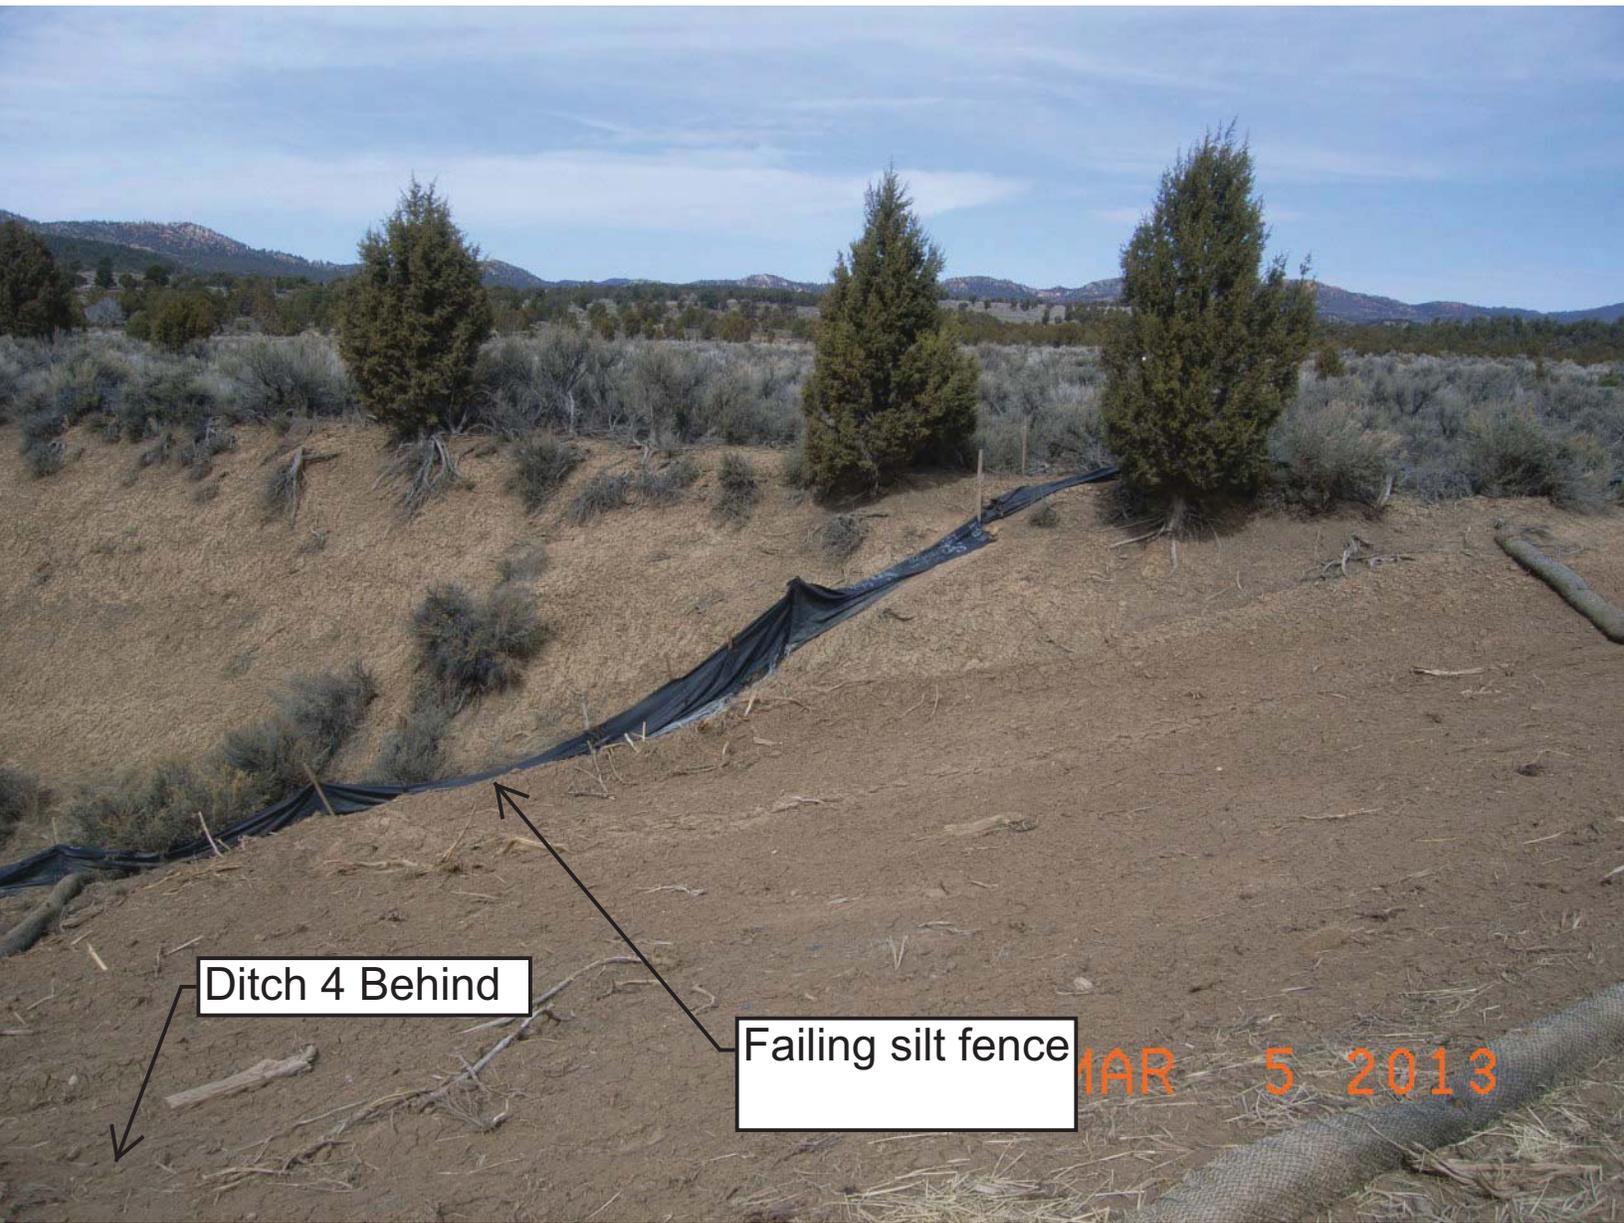
Ditch 4 Behind

Failing silt fence

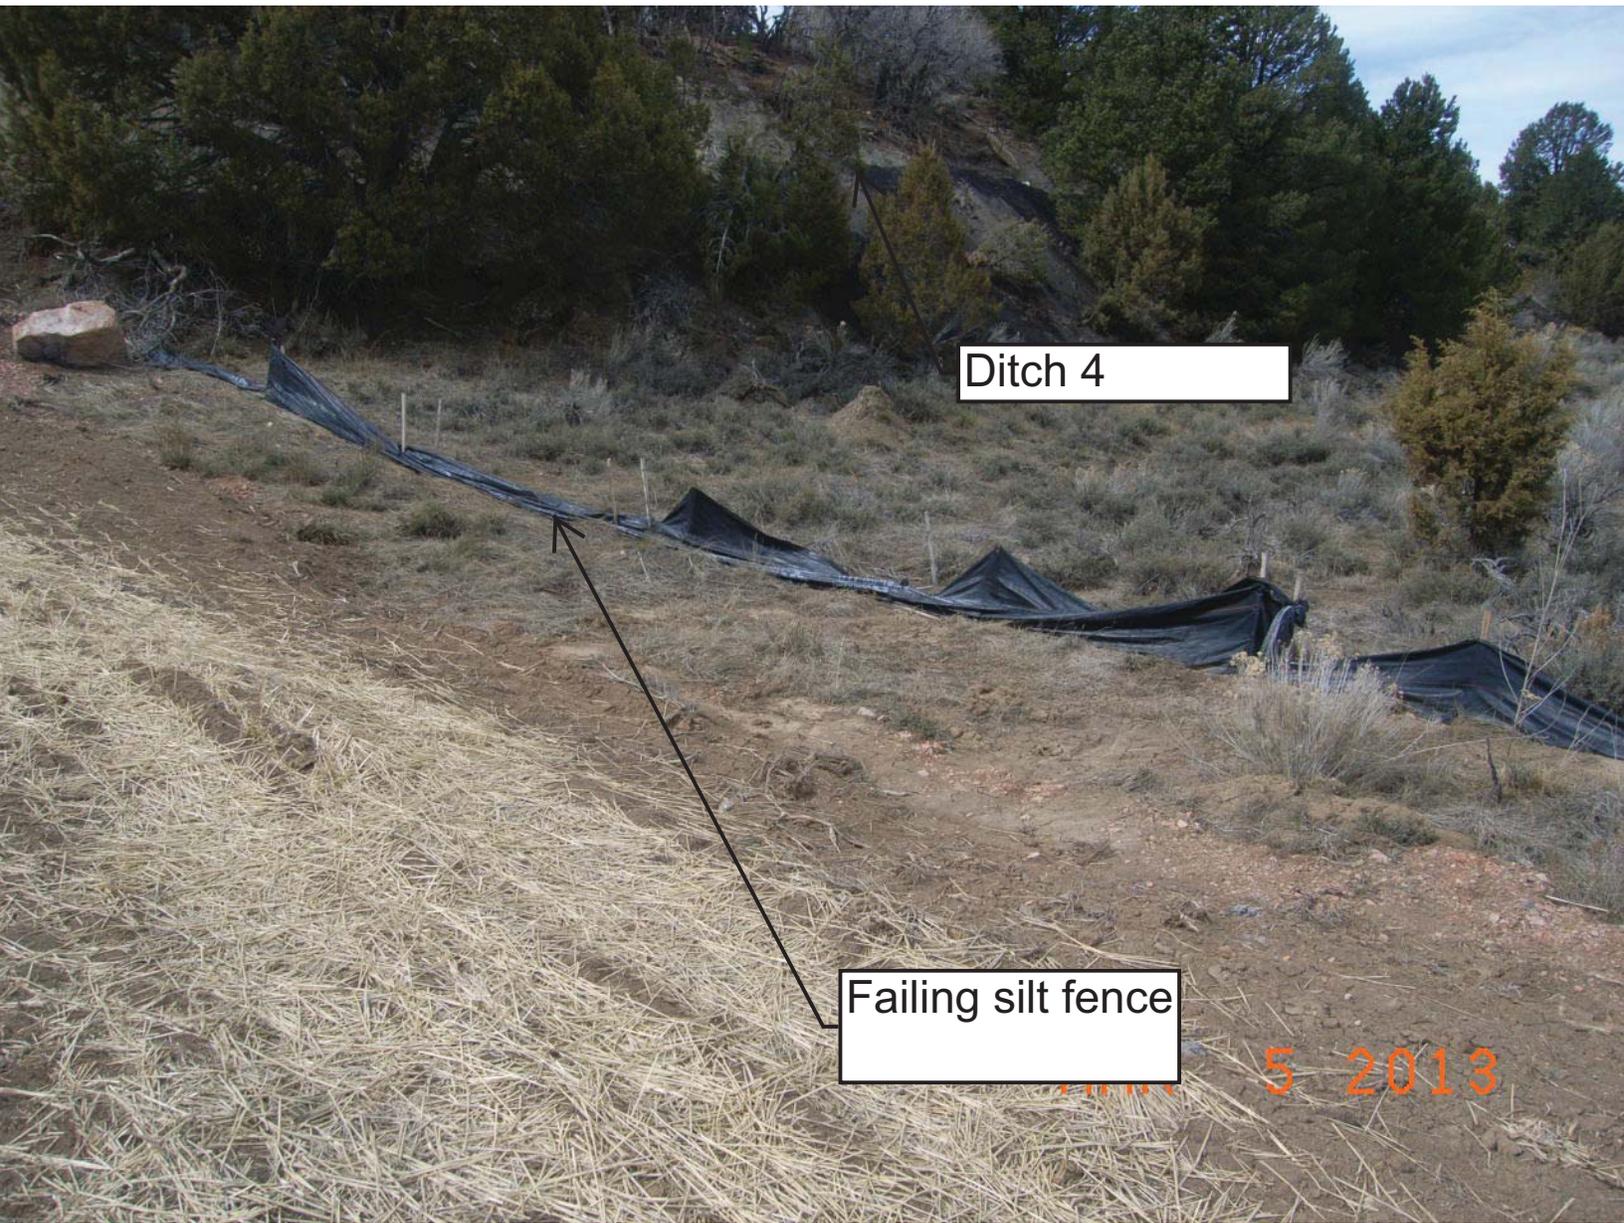
Ditch 4

Failing silt fence

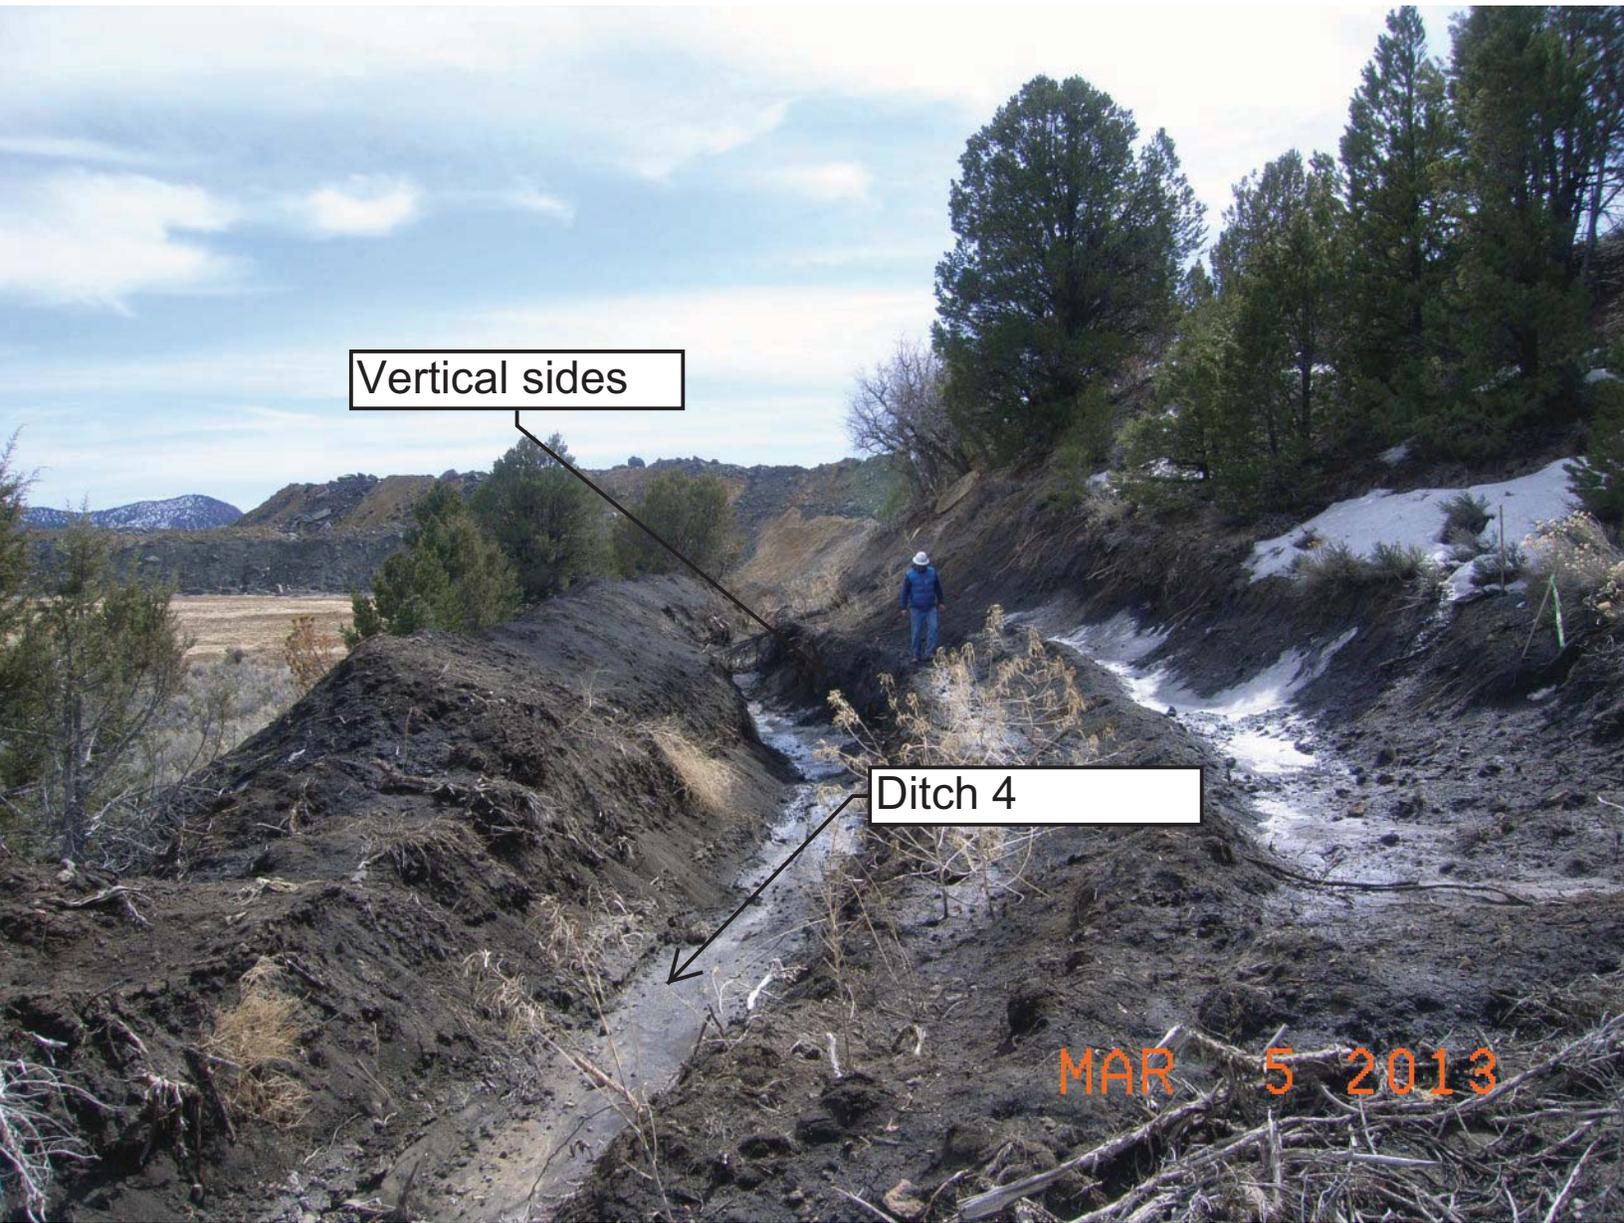
Ditch 2a, 2b, and 3 were observed and appeared to be constructed to plan and operating correctly. A small spring was flowing in Ditch 2b upgradient of the culvert. Ditch 4 was observed from beginning on the haul road to terminous at Pond 3. Many sections of Ditch 4 are not constructed to plan and the side slopes of the ditch do not meet a 2:1 slope. The current site conditions impede conducting corrective actions but Mr. Nicholes committed to having Ditch 4 in compliance with the MRP by no later than June 3, 2013. The start and end of Lower Robinson Creek diversion rip rap was observed and looked complete and holding well.

Vertical sides

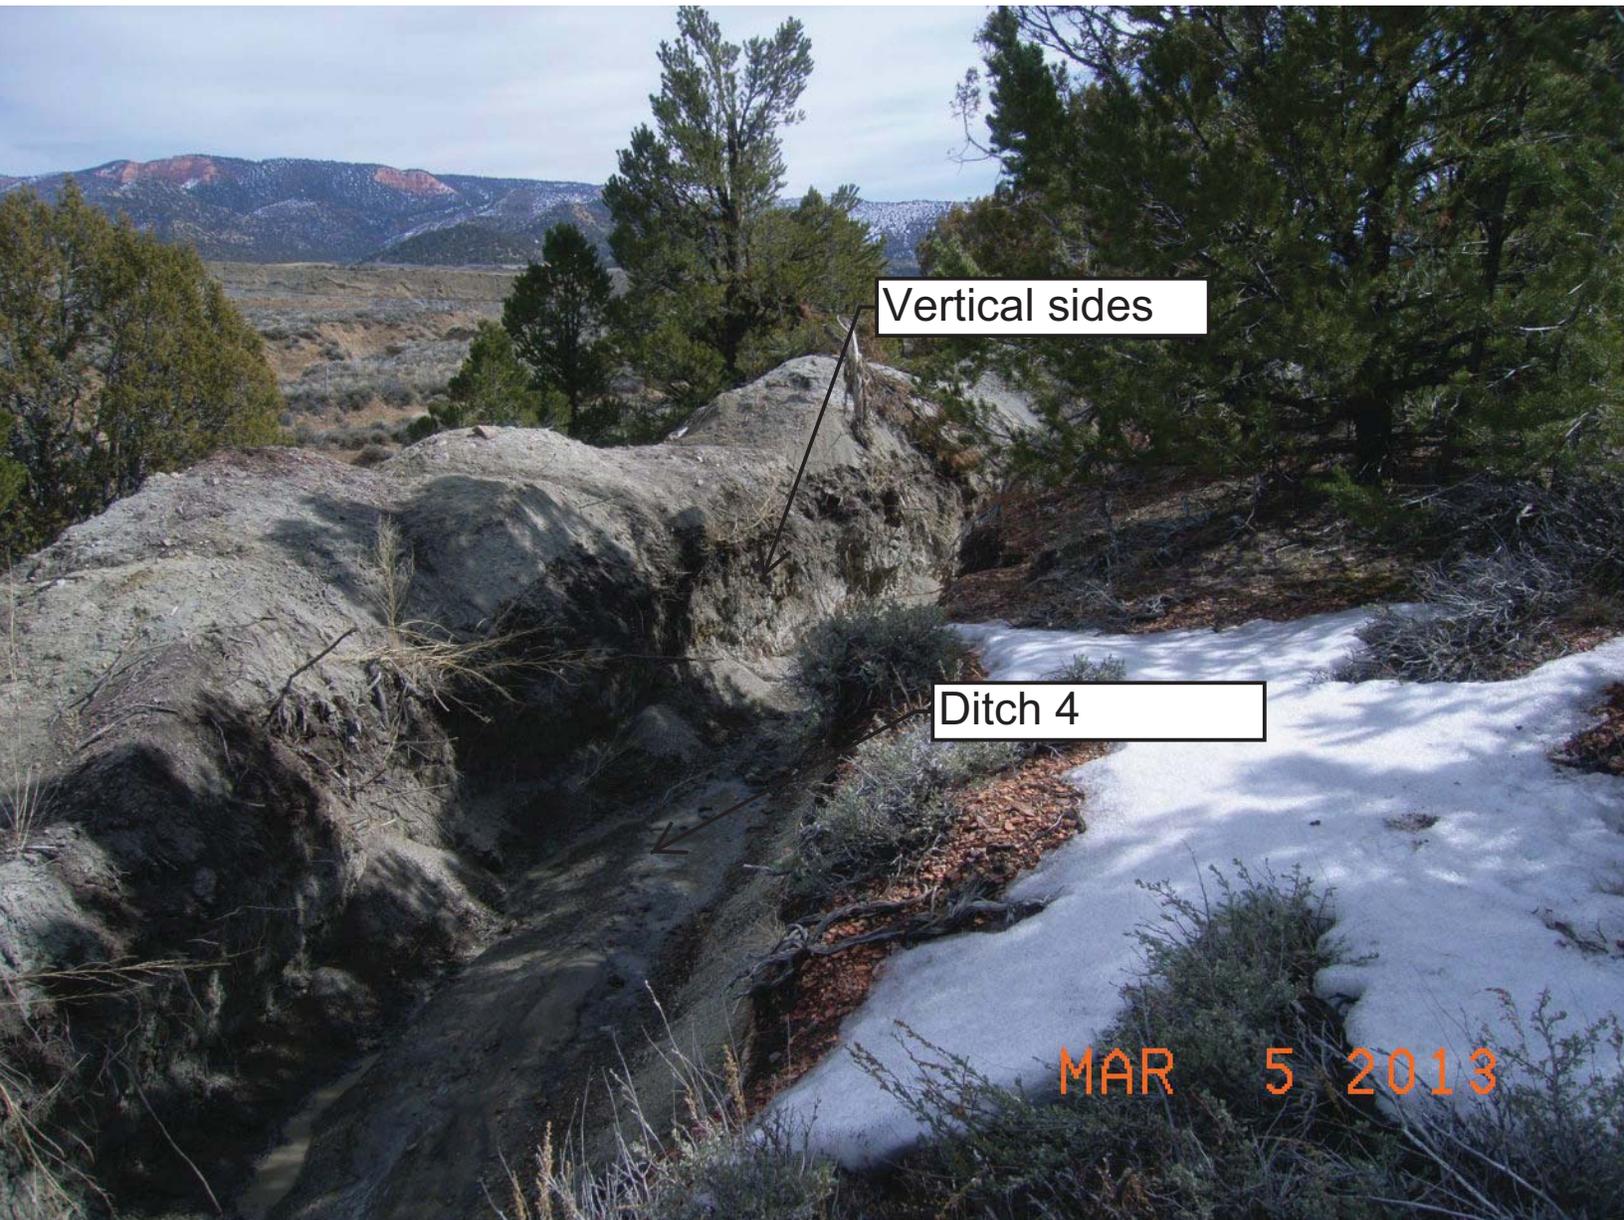
Ditch 4

Vertical sides

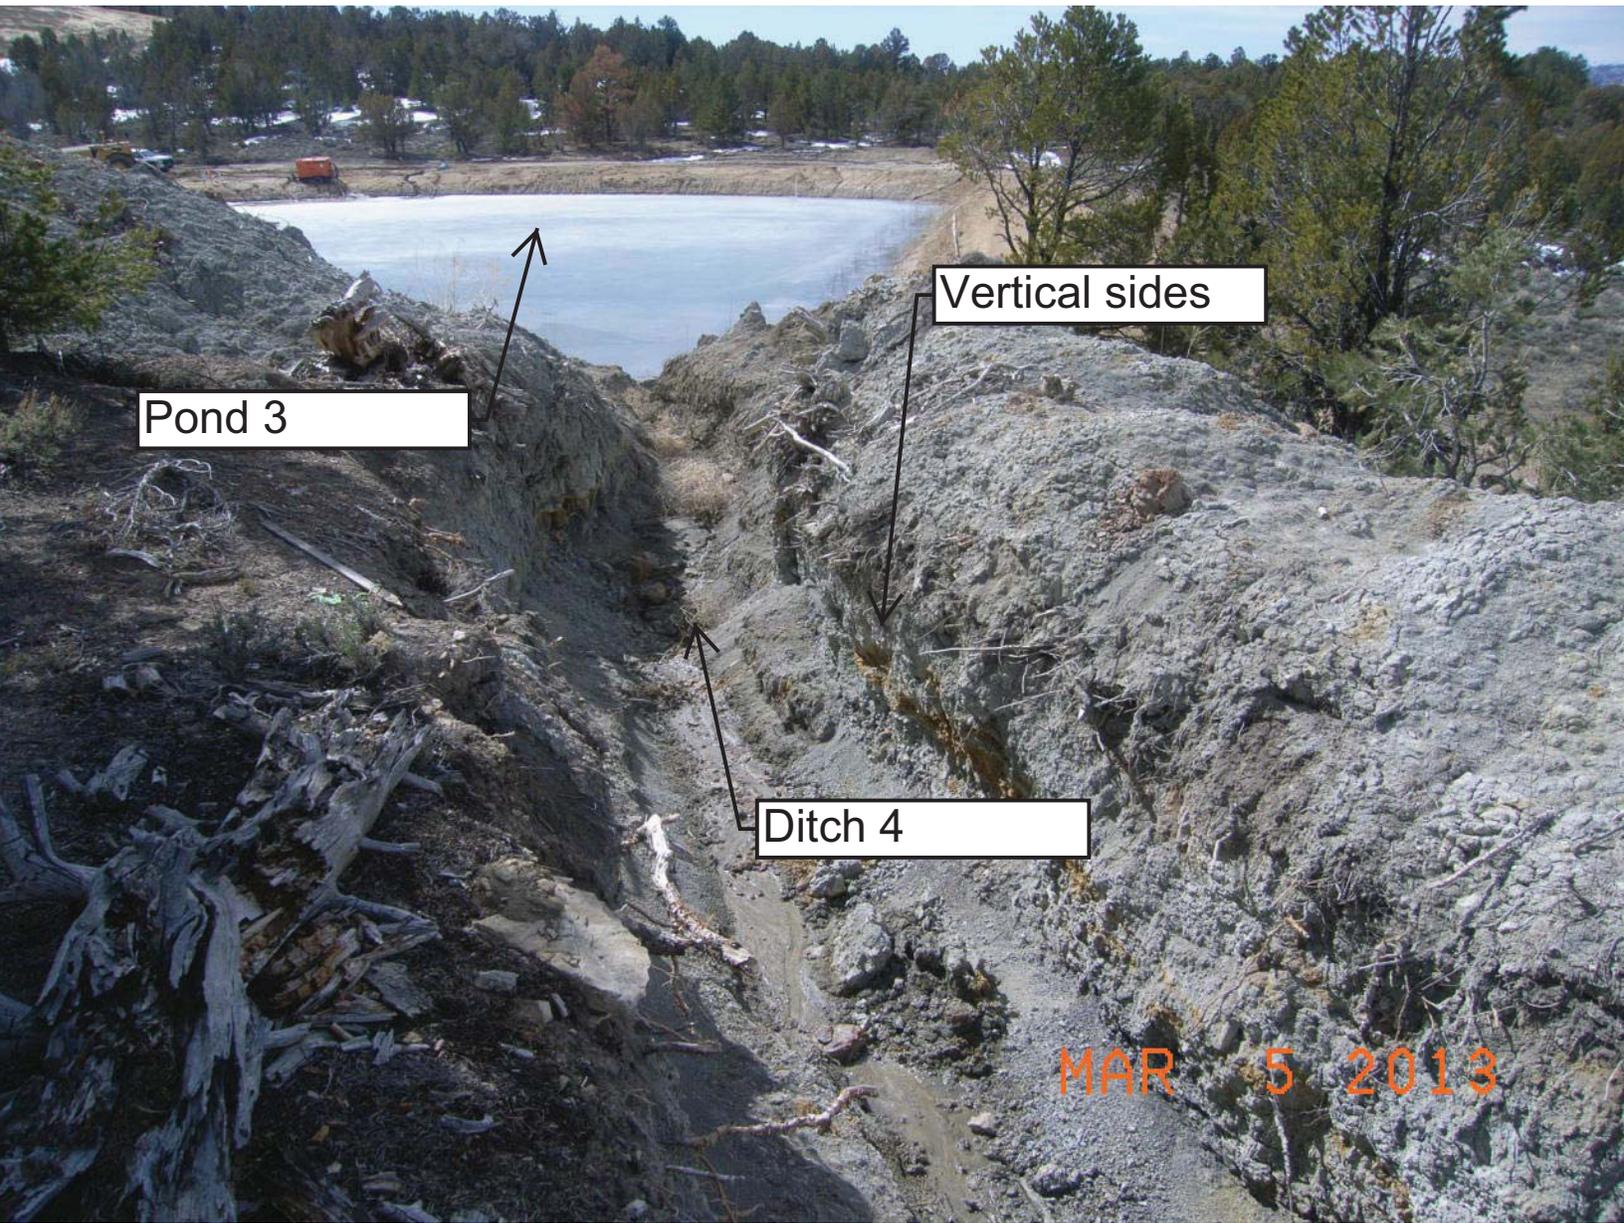
Ditch 4

Vertical sides
