# State of Utah

Division of Oil, Gas and Mining

## Inspection Report

Permittee: **ALTON COAL DEVELOPMENT LLC**  
 Operator: **ALTON COAL DEVELOPMENT LLC**  
 Site: **COAL HOLLOW**  
 Address: **463 North 100 West, Suite 1, CEDAR CITY UT 84720**  
 County: **KANE**  
 Permit Type: **PERMANENT COAL PROGRAM**  
 Permit Status: **ACTIVE**

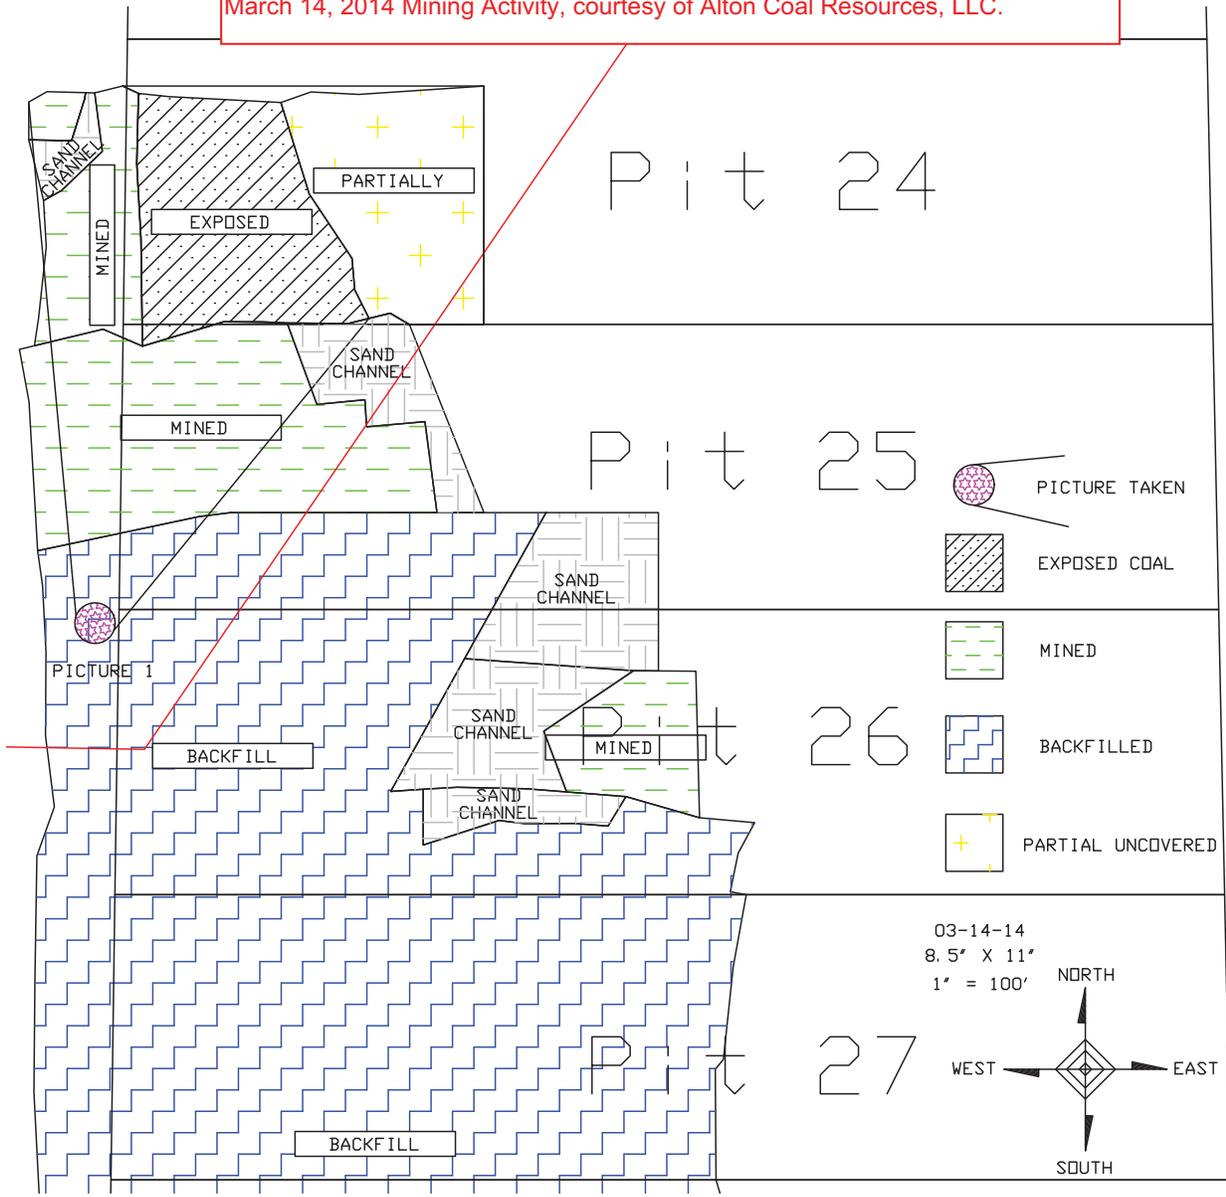
March 14, 2014 Mining Activity, courtesy of Alton Coal Resources, LLC.

Water encountered during pit development has resulted in truncated pits at the southern end of the permit area. A figure showing the progress of mining during the week ending 3/14/14 is attached to this inspection report.

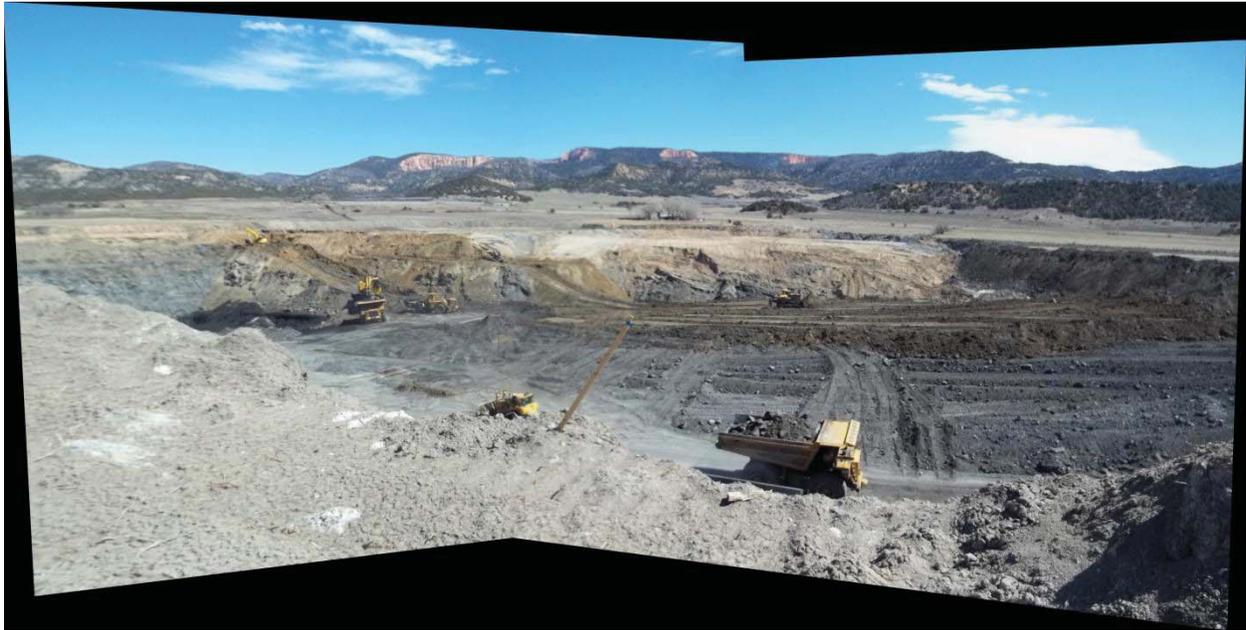
Pits 25 and 26 are being backfilled using a hoe and dozer from pit 24. Three of four truckloads of overburden from pit 24 are being long-hauled to pit 6. The fourth truckload is being unloaded at the edge of pit 26. Violation #10135 was issued February 5, 2014 and abatement was extended until April 17, 2014 for pit 6 to be brought to AOC. About half of the pit 6 void is filled at this time. Daily backfilling volumes must be increased to pit 6 if the April 17, 2014 deadline is to be met.

Looking east at Pits 24, 25, & 26. Picture location is the same as that shown on the weekly mine figure for 3/14/14.

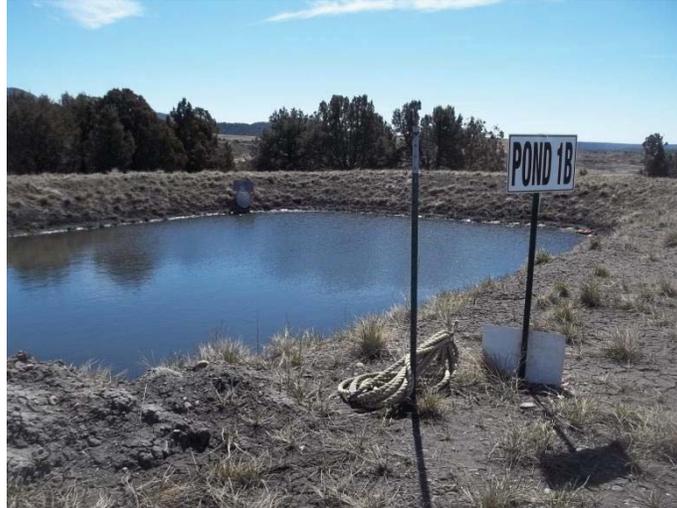
Pond 1B

All ponds were photographed. Sediment pond #1 was drained for scheduled sediment clean out. The inlet to sediment pond 2 needs to be cleaned out to direct flow to the pond and away from an excavated low area near pond 2 where water has been accumulating. Refer to Dwg. 5-3 for pond locations.

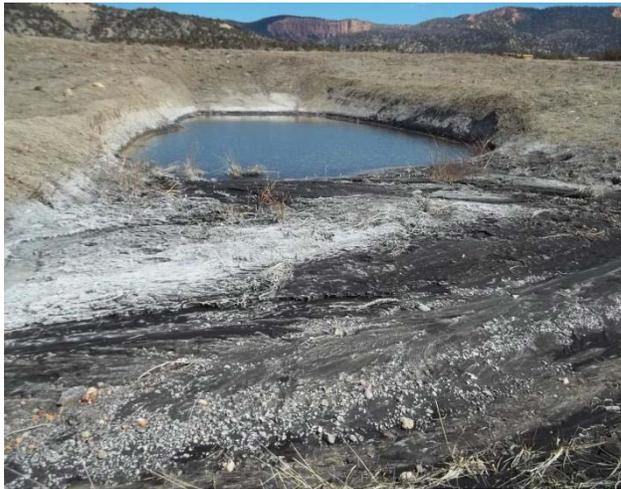
Depression to be filled near Pond 2.

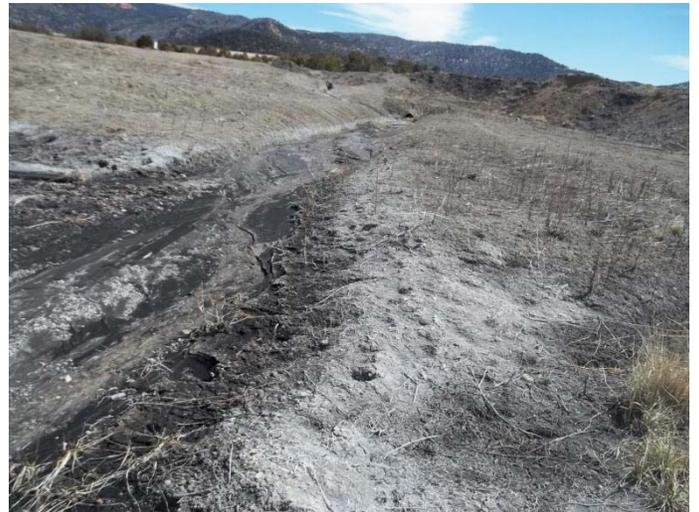
Inlet to pond 2 scheduled for maintenance

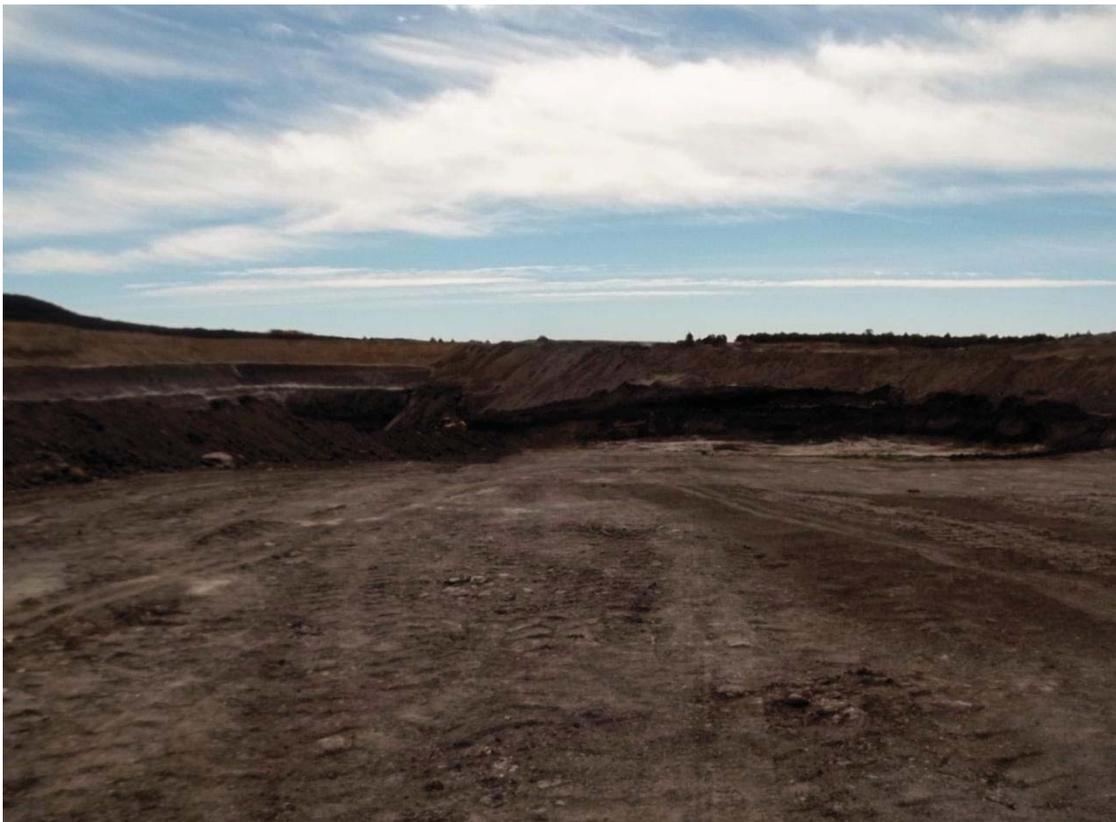
Looking south at construction of an access ramp down into Pit 9 for auger mining

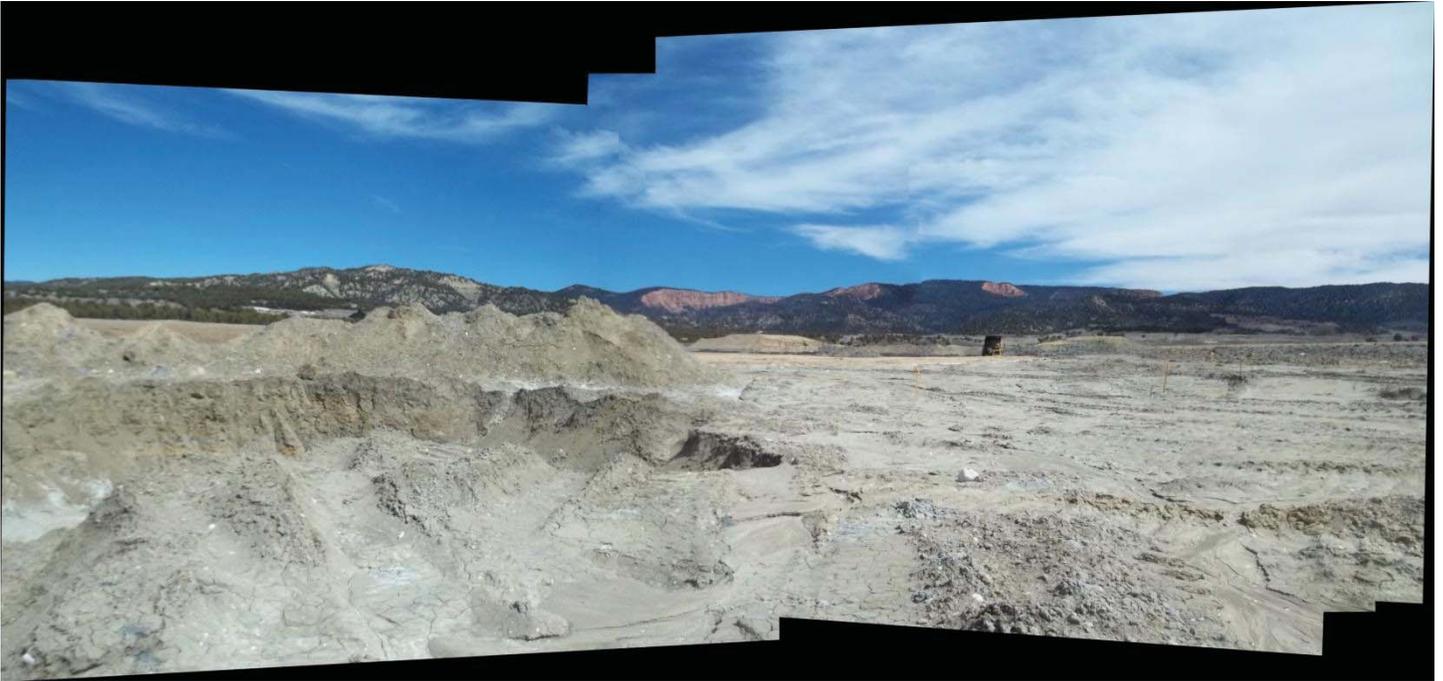
Pit 27 and 28 have been backfilled and brought to AOC. A subsoil pile adjacent to pit 28 will be spread out over the area prior to topsoiling. The meanders for the re-construction of Robinson Creek were surveyed and staked, but construction was discontinued to allow the fill to dry out.

Looking northeast at backfilled Pit #3 and Pit #5 with Robinson Creek reconstruction beginning. Note survey stakes for creek barely visible in the distance on the right.

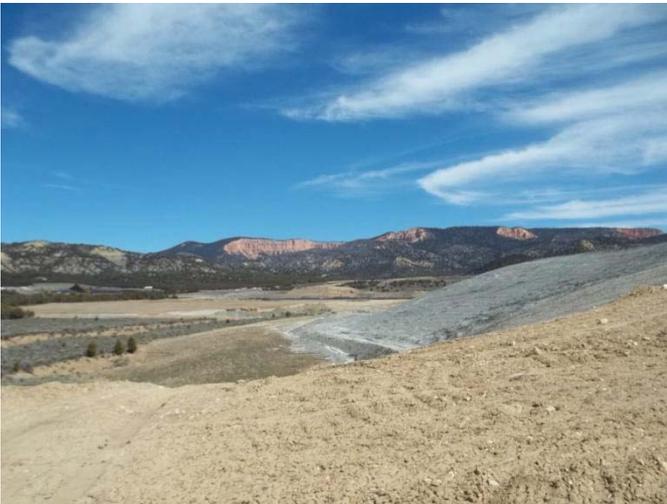
The December 2013 spoil pile inspection notes that 17 acres of the spoil pile were seeded in 2013 and 22 more acres were graded. A significant rill on the north side of the spoil pile was treated with excelsior logs and should be watched. Future grading of the subsoil and topsoil on the pile must be on the contour to avoid rilling.

View NE of graded spoil pile, topsoiled in foreground and subsoiled only in background. Ditch #4 at base of pile.

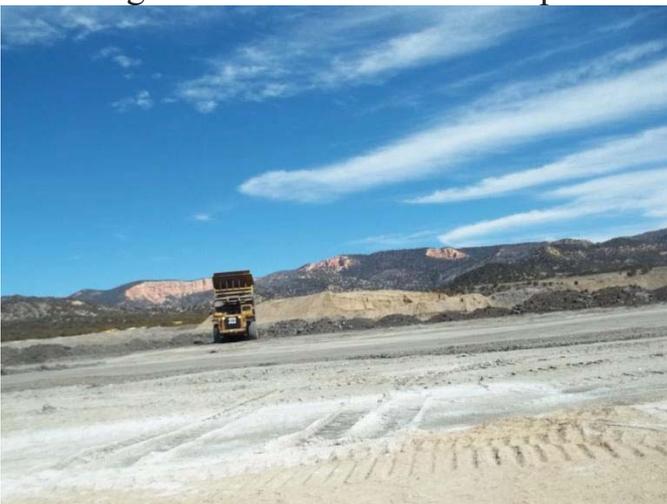
Backfilling Pit #6. Pit # 5 in foreground. Subsoil pile #2 in background.
