Inspection Report

Permit Number:	C0250005
Inspection Type:	PARTIAL
Inspection Date:	Wednesday, April 23, 2014
Start Date/Time:	4/23/2014 8:30:00 AM
End Date/Time:	4/23/2014 2:00:00 PM
Last Inspection:	Tuesday, March 18, 2014

Permittee: **ALTON COAL DEVELOPMENT LLC**

Site: **COAL HOLLOW**

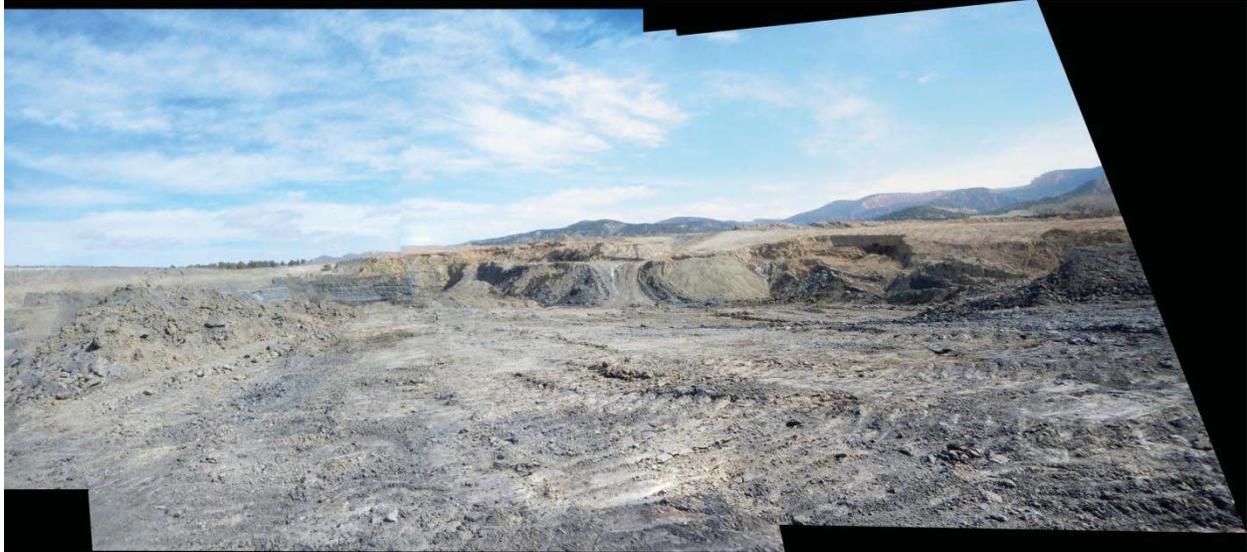
Pit 23 in background. Pit 26 in foreground.

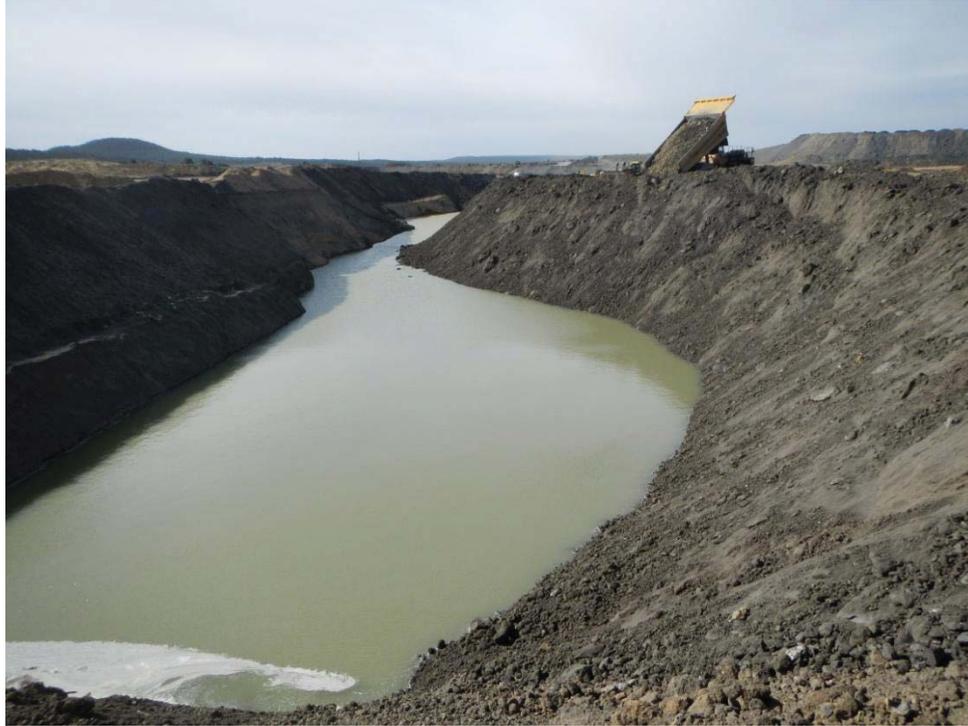
Backfilling of Pit 6 from Pit 22 overburden was ongoing.

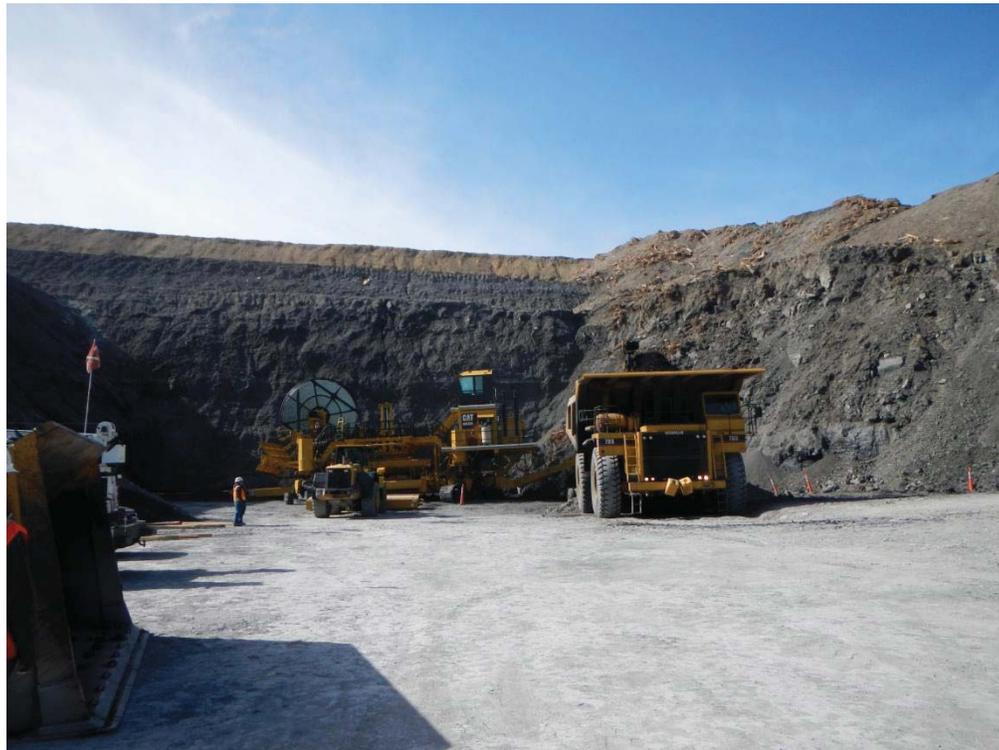
Coal conveyed to truck by auger mining in Pit 9.

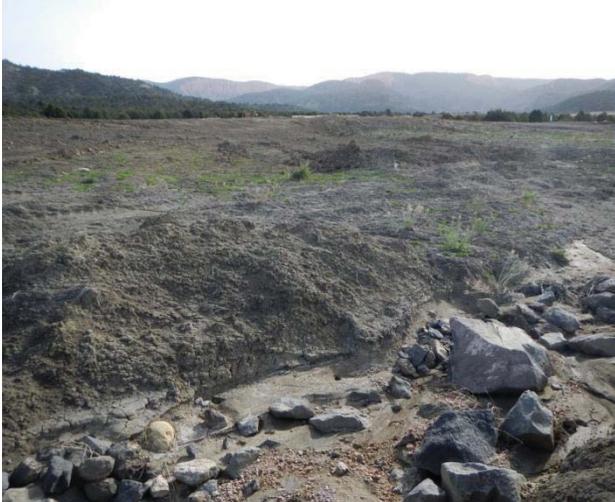
Maintenance is required on the ditch and inlet to pond 2 (Dwg 5-34 for design). The recent grading work on the slope adjacent to Pond 2 will be seeded with an interim mix to control erosion at the site. Kirk Nichols indicated that he wants to clean out the fan of sediment deposition in the inlet location inside Pond 2. Although the sediment level in Pond 2 is well below the 60% clean-out level, the deposition of sediment in the inlet area of the pond is fairly large.

Graded area near Pond #2 and inlet to Pond #2.

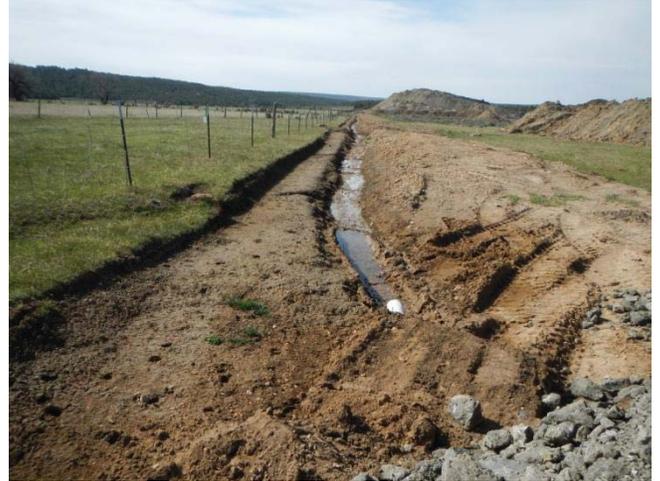
Looking south at Ditch 1 from Dame's access road. Subsoil in distance. Topsoil far right.

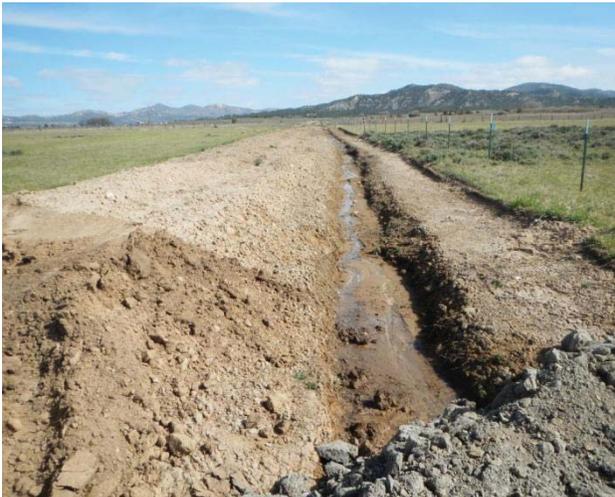
Looking north at Ditch 1 from Dame's access road.

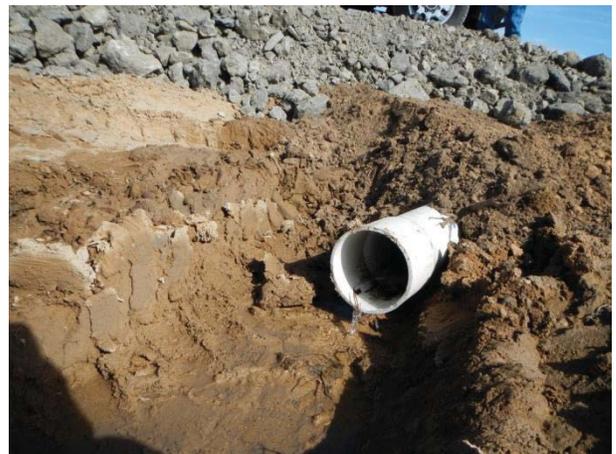
Ditch 4 to Pond 3 was dry (see Dwg 5-34 for ditch design). Ditch 4 appeared stable. No evidence of cutting or erosion was observed during the inspection. At the access to Dame property, undisturbed ditch 1 was flowing at about 1 - 2 gal/min. Refer to Dwg 7-15 for road access location and Dwg 5-33 for as-built ditch design. Both Ditch 4 and Ditch 1 were completed in 2013. Ditch 1 berm was seeded in July 2013.

Flow in diversion Ditch 1.

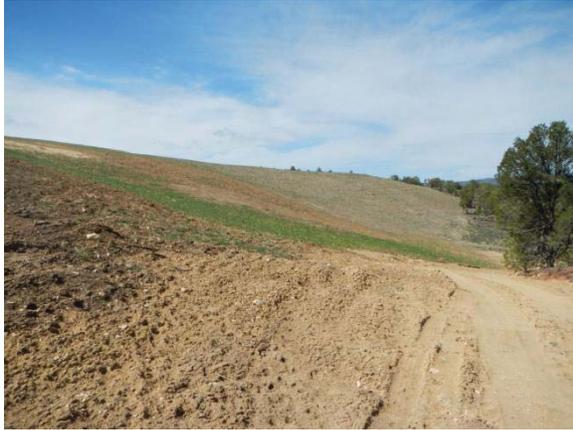
2012 Reclamation looking SW at the NW end of spoil pile

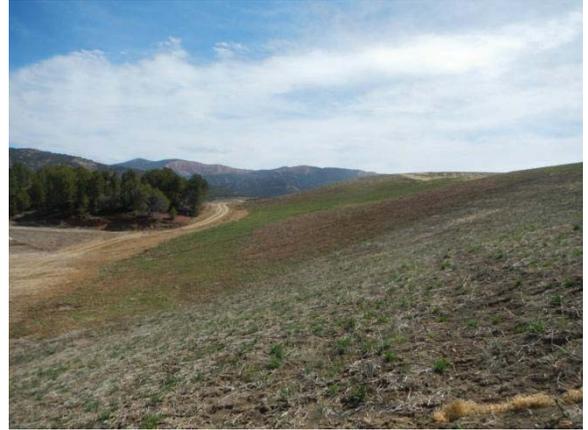
Looking north at the same section of 2012 reclamation as at left.

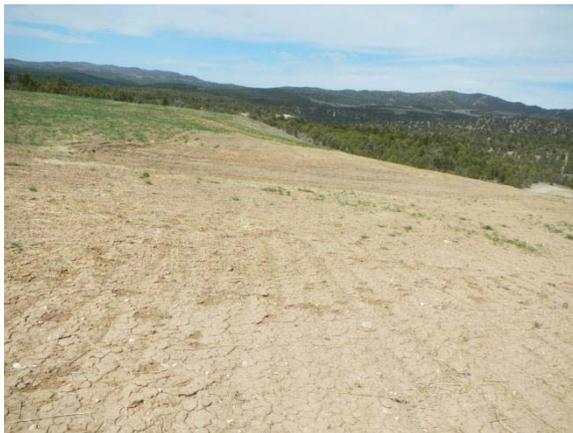
2013 reclamation looking east at reclamation on west side spoil pile.

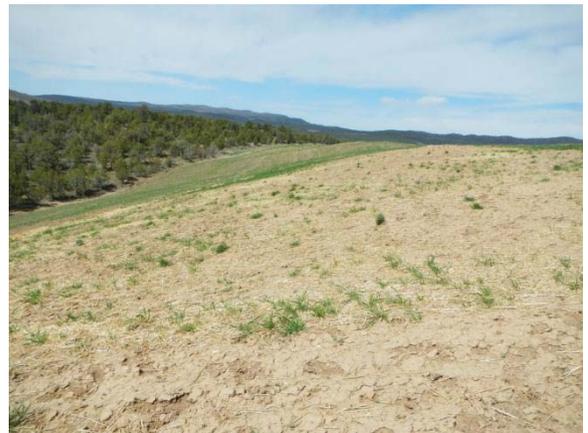
Looking west at same section of reclamation. (2013 reclamation is in the background.)

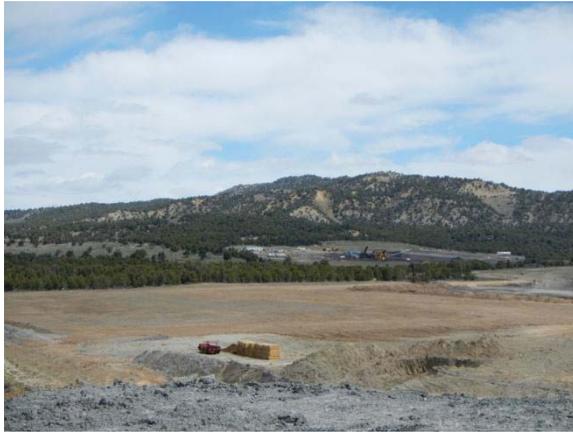
2013 reclamation near lower Robinson Creek

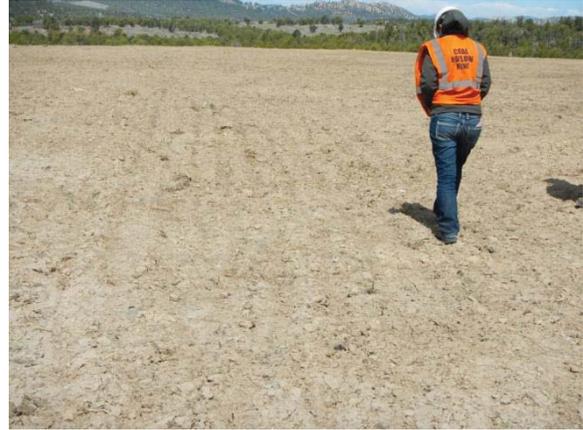
Small sprigs are emerging.

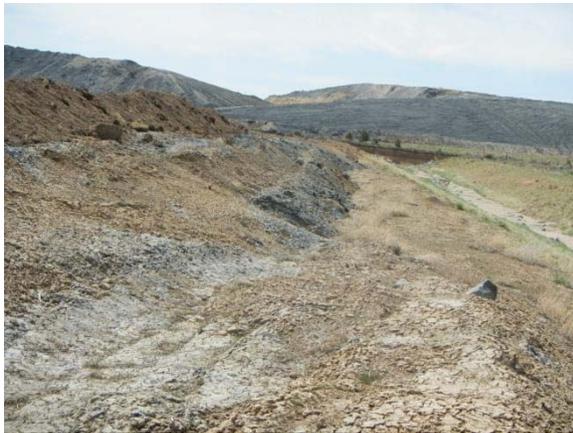
Topsoil berm along Lower Robinson Creek diversion to be used or spread out in 2014 reclamation.

Reclamation completed in 2013 was photographed. A small area along the surface of the spoil pile should be reworked to remove equipment tracks. Then it should be mulched and seeded this year. The topsoil berm left along the lower Robinson Creek diversion should be smoothed out or used in the 2014 reclamation of adjacent area.

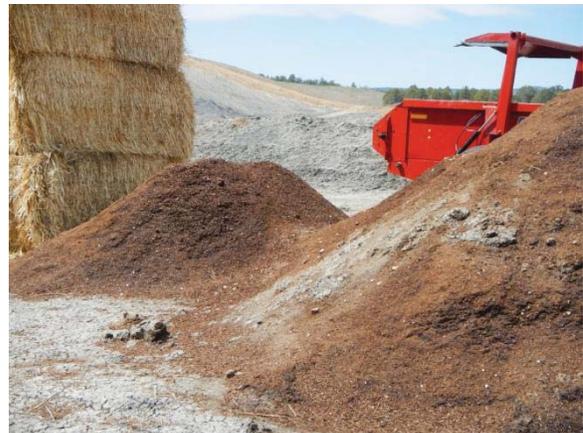
Turkey manure mulch and straw bales used in 2013 reclamation.

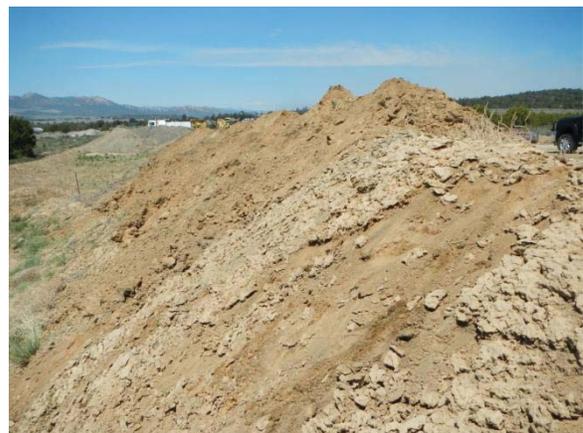
Loose soil in berm needs compaction.

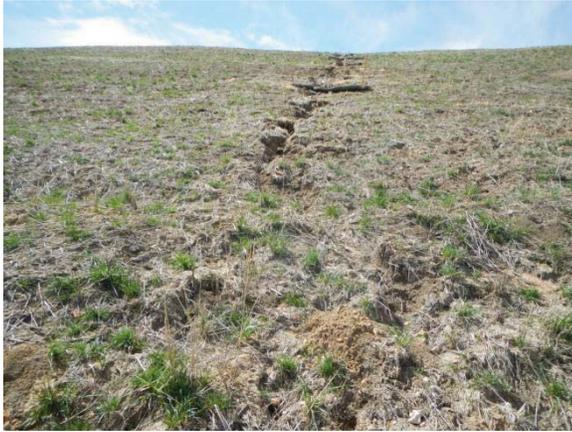
Rill in 2013 reclamation

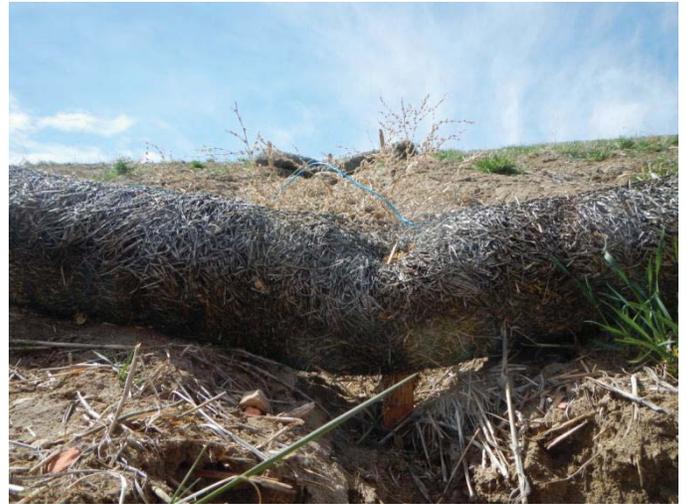
Excelsior logs need to be set into ground.

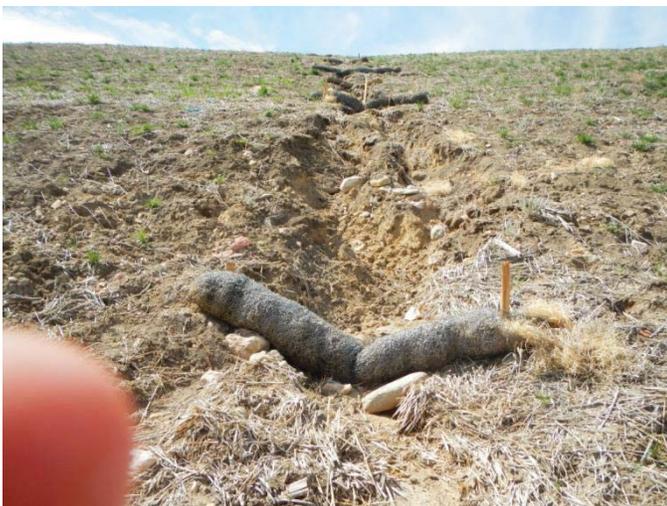
Rill needs attention.

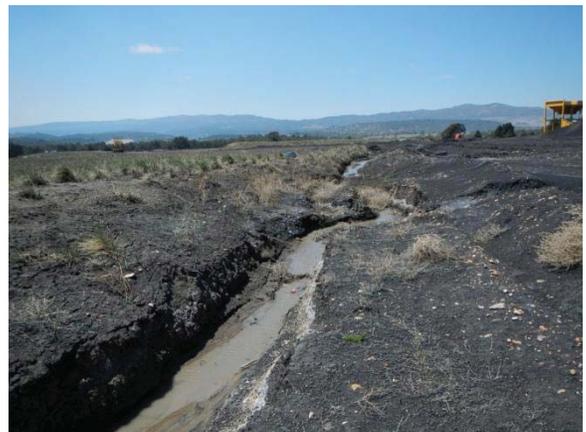
Overflowing water storage tanks are sending a large amount of water through culvert 7 along a ditch that flows to Pond 1A (see Dwg 5-3A). The storage tank water valve should be repaired ASAP and flow along this ditch should be watched because it is downcutting the ditch and creating a meanders in the ditch.

Ditch carrying overflow to Pond 1 in coal yard.

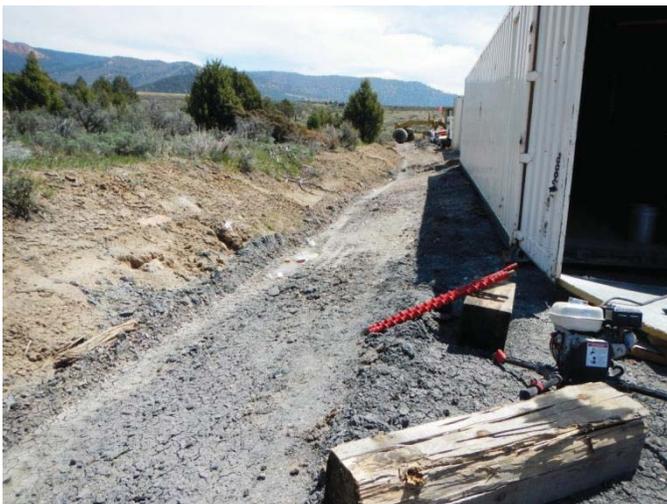
A disturbed area boundary sign is needed along the berm on the Lower Robinson Creek side of the road in the location of the storage yard.

Berm to control flow from storage yard is necessary.

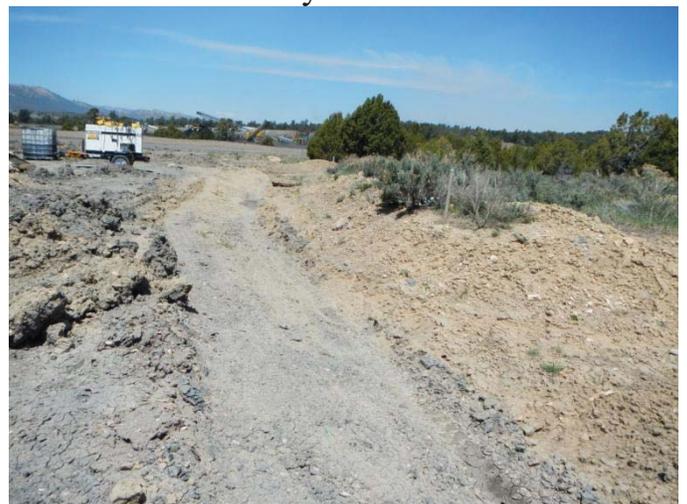
Topsoil access road berm requires maintenance on the north side of the road, upper section and on the south side above culvert 10. In addition, the berm running behind the storage units along the north side of the topsoil access road needs maintenance to prevent encroachment of mining activity into the undisturbed area and to separate the undisturbed and disturbed drainage. See Dwg 5-23 for berm design along this road.

Berm necessary to keep undisturbed and disturbed drainage separate.
