# Inspection Report

Permit Number:	C0250005
Inspection Type:	COMPLETE OVERSITE
Inspection Date:	Thursday, June 12, 2014
Start Date/Time:	6/12/2014 8:30:00 AM
End Date/Time:	6/12/2014 2:45:00 PM
Last Inspection:	Tuesday, May 06, 2014

Permittee: **ALTON COAL DEVELOPMENT LLC**

Site: **COAL HOLLOW**

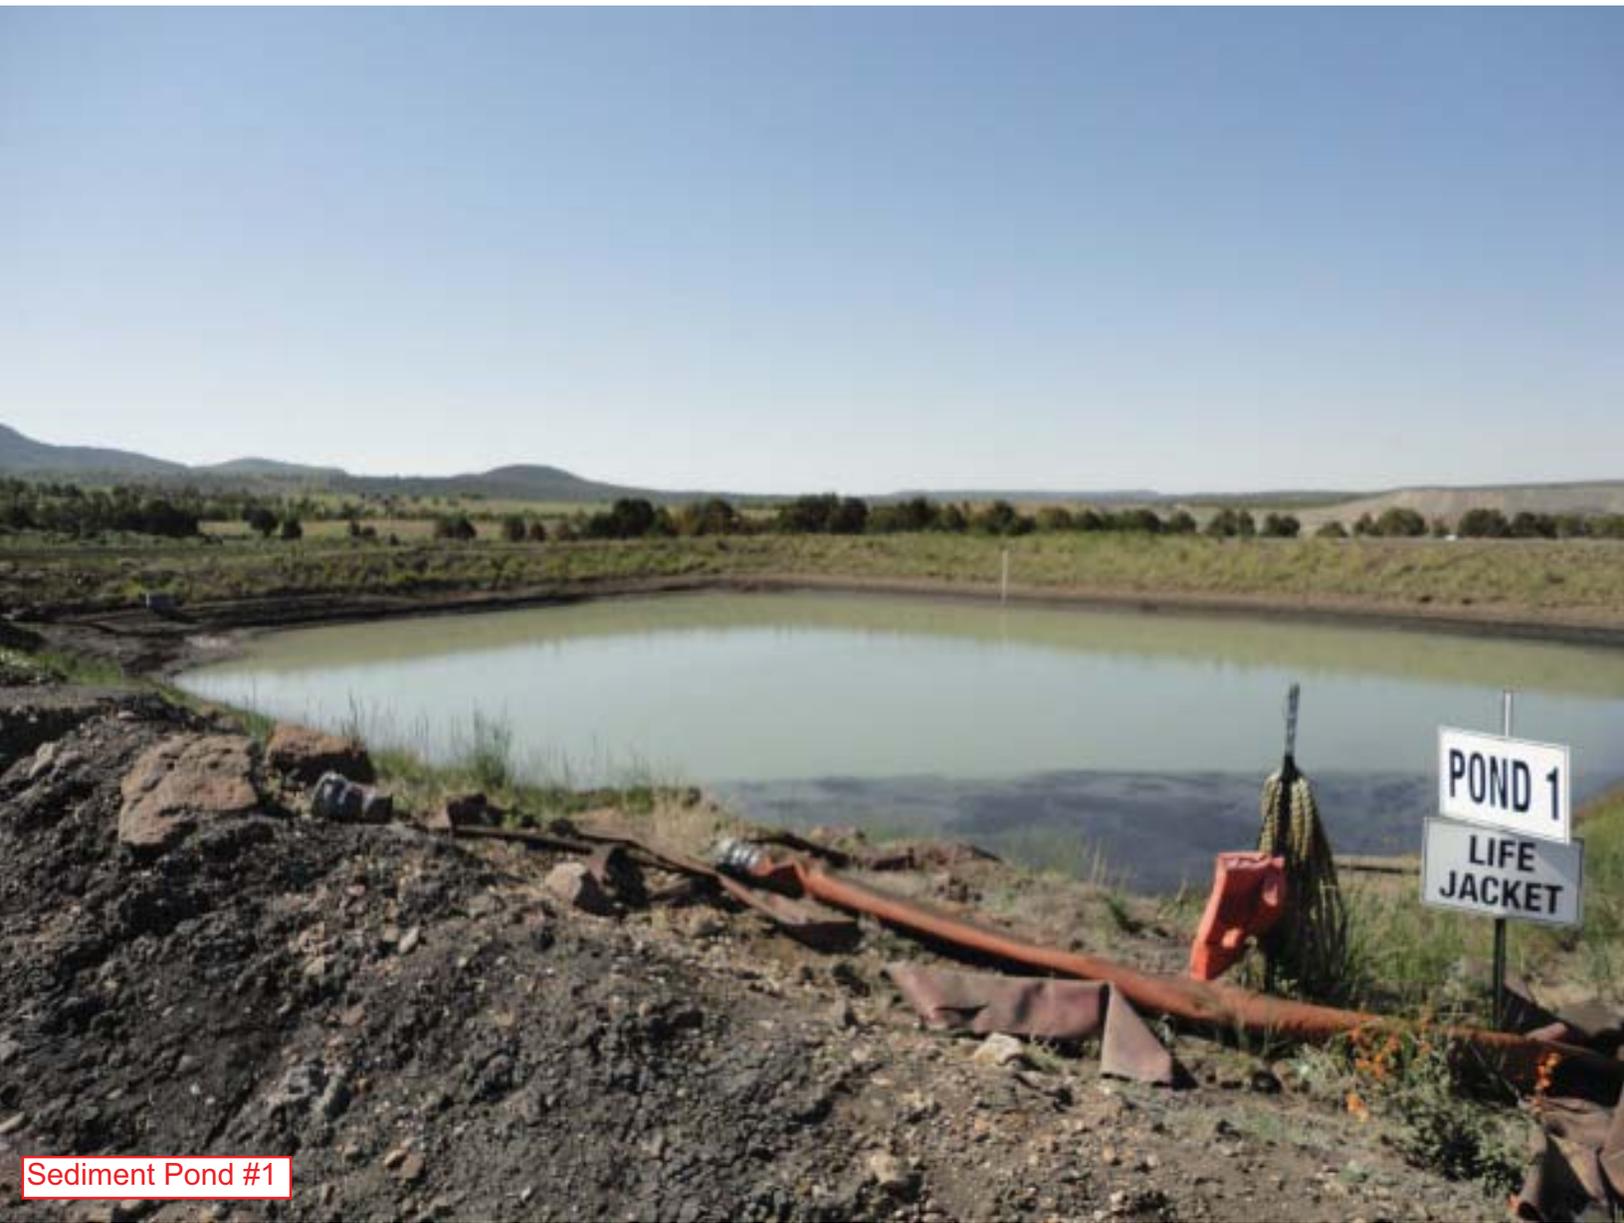
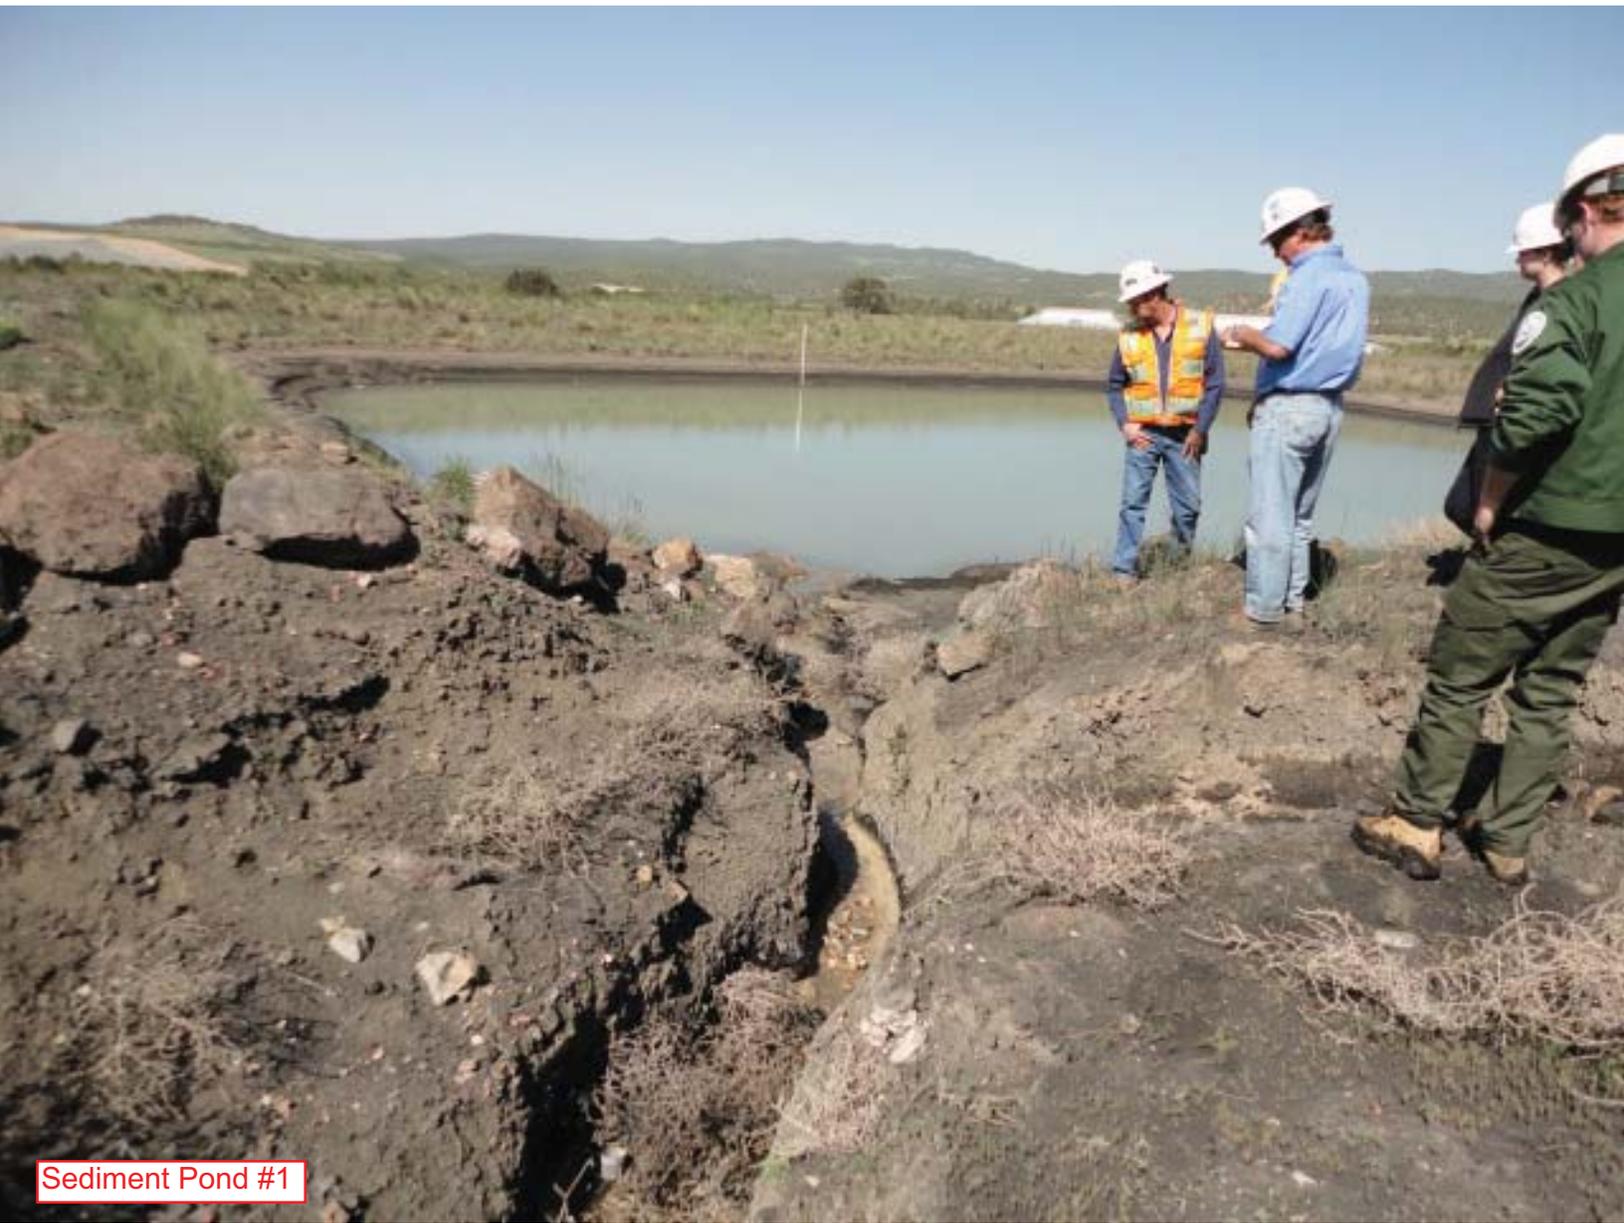
Sediment Pond #1

Three items of concern and future follow up were identified: 1) The inlet to Pond 1 is showing signs of erosion/cutting. Kirk Nichols indicated that maintenance would be conducted and the inlet potentially rip rapped/armored. If the approved MRP does not contain a rip-rap detail for Pond 1, a revision to the MRP (as-built) will be required. 2) The culvert that runs under the main haul road in ditch 2 needs to be cleaned. 3) The diversion ditch to Pond 3 requires maintenance. OSM personnel noted that a 2:1 slope in the channel was not evident in sections of the diversion and needed to be maintained. OSM personnel also noted a convex deposition of sediment in the channel that needed to be removed. Subsequent DOGM inspections will verify that the work/maintenance has been conducted.

Work is needed on the East inlet into pond #1.

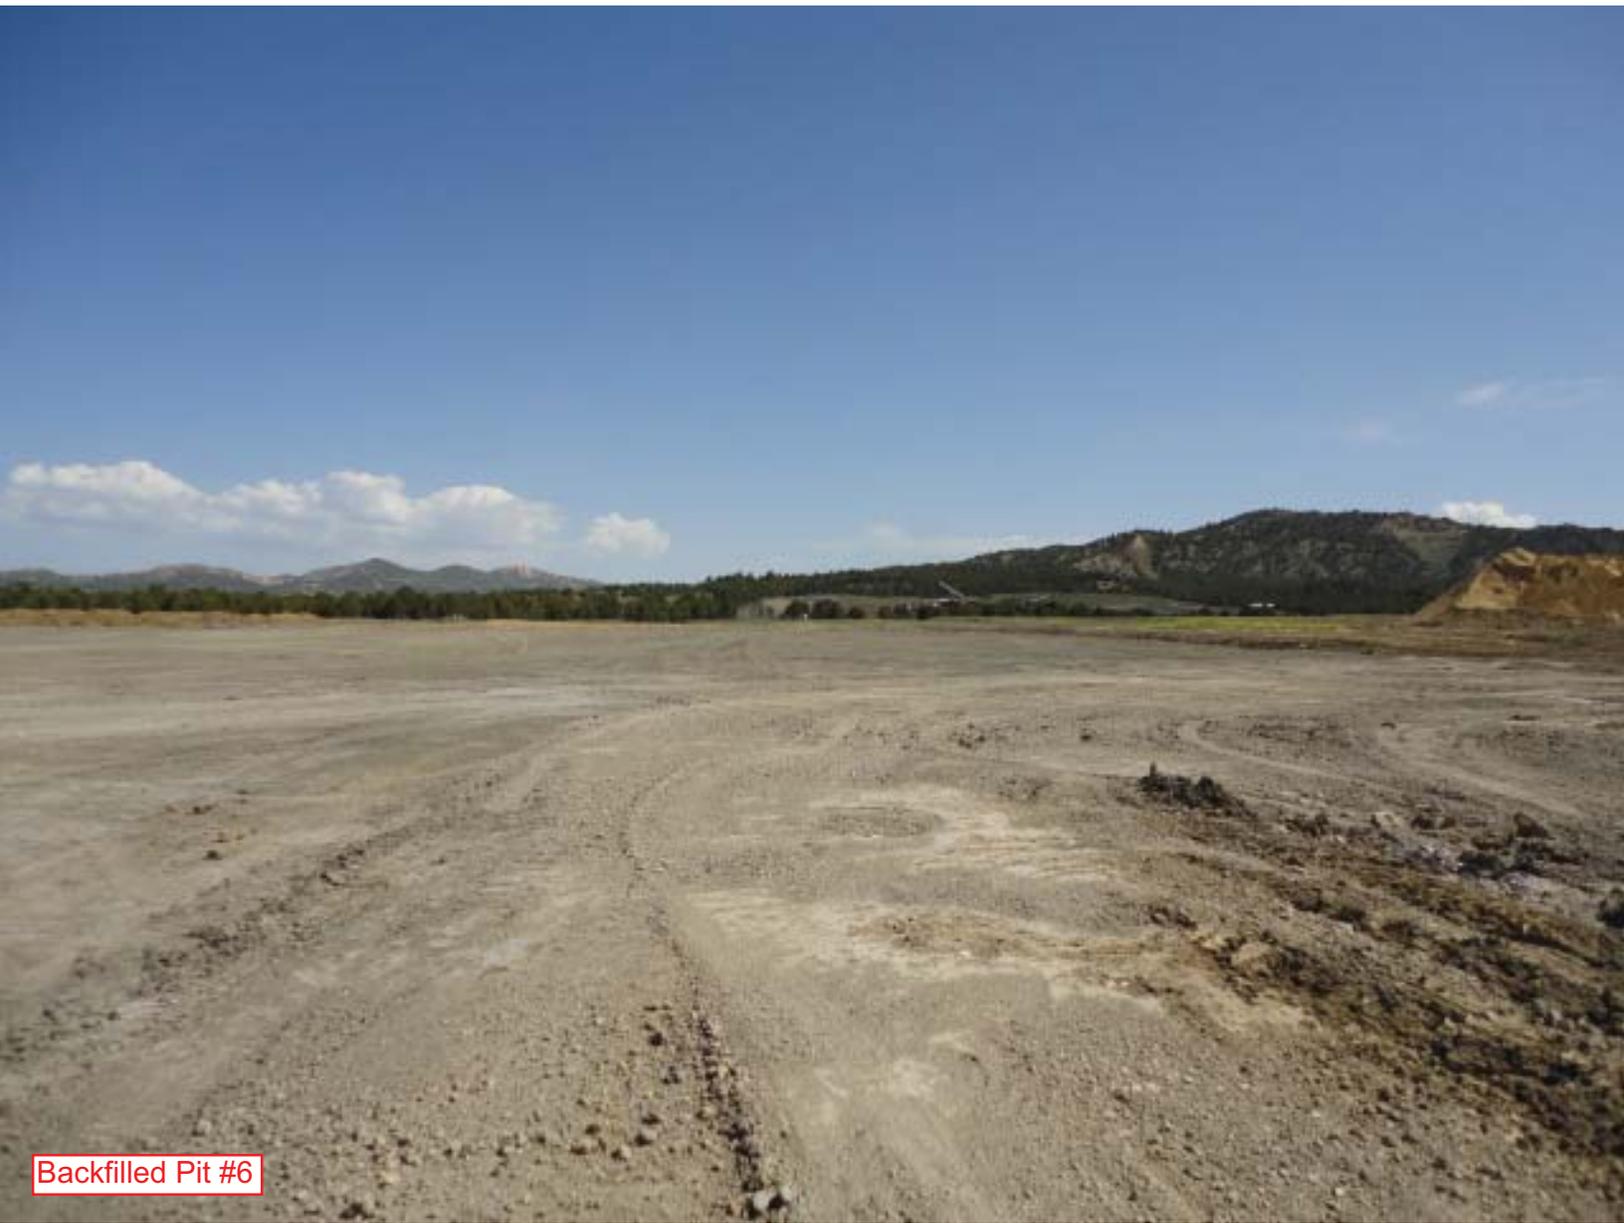
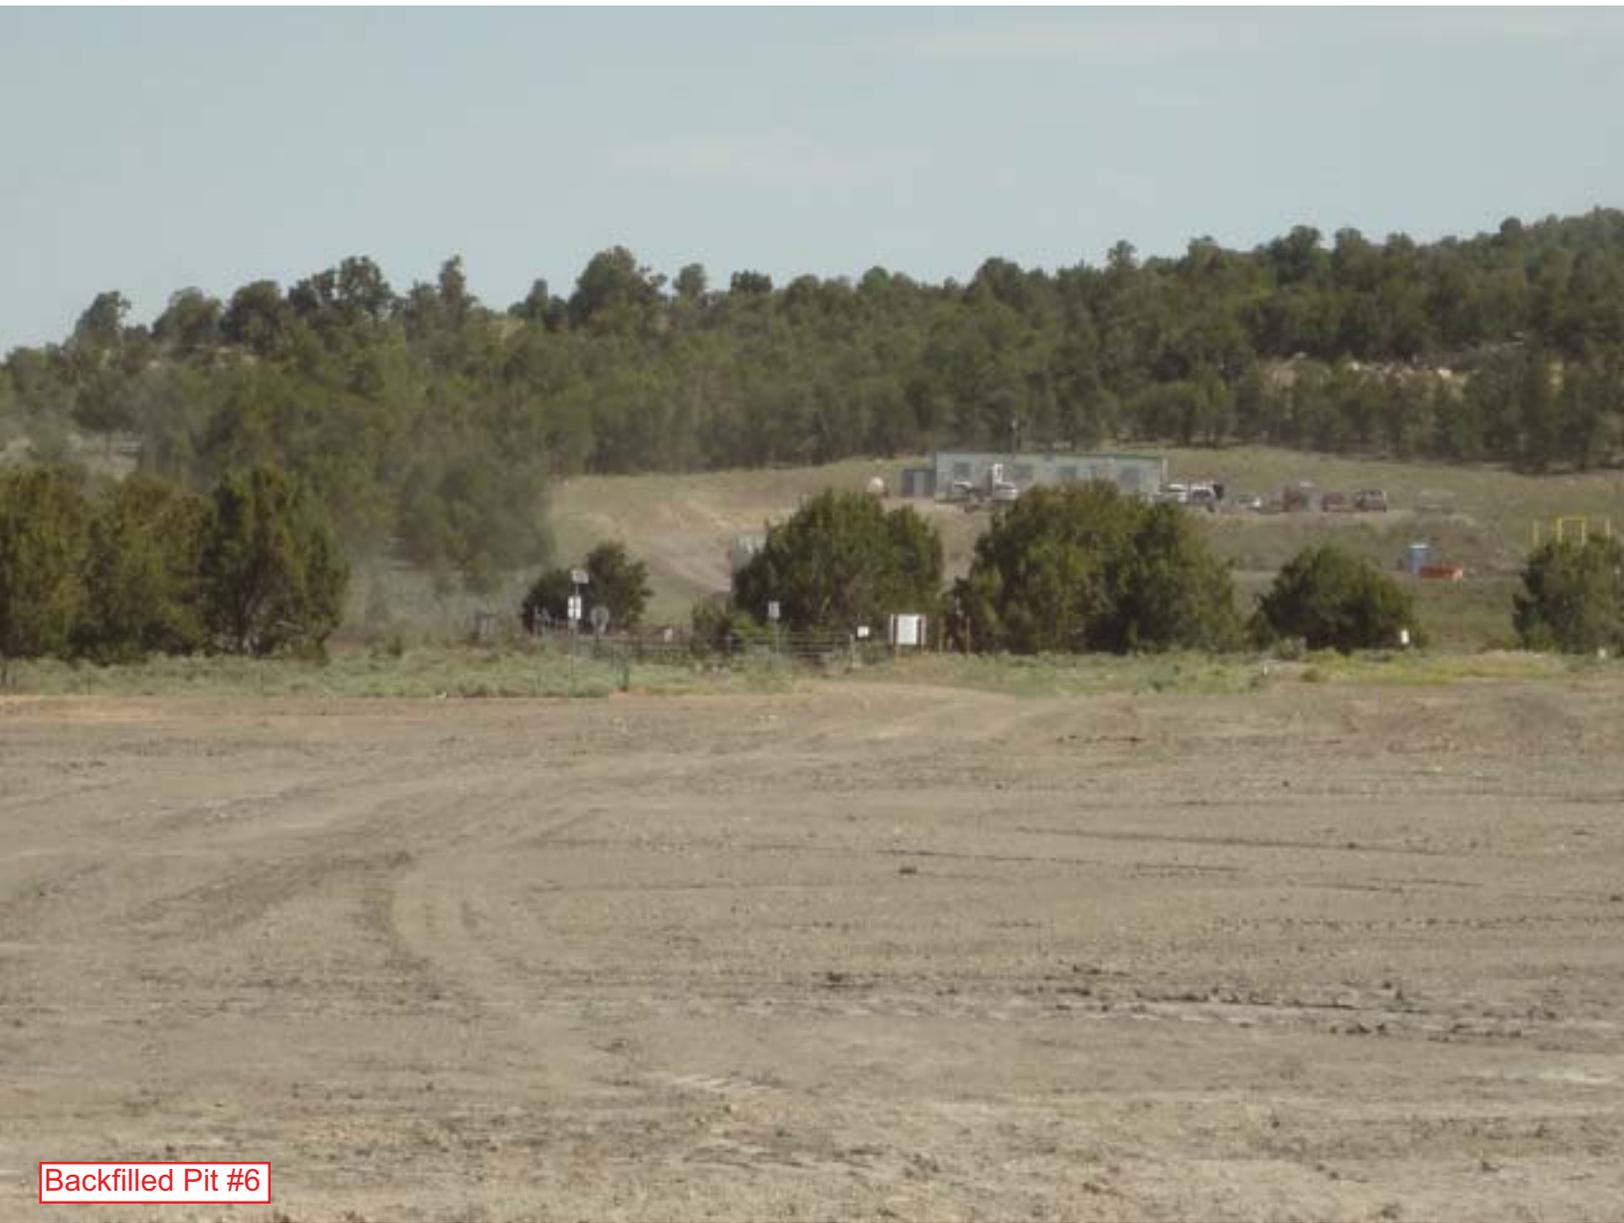
Backfilled Pit #6

Pit #6 is completely backfilled. Kirk Nichols indicated that the pit was completely filled on June 3, 2014. The last extension on NOV 10135 issued by Division Director John Baza was June 16, 2014. The violation can now be terminated.

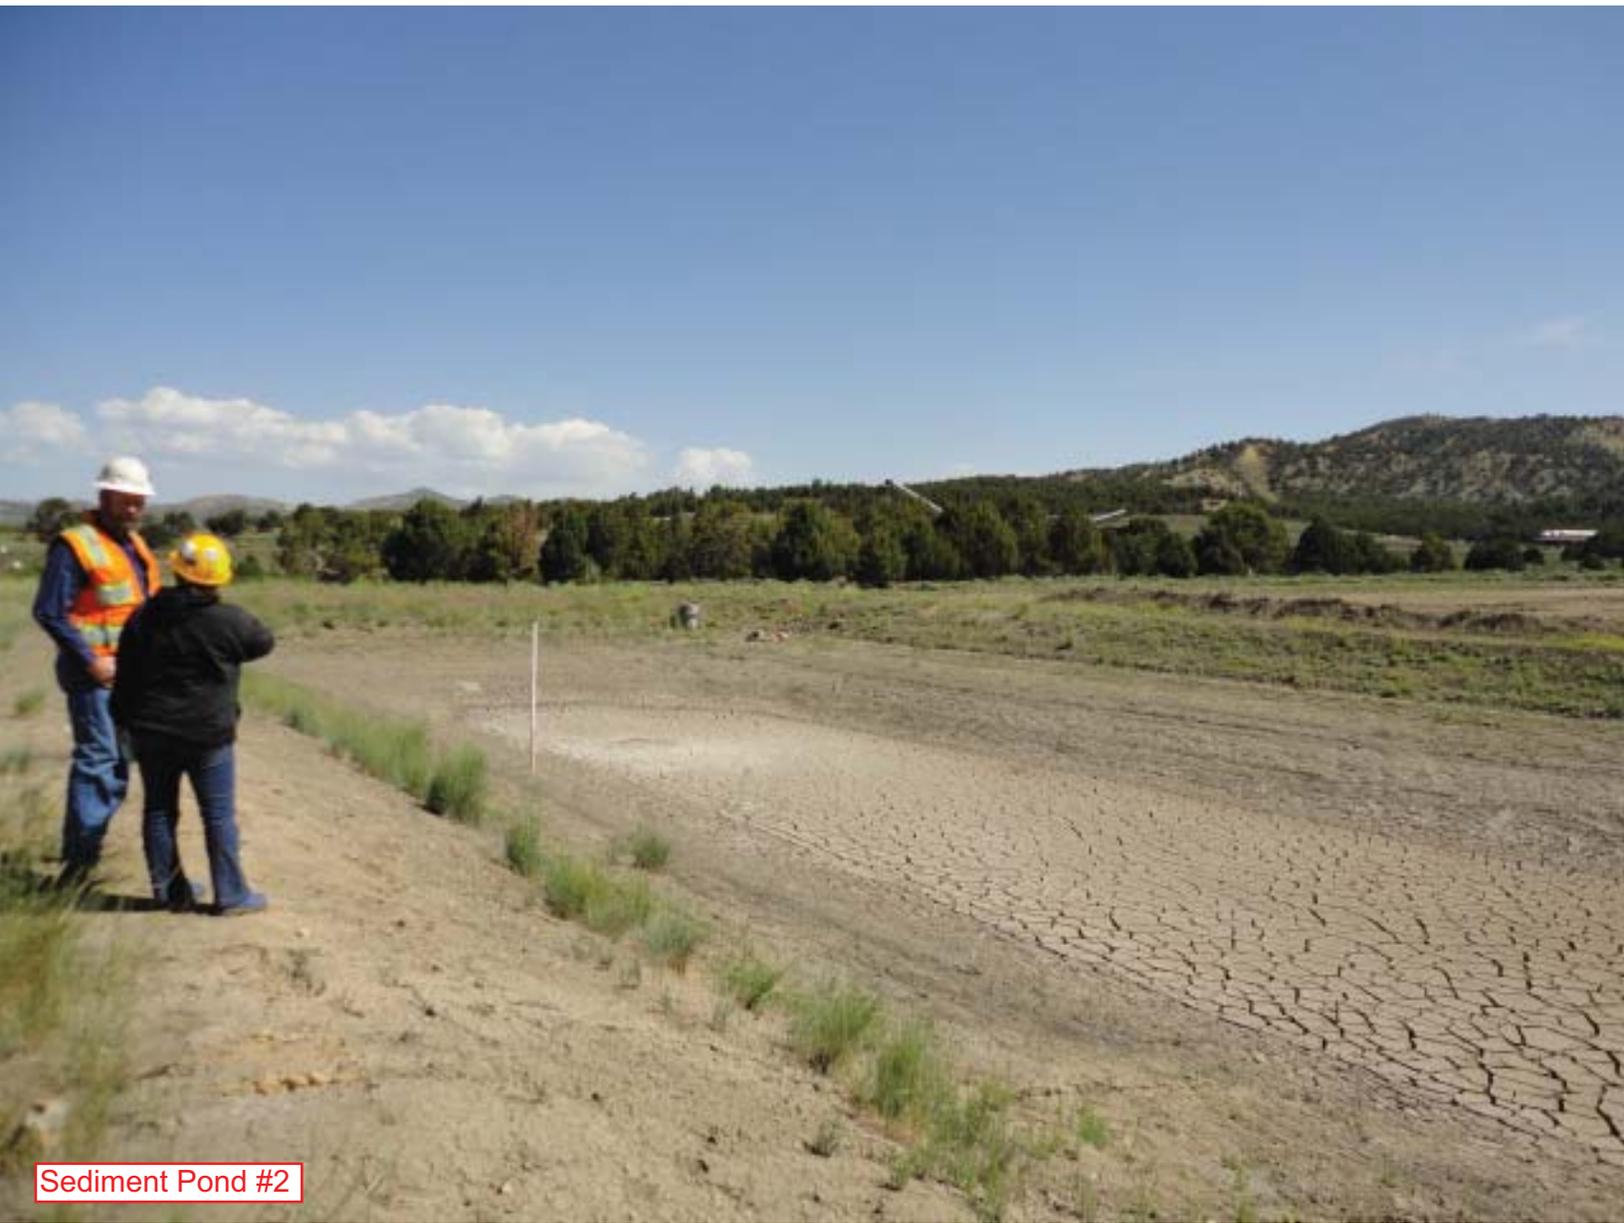
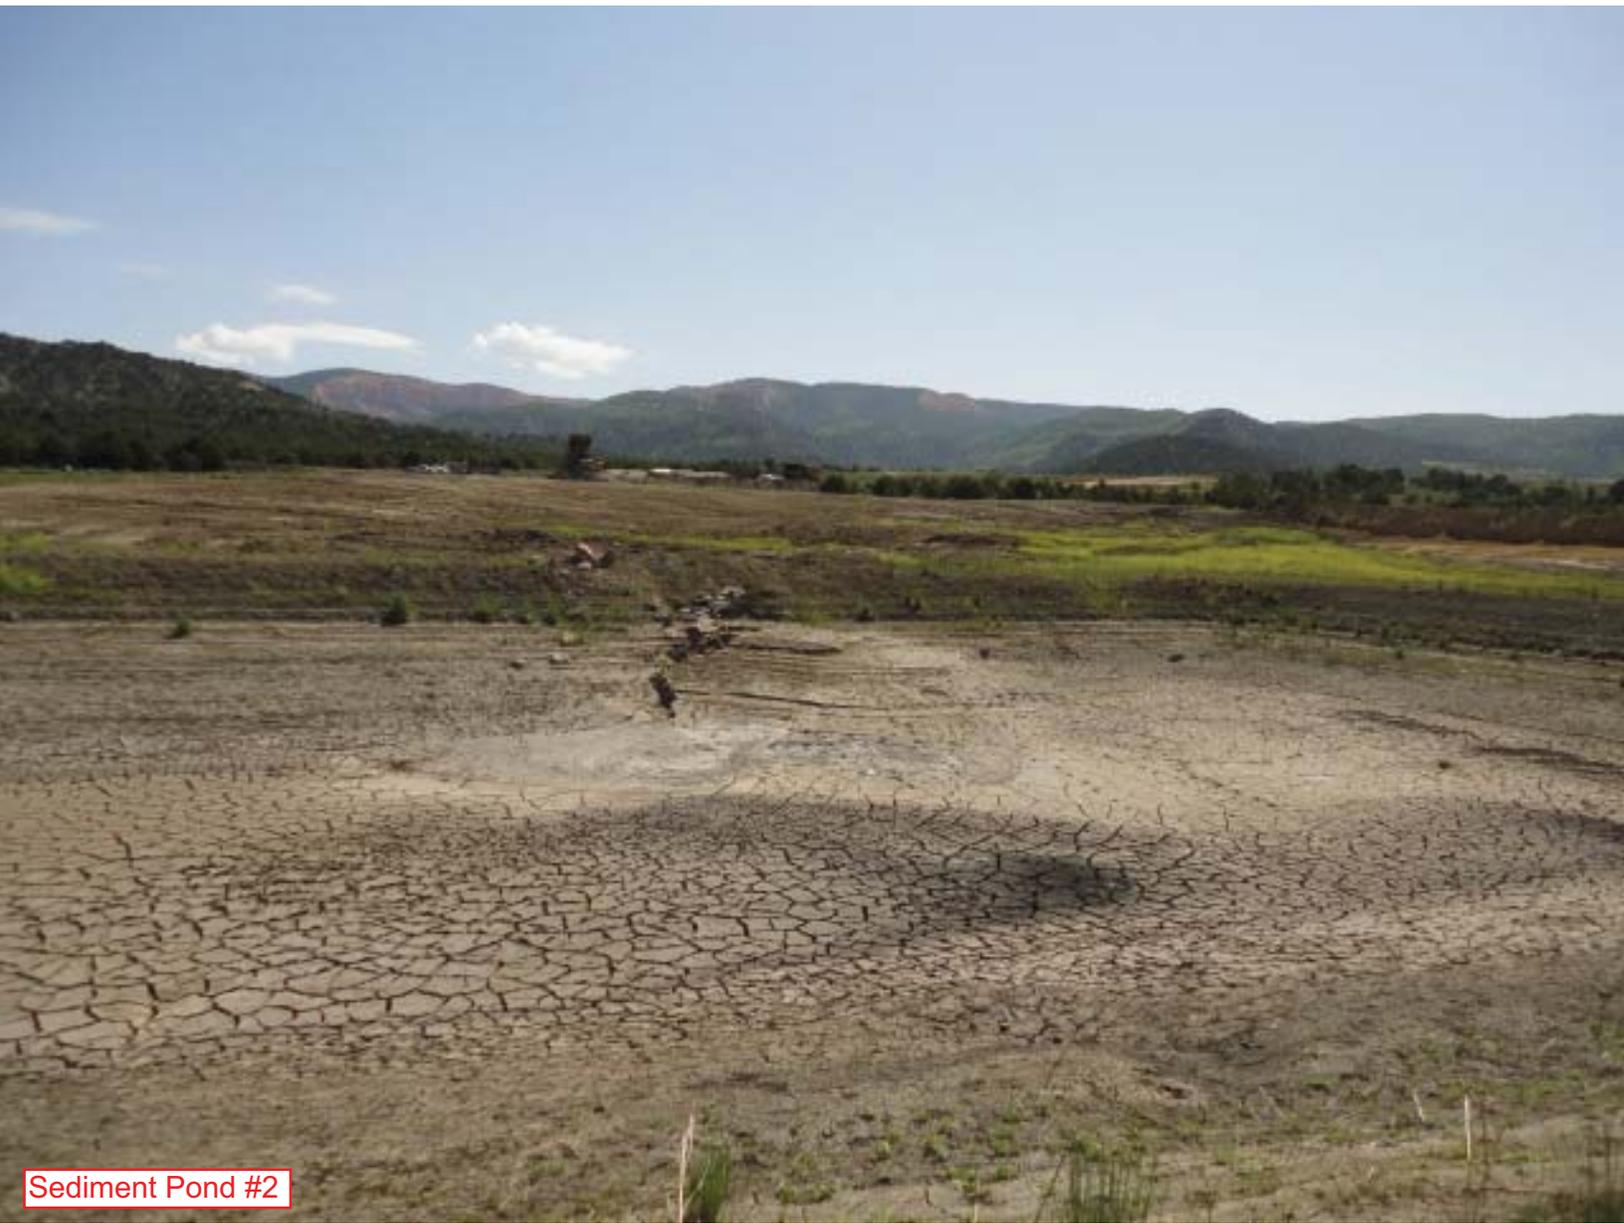
Sediment Pond #2

The culvert that directs flow under the mine haul road leading to Pond #2 needs maintenance. The sediment level is nearing the half capacity level.

Pictures of all the sediment ponds was taken during the inspection. Pond #2 is dry the other ponds 1, 1B, 3 and 4 contained water.

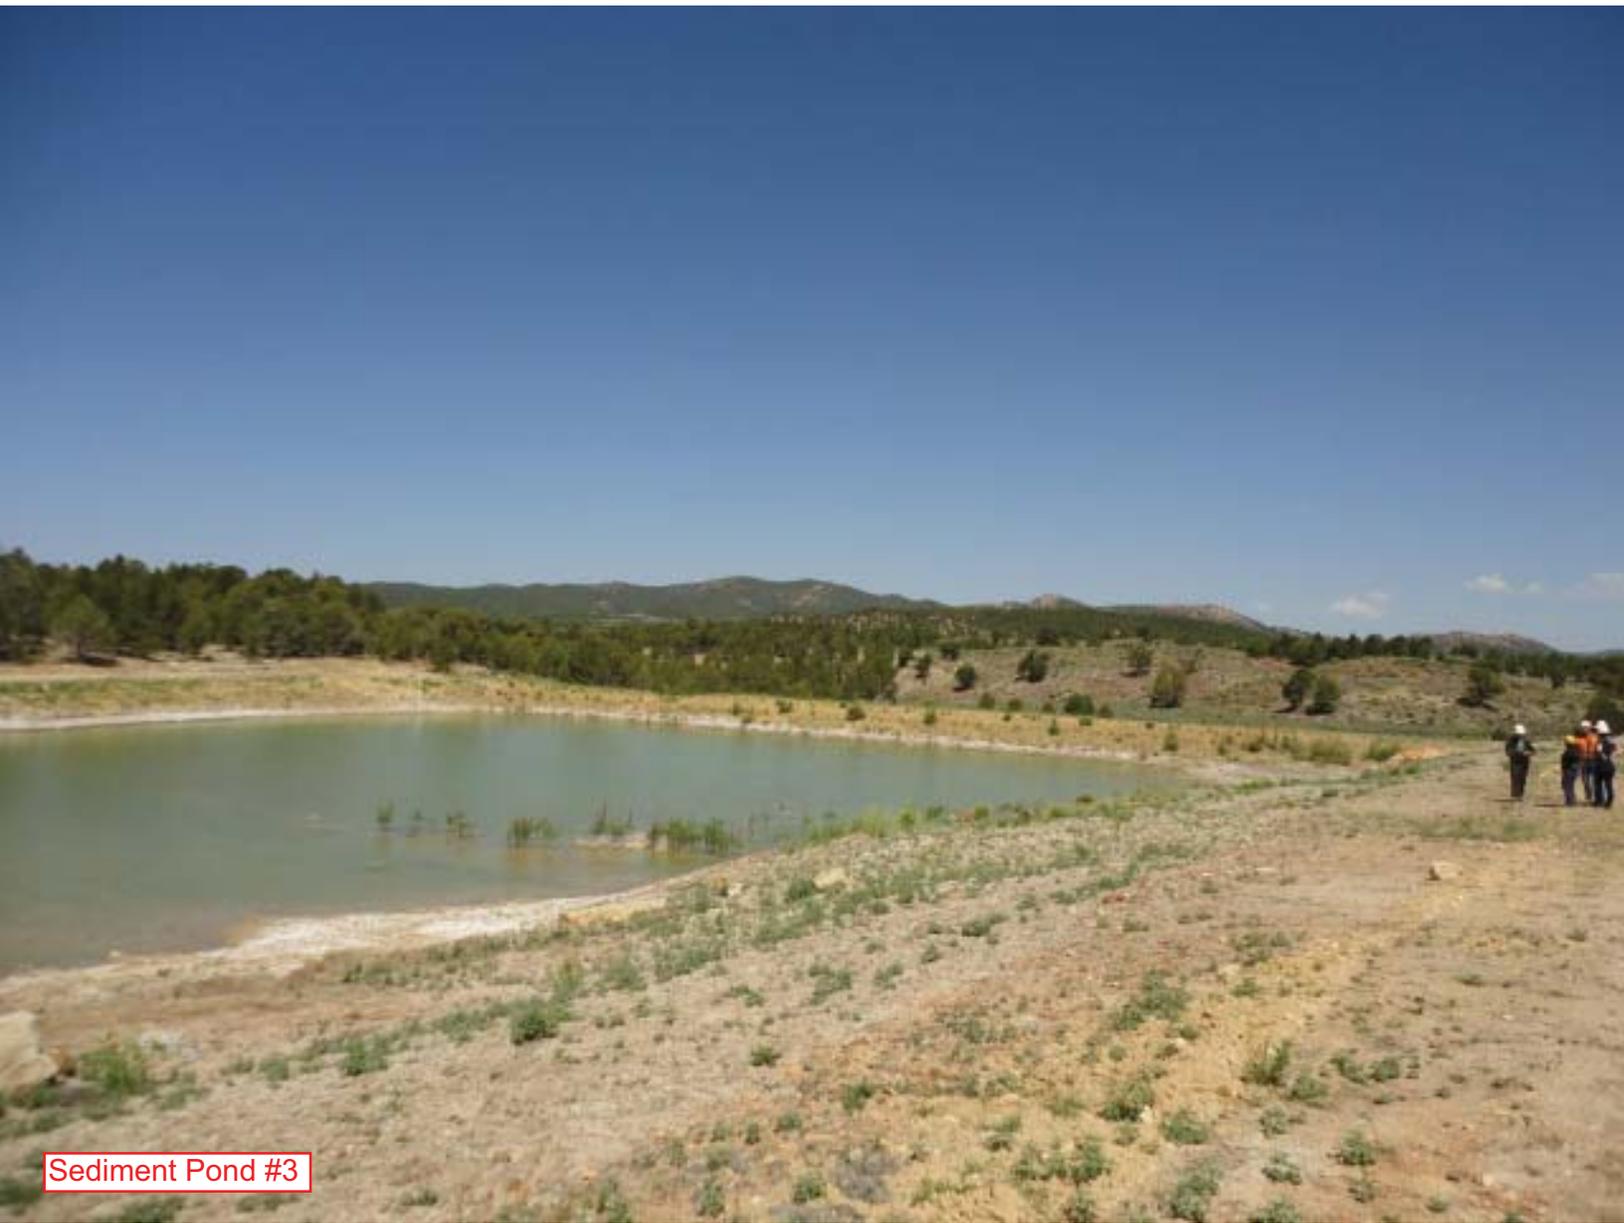
Sediment Pond #3

OSM expressed concerns on portions of the side slope of the diversion leading into pond #3. No measurements were taken. The side slopes should be at a two to one.

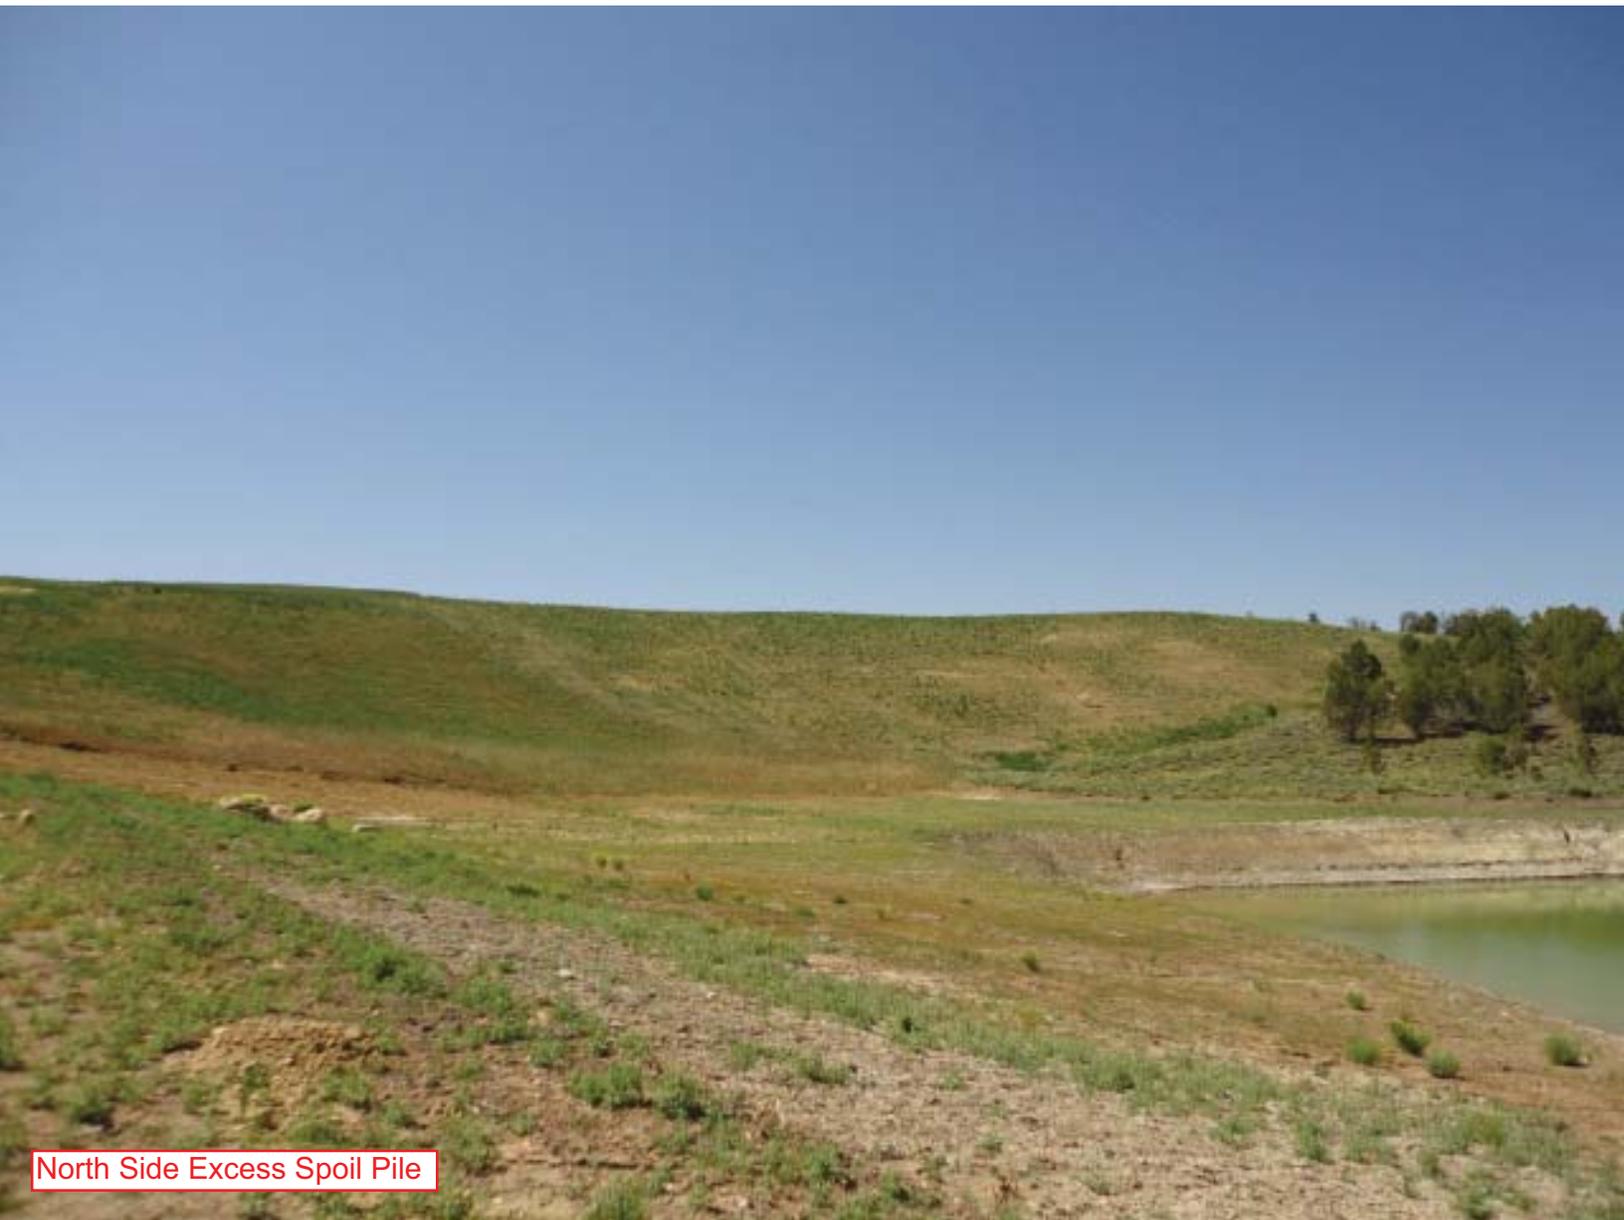
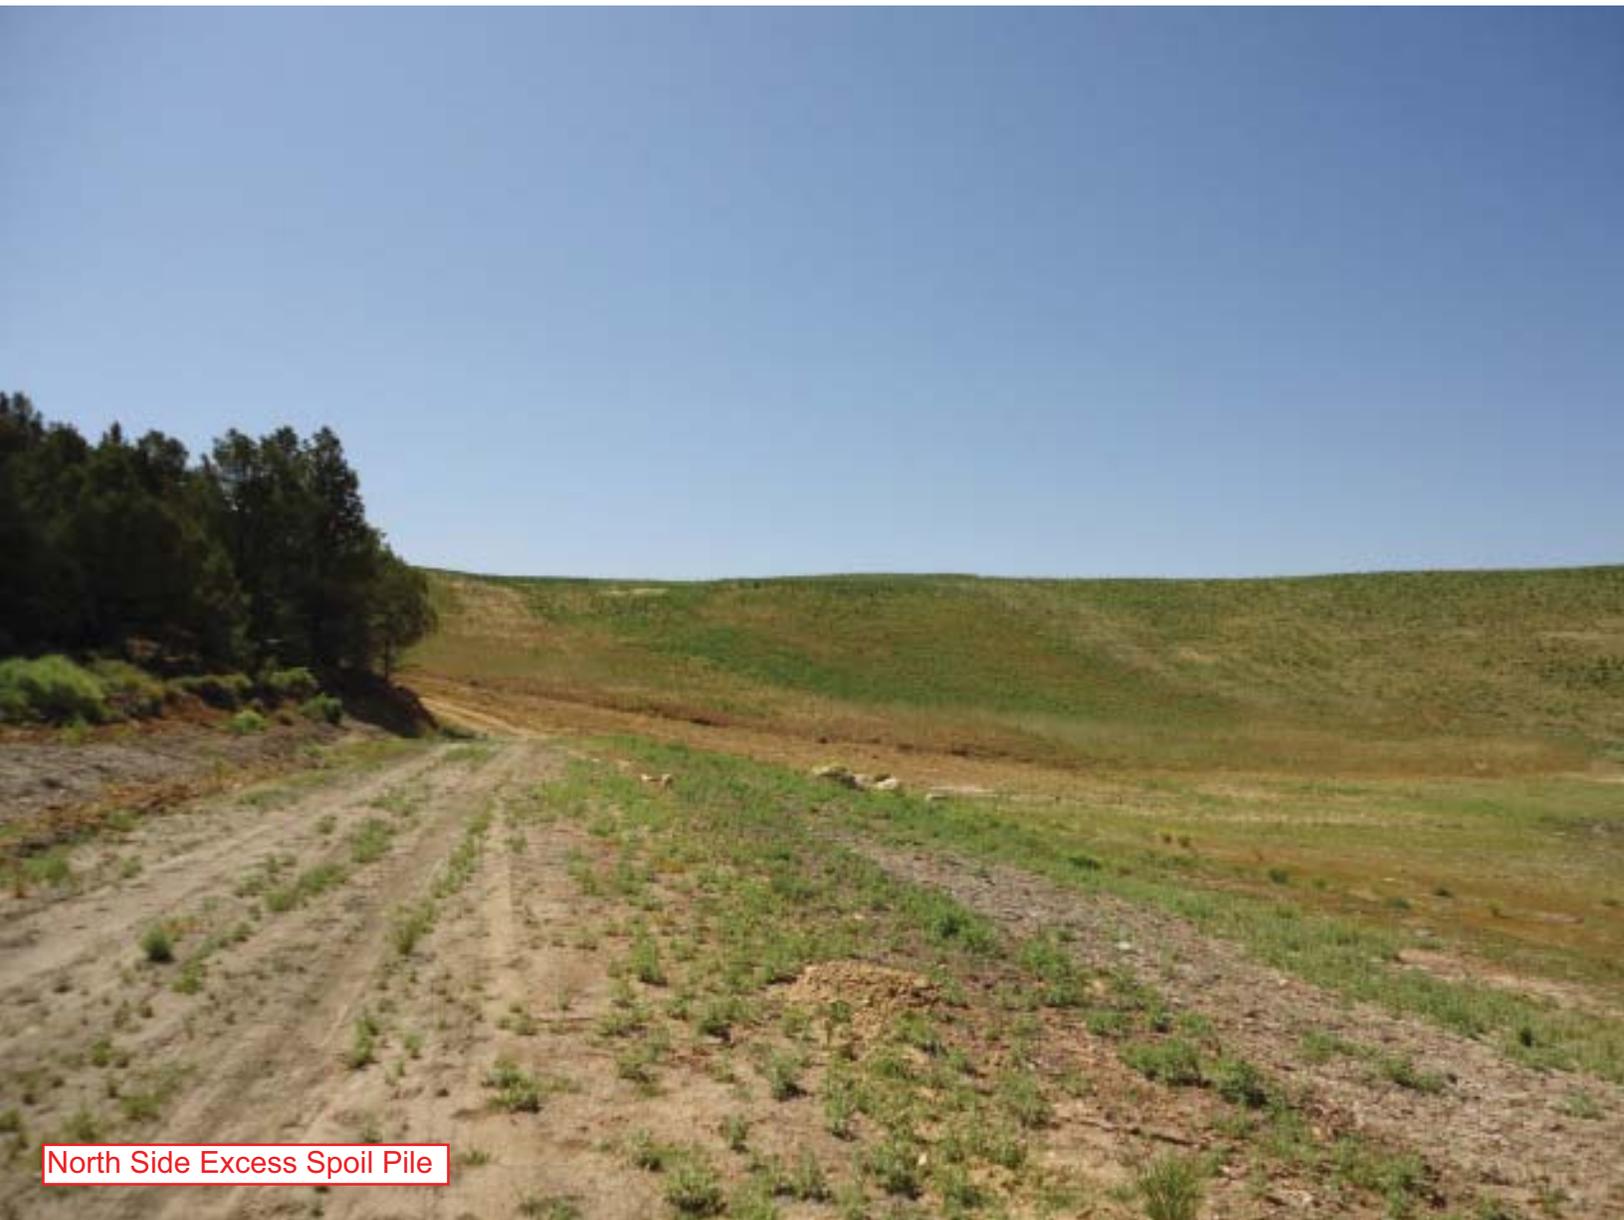
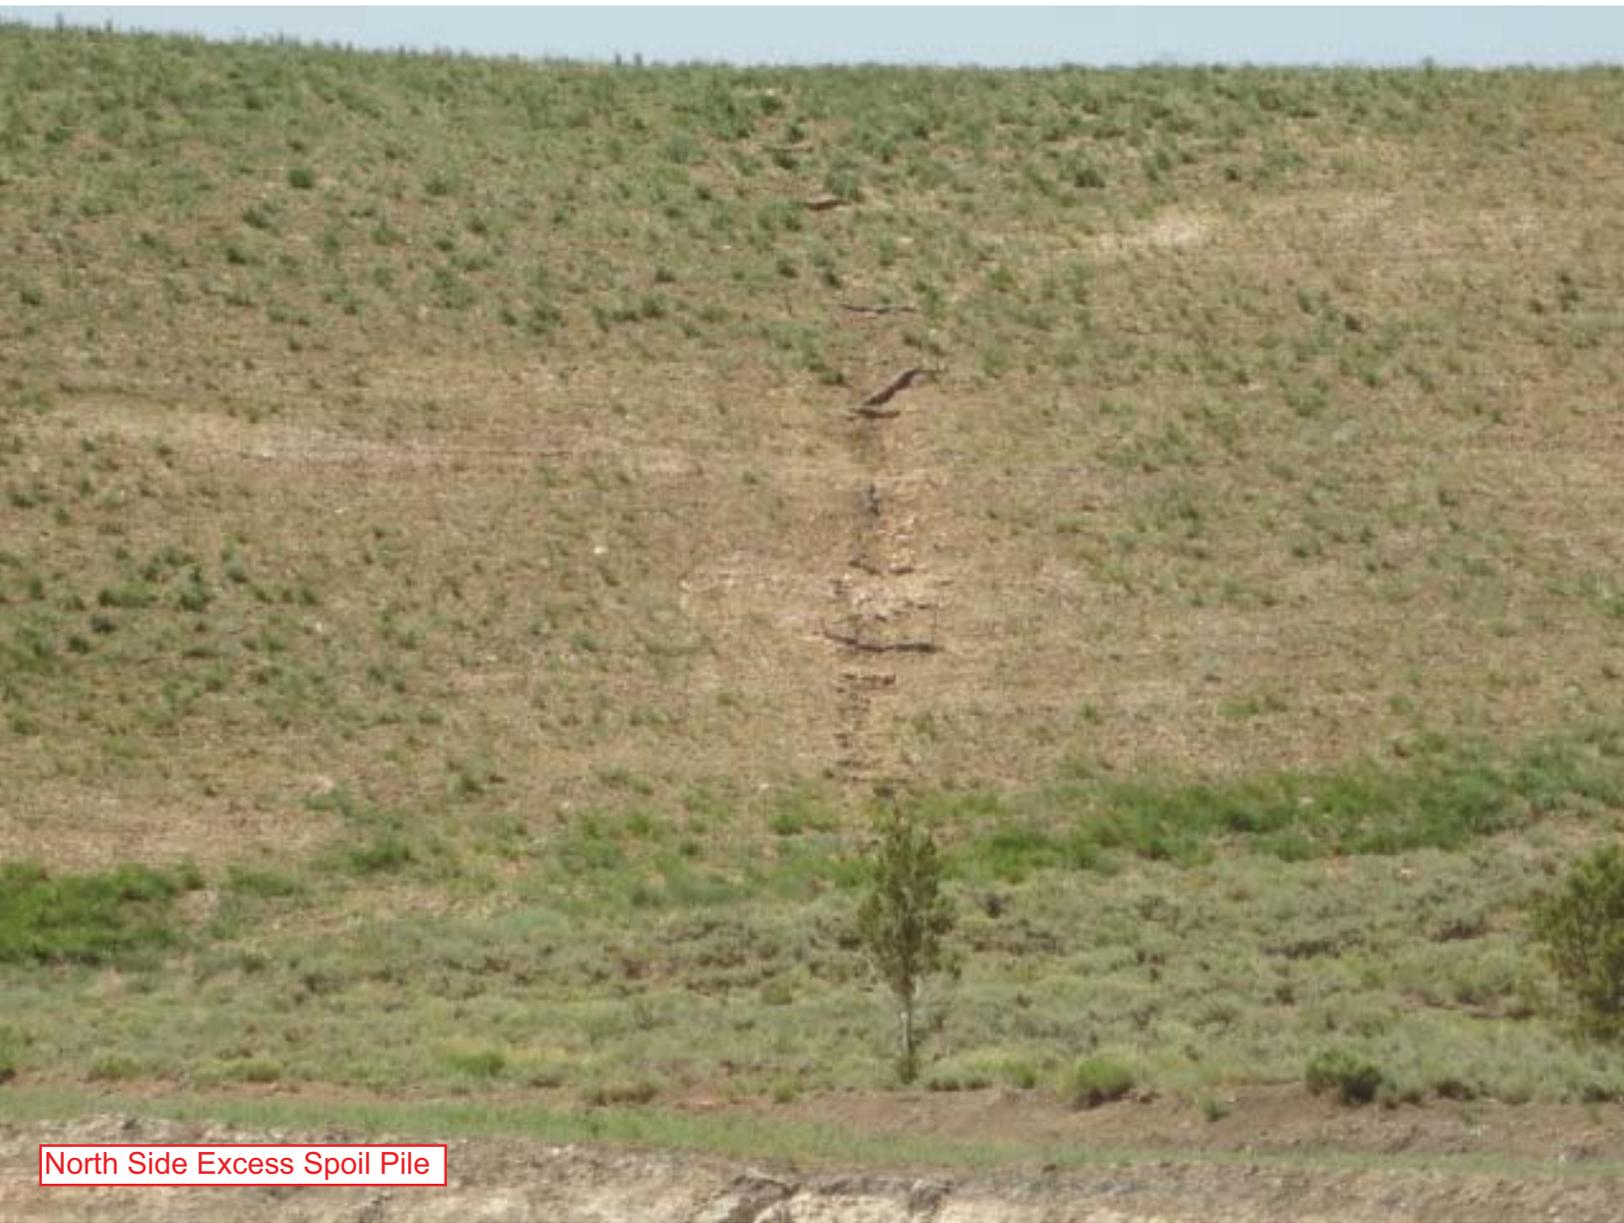
North Side Excess Spoil Pile

The excess spoil pile was inspected for the First Quarter 2014 on 03/26/2014. The report is P.E. dated signed and certified stamped.
