Division of Oil, Gas and Mining

Inspection Report

Permit Number:	C0250005
Inspection Type:	TECHNICAL
Inspection Date:	Monday, September 29, 2014
Start Date/Time:	9/29/2014 2:00:00 PM
End Date/Time:	9/30/2014 12:30:00 PM
Last Inspection:	Tuesday, September 09, 2014

Site: **COAL HOLLOW**

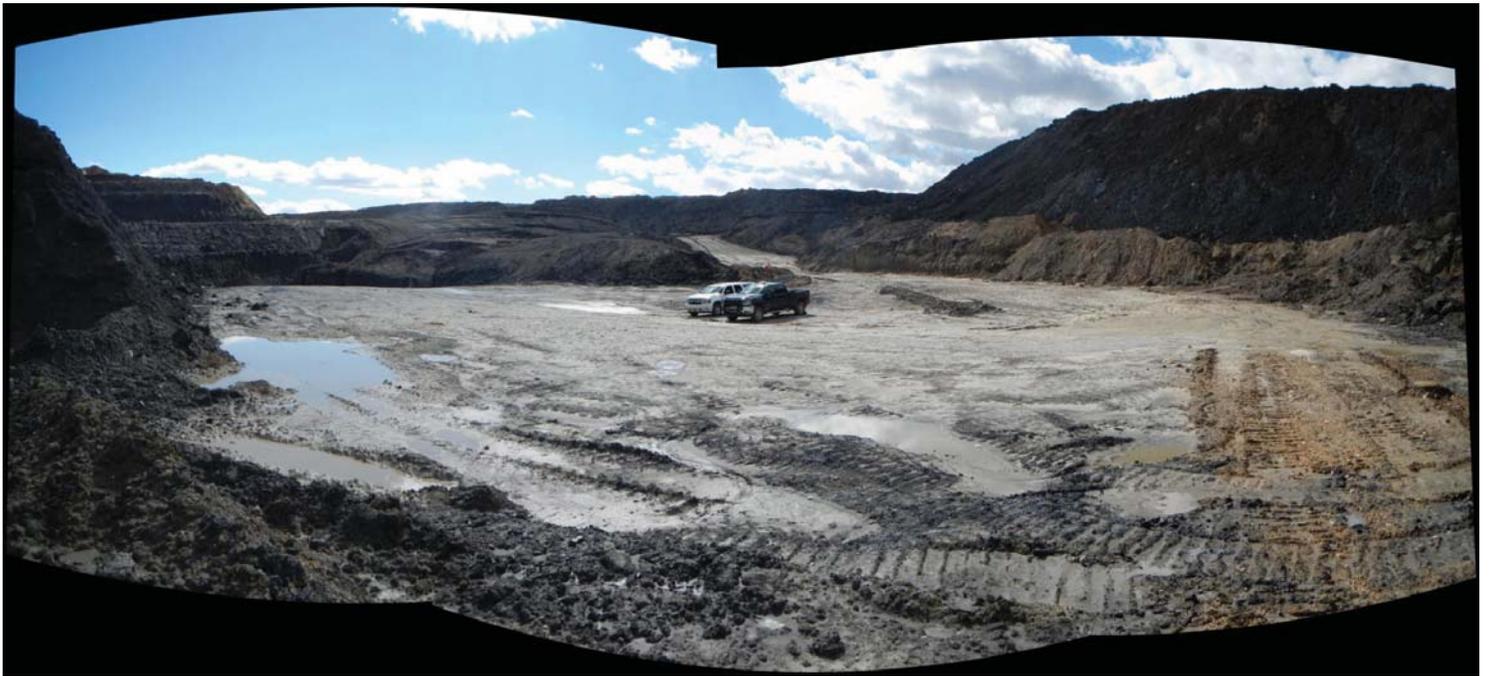
Pit 10 may be extended to the south to uncover the auger stuck in a panel in Pit 9. Pit 9 has been partially backfilled, but will not be completely backfilled until the stuck auger can be removed from the last panel. A second auger was used to complete mining in Pits 23 and 22 and was currently on the surface for maintenance. Pits 22 and 23 were partially backfilled. Auger panels were visible in Pit 22. Pits 6 was backfilled in mid-July 2014. Pits 26 - 28 have been backfilled.

Partially backfilled Pit 9 and entrance to pit 10.

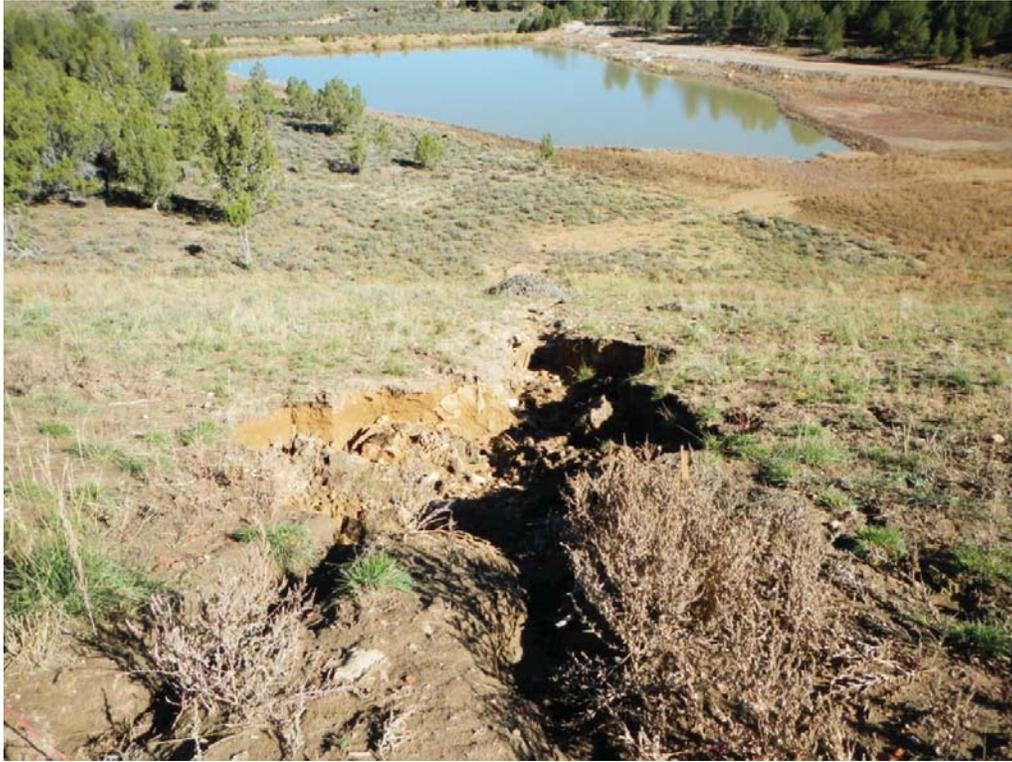
Recent storm events have exacerbated the rill located on the north side of the reclaimed spoil pile adjacent to Pond 3. A number of options were discussed with the Permittee including :pocking, ripping along the contour, mounding the depressions on the top of the pile to eliminate ponding, excelsior matting and wood straw, and ensuring good surface roughening before topsoil placement.

Looking downhill at erosion rill located on the northwest side of the reclaimed spoil pile adjacent to Pond 3.

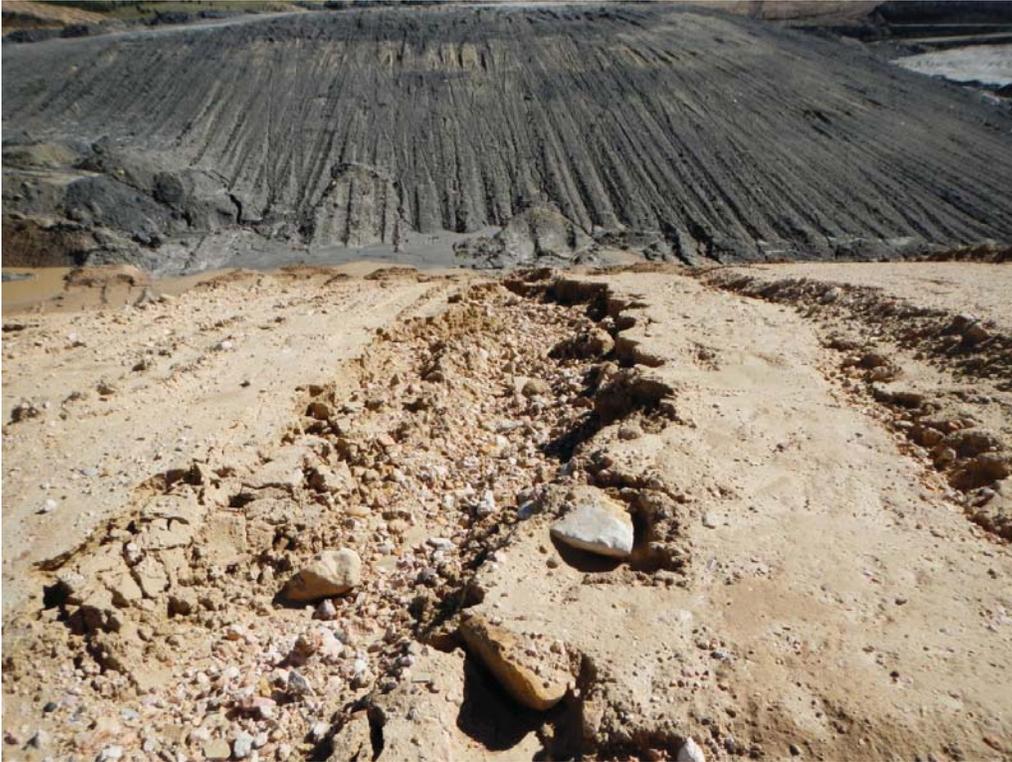
Erosion of subsoil on surface of the graded spoil pile will be roughened before topsoil placement.

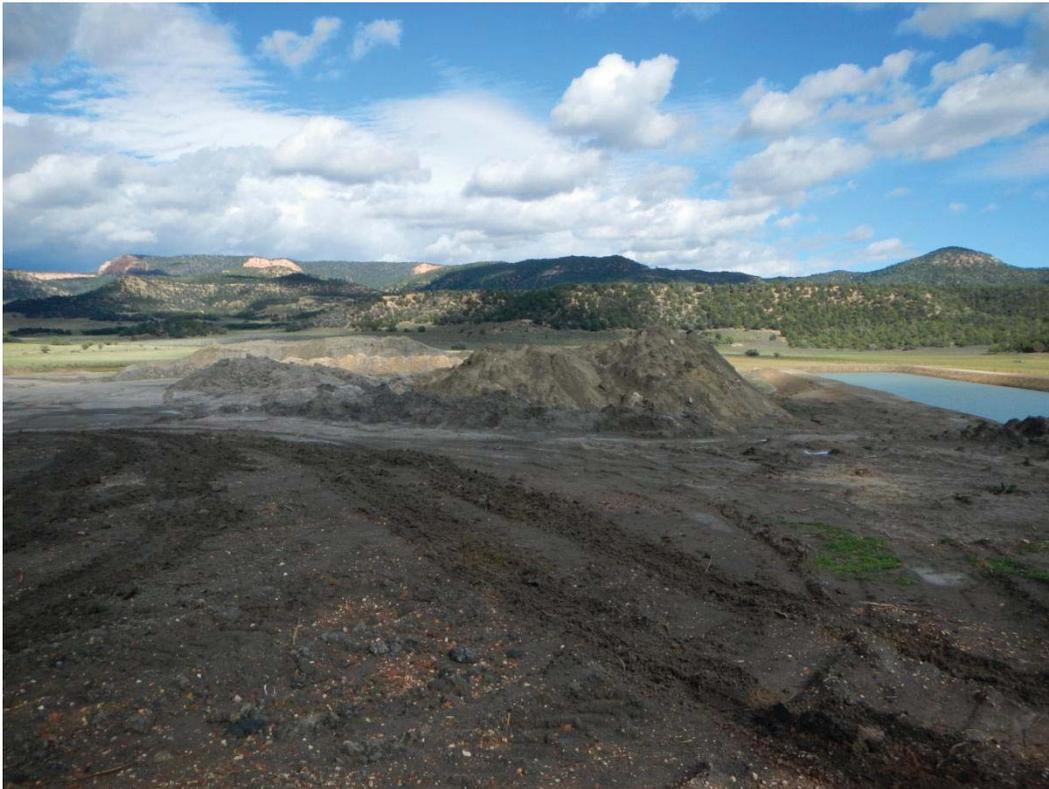
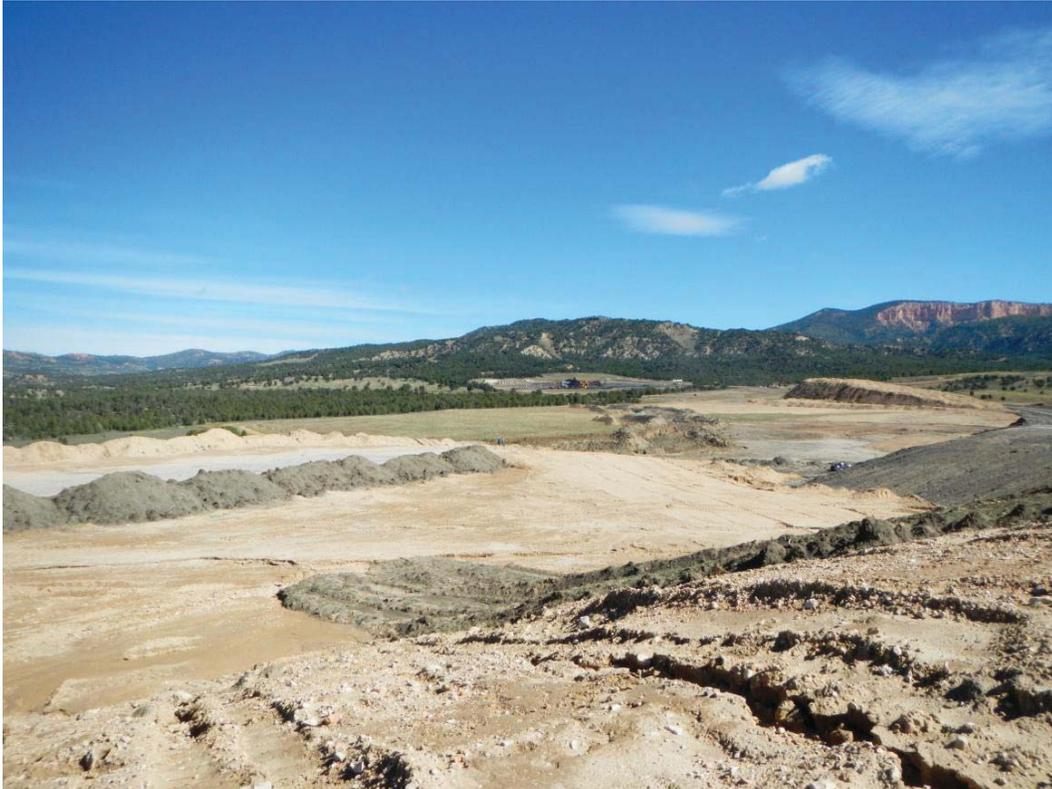
Topsoil was noted in a windrow on the contoured surface of pit 3 and 5, ready for redistribution over that surface. Topsoil was also noted windrowed on the east boundary of east of Pit 22 for redistribution over contoured pits 28 -25. Topsoil was also noted windrowed east of Pit 10. These stockpiles of topsoil will be used in reclamation this fall.

Above: topsoil and subsoil piles in the vicinity of graded pits 25 - 28. Below: Topsoil windrowed on graded pits 3 and 5 adjacent to graded spoil pile.
