State of Utah

Division of Oil, Gas and Mining

Inspection Report

Permittee: **ALTON COAL DEVELOPMENT LLC**
 Operator: **ALTON COAL DEVELOPMENT LLC**
 Site: **COAL HOLLOW**
 Address: **463 North 100 West, Suite 1, CEDAR CITY UT 84720**
 County: **KANE**
 Permit Type: **PERMANENT COAL PROGRAM**
 Permit Status: **ACTIVE**

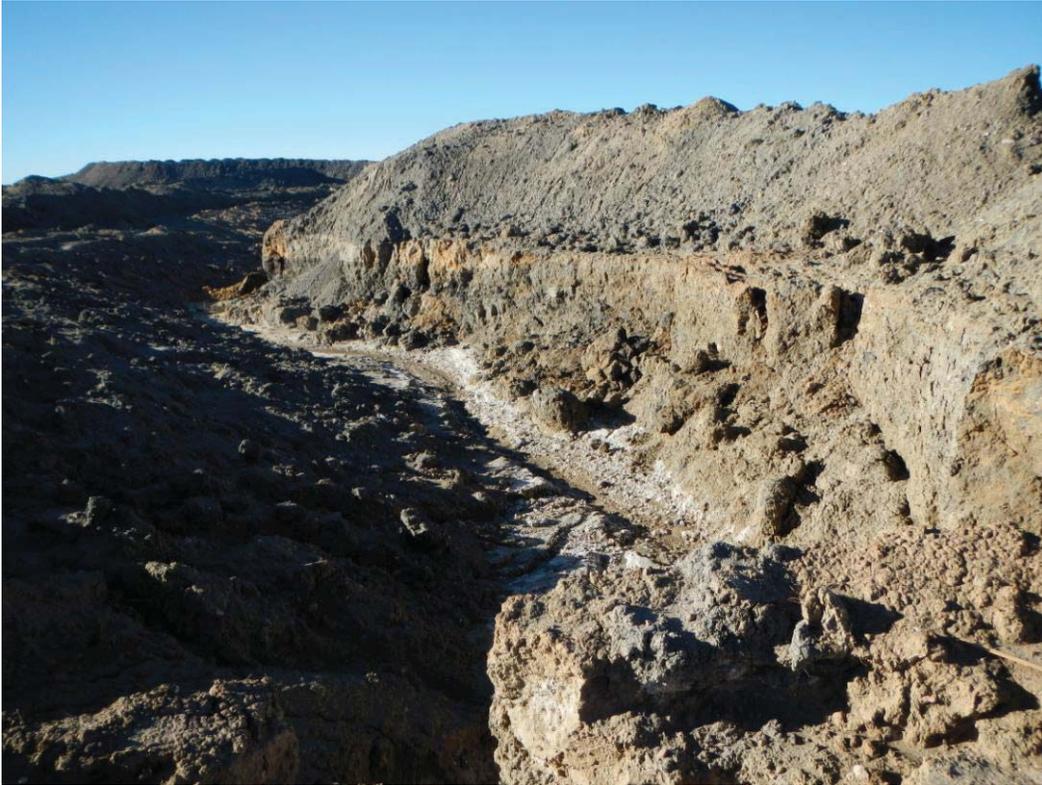
Looking east at the haul road. Pit 10 highwall is benched. Pit 10 is being enlarged to the south to recover the auger bit. Alluvium being pushed with dozer above the Pit 10 highwall. Alluvium is stockpiled to the south of pit 10 in a flat topped mound. The truck on the haulroad (far right) is approaching the location of Trench Highwall 1 (THW1) which is just west of the flat topped mound of alluvium.

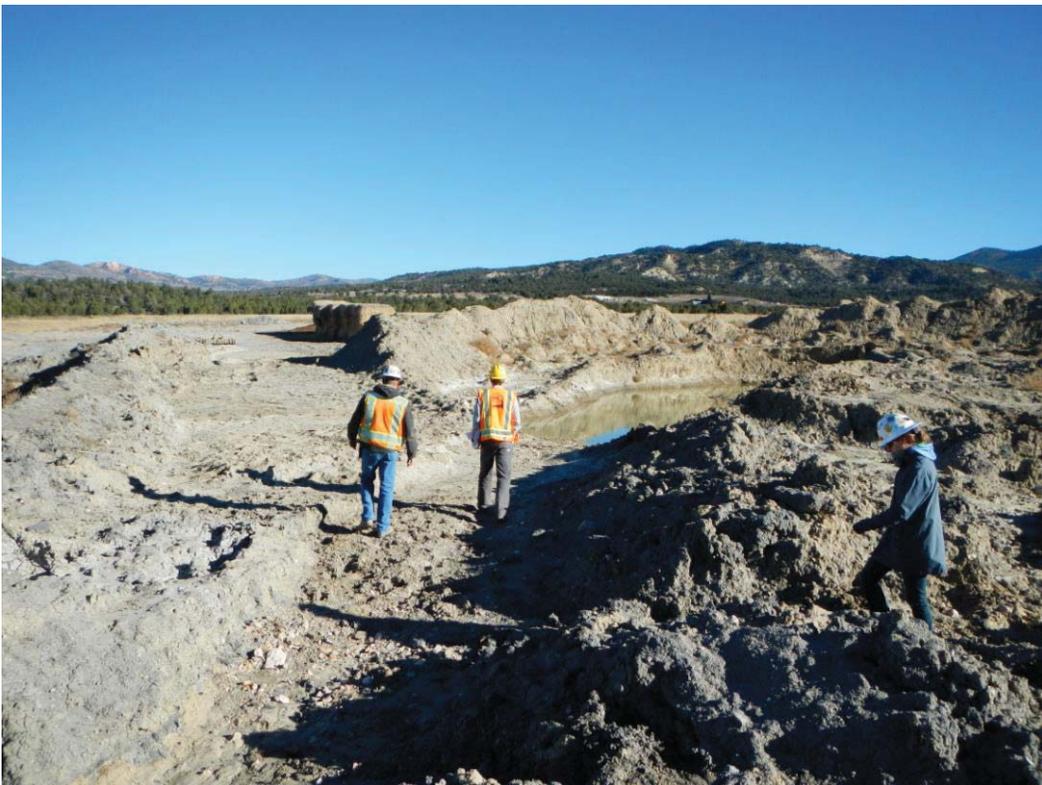
Above: northern end of the reconstruction of Robinson Creek. West side (left of photo) has been laid back 3h:1v. East side (on the right) will be laid back as well. Below: Southern end of Robinson Creek reconstruction with water held on site by an embankment.

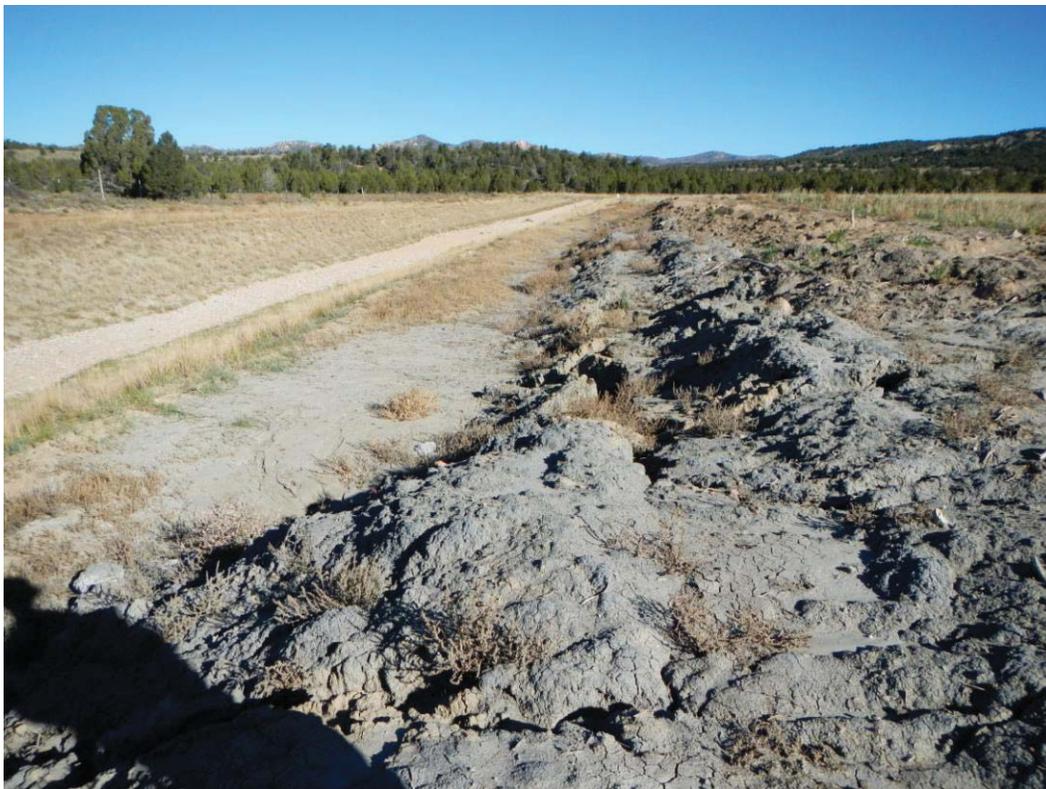
Above: Robinson Creek outlet to be repaired. Below: Realigned section of Robinson Creek on left. Note the interim seeding on the slope. On right subsoil and topsoil covers graded pit 3. This area will be graded, seeded and treated with sediment control before run off enters the realigned drainage.

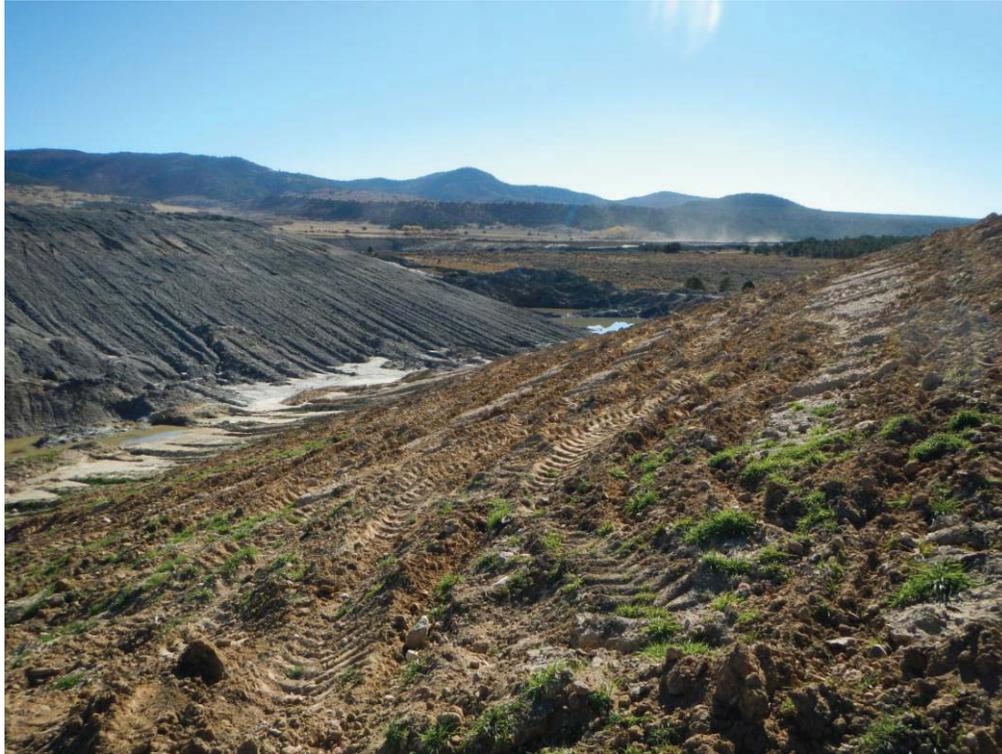
Reclamation for Watershed 6 (Dwg. 5-26) was staged upon a ~2 acre area in the southwestern corner of the watershed. This staging area is currently disturbed and does not have any soil stabilization or erosion mitigation measures to prevent runoff from flowing unmitigated into the abutting Lower Robinson Creek diversion and eventually offsite. Multiple rills and gullies were observed flowing from the disturbed area into the diversion. This area was identified as being a priority for soil stabilization and/or erosion control measures.

Just east of the re-aligned Robinson Creek, topsoil will be applied to the exposed subsoil and the surface will be seeded and mulched per plan. The toe of the slope abutting the reconstructed Robinson Creek will be protected with a silt fence or excelsior log immediately. Topsoil is stockpiled on top of the excess spoil pile. Topsoil was not applied to the gully repair on the west side of the Excess Spoil Pile.

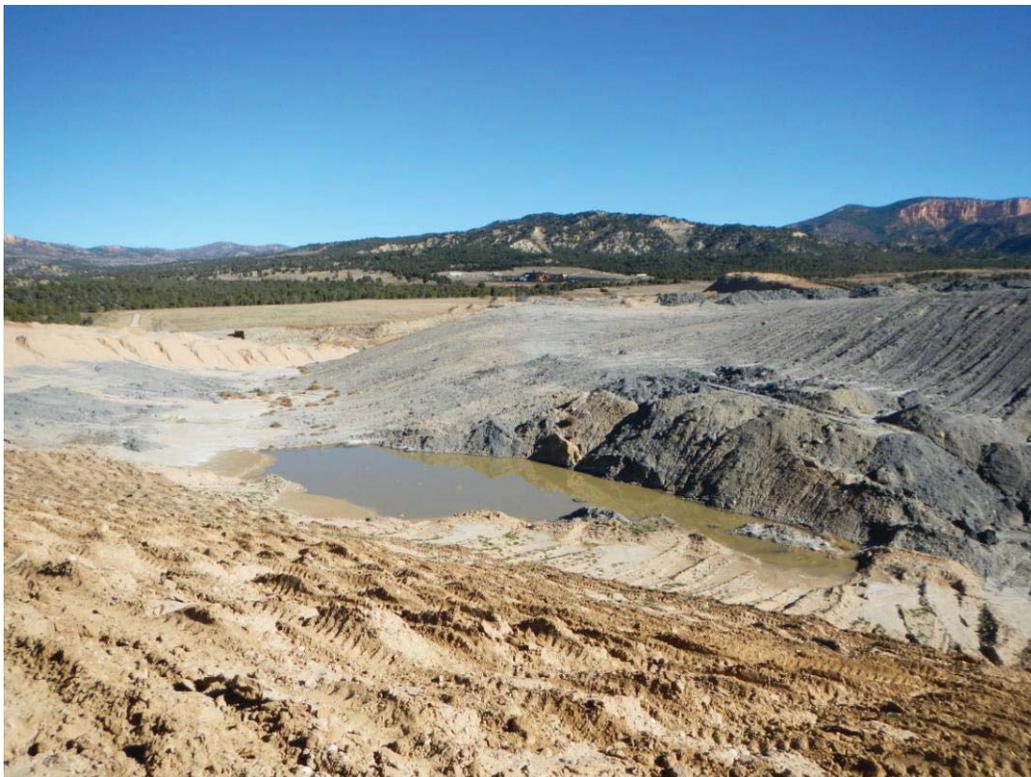
Subsoil had recently been ripped with a Harvey's Harrow on the east side of the Excess Spoil Pile. Subsoil had recently been placed on subsoil Pile #2. Pit 10 is being expanded to the south over Pit 9 panel 3 (Dwg 5-10A) in order to recover the lost cutter head. At the time of the inspection, alluvium was being removed from the surface of Pit 11 to create the Pit 10 high wall (see drawing 5-10). This highwall will be benched at 40 ft. intervals and result in approximately 280 ft. disturbance from the east edge of pit 10 shown on coal boundary shown on Dwg 5-10, covering both pit 11 and pit 12 area. Alluvium was stockpiled in a flat topped pile to the east of Trench 1 above panel 4 (Drawing 5-10A). Trench 1 construction has stalled at this point. The trench 1 highwall is partially developed out of pit 9 south to panels 1 & 4. The alluvium above panels 1 & 4 have been laid back to a 4h:1v slope. Alluvium had recently been blasted in Pit 21. Coal was being hauled from Pit 21.

Above: Ripping on contour of subsoil covering the east facing slope of the Excess Spoil Pile. Below: Drainage from permanent and new temporary spoil pile creates ponded water. Grading is needed to direct the water to Ditch #4.

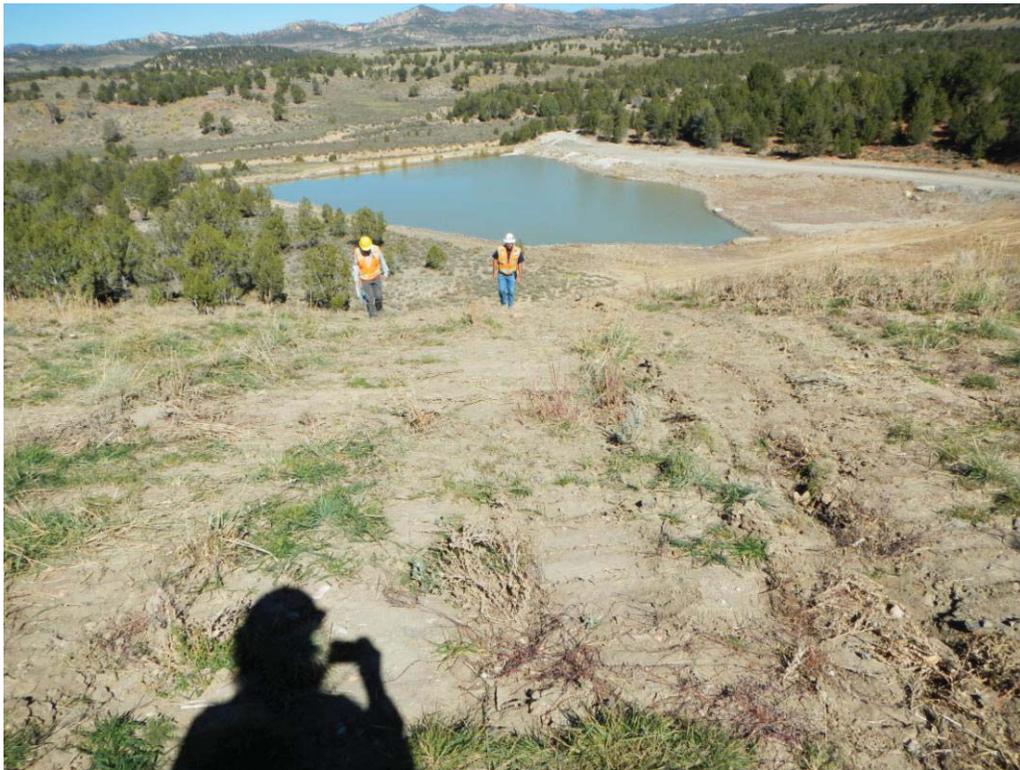
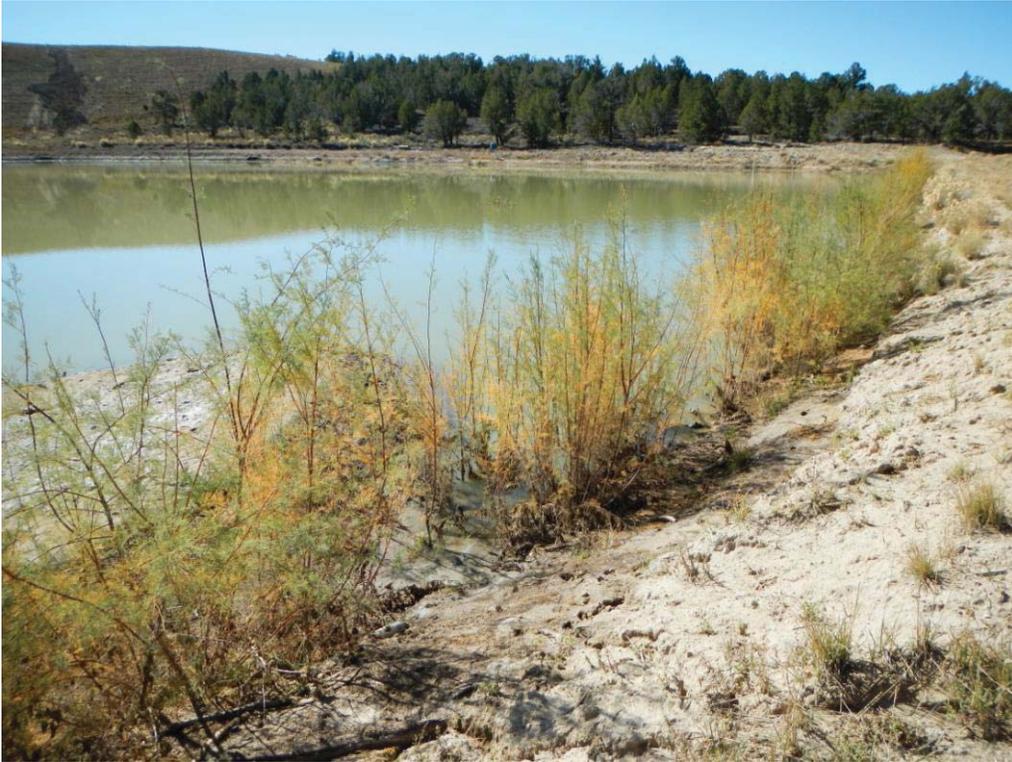
Above and below: Rill repair on the north side of the excess spoil pile. Site will be seeded and mulched.

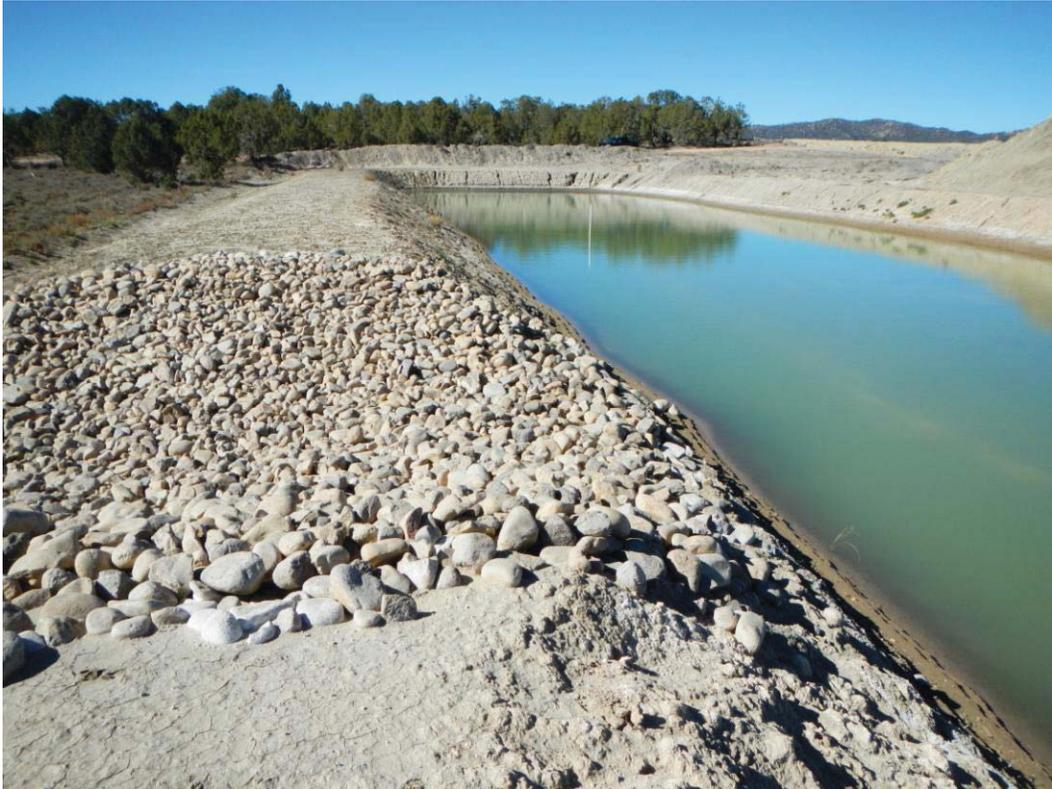
The spillway for Pond #3 is under repair. It will be built back to the specifications laid out in the MRP.

Above: Pond #3 with tamarisk beginning to invade. Below: Pond #3 spillway temporary repair.

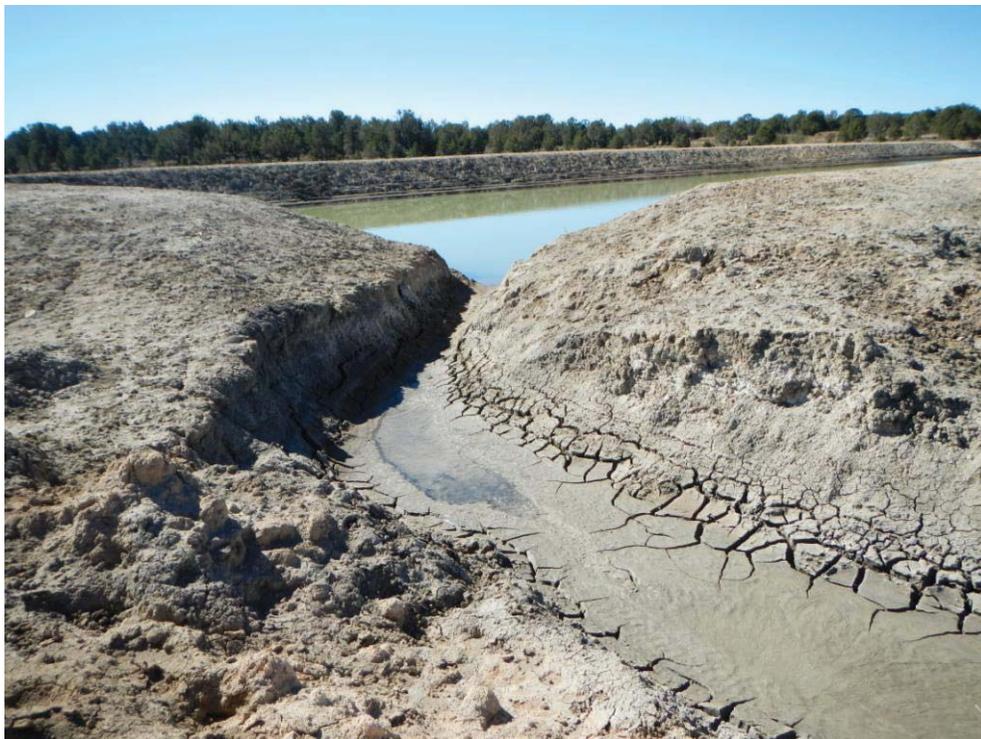
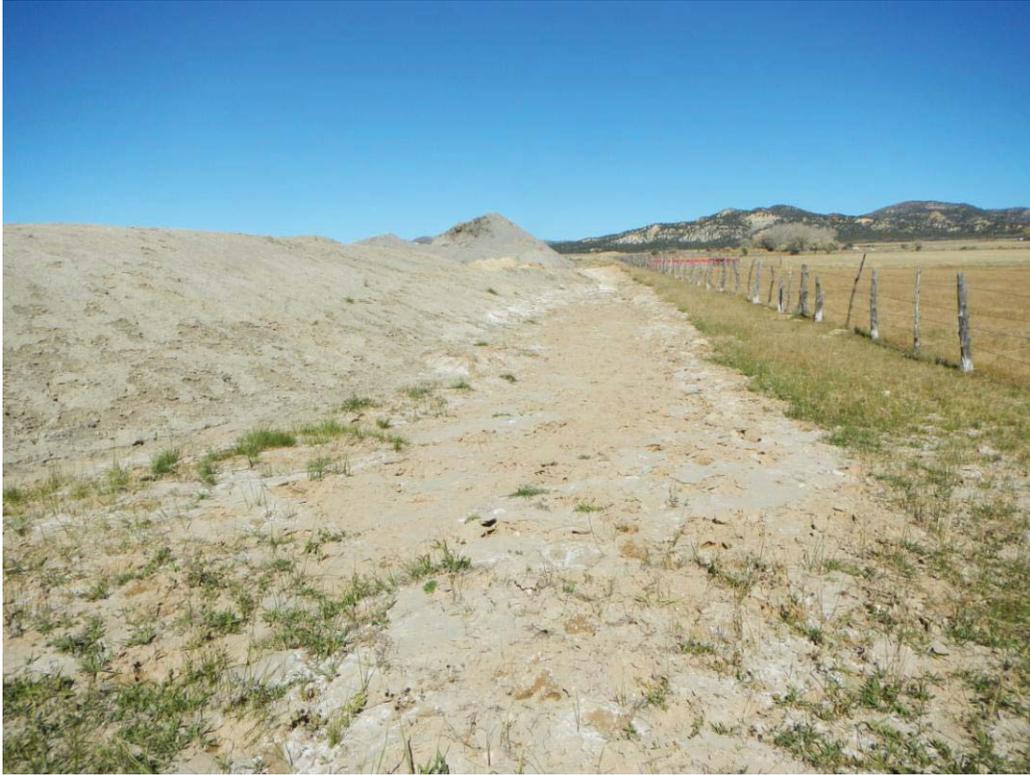
Above: Pond #4 spillway. Below: Pond #4 inlet.

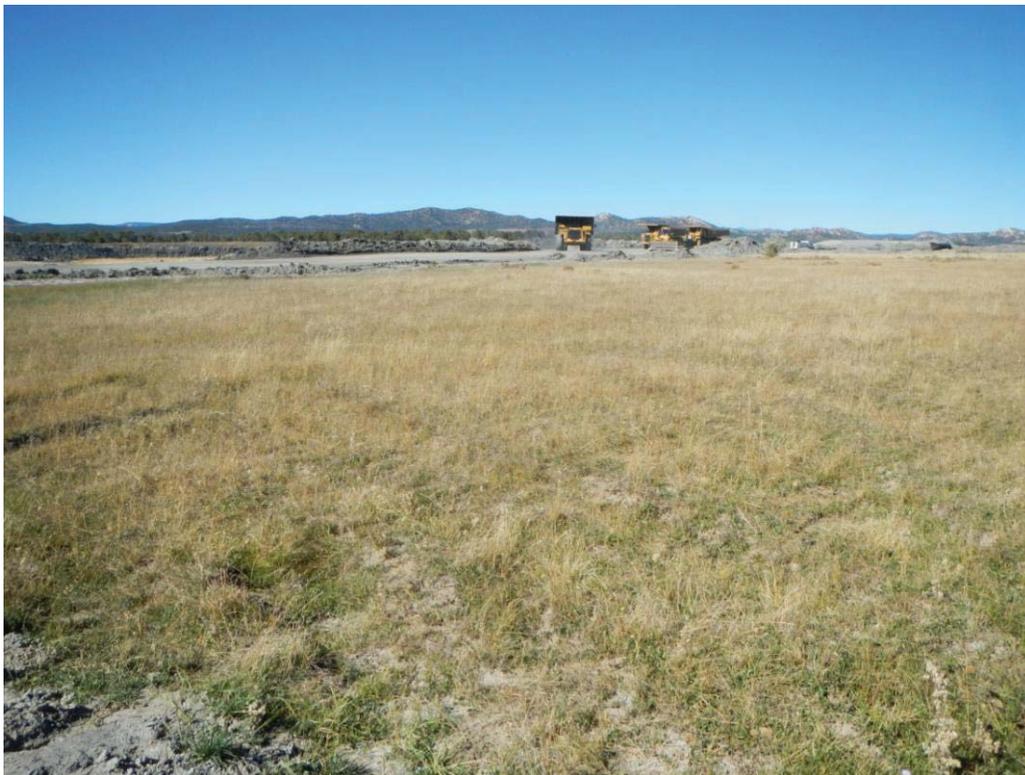
Above: Slumped area at south permit boundary likely due to former soil pit. Needs repair.
Below: Vegetation and disturbed area in front of Dames access.

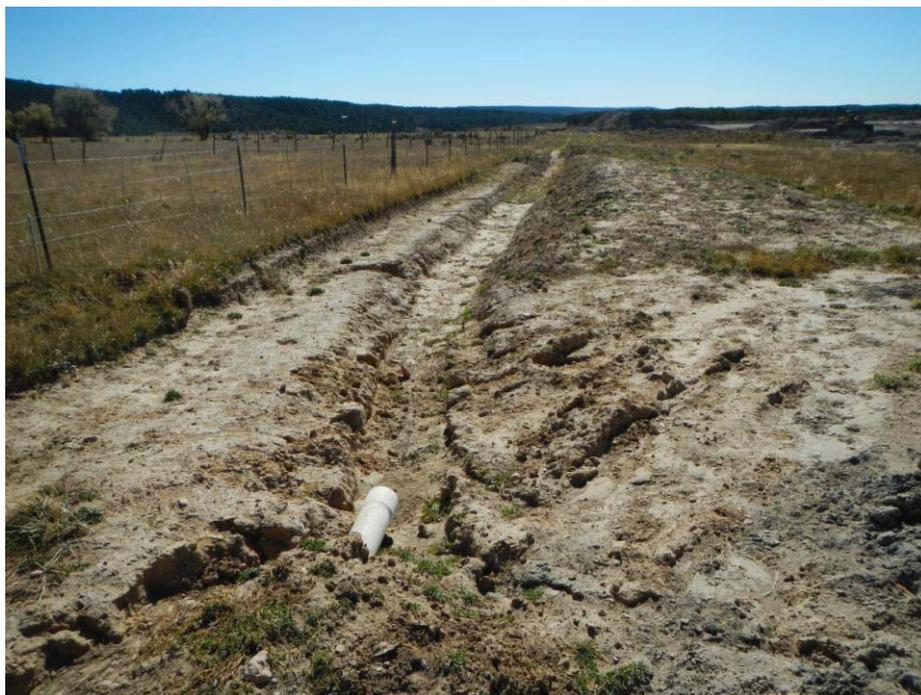
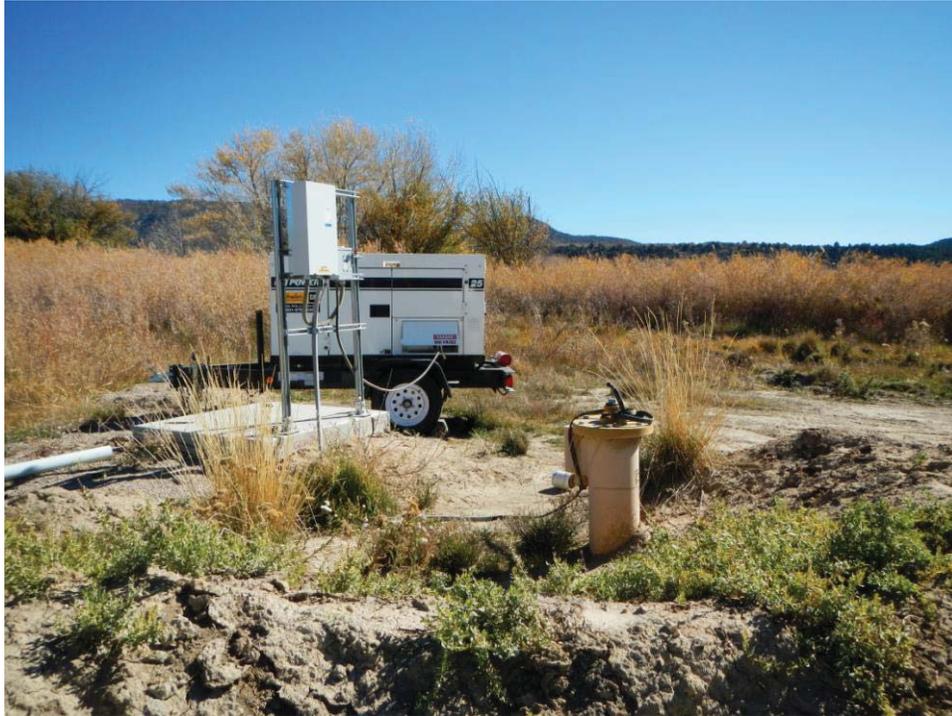
Above: Ditch #1 North of Dames access. Fence line is permit boundary.
Below: Ditch #1 South of Dames access.

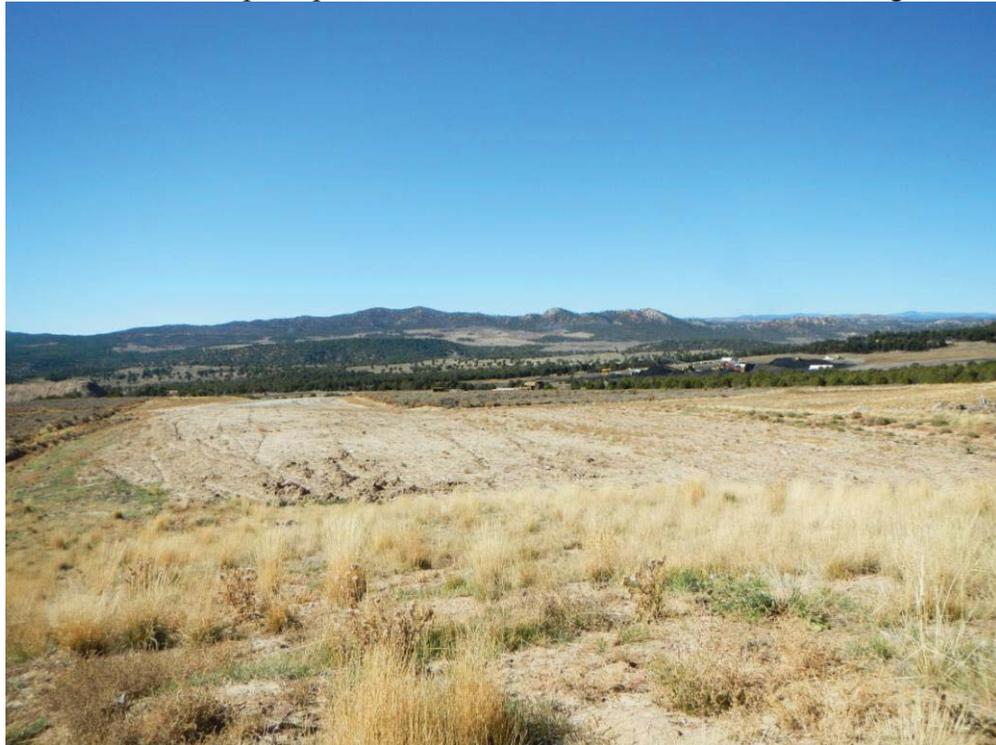
Above: Topsoil pile #2 surface.

Below: Area of topsoil pile #2 to be reseeded. mine facilities in background.
