Division of Oil, Gas and Mining

Inspection Report

Permit Number:	C0250005
Inspection Type:	COMPLETE
Inspection Date:	Tuesday, November 18, 2014
Start Date/Time:	11/18/2014 9:00:00 AM
End Date/Time:	11/18/2014 3:30:00 PM
Last Inspection:	Tuesday, October 28, 2014

Permitee: **ALTON COAL DEVELOPMENT LLC**
 Operator: **ALTON COAL DEVELOPMENT LLC**
 Site: **COAL HOLLOW**
 Address: **463 North 100 West, Suite 1, CEDAR CITY UT 84720**
 County: **KANE**
 Permit Type: **PERMANENT COAL PROGRAM**
 Permit Status: **ACTIVE**

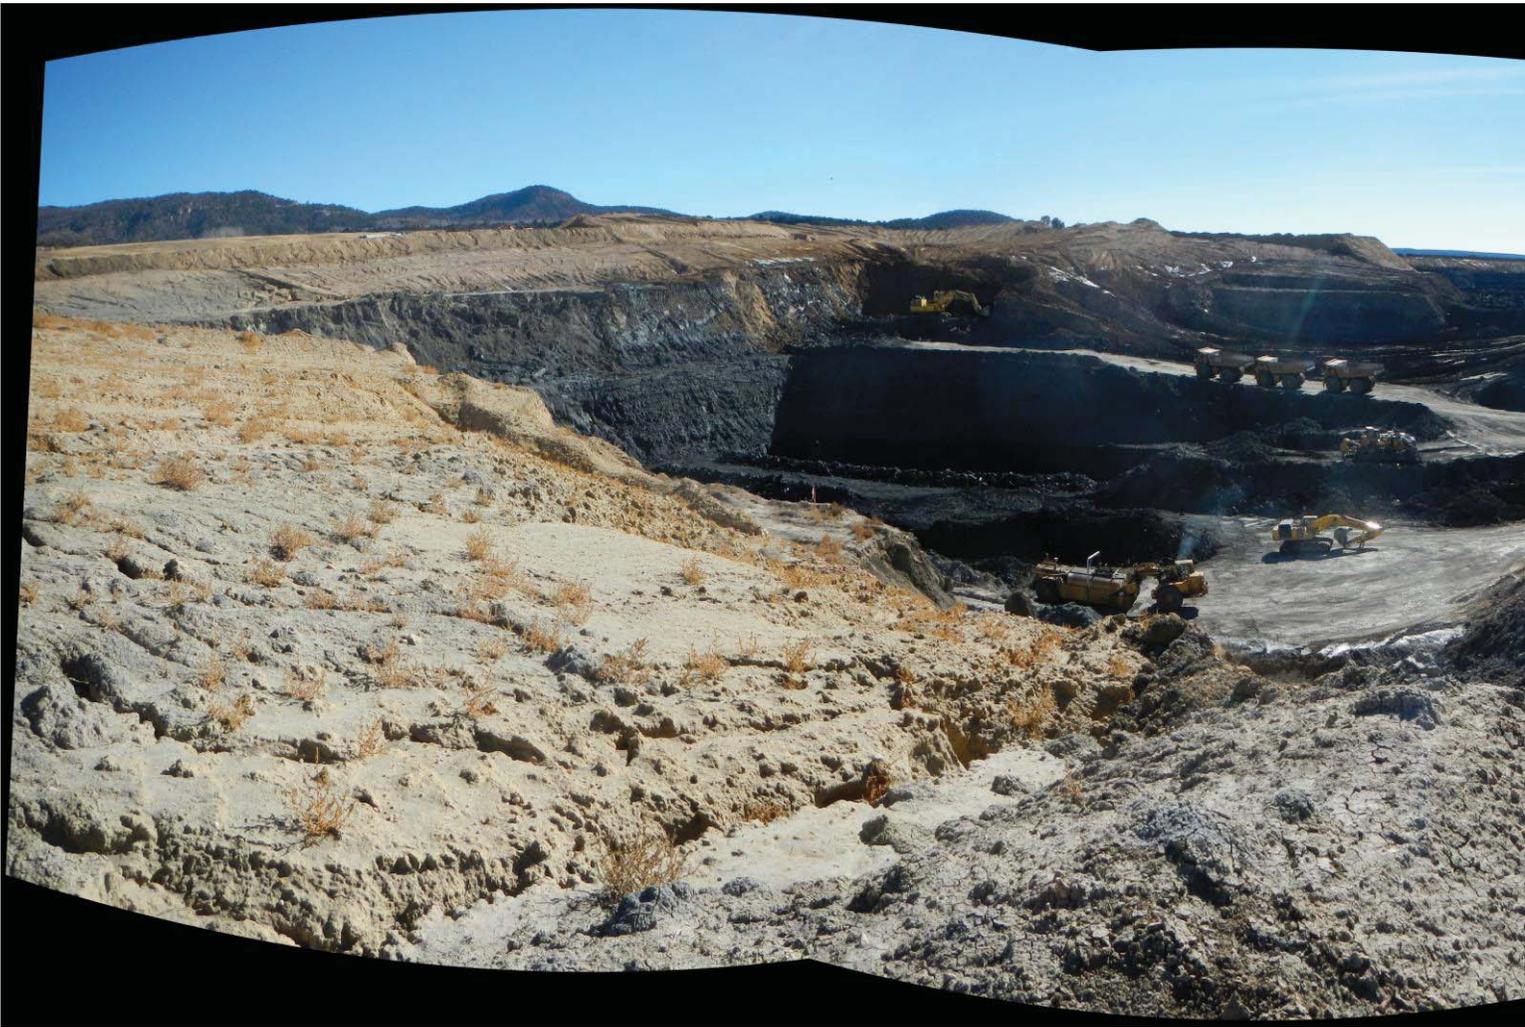
North end of pit 10 where spoil is being trucked from the highwall to the excess spoil pile loca

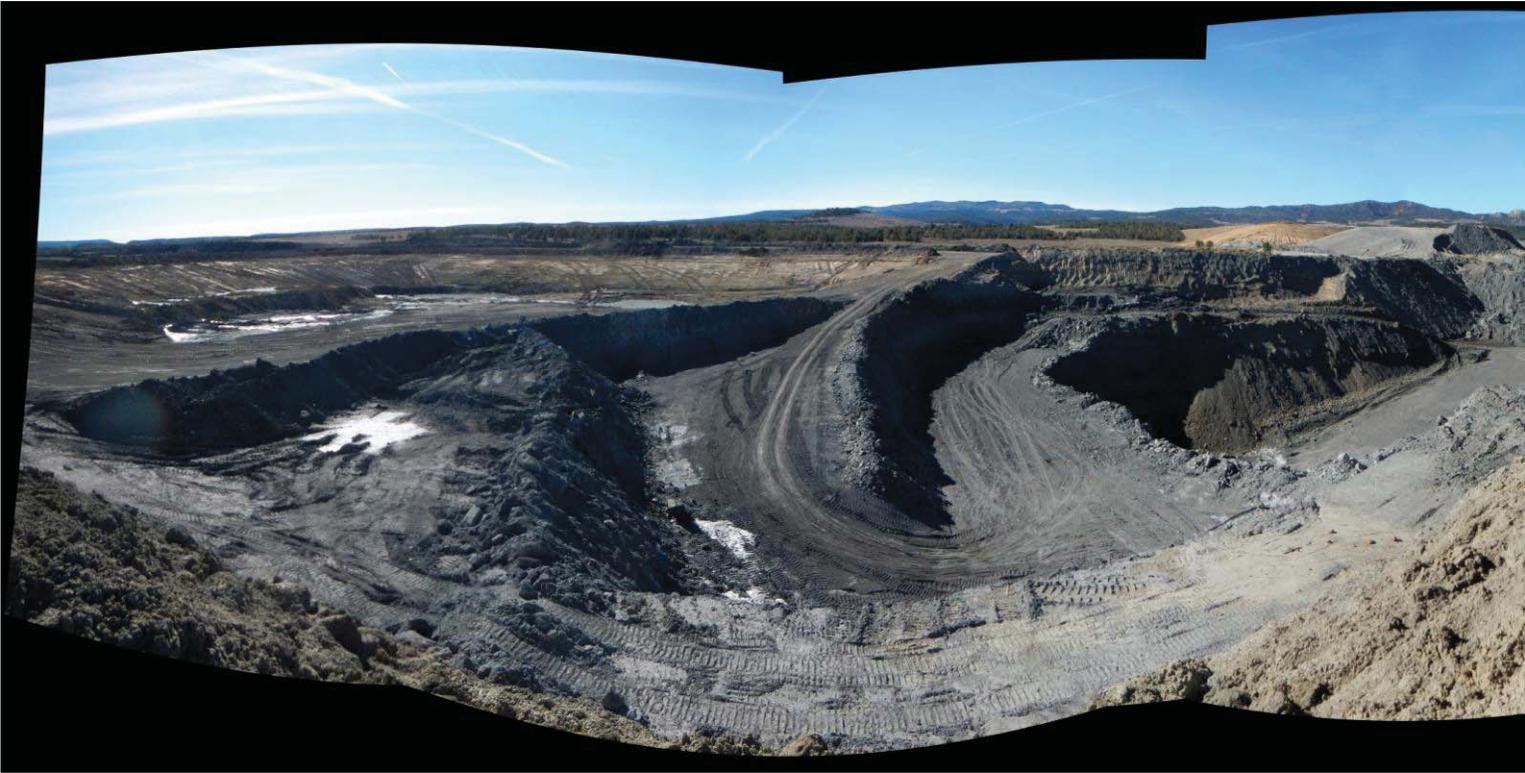
South end of pit 10 and location of HWT 1 development.

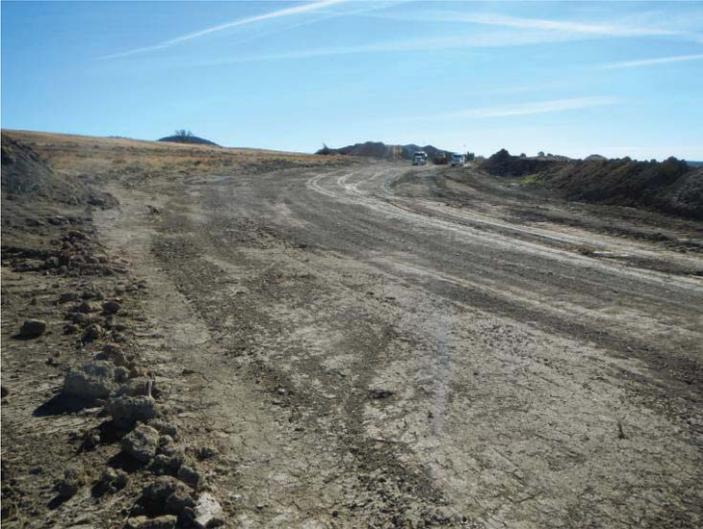
Above: access road on east side of pit 10. Below: access road approaches Sec. 19 20 29 30 corner. (fenceline)

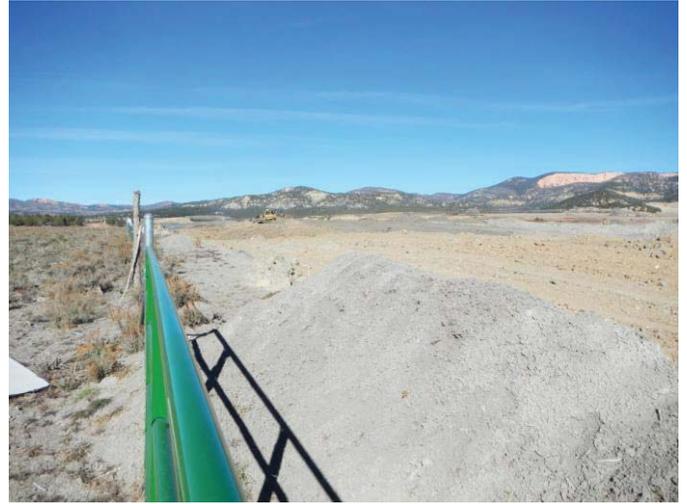
Signs are located at the north and south entrance and on the west side fence. The signs are legible and contain the required information. The west sign needs to be secured.

Western gate and location of ID sign. Dozer pushes fill above Pit 24.

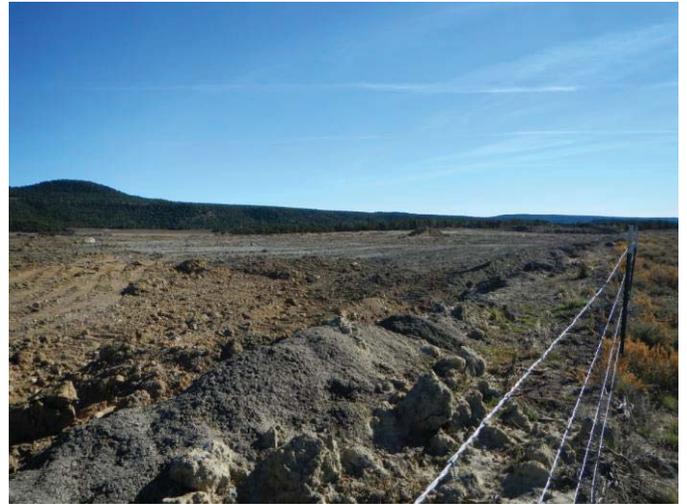
Looking south from west gate at backfilled pits 26, 27, 28.

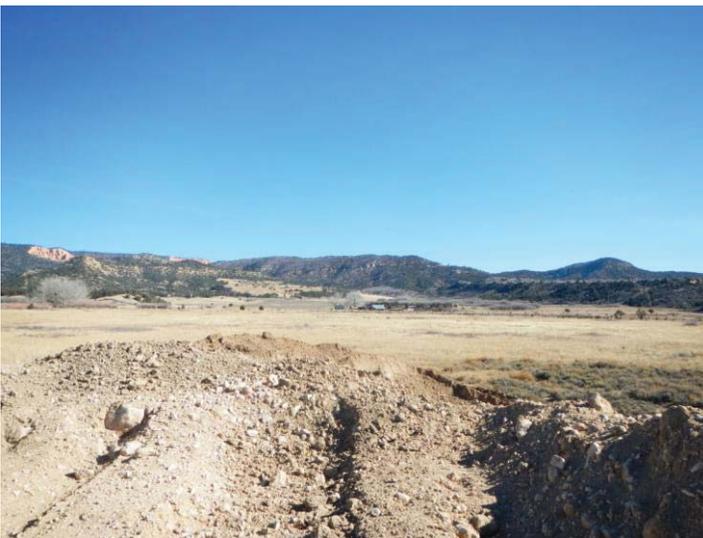
Above: farthest eastern edge of disturbance. Sorenson property in background.

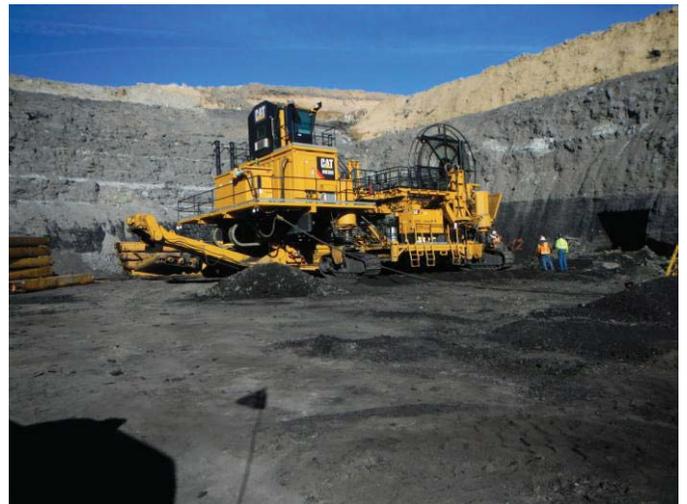
Auger miner in Pit 21 just completed panel 11.
