# Inspection Report

Permit Number:	C0250005
Inspection Type:	PARTIAL
Inspection Date:	Tuesday, December 16, 2014
Start Date/Time:	12/16/2014 7:30:00 AM
End Date/Time:	12/16/2014 12:00:00 PM
Last Inspection:	Tuesday, November 18, 2014

Permitee: **ALTON COAL DEVELOPMENT LLC**

Site: **COAL HOLLOW**

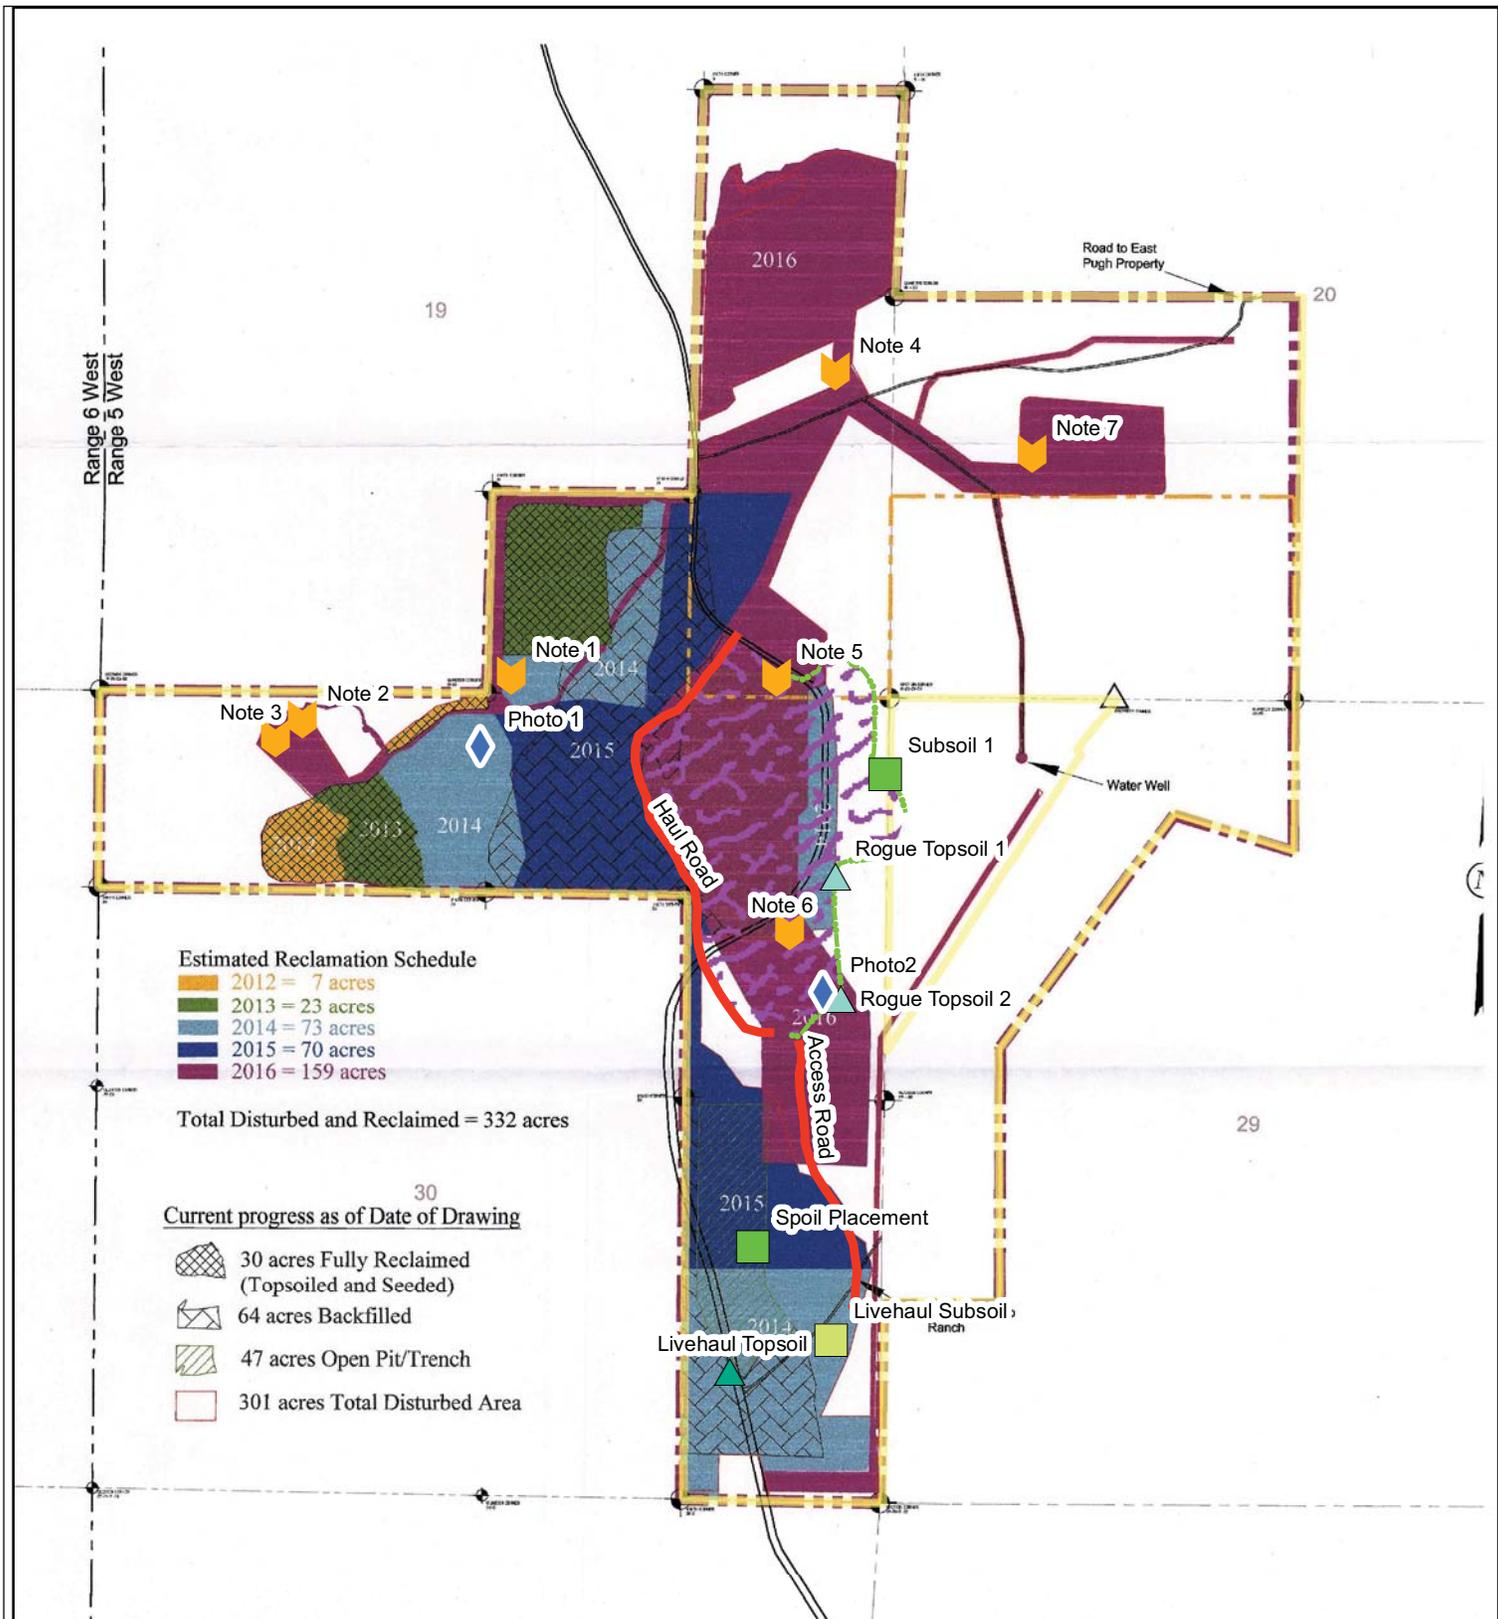
# Inspection Points

Date	Label	Comment
12/16/2014	Photo 1	Look at Robinson Creek Sitting on excess spoil pile with subsoil. Everything covered in snow is topsoil
12/16/2014	Note 1	Robinson diversion ditch repairs. Reshaped, bunched geotextile was visable between the riprap. Waddles added above. Rills below reclaimed pits repaired with waddles placed along stream edge.
12/16/2014	Note 2	Pond 3. Repair of rill looking good
12/16/2014	Note 3	Spillway location, Difference in pond water level photo. Geo mat visable at spillway inlet and outlet
12/16/2014	Note 4	Coal fines in creek and waddles needing maintenance.
12/16/2014	Note 5	Edge of Active Area. North western edge of pit 10
12/16/2014	Subsoil 1	Subsoil pile
12/16/2014	Rogue Topsoil 1	Rogue top soil pile with trash, requested to be removed by january
12/16/2014	Rogue Topsoil 2	Rogue top soil pile, requested to be removed by january
12/16/2014	Photo2	Photo looking into HW 1 trench

12/16/2014	Note 6	Edge of Active Area. Edge of bench above current HW1 trench
12/16/2014	Spoil Placement	Spoil placement over Pit 24
12/16/2014	Livehaul Subsoil	Subsoil to backfill current pits, rills present in the placed AOC subsoil that will need repairs.
12/16/2014	Livehaul Topsoil	Top soil pile to be spread over active subsoil area grading
12/16/2014	Note 7	Drill seeded 12/11/14. Seeded approximately 1 acre Topsoil pile #2

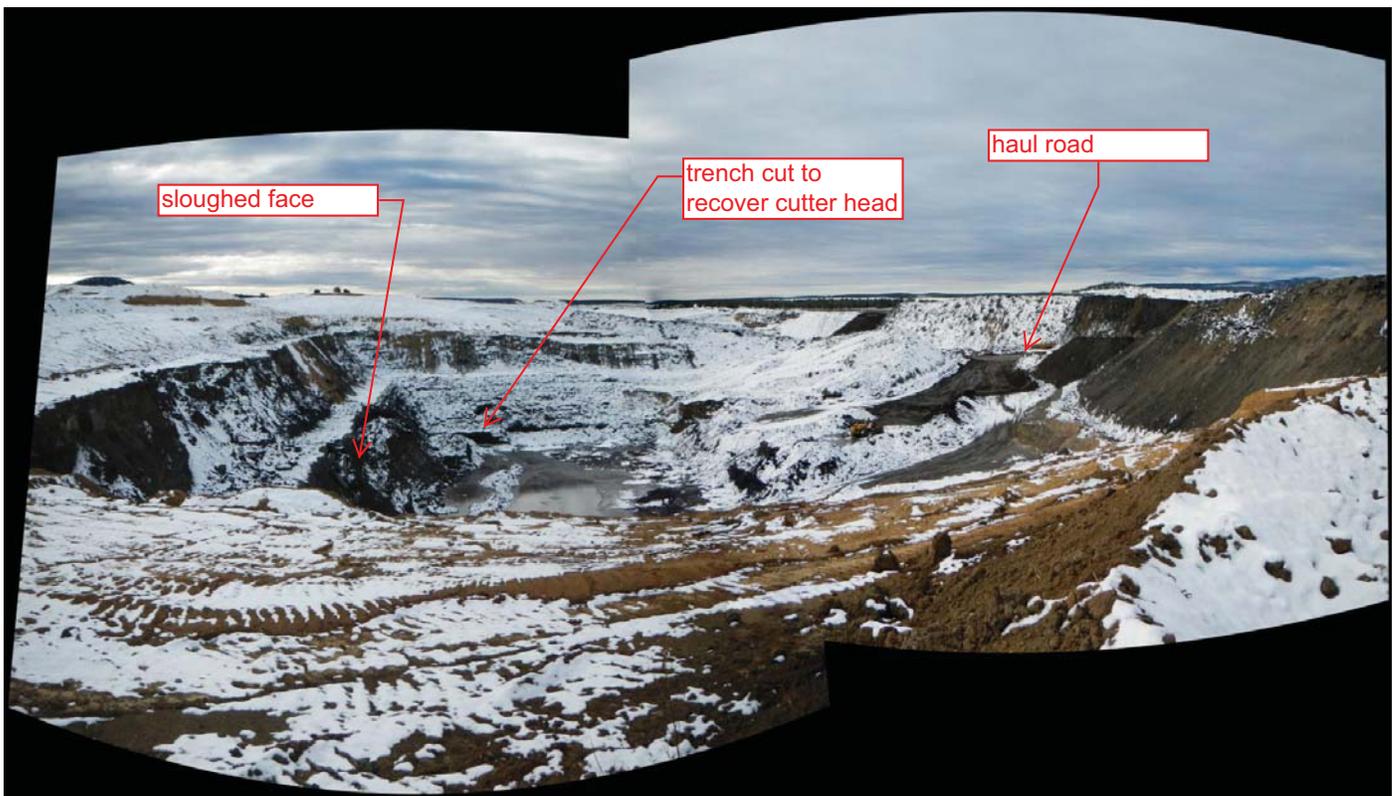
No activity in pit 10.

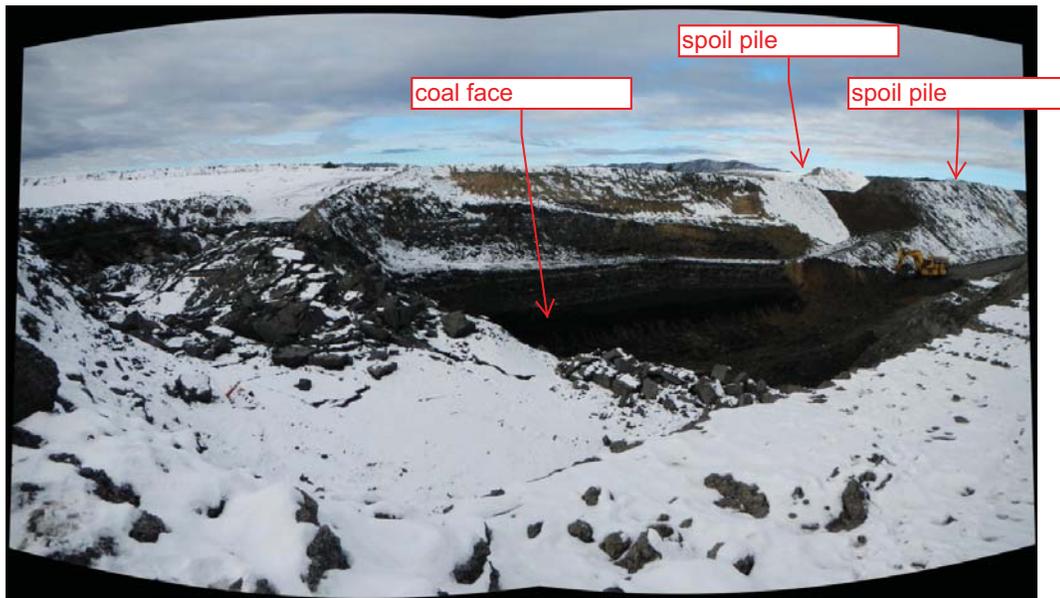
HWT 1 development.

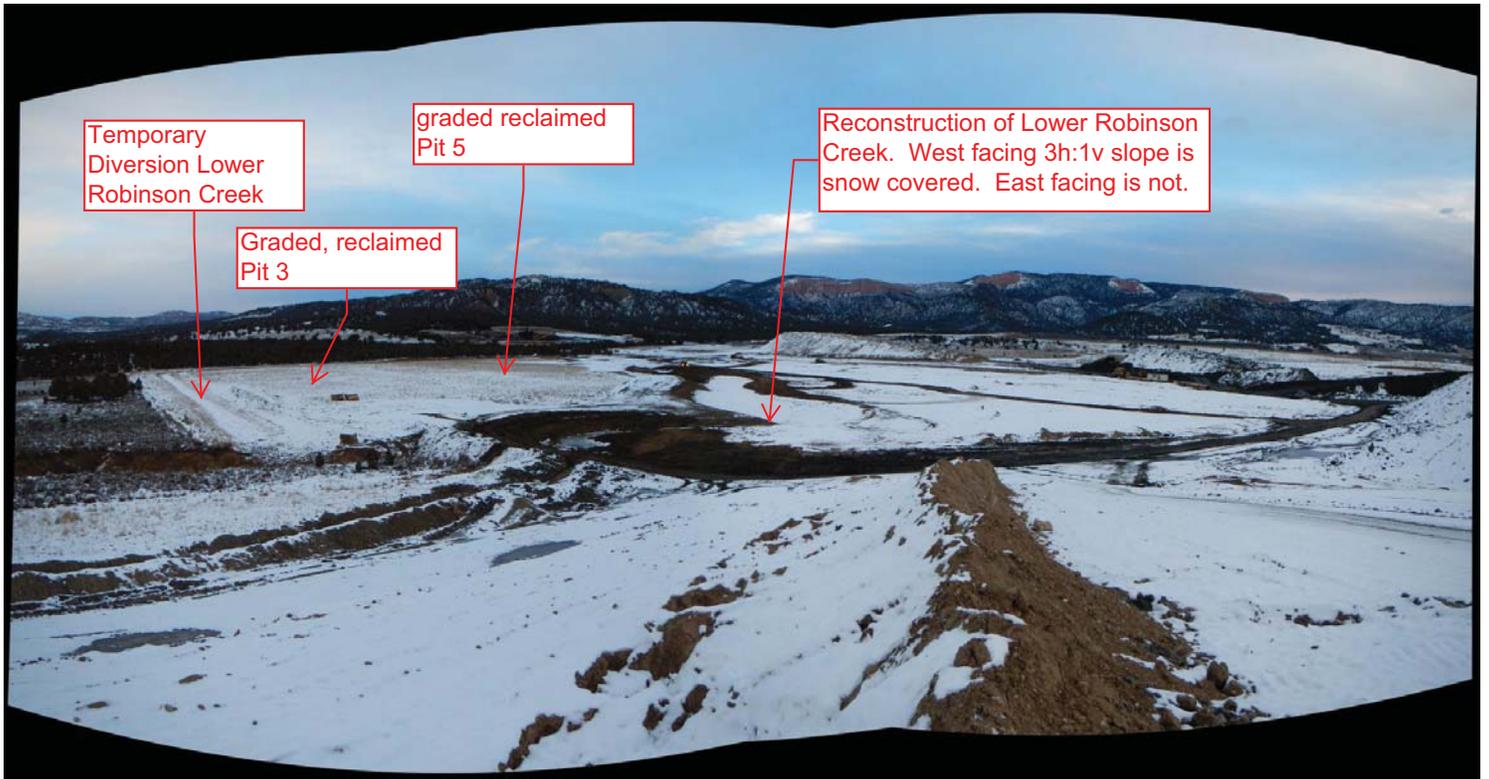
Robinson Creek Reconstruction refer to Dwgs 5-20A and 5-21A. We observed this work from a distance. Two road graders and a dozer were working the subsoil. According to the approved design, rock riprap and mulch matting will be installed.

Lower Robinson Creek reconstruction.

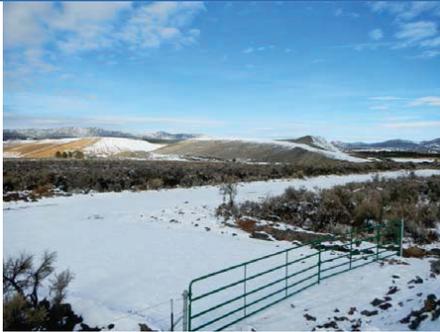
A two and a half acre area on the south side of the Excess Spoil pile was recently seeded. The area was snow covered and seen from a distance. Haul trucks were dumping spoil from High Wall Trench 1 onto the bench adjacent to the highwall. The temporary spoil pile east of the Excess Spoil pile was not being utilized.

Photo 1 : West fence and County Rd. Recently seeded Excess spoil pile in distance and to its right the second spoil pile.

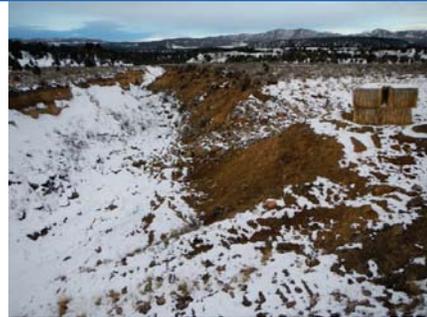
Photo 2 : Temporary Diversion outlet and Lower Robinson Creek

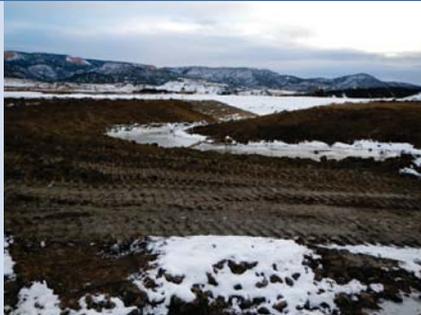
Photo 3 : South end of Robinson Creek Reconstruction

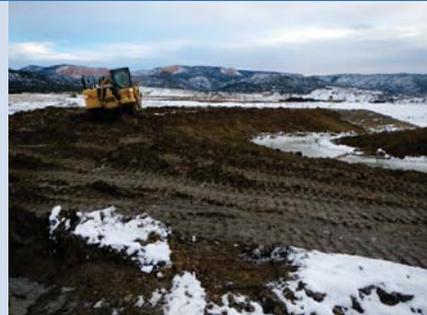
Photo 4 : Road grader levels south end of Reconstruction of Robinson Creek

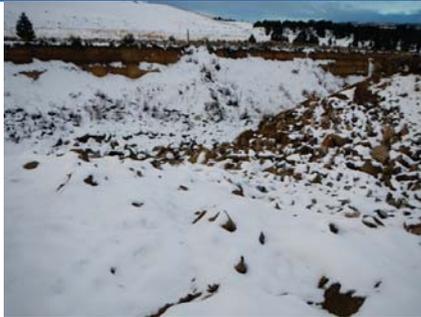
Robinson Creek Temporary Diversion: refer to Dwgs 5-20 and 5-21. The Robinson diversion ditch repairs were place with geofabric visable in bunches between the riprap.

Photo 5 : Repaired Robinson Creek Diversion outlet

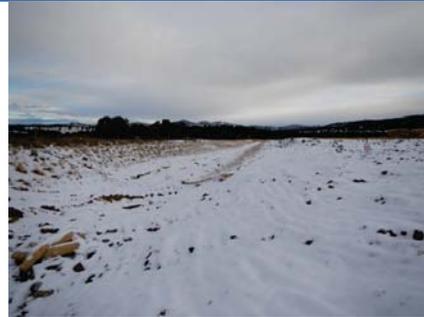
Excelsior logs were placed along the west side of reclaimed Pit #3. Logs were installed using wooden stakes, in the area recently graded. Extra logs at the site will be installed by January to connect the line of logs to the berm along the dam at the south end of the Reconstruction of Robinson Creek.

Photo 6 : Excelsior logs installed along reclaimed Pit 3 at Temporary Robinson Creek Diversion

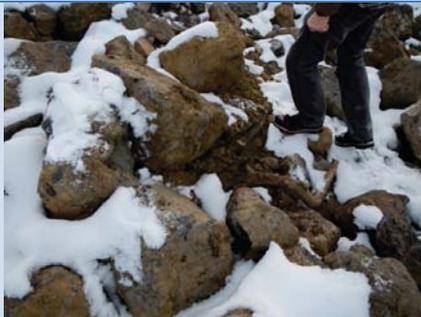
Photo 7 : Geotextile wadded up in Robinson Creek Diversion outlet

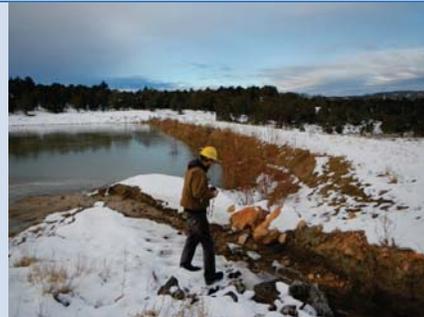
Photo 8 : Ditch 4 inlet to Pond 3

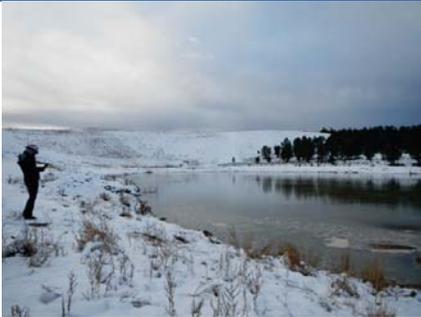
The gully on the Excess Spoil pile was seeded last week. Straw matting was placed over the seeded area and pinned down. One ton bale of hay was scattered at the crown of the hill. Additional waddles were added above the site of the repair to divert direct runoff from channeling. It was not closely inspected, due to snow cover. The repair was observed from Pond 3 and appeared to be stable.

Photo 9 : Pond 3 with Excess spoil repair visible in background

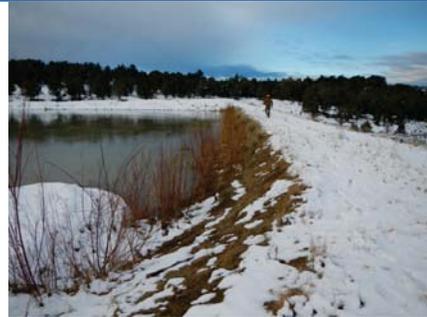
Photo 10 : Pond 3 Tamarix

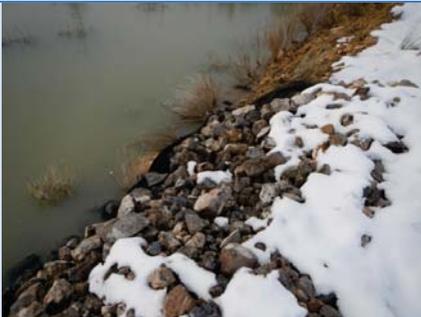
Sediment Pond #3 spillway: Refer to Dwg 5-30. The pond spillway has been rebuilt to design. Fabric has been laid beneath the rip-rap to strengthen the spillway outlet. The water level in the pond is still elevated from it was filled during the rain storms in September.

Photo 11 : Pond 3 geotextile fabric and rip rap repair of Spillway inlet

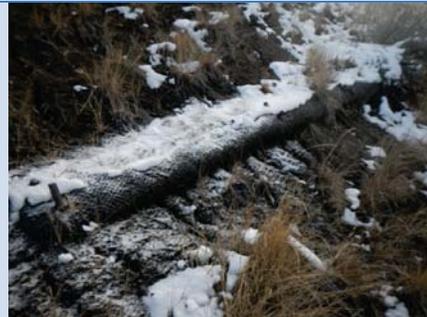
Photo 12: Waddles above Culvert 9 needing maintenance

Another excelsior log is requested above culvert C9.

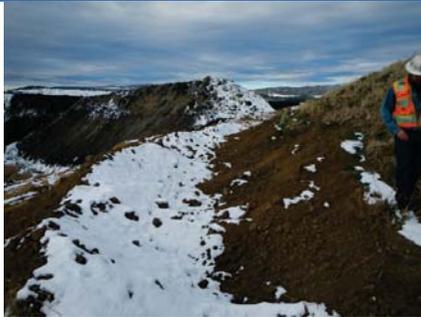
Topsoil pile 4 berm signs were visible. The southeast side berm was recently repaired and will be seeded. The west side berm along the road needs definition.

Photo 13 : Topsoil pile 4 berm repair

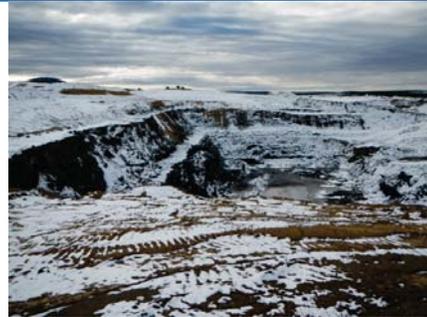
Photo 14 : Pit 10 Highwall sloughed and the coal face showing

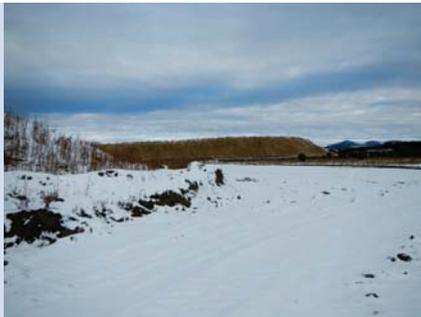
Photo 15 : Subsoil pile seen from east at topsoil pile 4

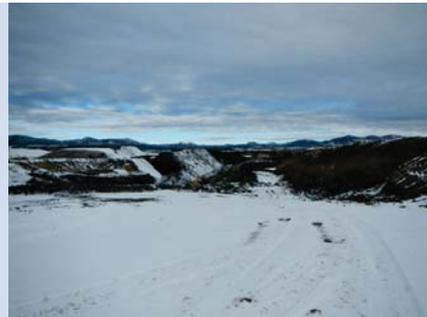
Photo 16: Highwall Trench 1 construction and spoil piles

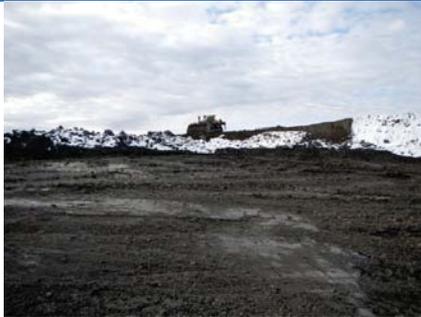
Photo 17 : Dozer grading spoil over Pit 24

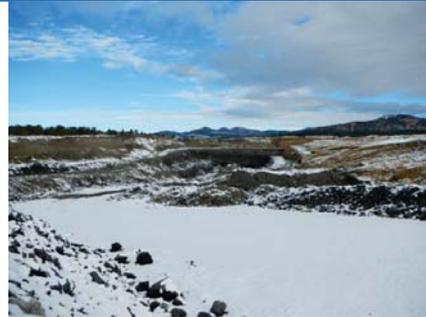
Photo 18 : Access to Pit 21

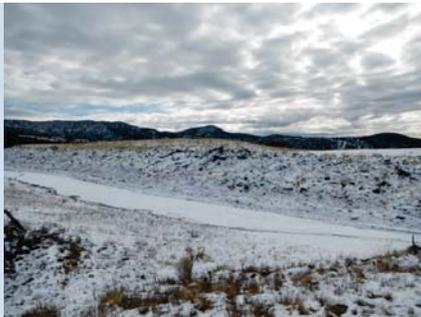
Photo 19 : Topsoil pile 2

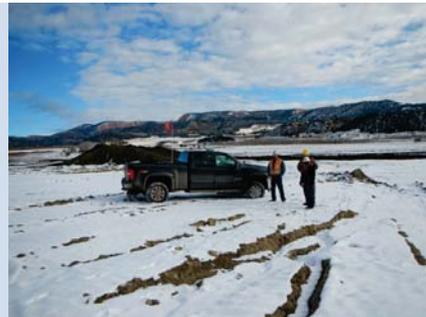
The subsoil that has been placed over Pits 26-27 appeared to have rills developing on the surface. The rills will need to be repaired before topsoil and seeding takes place.

A dozer was pushing fill over Pit 24, near Subsoil 2 on the attached figure. Subsoil was placed on the southern pits 28 - 26. Some erosion of the subsoil was evident near the permit boundary. This subsoil will require regrading prior to topsoil application. Grading to AOC continues along Pits 24-25 and along with the Robinson Creek reconstruction through Pits 3, 5, and 6. The attached figure shows the approximate disturbed area that contains active, open pit 9-10 and highwall mining operations.

Photo 20: Erosion of subsoil above reclaimed Pit 28 and subsoil pile
