Coal Hollow Mine 025005 Technical staff site inspection, 9/30/2014

Inspection Report

Permit Number:	C0250005
Inspection Type:	TECHNICAL
Inspection Date:	Monday, September 29, 2014
Start Date/Time:	9/29/2014 2:00:00 PM
End Date/Time:	9/30/2014 12:30:00 PM
Last Inspection:	Tuesday, September 09, 2014

Site: **COAL HOLLOW**

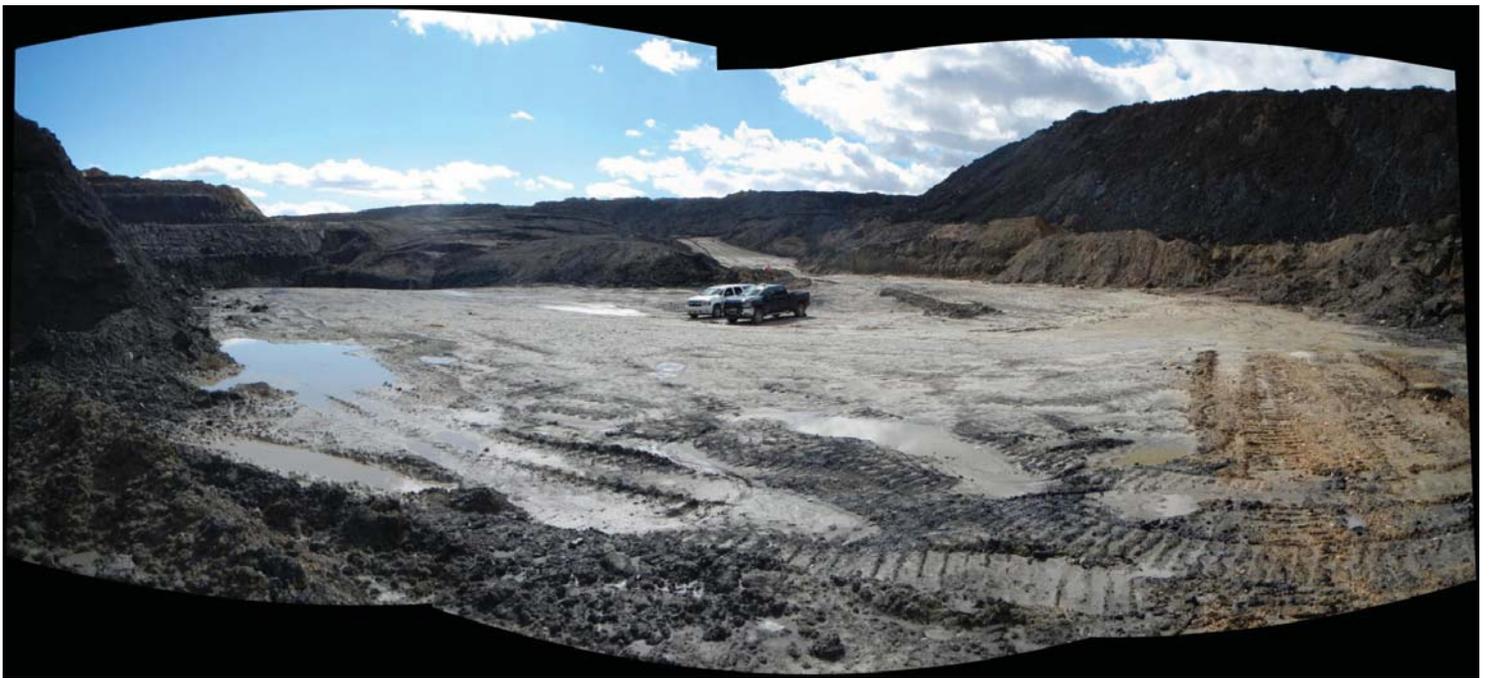
Pit 9 has been partially backfilled, but will not be completely backfilled until the stuck auger can be removed from the last panel. A second auger was used to complete mining in Pits 23 and 22 and was currently on the surface for maintenance. Pits 22 and 23 were partially backfilled. Auger panels were visible in Pit 22.

Partially backfilled Pit 9 and entrance to pit 10.

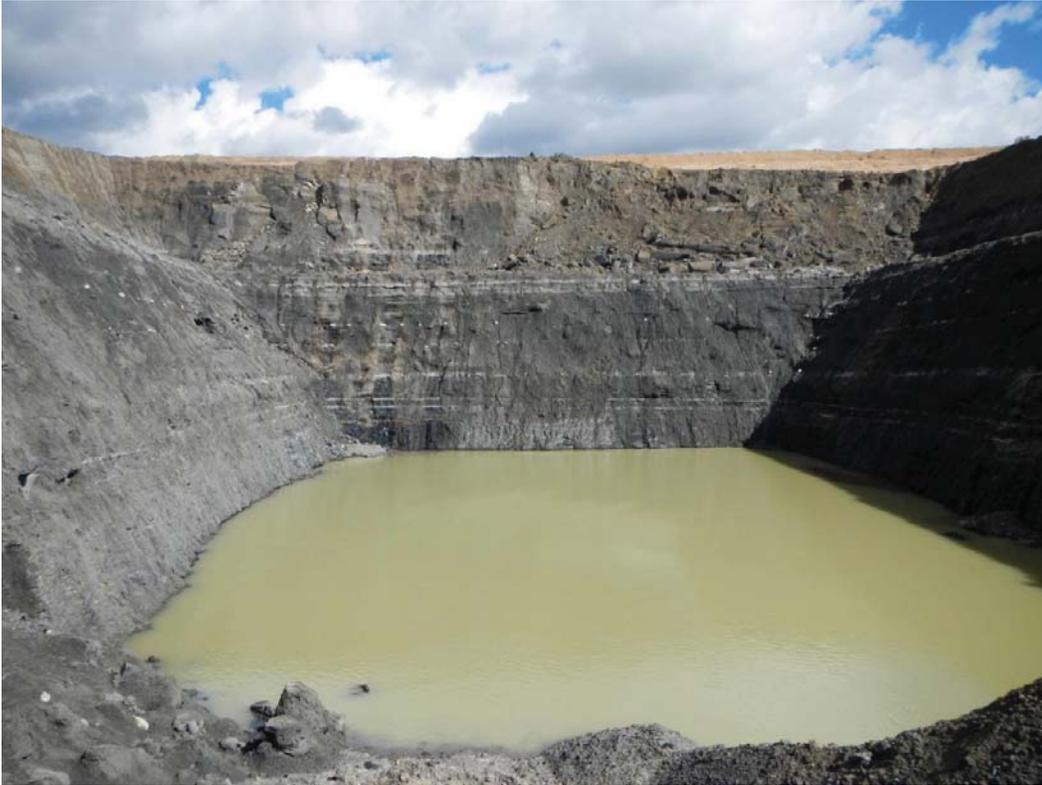
The coal seam was exposed in Pit 10 which has been opened on about one quarter of its length. Pit 10 may be the location of the proposed underground portals. The highwall in pit 10 is benched every 40 feet (two benches) and the alluvium height is approximately 30 ft. for a total of 110 ft. of cover. The 40 ft highwall above the portals would be shot-creted to prevent sloughing of the shale.

Above: Pit 10. Below: Kirk Nichols addresses Cheryl Parker, Lisa Reinhart, Joe Helfrich, Steve Christensen, Amanda Daniels, and Keenan Storer

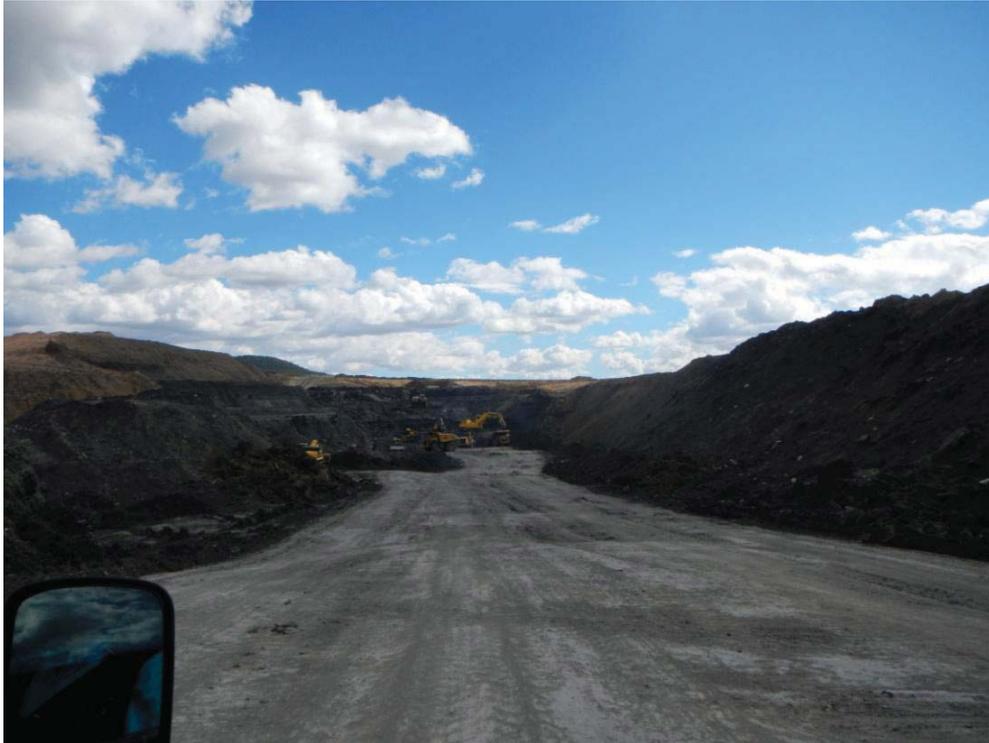
South end of Pit 9 where Trench 1 is under construction.

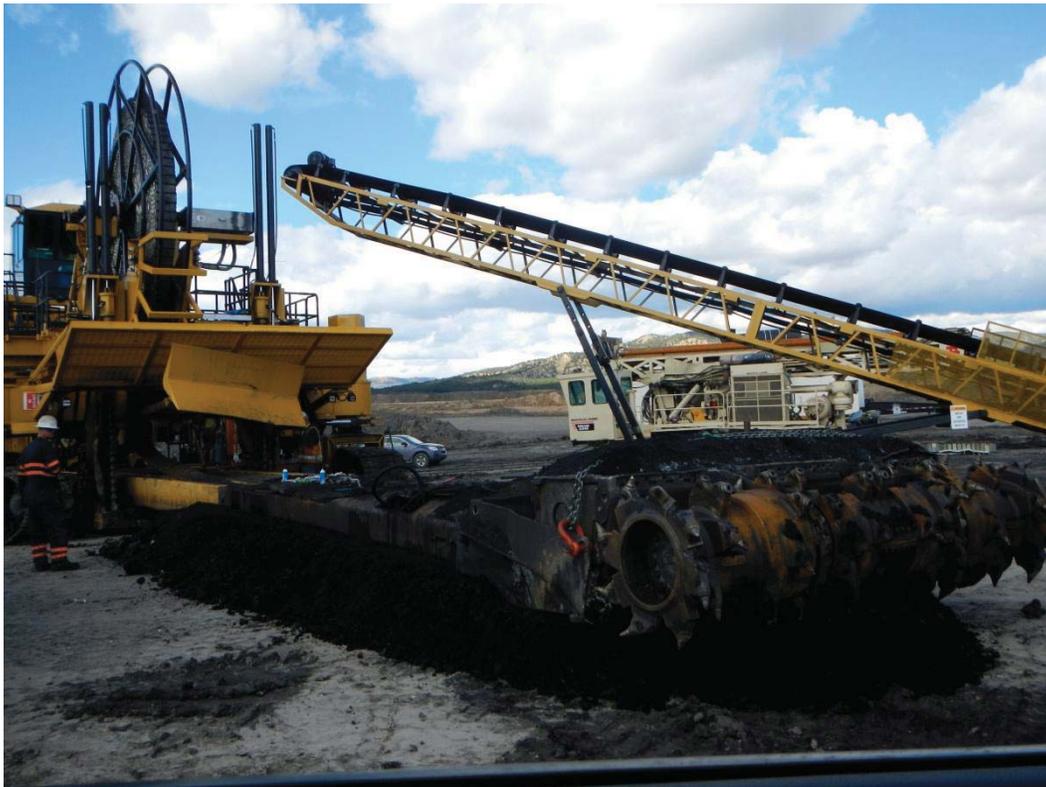
Auger bit under maintenance.

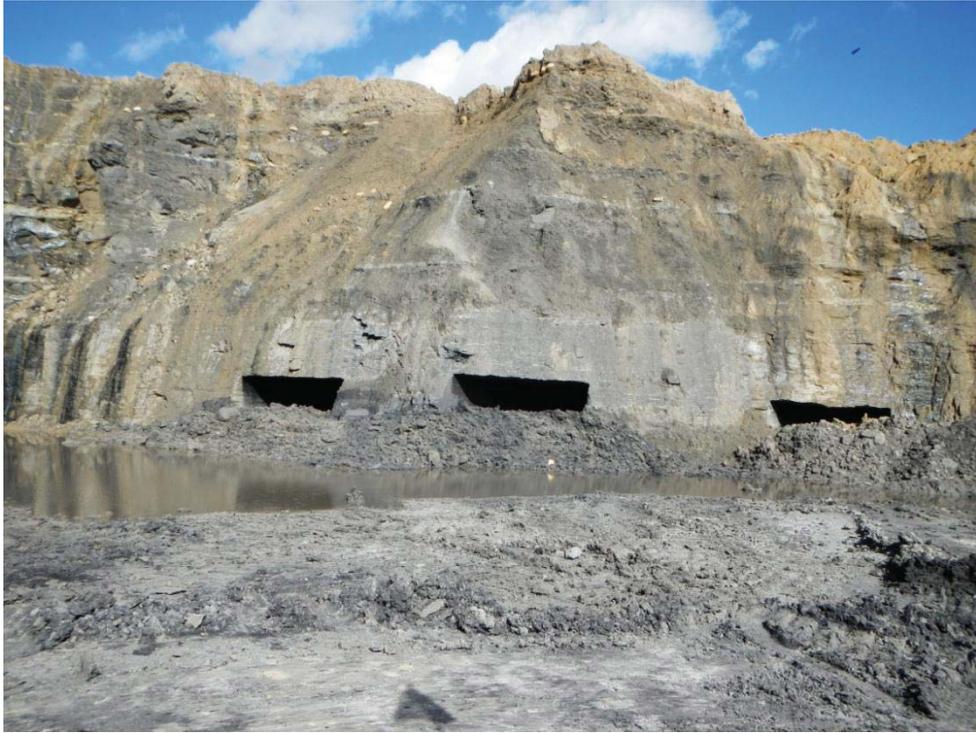
Above: Pit 22 partially backfilled.

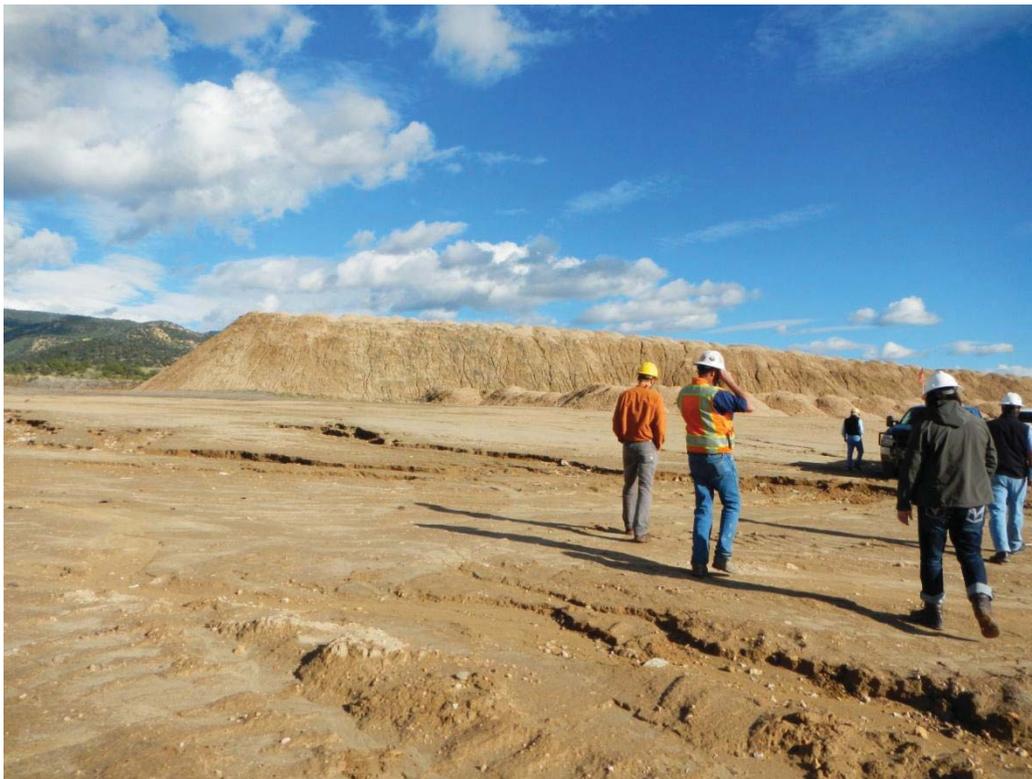
There was approximately 200,000 cu yards of subsoil stockpiled in the location of subsoil stockpile #2.

Graded pit 6 and 200,000 cu yds of subsoil stockpiled in background.

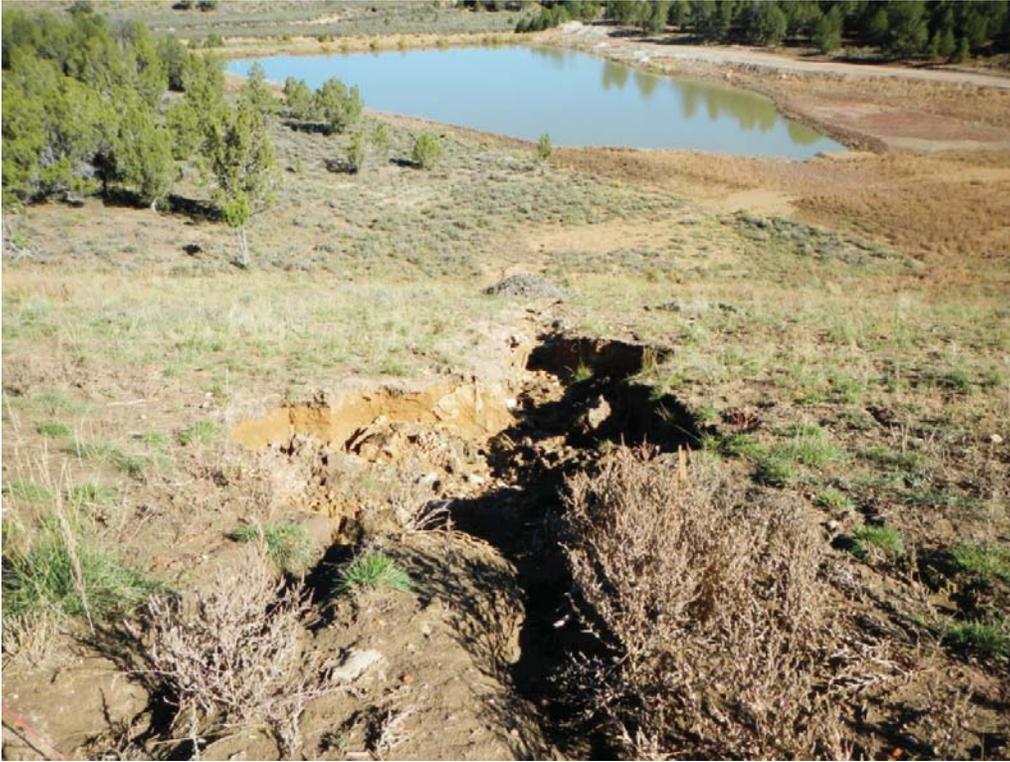
Recent storm events have exacerbated the rill located on the north side of the reclaimed spoil pile adjacent to Pond 3. A number of options were discussed with the Permittee including :pocking, ripping along the contour, mounding the depressions on the top of the pile to eliminate ponding, excelsior matting and wood straw, and ensuring good surface roughening before topsoil placement.

Looking downhill at erosion rill located on the northwest side of the reclaimed spoil pile adjacent to Pond 3.

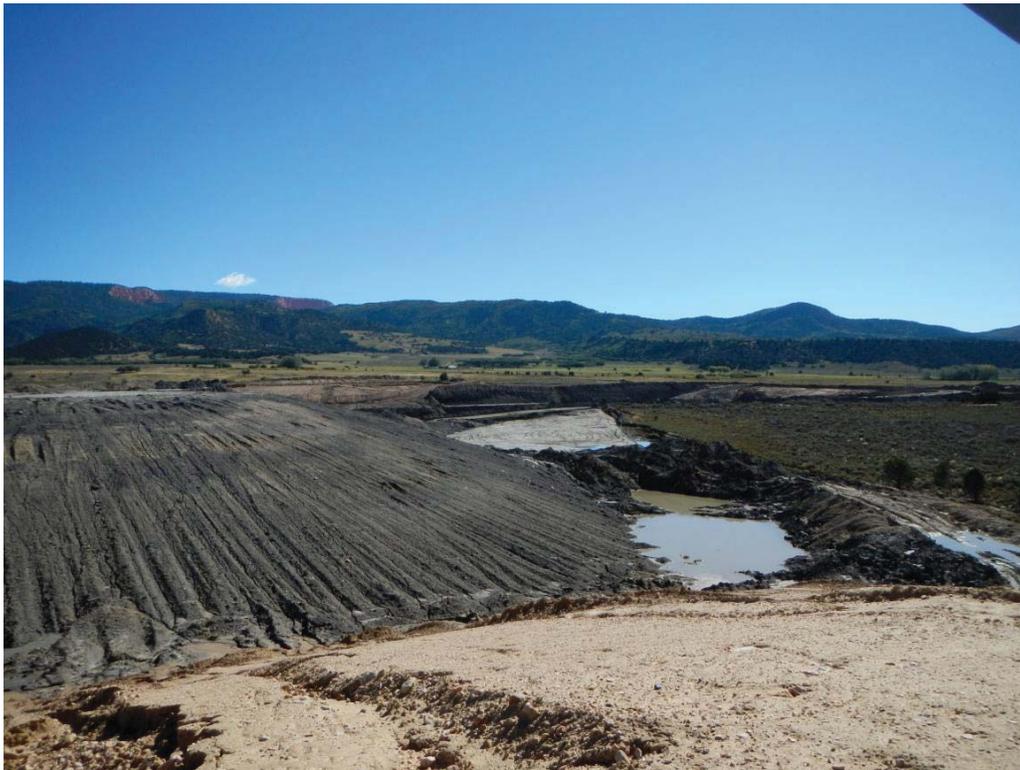
Spoil pile extending over former pits 7 & 8.

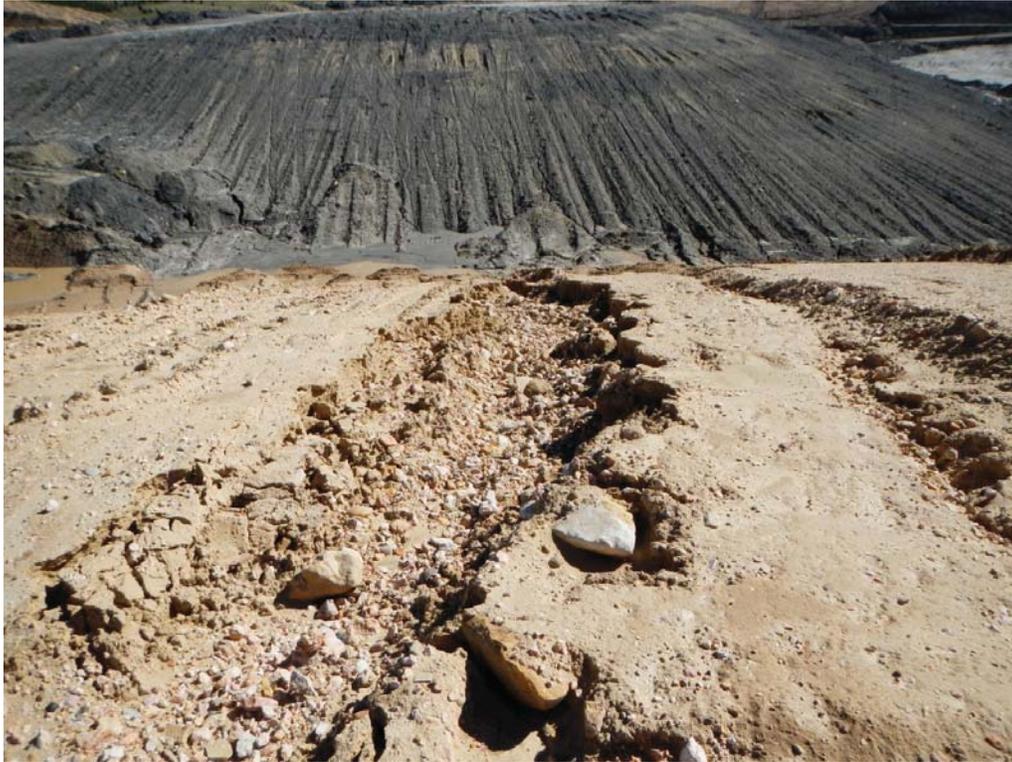
Erosion of subsoil on surface of the graded spoil pile will be roughened before topsoil placement.

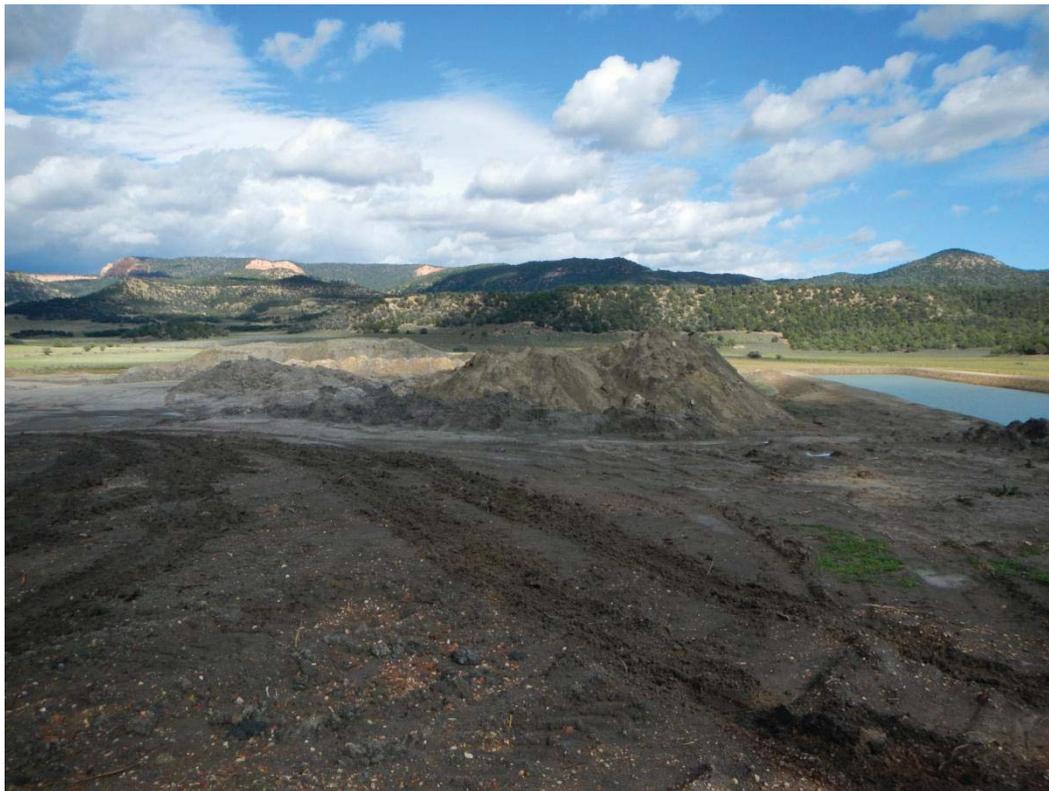
Topsoil was noted in a windrow on the contoured surface of pit 3 and 5, ready for redistribution over that surface. Topsoil was also noted windrowed on the east boundary of east of Pit 22 for redistribution over contoured pits 28 -25. Topsoil was also noted windrowed east of Pit 10. These stockpiles of topsoil will be used in reclamation this fall.

Above: topsoil and subsoil piles in the vicinity of graded pits 25 - 28. Below: Topsoil windrowed on graded pits 3 and 5 adjacent to graded spoil pile.

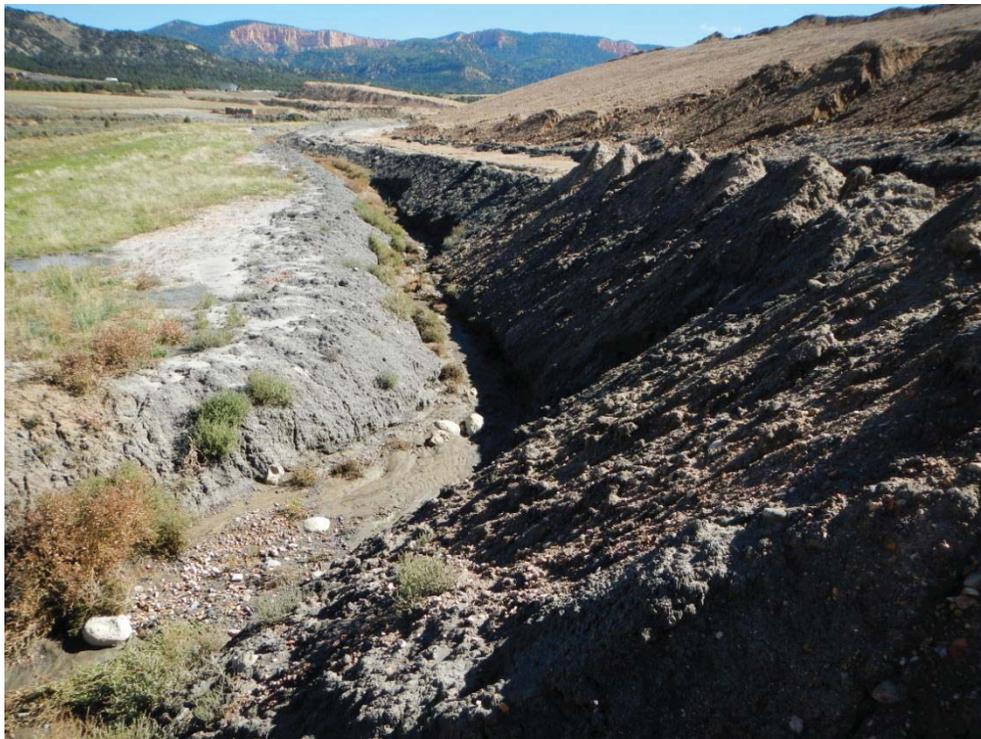
Ditch 4 overtopped and the outside berm requires maintenance.

Issue #4. Ditch #4 requires maintenance adjacent to the spoil pile.

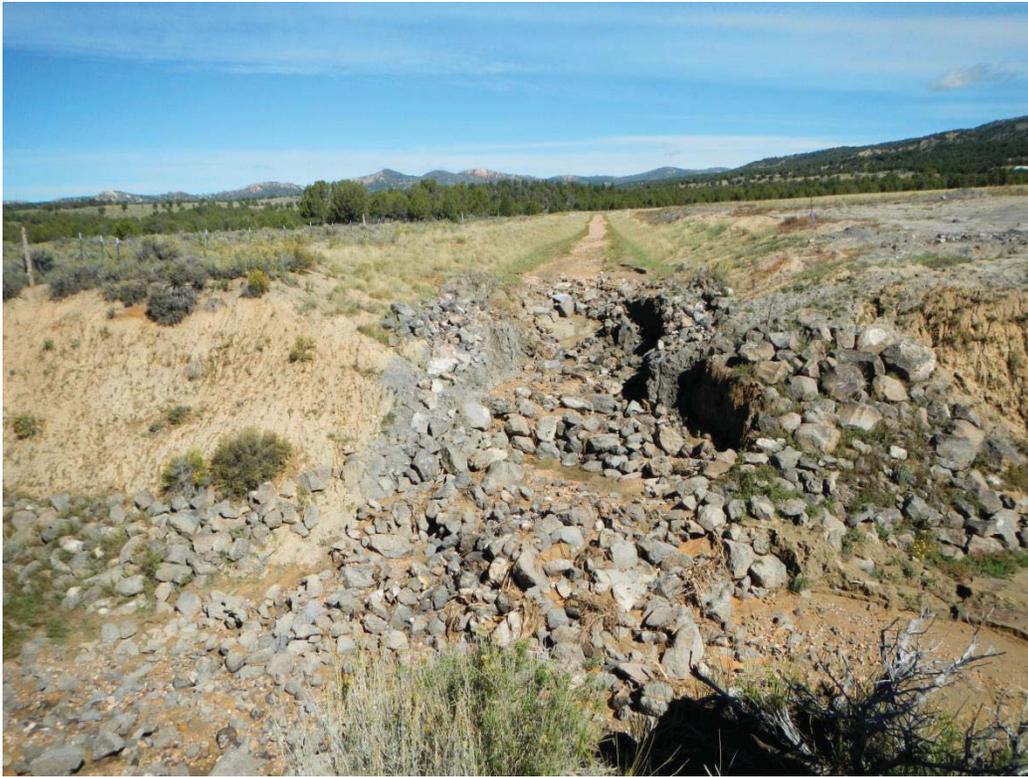
Excessive erosion was observed at the Robinson Creek diversion outlet (See picture). A significant amount of rip rap armoring had been dislodged and excessive cutting was observed on the side slopes of the diversion channel. The erosion has extended from the outlet up-gradient into the diversion channel itself (approximately 50 feet).

Erosion of Re-aligned Robinson Creek outlet.

The Permittee must repair the outlet of the Robinson Creek diversion to the natural drainage channel to comply with the approved design shown in Figure 5-21, Robinson Creek Temporary Diversion Design & Details. If, based on the amount of material that was lost from recent storm events, it's not possible/practical to re-establish the outlet to conform to the approved design, the Permittee must design a new outlet armoring plan and submit it to the Division for approval prior to construction. The plans would require certification per R645-301-512.

The Permittee must repair the eroded section of the Robinson Creek Diversion immediately up-gradient of the outlet to the natural Robinson Creek drainage. The approved diversion ditch details shown on Figure 5-21, Robinson Creek Temporary Diversion Design & Details provides a cross-sectional drawing for the diversion. The drawing details a trapezoidal channel with a 3:1 slope for the side channels, 2 feet of channel bottom and a minimum depth of 5 feet. The impacted sections of the diversion will need to be repaired to conform to the approved design.

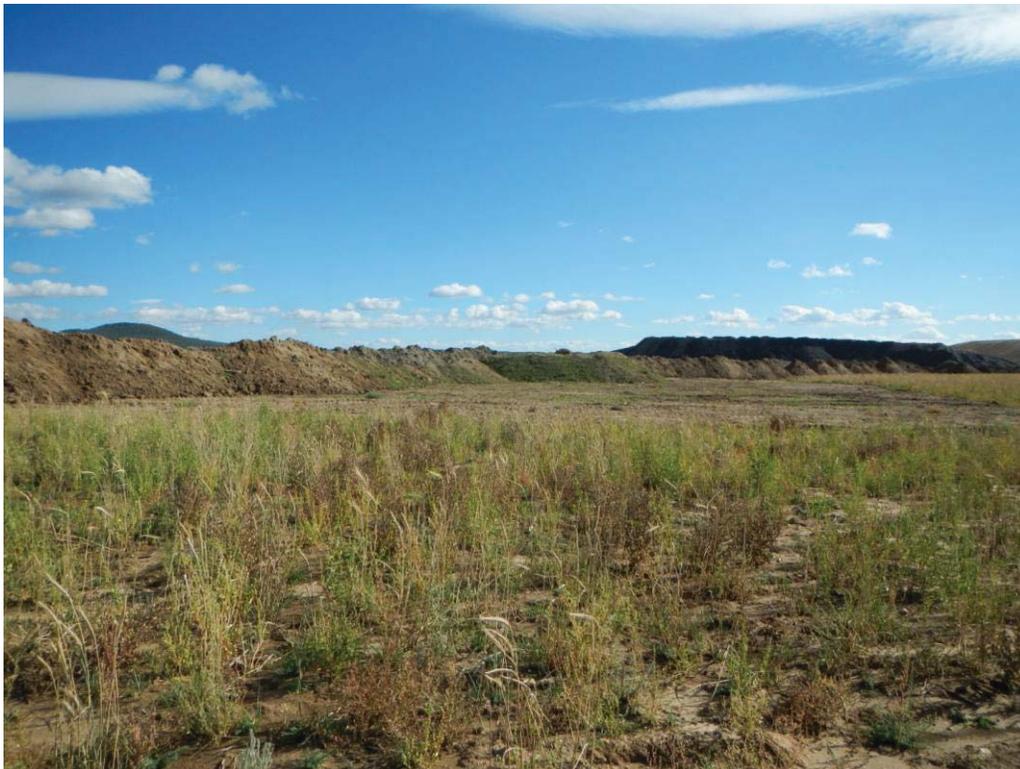
Pit 5 surface reclaimed in the fall 2013.
