# Inspection Report

Permit Number:	C0250005
Inspection Type:	PARTIAL
Inspection Date:	Tuesday, February 10, 2015
Start Date/Time:	2/10/2015 7:30:00 AM
End Date/Time:	2/10/2015 1:00:00 PM
Last Inspection:	Monday, January 12, 2015

Permittee: **ALTON COAL DEVELOPMENT LLC**  
 Operator: **ALTON COAL DEVELOPMENT LLC**  
 Site: **COAL HOLLOW**  
 Address: **463 North 100 West, Suite 1, CEDAR CITY UT 84720**  
 County: **KANE**  
 Permit Type: **PERMANENT COAL PROGRAM**  
 Permit Status: **ACTIVE**

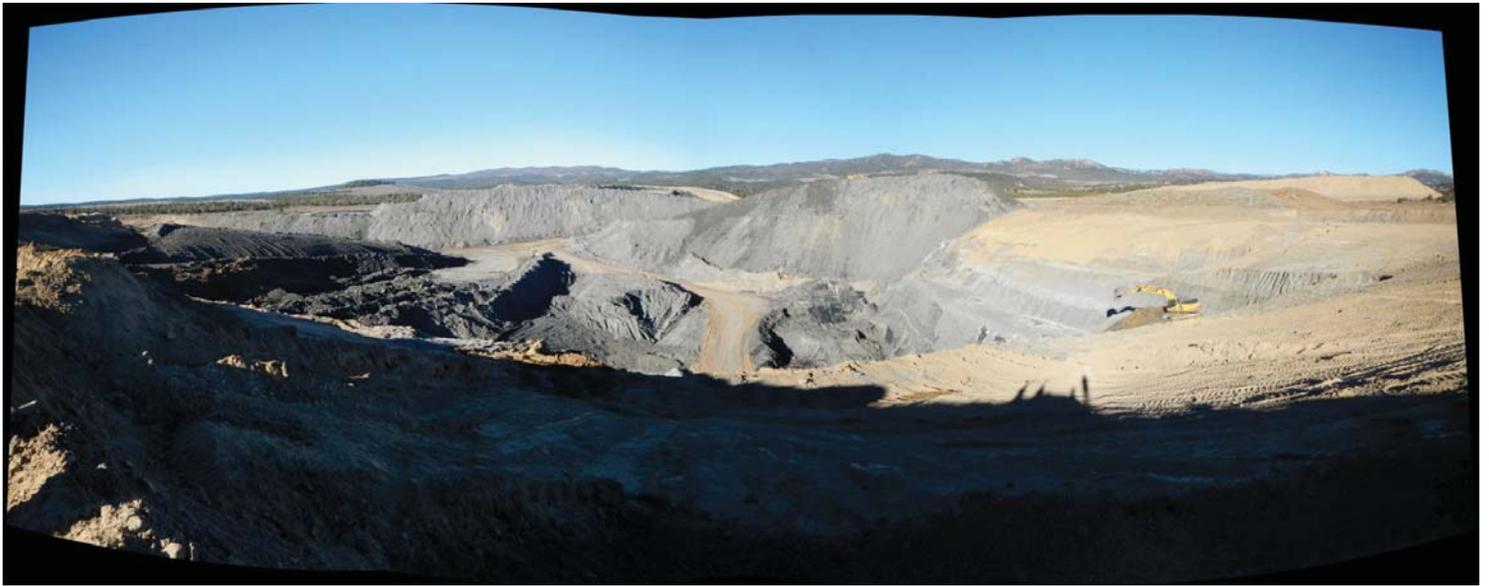
Panorama: Phase 1 area: Pit 9 is on the left. A hoe is facing up the Pit 10 highwall on the right. Dozers push the spoil pile in the center of the photo. Topsoil pile #4 is directly above pit #10. Subsoil Pile #2 is directly behind the topsoil pile.

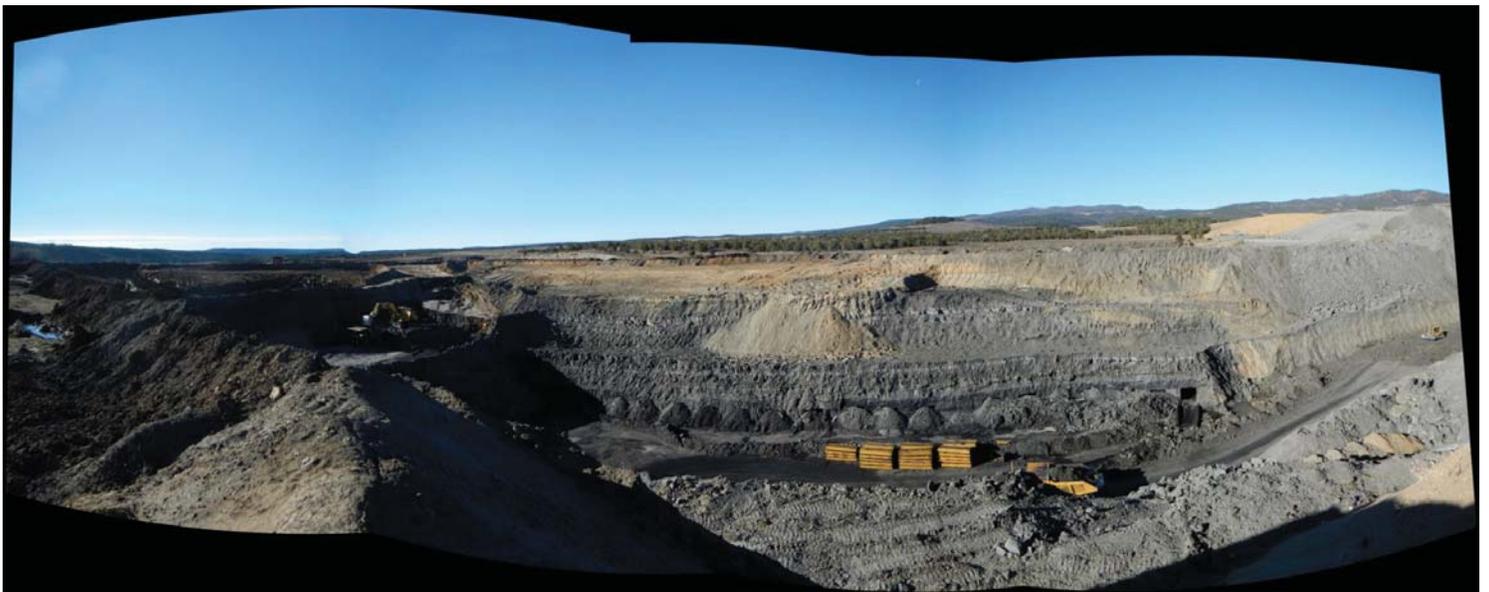
A trackhoe loads a haul truck with recently blasted rock in the onsouth end of HWT1. Auger panel extensions are stacked in front of backfilled panels in HWT 1. A haul truck loaded with spoil backs up to dump in pit #9. At far right, a dozer is ready to grade the dumped spoil.

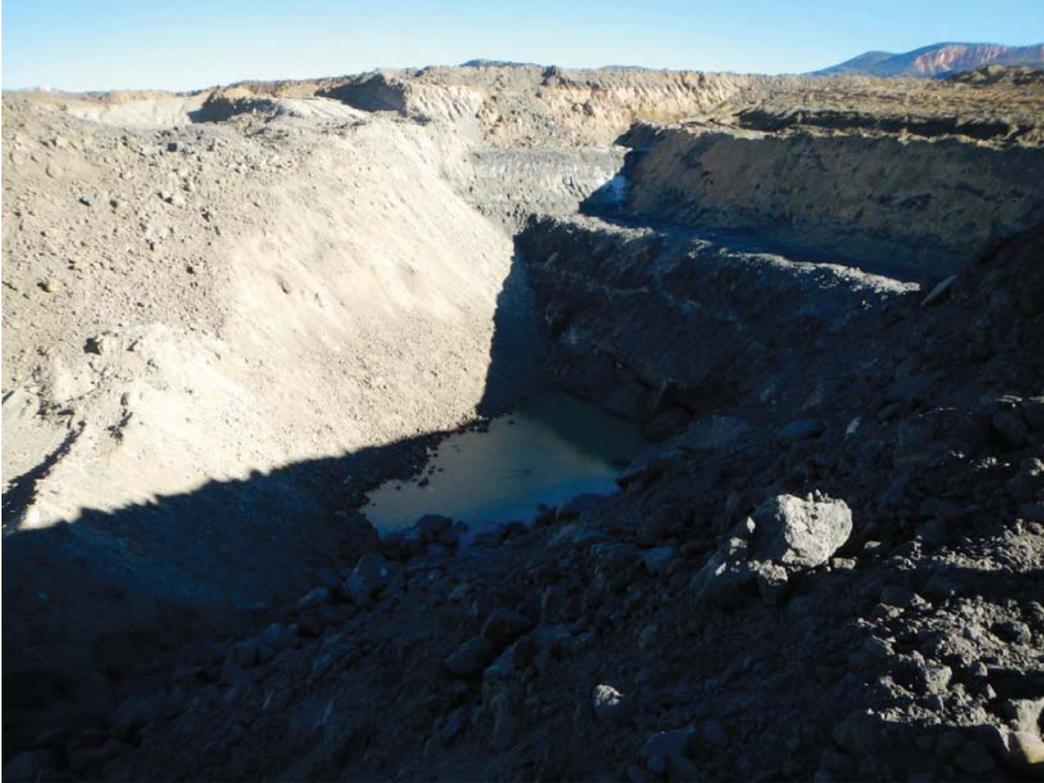
Pit 21 partially backfilled.

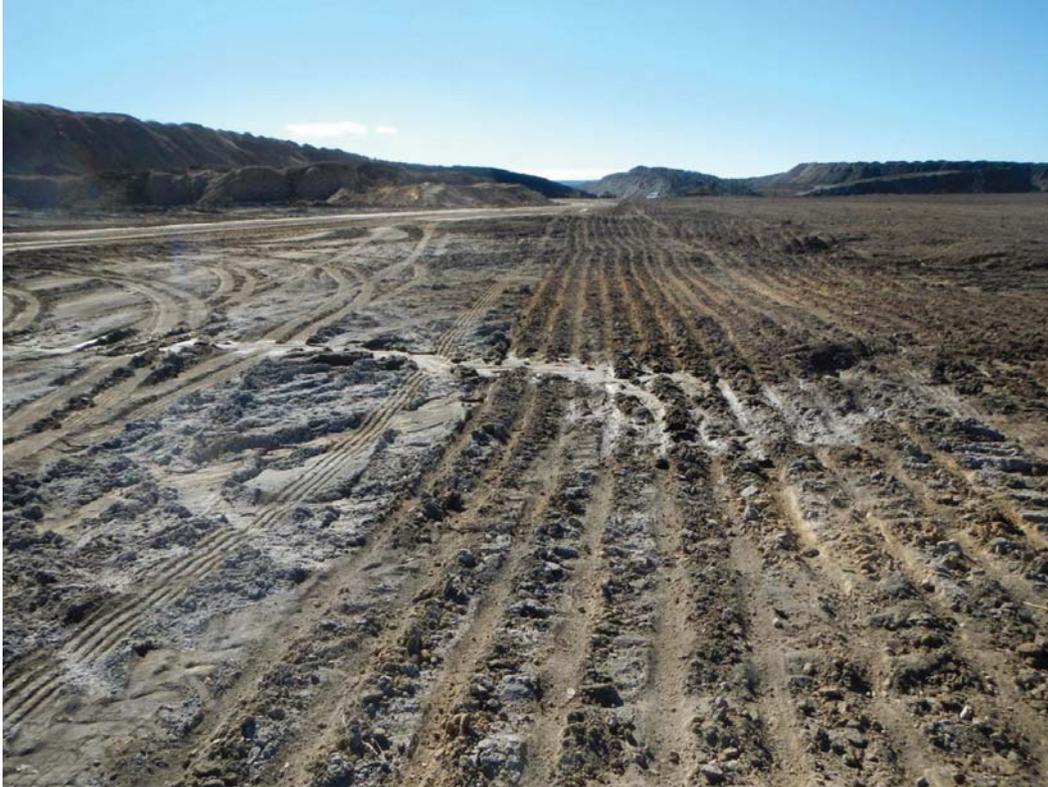
A berm is needed to stop the water flow from the operations area (left) from the Pit 5 area (right) included in bond release.

A berm or ditch is immediately required along the road just west of Pond #2 to prevent water draining from this area and creating rills in the recently topsoiled and seeded surface above Pit 5.

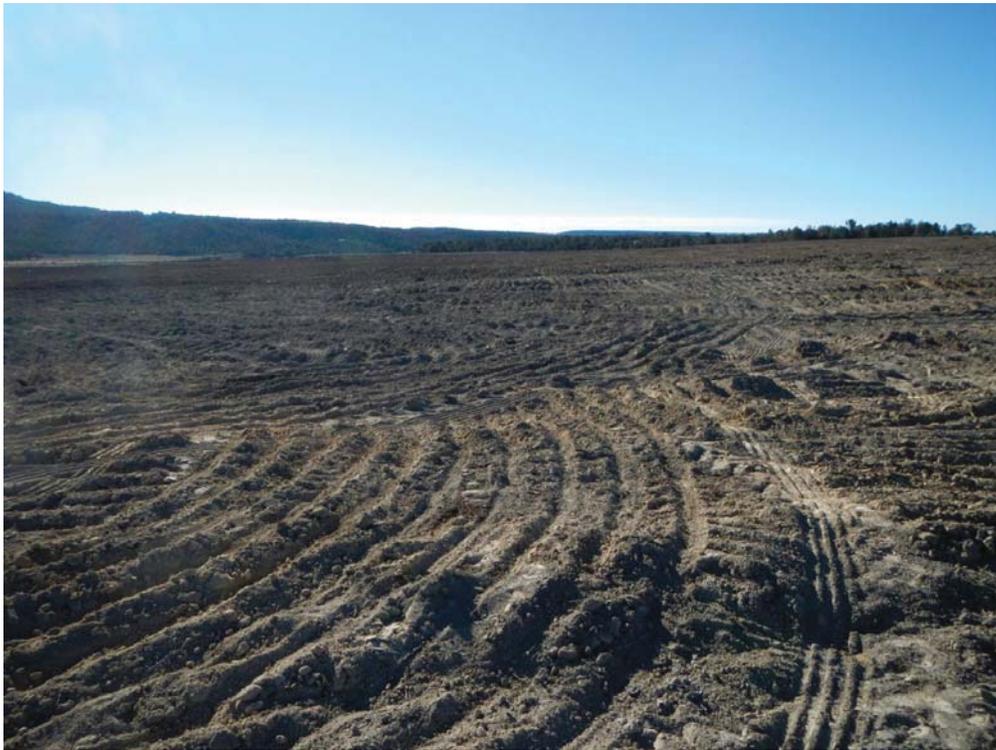
Phase 2 area (pits 28 - 25) included in bond release.

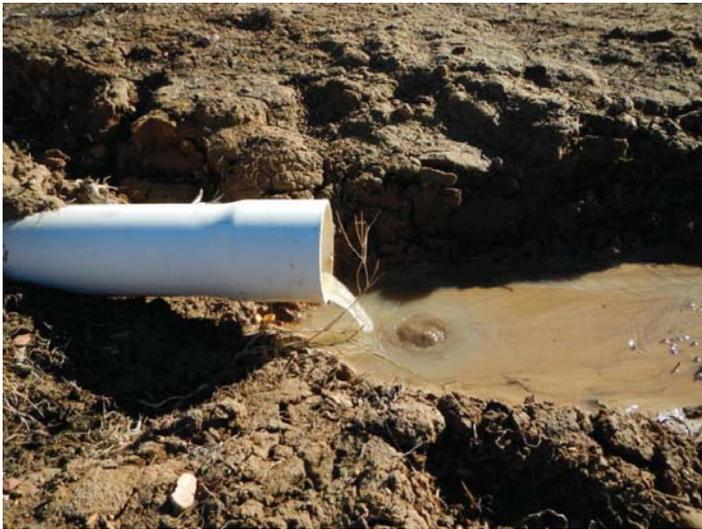
Water flowing in Ditch 1.

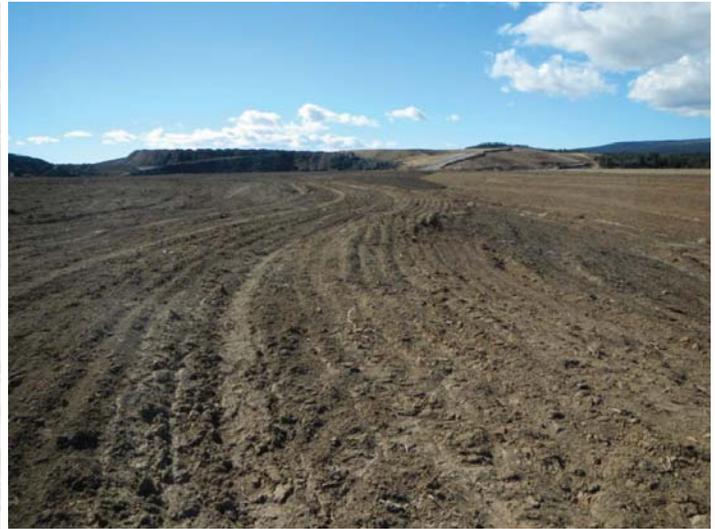
Ditch 4 has been installed in the wrong location along the eastern boundary of the Lower Robinson Creek reconstruction. Also, the elevation of the bottom of the ditch was measured along the ditch length using a GPS. There are low points in the ditch that will not allow runoff to be properly routed to Sediment Pond 3.

Looking South at Ditch #4 near its beginning.

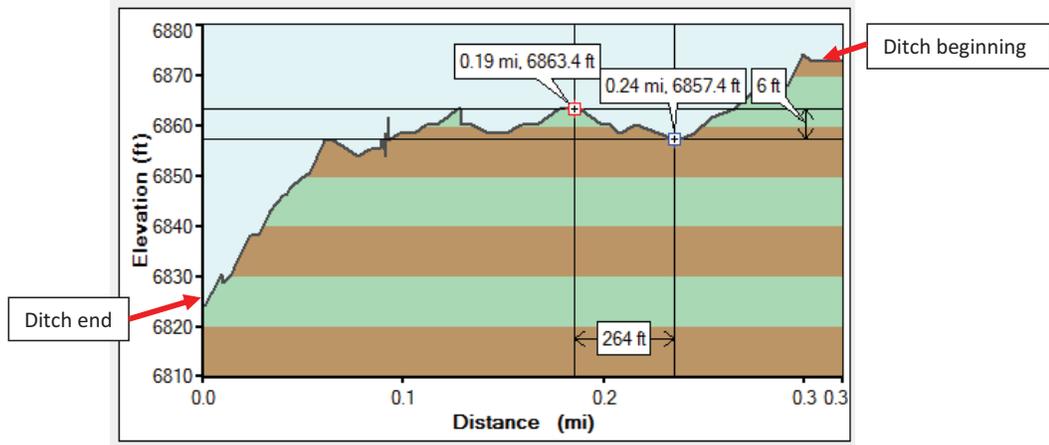
The newly constructed length of Ditch 4 along the eastern rim of Lower Robinson Creek reconstruction was inspected. We walked in the bottom of the ditch with a GPS held at a constant height and measured the elevation of the ditch along its length. A longitudinal profile of the ditch on page 6 shows a 6 ft hydrologic dip over a ~270 ft length of the ditch. The current construction of the ditch means ~20 acres of disturbance are treated by a single straw bale check dam at the lower end of the Lower Robinson Creek reconstruction before exiting the permit area. The Division hydrologist, Keenan, emailed the profile to Kirk and spoke with him over the phone about the current construction of the ditch on February 18, 2015 at 11:30 am. In the conversation, Kirk was asked to submit a surveyed longitudinal profile of the bottom elevation of the ditch along this newly reconstructed section. The ditch will be reinspected upon receipt of the longitudinal profile and during the bond release site visit planned for early March.

A longitudinal profile of Ditch 4 shows the ditch is not graded to properly drain water along its length. The maximum depth of the ditch is ~1 ft, therefore runoff within the ditch will not be able to flow over the 6 ft hydrologic “hump” highlighted in this cross-section.
