Division of Oil, Gas and Mining

Inspection Report

Permit Number:	C0250005
Inspection Type:	COMPLETE
Inspection Date:	Monday, March 23, 2015
Start Date/Time:	3/23/2015 2:30:00 PM
End Date/Time:	3/24/2015 3:30:00 PM
Last Inspection:	Tuesday, February 10, 2015

Site: **COAL HOLLOW**

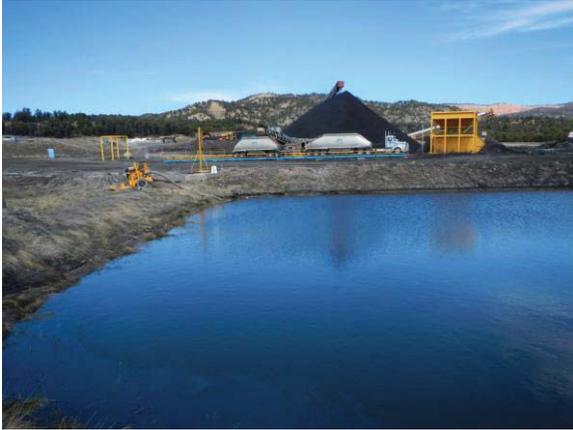
Pond #1 inlet requires maintenance where overland flow from the finished Coal Stockpile area, on the NE side enters. The clean water well valve had been left open and a continuous stream of water was entering pond #1 through culvert 6. The valve was closed during the inspection. Pond #1 was discharging during the inspection. Pond #1 is not sized for this inflow. A similar occurrence occurred in the spring of 2014 when the water storage tanks were continuously overflowing and water was continuously running overland, filling pond 1B. There can be no further leniency on this issue. The next occurrence of overflow from water tanks or clean water well will result in a violation of R645-301-731.120.

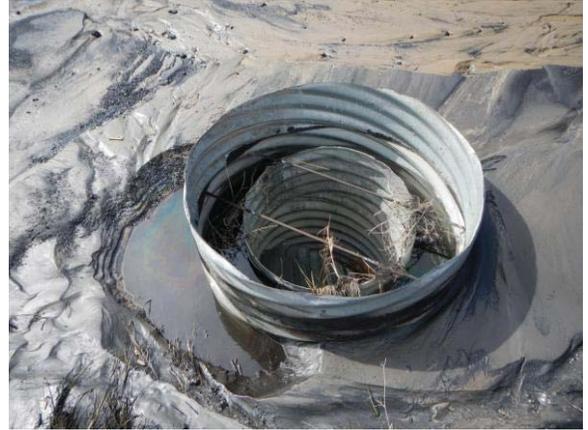
Pond #1 oil skimmer outlet.

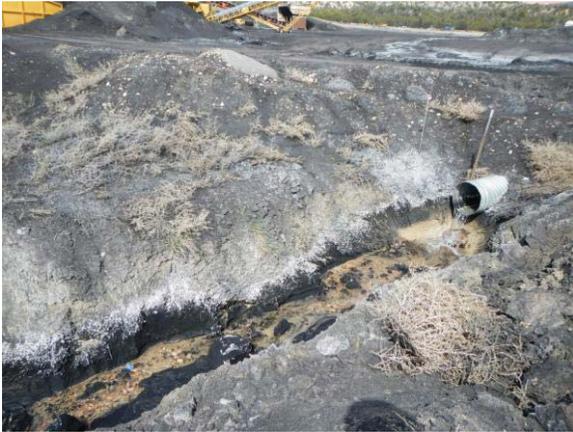
Flow into pond 1 from C6

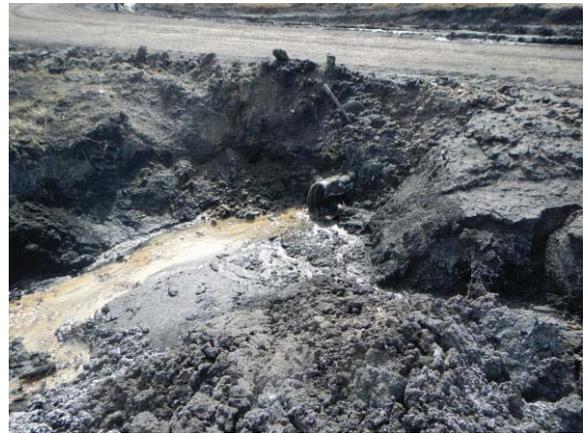
Culverts in the Facilities area shown on Dwg 5-3A were functioning, except C6 which has been crushed and needs repair prior to the next inspection.

Crushed C 6 inlet

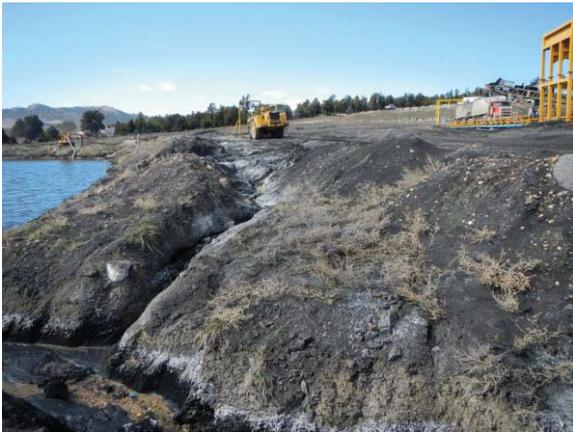
Location of pond #1 inlet clean up.

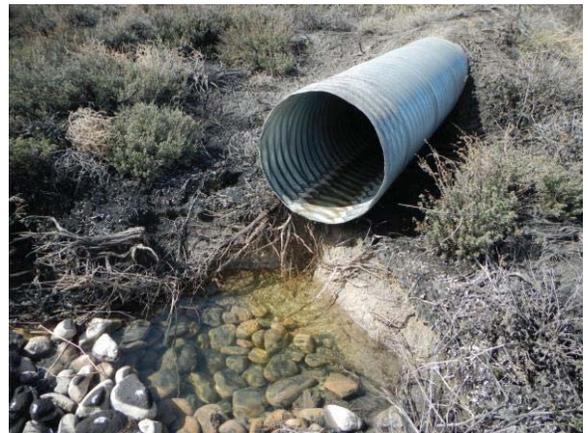
DMR sheets recorded no discharge from ponds between October 2014 and February 2015. In March 2015, Ponds 1B and 3 discharged during March 2014 and were sampled. DMR sheets were not available for March 2015. Pond #1 was discharging during the inspection and will be sampled. It was also discovered that Pond 2 is discharging through a leak in the overflow pipe. Pond 2 will be sampled once a week until the flow into Lower Robinson Creek ceases.

Pond #1 discharge

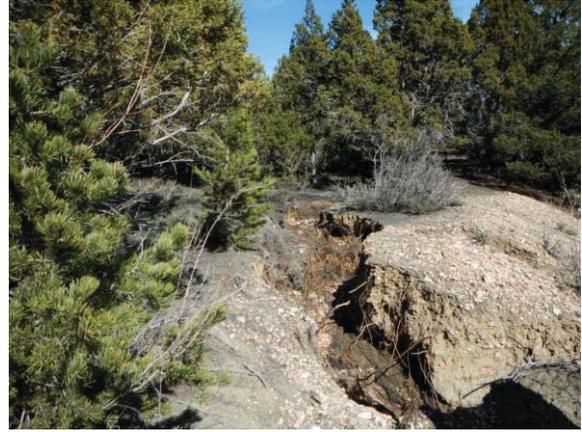
Erosion of undisturbed area due to pond discharges

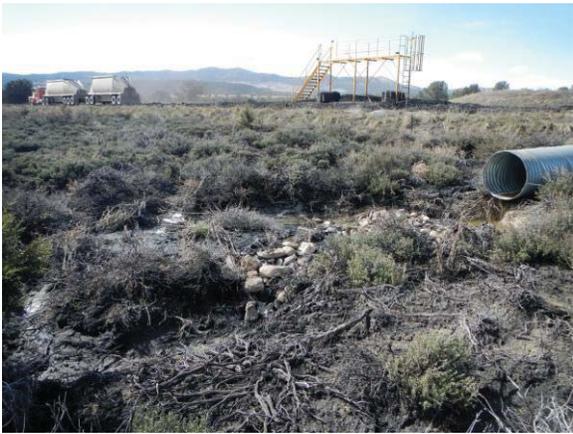
Coal fines on undisturbed land at pond 1 outlet (above and below)

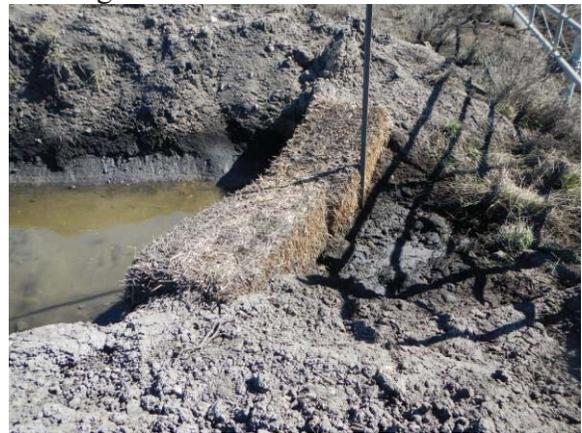
Catch basins at either side of the main entrance are presently holding water that is treated with straw bales. When the basins dry out, a third bale will be added to the south side and a second row and third bale will be added to the north side. The log will be removed from the north side.

West side catch basin at facility entrance

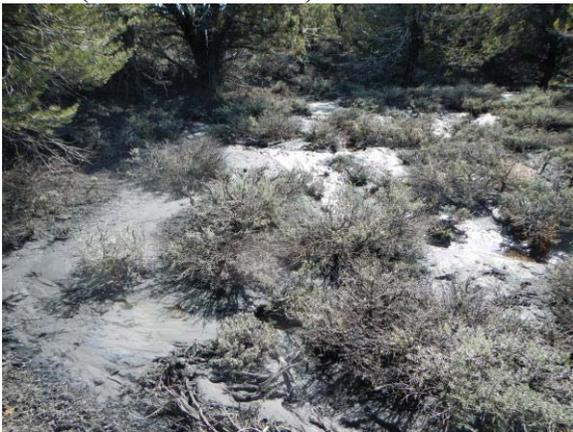
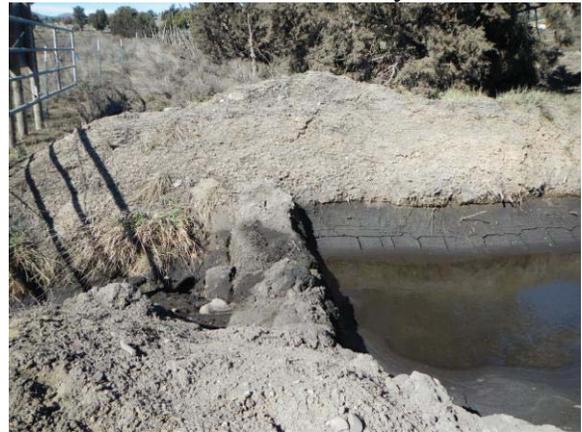
North Side catch basin at entrance

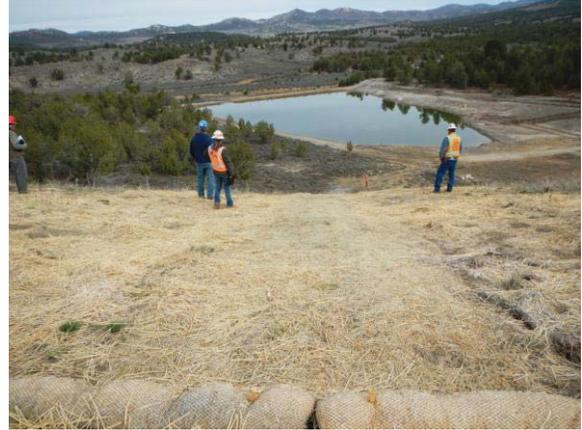
Pond 3 and repaired gully

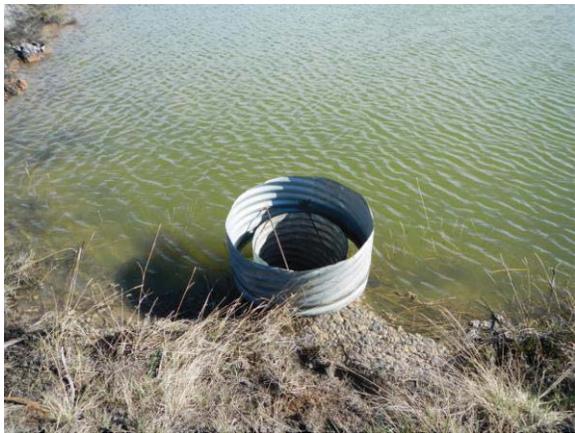
Pond #2 culvert overflow pipe was leaking at a joint in the pipe. The water level will be lowered and the leak will be fixed within 30 days or April 24.

Leaking Pond 2 outlet

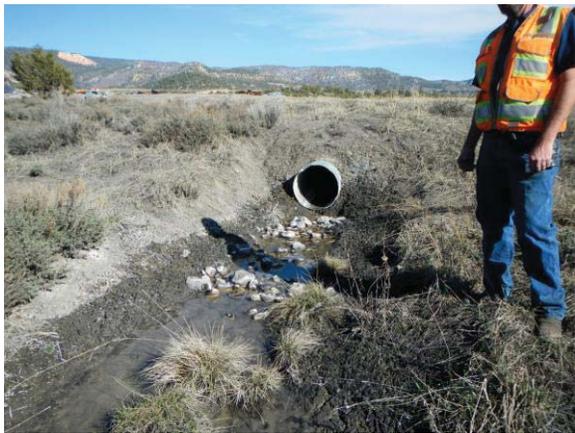
Pond 2 outlet discharge point

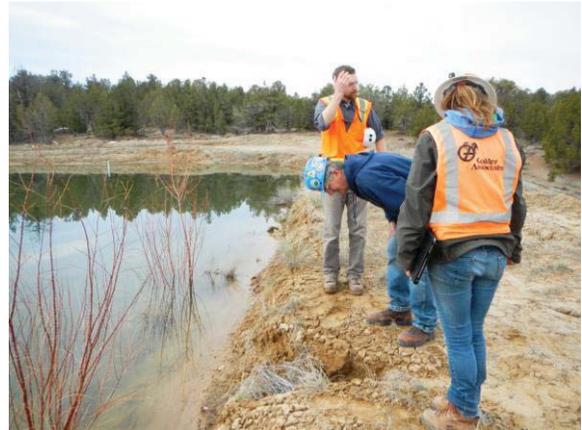
Tamarisk at pond 1, 1B and 3 must be removed or treated with herbicide that is non-toxic to aquatic life. One sage grouse was flushed from the Subsoil #2 area; 3 sage grouse were seen south of the Excess Spoils Pile; and 4 grouse were seen at Pond #3 during the inspection.

Tamarisk at pond 3 and sloughing embankment

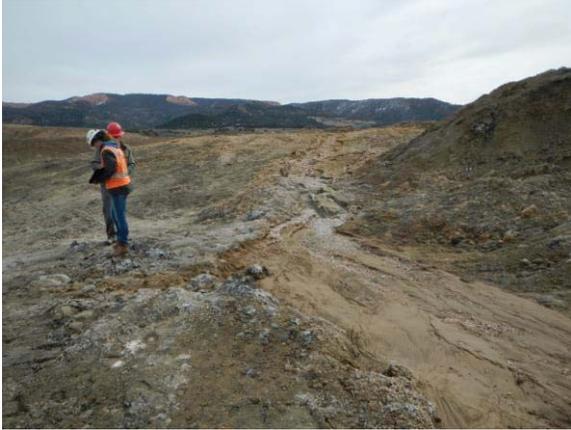
The following issues remain in contemporaneous reclamation areas: UD-4 along Robinson Creek is not correctly cited and will be relocated. The former location of UD-4 and the area re-disturbed by the relocation of UD-4 will need to be reseeded. Although the final grade in the southern permit area is gently sloping to the east, rilling has occurred south of the Dames' access road and water has ponded in a low spot east of pit 26. The rills and the pond must be graded out such that water does not create erosion or saline soil conditions.

UD 4 maintenance required (above and below)

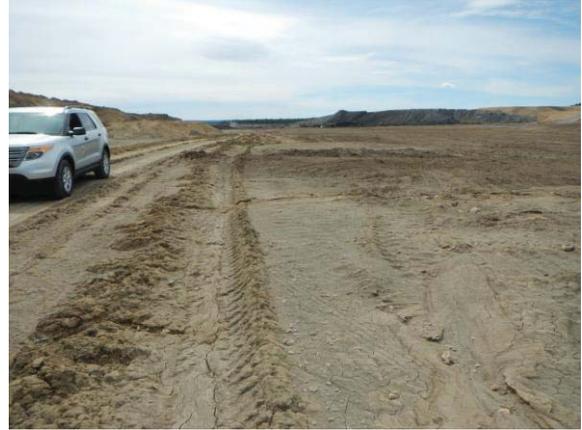
Flow control ditch along County road in Pit 6 location

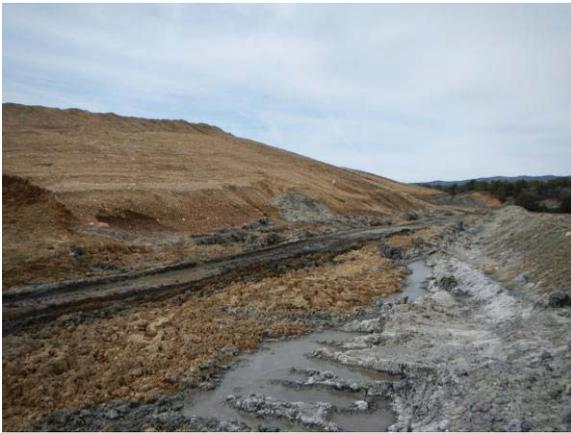
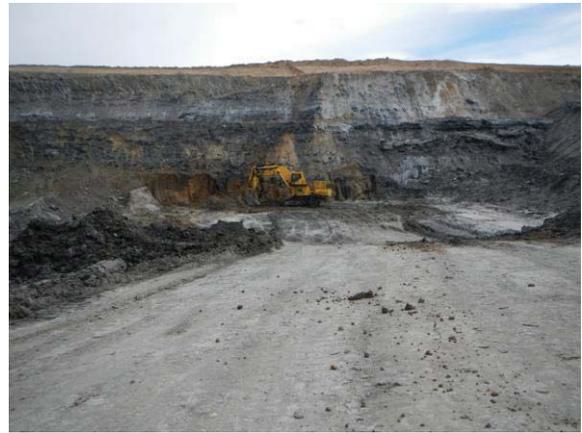
Pit 10 highwall benches prepared for underground portal development. Cement poured for substation

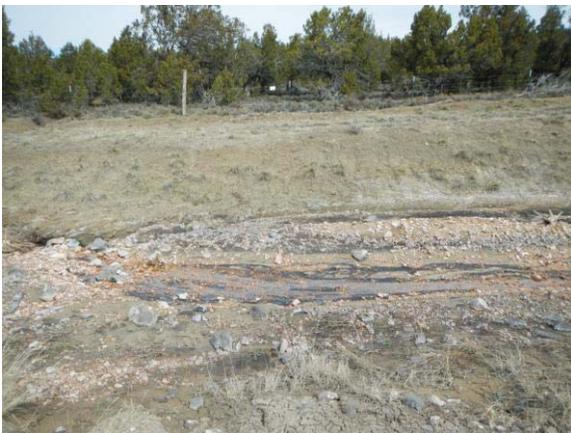
Coal fines in Robinson Creek Temporary Diversion within the Permit Area.

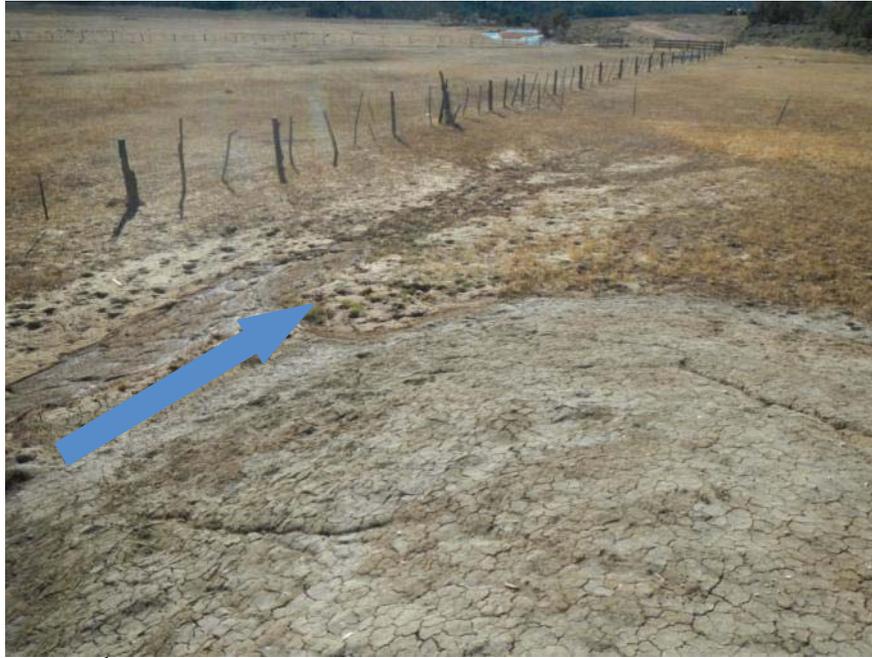
Figure 1: February 10th inspection. Outlet of Ditch 1 that handles undisturbed runoff. The wood fence line on left and T-post fence line at top right defines permit boundary. Arrow indicates the direction runoff flows from the outlet of undisturbed Ditch 1.

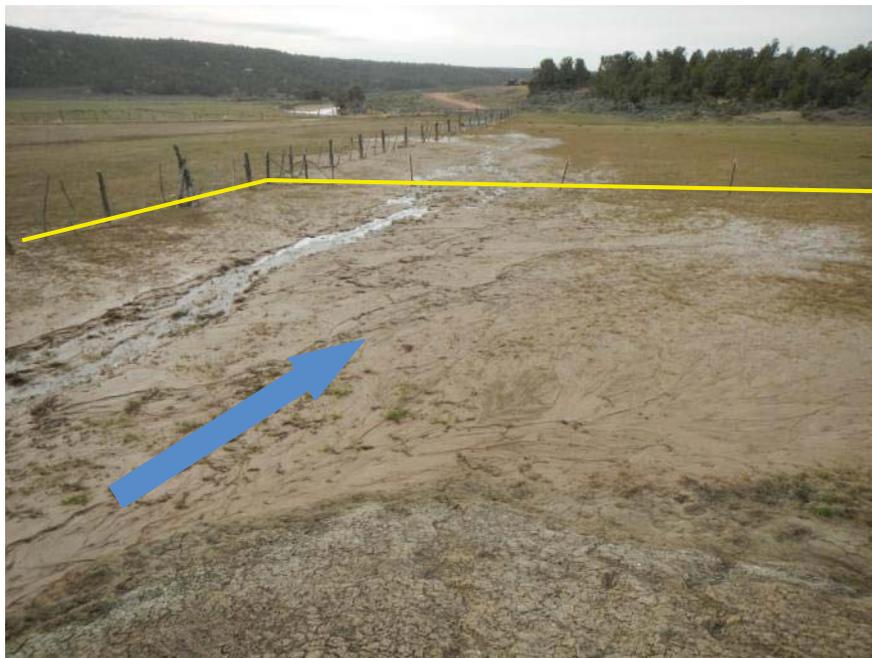
Dwg. 5-3 and 5-3A show the locations of ditches, berms and culverts in the disturbed area. During the Feb 10, 2015 inspection, final grading of subsoil piles was not yet complete near Pond #4, but drainage in the vicinity of Pond 4 and Ditch 1 was noted as requiring maintenance. During this March 24, 2015 inspection, this same area was submerged under a foot or two of water (see photographs). It was apparent that overland flow from the graded, reclaimed southern pits 25 - 28 has ponded at the NE corner of pond #4. The current grade of Watershed 4 has established the inlet of Ditch 1 to be lower than the spillway of Sediment Pond 4. This allowed excess runoff from snow melt to backup and pond on the southeast corner of Watershed 4, before water could discharge through the spillway of Sediment Pond 4. The ponded backwater breached the berm of Ditch 1 separating undisturbed runoff to the east from disturbed runoff to the west. Ditch 1 then carried the disturbed area flow outside the permit area, without treatment. The untreated runoff covered the grassy sod that used to act as an alternate sediment control to treat undisturbed Ditch 1 drainage. The grassy area is now covered with sediment and can no longer adequately treat runoff from the undisturbed ditch prior to leaving the permit area. Additionally, the section of Ditch 1 requiring immediate maintenance has not been fixed since the February inspection. This issue is the subject of NOV Citation #16150.

Figure 2: March 24th inspection. Sediment plume at outlet of Ditch 1 showing offsite impact. Permit boundary is roughly defined by yellow line.

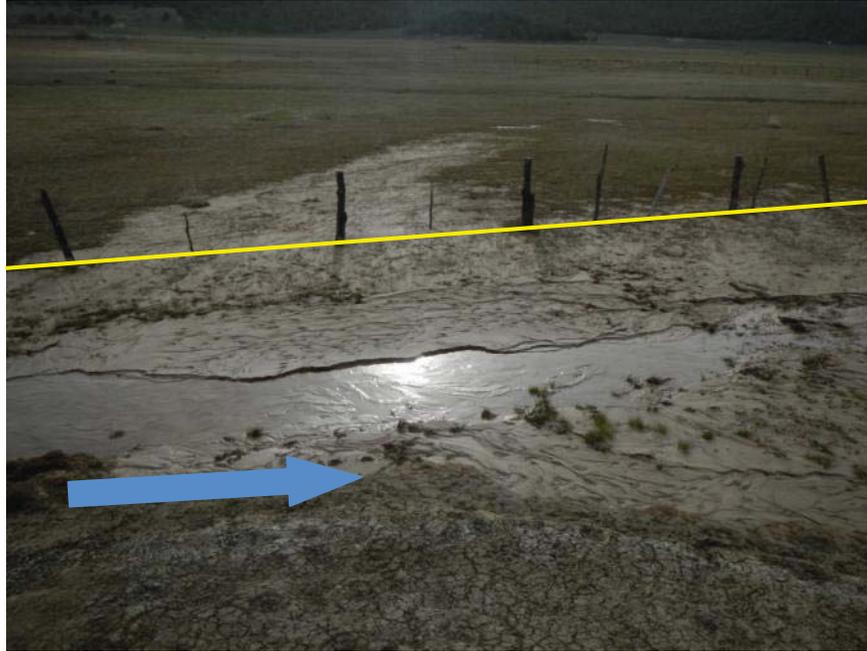
Figure 3: March 24th inspection. Sediment plume at outlet of Ditch 1 showing offsite impact. The undisturbed outlet of Ditch 1 is left of the photo. Flow is from left to right. Permit boundary is roughly defined by the yellow line.

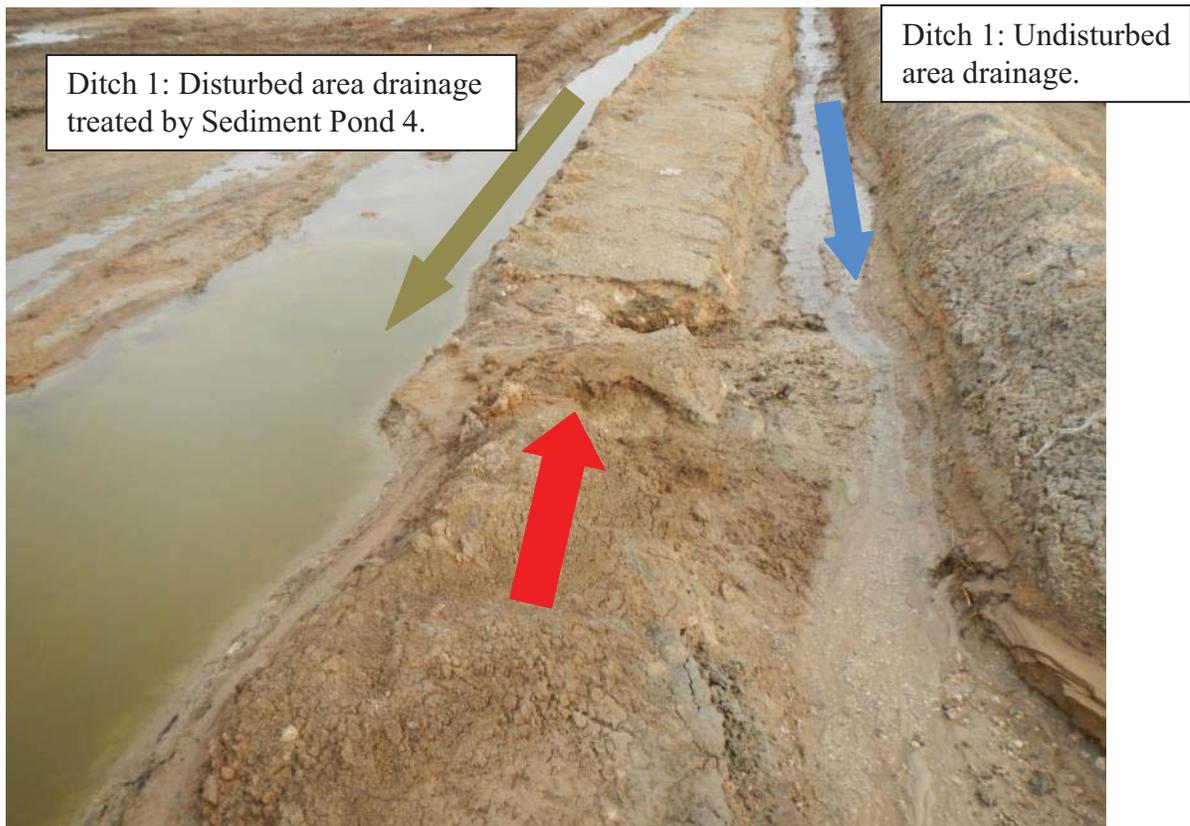
Figure 4: March 24th inspection. The red arrow points to the location where Ditch 1 failed allowing disturbed area runoff carry suspended sediment offsite untreated.

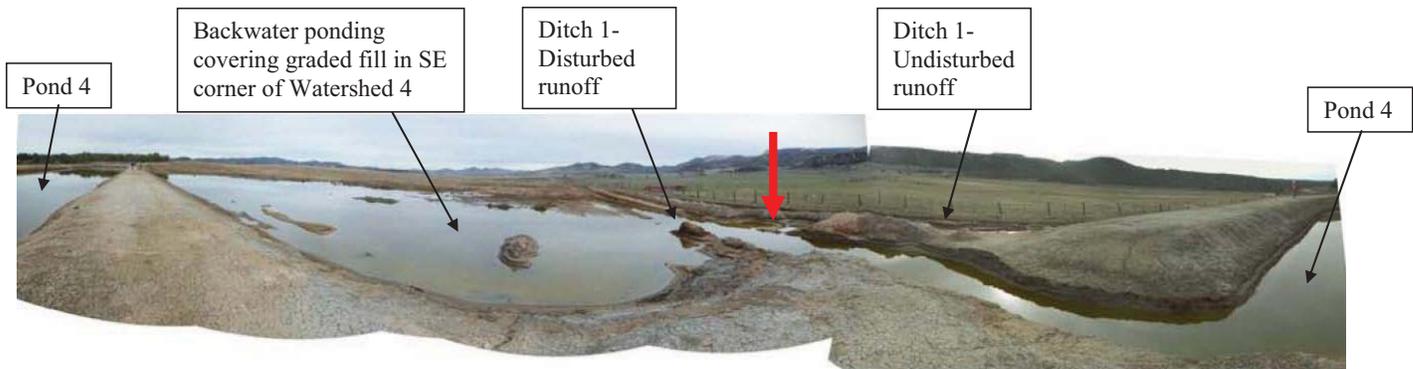
Figure 5. March 24th, 2015 inspection. ~300^o panoramic photo of backwater pond outside of Sediment Pond 4. Red arrow points to failure point of Ditch 1 where disturbed area runoff exited the site via the undisturbed ditch.

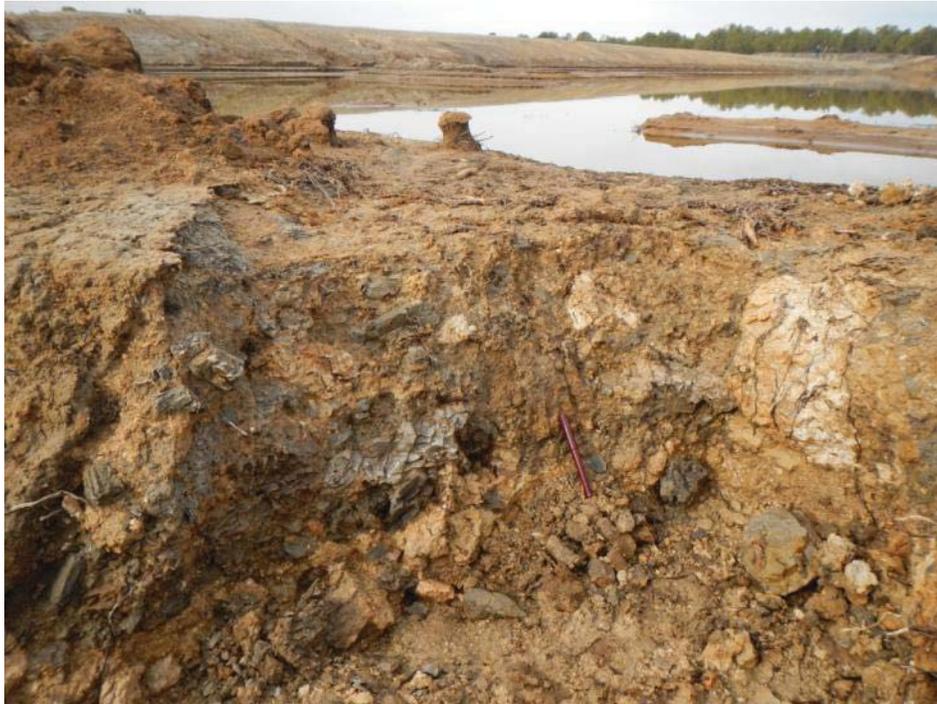
Figure 6: March 24th inspection. Failure point of Ditch 1 berm. Backwater ponding of Sediment Pond 4 seen in background of photo.

The graded area on the NE corner of Pond #4 must be graded to create positive flow into pond 4 and away from Ditch 1. An additional ponded area was seen closer to the Dame's access road. A gully had washed away topsoil just south of the Dame's access road. This entire area must be graded to drain into Pond #4, without ponding. This work must commence within 30 days or by April 24. These problem areas are all located north of pond #4, and east of the coal mined surface, in the southern most permit area, as shown on the coal extraction overview Dwg 5-9.

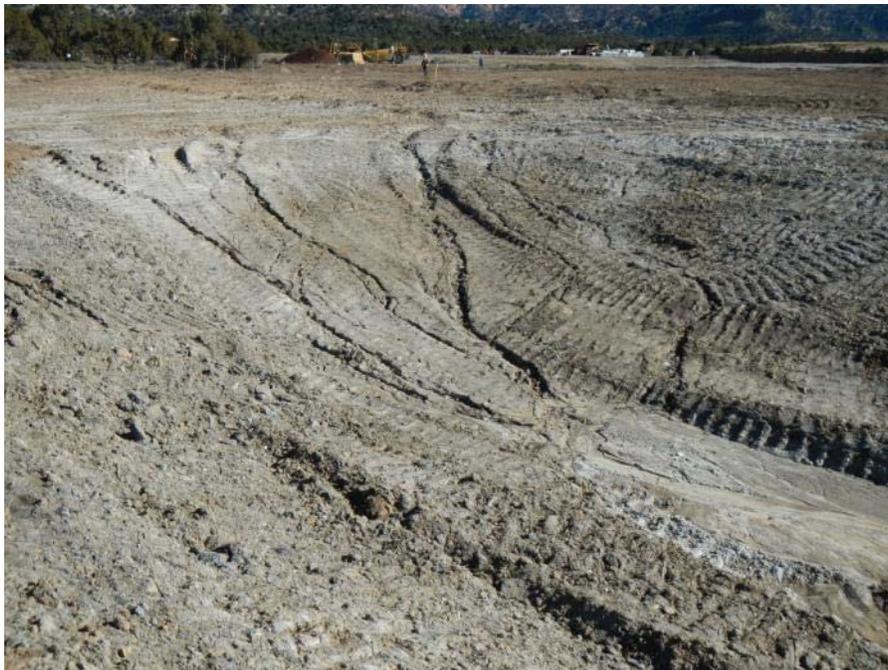
Figure 7: February 10th, 2015 inspection. Head of Lower Robinson Creek channel reconstruction. Ditch 4 is on the far side of the channel in this photo. It is designed to route water drained from the disturbed area in the photo's background to Sediment Pond 3.

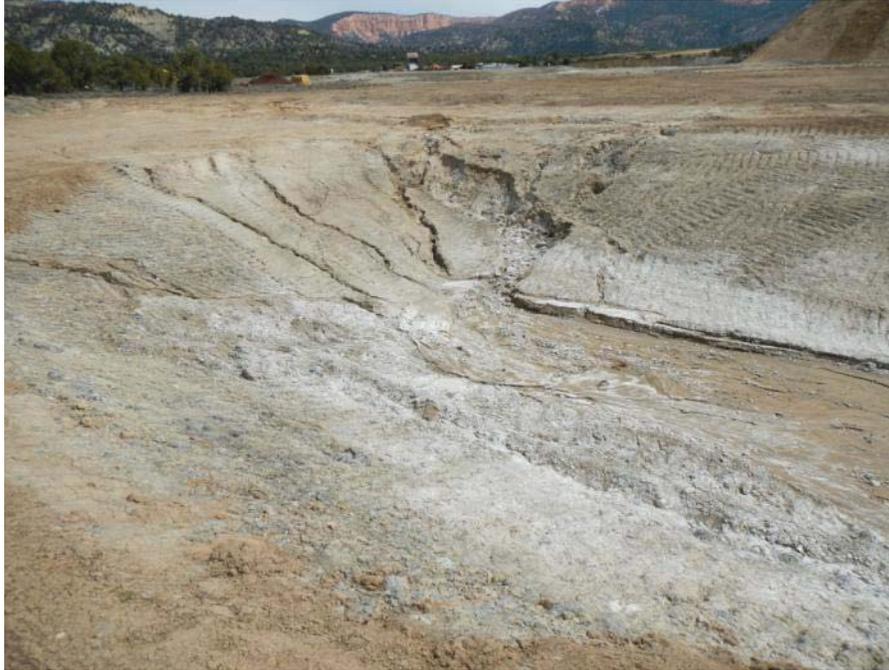
Ditch 4 has eroded in three locations along its length above Robinson Creek reconstruction area. During the site inspection at Coal Hollow on February 10th, 2015 it was found, and the Permittee was notified, Ditch 4 was not built to the approved design in Drawing 5-34. The failure of Ditch 4 in mid-March carried suspended solids from Watershed 3 disturbed area (Drawing 5-26) into the reconstructed channel of Lower Robinson Creek. From here, the runoff and suspended sediments flowed offsite prior to being adequately treated. NOV #16150 has been issued for this non-compliance.

Figure 8: March 24th, inspection. Ditch 4 failure #1. Disturbed area runoff and suspended sediment carried into the reconstructed channel of Lower Robinson Creek.

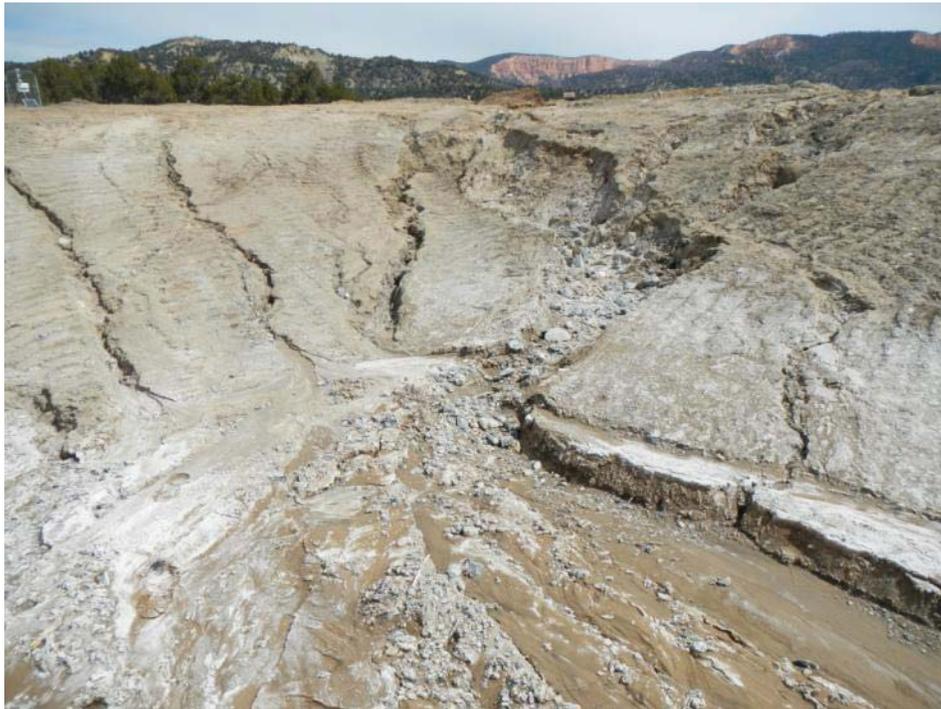
Figure 10: March 24th, 2015 inspection. Ditch 4 failure #1. Disturbed area runoff and suspended sediment carried into the reconstructed channel of Lower Robinson Creek.

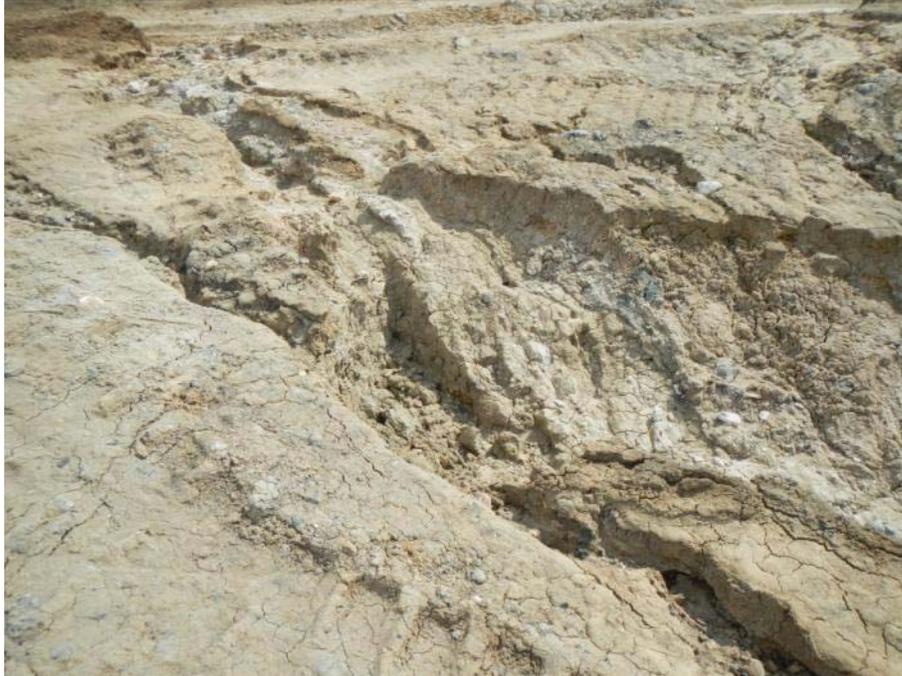
Figure 9: March 24th, inspection. Ditch 4 failure #1. Disturbed area runoff and suspended sediment carried into the reconstructed channel of Lower Robinson Creek.

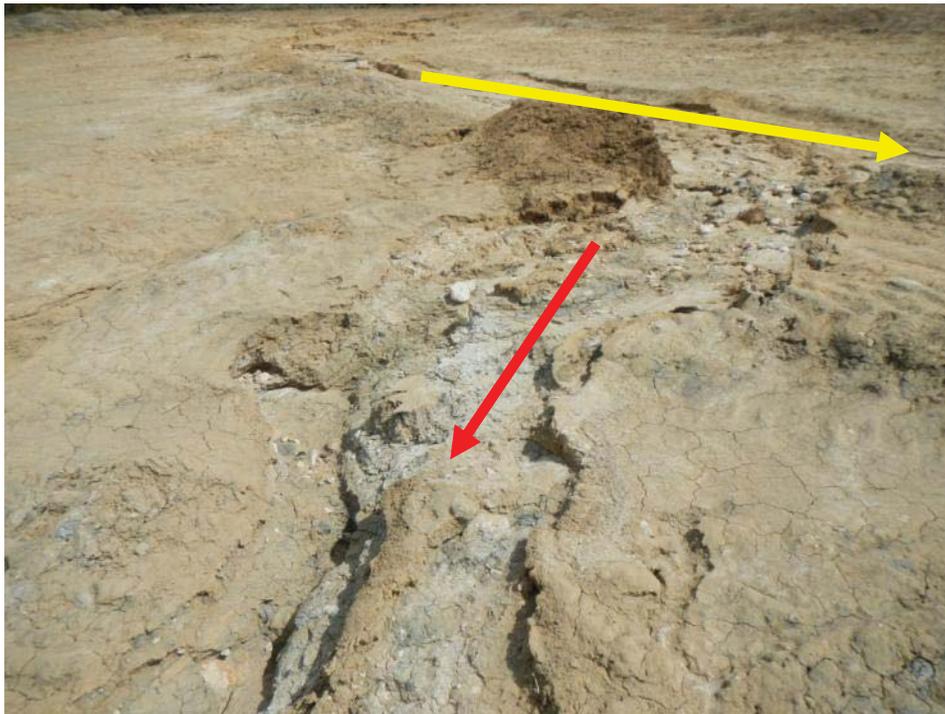
Figure 10: March 24th, 2015 inspection. Ditch 4 failure #1. Yellow arrow points shows direction of design flow in Ditch 4. Red arrow shows failure #1 where Ditch 4 was overtopped by runoff from Watershed 3.

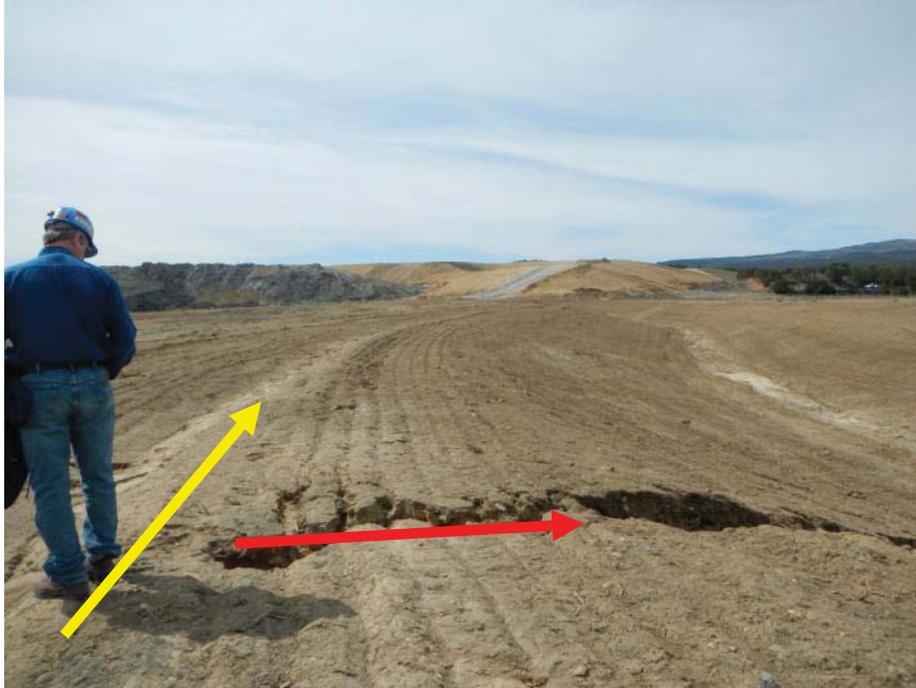
Figure 11: March 24th inspection. Ditch 4 failure #2. Yellow arrow shows design flow direction. Red arrow shows failure point and subsequent flow into the reconstructed Lower Robinson Creek channel.

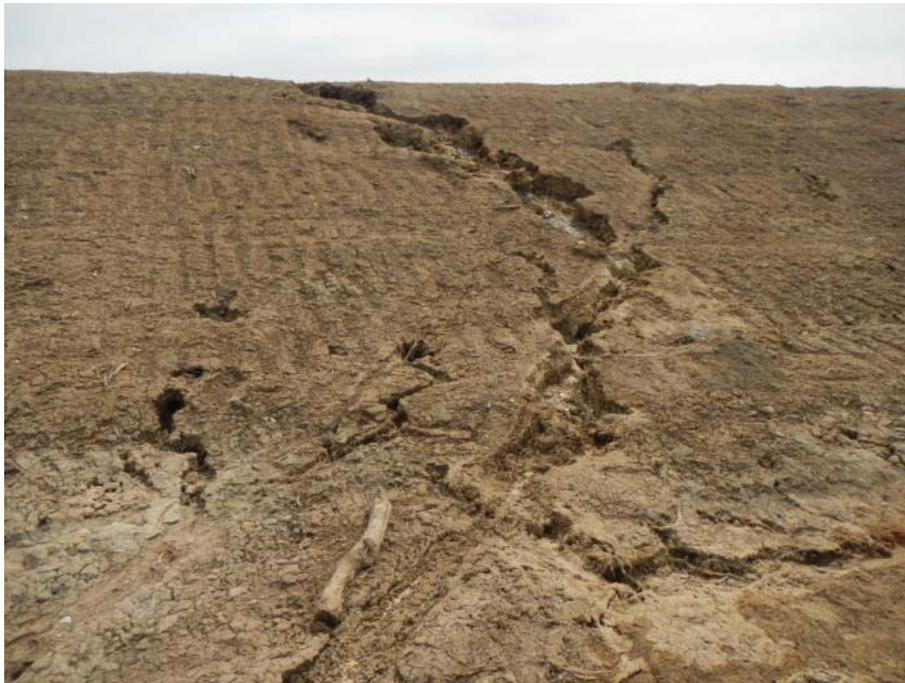
Figure 12: March 24th inspection. Ditch 4 failure #2, looking up from bottom of Lower Robinson Creek reconstructed channel.

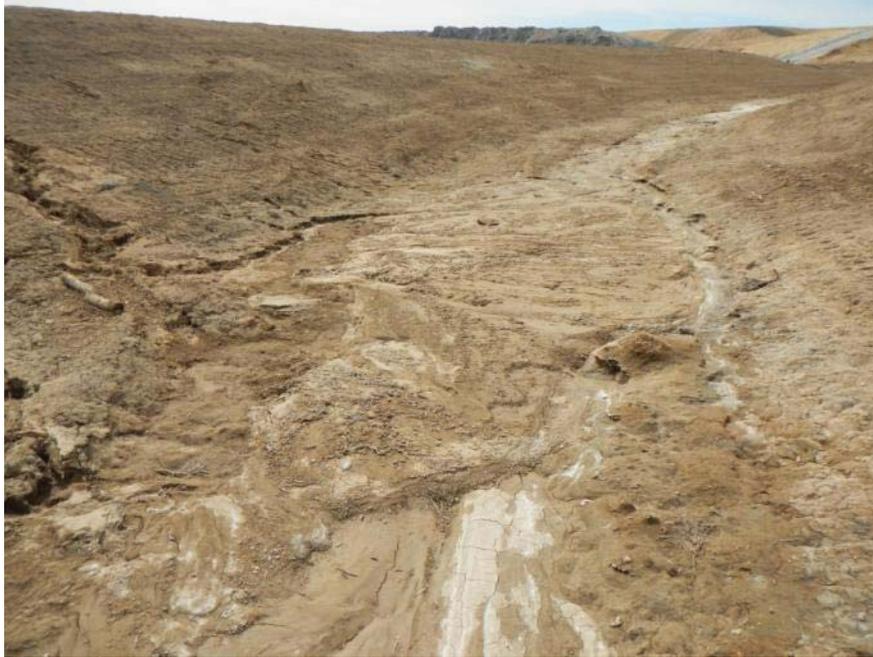
Figure 13: March 24th inspection. Ditch 4 failure #2. Photo taken from bottom of Lower Robinson Creek reconstructed channel. Alluvial fan deposited at base of gully shows a significant amount of sediment was suspended in the runoff.

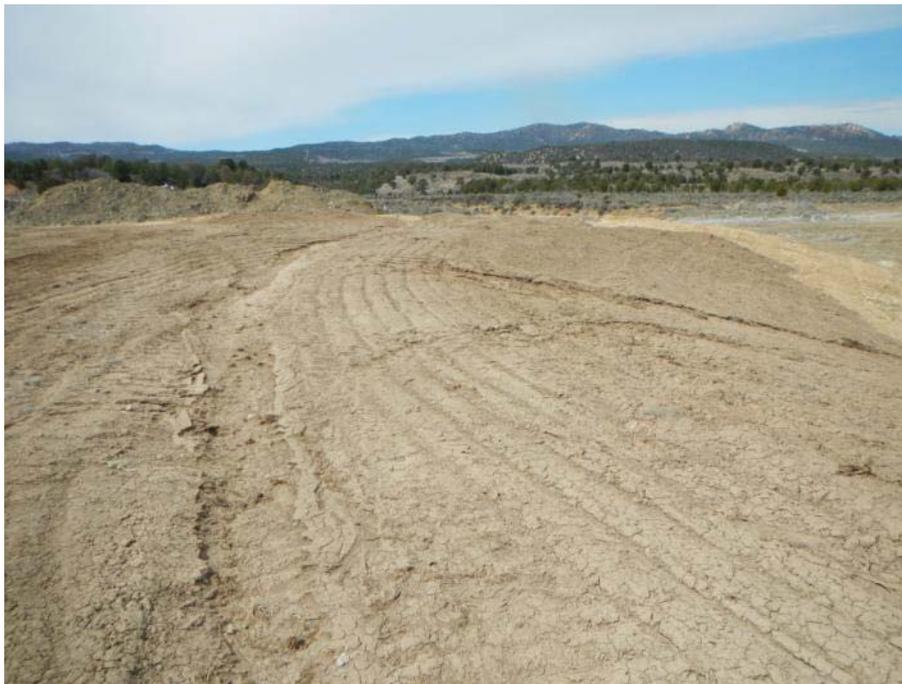
Figure 14: March 24th inspection. Ditch 4 failure #3. Gully is seen running from Ditch 4 down into Lower Robinson reconstructed channel on photo right.

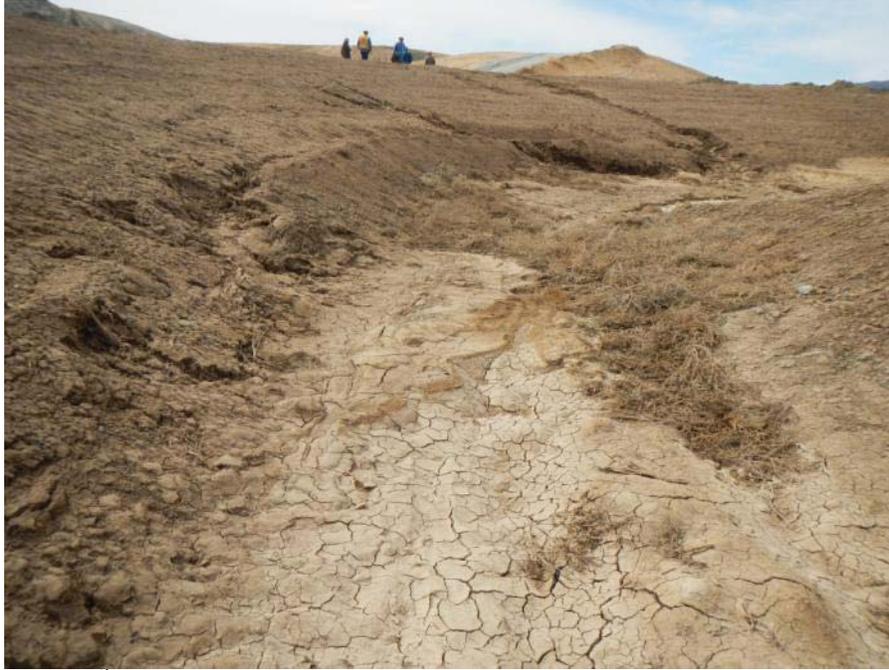
Figure 15: March 24th inspection. Ditch 4 failure #3. Gully is seen running from Ditch 4 down into Lower Robinson reconstructed channel. Photo taken from bottom of reconstructed channel.

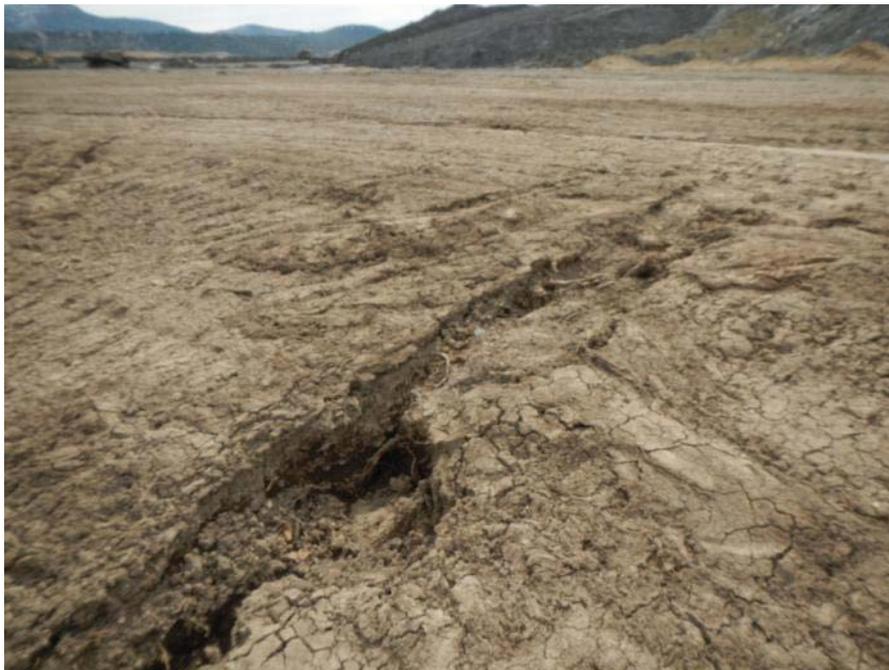
Figure 16: March 24th inspection. Ditch 4 failure #3. Failure point where gully begins running from Ditch 4 down into Lower Robinson reconstructed channel.

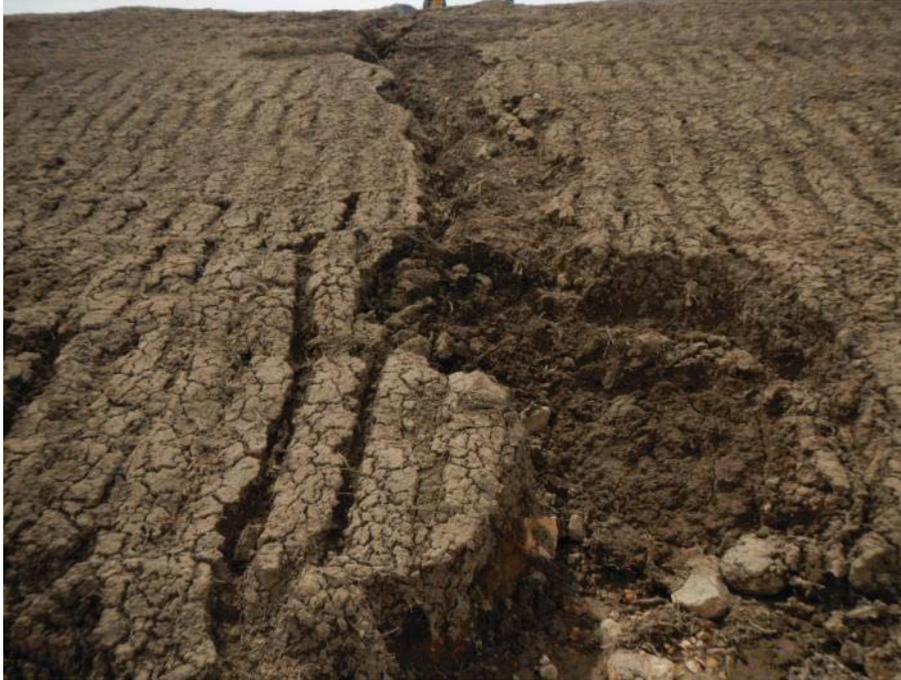
Figure 17: March 24th inspection. Ditch 4 failure #3. Failure showing gully running from Ditch 4 down into Lower Robinson reconstructed channel. Photo taken from bottom of channel looking up towards Ditch 4.

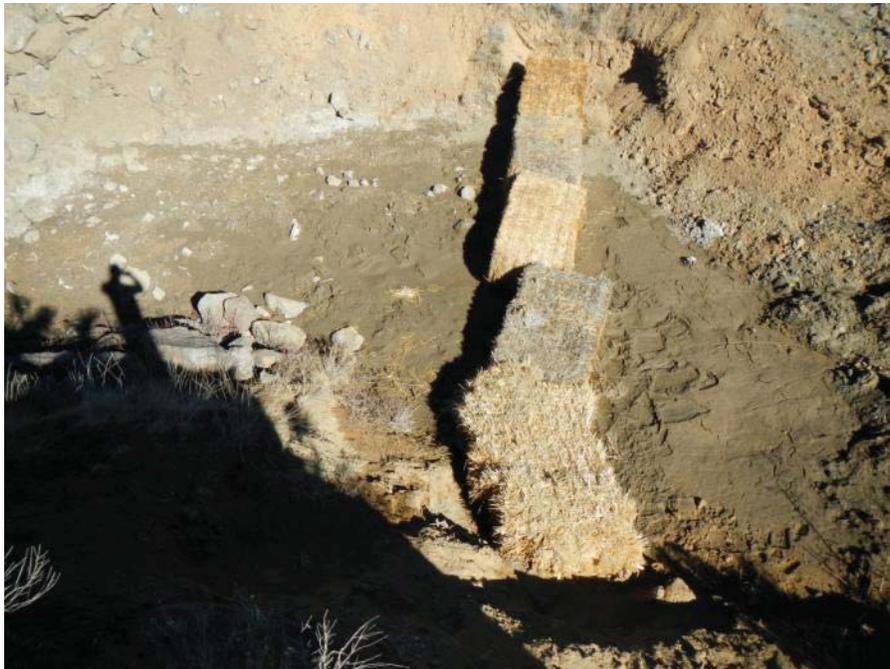
During the February 10th, 2015 inspection the Permittee was notified to fill the gaps in the straw bale check dam at the end of Lower Robinson Creek reconstruction in order for the structure to function properly. While the Permittee added a small straw bale on the end of the structure, the Permittee did not fill the gaps between abutting straw bales. The straw bale check dam does not currently function as an alternative sediment control feature because it allows flow to be piped between abutting straw bales. A properly functioning straw bale check dam should capture runoff and allow it to pond and settle out suspended solids prior to allowing runoff to flow offsite.

Figure 18: February 10th, 2015 inspection. Straw bale check dam installed at outlet of reconstructed Lower Robinson Creek.

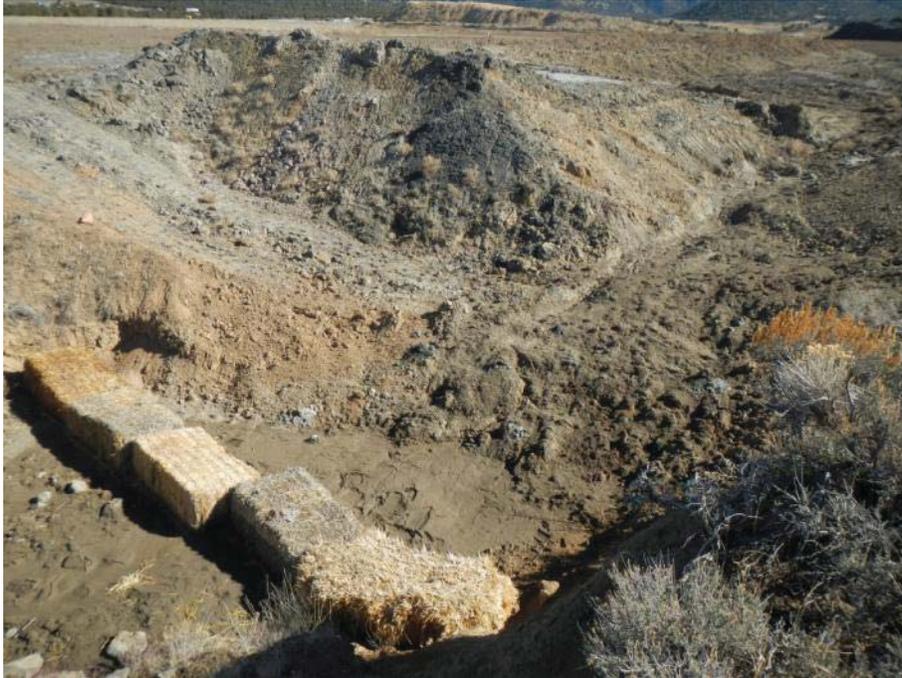
Figure 19: February 10th, 2015 inspection. Straw bale check dam installed at outlet of reconstructed Lower Robinson Creek.

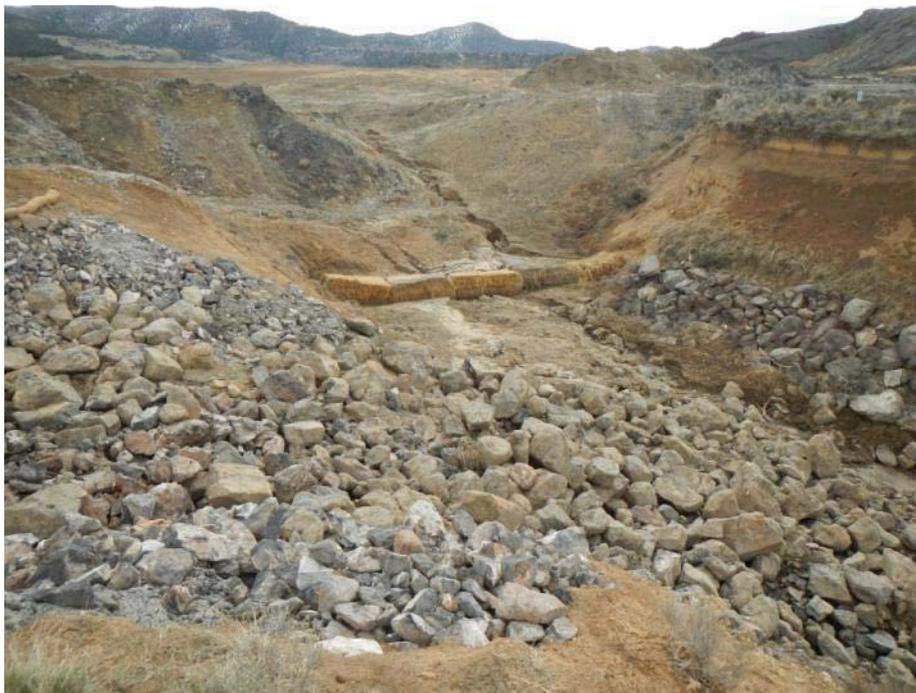
Figure 20: March 24th, 2015 inspection. Excess runoff from failed Ditch 4 formed gully at outlet Lower Robinson Creek channel reconstruction.

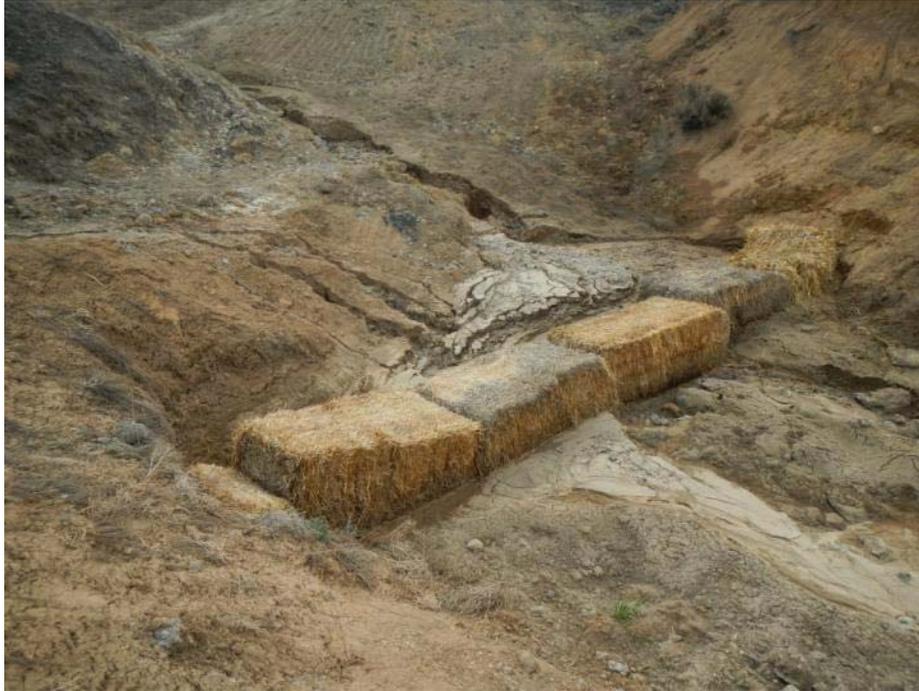
Figure 21: March 24th, 2015 inspection. Excess runoff from failed Ditch 4 formed gully at outlet Lower Robinson Creek channel reconstruction.

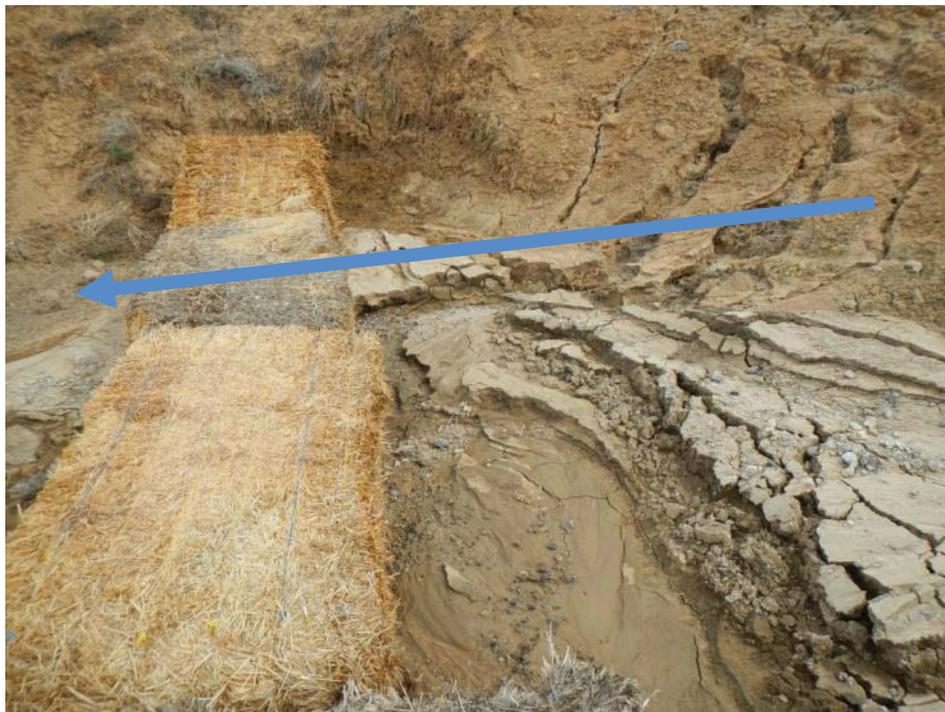
Figure 22: March 24th, 2015 inspection. Straw bale check dam at end of Lower Robinson Creek reconstruction; disturbed area runoff flows from photo right to left across the structure.
