Division of Oil, Gas and Mining

Inspection Report

Permit Number:	C0250005
Inspection Type:	COMPLETE
Inspection Date:	Monday, March 23, 2015
Start Date/Time:	3/23/2015 2:30:00 PM
End Date/Time:	3/24/2015 3:30:00 PM
Last Inspection:	Tuesday, February 10, 2015

Site: **COAL HOLLOW**

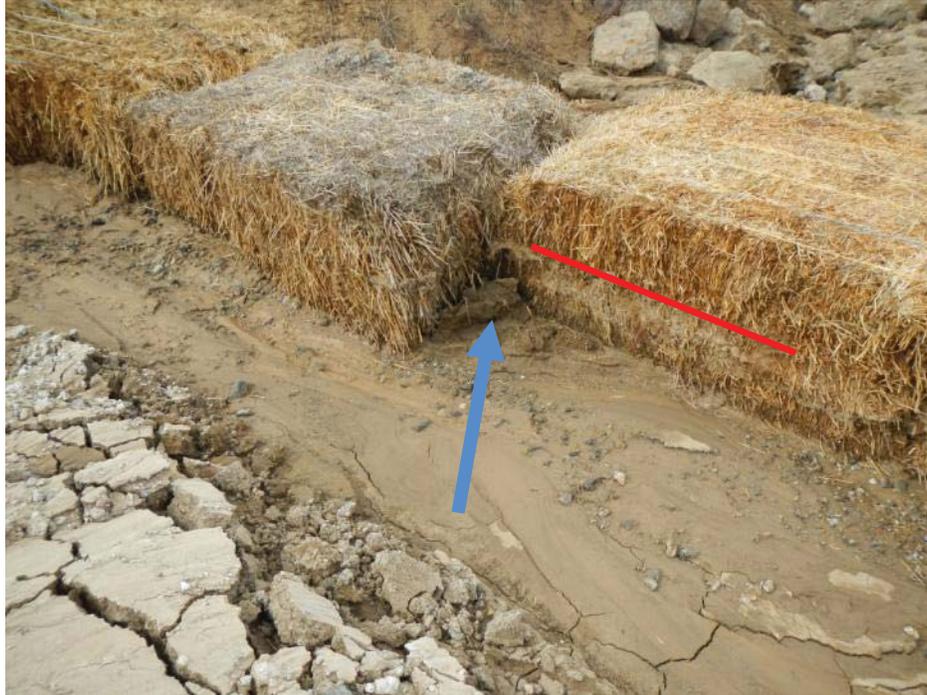
During the February 10th, 2015 inspection the Permittee was notified to fill the gaps in the straw bale check dam at the end of Lower Robinson Creek reconstruction in order for the structure to function properly. While the Permittee added a small straw bale on the end of the structure, the Permittee did not fill the gaps between abutting straw bales. The straw bale check dam does not currently function as an alternative sediment control feature because it allows flow to be piped between abutting straw bales. A properly functioning straw bale check dam should capture runoff and allow it to pond and settle out suspended solids prior to allowing runoff to flow offsite.

Figure 23: March 24th inspection. The straw bale check dam did not properly treat disturbed area runoff. Instead of ponding runoff and allowing suspended sediment to settle out, the runoff piped under and between the two abutting straw bales. The red line indicates the height water pooled, before flowing under and through the joint.

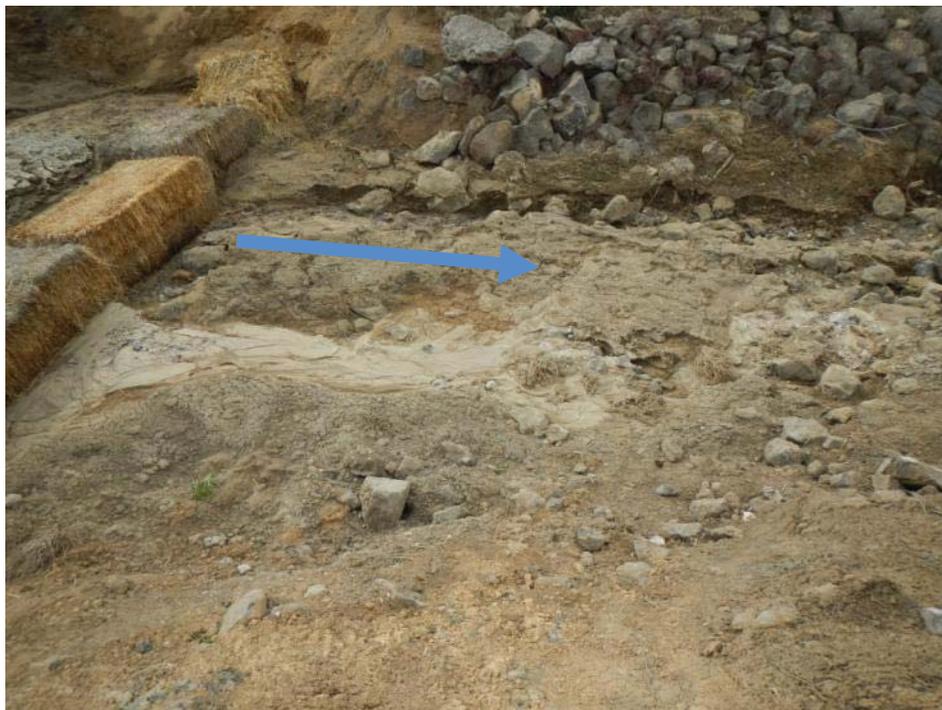
Figure 24: March 24th inspection. The scoured gully shows runoff and sediment made it past the straw bale check dam and flowed offsite. The permit boundary is < 30ft to the left of the photo.

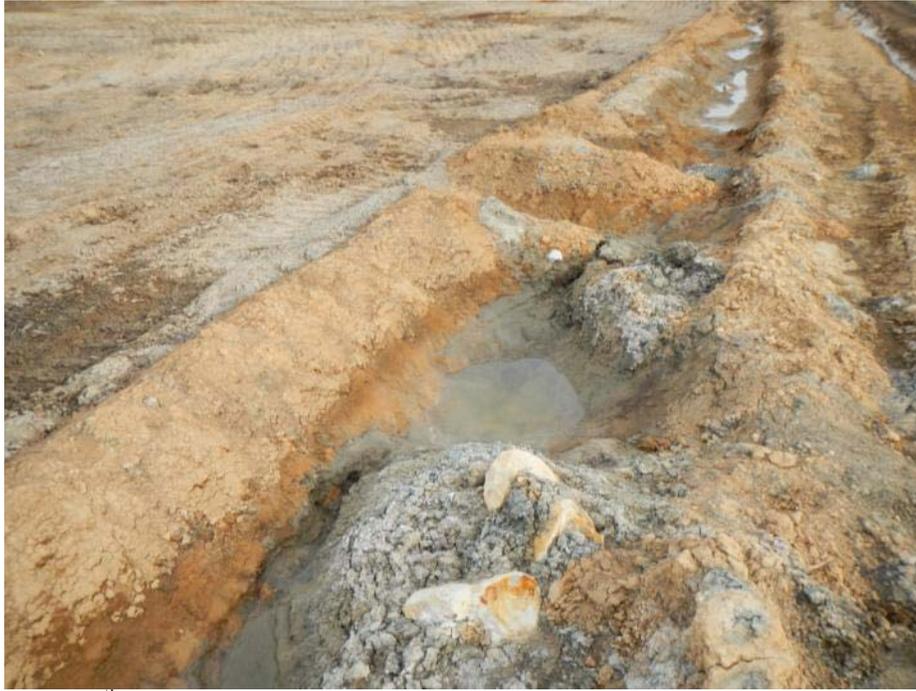
Figure 25: March 24th inspection. Unmaintained section of Ditch 1. This blockage will keep runoff from flowing to Sediment Pond 4.

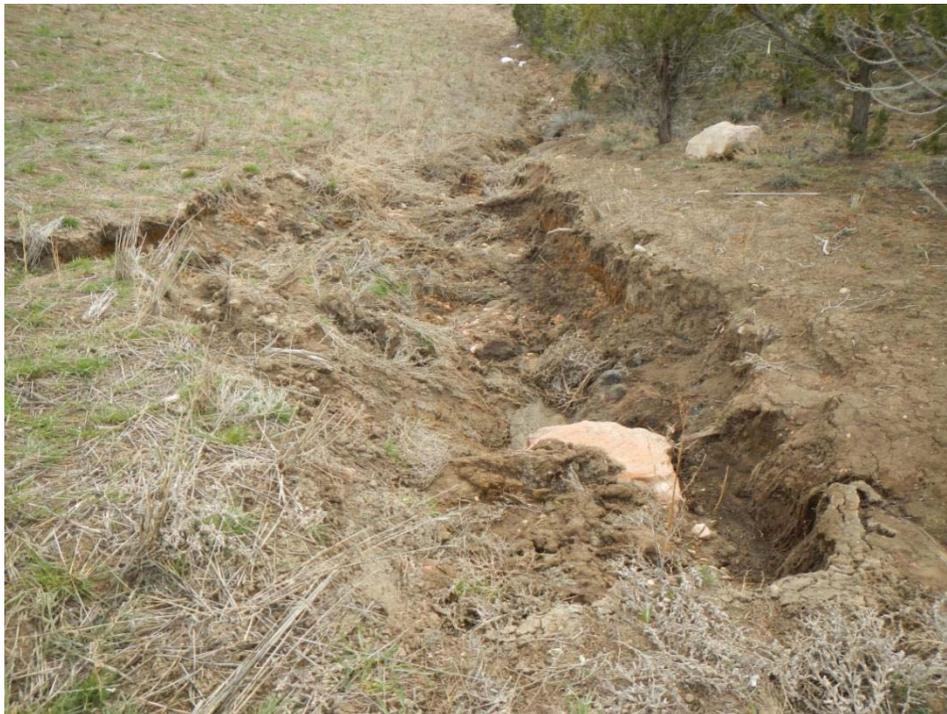
A large gully has formed where the south-west corner of the refuse pile adjoins with the undisturbed local topography (Figure 26). This is likely due to discharge of sub-surface lateral flow at the refuse pile-natural topography junction.

Figure 26. March 24th inspection. Gully erosion on south side of refuse pile.

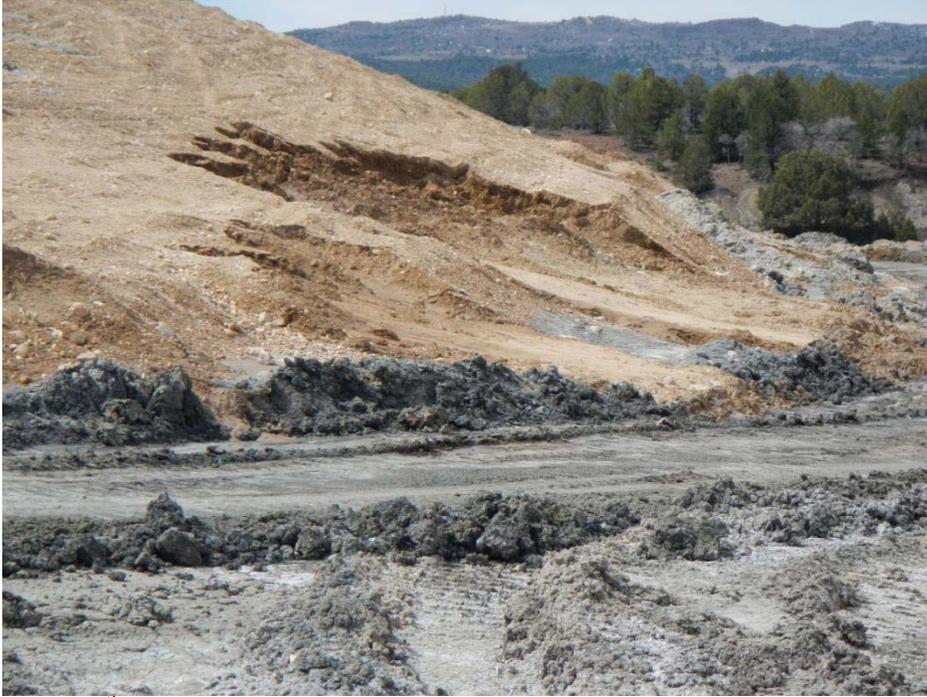
Subsoil sloughed from slope on NE corner of refuse pile (Figure 27).

Figure 27. March 24th inspection. Subsoil sloughing from slope on NE corner of refuse pile.
