Division of Oil, Gas and Mining

Inspection Report

Permit Number:	C0250005
Inspection Type:	PARTIAL
Inspection Date:	Wednesday, April 29, 2015
Start Date/Time:	4/29/2015 9:00:00 AM
End Date/Time:	4/29/2015 2:30:00 PM
Last Inspection:	Tuesday, April 14, 2015

Permitee: **ALTON COAL DEVELOPMENT LLC**
 Operator: **ALTON COAL DEVELOPMENT LLC**
 Site: **COAL HOLLOW**
 Address: **463 North 100 West, Suite 1, CEDAR CITY UT 84720**
 County: **KANE**
 Permit Type: **PERMANENT COAL PROGRAM**
 Permit Status: **ACTIVE**

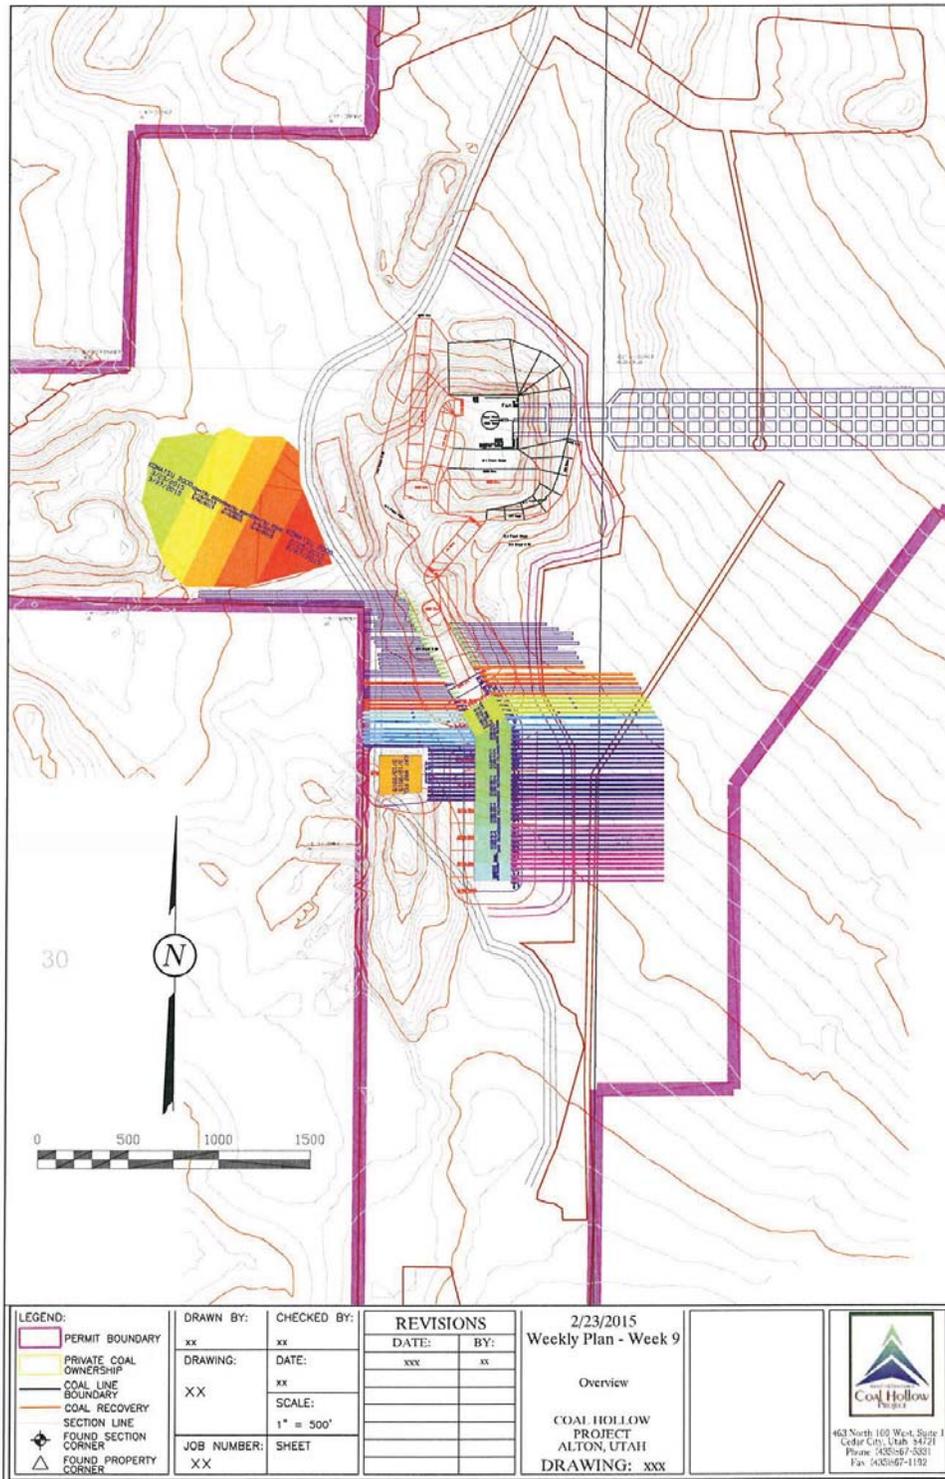
Pit 20 and 21 are mined out. Pit 9 and Trench 1 is mined out. The highwall/auger miner is mining to the west at the bend in Trench 2. Within pit 10 slopes are being graded and faced up. Above Pit 10 the alluvium is being laid back and prepared for seeding. Trucks were end-dumping excess spoil in Pit 20. We checked drainage and drainage controls in the facility yard and at ponds 1, 1b, 2 and 4. We observed partially completed work in UD 1 and pond 4 (to abate NOV 16150). DD-4 is staked, but not installed along its length.

Mining Disturbance Map showing mine progress as described in this report's summary.

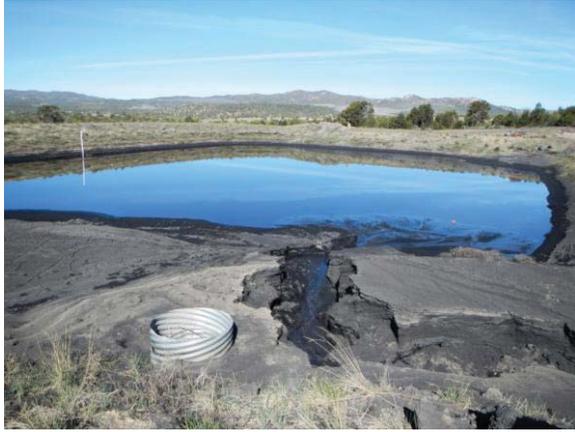
During the inspection the inlet to pond #1 was evaluated. Sediment has accumulated at the inlet due to overland flow from the loadout. The principal and emergency spillway was found to be clogged with coal fines. The need to redesign the overland flow inlet was apparent because the inlet and outlet are at the same location and are short-circuiting the detention time of the pond. In addition, culvert #6 which reports to pond #1 has not been repaired. Culvert #6 is a maintenance item carried over from the last inspection. Culvert #6 is a compliance issue and must be repaired before the next inspection.

Pond #1 inlet adjacent to outlet

Upon investigation of Dwg 5-28 at the Division office, the site configuration was not to be consistent with the design for Pond #1 and an email was sent on April 30 outlining the maintenance required by May 8, 2015, as follows:
"To remain in compliance, begin doing the work that is necessary to remove the fines from the oil skimmer and restore the pond embankment to the design shown on Dwg 5-28, with no overland flow inlet near the outlet. Complete this work by May 8, 2015. Concurrently, provide a certified design showing elevations of the inlet and outlet and the maximum sediment elevation, the 60% sediment elevation and sediment marker location AND the proposed location of the overland flow inlet to to the Division for expedited, hydro review, and then once approved, you can construct the new inlet at the desired location." The Pond #1 skimmer was cleared of debris and the Pond #1 amendment to the MRP was received on May 8, 2015, Task 4894.

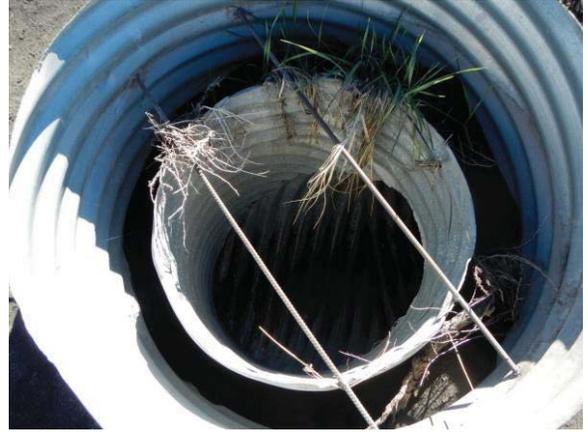
Pond #1 oil skimmer outlet.

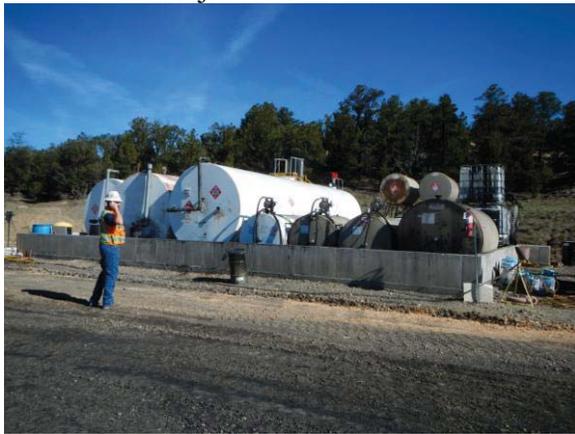
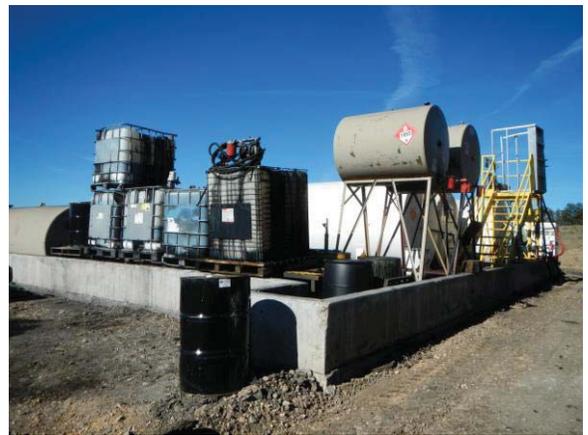
Within the spill containment structure there are three 10,000 gal tanks; three 5,000 gal tanks, and two 300 gal tanks on stilts. See attached photos of the containment structure.

Containment facility

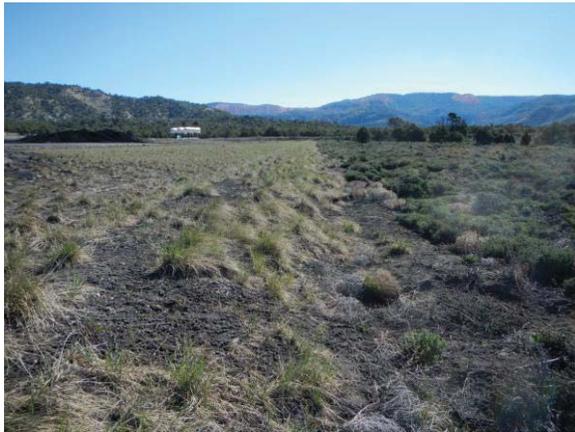
Disturbed/undisturbed boundary within permit area.

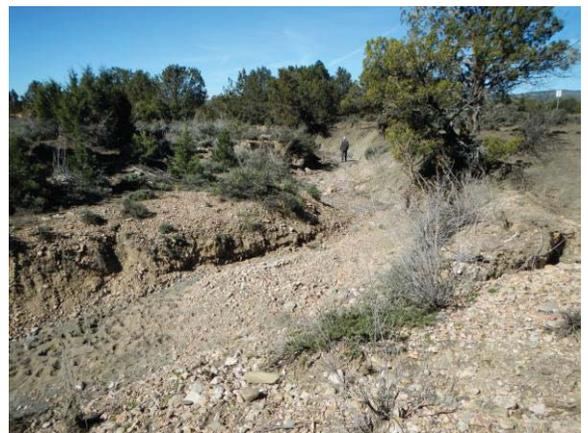
Lower Robinson Creek at outlet of Ponds #1 and 1B, undisturbed within permit area.

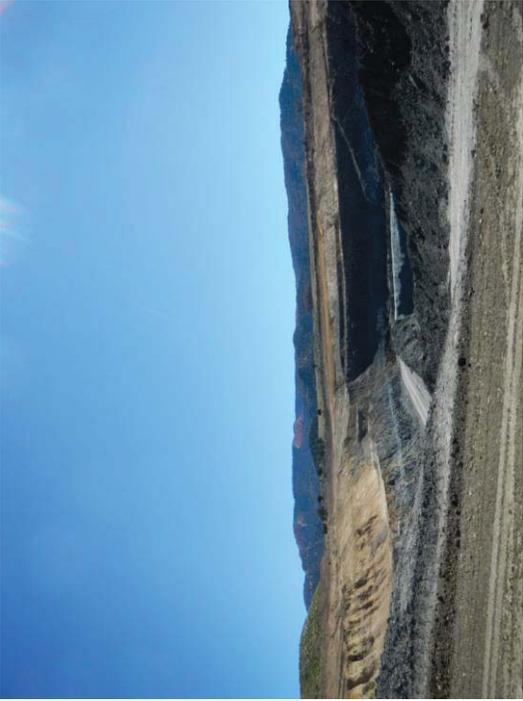
PIT 10 access.

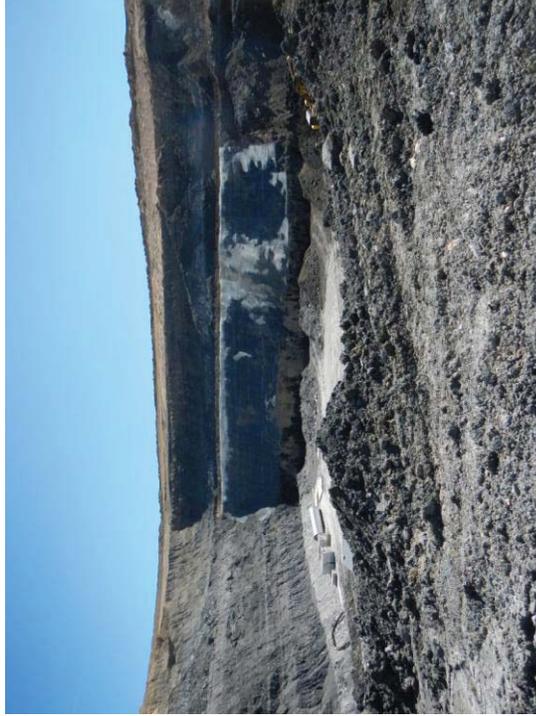
PIT 10 highwall covered with chain mesh.

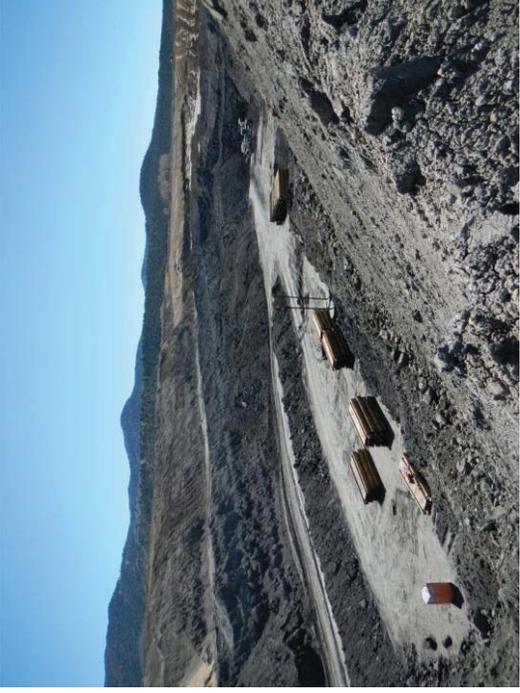
We observed that recent heavy rains have created saturated conditions in the overburden above HWT 2 (which sloughed onto the bench); in the highwall fill of Pit 10 (where an excavator was stuck) and in the backfill of Pit 20.

HWT 1 and HWT 2 with auger at HWT 2 panel 1 E

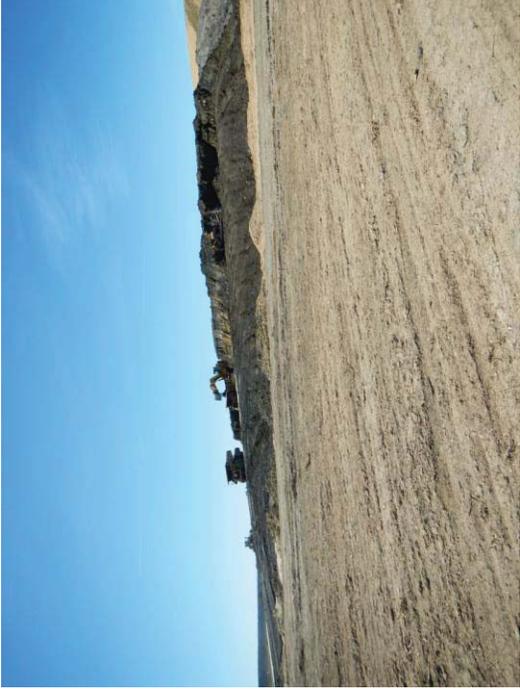
Temporary spoil pile

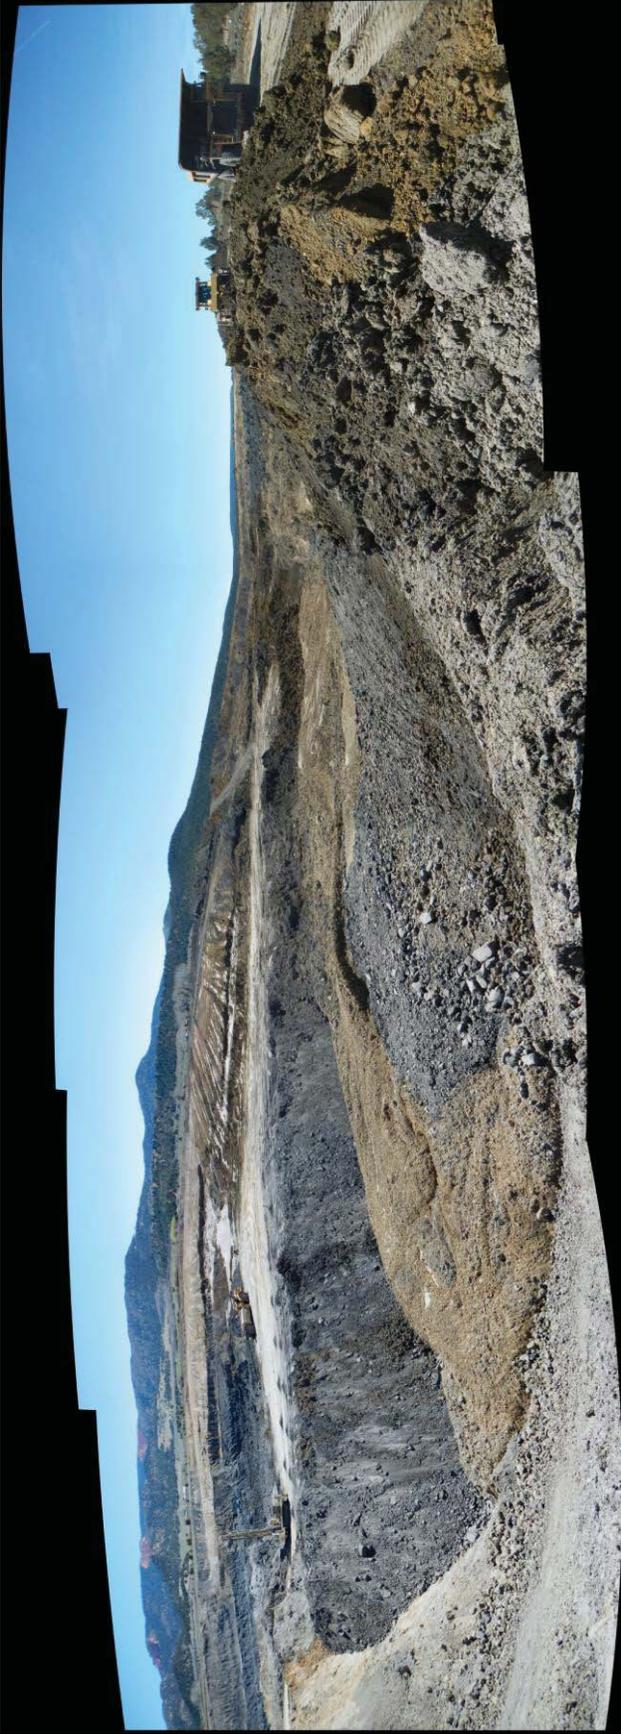
During the inspection pit 10 slopes were being graded and faced up. An excavator got stuck working the saturated fill of Pit 10. Above Pit 10 the alluvium was being laid back and prepared for seeding. Trucks were end-dumping excess spoil in Pit 20. Auger mining was ongoing at the bend in HWT 2 where augers were mining coal to the West, see attached Dwg XXX. Coal had been covered in Trench #1. The open pit into trench #2 was less than 1,300 ft, according to Mr. Nicholes.

Equipment on left side is at the top of HWT 2. Equipment on the right is end dumping into Pit 20.
