Inspection Report

Permit Number:	C0250005
Inspection Type:	PARTIAL
Inspection Date:	Tuesday, June 02, 2015
Start Date/Time:	6/2/2015 11:00:00 AM
End Date/Time:	6/2/2015 1:30:00 PM
Last Inspection:	Wednesday, May 13, 2015

Permittee: **ALTON COAL DEVELOPMENT LLC**
 Operator: **ALTON COAL DEVELOPMENT LLC**
 Site: **COAL HOLLOW**
 Address: **463 North 100 West, Suite 1, CEDAR CITY UT 84720**
 County: **KANE**
 Permit Type: **PERMANENT COAL PROGRAM**
 Permit Status: **ACTIVE**

This inspection examined all completed work associated with NOV 16150. Additional areas inspected included, the areas included in the most recent Phase I Bond Release Task #4903, Pond 1, Subsoil Pile #2, and the rill on the southwest side refuse pile.

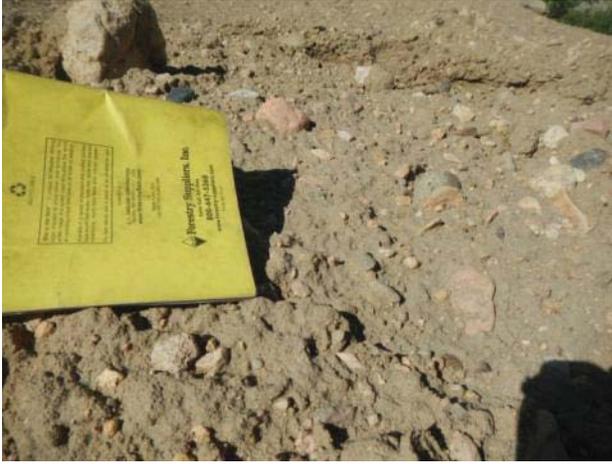
We stopped at the southern end of Subsoil Pile #2 to examine the soil tackifier the Permittee applied. We walked roughly a 150 yd loop up the side slope of the pile, onto the top of the pile, and back down the roughened road ramp. I checked to see if a crust was present or absent through visual observation and by lightly patting the soil (Figure 1). A crust was present over the majority of the area I covered, supporting the Permittee's claim that tackifier had been applied to subsoil pile.

Figure 1. Soil tackifier applied on Subsoil pile #2.

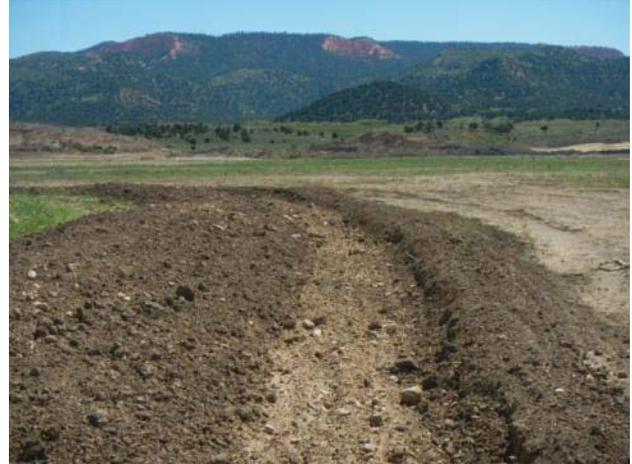
NOV 16150 required the Permittee to construct Ditch 4 to match the approved design in the MRP. I walk the newly constructed length of Ditch 4 and found it was properly constructed and will now fully convey all runoff to Sediment Pond 3 (Figure 2).

Figure 2. Ditch 4 correctly installed

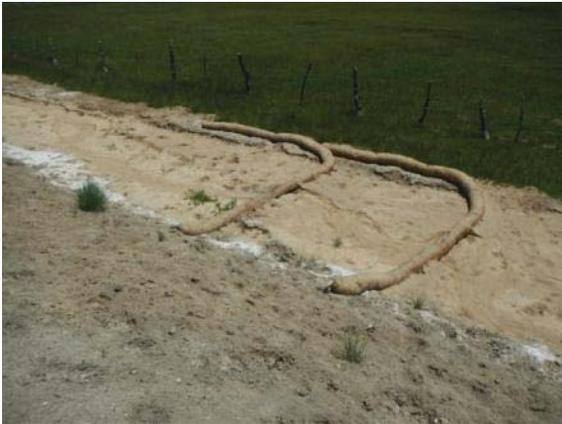
NOV 16150 required the Permittee to install the best technology currently available at the outlet of Ditch 1 to treat flow in the ditch and prevent offsite sediment impacts. The Permittee has installed two straw wattles at the end of the Ditch 1 (Figure 3). In the time since the wattles have been installed they have experienced flow that has cut under the wattles and reduced the effectiveness of the treatment. The Permittee has met the minimum requirement by installing the best technology currently available in this area, however the wattles are now in need maintenance in order for them to properly function.

Figure 3. Straw wattles at outlet of Ditch 1. Maintenance is required on these to make them function more effectively.

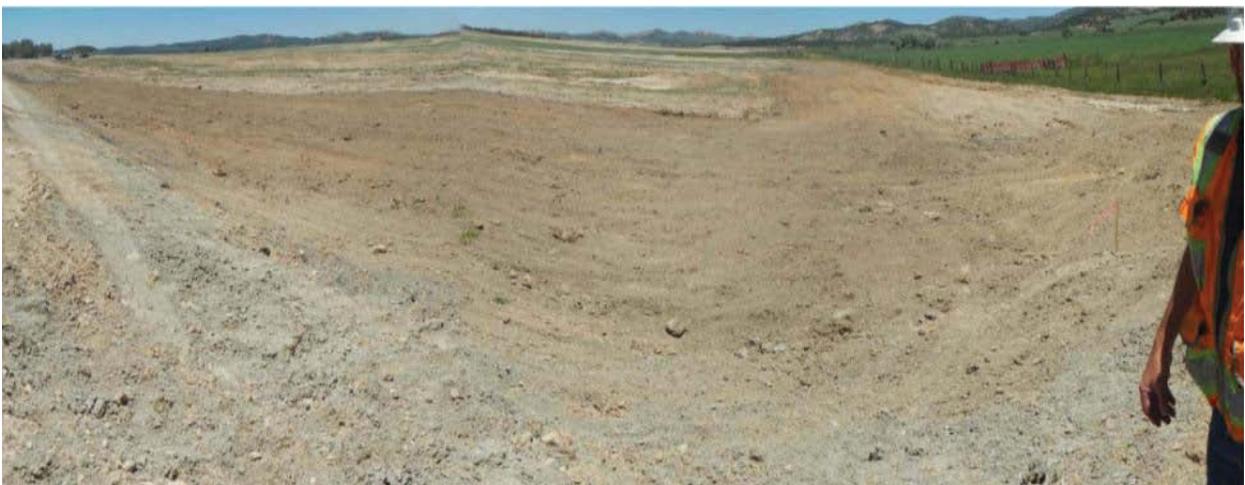
The Permittee has lifted the area to the north of Pond 4 to prevent ponding in this zone. This newly lifted area will now direct runoff to the inlet of Sediment Pond 4. This lifted area is now compliant with the MRP (Figure 4).

Figure 4. Area north of Pond 4 has been lifted.

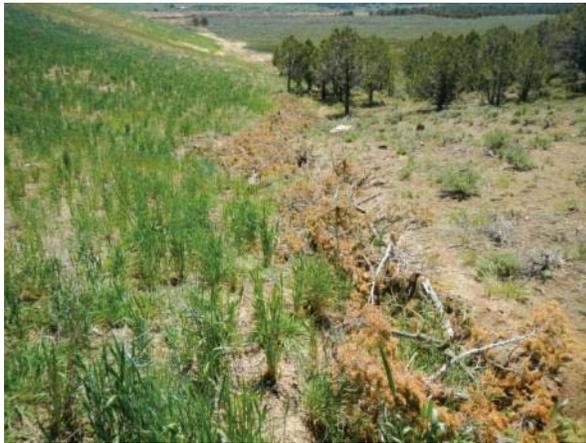
The gully on the south side of the spoil pile was inspected. This gully was first discovered by the Division during the Phase I Bond Release inspection on March 23, 2015. The Permittee has cleared pinion pine and juniper to the south of the gully, within the permit area, and placed the large woody debris in the gully (Figure 5). This is not considered a long term fix to stop/prevent further gully erosion at this location. I followed up with Mr. Nicholes over the phone on June 8th, 2015 about the current status of the gully. We discussed potential solutions to this problem area, such as smoothing out the gully and installing a compacted granular filter within the swell. The branches could then be placed back on top of the granular filter to add roughness to the swell. We did not set a final date for completion of this work. I have advised inspectors in the near future to set a work completion date with Mr. Nicholes.

Figure 5. Gully on south side of spoil pile filled with large woody debris.

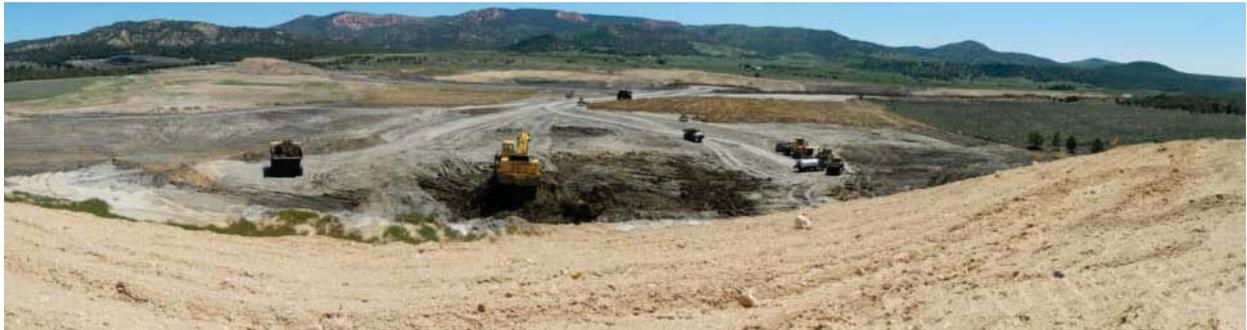
The Division received an amendment from the Permittee on May 29, 2015 for Phase I Bond Release in two areas: BRP1-5 and BRP1-6. I did not directly inspect BRP1-6, but was able to photograph BRP1-5 from the top of the spoil pile looking east over the bond release area. The area BRP1-5 was not backfilled and up to its final grade (see Figure 6). The photo shows the large excavator moving excess spoil pile material into trucks and the trucks hauling the material for backfilling a pit.

Figure 6. Application for phase I bond release showing the area BRP1-5. The area is still under active reclamation with the excavator and haul trucks removing excess spoil pile material away to backfill pits.

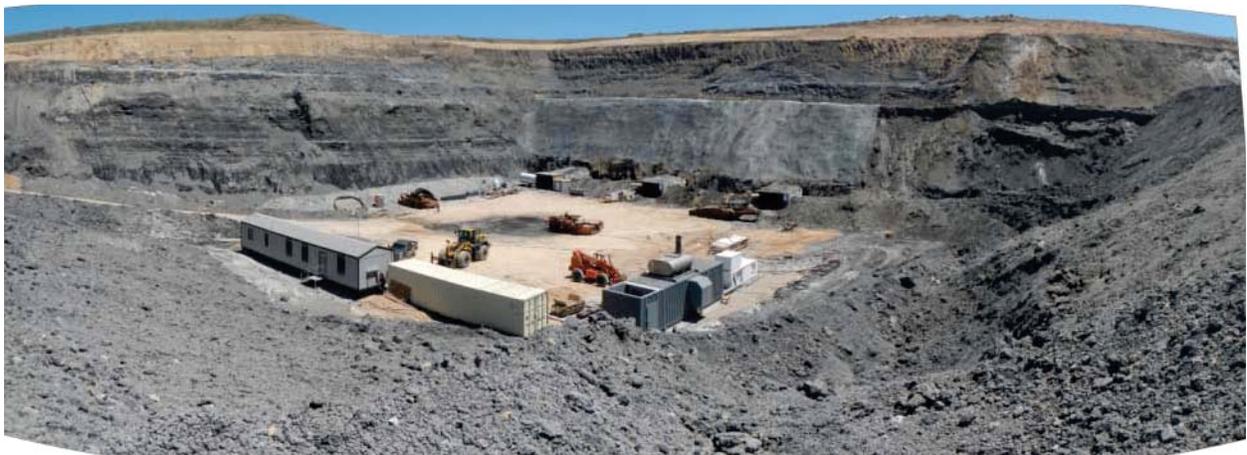
There is active development of portals and facilities in preparation of underground mining in Pit 10 (Figure 7). The Permittee has extended a pipe from a sump at the northwest bottom of Pit 10 (seen in the left of the photo) up to the first bench. The Permittee indicated they would like to extend the pipe to Sediment Pond 3 to use as a mine water discharge system. I have notified the Permittee needs to submit a narrative that includes calculations and engineered maps and cross-sections for this mine de-watering system. Additionally, I discussed with Mr. Nicholes, the decant pipe that has been designed and approved for Sediment Pond 3 will need to be installed prior to the pond receiving underground mine discharge.

Figure 7. Development of underground facilities and portals in Pit 10.
