## Inspection Report

Permit Number:	C0250005
Inspection Type:	TECHNICAL
Inspection Date:	Tuesday, June 30, 2015
Start Date/Time:	6/30/2015 8:00:00 AM
End Date/Time:	6/30/2015 1:00:00 PM
Last Inspection:	Tuesday, June 16, 2015

Permittee: **ALTON COAL DEVELOPMENT LLC**

Site: **COAL HOLLOW**

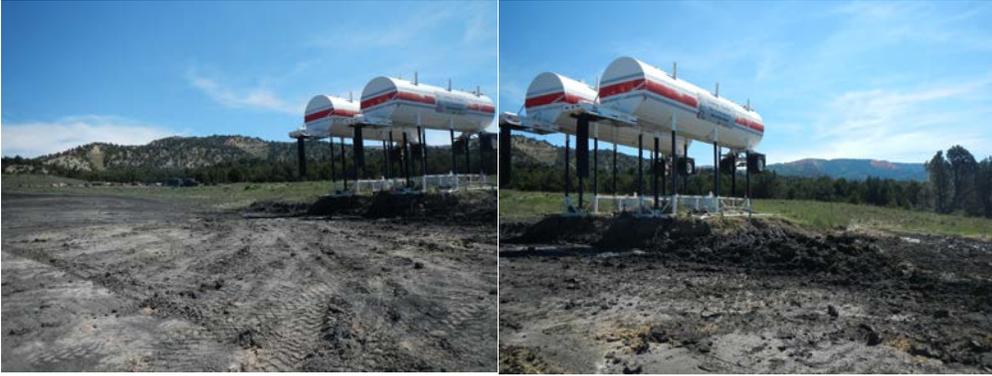
Maintenance was completed on a leaking valve at the water tanks located on the far east side of the facilities area. The area around the south side of the water tanks was saturated and had clearly been worked by equipment. In the process of the repairs to Ditch C7 a stockpile of saturated soil sits south of the tanks. The June 16th inspection requested that the weeds and sediment be cleared from C7. While some work was clearly done, the area still requires some fine grading to establish flow to ditch C7. The Permittee was told to move the stockpiled soil south of the water tanks to the appropriate stockpile area and to stabilize it. See photos 1 through 6 for details.

1. Water tanks on East side of the facilities area

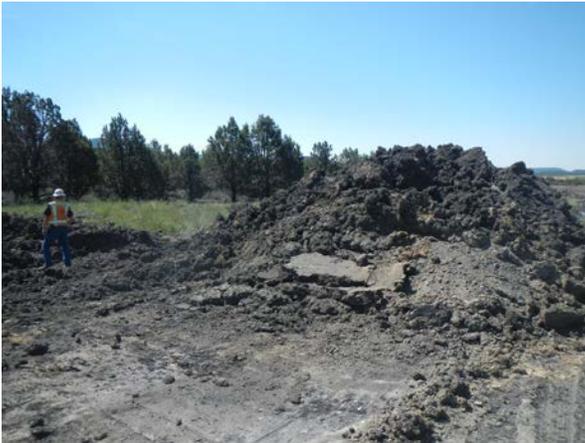
2. Soil pile from maintenance work completed at water tanks

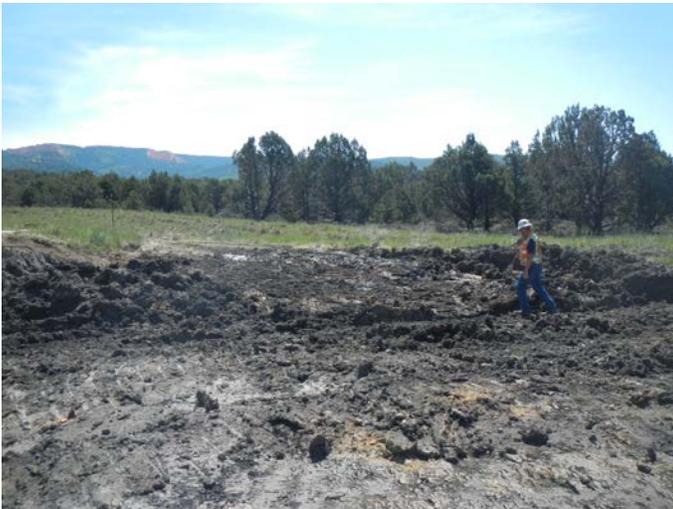
3. Wet material still present where pipe was repaired

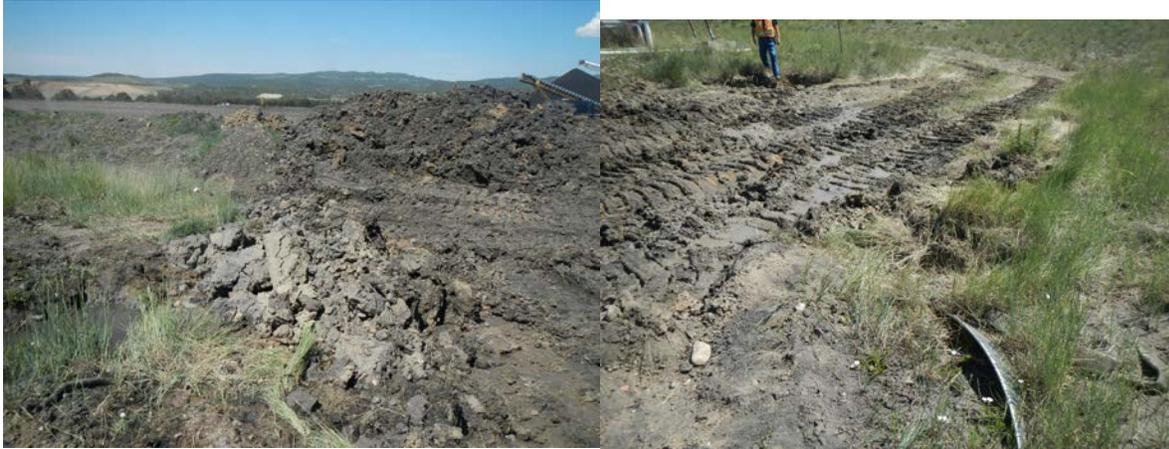
4. Material pushed onto undisturbed area

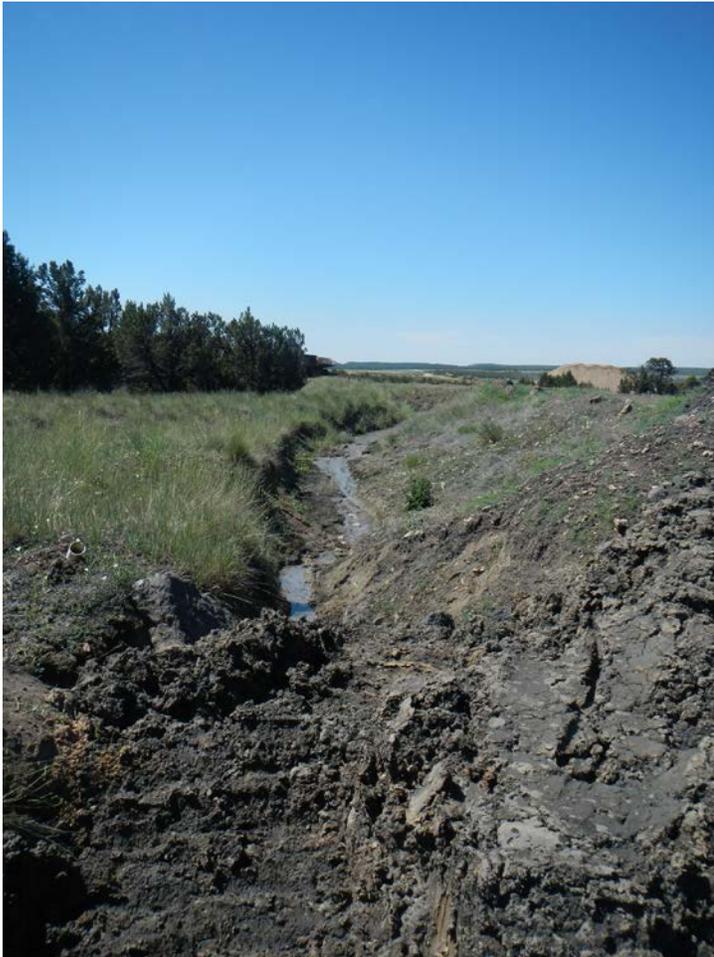
5. Flow from water tanks into ditch C7

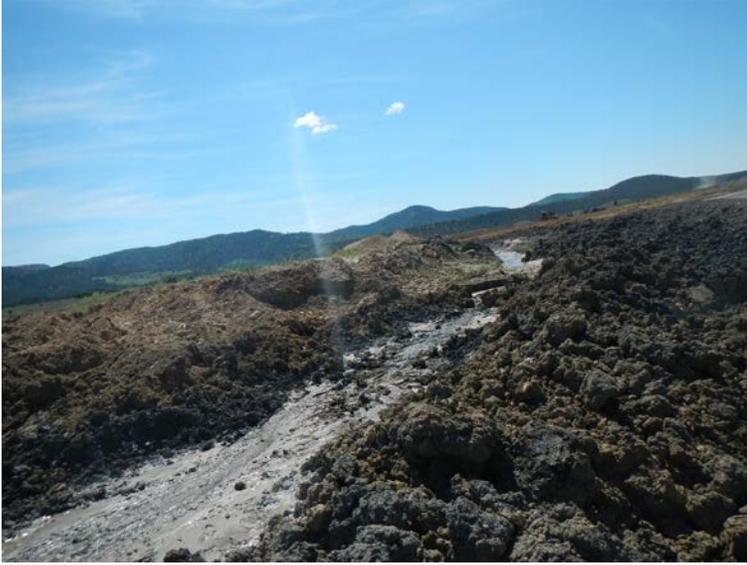
6. Road drainage before junction with DD#4

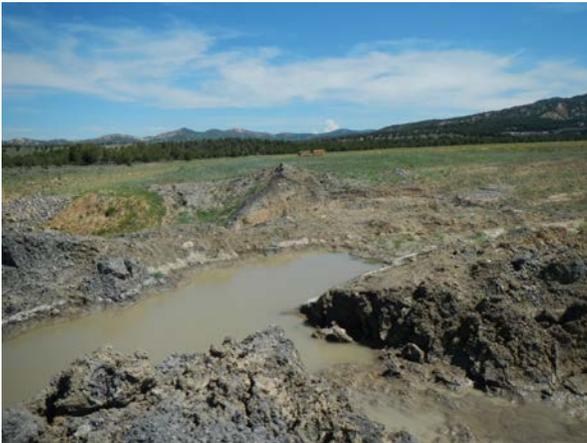
Diversion Ditch DD#4 berms had been recently worked. A high spot still remains just south of where the road drainage ditch connects with the newly constructed DD#4. The area is still ponding water but is dry enough that equipment should be able to clear the high spot so that drainage may free flow to Pond 3. The Permittee was told to remove the final high area within DD#4 that is acting like a plug in the flow of the ditch. See photos 7 through 8 for details.

7. Junction of Road drainage and DD#4

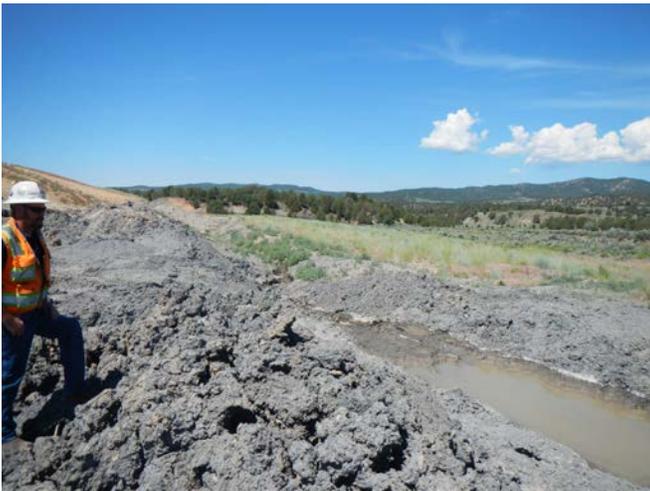
8. Flow West of DD#4 after junction to Pond 3

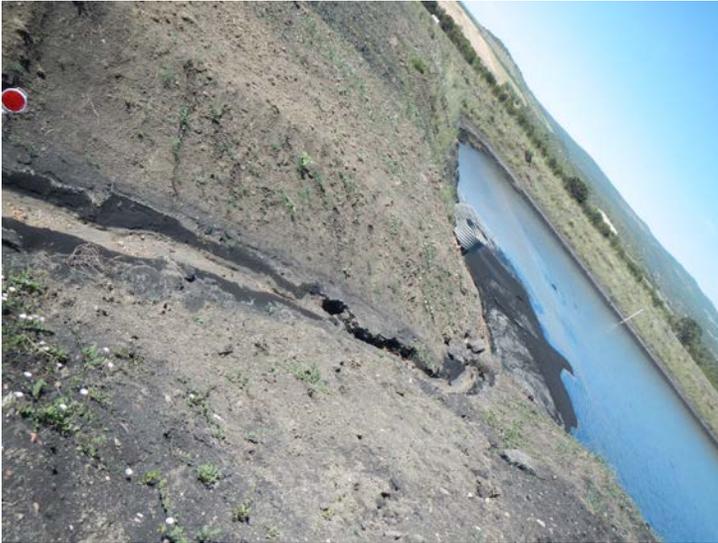
The Permittee stated that the second quarter certified pond and spoil inspections were completed the previous week and the final copies had yet to be received. The water truck was pulling water from Pond three at the time of the inspection. All ponds were inspected and found that the levels were relatively low with sediment levels below all the clean out marks. See Photos 12 for an example of water level height. Pond 1 has a gully on the east bank that still needs repairing along with riprap placed in the outlet. These maintenance tasks were required to be completed in the June 16 inspection by June 30. The Permittee submitted a design to modify the current inlet to Pond one. The Modification showed that the stated maintenance will be repaired during the construction of the modifications. The Pond one amendment was sent back deficient, Task 4894, on 6/9/15 and the Division has yet to receive the amended application. In the meantime, the maintenance needs to be completed before the rain season starts so riprap should be placed no later than 7/13/15, per as build drawing C9.0 for pond 1 attached. If the intent is to complete the required maintenance during the amendment's construction, Task 4894, the Permittee needs to resubmit the plans by 7/13/15. See photo 9.

9. Pond 1 inlet

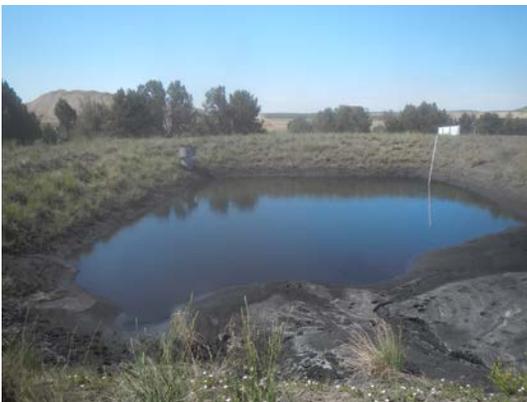
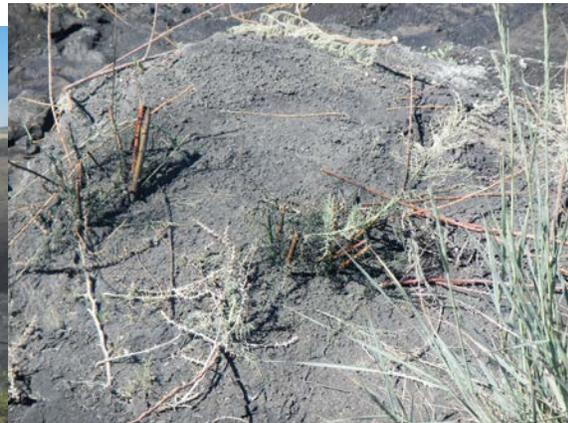
Tamarisk plants at all the ponds one through four were cut and treated with Garland on 6/25/15. This action meets the requirements stated in the June 16th inspection and R645-301-742.123. See photo 10 for example of treatment at Pond 1B.

10. Pond 1B with Tamarisk cut

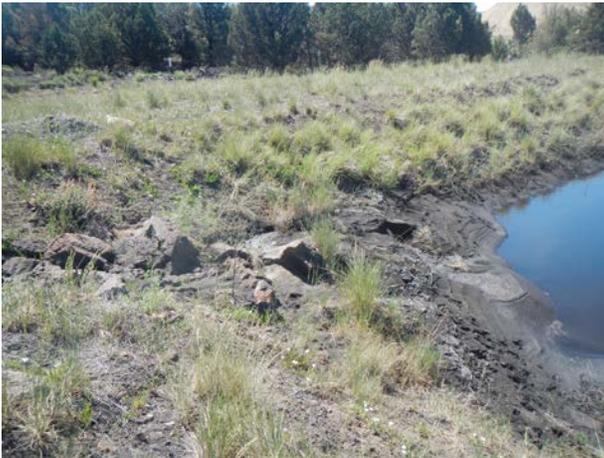
11. Pond 1B inlet

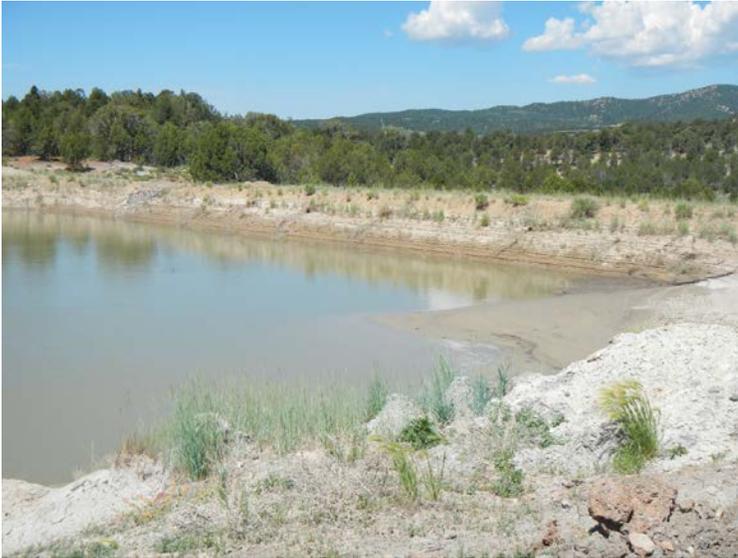
Pond three still requires maintenance on the inlet armoring. The June 16th inspection stated the need for maintenance on the inlet to repair the pond to the Asbuilt design. The water level of the pond is low creating an opportune time to make said improvements.

12. Sediment deposit fan at Pond 3 inlet

There was a discussion with the Permittee for upcoming amendments that would include improvements to Pond 3. The Permittee should submitted amendments to the Division on or before July 21st. See Photos 12 through 14.

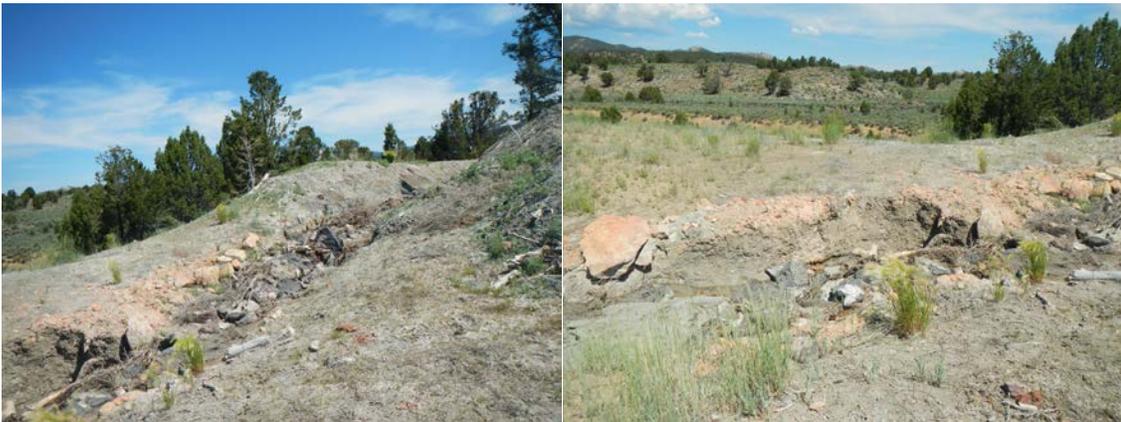
13. DD#4 armoring at inlet to Pond 3 were maintenance is required

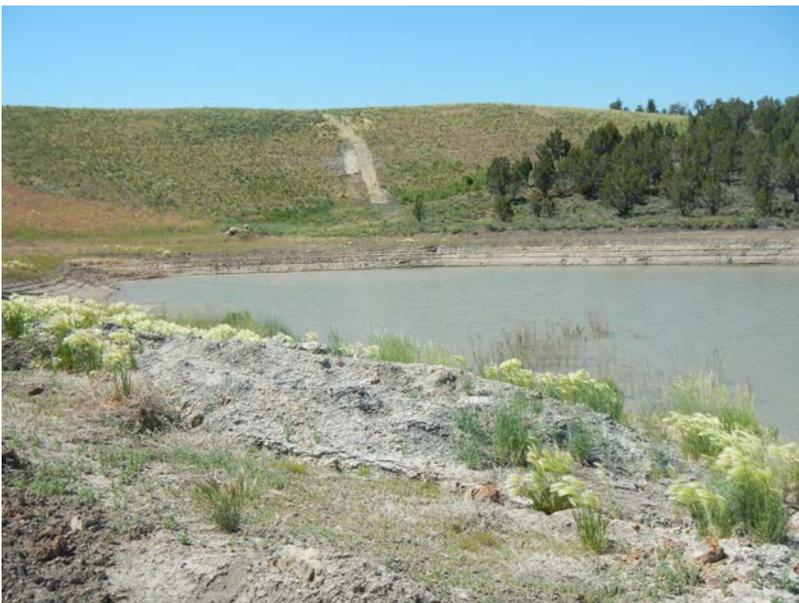
14. Exposed Tamarisk within Pond 3 that were not treated due to limited access

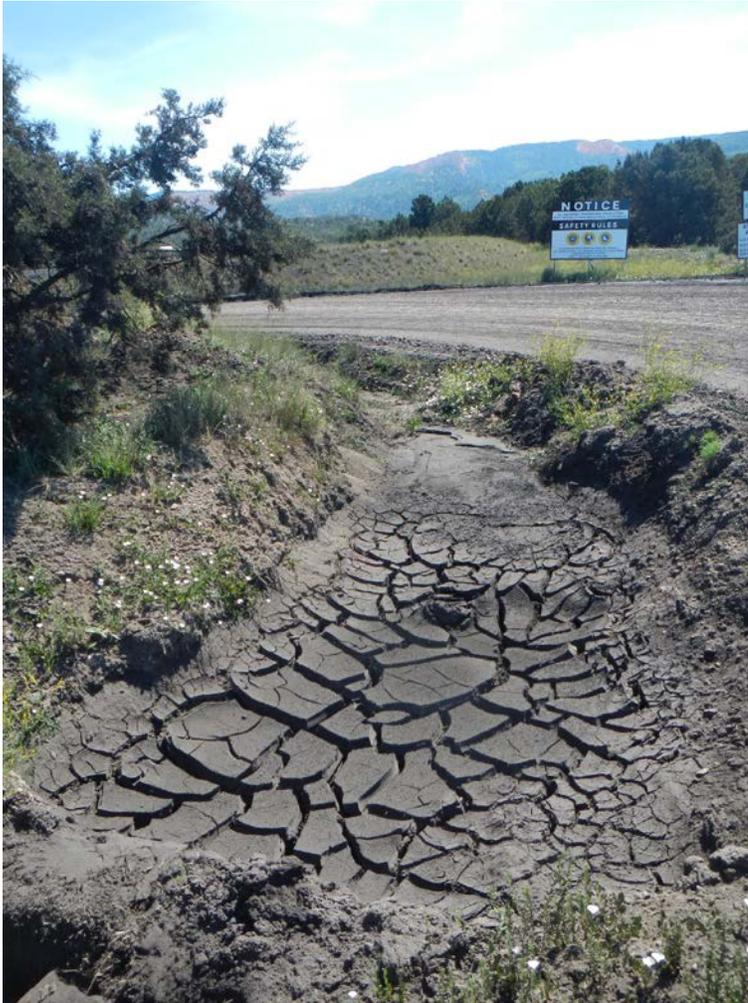
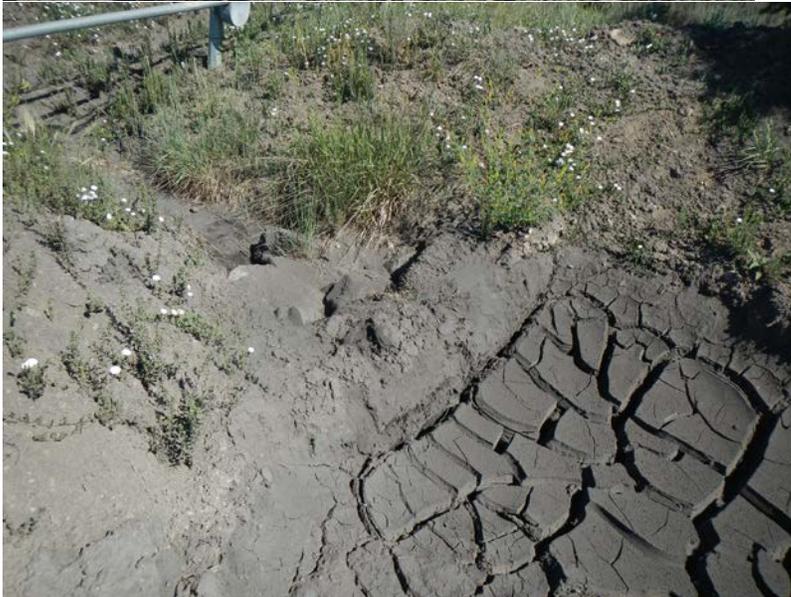
The main entrance ASCA and culvert were inspected, see photos 15 through 17 for details. The June 16th inspection report 4219 detailed that the area has been sufficiently dry for some time and that maintenance needed to be completed prior to the next inspection. NOV 20153 is being issued for failure to maintain this ASCA and the entrance culvert.

15. Main entrance North side ASCA sediment and straw bales.

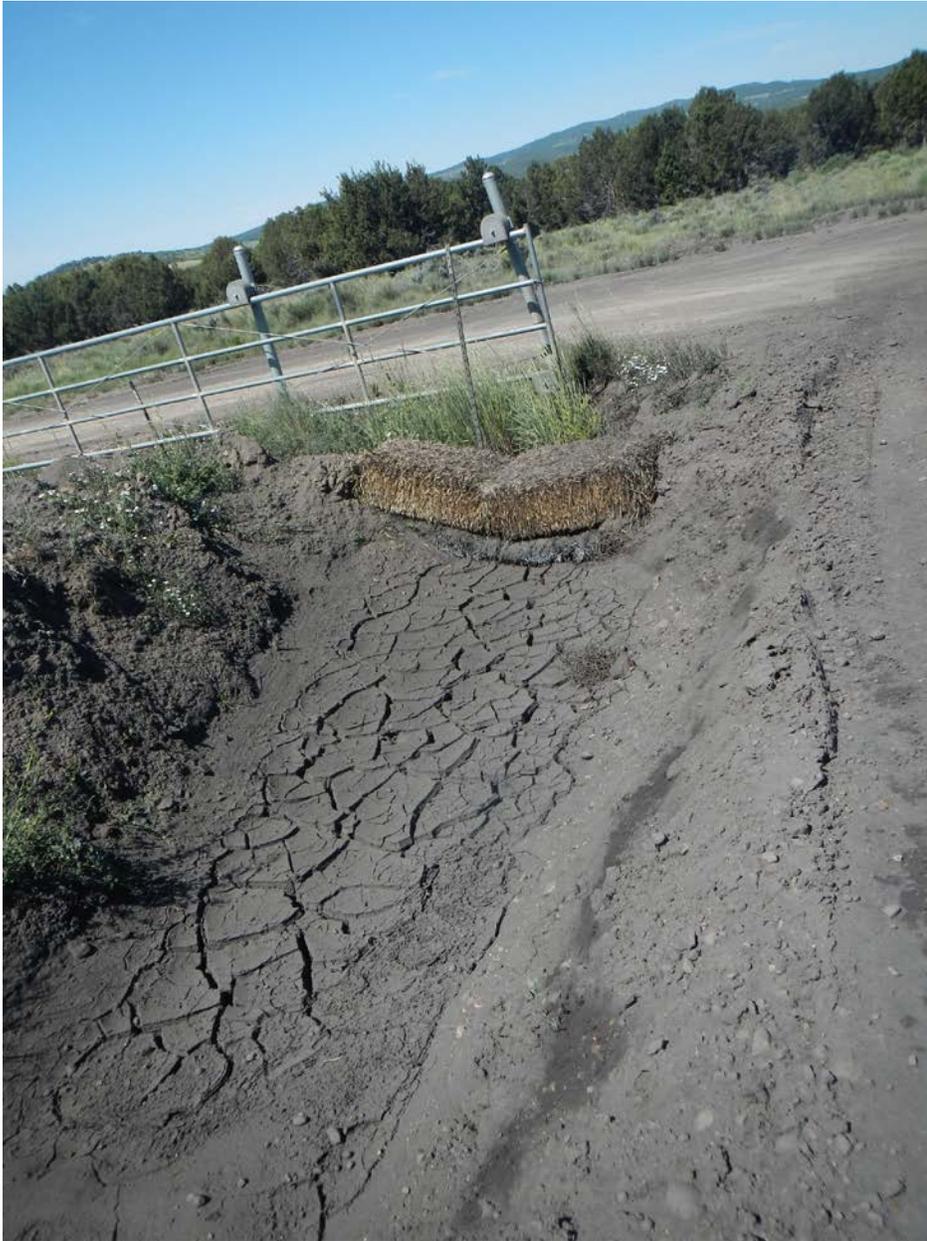
16. Main entrance South Side ASCA

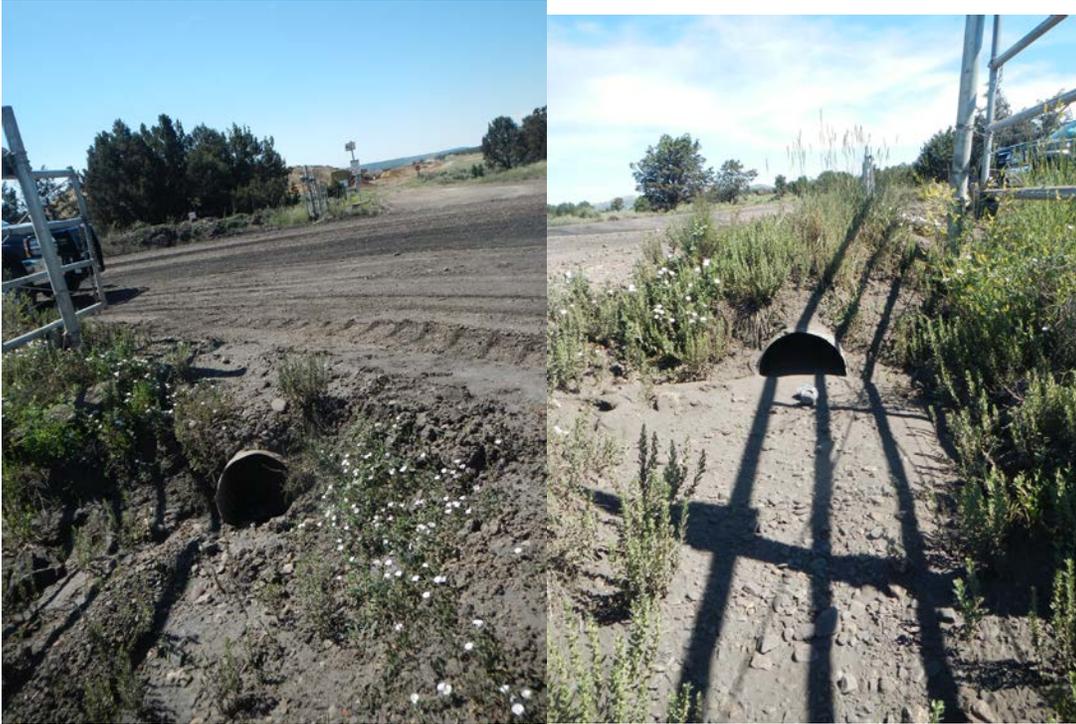
17. Main Entrance Culvert

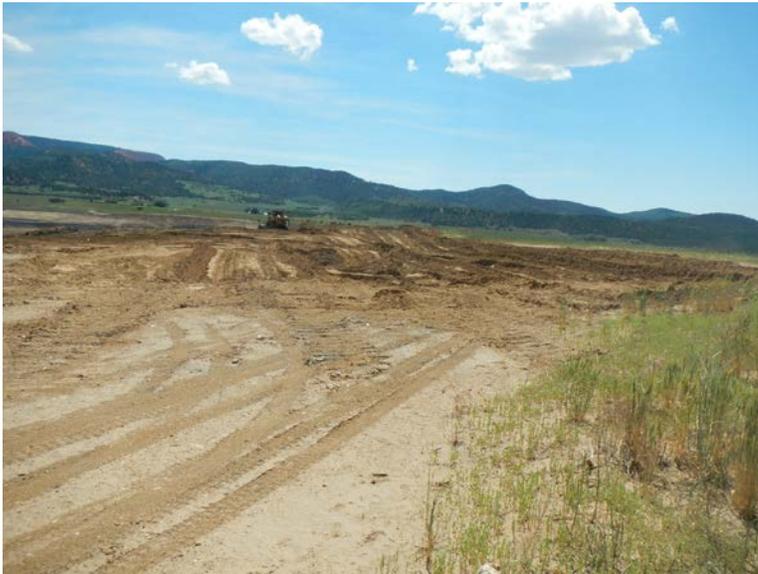
Work on the excess spoil pile has begun again. A dozer was pushing spoil east down off the excess spoil onto the old Pit 7 site at the time of the inspection. Wiggle wagons were hauling wet alluvium to be placed into HWT 1 along with Haul trucks hauling subsoil from the subsoil pile #2. See Photos 18 through 23. East of Pit 10 berms had not been installed at the time of this inspection.

18. Dozer pushing subsoil off excess spoil pile.

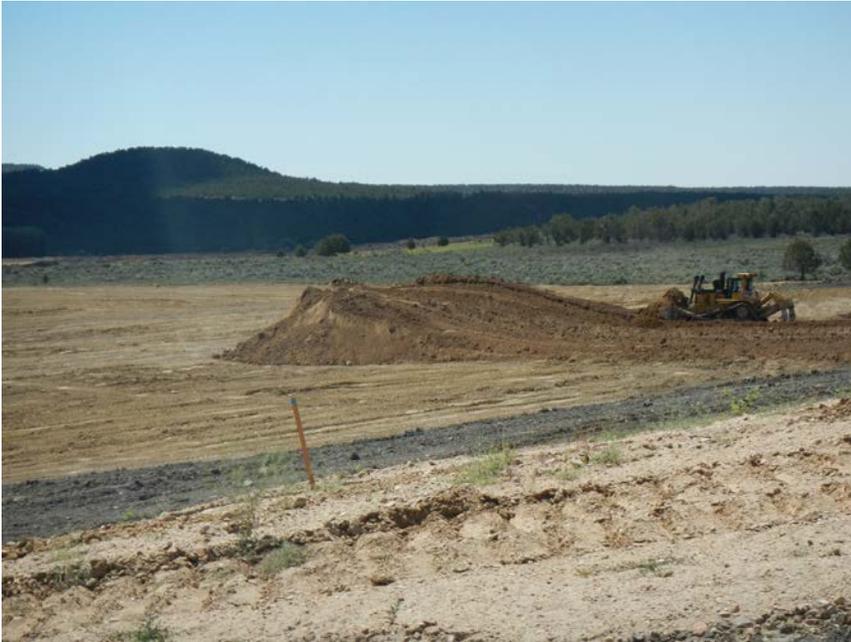
The Excess spoil pile was being worked above former Pit 2 and Pit 7 by the removal and storage of subsoil. The subsoil pile will need to be signed stabilized if it is not placed for final reclamation. Trucks were hauling subsoil and alluvium to HWT 1 at the time of inspection.

19. Subsoil Pile at base of excess spoil pile

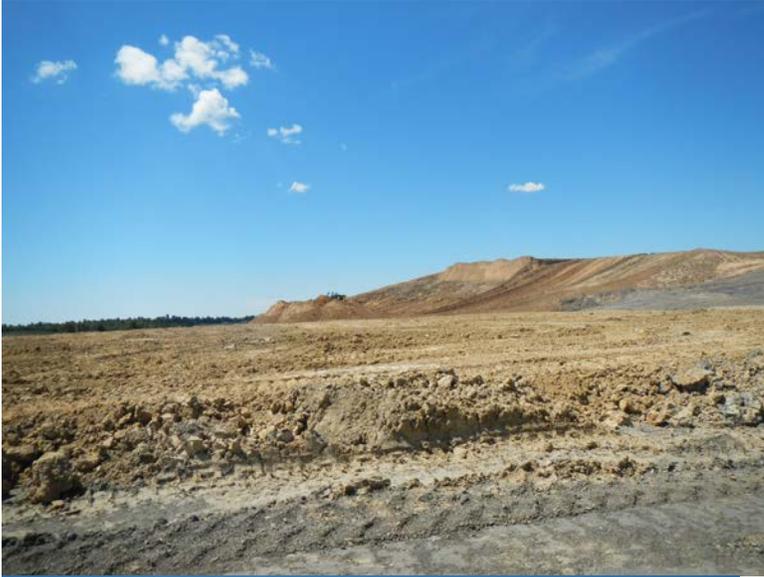
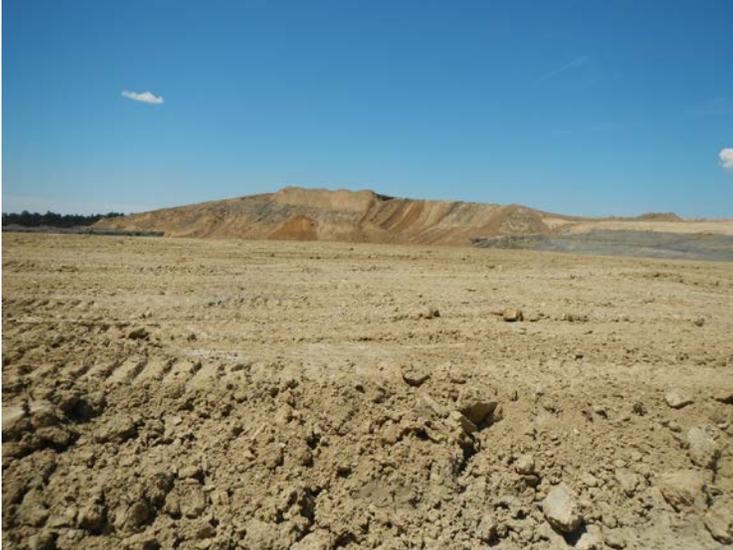
20. Working face of excess spoil pile

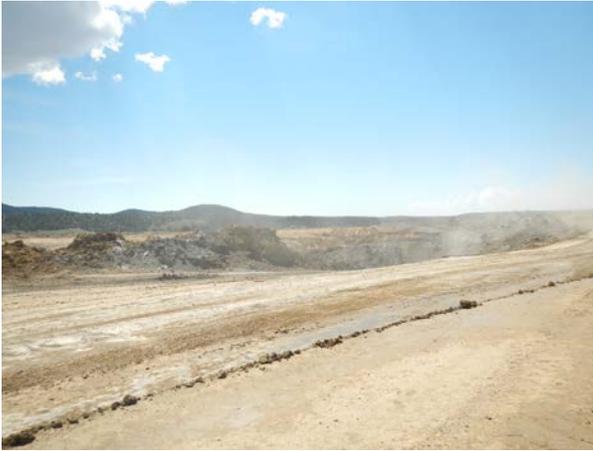
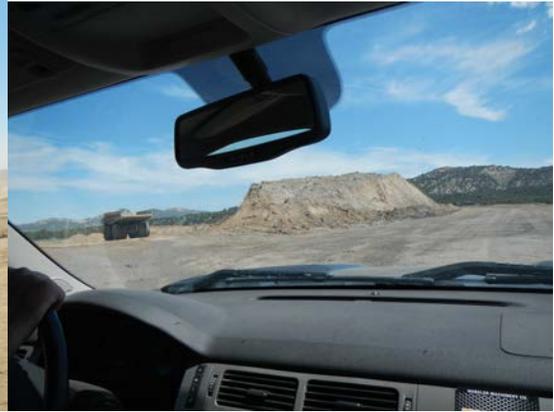
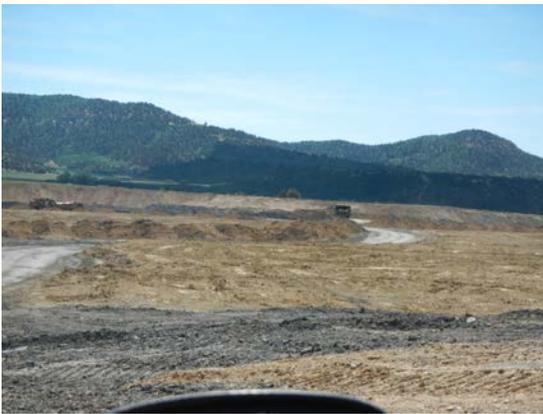
21. Trucks hauling sub soil to HWT 1

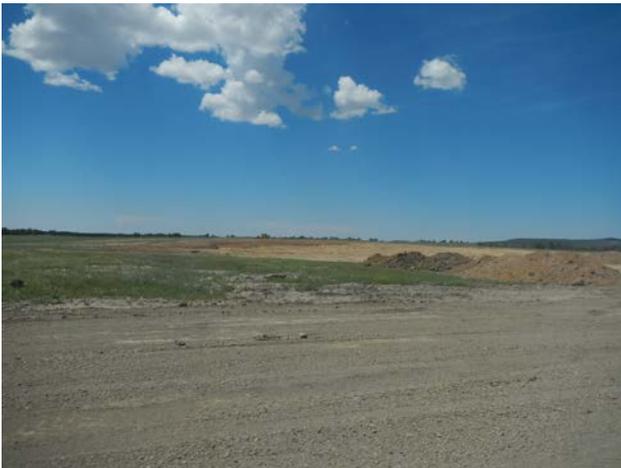
Topsoil was being applied by equipment on the north side of Dames access road, previous pits 21-20. The topsoil pile north of Pit 10 remains stable.

22. Topsoil being stockpiled for dozing in southern area.

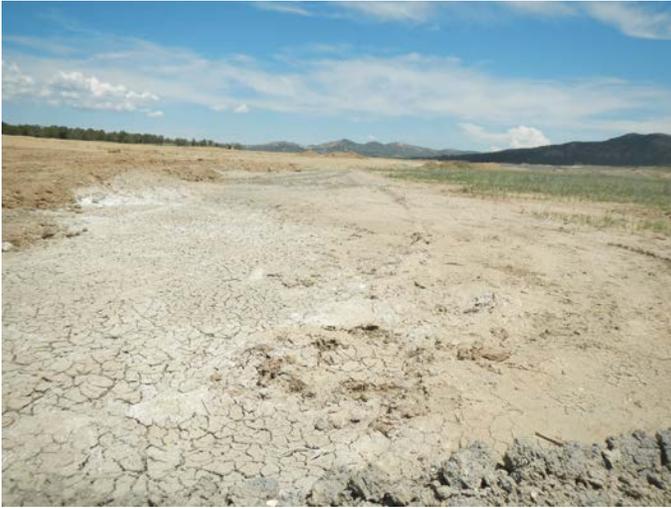
The ponding area adjacent to the reconstruction of Dames access road was witnessed during inspection. Top soil piles were witnessed in the vicinity to be placed shortly over the area north of the Dames's access road. The Permittee was advised to grade the area to drain so as to avoid salt pooling at the site that would hinder vegetation growth. As discussed, a culvert should not be placed due to the continuing maintenance required. With proper grading the area will drain to the south and flow through the gravel surface which will be placed on the Dames's access road. See Photo 23. The Division wishes to reiterate that top soil should not be used for grading. The Division will conduct tests to verify the topsoil depth in bond release areas during a bond release inspection.

23. Dames Access low spot

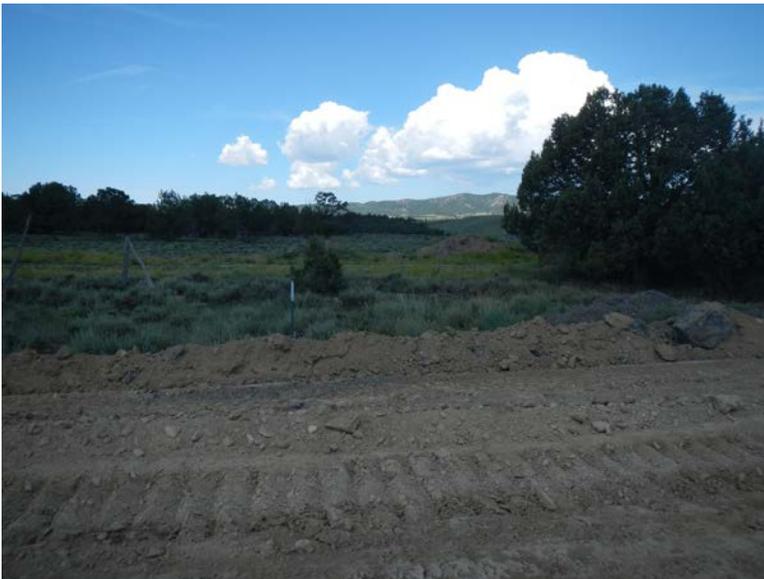
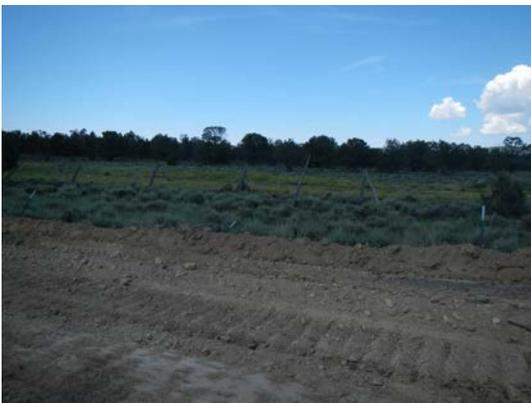
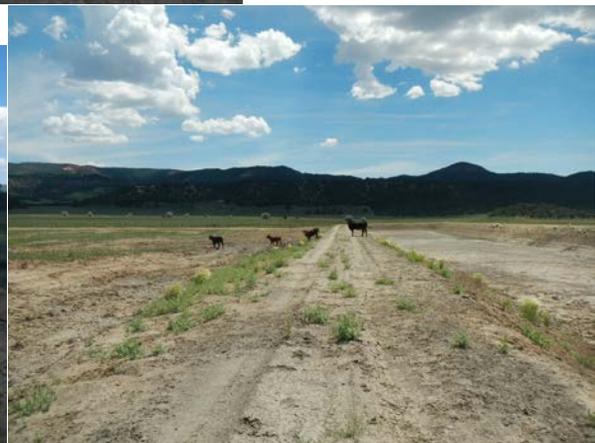
A section of fence was broken during reclamation activities around Pit 21. The fence is now laying down and requires maintenance. Photo 24 shows how the fence is on the ground. Cattle have been entering the mine site due to the broken fence. The cattle were witnessed at Pond 4 during the time of this inspection as well as the previous July 16th inspection. The Permittee has contacted the rancher and will follow up with fence maintenance.

24. Fence down around Pit 21 and cattle at Pond 4

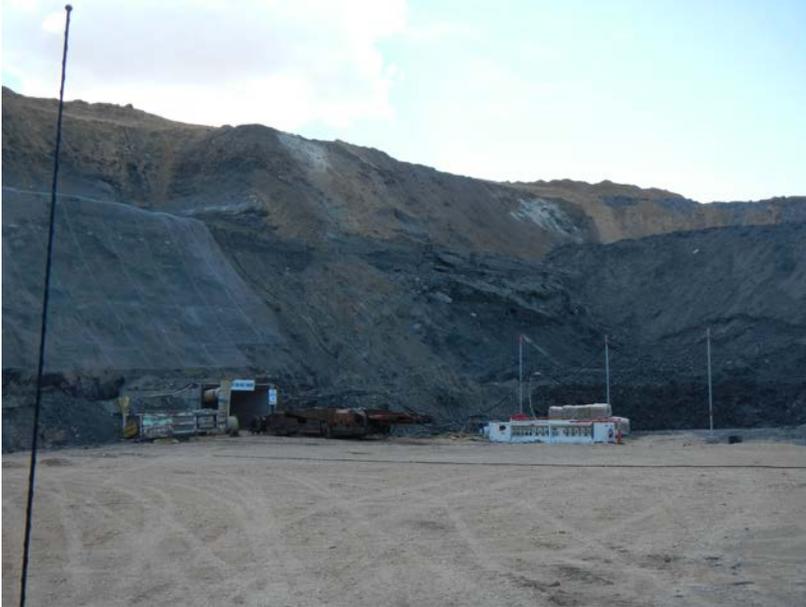
Within Pit 10 along the south slope there has been a series of sloughing as the slope is sloughing back. The Permittee stated that the area is no longer receiving water and is expected to remain stable now. See photo 25.

25. Pit 10 southern slope sloughing

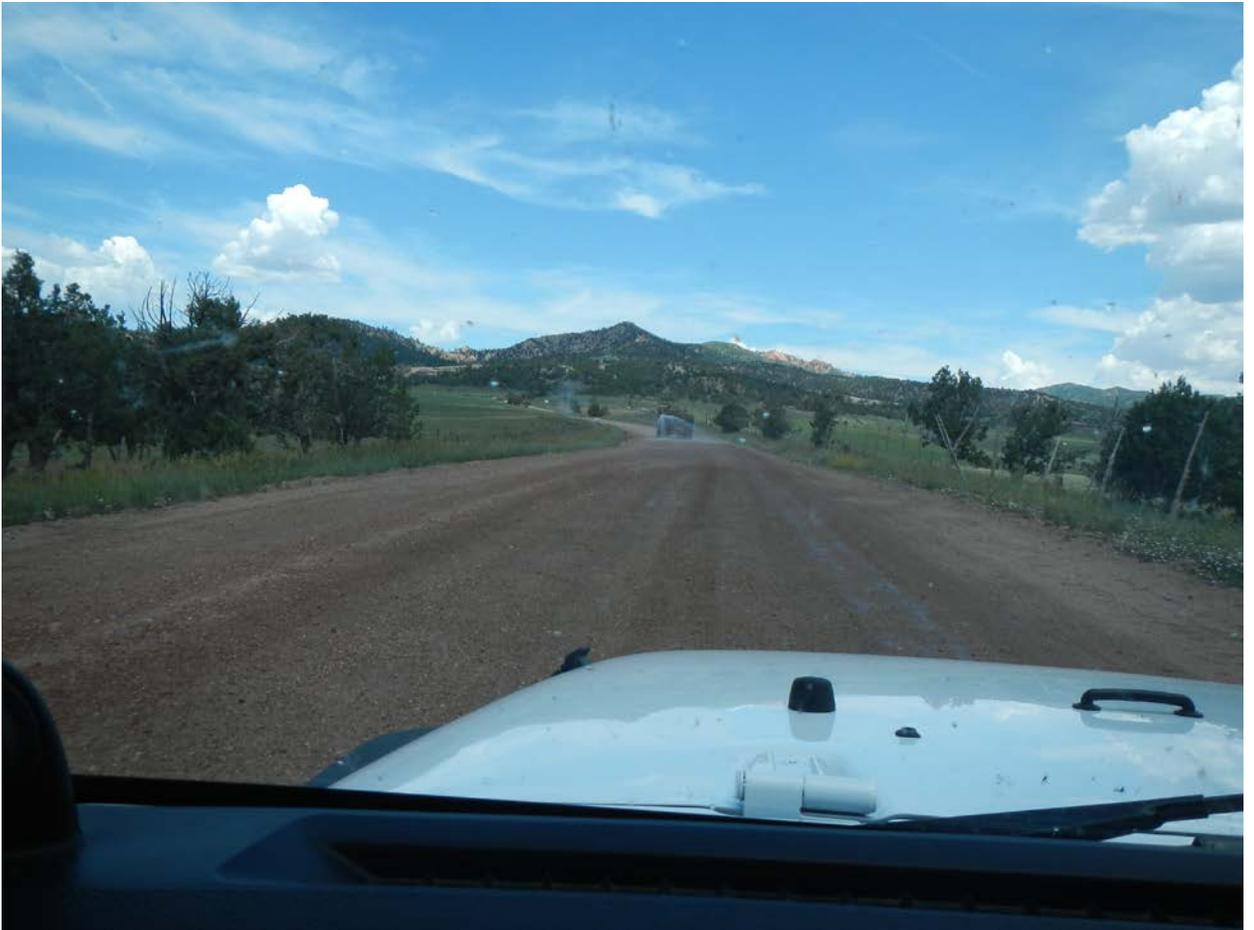
The grader was witnessed surfacing the current haul road. The water truck was also witnessed maintaining dust control. See photo 26.

26. Water truck watering the mine access road

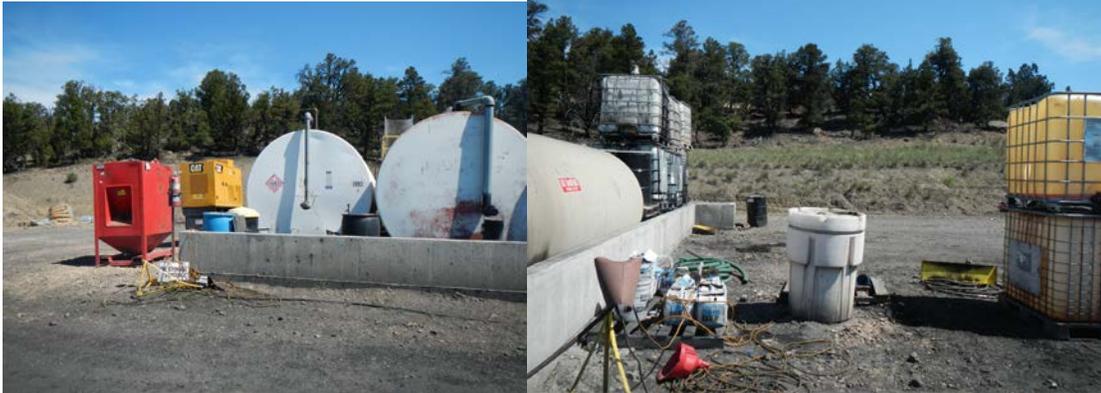
The secondary containment area was inspected to insure that the SPCC plan was being followed. See photo 27. Approximately 2 inches of water was observed within the fuel containment structure.

27. Spill containment Area
