Division of Oil, Gas and Mining

Inspection Report

Permit Number:	C0250005
Inspection Type:	PARTIAL
Inspection Date:	Friday, July 10, 2015
Start Date/Time:	7/10/2015 9:00:00 PM
End Date/Time:	7/10/2015 2:00:00 PM
Last Inspection:	Tuesday, June 30, 2015

Permittee: **ALTON COAL DEVELOPMENT LLC**
 Operator: **ALTON COAL DEVELOPMENT LLC**
 Site: **COAL HOLLOW**
 Address: **463 North 100 West, Suite 1, CEDAR CITY UT 84720**
 County: **KANE**
 Permit Type: **PERMANENT COAL PROGRAM**
 Permit Status: **ACTIVE**

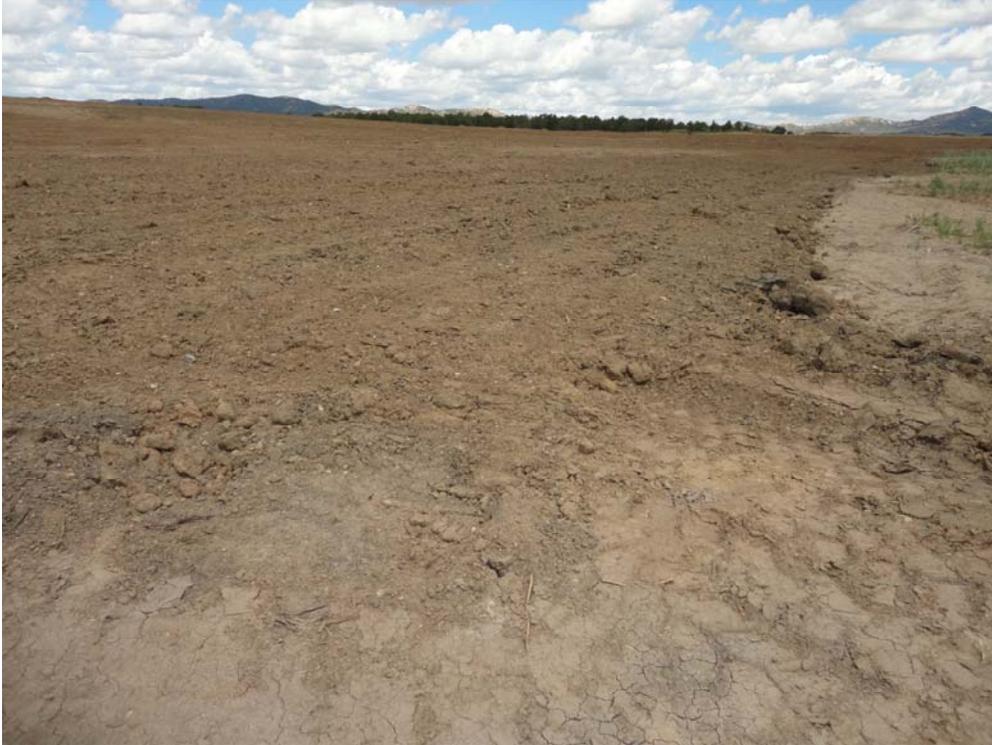
Topsoil is fully applied along the northern section of Dames access road (Figure 1).

Figure 1. Topsoil applied to the north of the Dames access road.

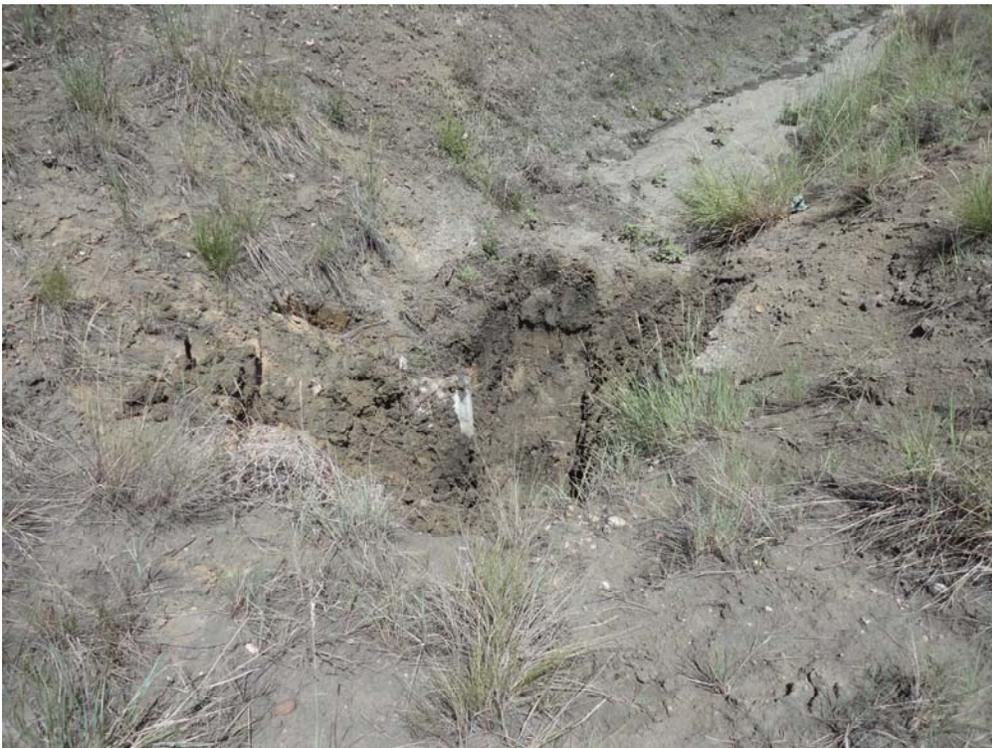
The inlet of culvert C7 just down from the water tanks was clear of sediment and properly functioning (Figure 2).

Figure 2. Culvert 7 is cleaned out and is properly functioning.

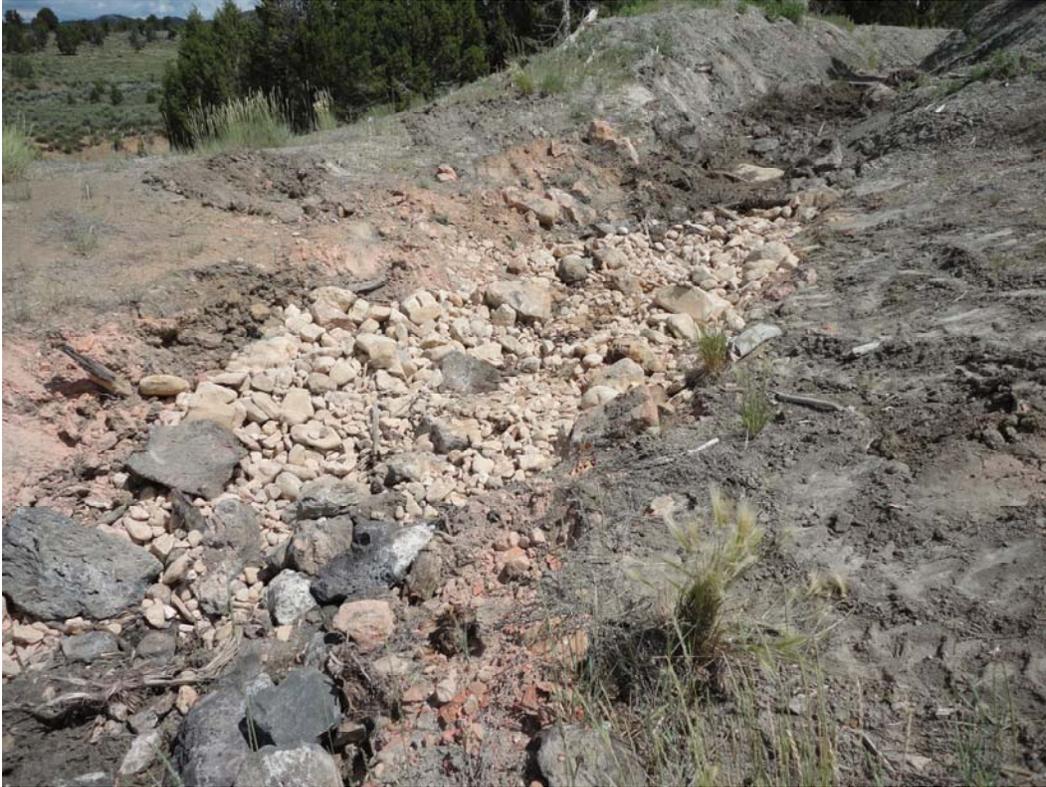
The inlets to Pond 1 and Pond 3 had been rip-rapped. It was discussed that a fabric or granular filter under the rip-rap at the inlets may help further stabilize these features if they continue to erode and be problematic in the future (Figure 3).

Figure 3. Pond 3 inlet has been rip-rapped.

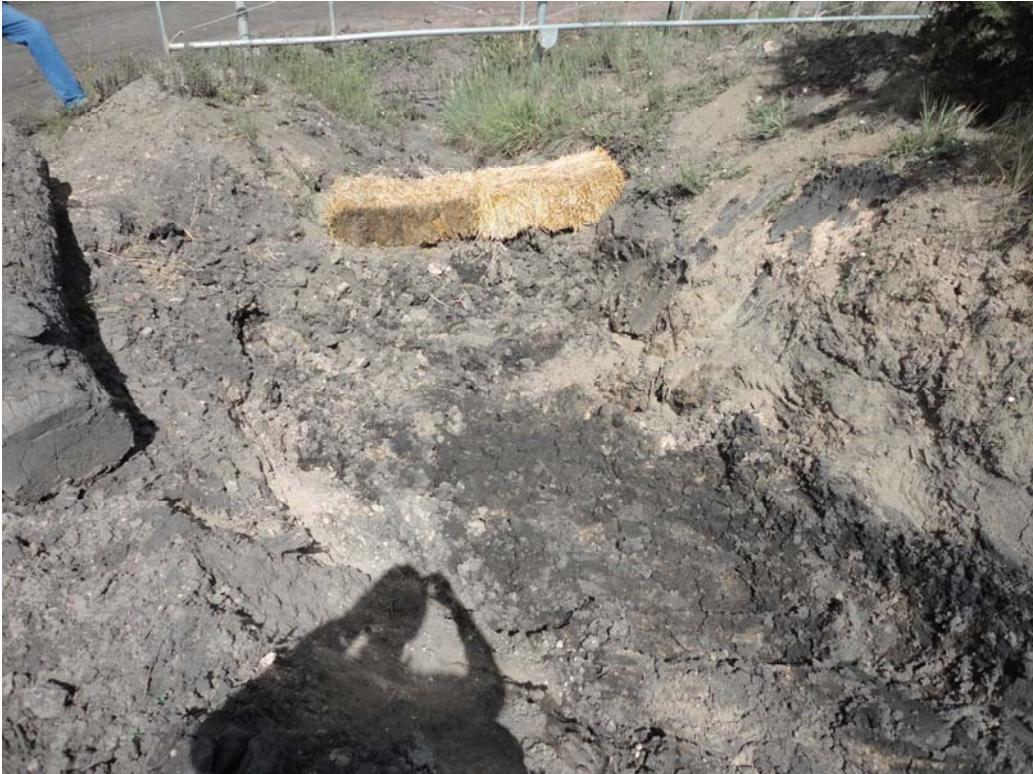
The Best Technology Currently Available (BTCA or alternative sediment control measure/ASC) at the main entrance was repaired. The ditch to the north of the road had been cleaned out and new straw bales have been installed at both the north and south ditches. The entrance culvert was cleaned out as well (Figure 4 & 5).

Figure 4. BTCA on north side of main entrance.

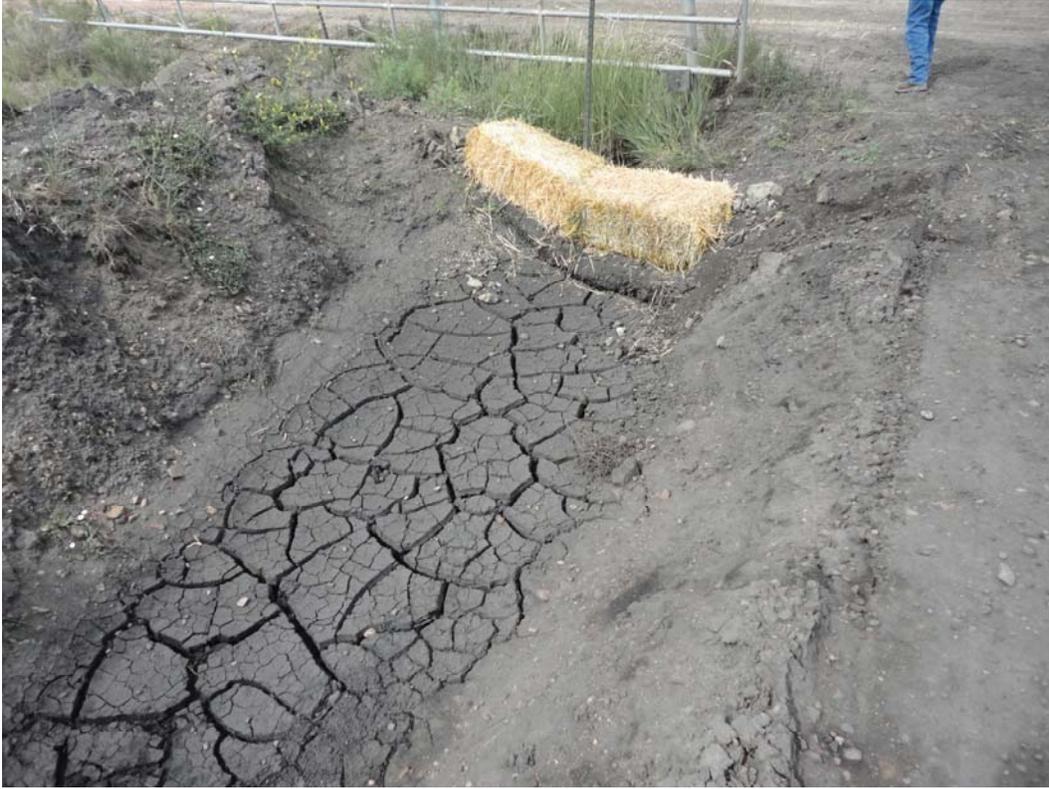
Figure 5. BTCA on south side of main entrance.

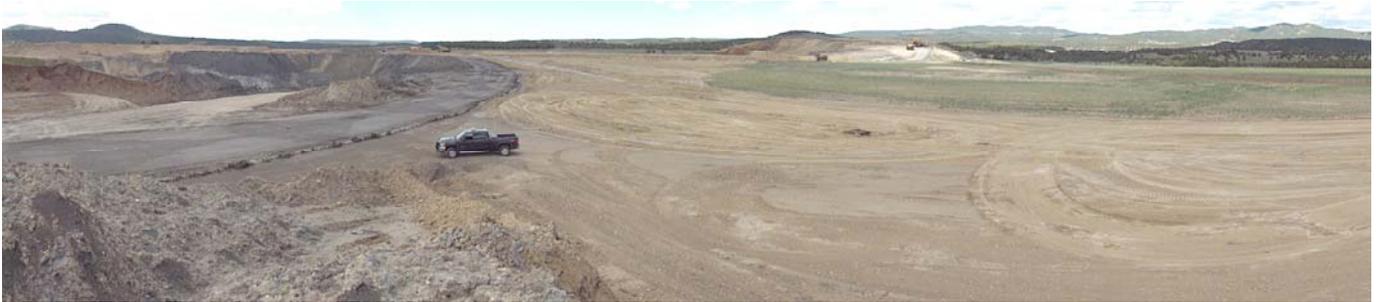
An excavator, bulldozers, and haul trucks were working on the eastern side of the excess spoil pile. Subsoil and excess spoil were being dozed downslope and piled at the base. The piles were being loaded and hauled to fill the highwall trench (Figure 6). Mr. Nicholes was notified to properly handle and account for the small area of topsoil that was on the NE corner of the excess spoil pile. This topsoil had accidentally been placed in this area a while ago and was nearly in the way of where they are currently working on the excess spoil.

Figure 6. Pit 10 photo left. Excess spoil with equipment working photo right-center.

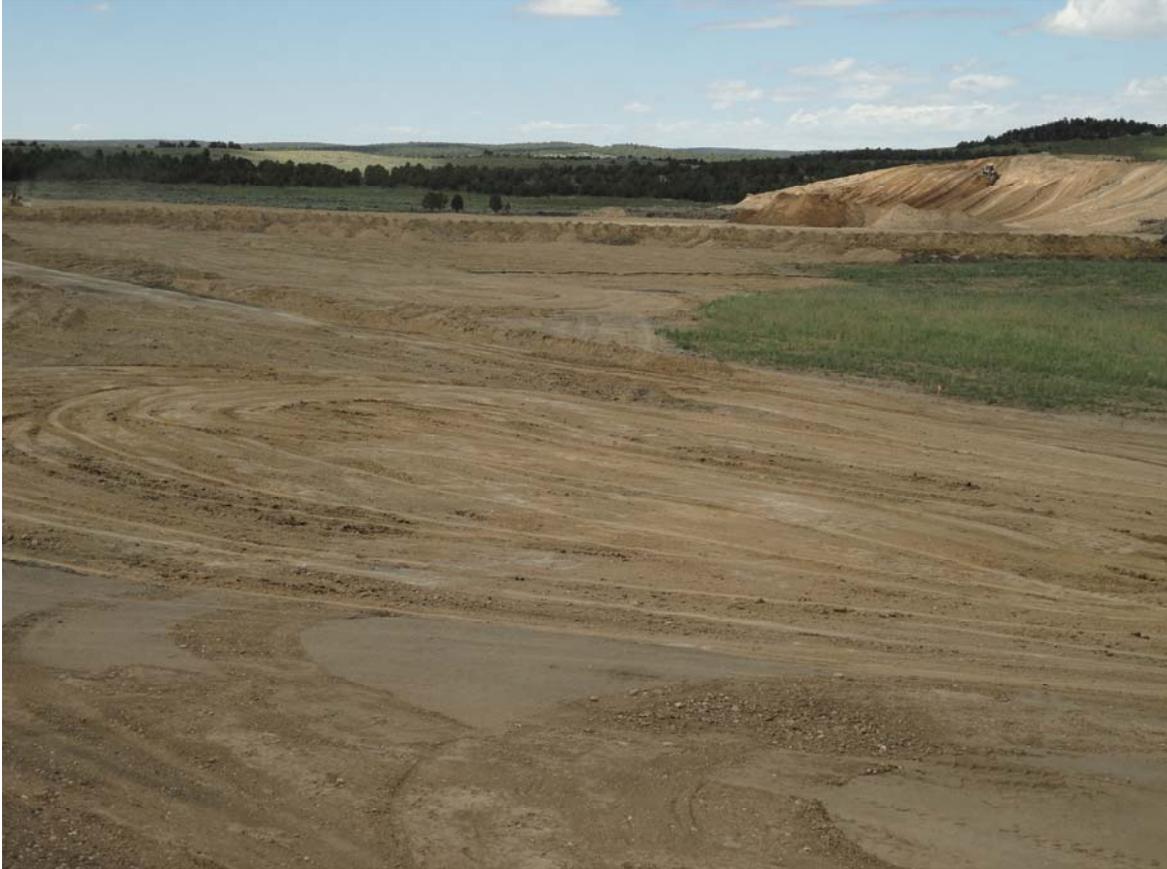
Subsoil has been applied to almost the entire bond release area to the east of the excess spoil pile or Pit 7 area. In the mean time, a haul road cuts through this area and is used for hauling excess spoil to backfill HWT 2 & 3. Subsoil piles have been placed along the length of this road and will be used to bring this haul road area to final grade once the road is no longer needed (Figure 7).

Figure 7. Subsoil seen piled along length of haul road from HWT 2 to excess spoil pile.

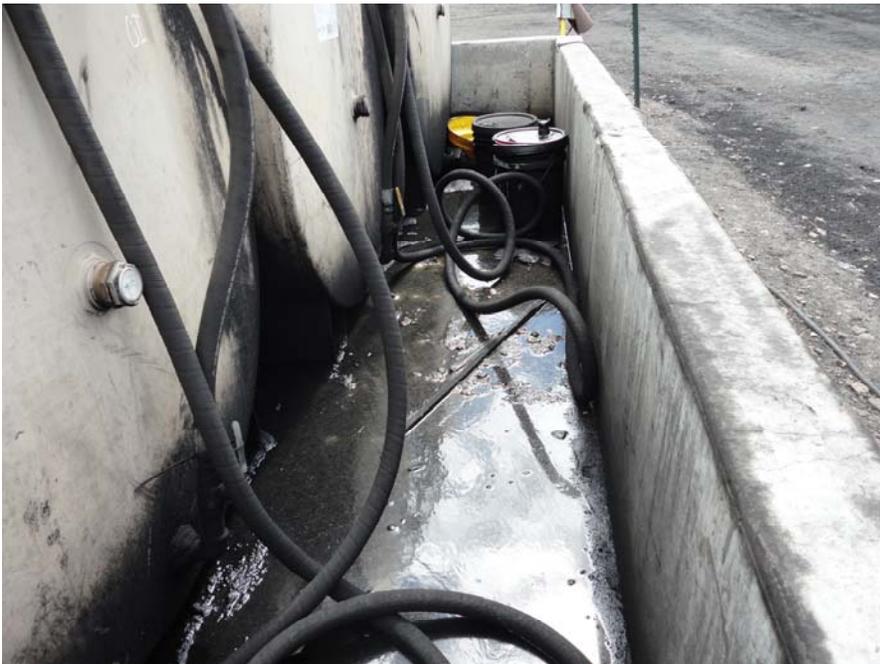
The SPCC fuel containment structure was mostly dry except for a shallow puddle (< 1/2") in the bottom along the southern wall (Figure 8).

Figure 8. Shallow puddle (<math><1/2\text{''}</math>) in the bottom of the SPCC fuel containment structure.
