Inspection Report

Permit Number:	C0250005
Inspection Type:	PARTIAL
Inspection Date:	Monday, July 13, 2015
Start Date/Time:	7/13/2015 9:00:00 AM
End Date/Time:	7/13/2015 3:00:00 PM
Last Inspection:	Friday, July 10, 2015

Permittee: **ALTON COAL DEVELOPMENT LLC**

Site: **COAL HOLLOW**

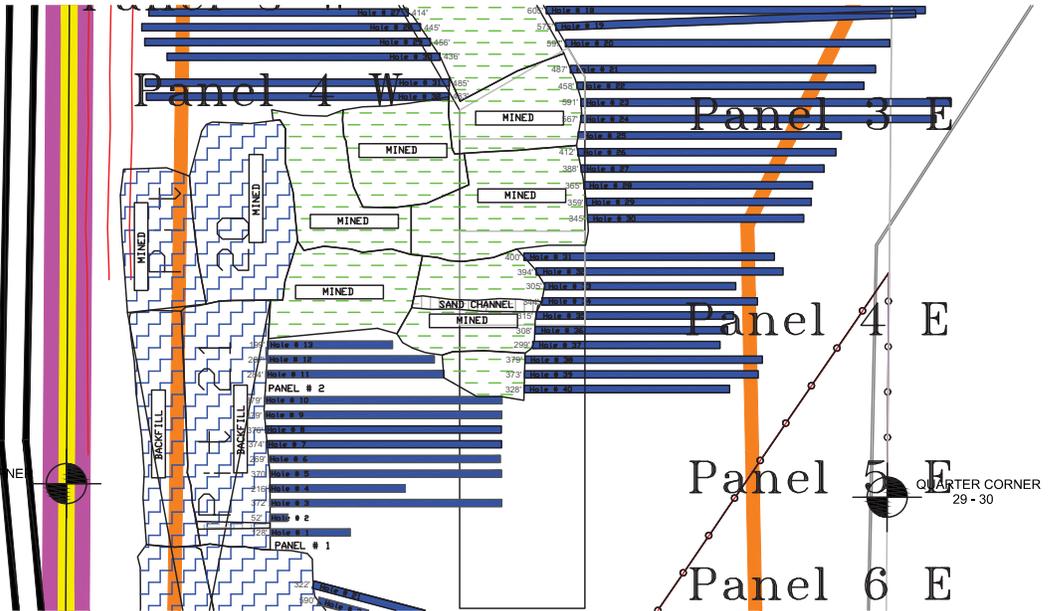
HWT 1 & 2 were being backfilled. Water is ponding in the bottom of HWT 2. Mining has ceased in HWT 2. The location of the last auger panels is shown on the attached figure provided by Joe K. The last four auger panels need to be backfilled immediately.

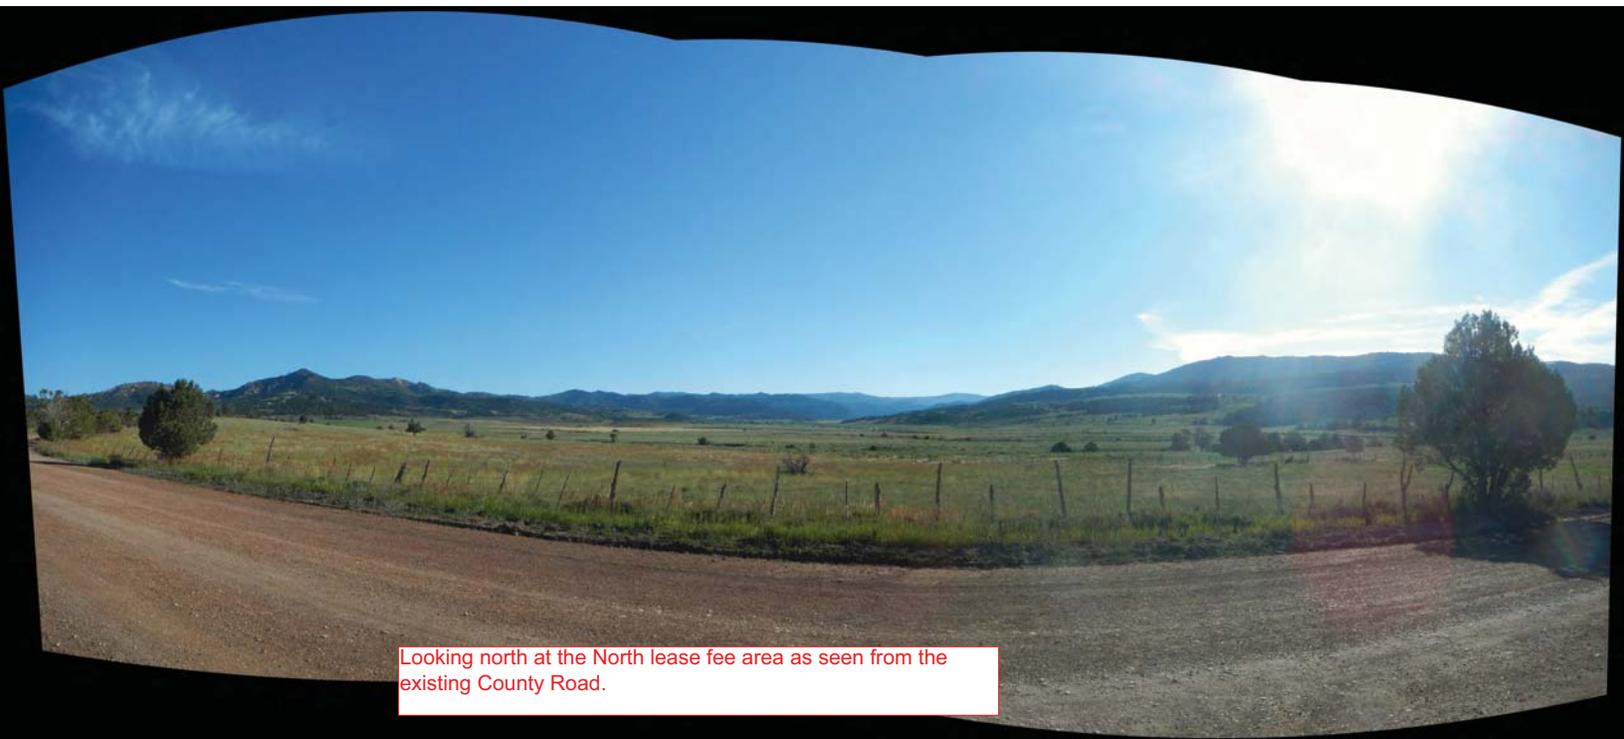
Looking north at the North lease fee area as seen from the existing County Road.

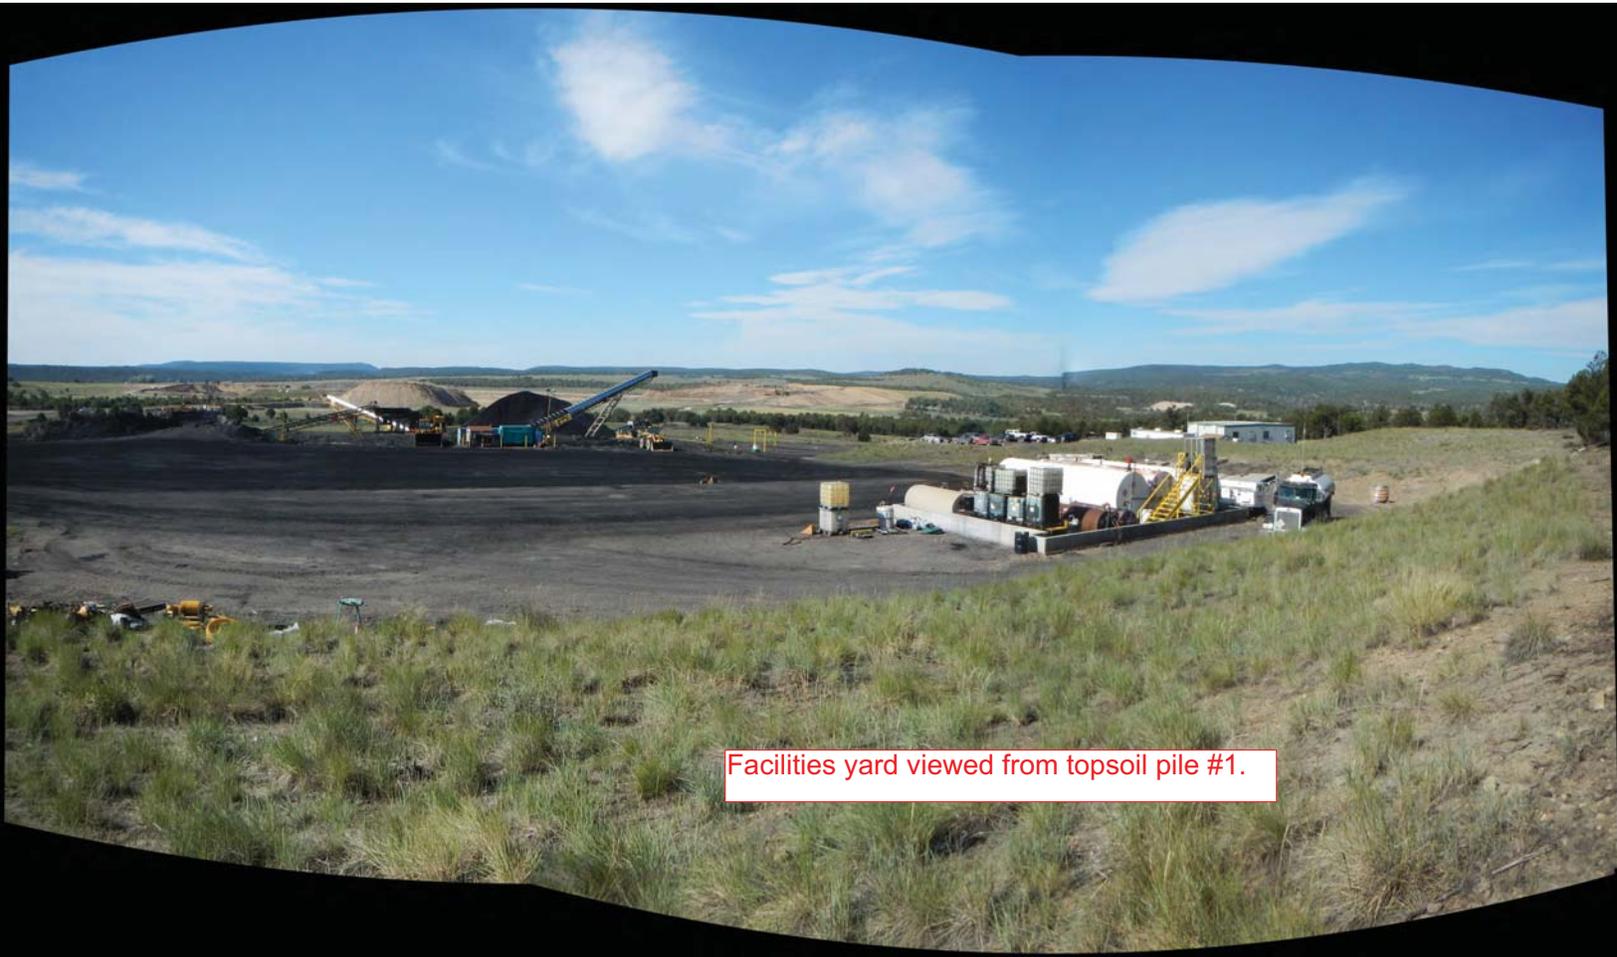
Facilities yard viewed from topsoil pile #1.

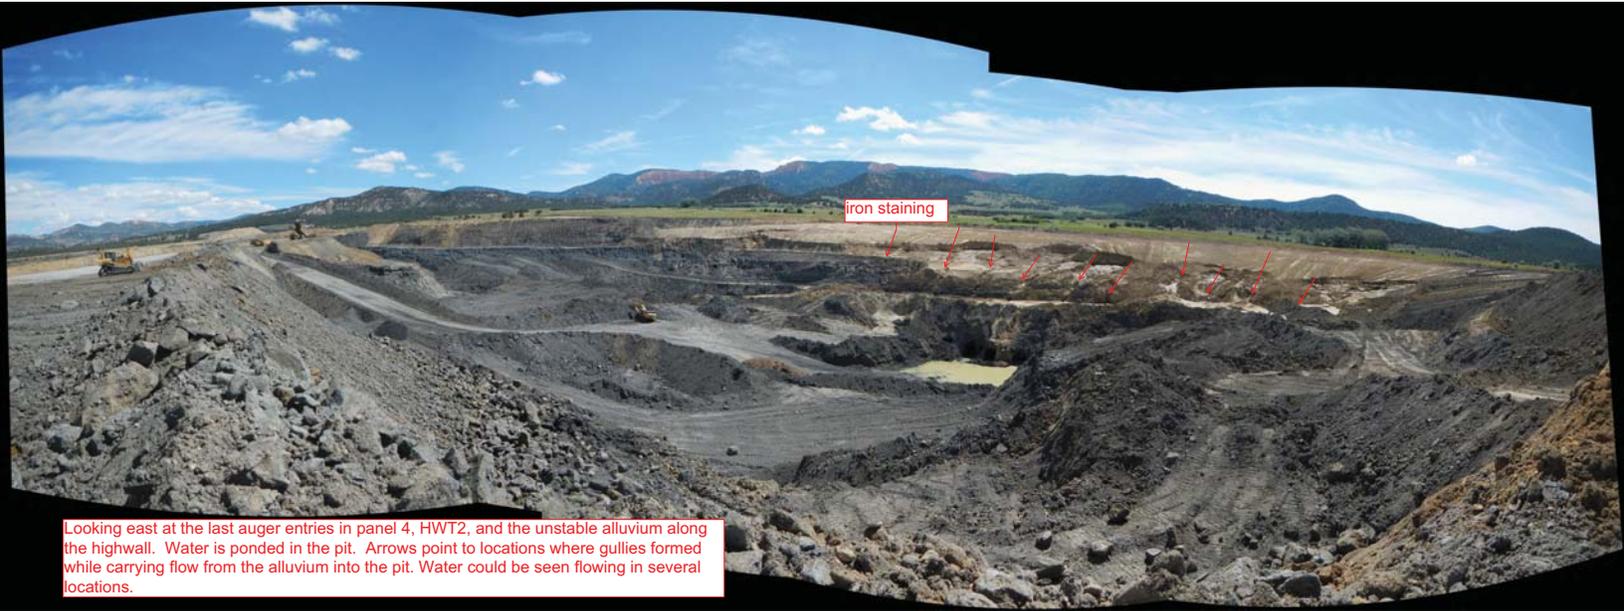
Alluvium laid back above HWT 2 on the east side is unstable and sloughing. Six streams of water could be seen flowing in gullies from the alluvium at its interface with the shale overburden. The water is flowing into the pit. One gully stream was red with oxidized metals. The flow of water was difficult to determine at a distance, but an estimate of 10 gpm at one gully was discussed as likely. MRP Table 7-9 Estimated Rates of Groundwater Inflows projects 1.7 gpm to 6 gpm per 100 linear feet inflow for areas C3 and C4. (Refer to Dwg 7 - 10 for well locations.)

Looking east at the last auger entries in panel 4, HWT2, and the unstable alluvium along the highwall. Water is ponded in the pit. Arrows point to locations where gullies formed while carrying flow from the alluvium into the pit. Water could be seen flowing in several locations.

Supplemental monitoring of springs and wells is required in conjunction with the highwall mining (MRP Vol 7, Chap 7, page 7-60). The most recent monitoring report on file with the Division is dated January 7, 2015. Reporting of monitoring data in conjunction with the highwall mining is long overdue and should be provided to the Division immediately.

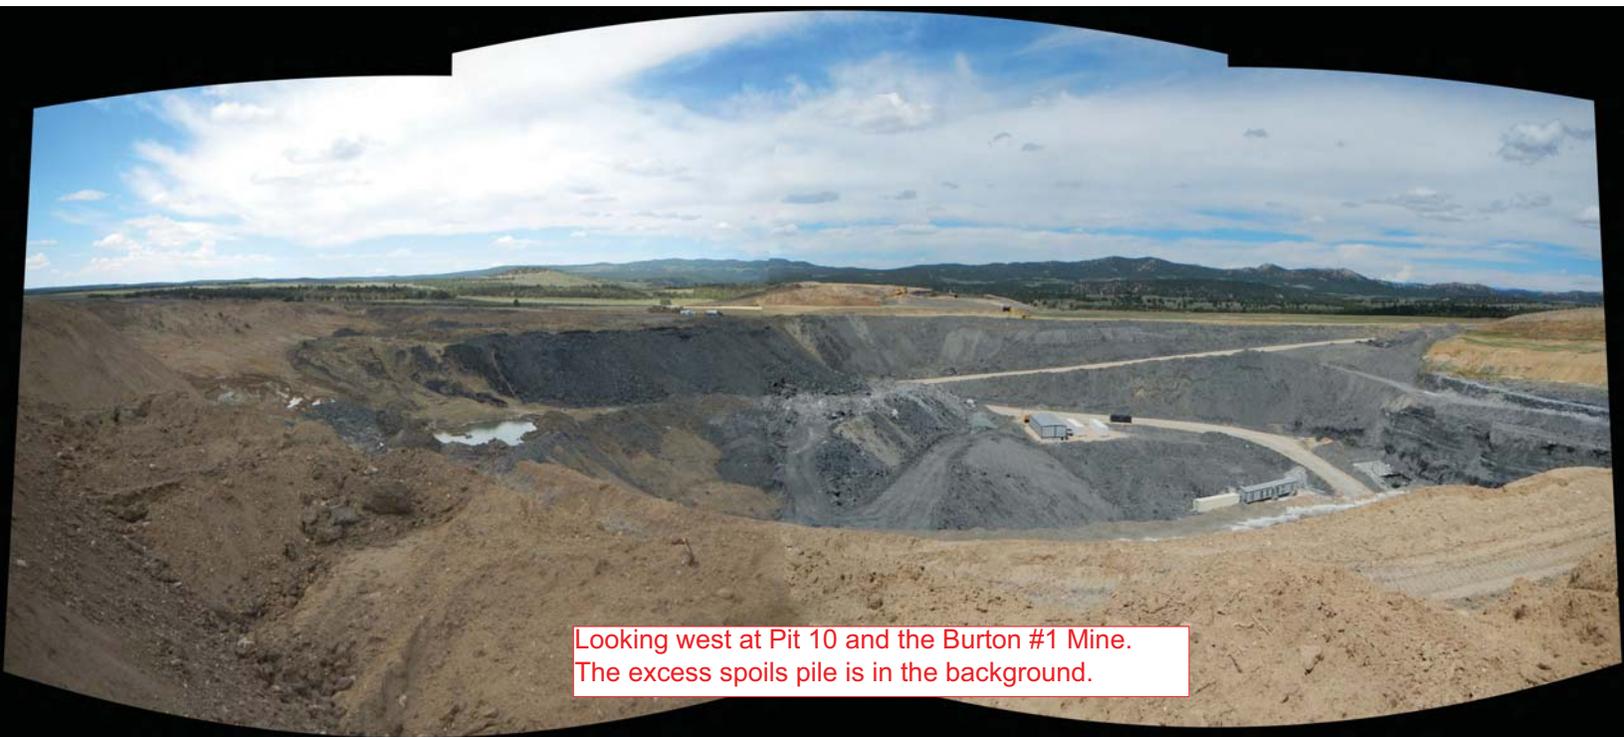
Looking west at Pit 10 and the Burton #1 Mine.
The excess spoils pile is in the background.

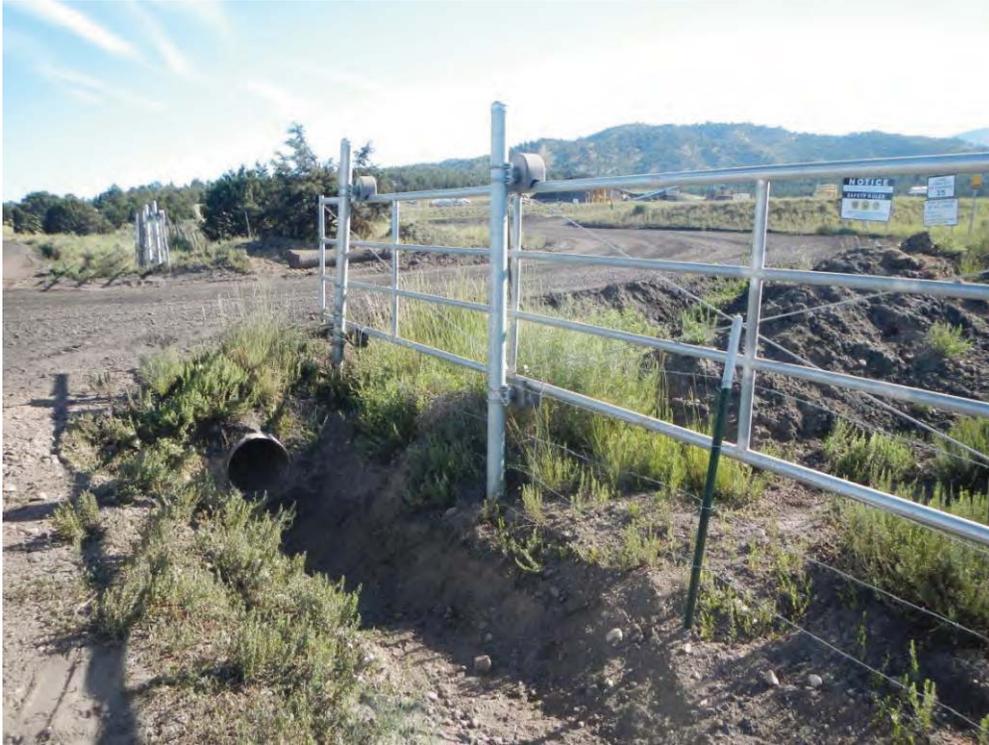
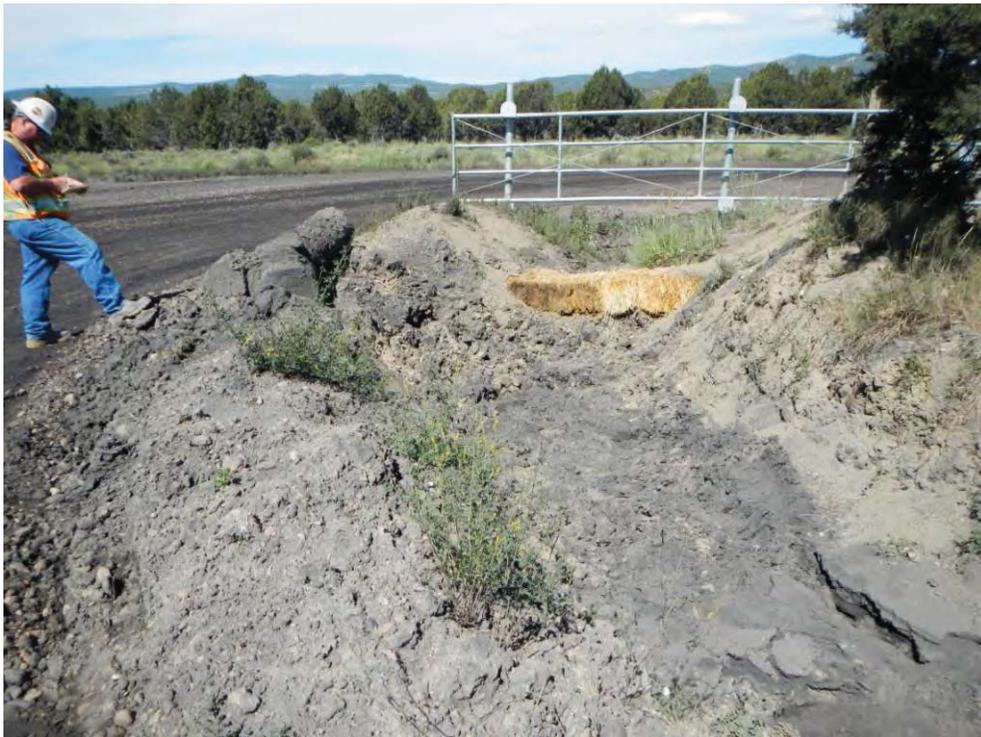
Work was completed to abate NOV 20153 issued 7/7/2015 for failure to maintain the Alternate Sediment Control Area (ASCA) at the mine entrance .

Above and Below: Mine entrance ASCA culvert cleared (abatement to NOV 20153).

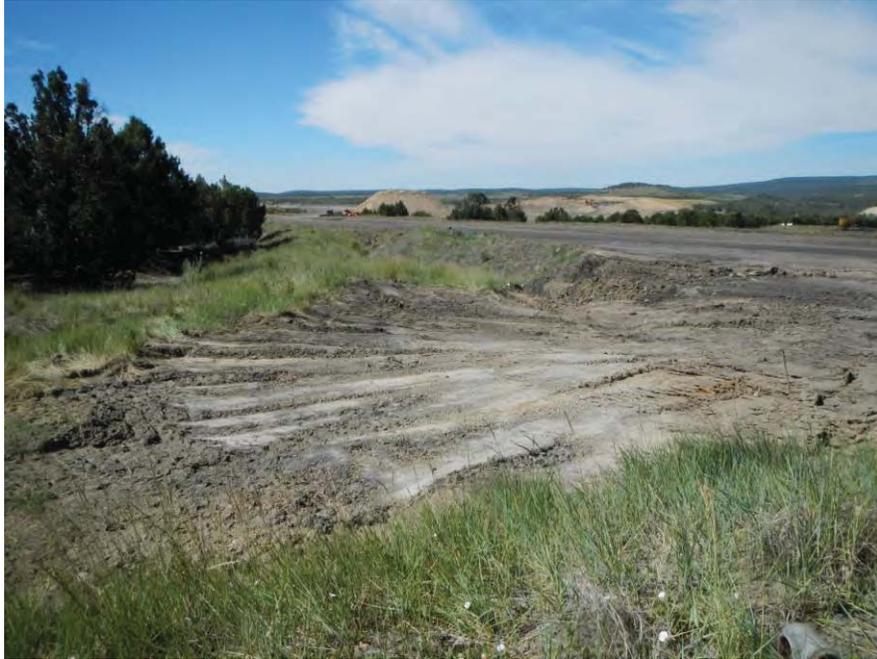
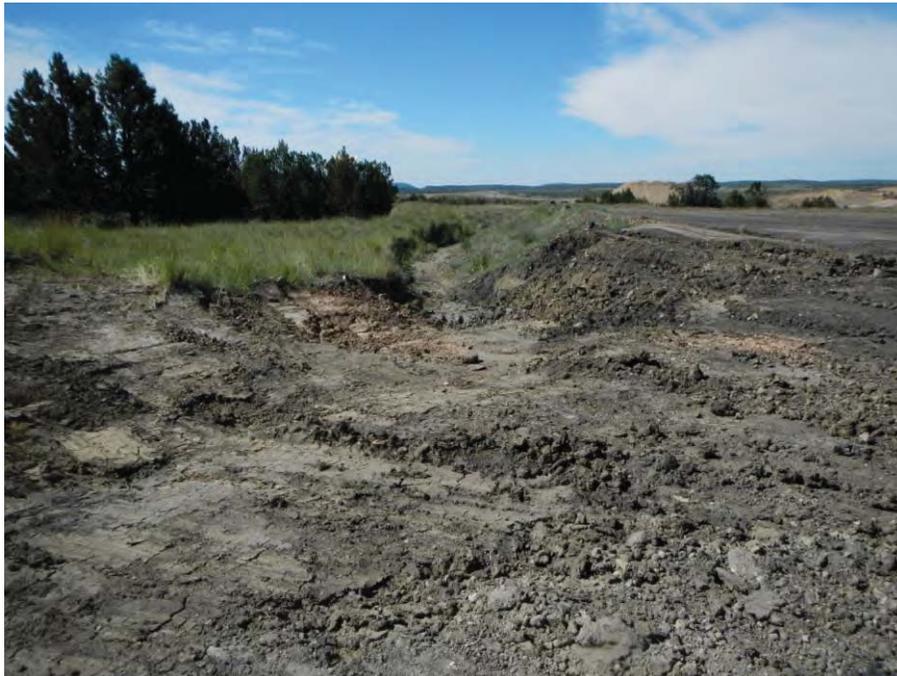
The ditch from the water tank to C7 was cleaned out. The disturbed ground was seeded.

Above and Below: Water Tank and ditch leading to C7 cleared and seeded.

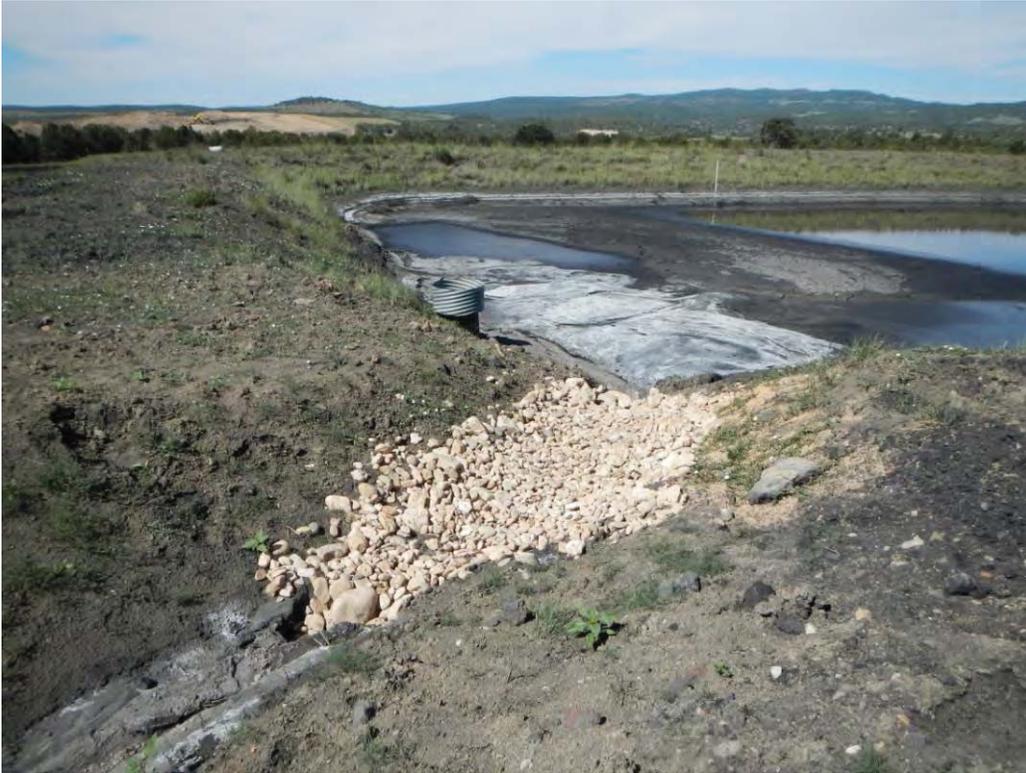
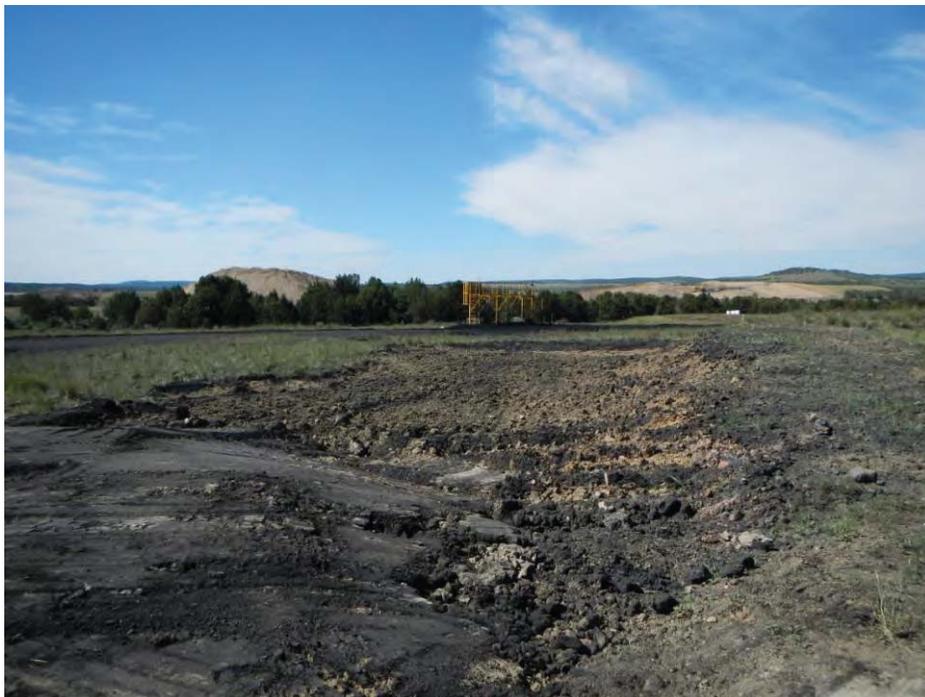
Quarterly pond inspections were completed on June 24, 2015. Water in all ponds was very low. Cobble size riprap was placed in the inlet to Pond #1 and Pond #3. This riprap does not meet the D50 requirement of six inches. When the Pond #1 and Pond #3 amendments are approved, the riprap placed in the inlet must meet with the requirements of the approved design. Dried sludge was removed from the embankment of pond #1. The disturbed area was seeded.

Above and Below: Inlet to Pond #1 riprapped with cobbles and area disturbed by sludge placement was seeded.

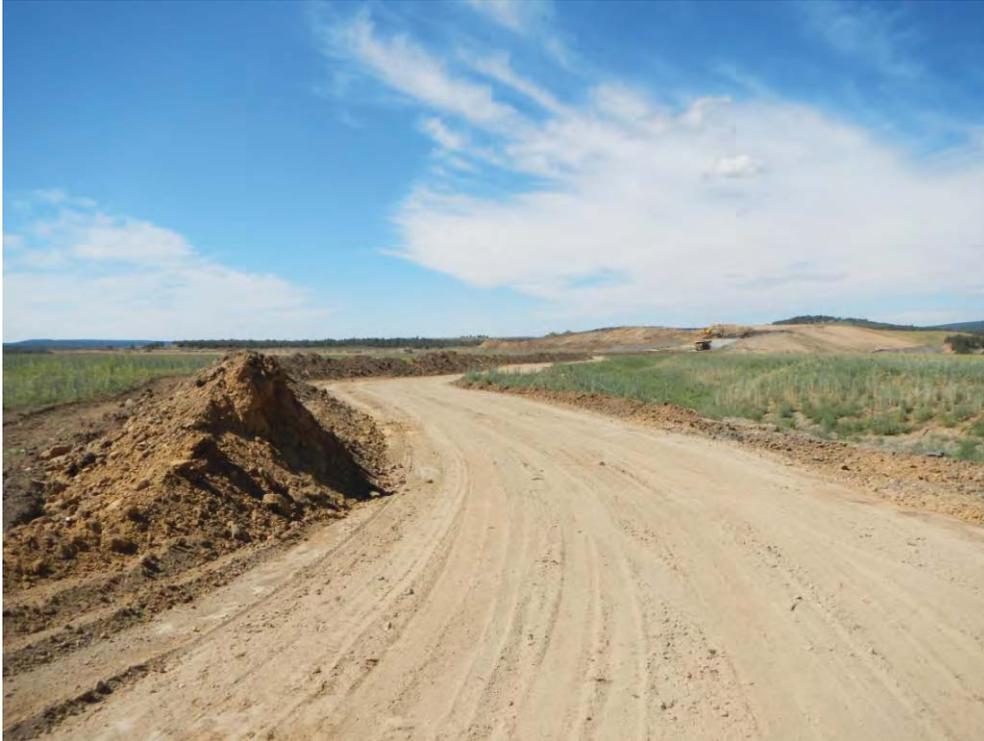
Above: Topsoil was removed from west side of the reconstructed Robinson Creek to allow truck travel for riprap placement in the channel.

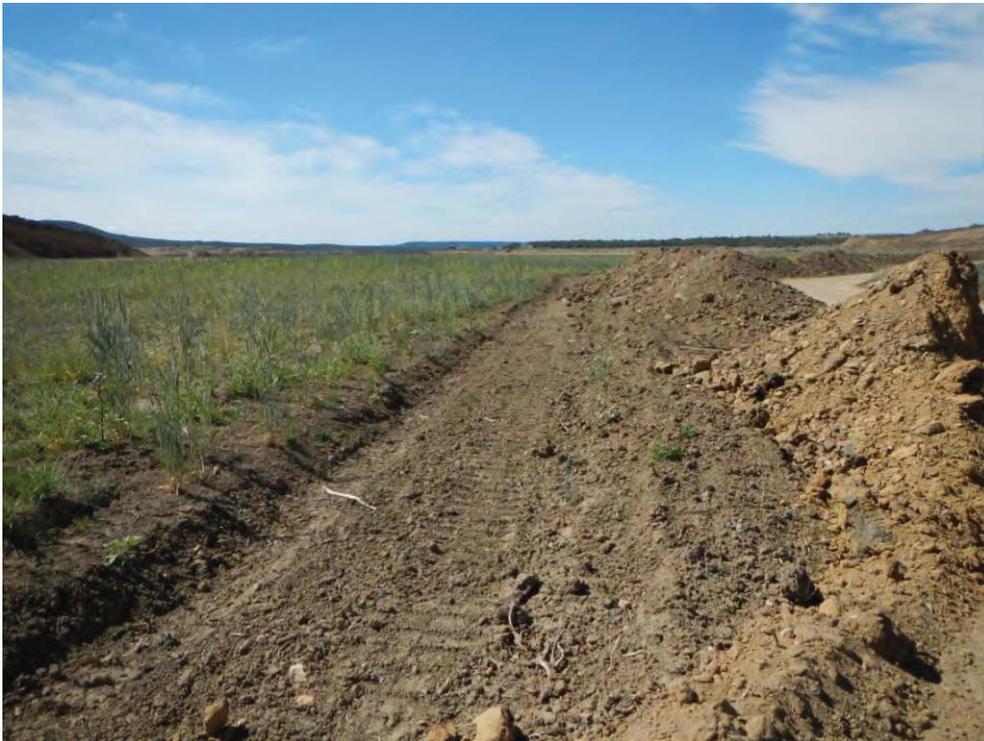
Topsoil was scraped into a long berm along the east side of DD4 to allow for passage of truckloads of rock during placement of riprap along the length of the Robinson Creek channel this week. The subsoil will be ripped prior to topsoil replacement.

Above: topsoil stockpiled along length of eastern side of DD#4

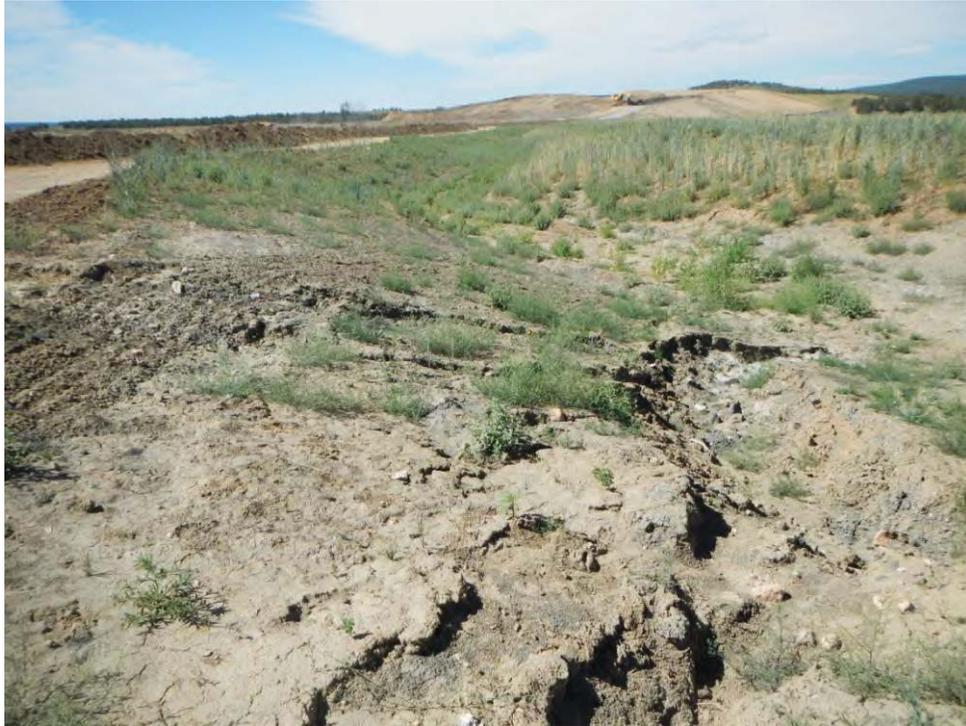
Above: A gully at the north end of the reconstructed Robinson Creek will be repaired during the reconstruction work.

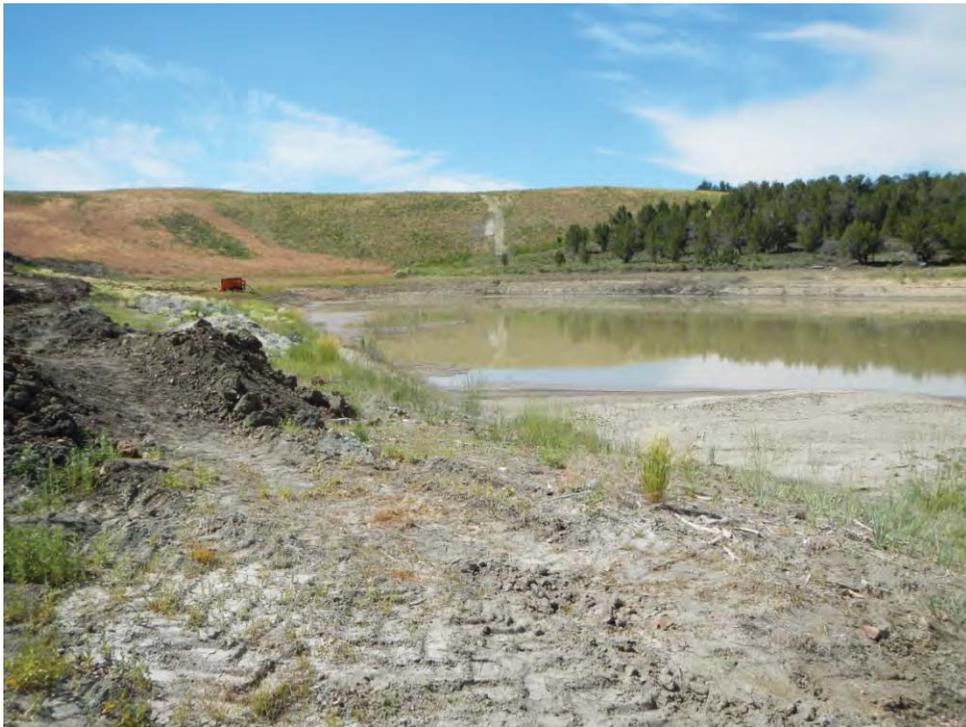
Tamarisk in standing water of Pond 3 will be removed when the level of Pond 3 is reduced and the plants are within reach of men and equipment (in the next couple of weeks).

Above: Water is being lowered in Pond #3 to allow construction of emergency spillway (Task 4951) and removal of tamarisk.

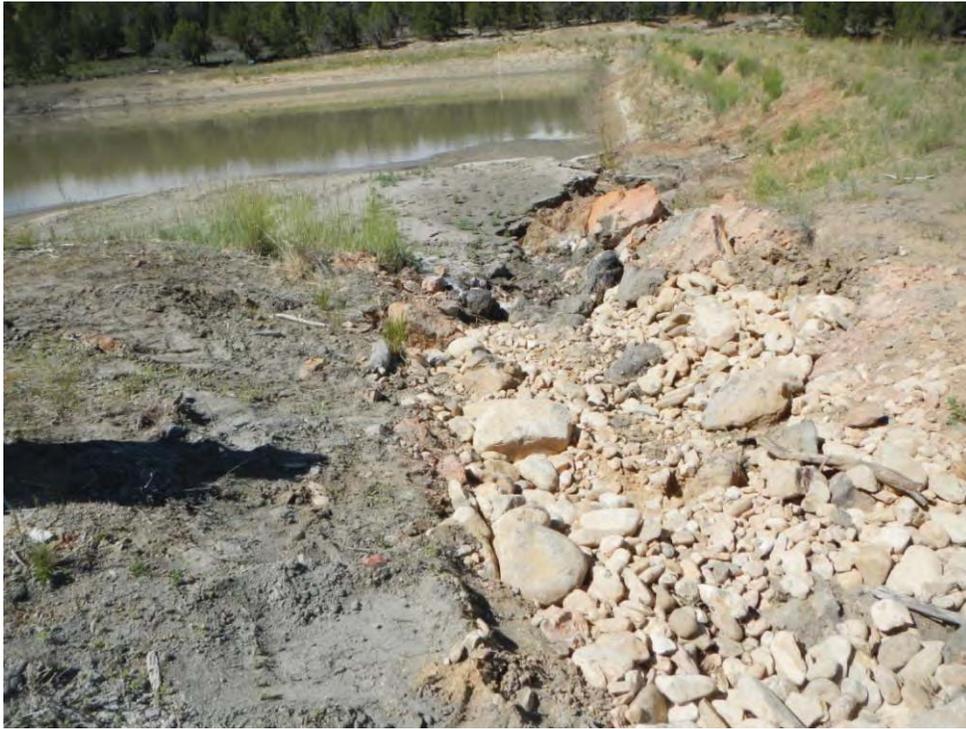
Above: Cobbles Pond #3 inlet.

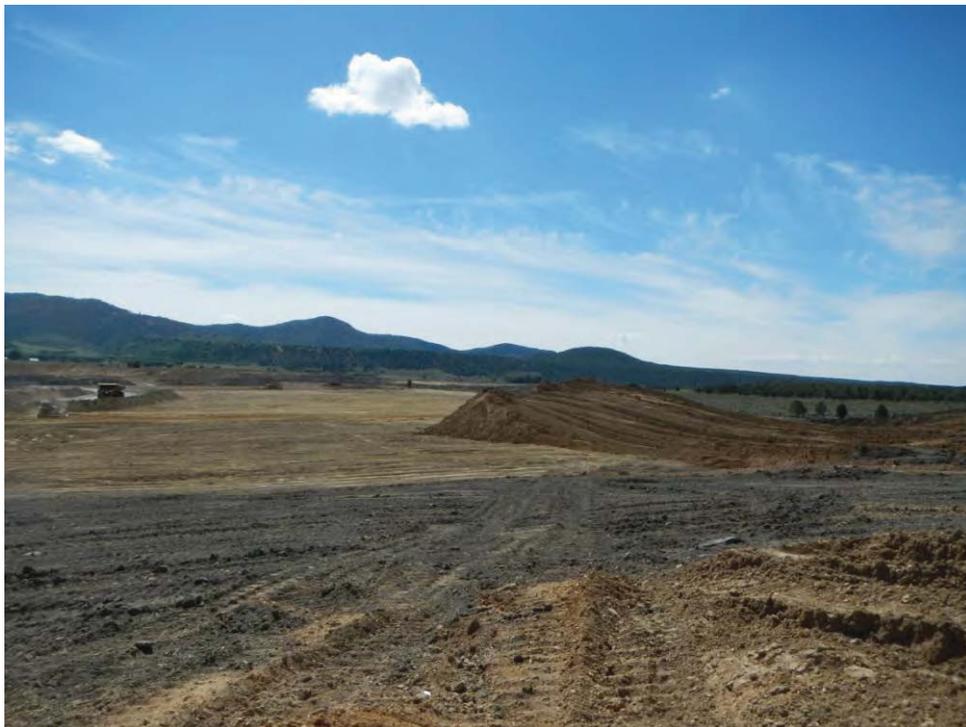
Subsoil is being removed from the crest of the reclaimed excess spoil pile in advance of spoil removal. The subsoil removed from the excess spoil pile is being stockpiled at the base of the excess spoil pile. The stockpiles must be protected with a berm or other sediment control measure and signed. An accounting of the topsoil and subsoil removed from the excess spoil pile was requested.

Above: Removing spoil from excess spoil pile surface.

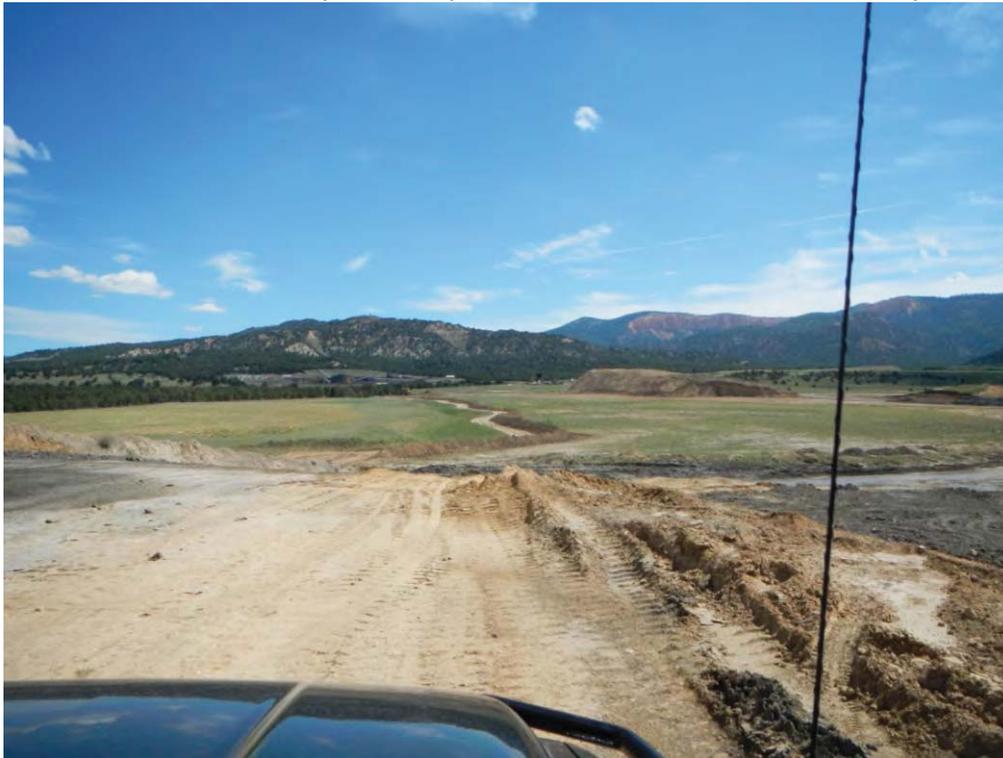
Above: Temporary access for the reconstruction of Robinson Creek as seen from the excess spoil pile.

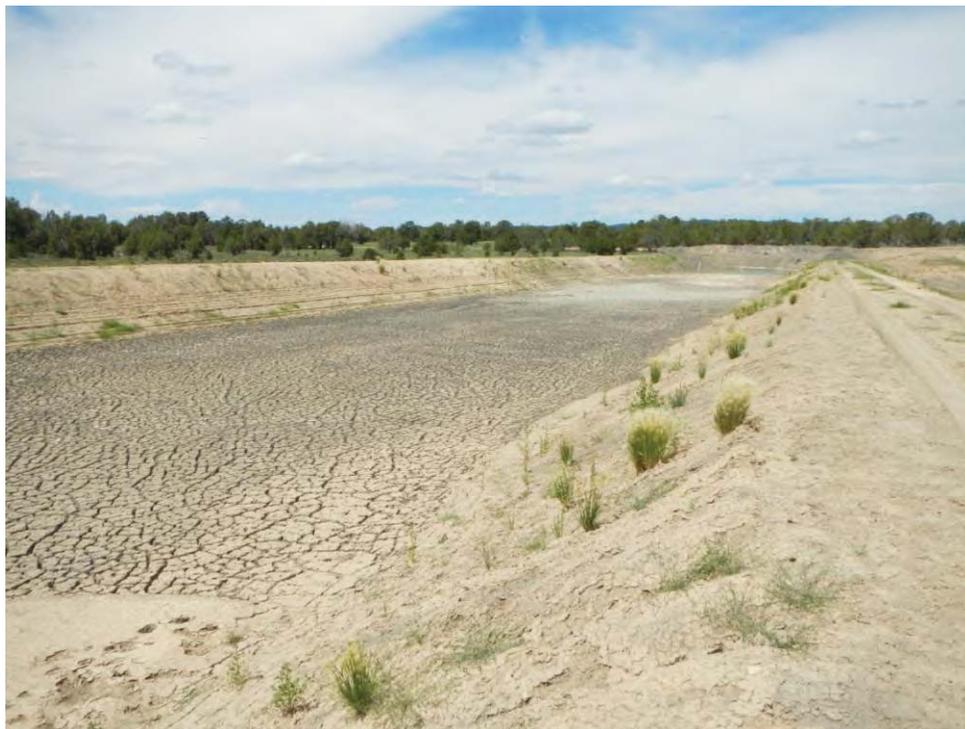
A small area near pond 4 was too muddy to topsoil and it also will require ripping prior to topsoil placement.

Above: Pond #4.

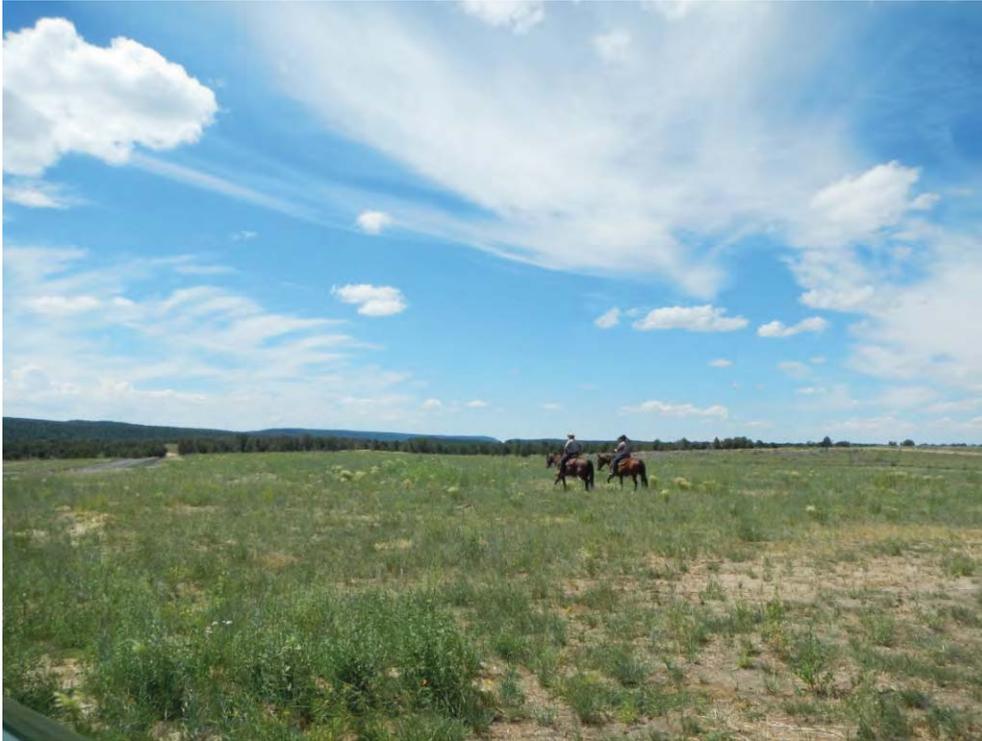
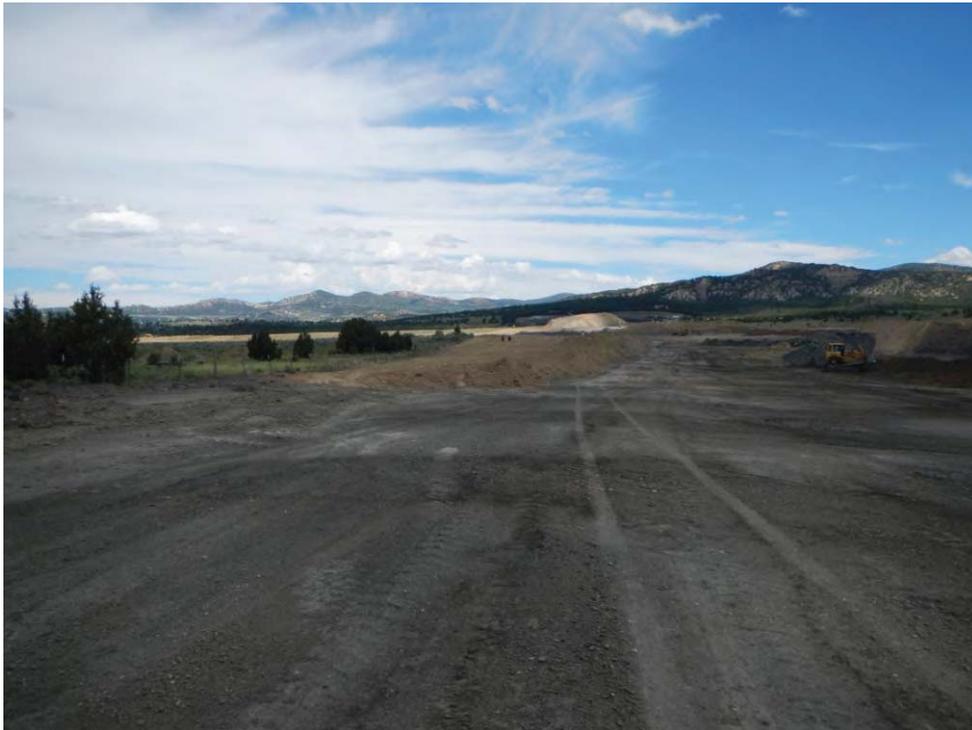
Just recently, four cows wandered in to the reclaimed area when the gate was left open by a contractor hired by a landowner. The grazing permittee (MacElprang) was rounding them up.

Herding cattle on the reclaimed Pits 25 – 28, above, and on the south side of the excess spoils pile, below.
