Inspection Report

Permit Number:	C0250005
Inspection Type:	COMPLETE
Inspection Date:	Tuesday, September 22, 2015
Start Date/Time:	9/22/2015 9:00:00 AM
End Date/Time:	9/22/2015 4:00:00 PM
Last Inspection:	Thursday, August 27, 2015

Permittee: **ALTON COAL DEVELOPMENT LLC**

Site: **COAL HOLLOW**

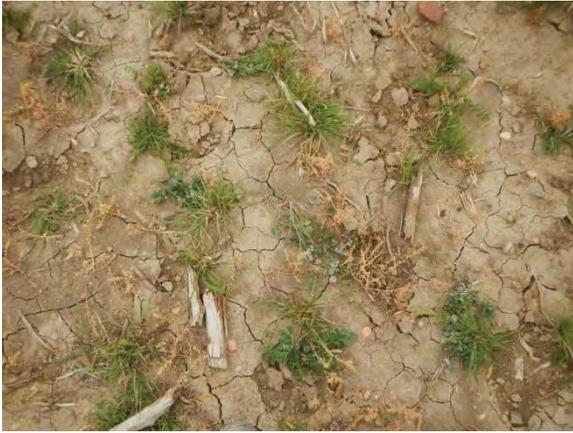
Twenty head of cattle were grazing on topsoil pile #2. This topsoil pile is well vegetated, except at the west end. Since this topsoil will be a longterm pile to be used for Pit 10 reclamation, the west end should be reseeded each fall until adequate vegetation is established.

Grazed topsoil pile 2 west end

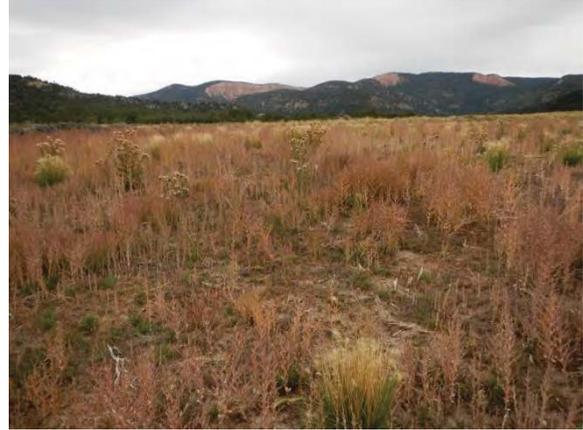
Topsoil pile 2 west end.

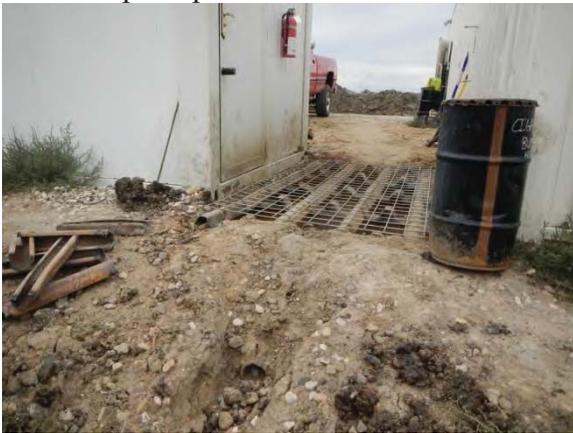
A berm creating UD2 and separating shop activity from Lower Robinson Creek had been breeched. A small pipe had been installed to drain a cleaning station that was installed between two portable buildings (Conex containers). NOV 21158 was issued for failure to maintain diversions and failure to prevent additional contributions of suspended solids to the stream channel. Ditch DD4 needs cleaning up and dressing up at the location above the transition zone of Lower Robinson Creek. This site has been a maintenance item in previous inspections, when it was noted that the area needed to dry out. The area was dry as can be expected and ditch DD4 was included in the above violation.

NOV 21158 Boot wash station discharge enters UD2.

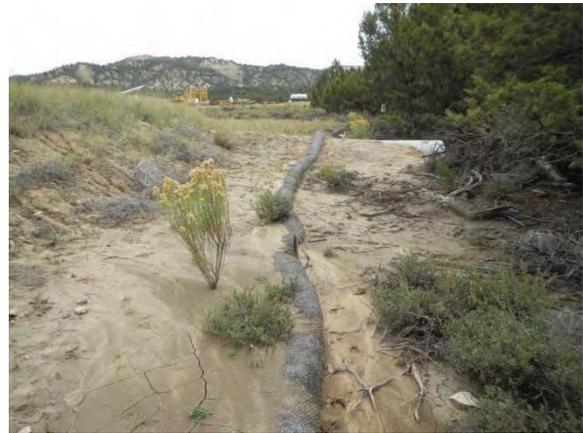
Excelsior logs need to be maintained along the stream buffer zone in the vicinity of Pond 1B and Pond 3 dam outslope.

Excelsior logs along stream buffer zone require maintenance.

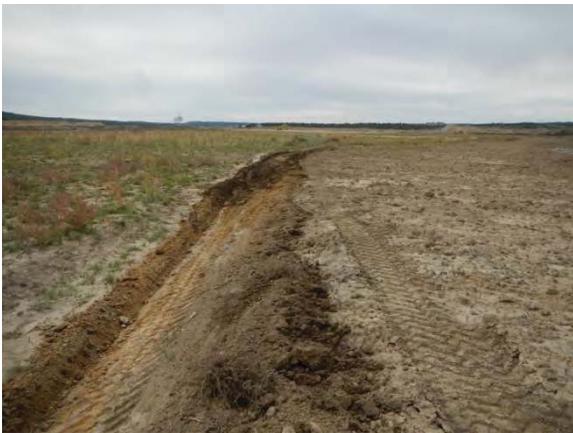
Topsoil was replaced along the length of DD4, except at the transition zone. Topsoil has not been replaced along the north side of Pond 4 where grading work was recently done. Subsoil was being removed from the subsoil pile #2 and placed on the west side of pit 20.

DD4 and topsoil respread along Lower Robinson channel. Needs mulch and seed.

Topsoiled areas around Lower Robinson Creek and Pit 21 are scheduled for mulch and seed this fall.

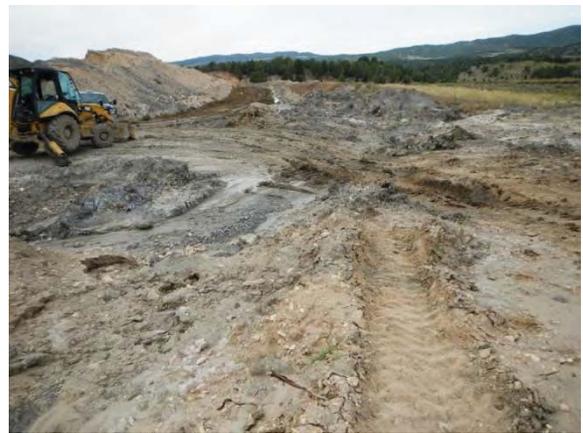
NOV 21158. DD4 discontinuous at the transition zone.

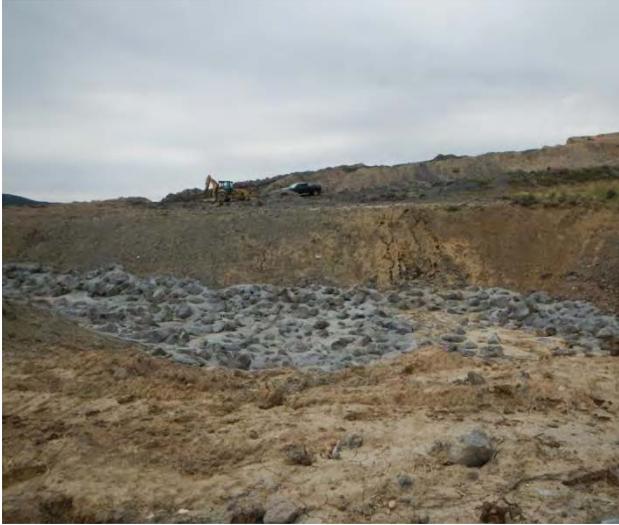
NOV 21158. Erosion of south bank where DD4 is discontinuous.

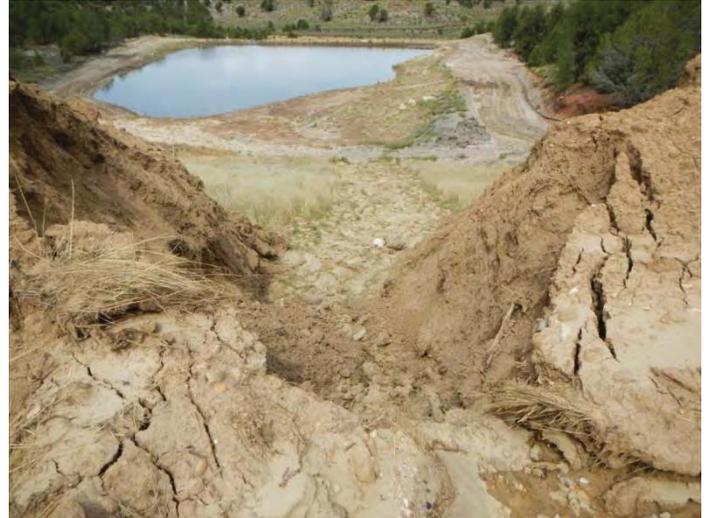
Topsoil was removed from the Excess Spoil pile and stockpiled in a large pile on top of the excess spoils pile and also windrowed on the south and west sides of the pile. On the west side, the windrowed topsoil was eroded by water. NOV 21157 was issued for failure to protect the topsoil.

NOV 21157. Topsoil stockpile erosion west side Excess spoil pile.

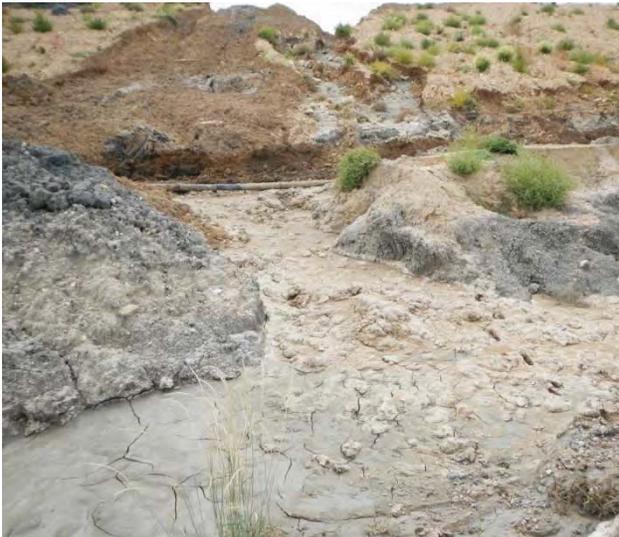
NOV 21158. DD4 berm failure.

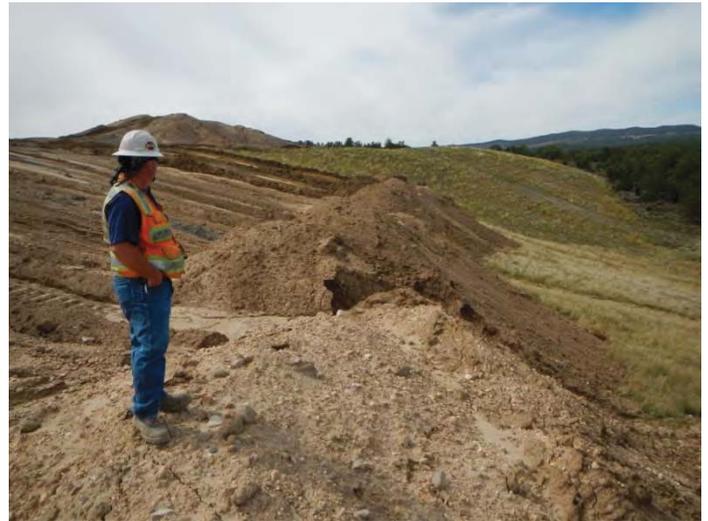
NOV 21157. Topsoil west side Excess Spoil

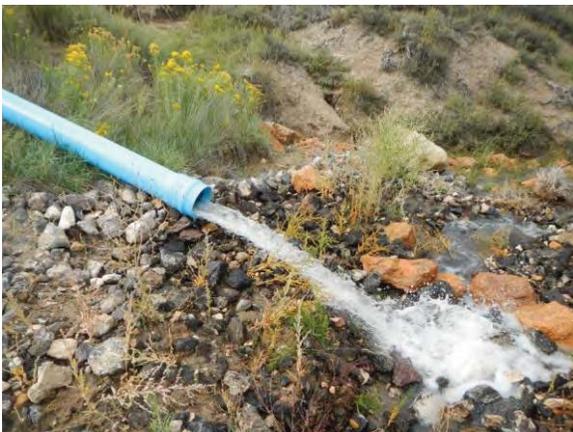
A rainstorm last week filled ponds 1, 1B and 3 to discharging. Discharge was sampled on Sunday 9/20/2015. Measures were being taken to pump down those ponds. Pond 1 has sediment clogging the outlet again. The inlet was cleaned out last quarter as stated in the June 24, 2015 pond inspection. Plans to change the location of the inlet to this pond are still not adequate and have been returned to the Permittee. Pond 3 was discharging from the stand pipe at approximately 0.25 cfs during the inspection. Pond 2 was discharging a trickle due to a leak in the culvert. Pond 1 was discharging about 1 gpm during the inspection possibly due to a leak in the culvert. Ponds 4 and 1B were not discharging during the inspection. The MRP describes the allowable pond discharge after a storm event on p. 7-78.

Pond 3 discharge.

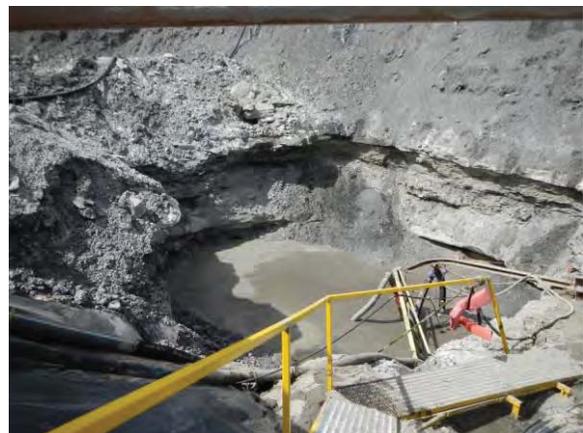
Sediment catch basins and drainage channels have been necessary along the primary road in Pit 10. If these sediment controls for these miscellaneous flows are to remain permanently, they must be described in the MRP and shown on a map in accordance with R645-301-742.330 and R645-301-742.411. A modification to the MRP narrative and to the underground facilities map is required.

Pit 10 sump
