Subject: Request for more information Phase I Bond Release Application, Alton Coal Development, LLC, Coal Hollow Mine, C/025/0005, Task ID #4788

PROJECT
**COAL HOLLOW
C/025/005**

TITLE
**PHASE I BOND RELEASE
TASK #4788**

Technical Analysis and Findings

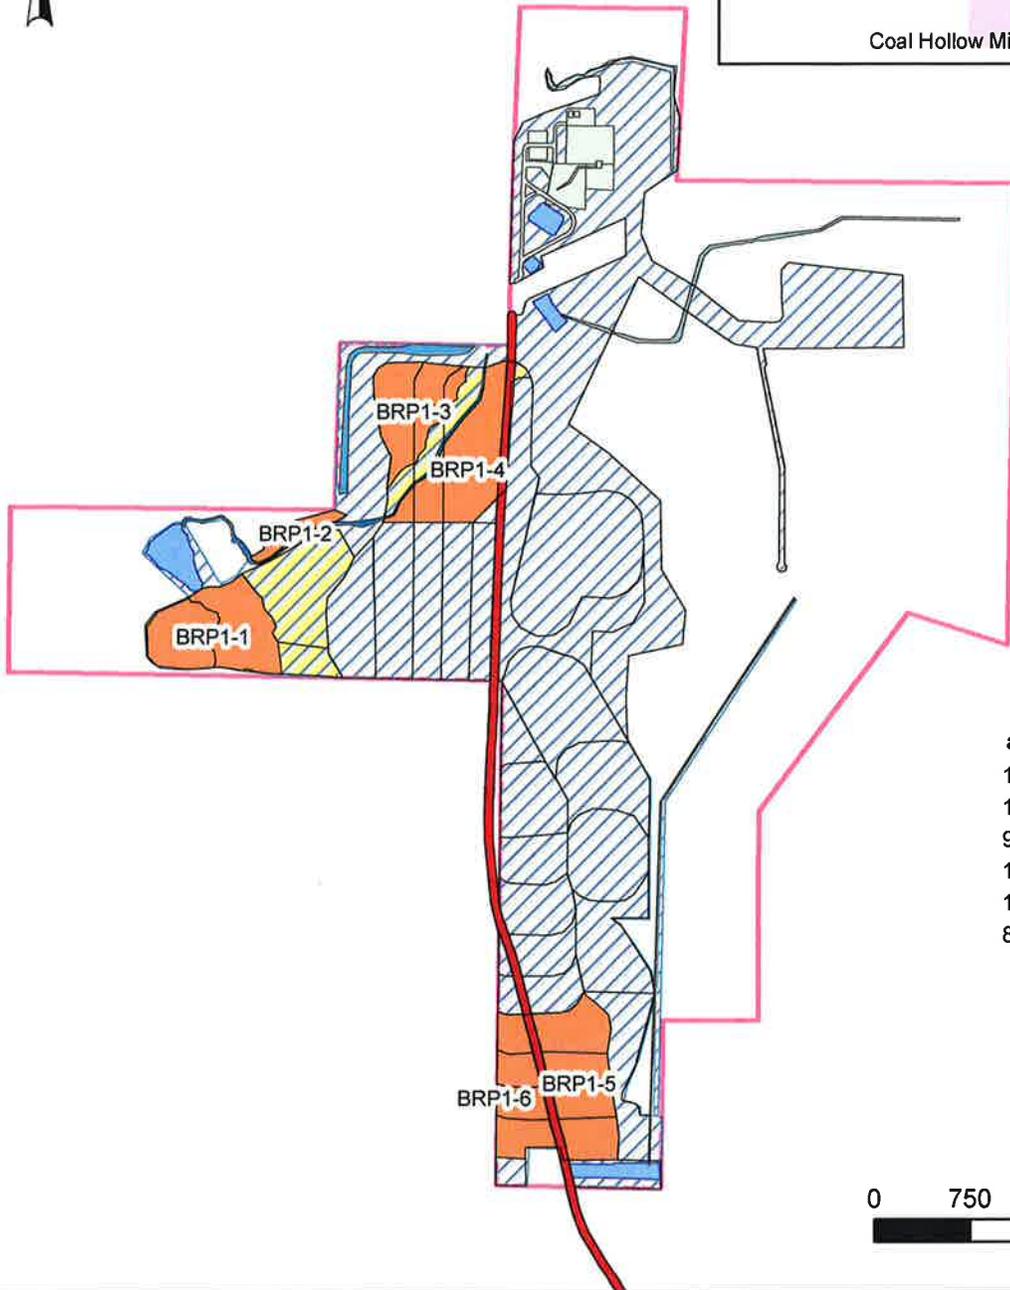
PROJECT Coal Hollow MINE Alton Coal Development Ref. C/025/005 FIGURE **A**

- The area detailed as BRP1-2 on Figure 1 within the application contains the sections of Ditch 4. The application includes a requested release of 2.1 acres for said area, however, Ditch 4 is scheduled to be removed after reclamation therefore the area is not at final grade. The section of BRP1-2 that contains Ditch 4 does not meet the requirements of R645-301-553 for phase I bond release and will be surveyed and flagged by the Permittee to determine the new area, see Division Figure A.

for phase I bond release and the area associated with the Lower Robinson Reconstruct will need to be surveyed and flagged by the Permittee to determine the area needing to be removed from the application. The Division estimates that the survey will likely result in changing the area associated with BRP1-3 to approximately 9 acres, see Division Figure A.

- Ditch 4 is also currently in the process of being reconstructed as designed in the MRP and the area associated with the ditch location will also need to be removed from the original BRP1-3 area thus creating a new area detailed BRP1-4 on Figure A totaling 12.1 acres. The section of BRP1-3 that contains Ditch 4 does not meet the requirements of R645-301-553 for phase I bond release and will be surveyed and flagged by the Permittee to determine the new area, see Division Figure A.

- BRP1-4 and BRP1-5, as detailed on Division Figure A, intersect with the Kane County road. According to the agreement outlined in the MRP Appendix 1-7, approval from Kane County DOT is required to include the areas as final grading. Until documentation showing that the area meets the Counties requirements, BRP1-4 in the application Figure 1 will be divided to exclude the County road from each edge of right away and be labeled BRP1-5 and BRP1-6, as shown on Division Figure A.

In conclusion, the Permittee will conduct surveys and flag the area described above and deliver to the Division the necessary documentation and new bond release acreage.
