Citation for Non-Compliance
Utah Coal Regulatory Program
 1594 West North Temple, Salt Lake City, UT 84114
 Phone: (801) 538-5340 Fax: (801) 359-3940

Citation #: 16150
Permit Number: C0250005
Date Issued: 04/08/2015

NOTICE OF VIOLATION **CESSATION ORDER (CO)** **FAILURE TO ABATE CO**

Permittee Name: ALTON COAL DEVELOPMENT LLC	Inspector Number and ID: 71 KSTORRAR
Mine Name: COAL HOLLOW	Date and Time of Inspection: 03/24/2015 8:30 am
Certified Return Receipt Number: 7012 3460 0002 9559 6328	Date and Time of Service: 04/01/2015 11:00 am

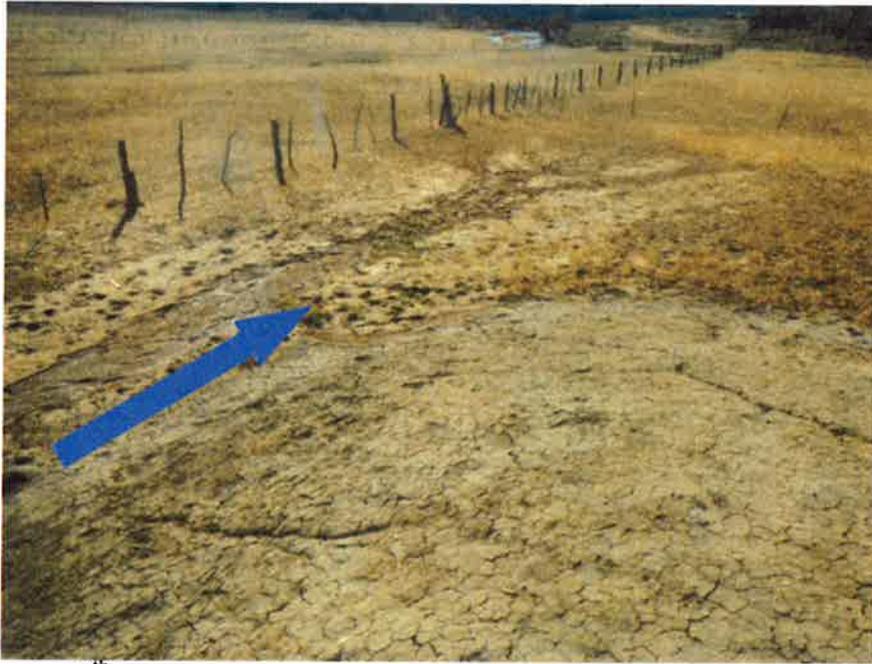
Figure 1: February 10th inspection. Outlet of Ditch 1 that handles undisturbed runoff. The wood fence line on left and T-post fence line at top right defines permit boundary. Arrow indicates the direction runoff flows from the outlet of undisturbed Ditch 1.

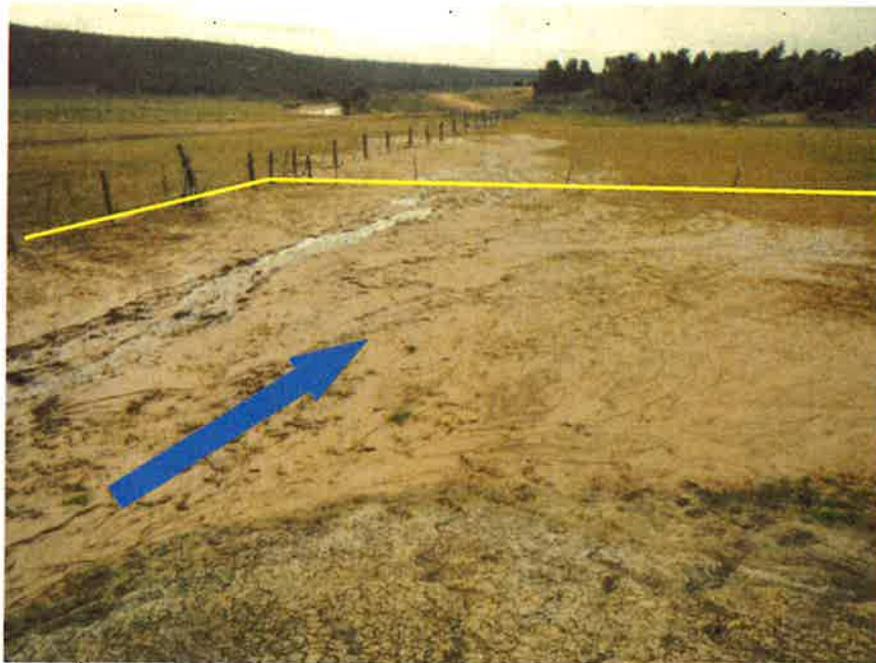
Figure 2: March 24th inspection. Sediment plume at outlet of Ditch 1 showing offsite impact. Permit boundary is roughly defined by yellow line.

- 5) Sediment Pond 4 will be built to the approved design in Drawing 5-31. Drawing 5-31 depicts Pond 4 inlet elevation as 6,834'.
- 6) Best technology currently available will be implemented within the undisturbed side of Ditch 1 to prevent suspended solids from exiting the permit area.

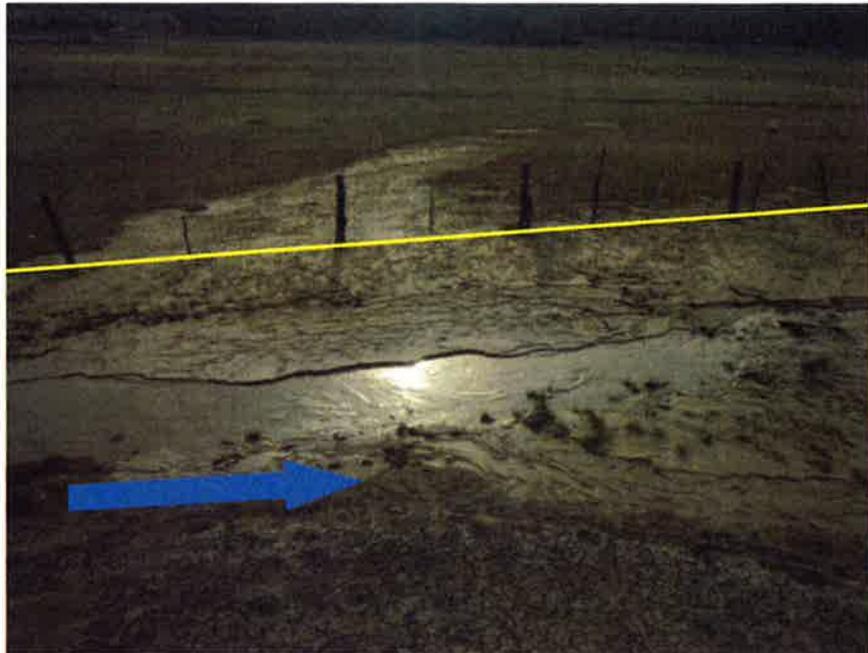
Figure 3: March 24th inspection. Sediment plume at outlet of Ditch 1 showing offsite impact. The undisturbed outlet of Ditch 1 is left of the photo. Flow is from left to right. Permit boundary is roughly defined by the yellow line.

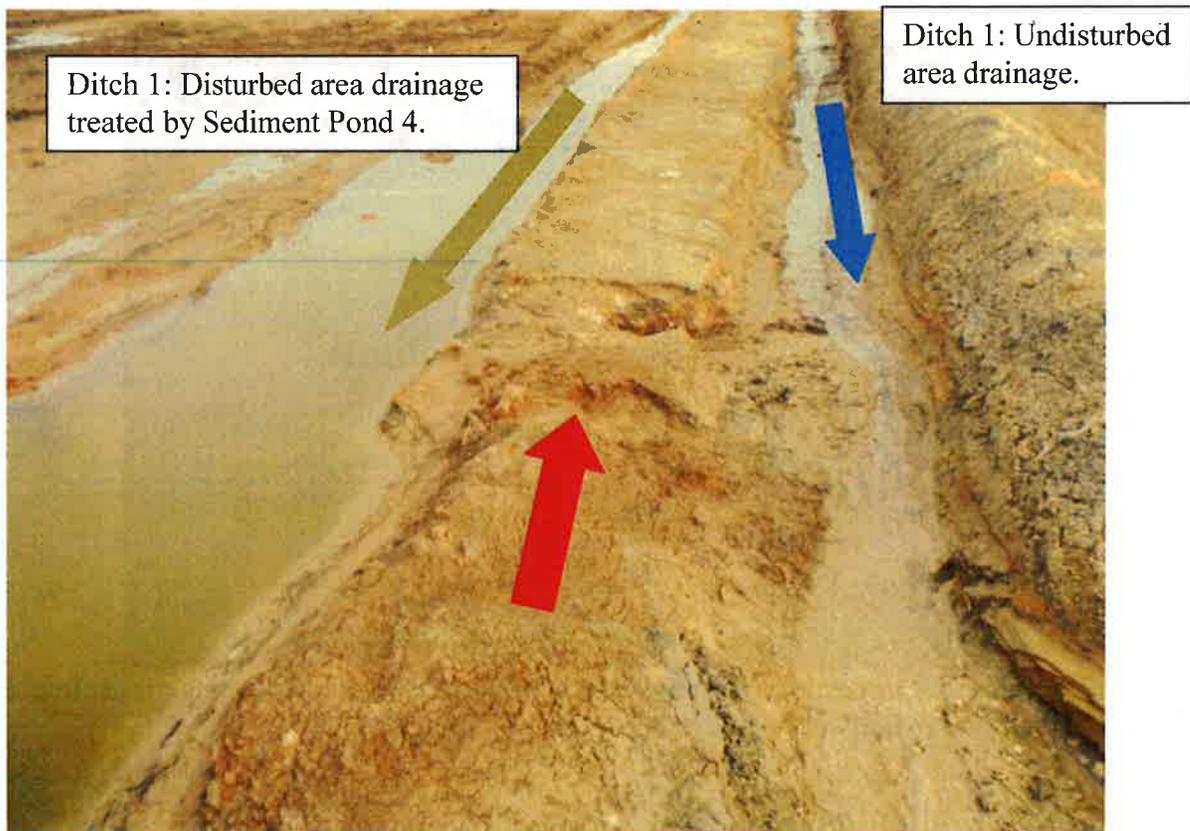
Figure 4: March 24th inspection. The red arrow points to the location where Ditch 1 failed allowing disturbed area runoff carry suspended sediment offsite untreated.

- 2) Ditch 1 must be built to the approved design shown in Drawing 5-33. This design shows Ditch 1 capturing runoff from the undisturbed area to the east and having a 1' berm running along the western edge of the ditch.

- 4) The west side of Ditch 1 (disturbed runoff side) will be graded and sloped to drain water to Sediment Pond 4's inlet. No ditch or depression may run along the western side of the Ditch 1 berm.

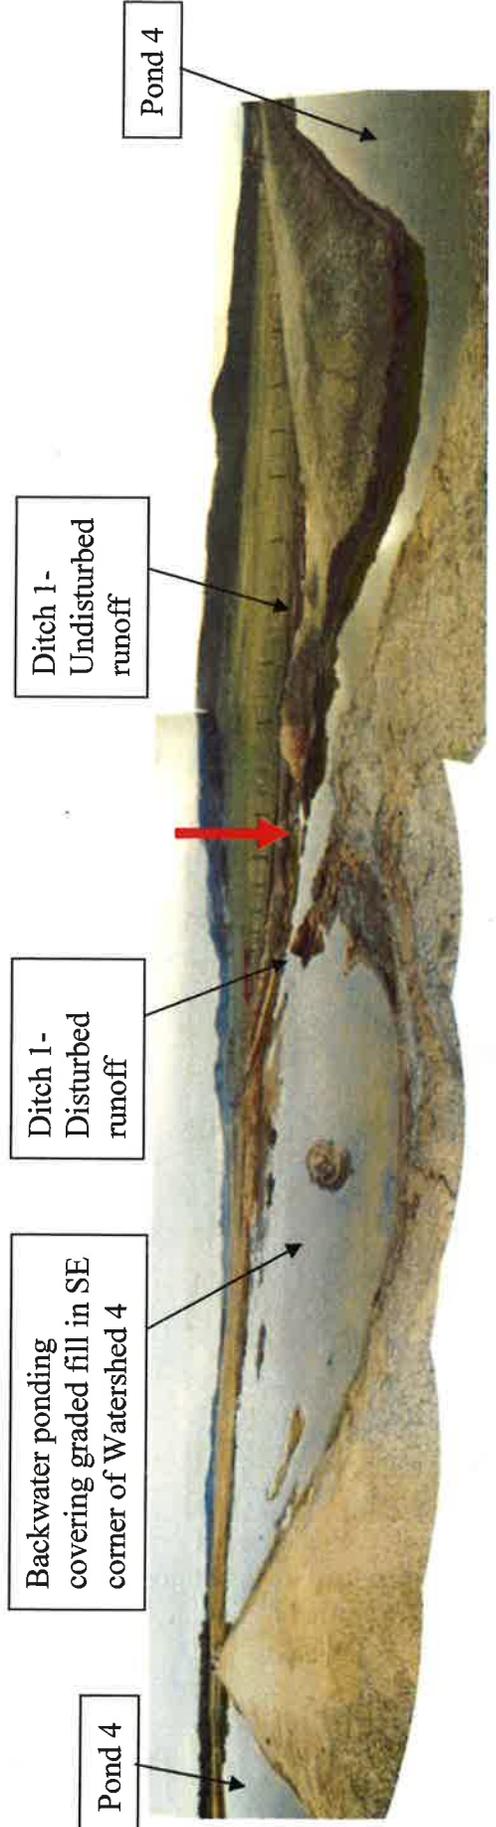
Figure 5. March 24th, 2015 inspection. ~300° panoramic photo of backwater pond outside of Sediment Pond 4. Red arrow points to failure point of Ditch 1 where disturbed area runoff exited the site via the undisturbed ditch.

- 3) The southeast corner of Watershed 4 will be lifted and graded to prevent backwater ponding and will be sloped to drain disturbed area runoff from Watershed 4 to Sediment Pond 4's inlet.

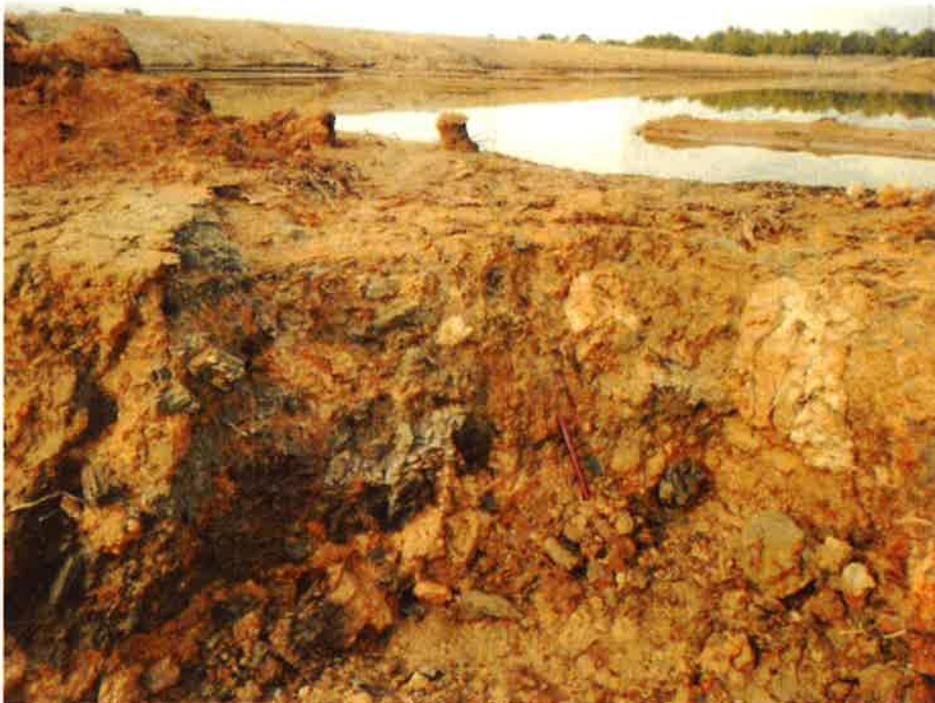
Figure 6: March 24th inspection. Failure point of Ditch 1 berm. Backwater ponding of Sediment Pond 4 seen in background of photo.

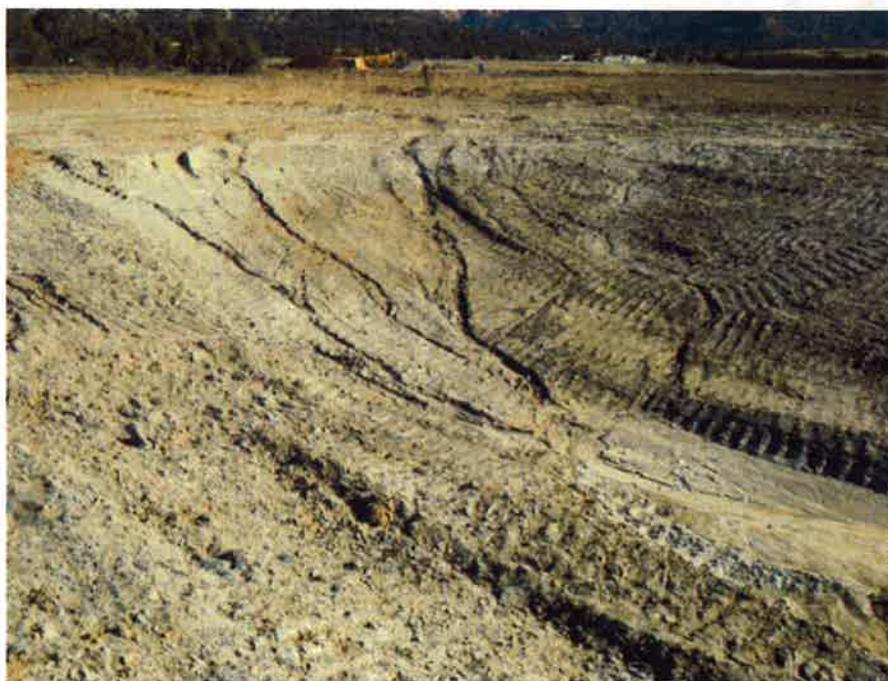
Figure 7: February 10th, 2015 inspection. Head of Lower Robinson Creek channel reconstruction. Ditch 4 is on the far side of the channel in this photo. It is designed to route water drained from the disturbed area in the photo's background to Sediment Pond 3.

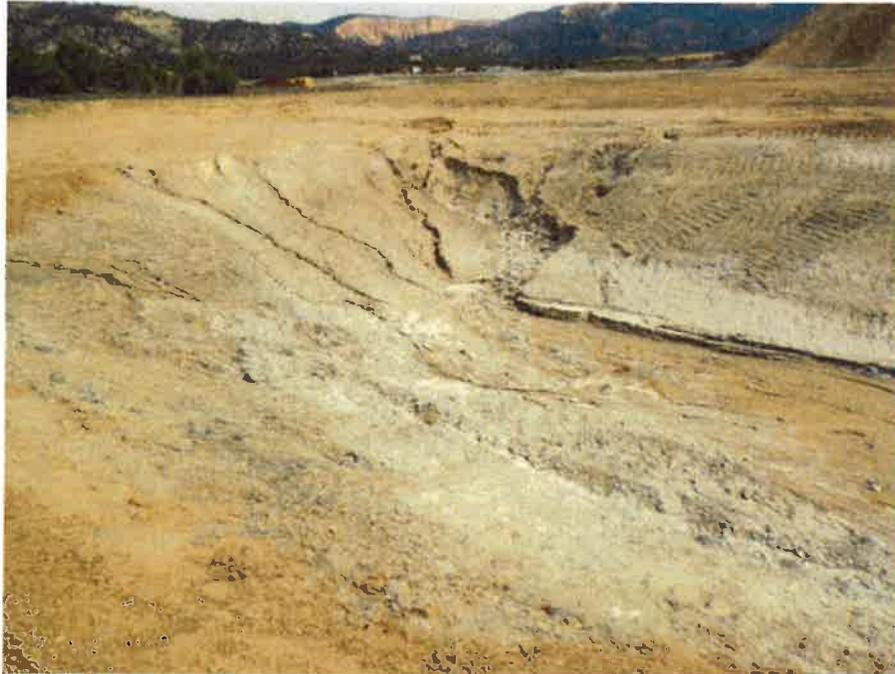
Figure 8: **March 24th, inspection.** Ditch 4 failure #1. Disturbed area runoff and suspended sediment carried into the reconstructed channel of Lower Robinson Creek.

The Permittee must construct Ditch 4 to match the approved design in Drawing 5-34. ACD must submit to DOGM a surveyed longitudinal profile of the bottom of the ditch along the newly constructed length to demonstrate water will flow downhill along its length.

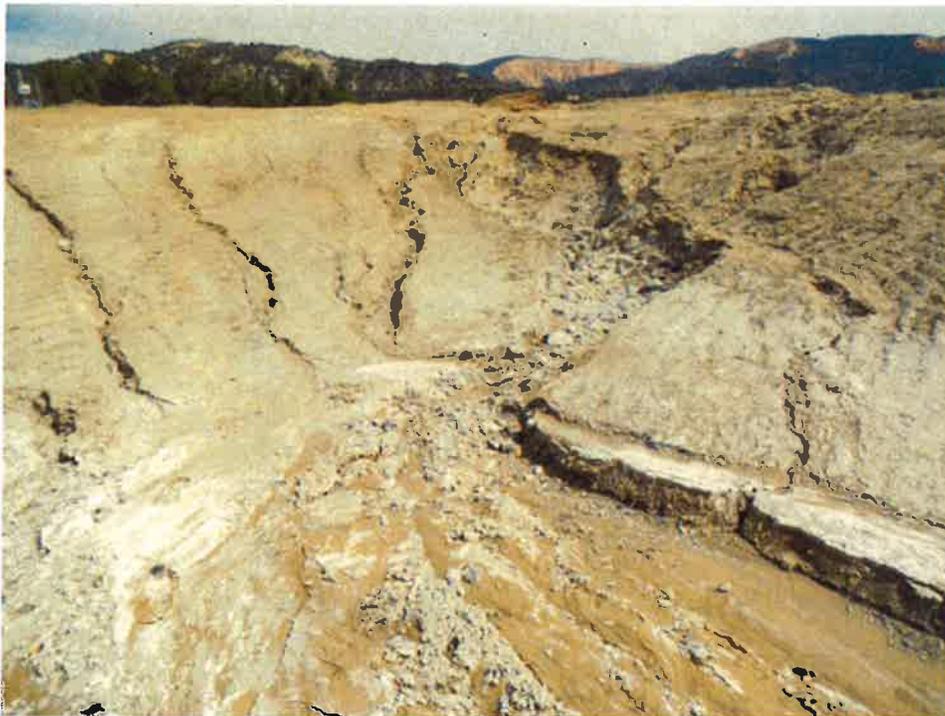
Figure 10: **March 24th, 2015 inspection.** Ditch 4 failure #1. Disturbed area runoff and suspended sediment carried into the reconstructed channel of Lower Robinson Creek.

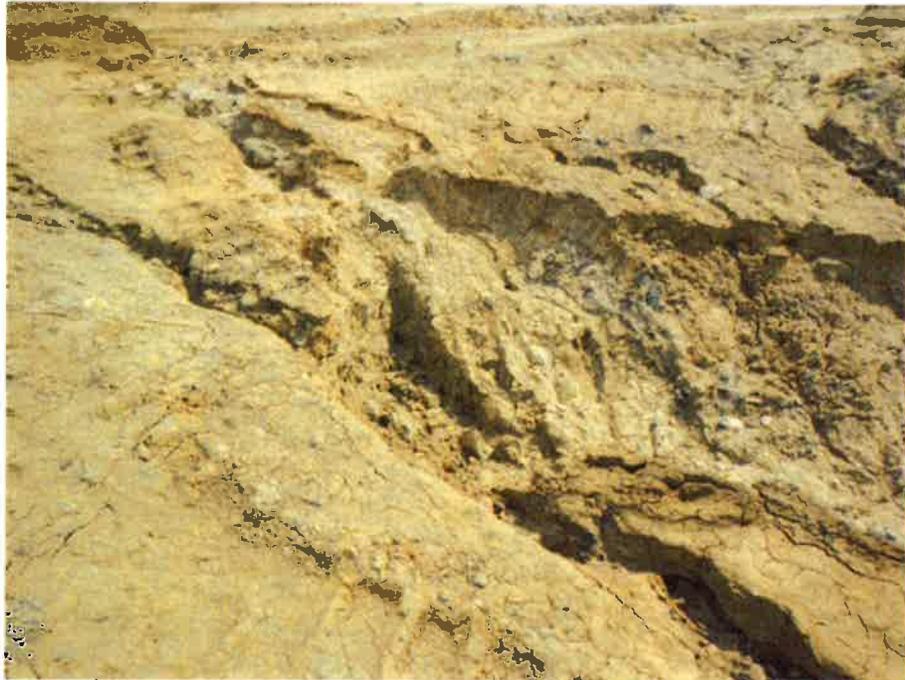
Figure 9: March 24th, inspection. Ditch 4 failure #1. Disturbed area runoff and suspended sediment carried into the reconstructed channel of Lower Robinson Creek.

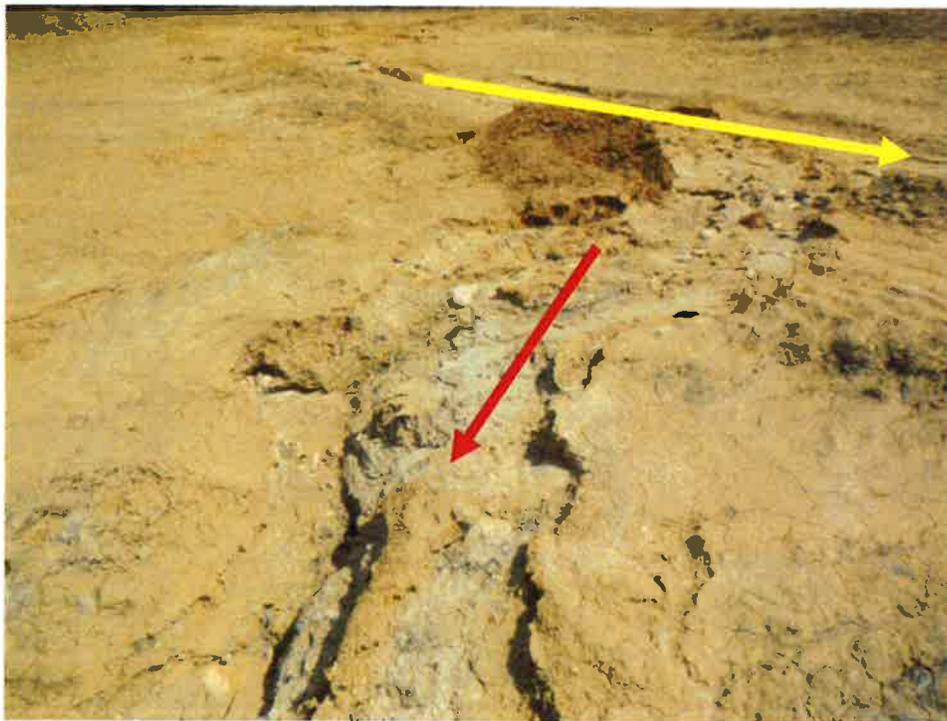
Figure 10: March 24th, 2015 inspection. Ditch 4 failure #1. Yellow arrow points shows direction of design flow in Ditch 4. Red arrow shows failure #1 where Ditch 4 was overtopped by runoff from Watershed 3.

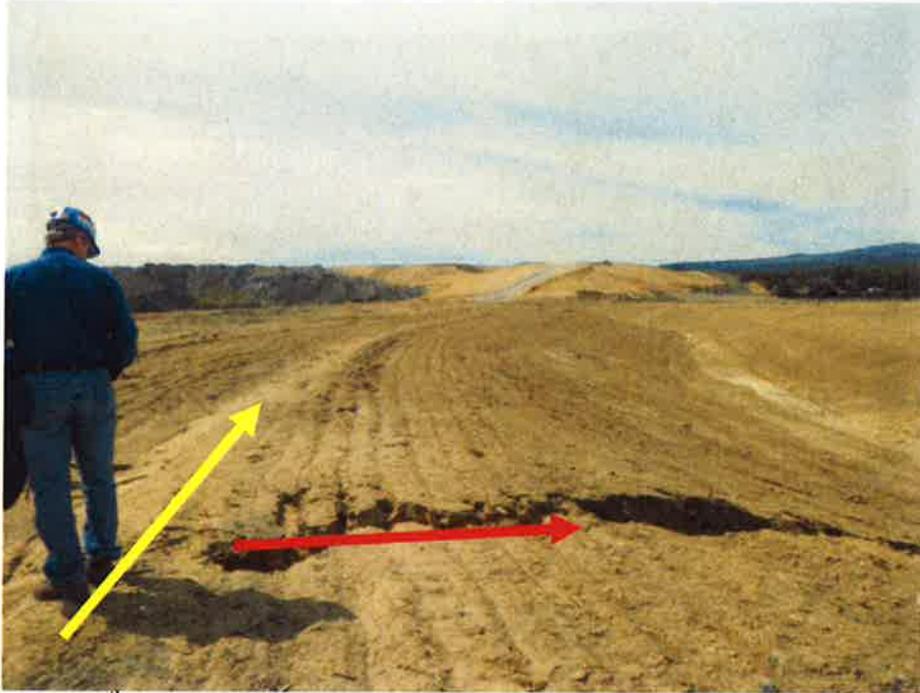
Figure 11: March 24th inspection. Ditch 4 failure #2. Yellow arrow shows design flow direction. Red arrow shows failure point and subsequent flow into the reconstructed Lower Robinson Creek channel.

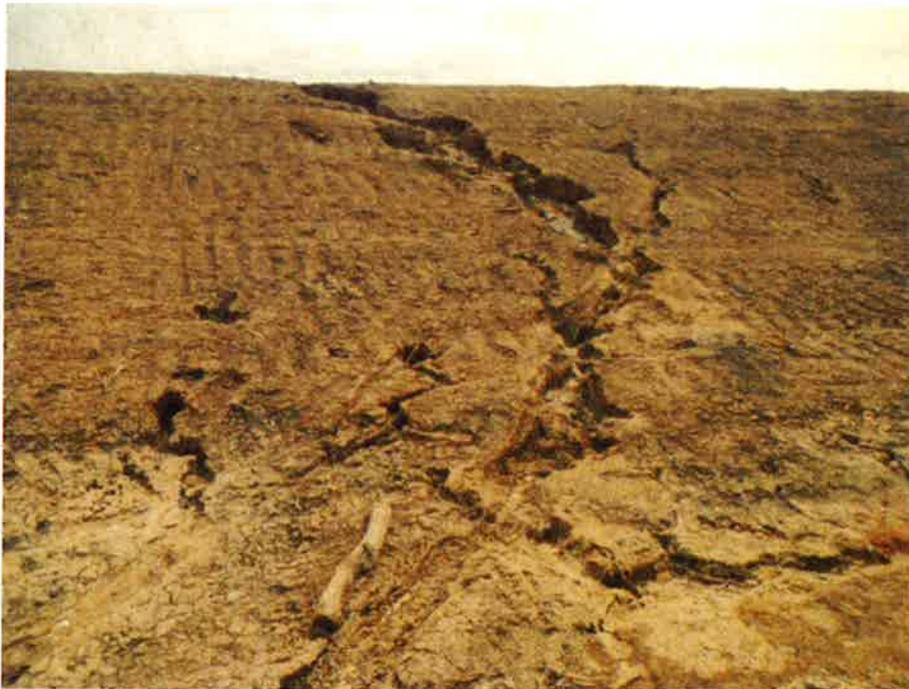
Figure 12: March 24th inspection. Ditch 4 failure #2, looking up from bottom of Lower Robinson Creek reconstructed channel.

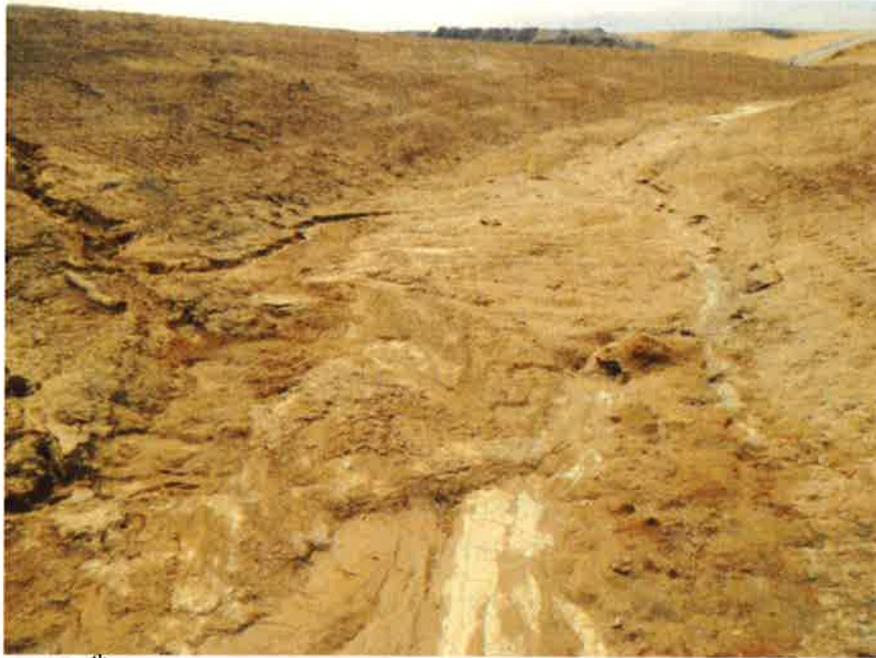
Figure 13: March 24th inspection. Ditch 4 failure #2. Photo taken from bottom of Lower Robinson Creek reconstructed channel. Alluvial fan deposited at base of gully shows a significant amount of sediment was suspended in the runoff.

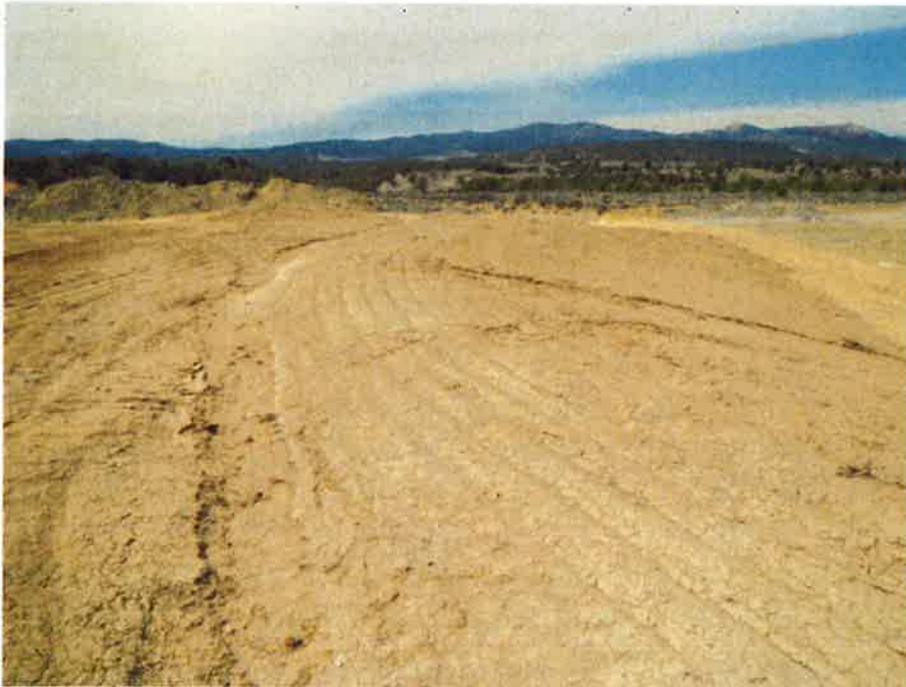
Figure 14: March 24th inspection. Ditch 4 failure #3. Gully is seen running from Ditch 4 down into Lower Robinson reconstructed channel on photo right.

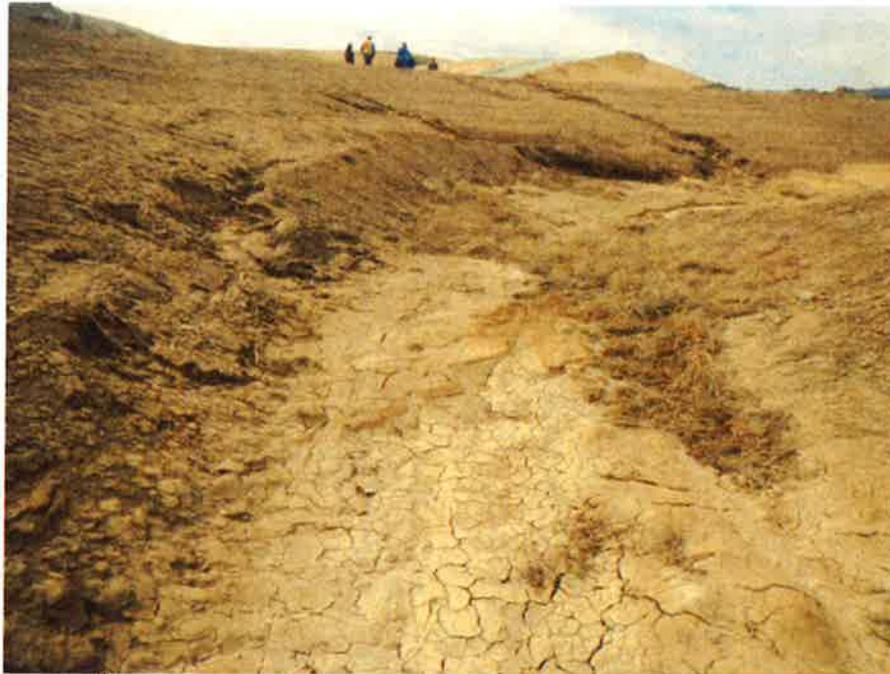
Figure 15: March 24th inspection. Ditch 4 failure #3. Gully is seen running from Ditch 4 down into Lower Robinson reconstructed channel. Photo taken from bottom of reconstructed channel.

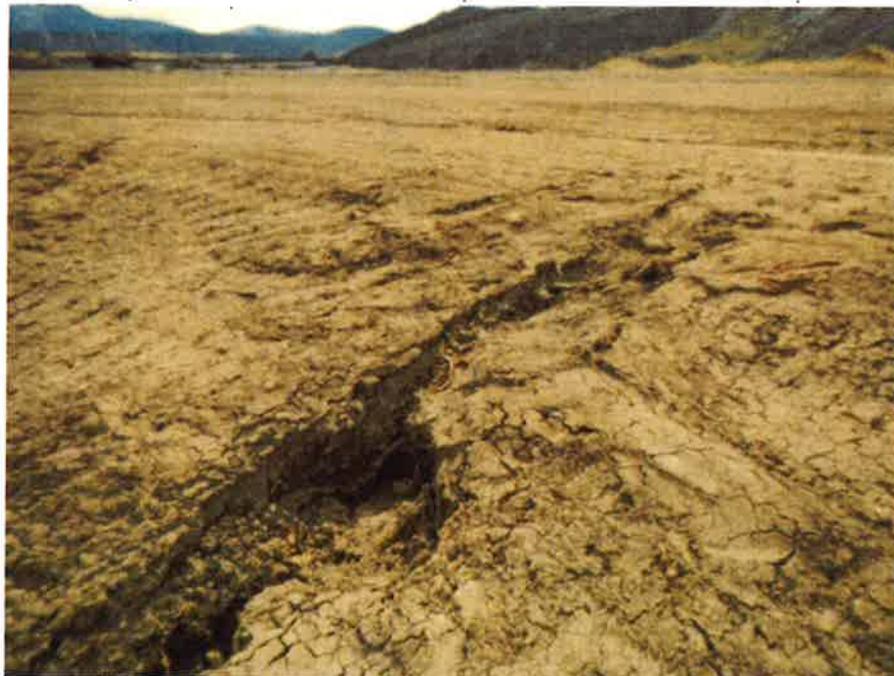
Figure 16: March 24th inspection. Ditch 4 failure #3. Failure point where gully begins running from Ditch 4 down into Lower Robinson reconstructed channel.

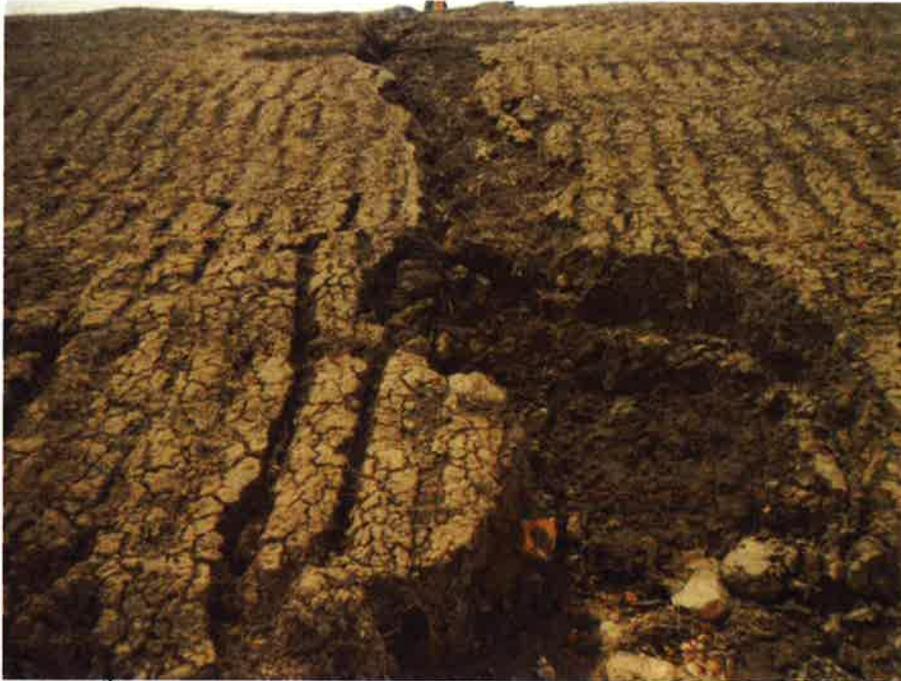
Figure 17: March 24th inspection. Ditch 4 failure #3. Failure showing gully running from Ditch 4 down into Lower Robinson reconstructed channel. Photo taken from bottom of channel looking up towards Ditch 4.

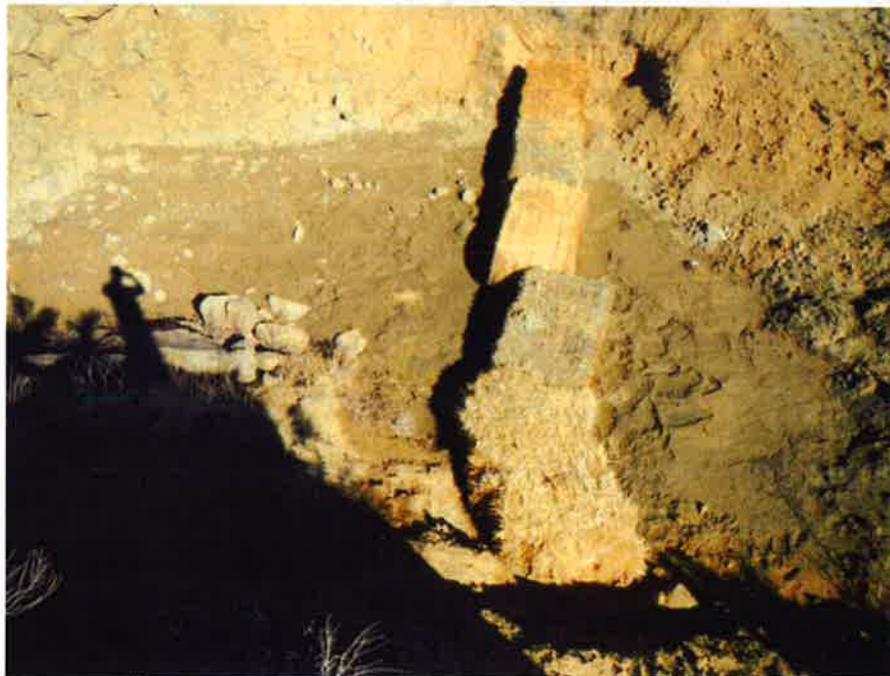
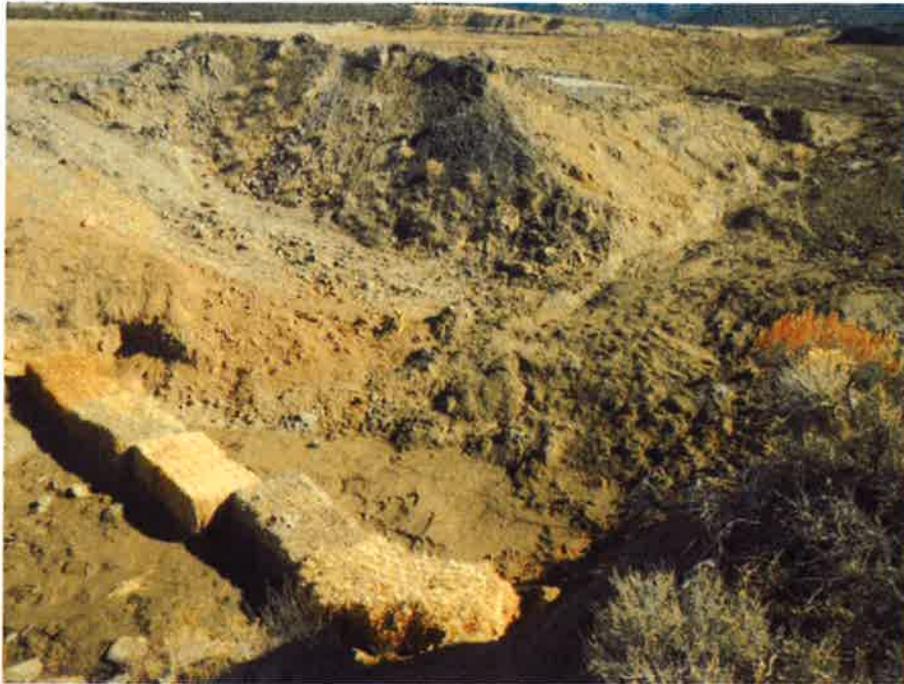
Figure 18: February 10th, 2015 inspection. Straw bale check dam installed at outlet of reconstructed Lower Robinson Creek.

Figure 19: February 10th, 2015 inspection. Straw bale check dam installed at outlet of reconstructed Lower Robinson Creek.

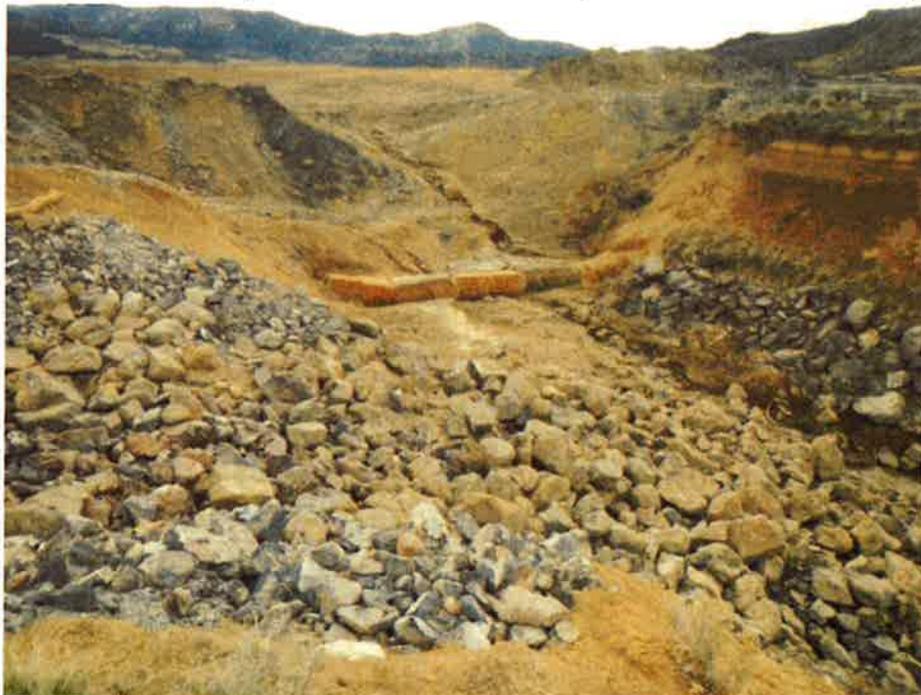
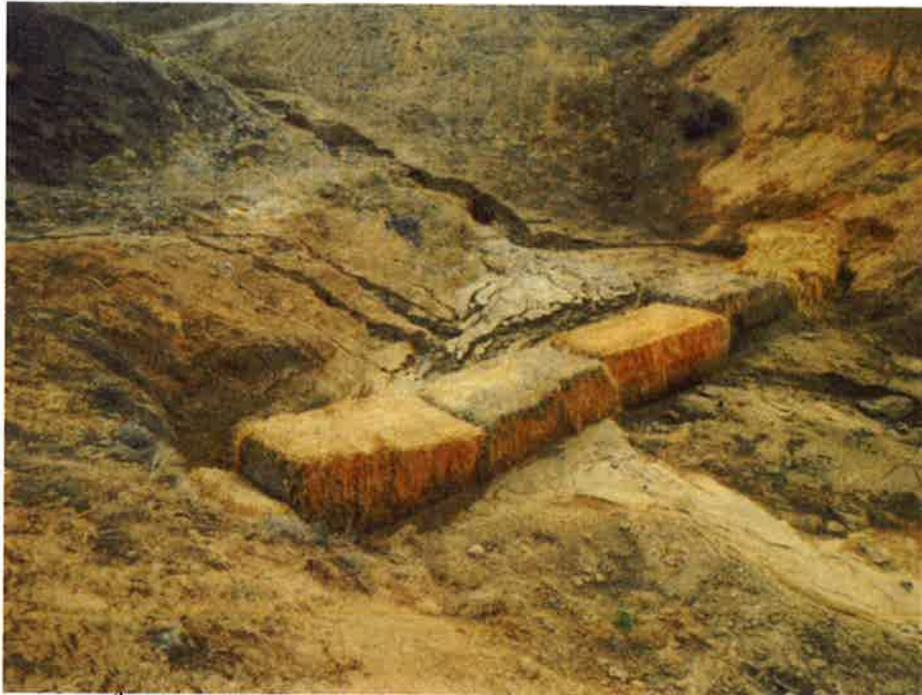
Figure 20: March 24th, 2015 inspection. Excess runoff from failed Ditch 4 formed gully at outlet Lower Robinson Creek channel reconstruction.

Figure 21: March 24th, 2015 inspection. Excess runoff from failed Ditch 4 formed gully at outlet Lower Robinson Creek channel reconstruction.

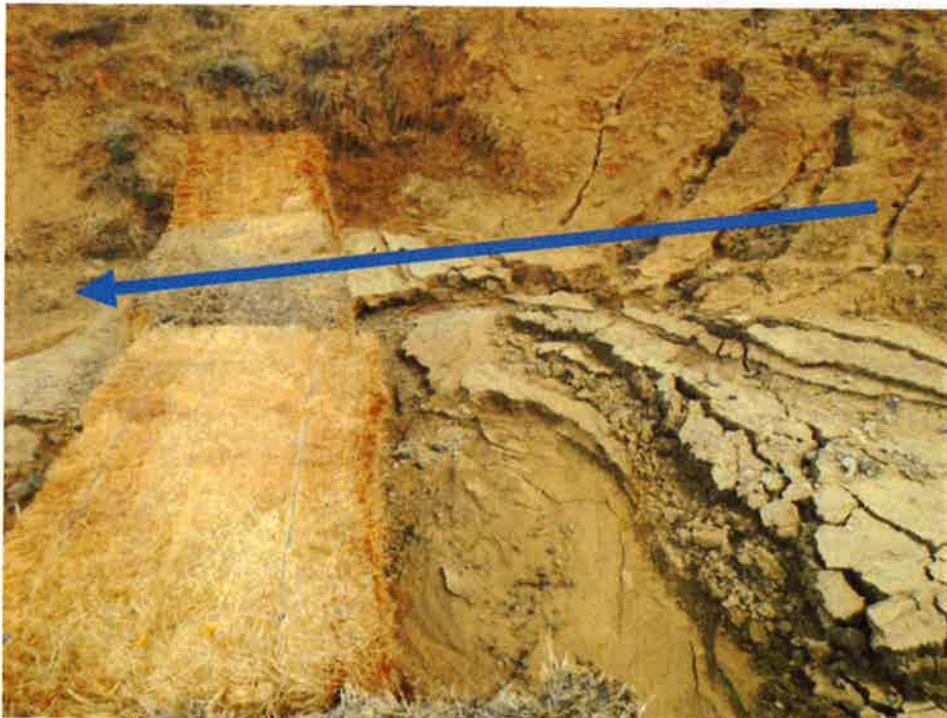
Figure 22: March 24th, 2015 inspection. Straw bale check dam at end of Lower Robinson Creek reconstruction; disturbed area runoff flows from photo right to left across the structure.

The straw bale check dam at the outlet of the reconstructed Lower Robinson Creek needs additional maintenance. A properly functioning straw bale check dam in this location will capture runoff and allow it to pond and settle out suspended solids prior to allowing runoff to flow offsite.

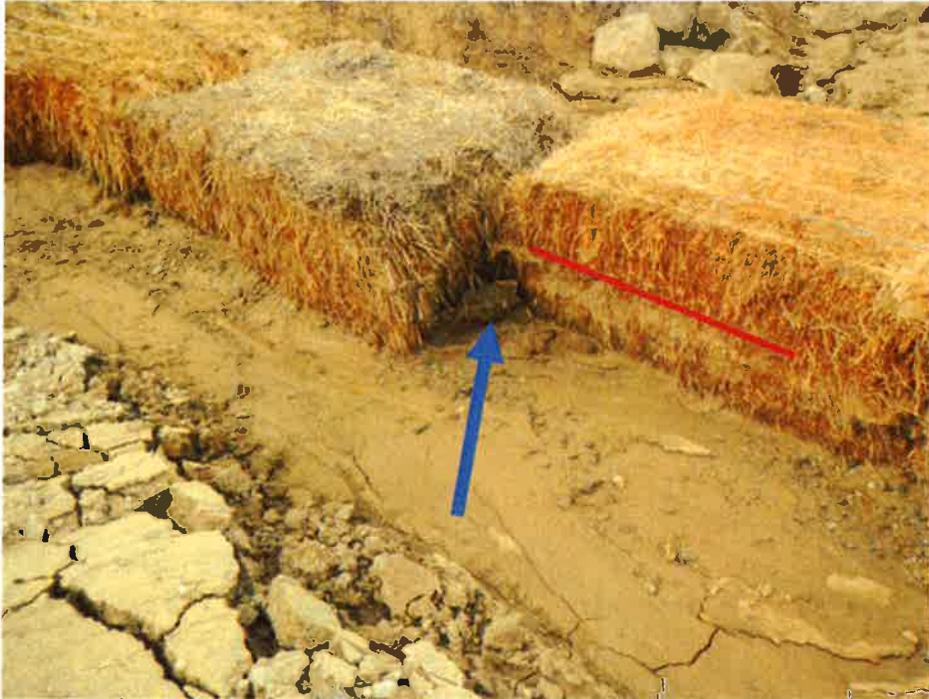
Figure 23: March 24th inspection. The straw bale check dam did not properly treat disturbed area runoff. Instead of ponding runoff and allowing to suspended sediment to settle out, the runoff piped under and between the two abutting straw bales. The red line indicates the height water pooled, before flowing under and through the joint.

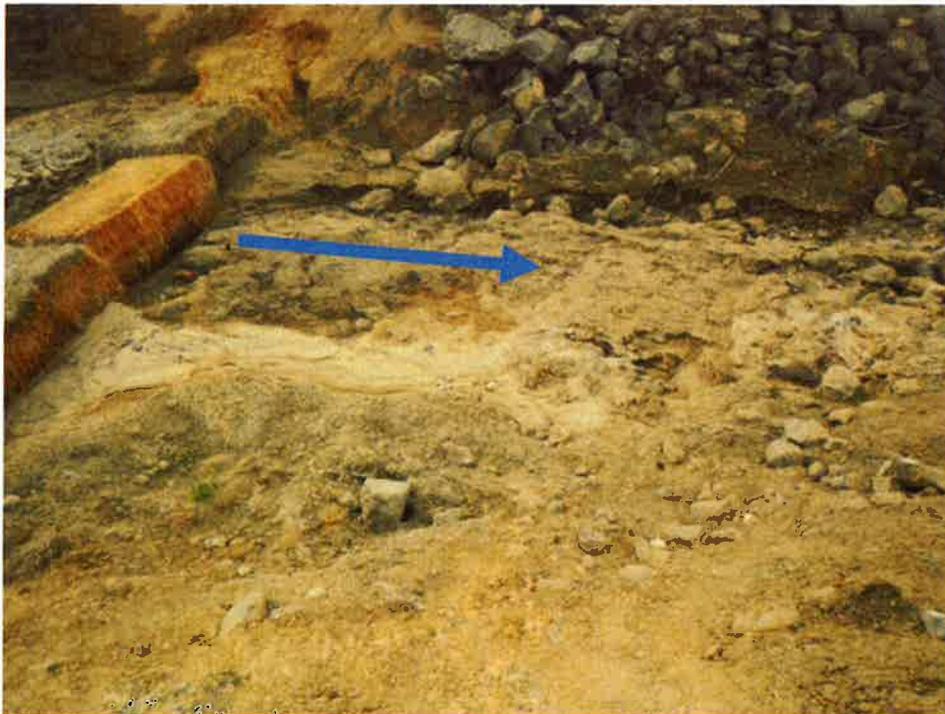
Figure 24: March 24th inspection. The scoured gully shows runoff and sediment made it past the straw bale check dam and flowed offsite. The permit boundary is < 30ft to the left of the photo.

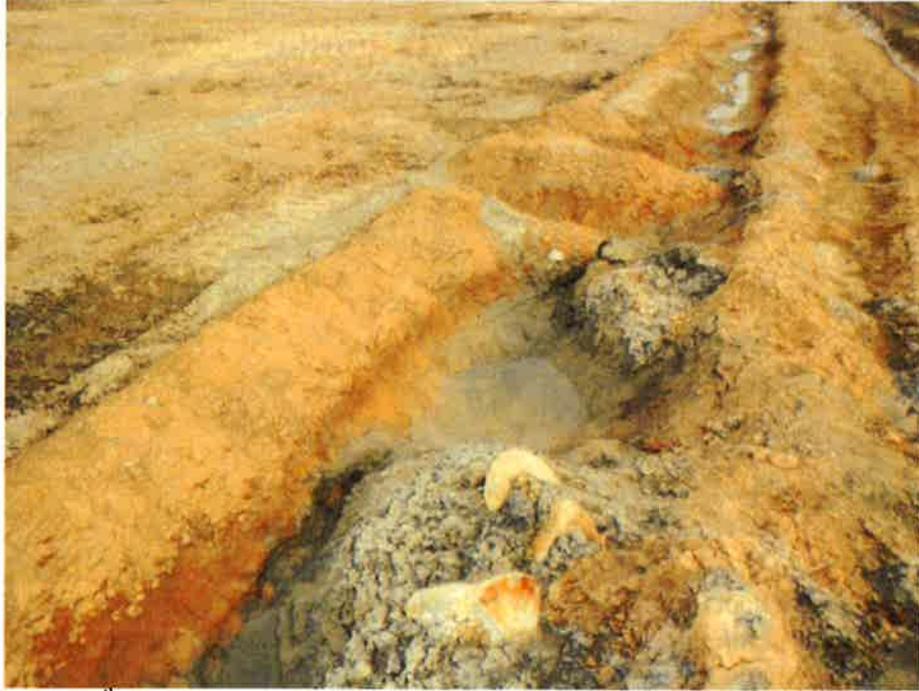
Figure 25: March 24th inspection. Unmaintained section of Ditch 1. This blockage will keep runoff from flowing to Sediment Pond 4.
