## 0250005 Coal Hollow Complete Insp Rpt # 4145

# Inspection Report

Permit Number:	<b>C0250005</b>
Inspection Type:	COMPLETE
Inspection Date:	Monday, March 23, 2015
Start Date/Time:	3/23/2015 2:30:00 PM
End Date/Time:	3/24/2015 3:30:00 PM
Last Inspection:	Tuesday, February 10, 2015

Permittee: **ALTON COAL DEVELOPMENT LLC**  
 Operator: **ALTON COAL DEVELOPMENT LLC**  
 Site: **COAL HOLLOW**  
 Address: **463 North 100 West, Suite 1, CEDAR CITY UT 84720**  
 County: **KANE**  
 Permit Type: **PERMANENT COAL PROGRAM**  
 Permit Status: **ACTIVE**

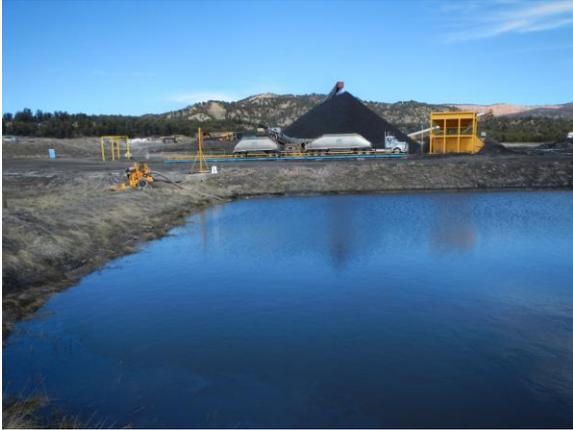
Pond #1 inlet requires maintenance where overland flow from the finished Coal Stockpile area, on the NE side enters. The clean water well valve had been left open and a continuous stream of water was entering pond #1 through culvert 6. The valve was closed during the inspection. Pond #1 was discharging during the inspection. Pond #1 is not sized for this inflow. A similar occurrence occurred in the spring of 2014 when the water storage tanks were continuously overflowing and water was continuously running overland, filling pond 1B. There can be no further leniency on this issue. The next occurrence of overflow from water tanks or clean water well will result in a violation of R645-301-731.120.

Grade the inlet at Pond #1.

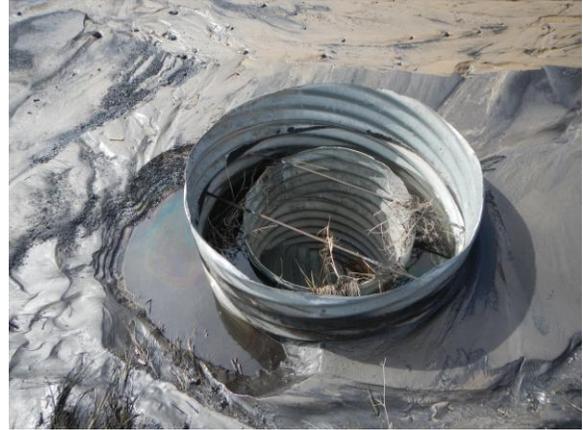
Pond #1 oil skimmer outlet.

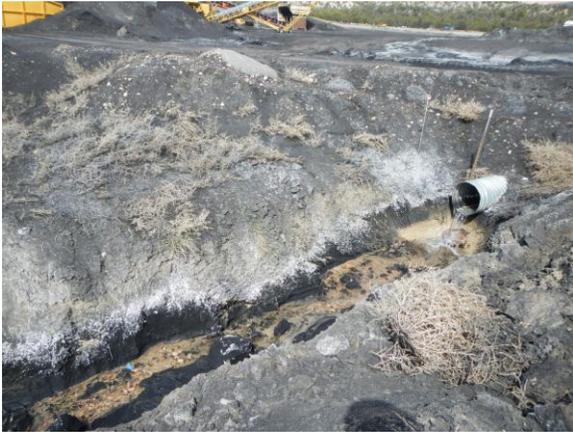
Flow into pond 1 from C6

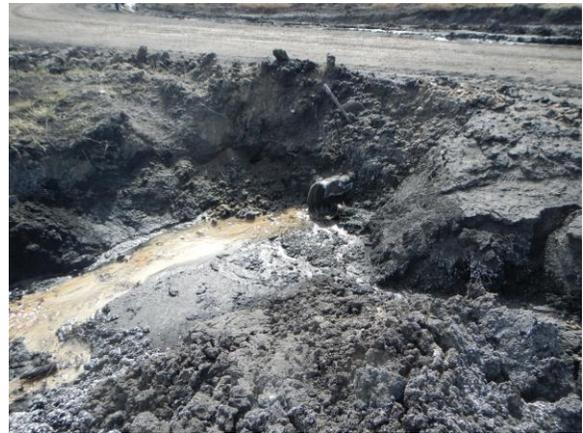
Culverts in the Facilities area shown on Dwg 5-3A were functioning, except C6 which has been crushed and needs repair prior to the next inspection.

Crushed C 6 inlet

Repair crushed C-6 culvert.

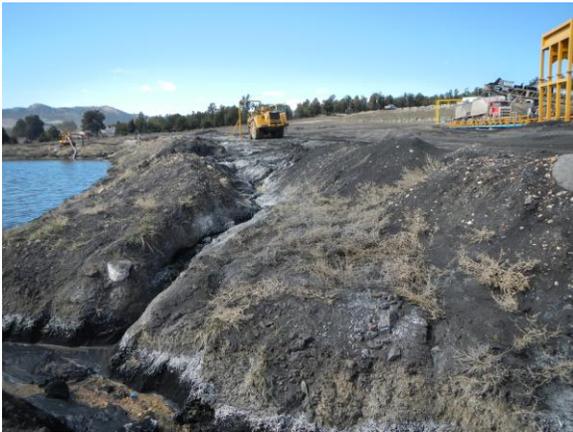
Location of pond #1 inlet clean up.

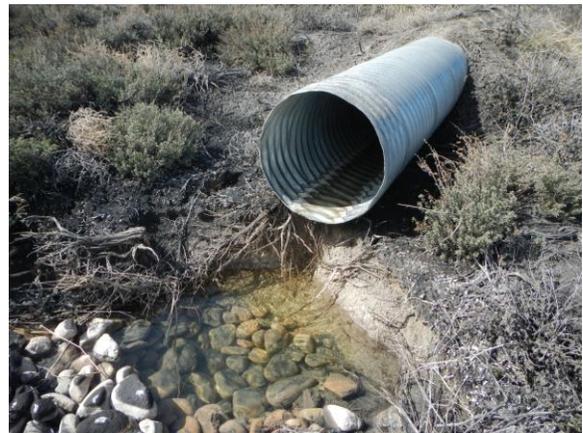
Pond #1 discharge

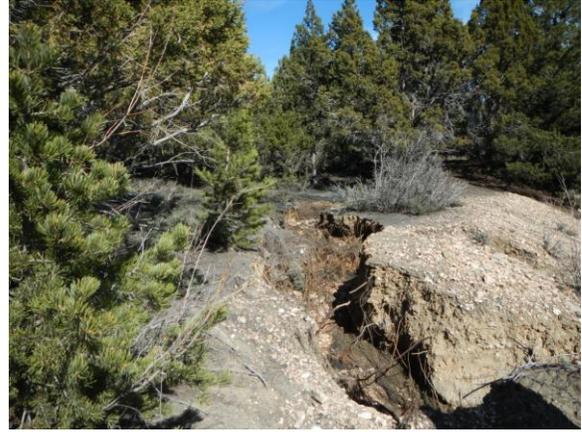
Erosion of undisturbed area due to pond discharges

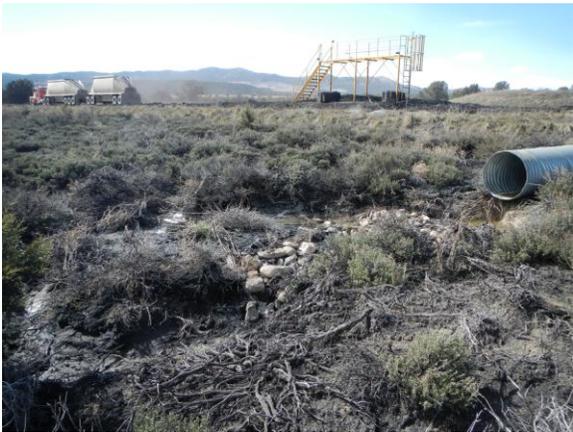
Coal fines on undisturbed land at pond 1 outlet (above and below)

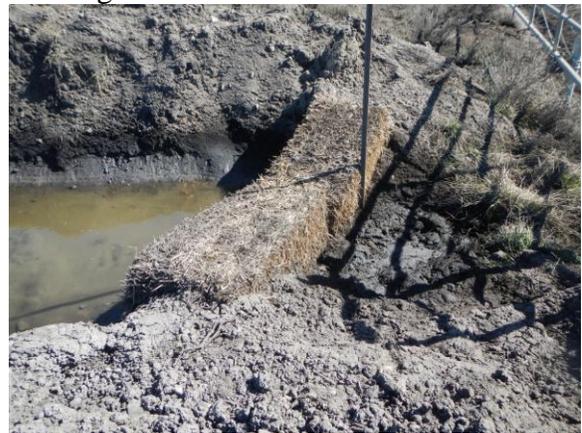
Catch basins at either side of the main entrance are presently holding water that is treated with straw bales. When the basins dry out, a third bale will be added to the south side and a second row and third bale will be added to the north side. The log will be removed from the north side.

West side catch basin at facility entrance

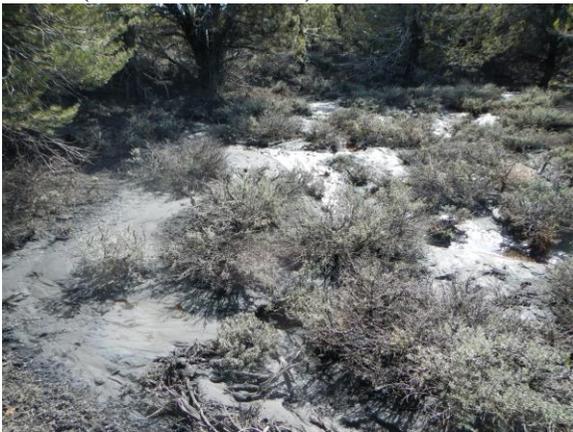
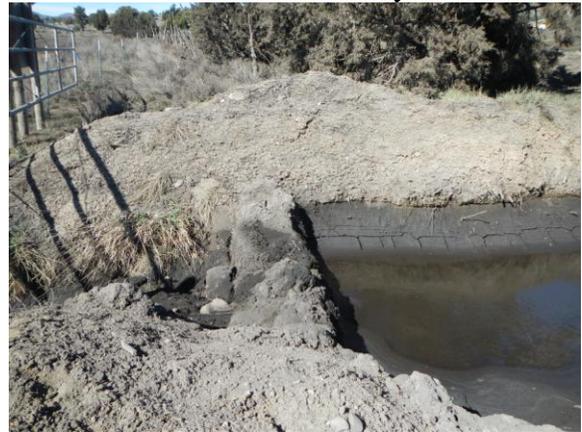
North Side catch basin at entrance

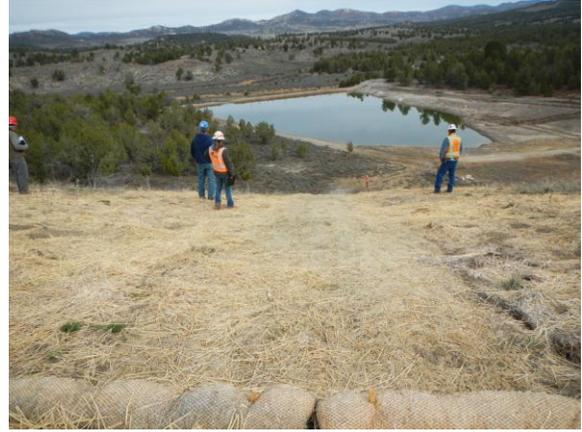
Pond 3 and repaired gully

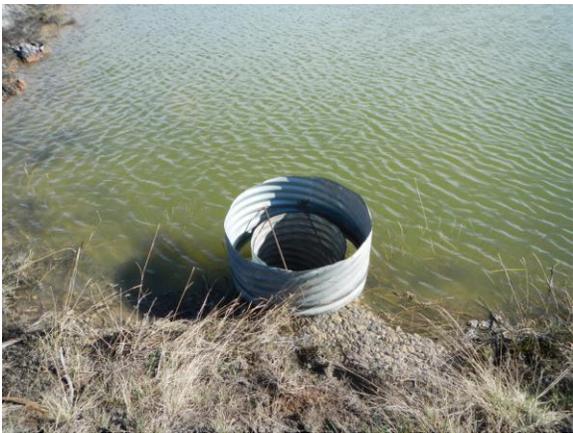
Pond #2 culvert overflow pipe was leaking at a joint in the pipe. The water level will be lowered and the leak will be fixed within 30 days or April 24.

Leaking Pond 2 outlet

Repair the leak in the overflow pipe of Pond #2.

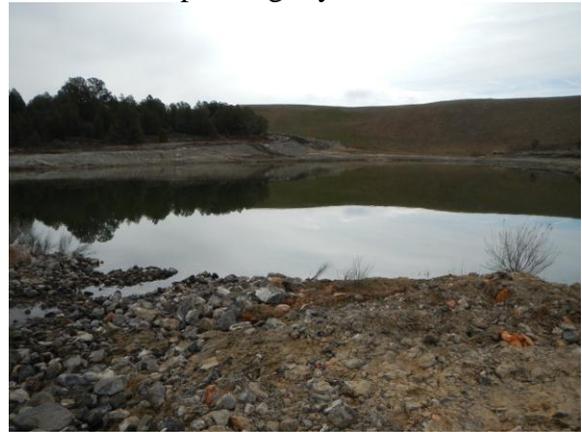
Pond 3 outlet is

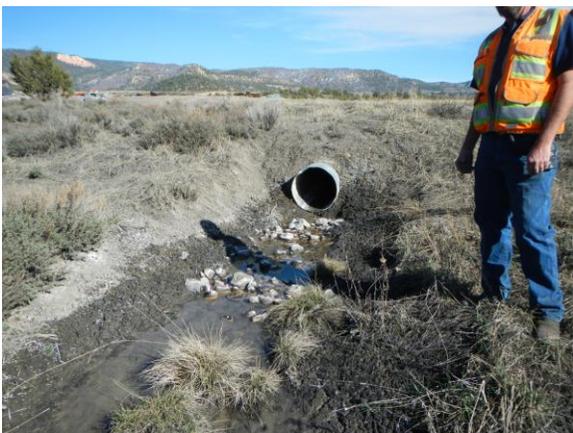
Pond 2 outlet discharge point

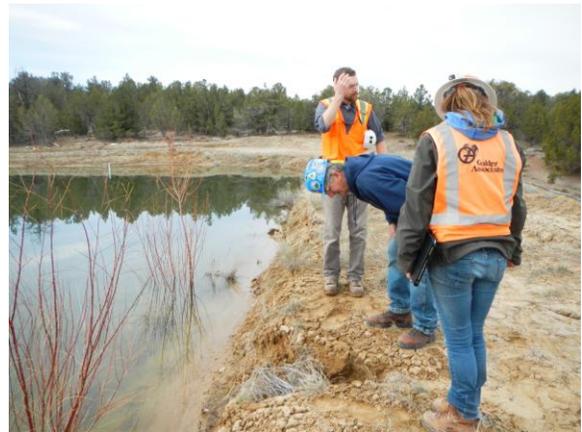
Tamarisk at pond 3 and sloughing embankment

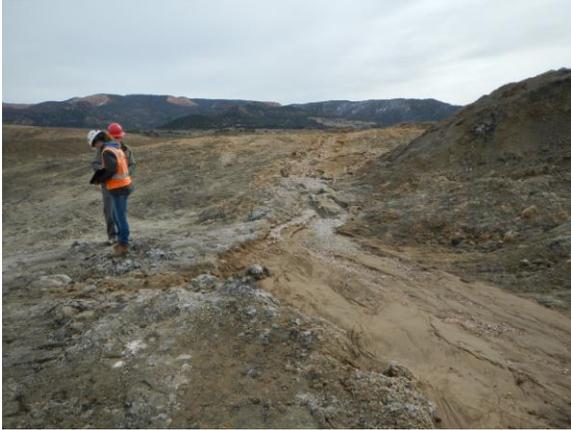
The following issues remain in contemporaneous reclamation areas: UD-4 along Robinson Creek is not correctly cited and will be relocated. The former location of UD-4 and the area re-disturbed by the relocation of UD-4 will need to be reseeded. Although the final grade in the southern permit area is gently sloping to the east, rilling has occurred south of the Dames' access road and water has ponded in a low spot east of pit 26. The rills and the pond must be graded out such that water does not create erosion or saline soil conditions.

UD 4 maintenance required (above and below)

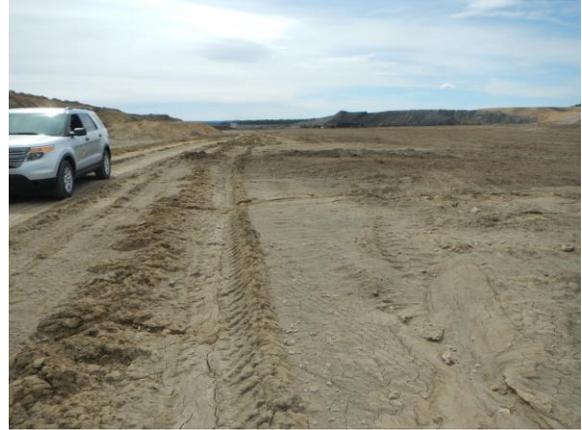
Flow control ditch along County road in Pit 6 location

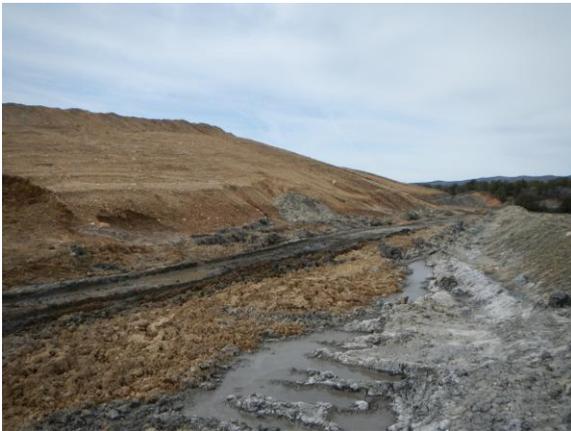
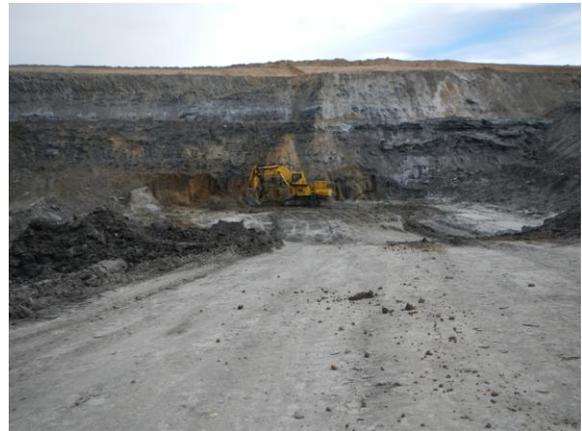
Pit 10 highwall benches prepared for underground portal development. Cement poured for substation

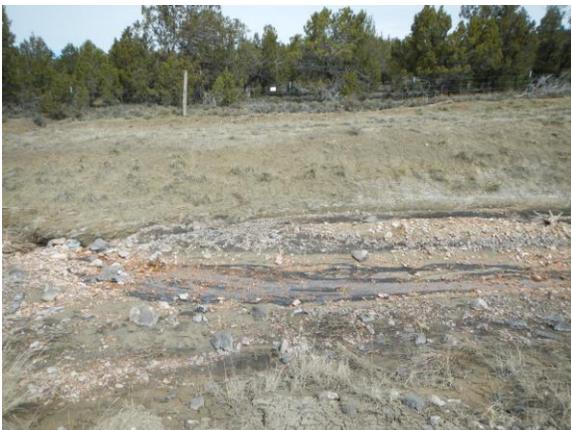
Coal fines in Robinson Creek Temporary Diversion within the Permit Area.

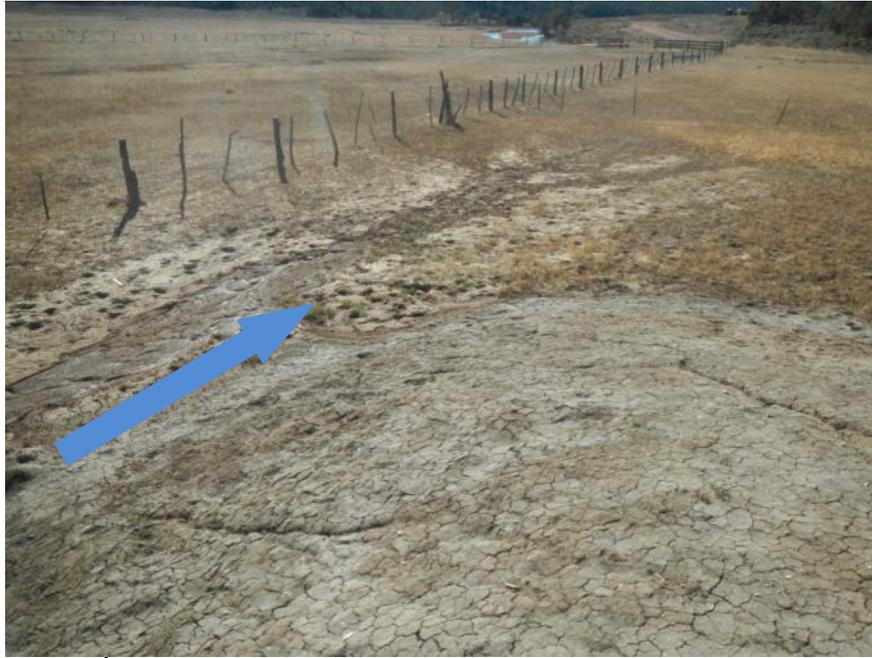
Figure 1: February 10<sup>th</sup> inspection. Outlet of Ditch 1 that handles undisturbed runoff. The wood fence line on left and T-post fence line at top right defines permit boundary. Arrow indicates the direction runoff flows from the outlet of undisturbed Ditch 1.

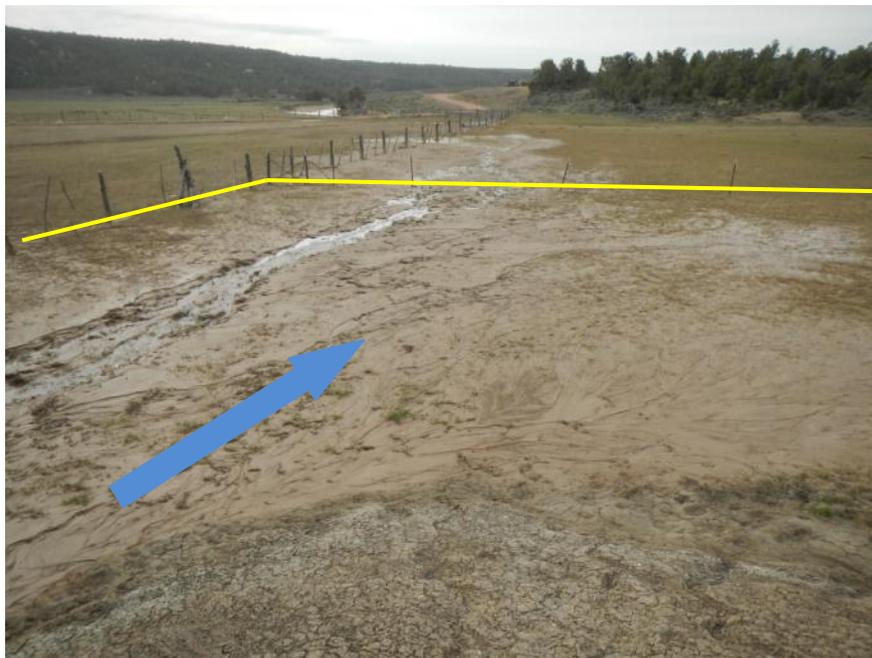
Dwg. 5-3 and 5-3A show the locations of ditches, berms and culverts in the disturbed area. During the Feb 10, 2015 inspection, final grading of subsoil piles was not yet complete near Pond #4, but drainage in the vicinity of Pond 4 and Ditch 1 was noted as requiring maintenance. During this March 24, 2015 inspection, this same area was submerged under a foot or two of water (see photographs). It was apparent that overland flow from the graded, reclaimed southern pits 25 - 28 has ponded at the NE corner of pond #4. The current grade of Watershed 4 has established the inlet of Ditch 1 to be lower than the spillway of Sediment Pond 4. This allowed excess runoff from snow melt to backup and pond on the southeast corner of Watershed 4, before water could discharge through the spillway of Sediment Pond 4. The ponded backwater breached the berm of Ditch 1 separating undisturbed runoff to the east from disturbed runoff to the west. Ditch 1 then carried the disturbed area flow outside the permit area, without treatment. The untreated runoff covered the grassy sod that used to act as an alternate sediment control to treat undisturbed Ditch 1 drainage. The grassy area is now covered with sediment and can no longer adequately treat runoff from the undisturbed ditch prior to leaving the permit area. Additionally, the section of Ditch 1 requiring immediate maintenance has not been fixed since the February inspection. This issue is the subject of NOV Citation #16150.

Figure 2: March 24<sup>th</sup> inspection. Sediment plume at outlet of Ditch 1 showing offsite impact. Permit boundary is roughly defined by yellow line.

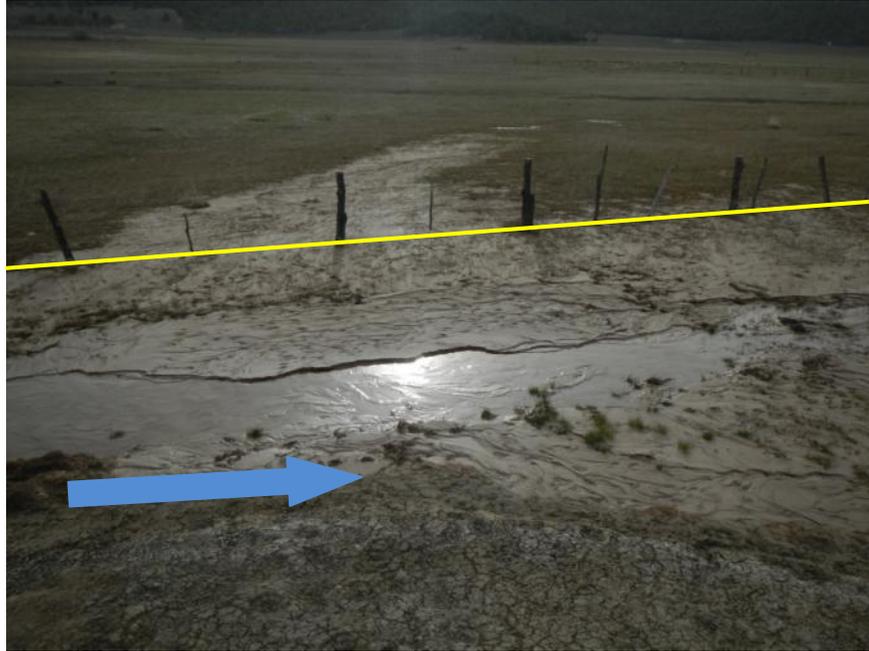
Figure 3: March 24<sup>th</sup> inspection. Sediment plume at outlet of Ditch 1 showing offsite impact. The undisturbed outlet of Ditch 1 is left of the photo. Flow is from left to right. Permit boundary is roughly defined by the yellow line.

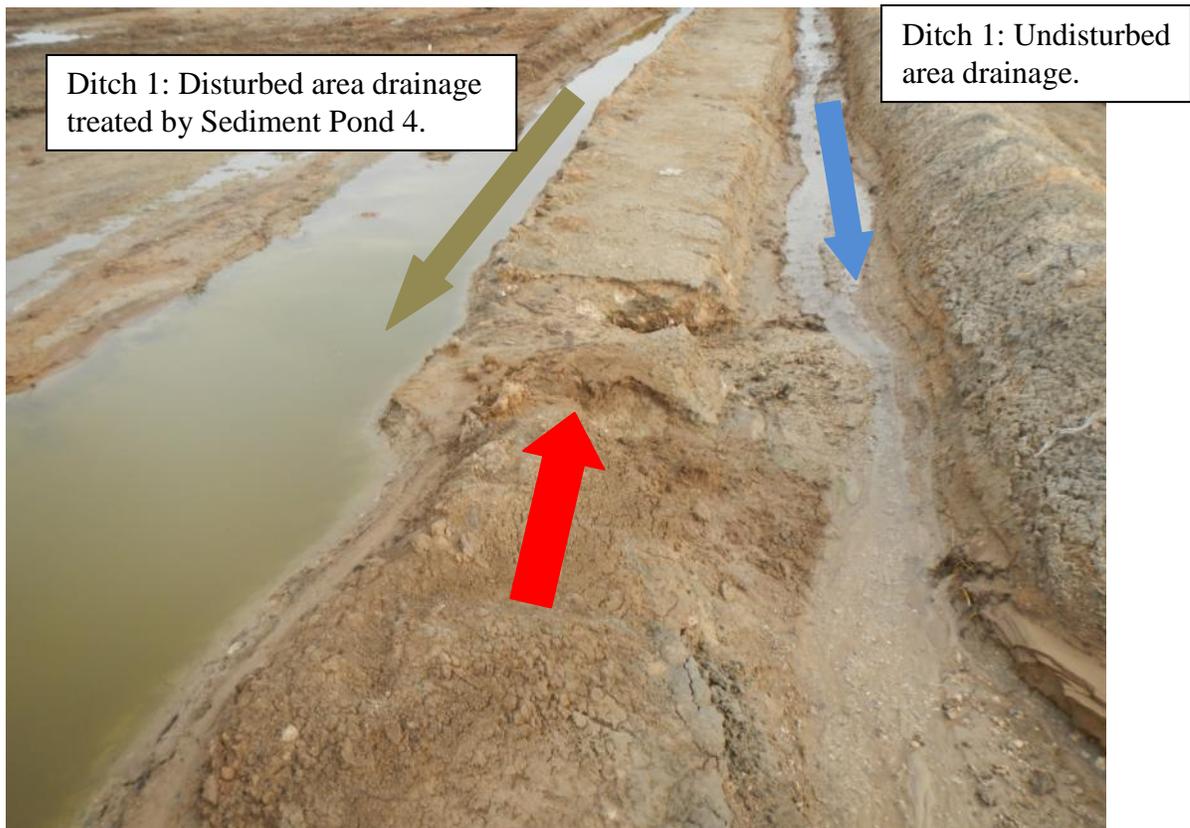
Figure 4: March 24<sup>th</sup> inspection. The red arrow points to the location where Ditch 1 failed allowing disturbed area runoff carry suspended sediment offsite untreated.

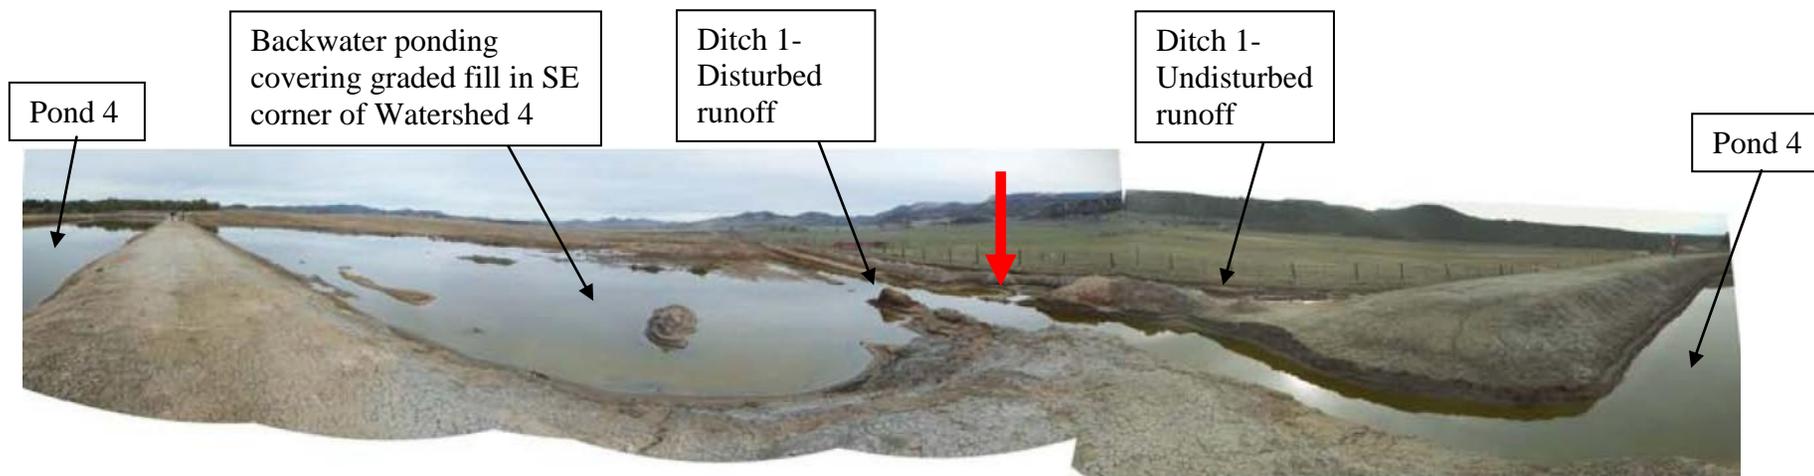
Figure 5. March 24<sup>th</sup>, 2015 inspection. ~300<sup>o</sup> panoramic photo of backwater pond outside of Sediment Pond 4. Red arrow points to failure point of Ditch 1 where disturbed area runoff exited the site via the undisturbed ditch.

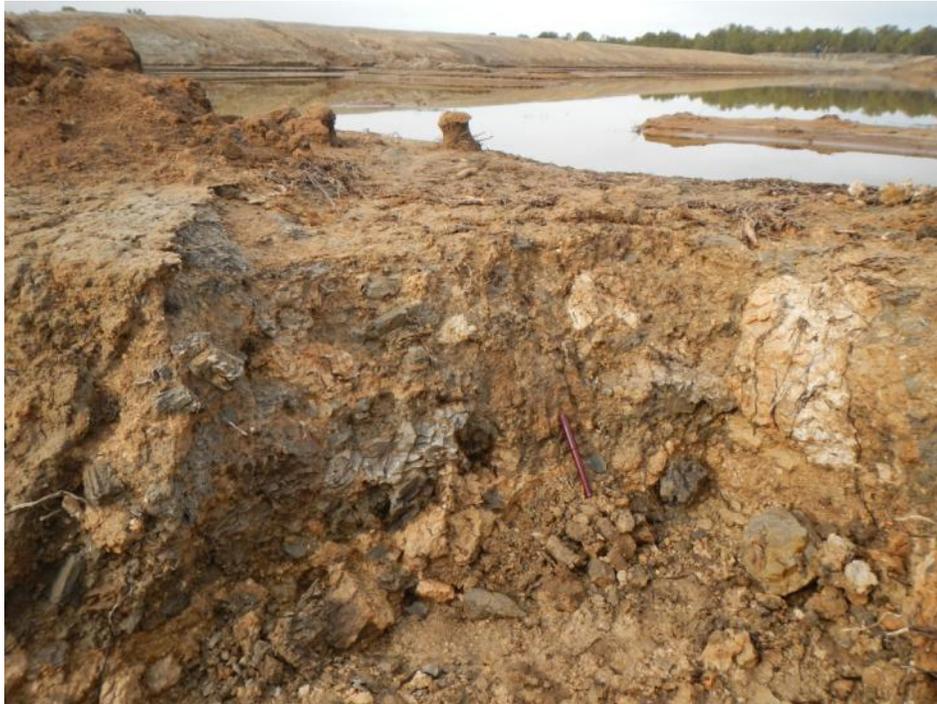
Figure 6: March 24<sup>th</sup> inspection. Failure point of Ditch 1 berm. Backwater ponding of Sediment Pond 4 seen in background of photo.

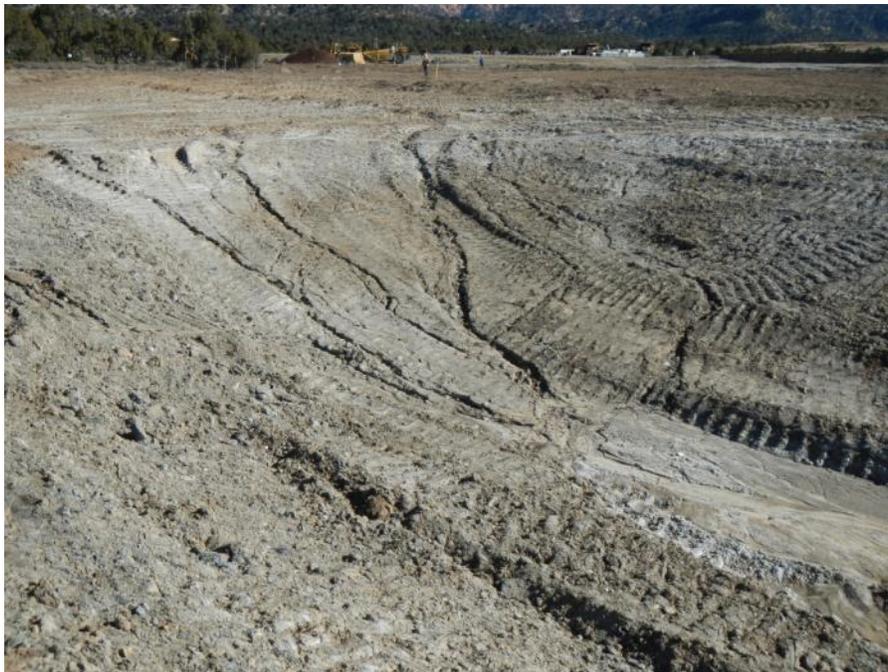
Figure 7: February 10<sup>th</sup>, 2015 inspection. Head of Lower Robinson Creek channel reconstruction. Ditch 4 is on the far side of the channel in this photo. It is designed to route water drained from the disturbed area in the photo's background to Sediment Pond 3.

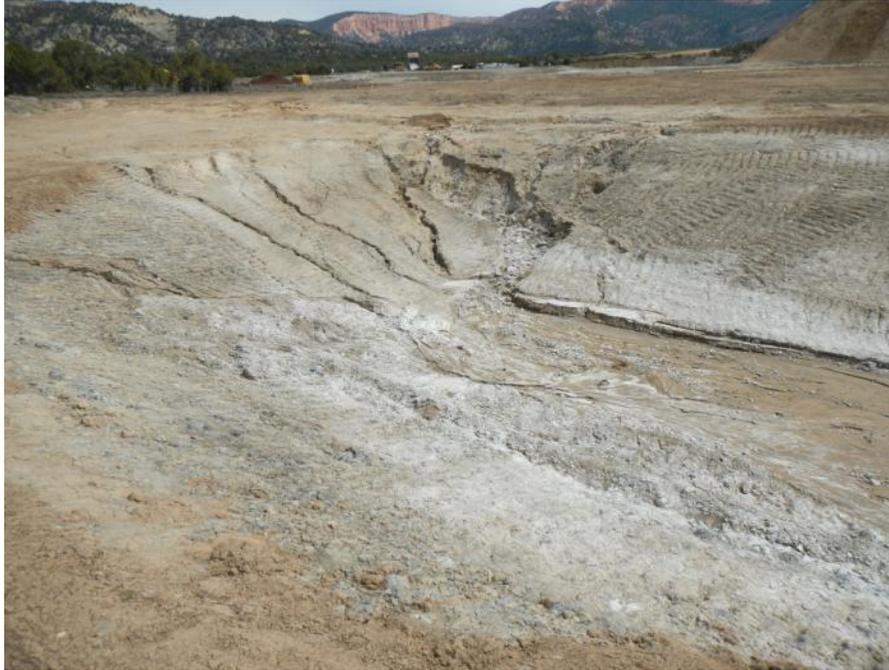
Ditch 4 has eroded in three locations along its length above Robinson Creek reconstruction area. During the site inspection at Coal Hollow on February 10th, 2015 it was found, and the Permittee was notified, Ditch 4 was not built to the approved design in Drawing 5-34. The failure of Ditch 4 in mid-March carried suspended solids from Watershed 3 disturbed area (Drawing 5-26) into the reconstructed channel of Lower Robinson Creek. From here, the runoff and suspended sediments flowed offsite prior to being adequately treated. NOV #16150 has been issued for this non-compliance.

Figure 8: March 24<sup>th</sup>, inspection. Ditch 4 failure #1. Disturbed area runoff and suspended sediment carried into the reconstructed channel of Lower Robinson Creek.

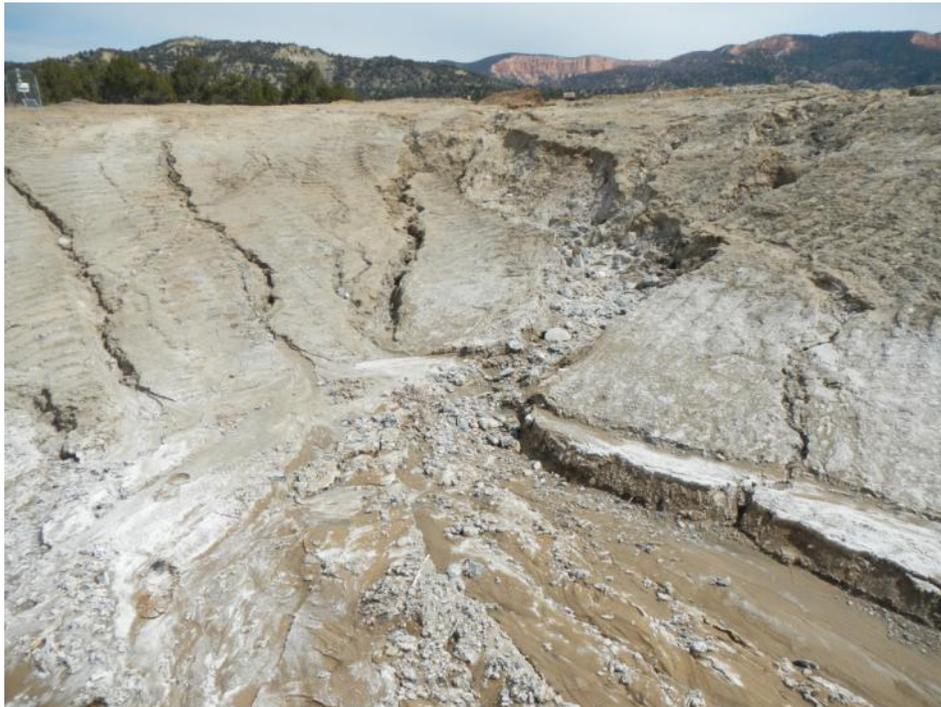
Figure 10: March 24<sup>th</sup>, 2015 inspection. Ditch 4 failure #1. Disturbed area runoff and suspended sediment carried into the reconstructed channel of Lower Robinson Creek.

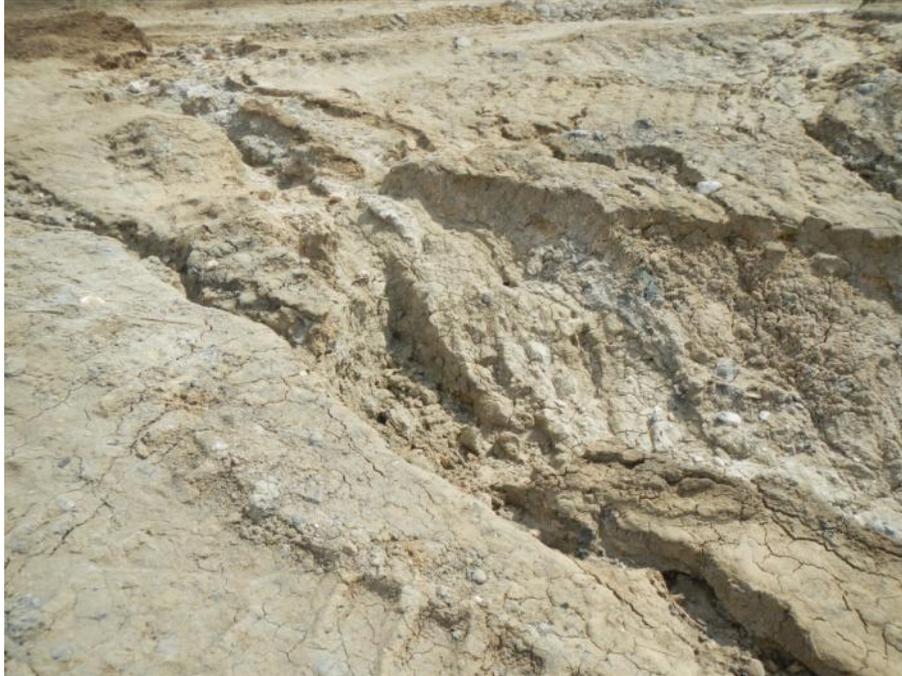
Figure 9: March 24<sup>th</sup>, inspection. Ditch 4 failure #1. Disturbed area runoff and suspended sediment carried into the reconstructed channel of Lower Robinson Creek.

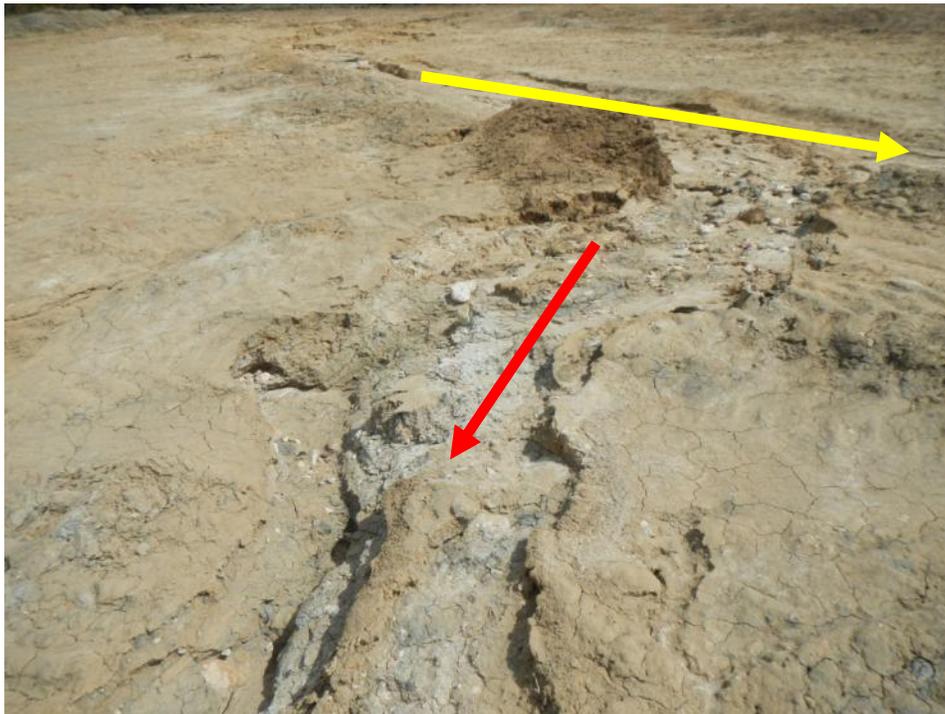
Figure 10: March 24<sup>th</sup>, 2015 inspection. Ditch 4 failure #1. Yellow arrow points shows direction of design flow in Ditch 4. Red arrow shows failure #1 where Ditch 4 was overtopped by runoff from Watershed 3.

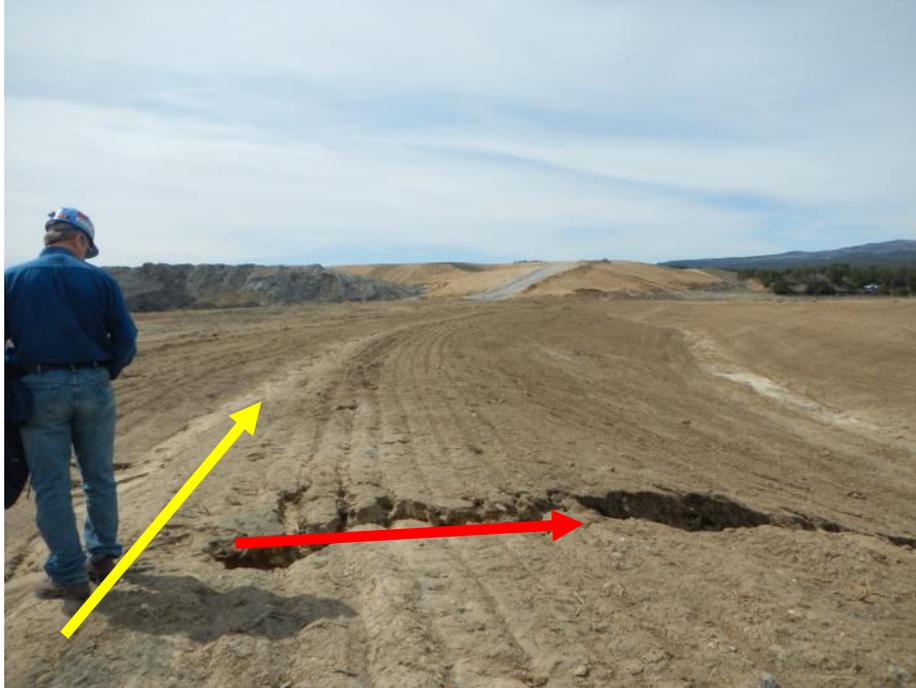
Figure 11: March 24<sup>th</sup> inspection. Ditch 4 failure #2. Yellow arrow shows design flow direction. Red arrow shows failure point and subsequent flow into the reconstructed Lower Robinson Creek channel.

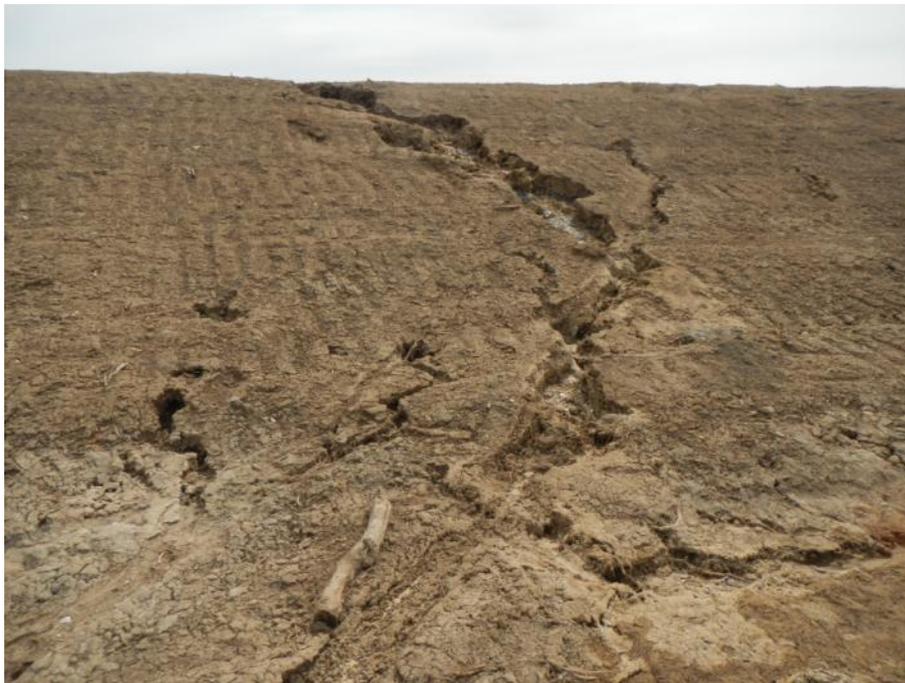
Figure 12: March 24<sup>th</sup> inspection. Ditch 4 failure #2, looking up from bottom of Lower Robinson Creek reconstructed channel.

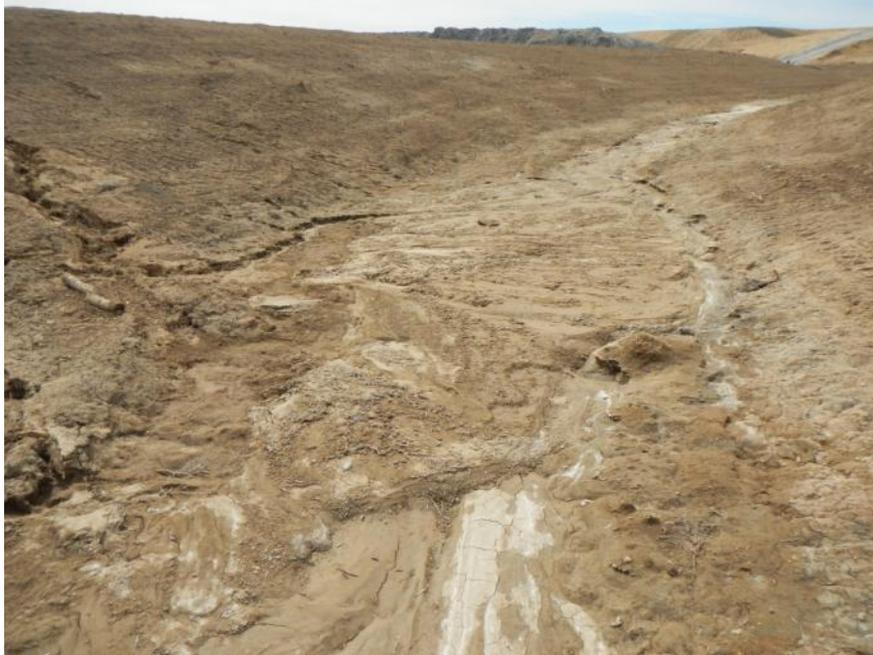
Figure 13: March 24<sup>th</sup> inspection. Ditch 4 failure #2. Photo taken from bottom of Lower Robinson Creek reconstructed channel. Alluvial fan deposited at base of gully shows a significant amount of sediment was suspended in the runoff.

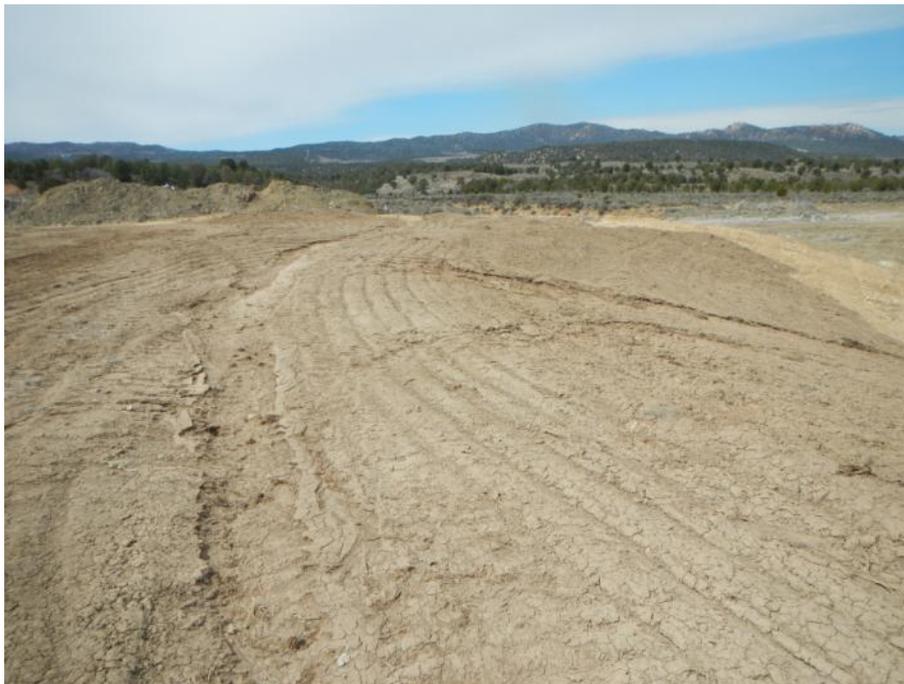
Figure 14: March 24<sup>th</sup> inspection. Ditch 4 failure #3. Gully is seen running from Ditch 4 down into Lower Robinson reconstructed channel on photo right.

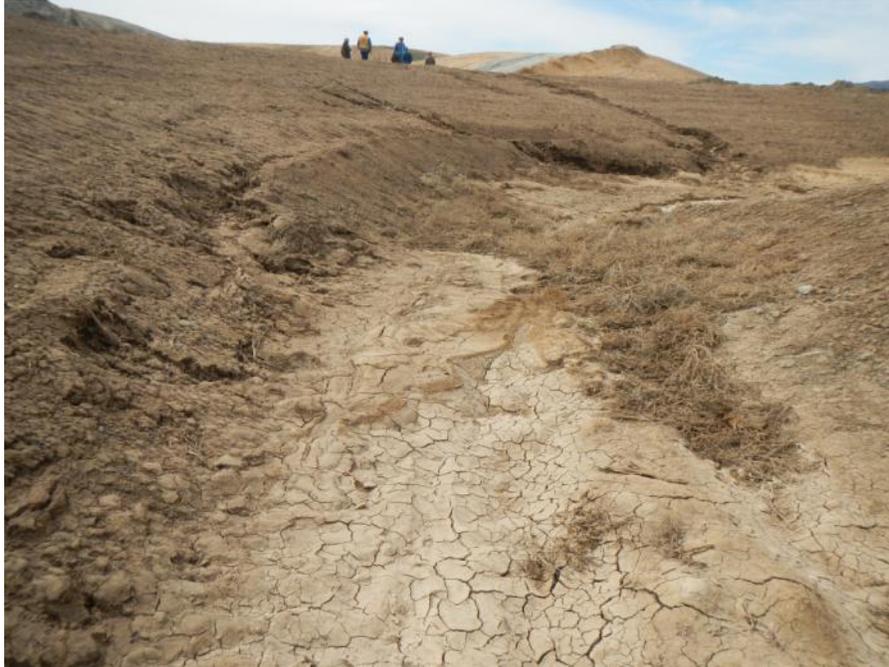
Figure 15: March 24<sup>th</sup> inspection. Ditch 4 failure #3. Gully is seen running from Ditch 4 down into Lower Robinson reconstructed channel. Photo taken from bottom of reconstructed channel.

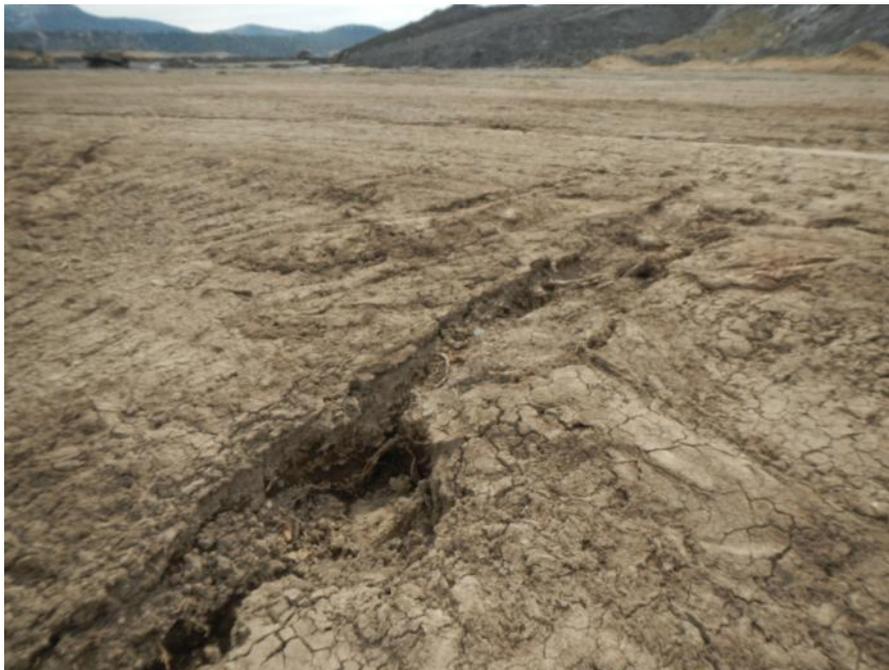
Figure 16: March 24<sup>th</sup> inspection. Ditch 4 failure #3. Failure point where gully begins running from Ditch 4 down into Lower Robinson reconstructed channel.

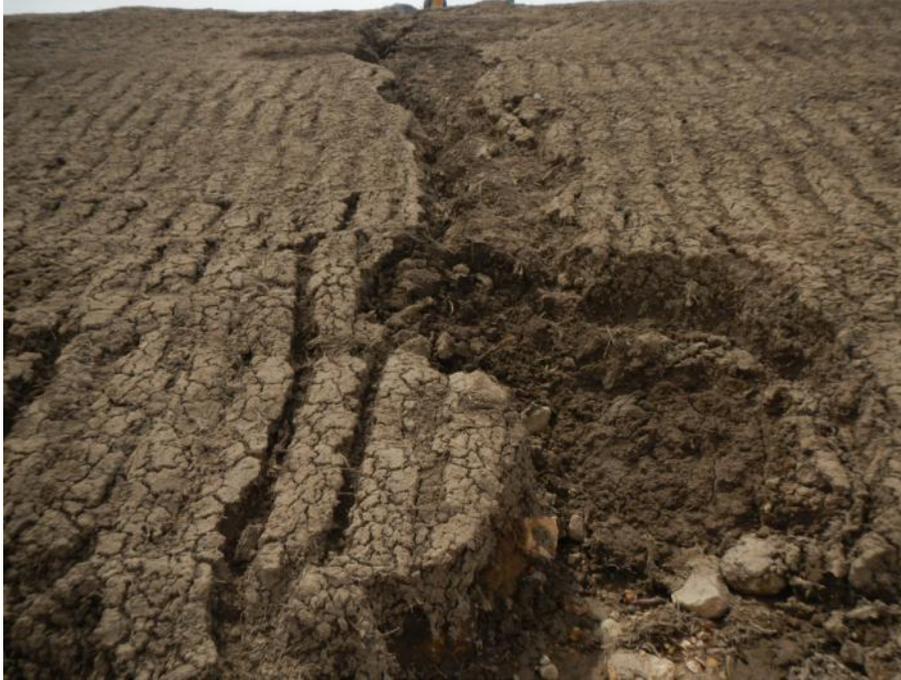
Figure 17: March 24<sup>th</sup> inspection. Ditch 4 failure #3. Failure showing gully running from Ditch 4 down into Lower Robinson reconstructed channel. Photo taken from bottom of channel looking up towards Ditch 4.

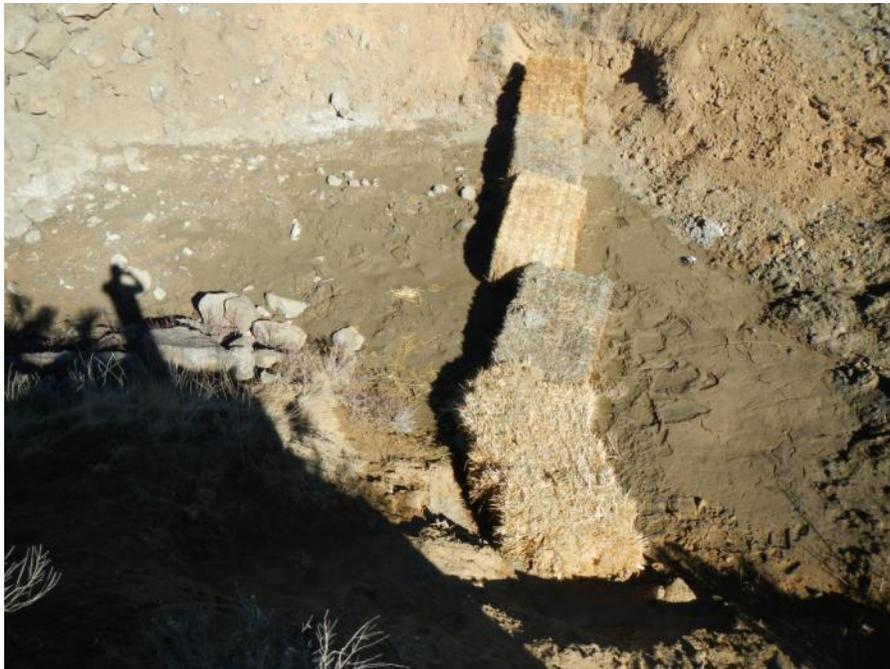
Figure 18: February 10<sup>th</sup>, 2015 inspection. Straw bale check dam installed at outlet of reconstructed Lower Robinson Creek.

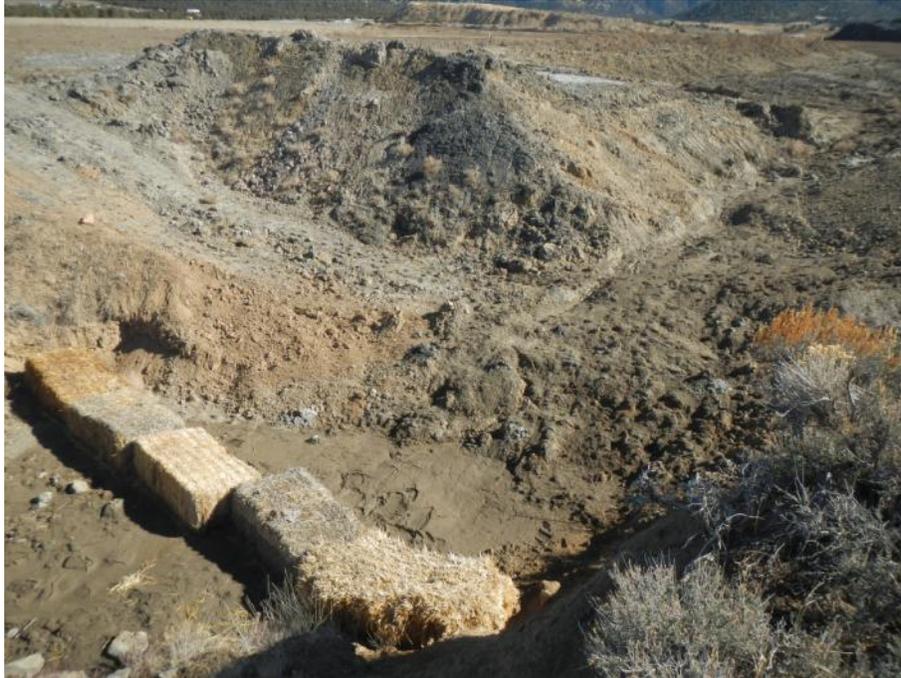
Figure 19: February 10<sup>th</sup>, 2015 inspection. Straw bale check dam installed at outlet of reconstructed Lower Robinson Creek.

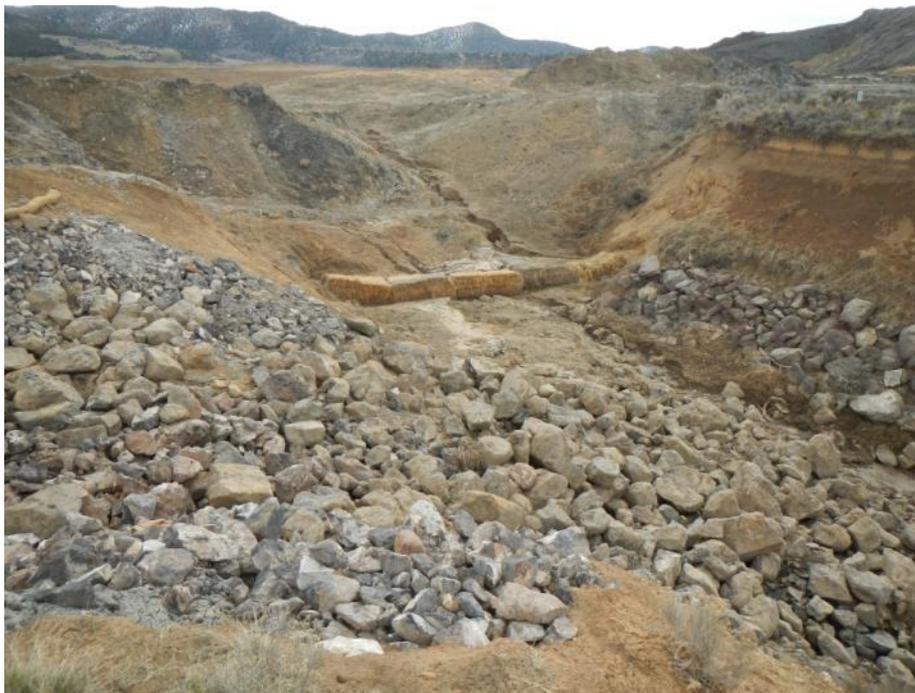
Figure 20: March 24<sup>th</sup>, 2015 inspection. Excess runoff from failed Ditch 4 formed gully at outlet Lower Robinson Creek channel reconstruction.

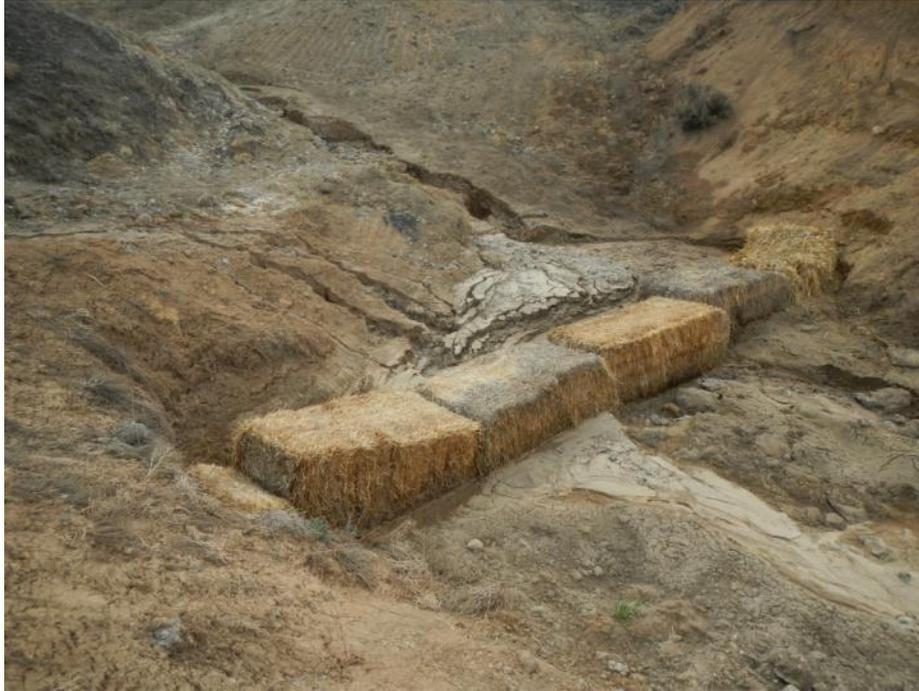
Figure 21: March 24<sup>th</sup>, 2015 inspection. Excess runoff from failed Ditch 4 formed gully at outlet Lower Robinson Creek channel reconstruction.

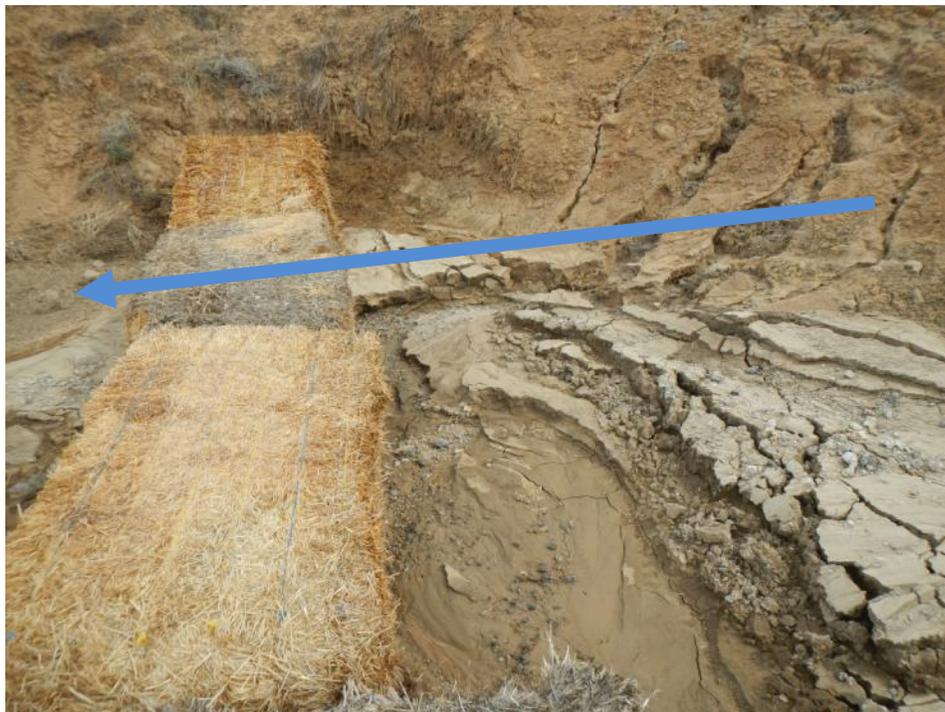
During the February 10th, 2015 inspection the Permittee was notified to fill the gaps in the straw bale check dam at the end of Lower Robinson Creek reconstruction in order for the structure to function properly. While the Permittee added a small straw bale on the end of the structure, the Permittee did not fill the gaps between abutting straw bales. The straw bale check dam does not currently function as an alternative sediment control feature because it allows flow to be piped between abutting straw bales. A properly functioning straw bale check dam should capture runoff and allow it to pond and settle out suspended solids prior to allowing runoff to flow offsite.

Figure 22: March 24<sup>th</sup>, 2015 inspection. Straw bale check dam at end of Lower Robinson Creek reconstruction; disturbed area runoff flows from photo right to left across the structure.
