## 0250005 Coal Hollow Complete Insp Rpt # 4145

# Inspection Report

Permit Number:	<b>C0250005</b>
Inspection Type:	COMPLETE
Inspection Date:	Monday, March 23, 2015
Start Date/Time:	3/23/2015 2:30:00 PM
End Date/Time:	3/24/2015 3:30:00 PM
Last Inspection:	Tuesday, February 10, 2015

Permittee: **ALTON COAL DEVELOPMENT LLC**  
 Operator: **ALTON COAL DEVELOPMENT LLC**  
 Site: **COAL HOLLOW**  
 Address: **463 North 100 West, Suite 1, CEDAR CITY UT 84720**  
 County: **KANE**  
 Permit Type: **PERMANENT COAL PROGRAM**  
 Permit Status: **ACTIVE**

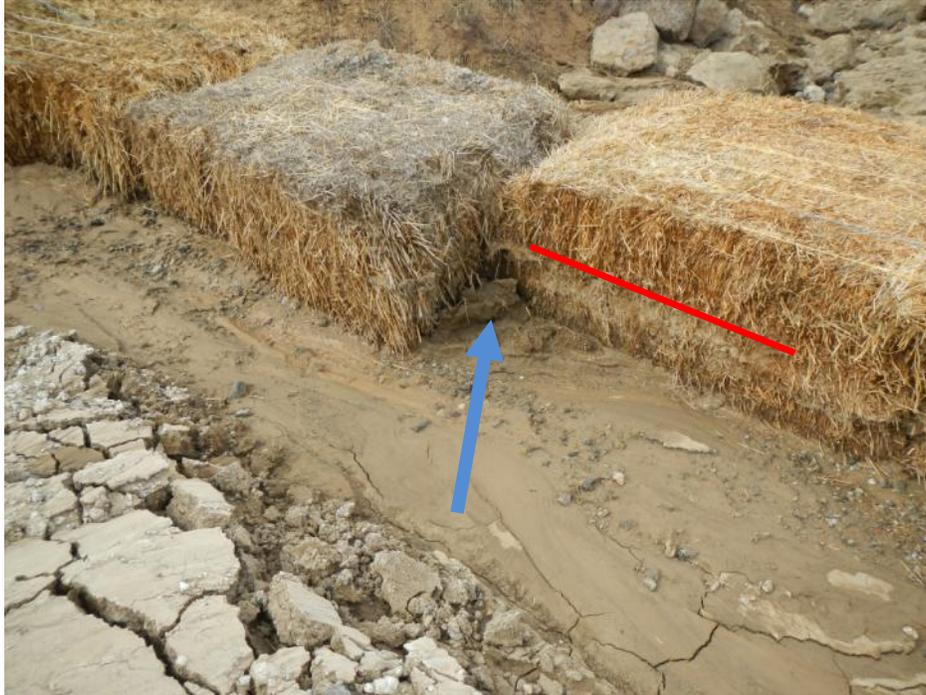
Figure 23: March 24<sup>th</sup> inspection. The straw bale check dam did not properly treat disturbed area runoff. Instead of ponding runoff and allowing suspended sediment to settle out, the runoff piped under and between the two abutting straw bales. The red line indicates the height water pooled, before flowing under and through the joint.

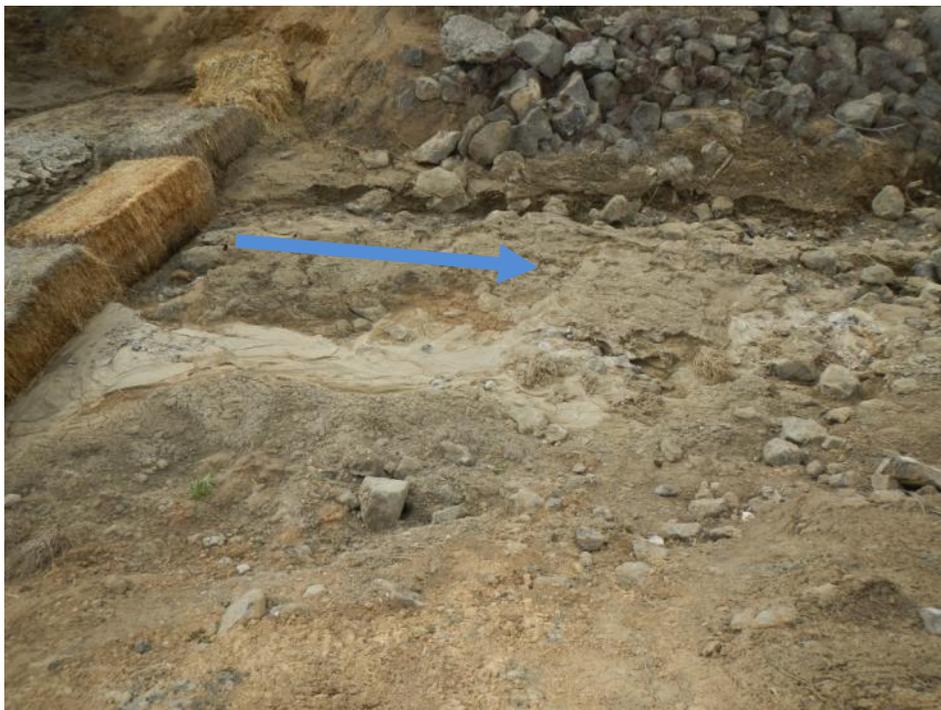
Figure 24: March 24<sup>th</sup> inspection. The scoured gully shows runoff and sediment made it past the straw bale check dam and flowed offsite. The permit boundary is < 30ft to the left of the photo.

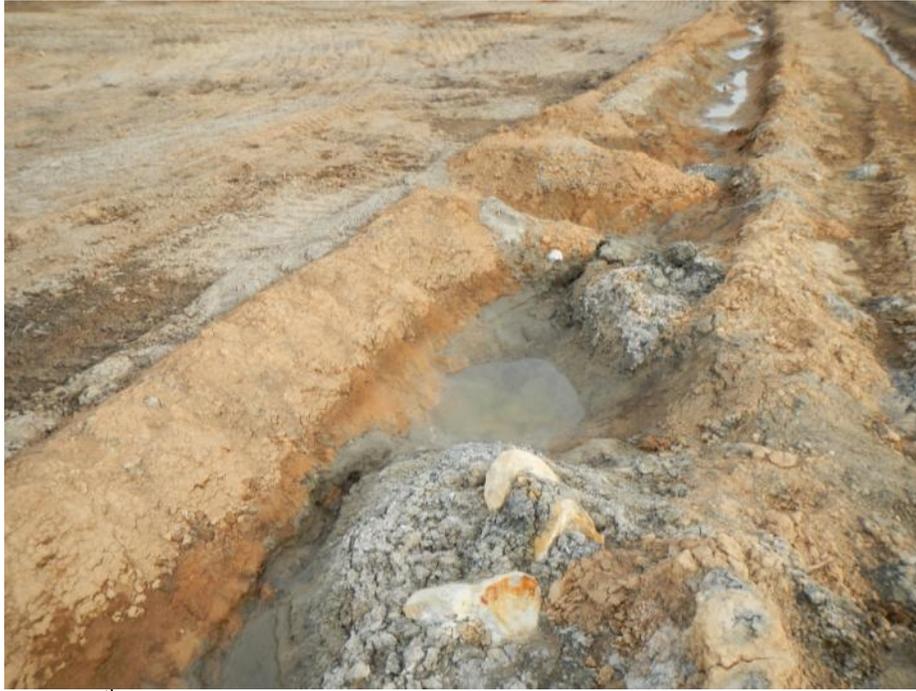
Figure 25: March 24<sup>th</sup> inspection. Unmaintained section of Ditch 1. This blockage will keep runoff from flowing to Sediment Pond 4.

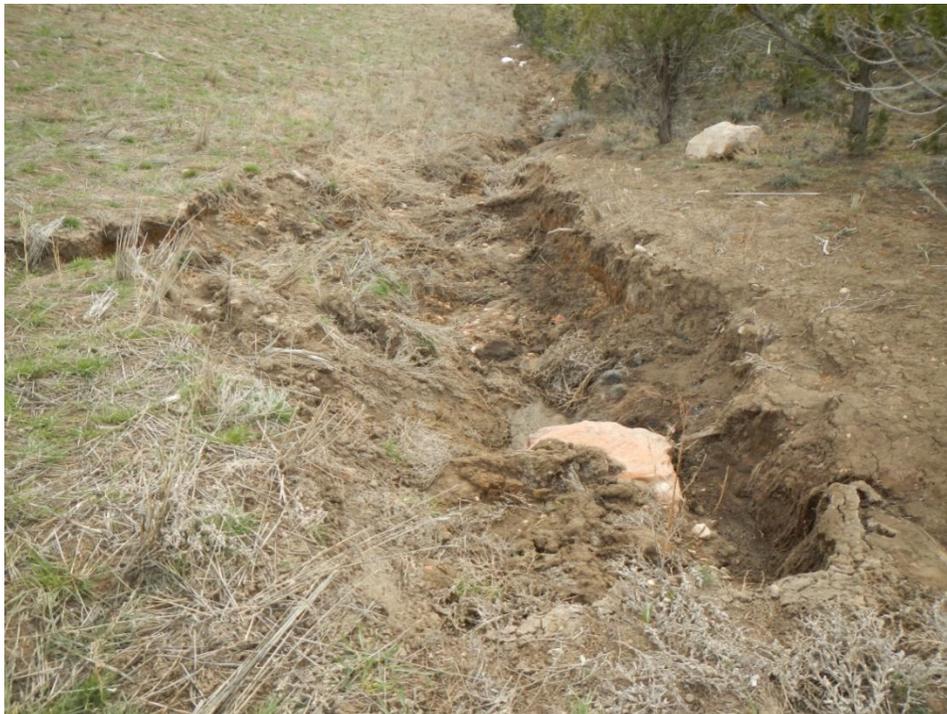
A large gully has formed where the south-west corner of the refuse pile adjoins with the undisturbed local topography (Figure 26). This is likely due to discharge of sub-surface lateral flow at the refuse pile-natural topography junction.

Figure 26. March 24<sup>th</sup> inspection. Gully erosion on south side of refuse pile.

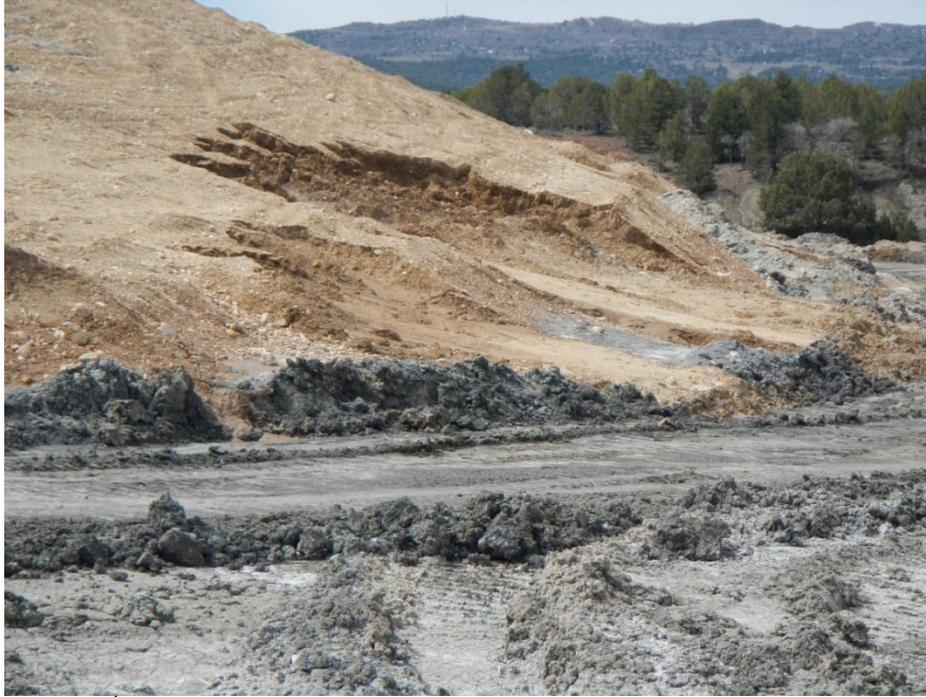
Subsoil sloughed from slope on NE corner of refuse pile (Figure 27).

Figure 27. March 24<sup>th</sup> inspection. Subsoil sloughing from slope on NE corner of refuse pile.
